Smith Group Property Inspections

Property Inspection Report

12223 Kingslake Forest Dr, Houston, TX 77044
Inspection prepared for: Edwin Jimenez

Date of Inspection: 04/05/2023 Time: 8:00AM
Age of Home: 1980 Size: 1248 sqft

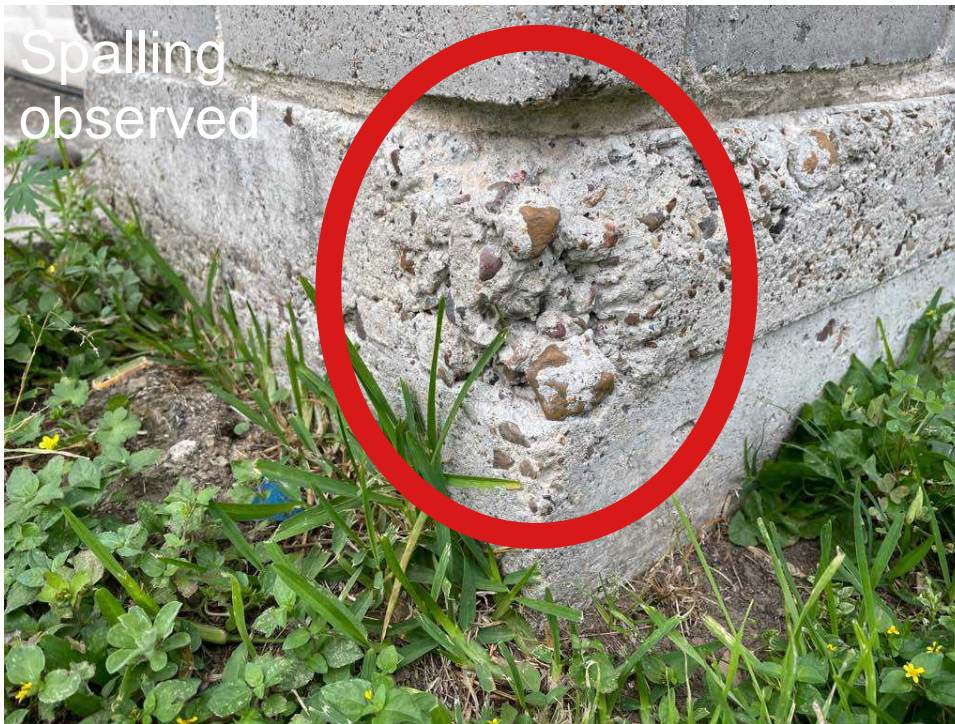
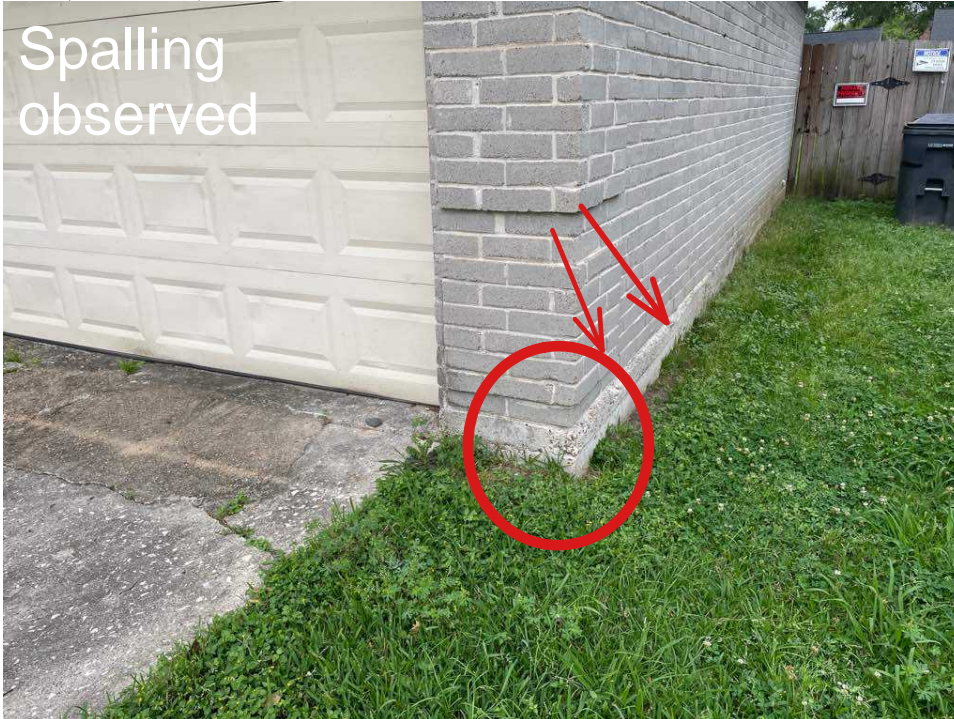
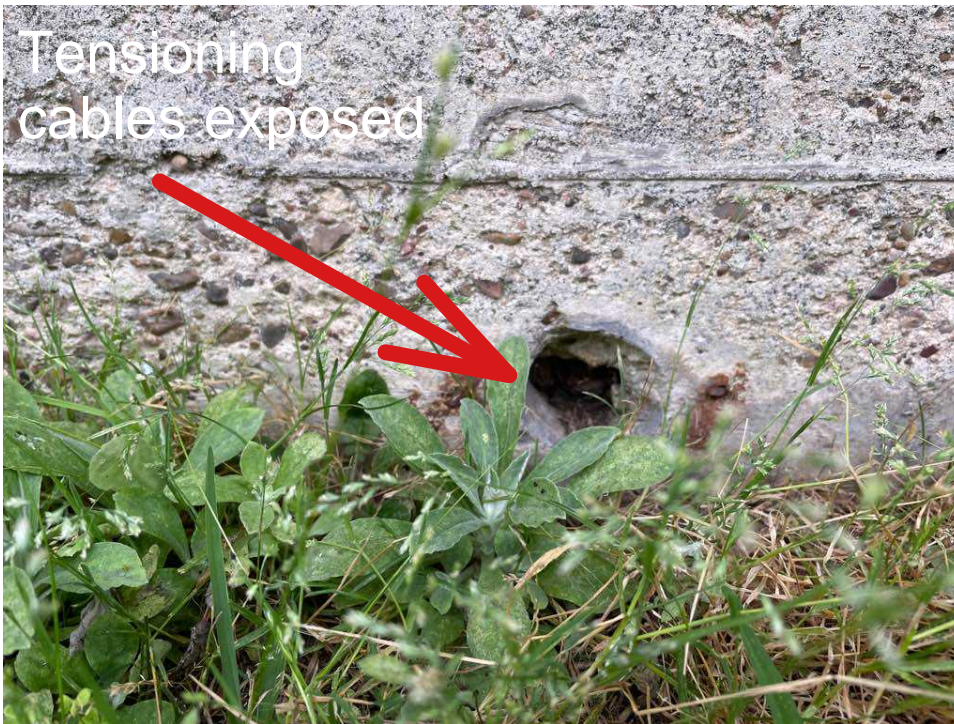
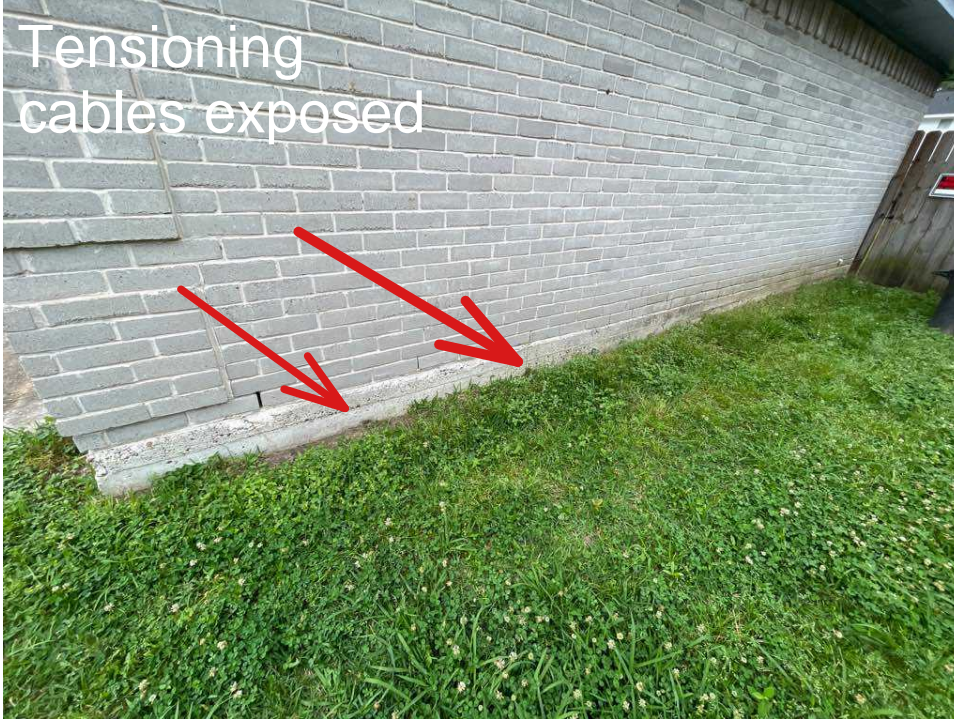
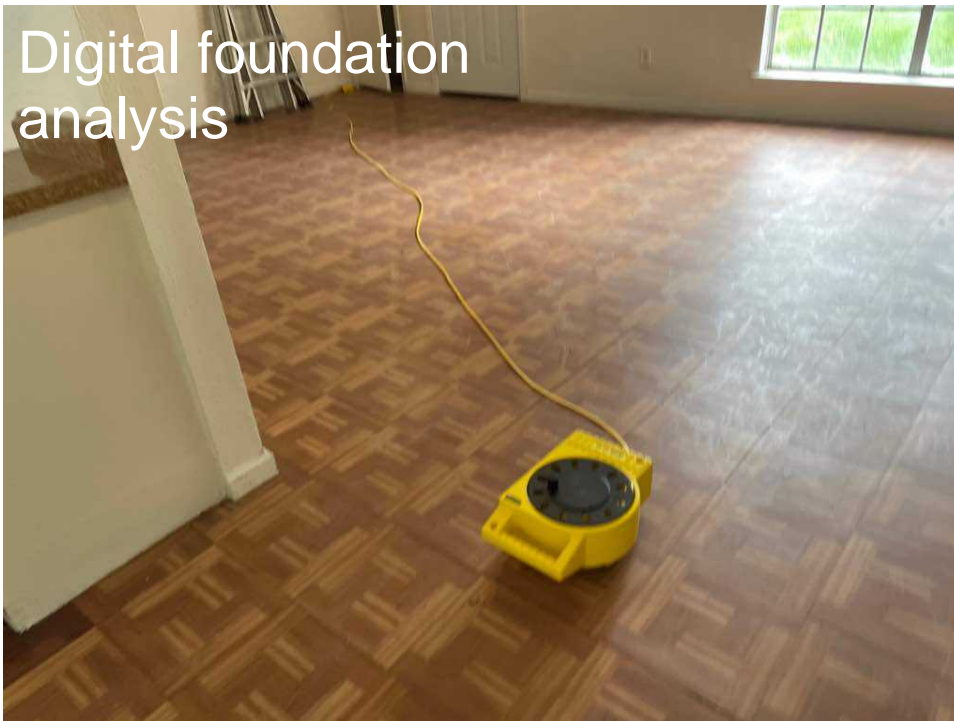
1. Corner fractures were noted on the corner(s) of the foundation, these are usually considered cosmetic nature unless other movement is noted.

2. Tensioning cables exposed at foundation in multiple locations.

Exposed tensioning cables can possibly allow moisture / pest intrusion.

Recommend sealing all cracks to help prevent further deterioration.

Correction recommended by qualified contractor.

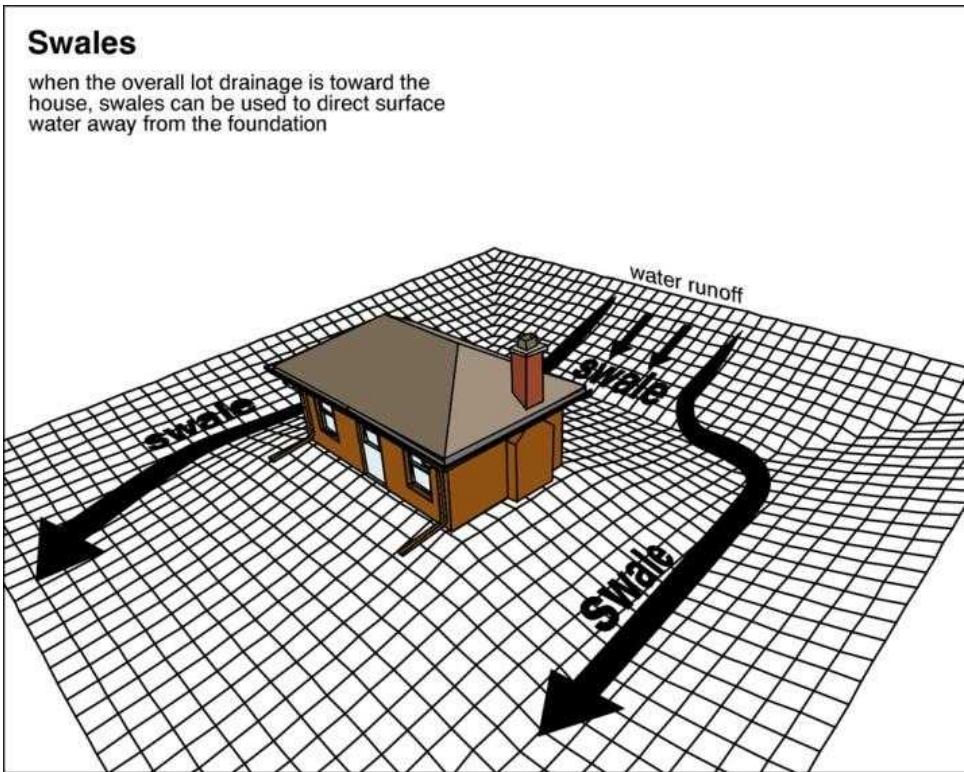
Comments: Moderate slope,
Soil / mulch too high at foundation (multiple).

Soil (or mulch) too high at foundation can potentially promote pest intrusion.

It is recommended that at least 4 of foundation be visible.

Correction recommended by qualified contractor.

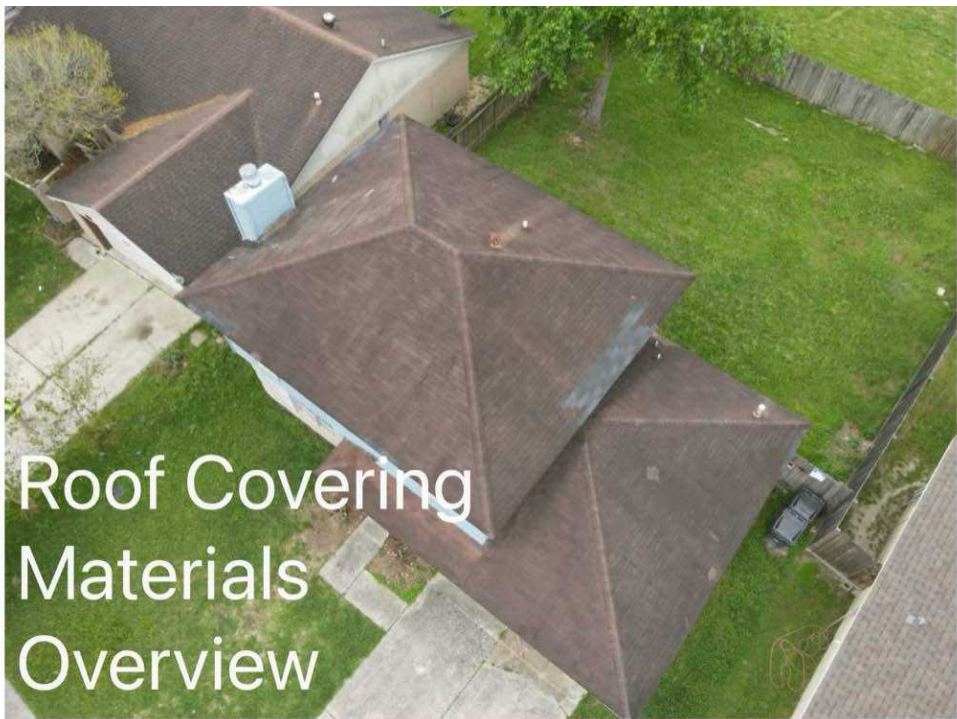
1. Observed missing / damaged shingles and prior repair.

2. Observed unpainted roof vents.

3. Observed missing saddle / cricket at chimney and roof interface.

Further evaluation and correction recommended by a qualified contractor.

Roof vents should be painted to minimize UV damage to PVC vents

Correction recommended by qualified contractor

Correction recommended by a qualified contractor to prevent water intrusion.

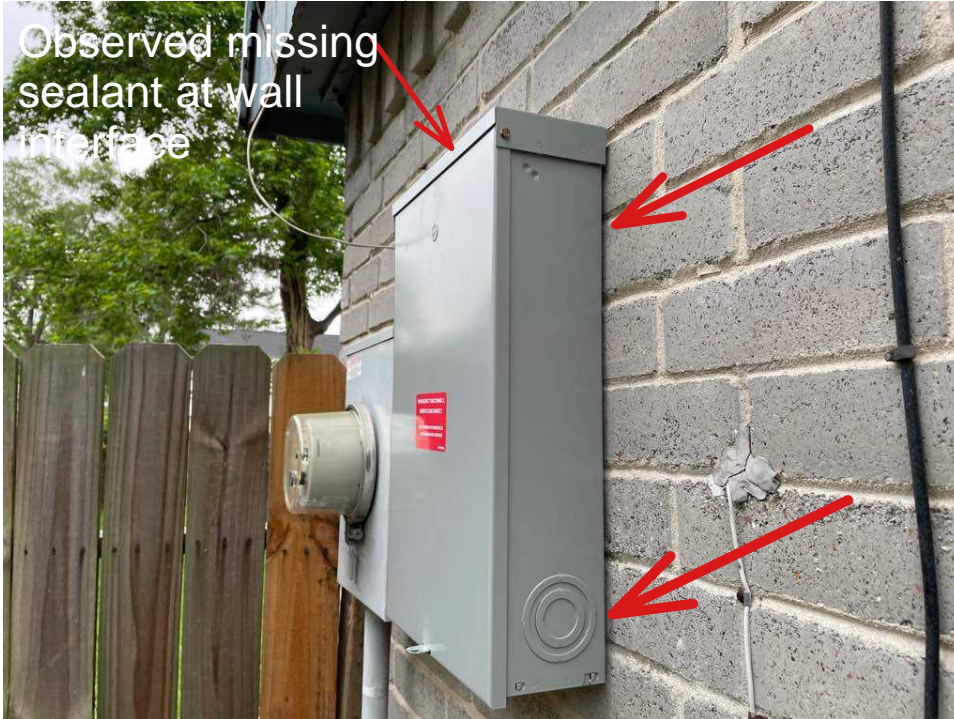
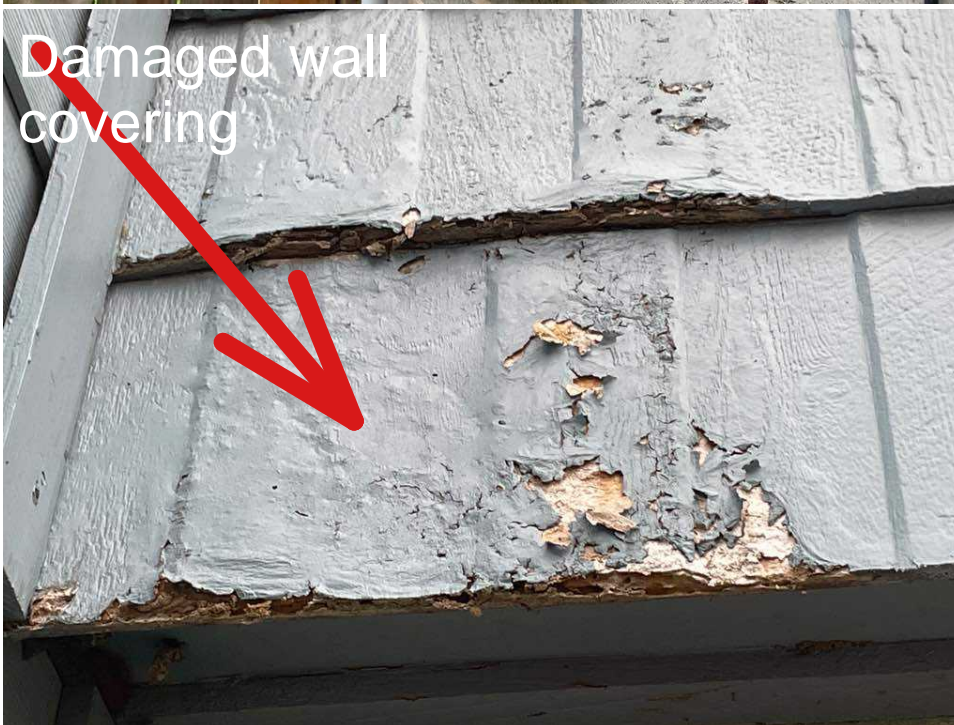
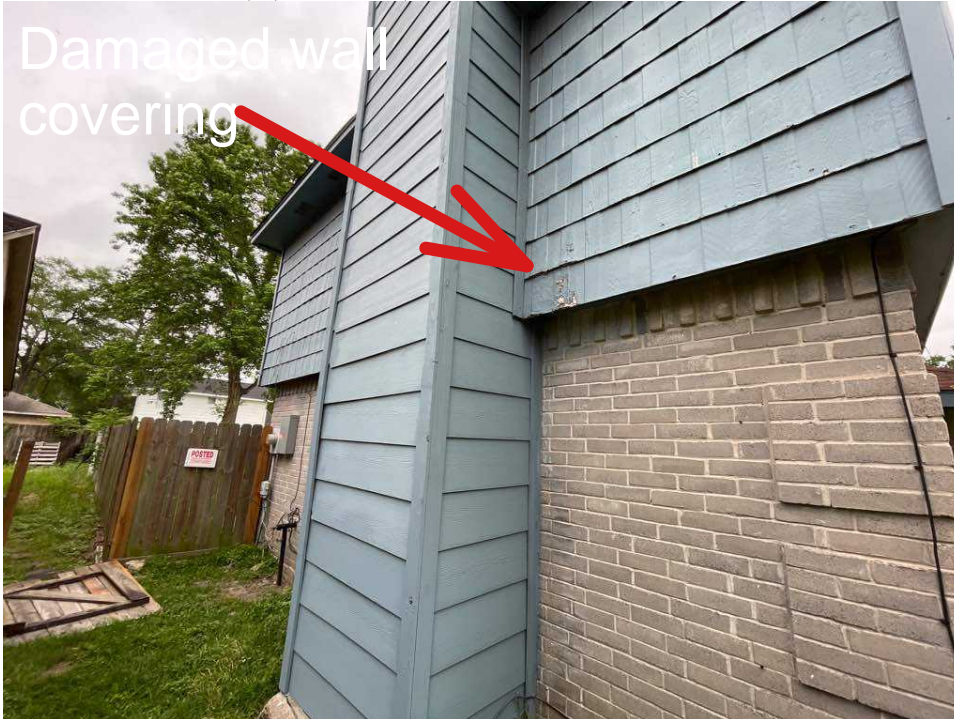
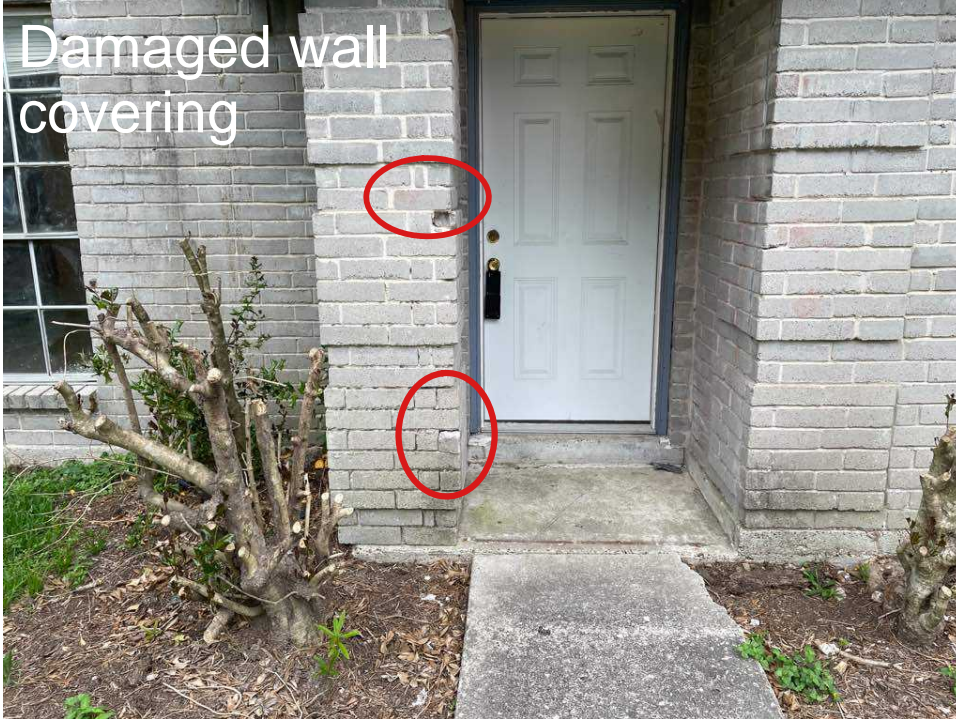
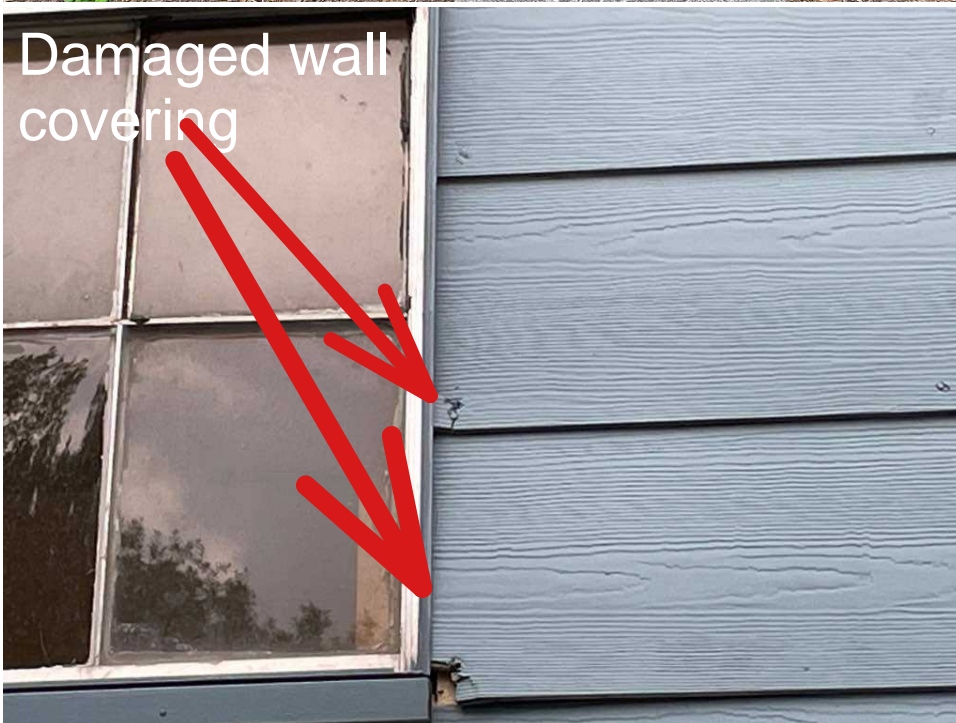
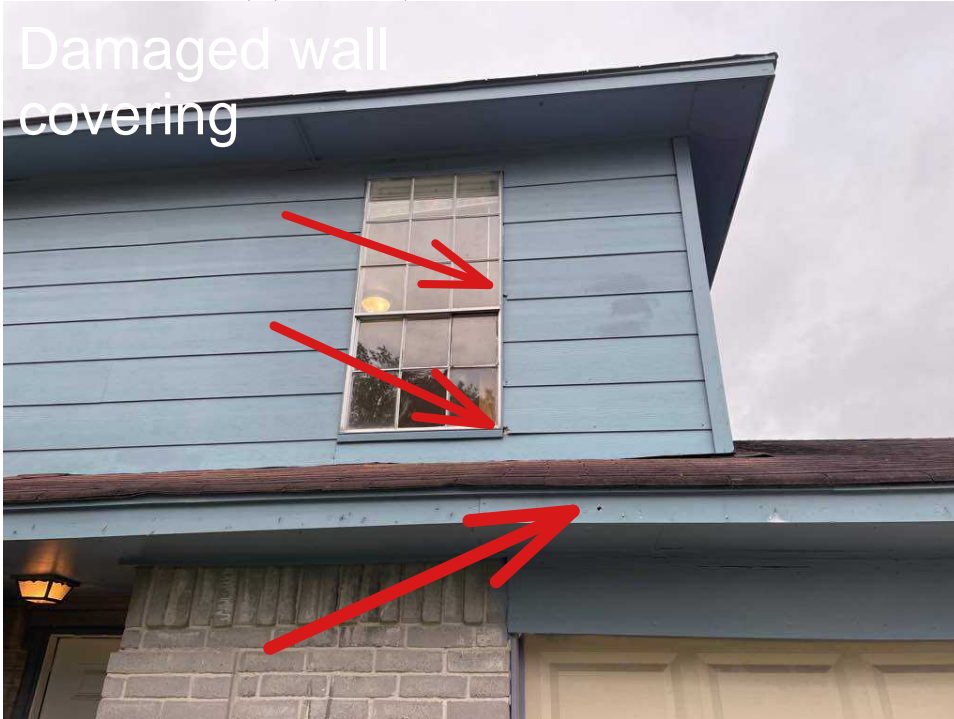
1. Observed missing sealant at wall interface with multiple fixtures (not weathertight).

2. Damaged wall covering (exterior) observed.

3. Missing / damaged soffit board (multiple sides of home).

4. Observed organic growth in garage.

5. Damaged wall covering (interior) observed.

Correction recommended by qualified contractor to minimize possible moisture / pest intrusion

Correction recommended to minimize possibility of moisture / pest intrusion.

Correction recommended to avoid future moisture penetration.

Correction recommended by a qualified contractor.

Correction recommended to avoid further deterioration of wall coverings.

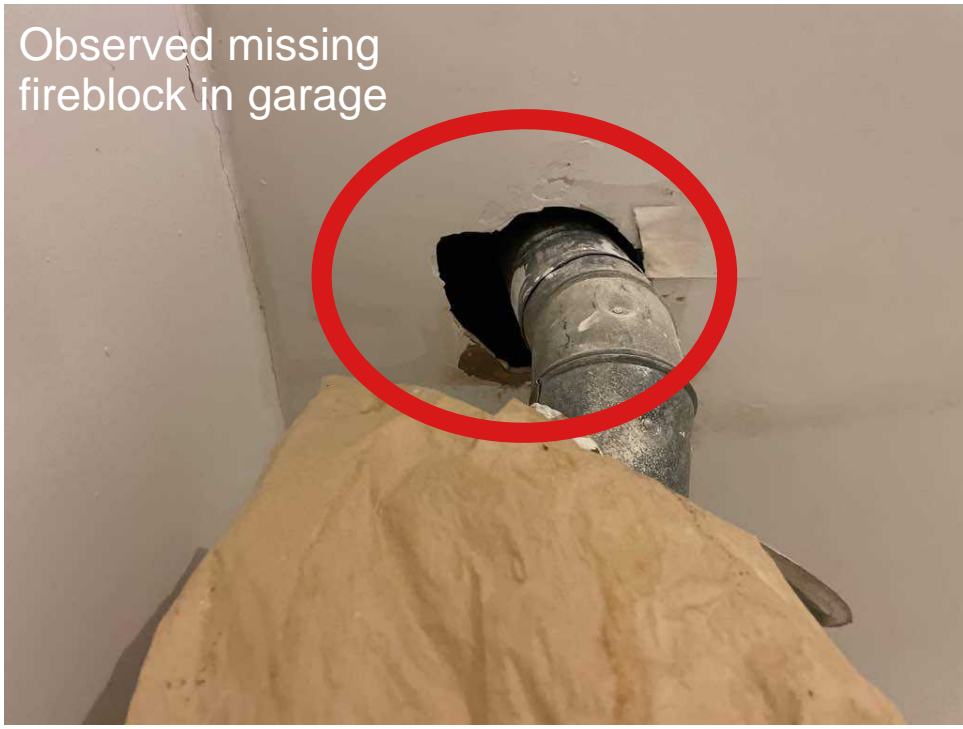
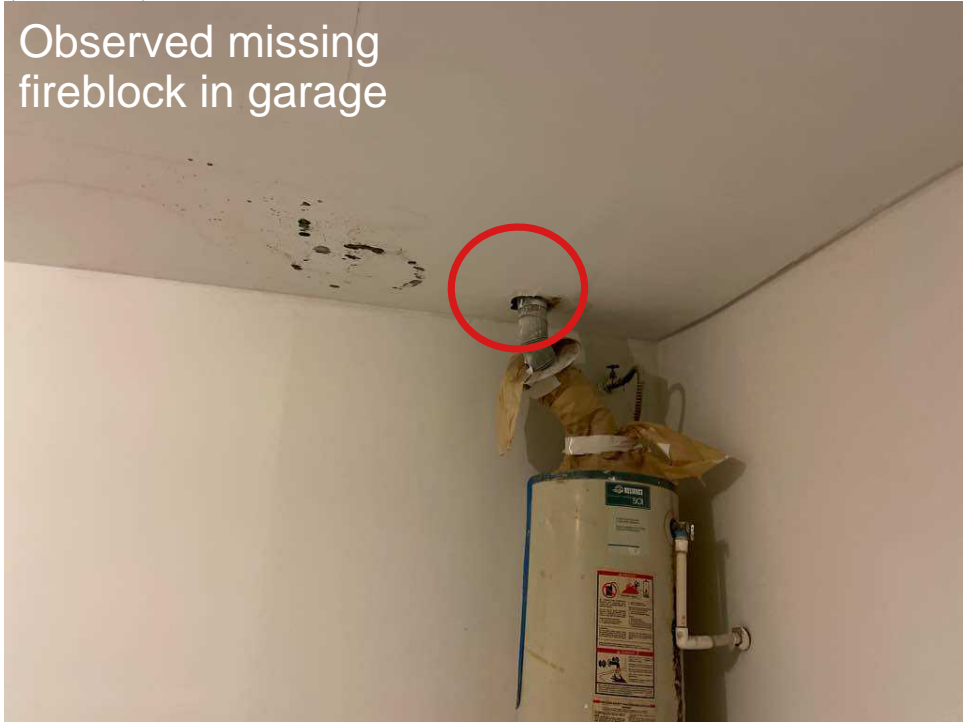
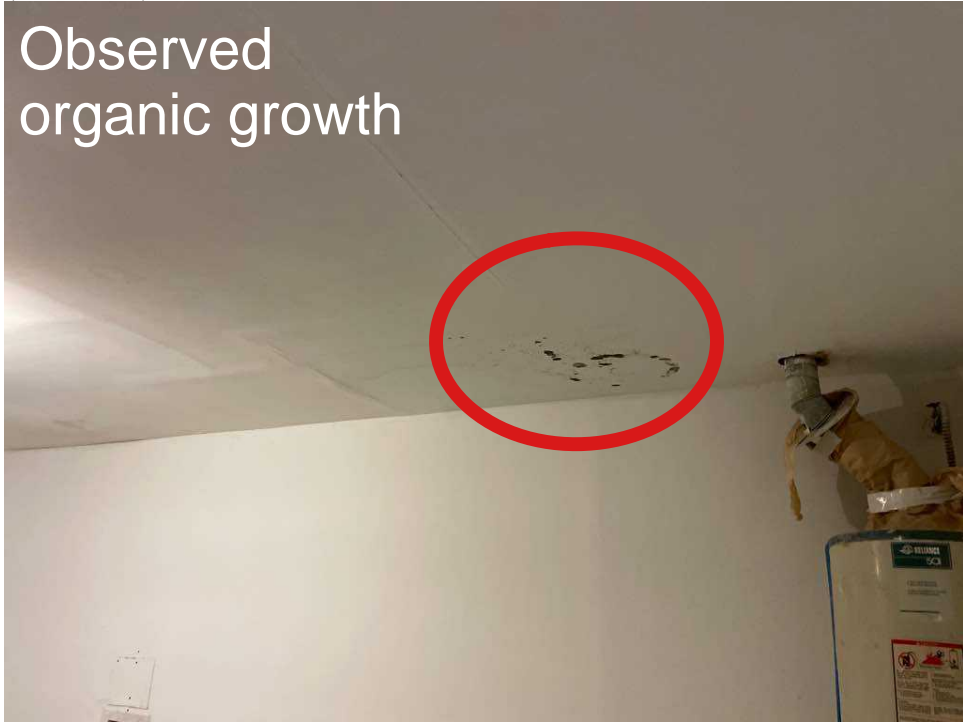
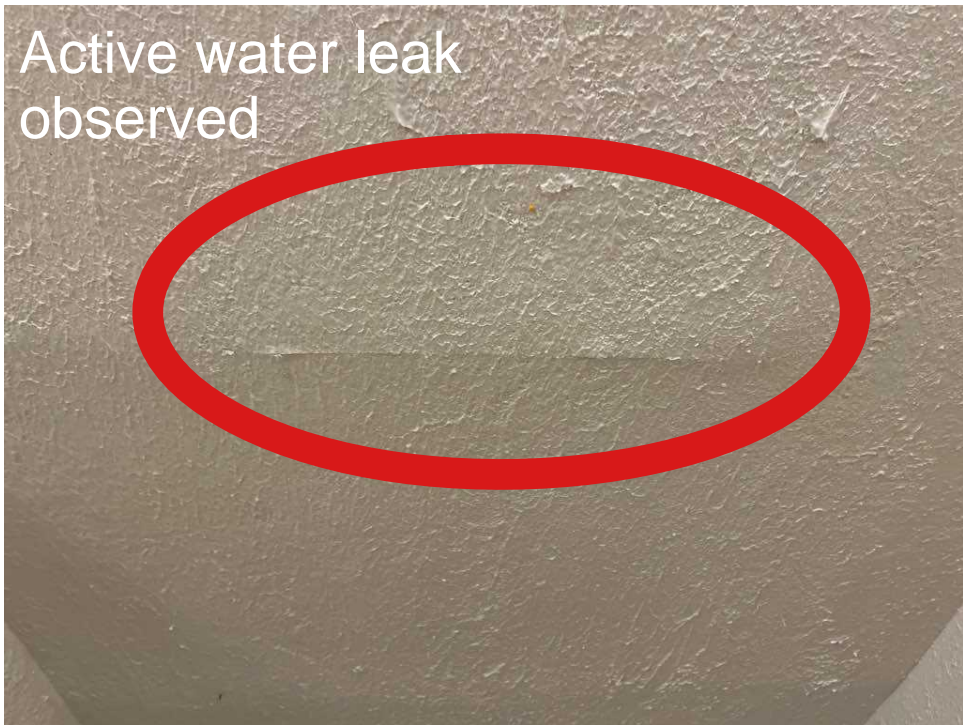
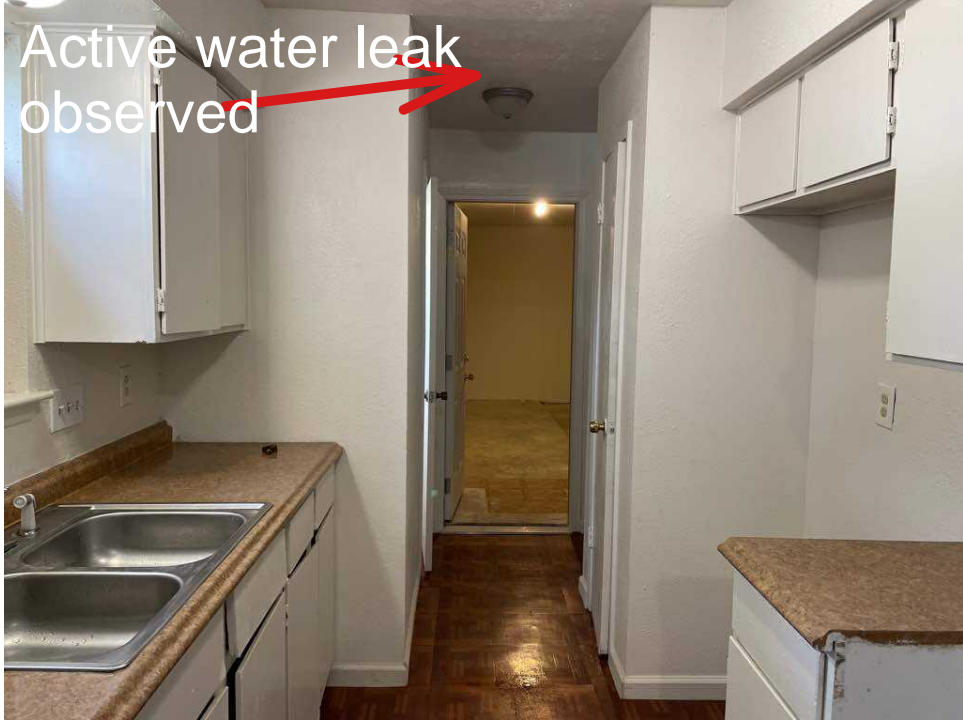
1. Observed missing fireblock in garage.

2. Observed organic growth.

3. Observe active water leak.

Correction recommended by qualified contractor to minimize fire spread possibility (in emergency situation).

Correction recommended by a qualified contractor.

Further evaluation and correction recommended by a qualified contractor to prevent further damage.

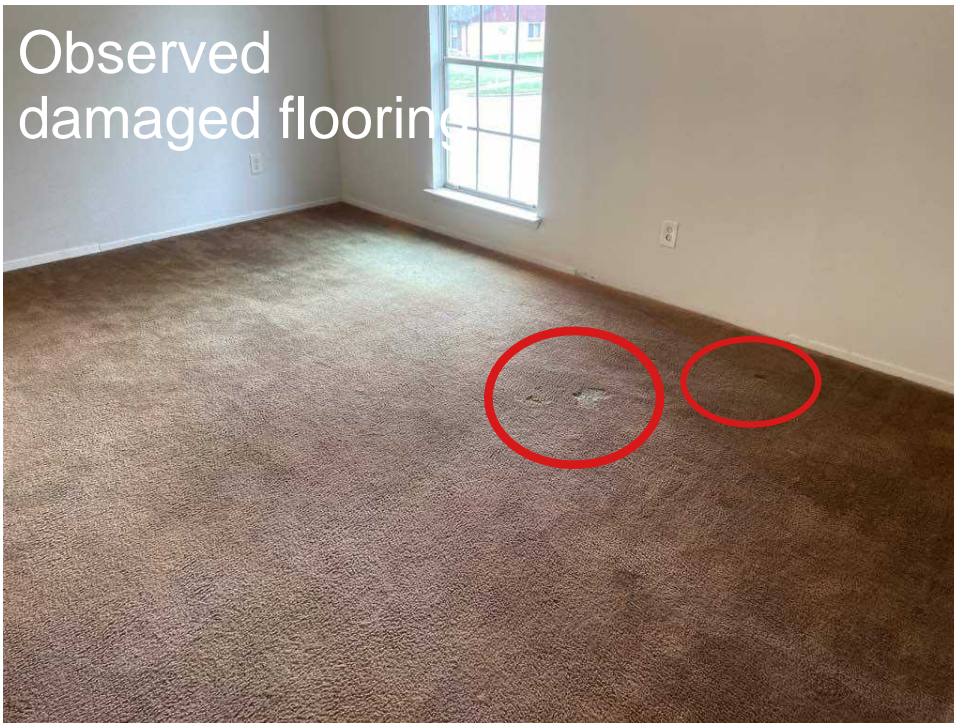
Comments: Laminate, Carpet,
1. Observed damaged flooring.

Further evaluation & correction recommended by qualified contractor.

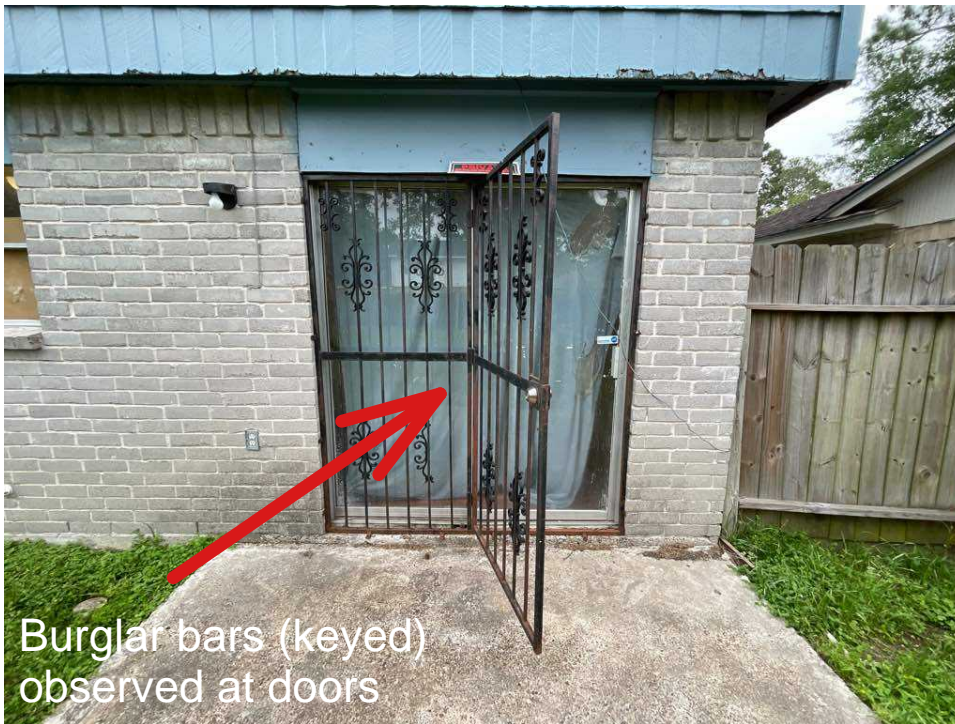
Man Door (attached garage)

1. Burglar bars (keyed) observed at doors.

2. Missing doorstop observed.

Further evaluation and correction recommended by qualified contractor.

Correction recommended by qualified contractor to avoid wall damage.

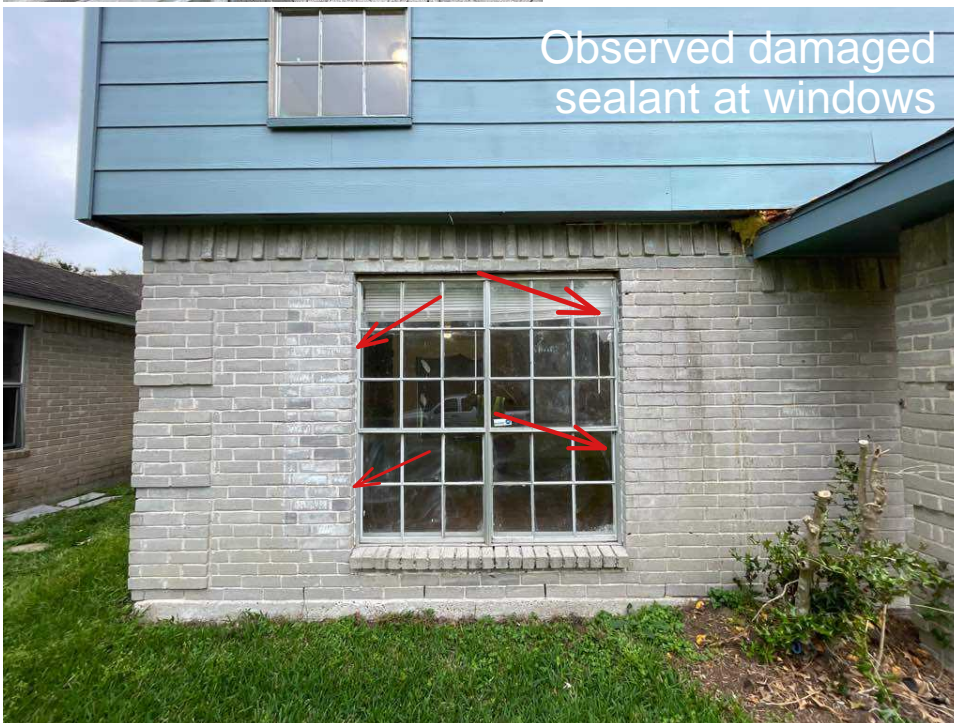
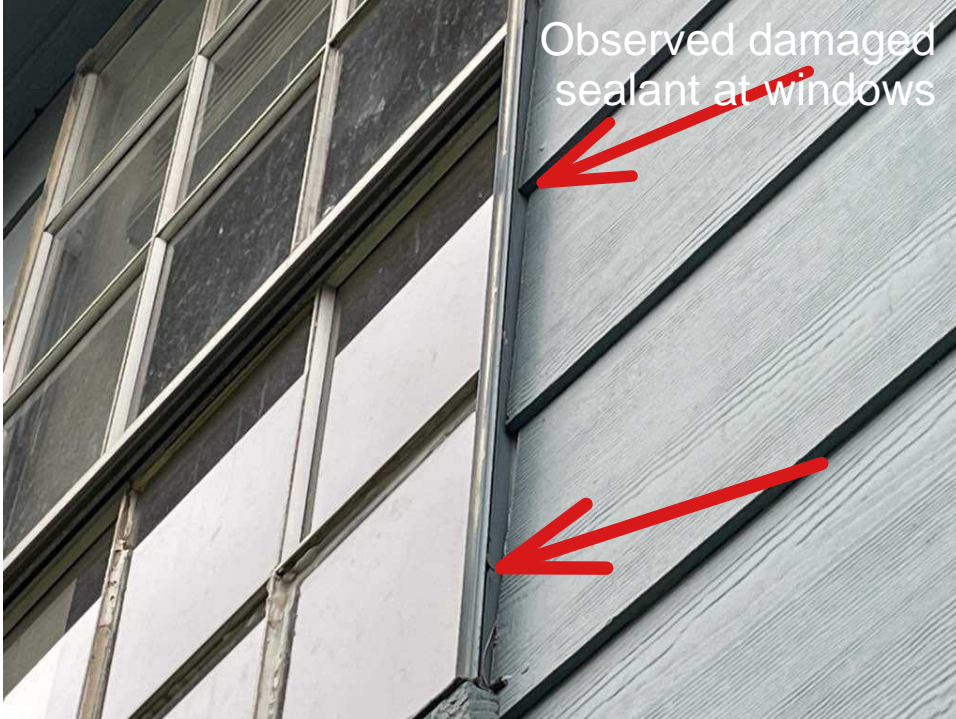
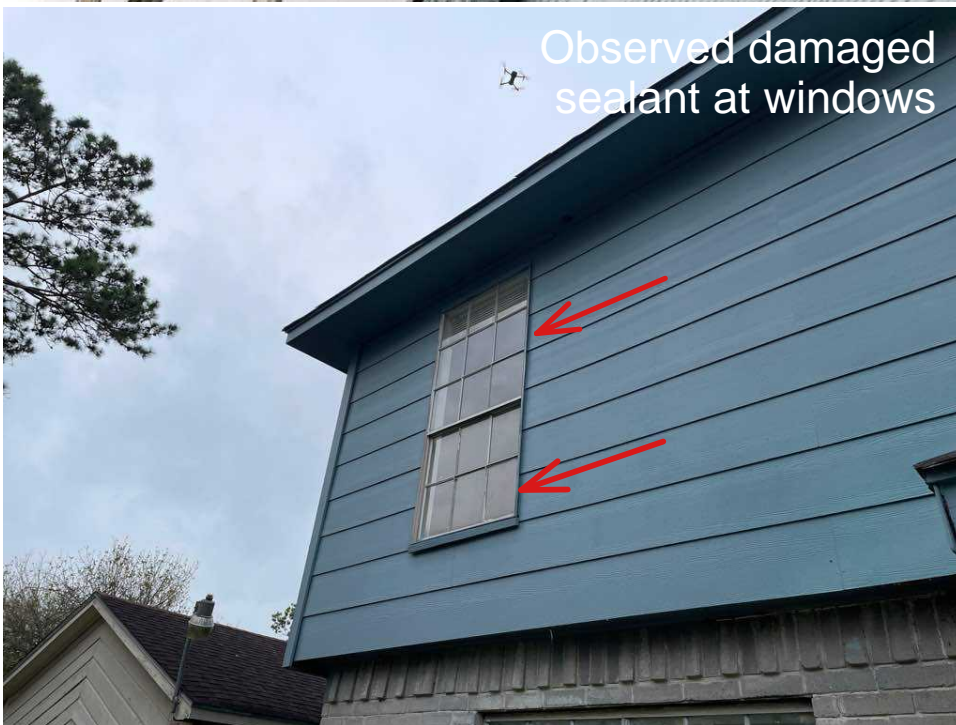
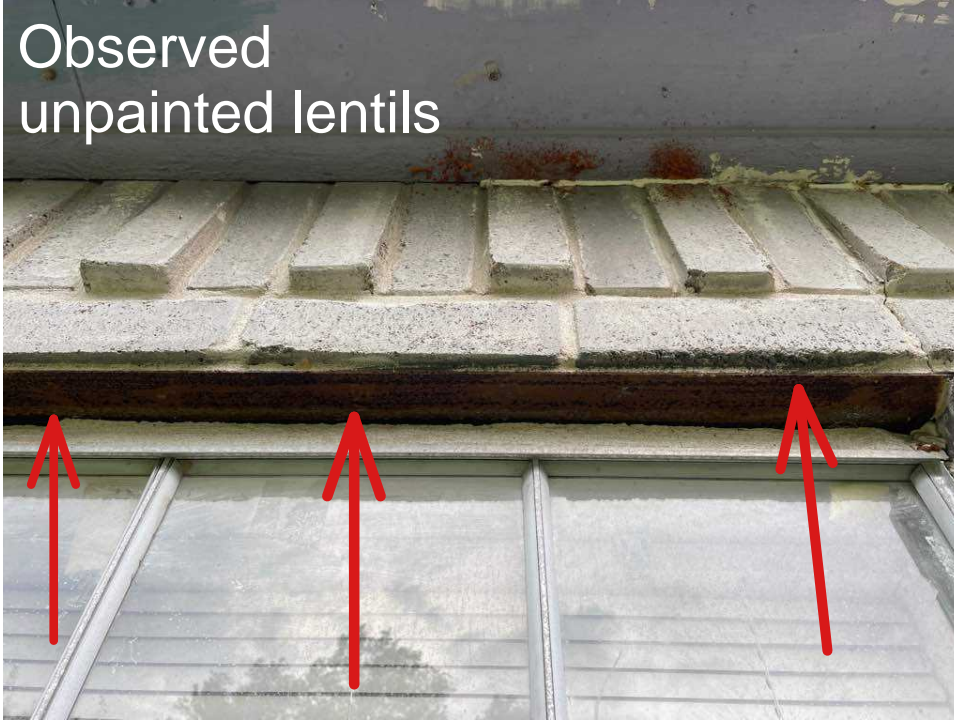
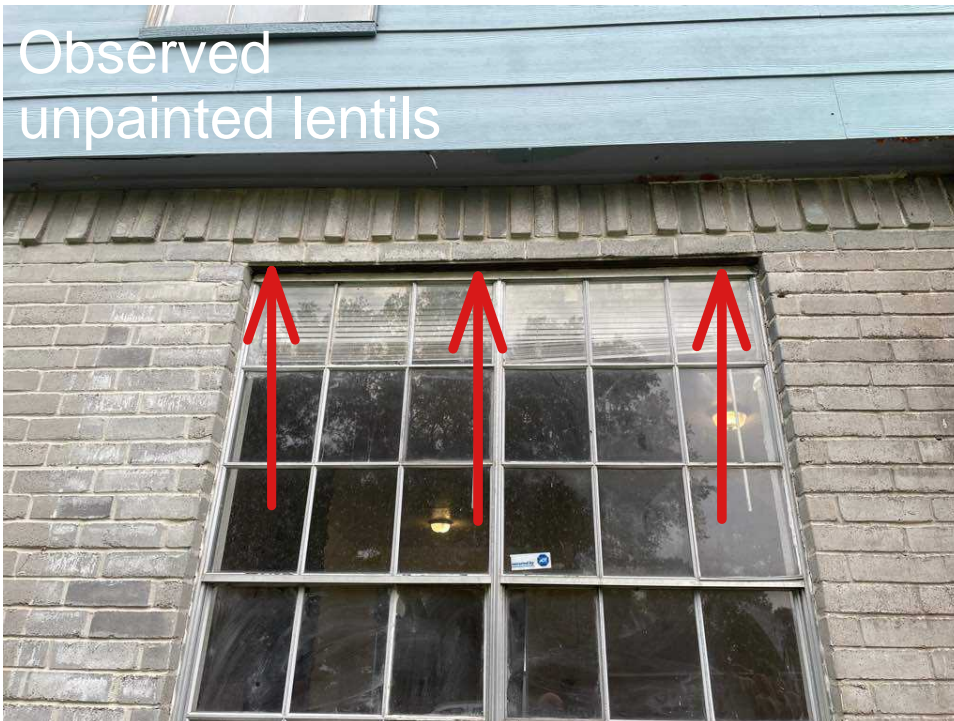
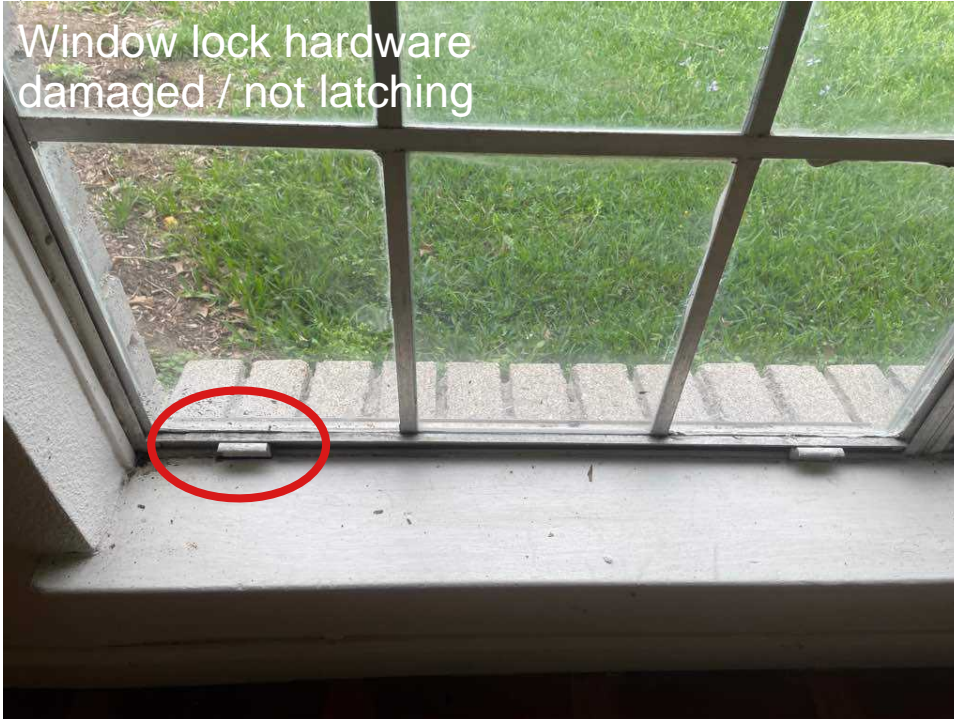
- 1. Observed damaged sealant at windows

- 2. Observed unpainted lentils above windows.

- 3. Window lock hardware damaged / not latching (multiple windows).

- 4. Observed safety glass not installed on multiple windows (safety hazard).

Windows with sill heights less than 18 from finished floor elevation - safety glass with a tempered stamp should be installed in all hazardous locations, such as:

Correction recommended to minimize possible moisture intrusion

Correction recommended by a qualified contractor to prevent wall covering damage and premature failure of lentil.

Correction recommended by qualified contractor.

Further evaluation and correction recommended by qualified contractor.

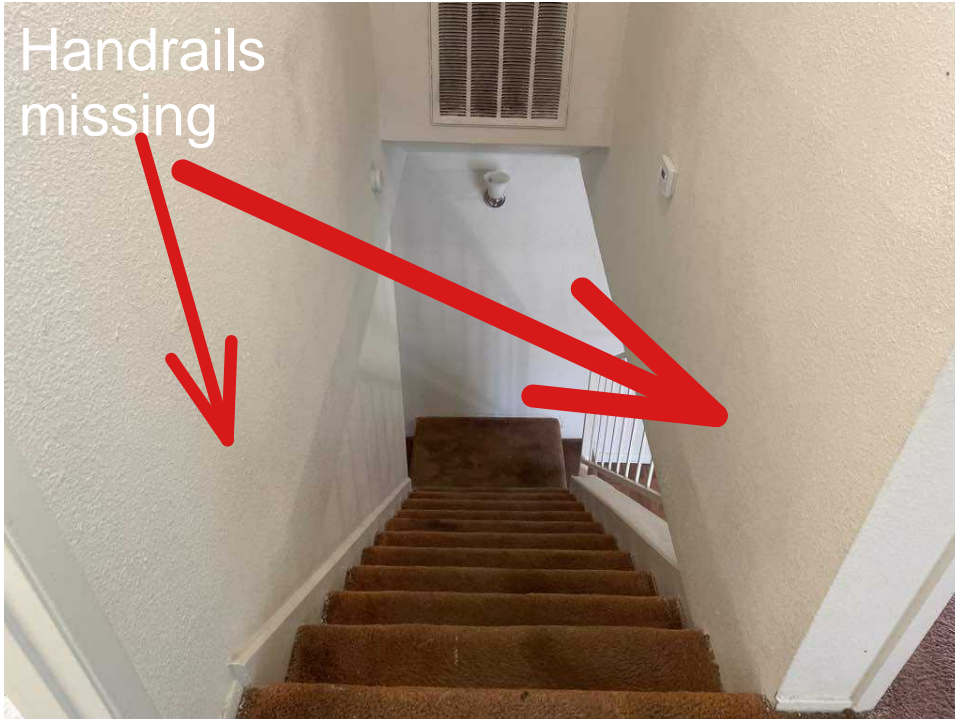
Comments: Wood stairs with metal handrails,
Handrails missing (Safety)

Correction recommended by qualified contractor.

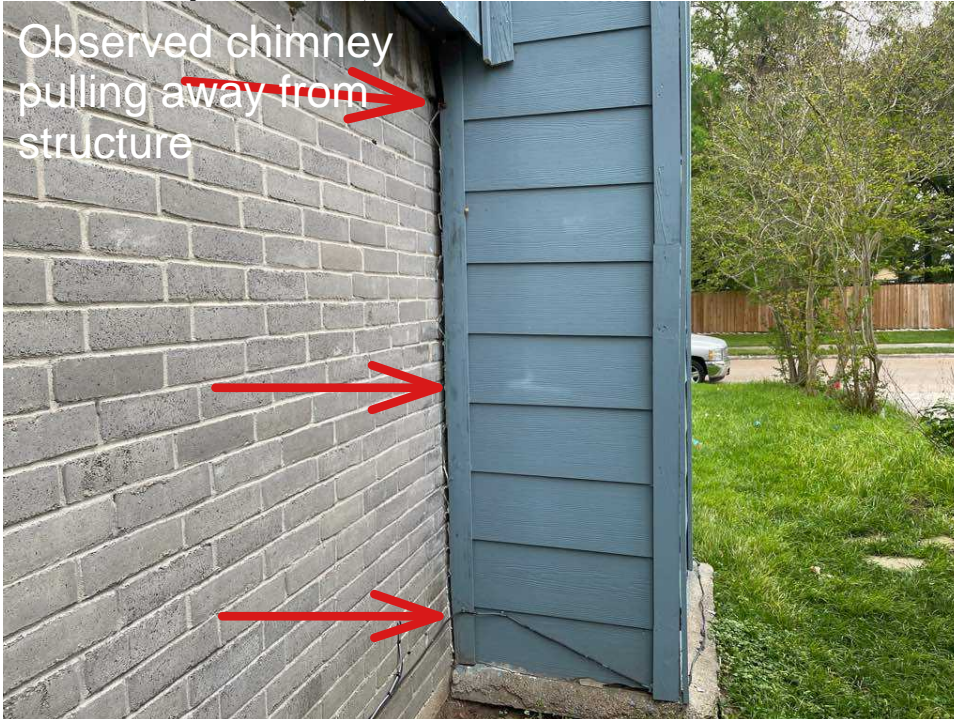
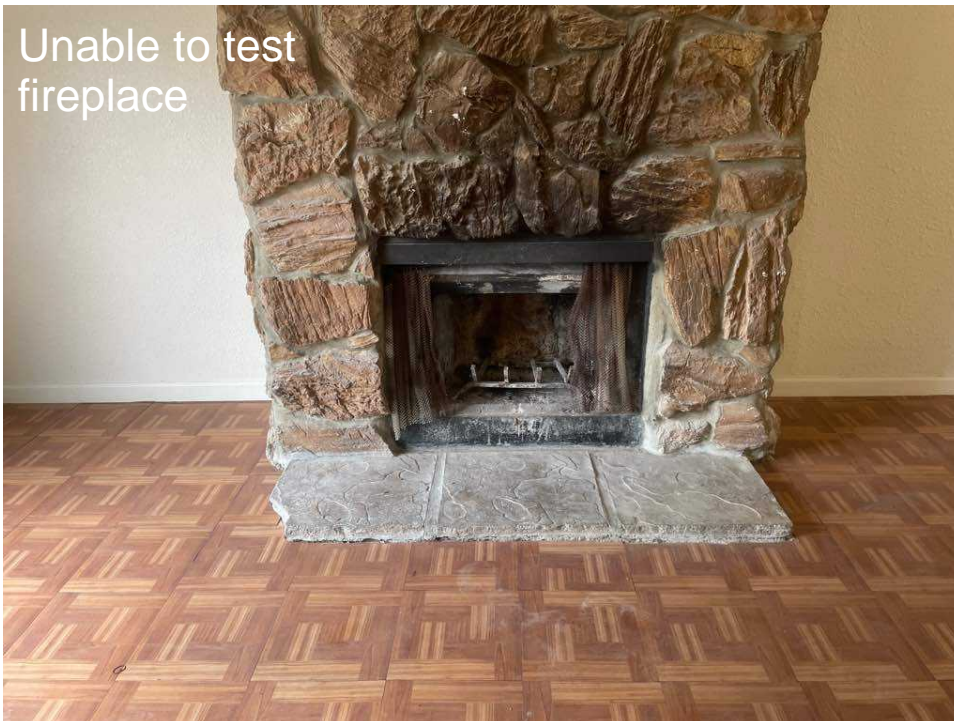
1. Observed chimney pulling away from structure.

Further evaluation and correction recommended by a qualified contractor to prevent further damage, pest intrusion, and water intrusion .

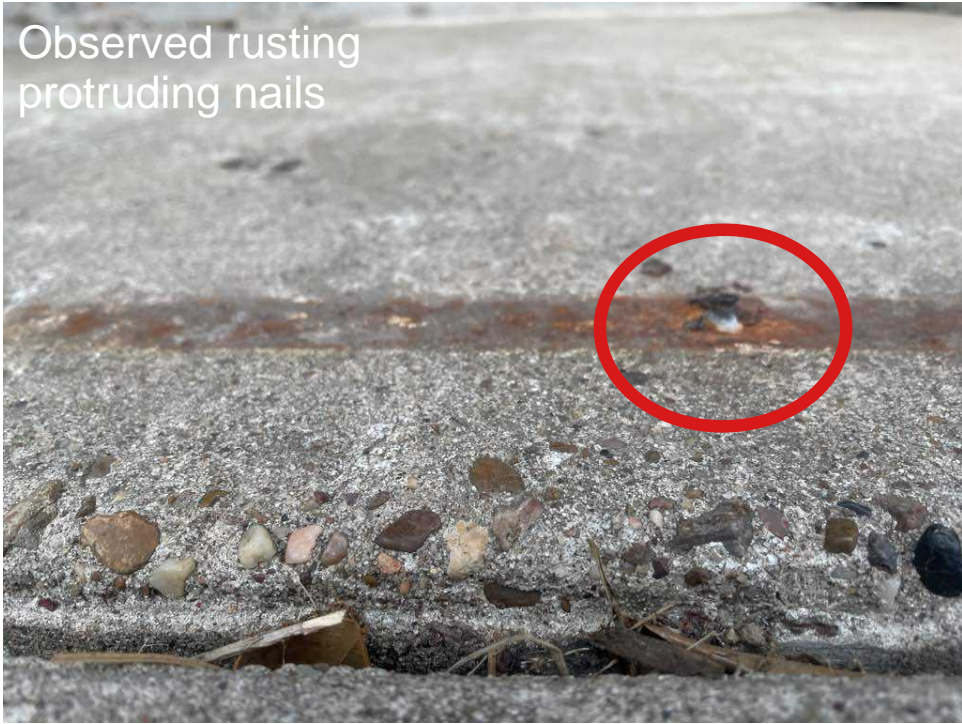
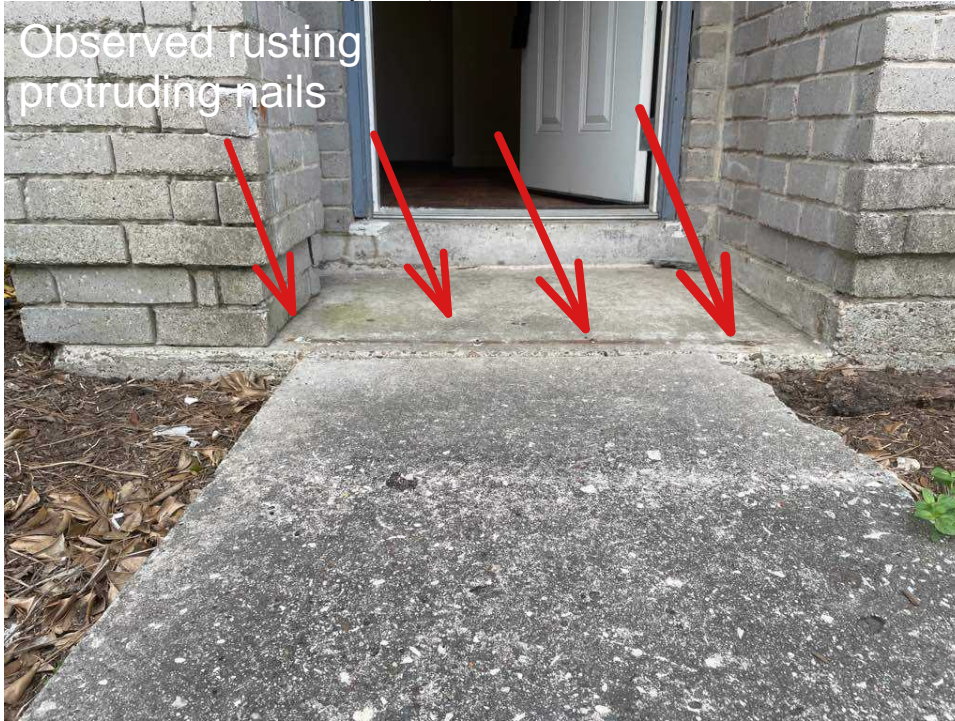
Comments: Wood,
Observed rusting protruding nails from walking surface (safety issue).

Correction recommended by a qualified contractor.

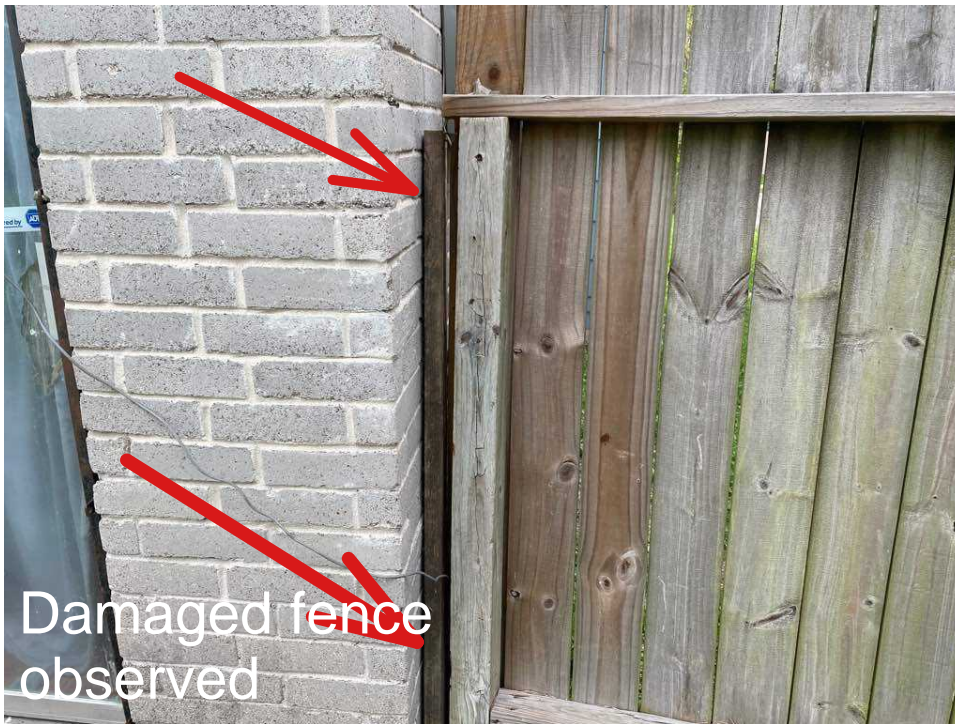
Comments: Wood Fence,
Damaged fence observed

Correction recommended by qualified contractor
