Smith Group Property Inspections

Property Inspection Report

12223 Kingslake Forest Dr, Houston, TX 77044
Inspection prepared for: Edwin Jimenez

Date of Inspection: 04/05/2023 Time: 8:00AM
Age of Home: 1980 Size: 1248 sqft

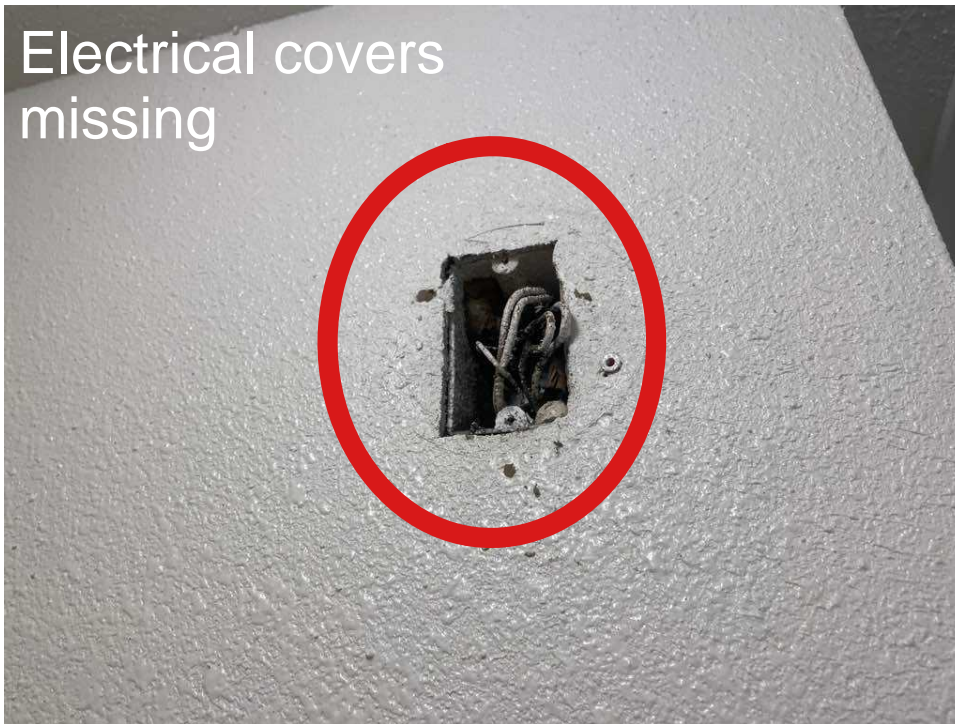
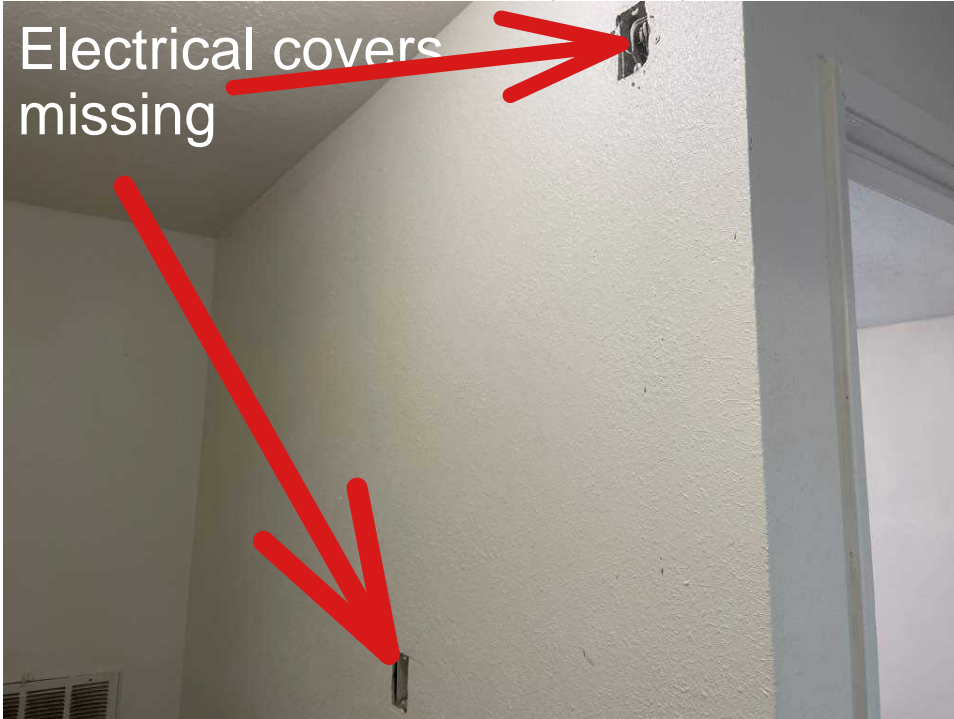
2. Observed electrical connections not made in junction box - safety item.

Correction recommended by qualified contractor

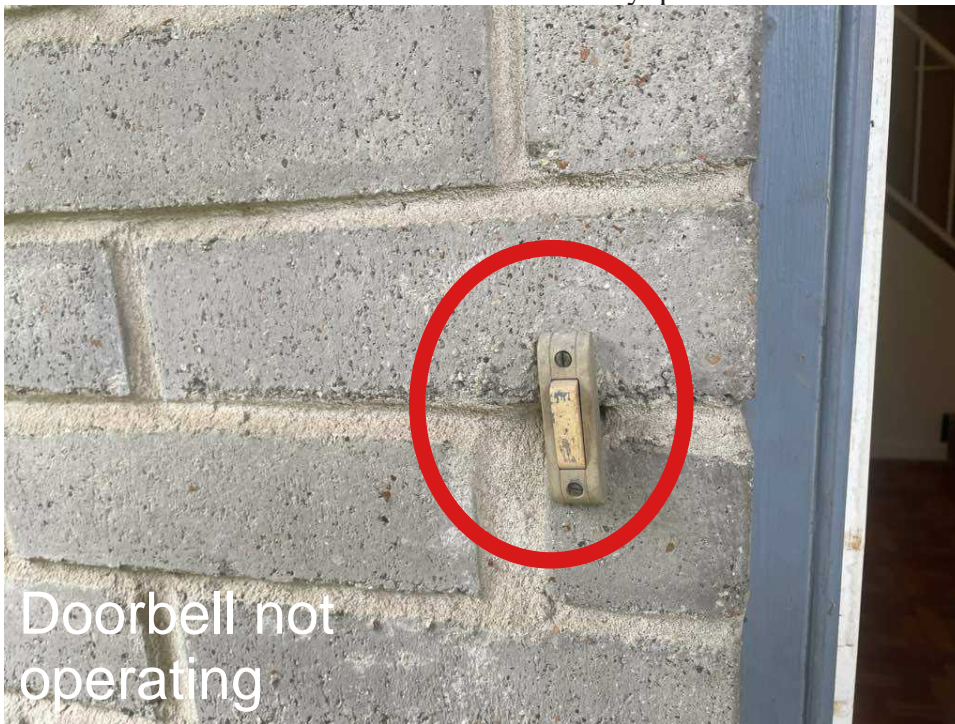
Comments: Exterior (front entrance to property),
Doorbell not operating at time of inspection.

Further evaluation & correction recommended by qualified contractor.

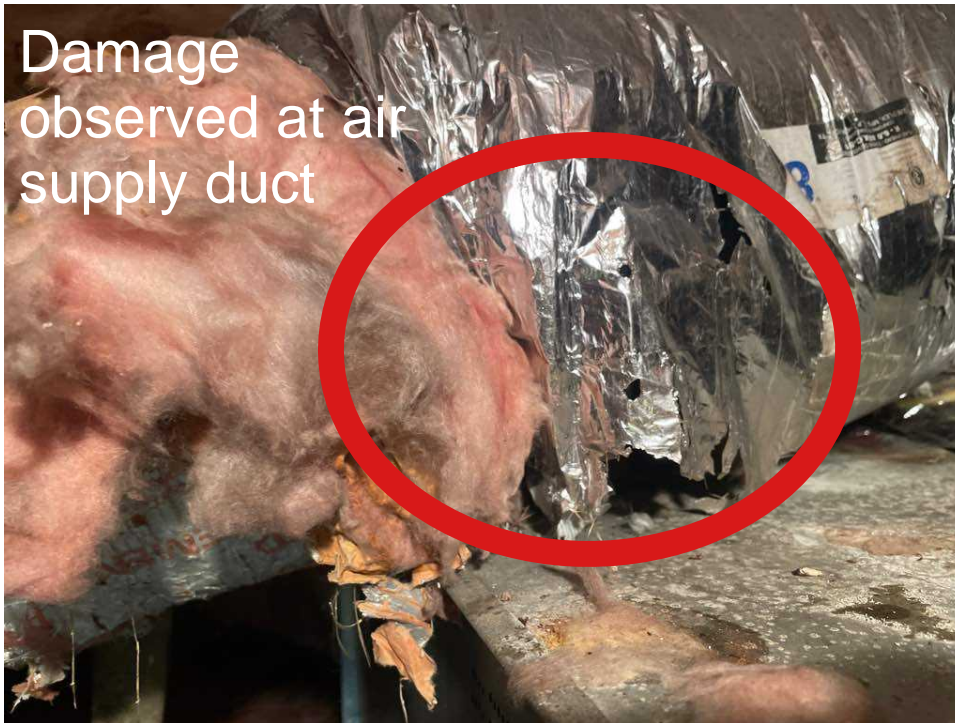
1. Damage observed at air supply duct in the attic.

Correction recommended by qualified contractor.

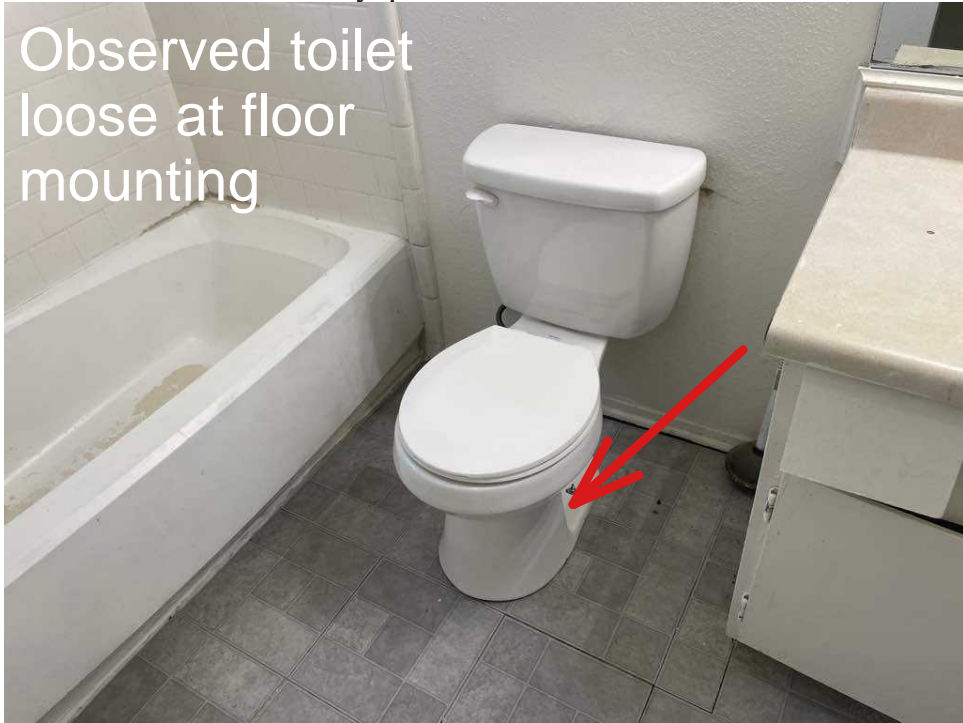
2. Toilets not sealed completely at floor interface (multiple).

Correction recommended by qualified contractor

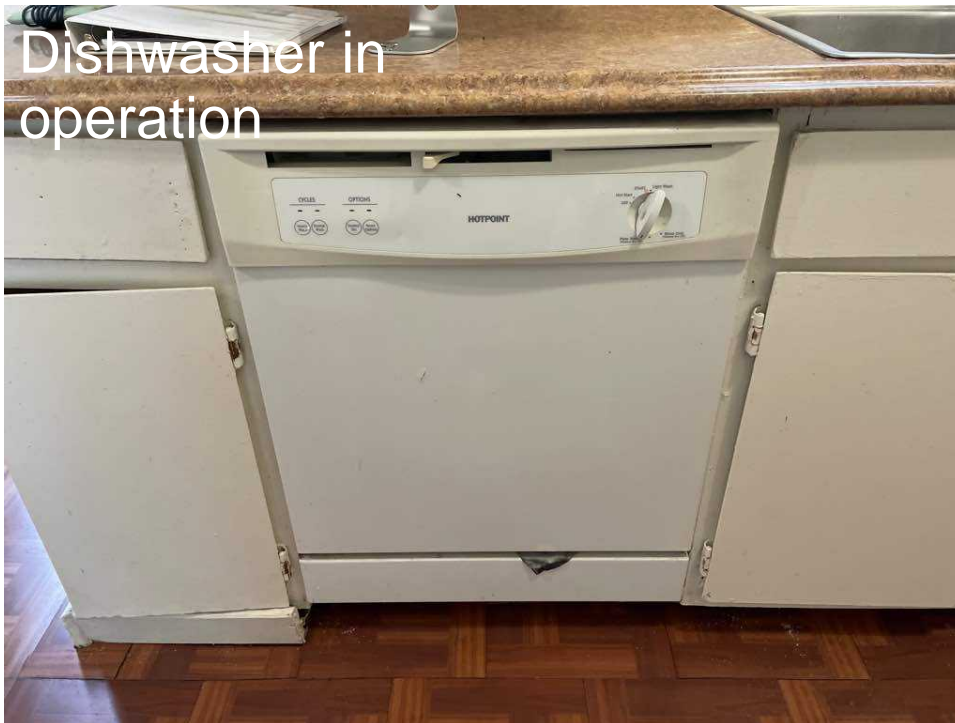
Comments: Hotpoint,
Standing water observed in dishwasher

Further evaluation and correction recommended by qualified contractor

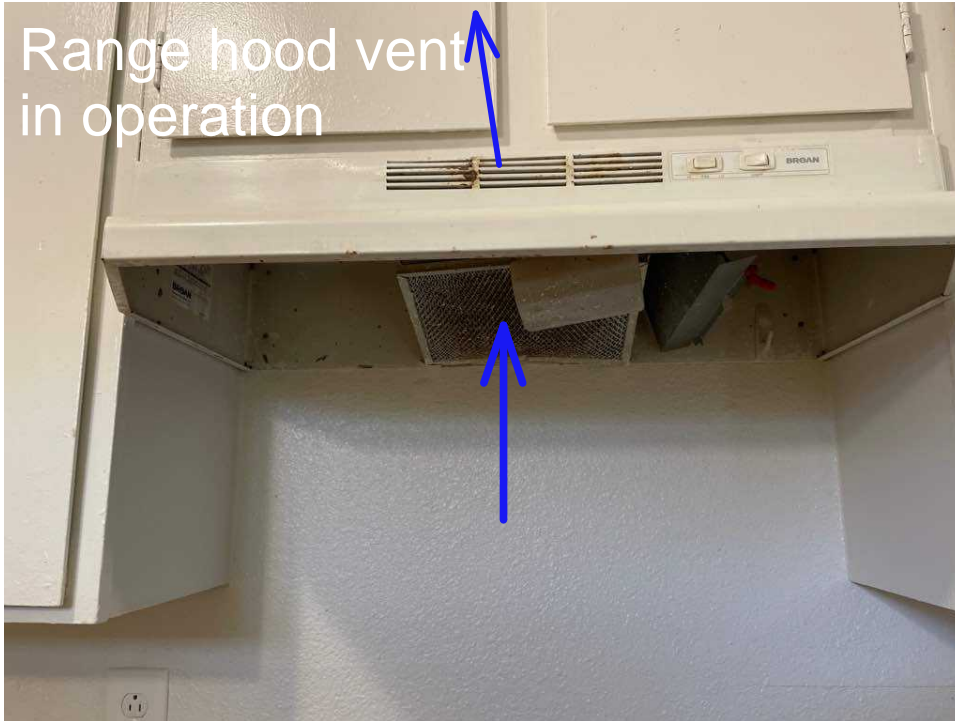
Comments: Broan,
Range hood exhaust vent did not operate at time of inspection.

Correction recommended by qualified contractor.

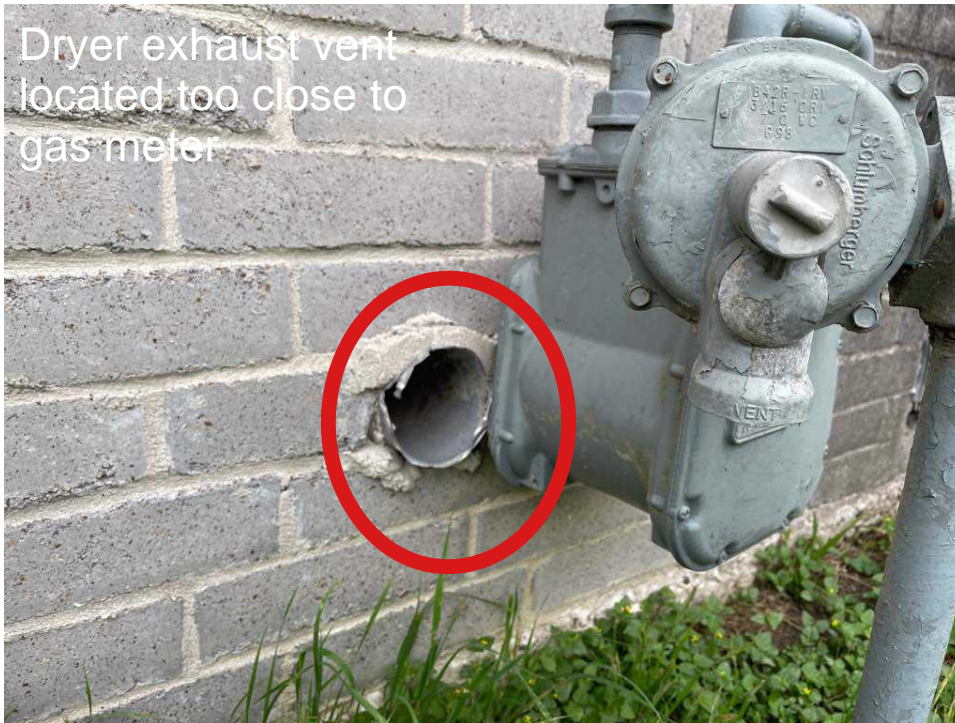
2. Dryer exhaust vent cover (at exterior) not sealed / secured properly.

Correction recommended by qualified contractor to minimize potential of pest / moisture intrusion.
