Inspection Report

Property Address:
786 County Road 308
Cleveland Texas 77327

Lone Star Home Inspections PLLC

PROPERTY INSPECTION REPORT FORM

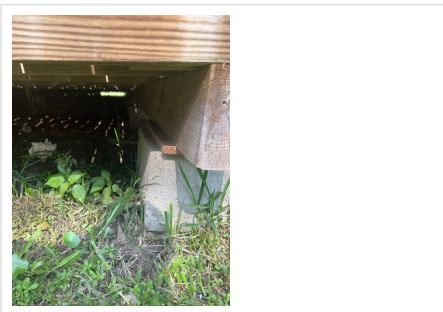
(2) Observed limited access to crawl space due to lack of headroom. Inspected crawl space from exterior portion of the foundation.

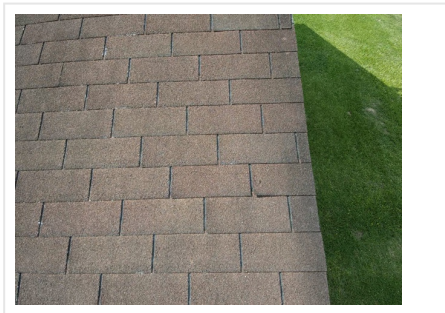
(4) Worn aggregate or gravel finish observed.

**** June 2023:
Roof replaced Coburn Roofing with 35
year shingles,**

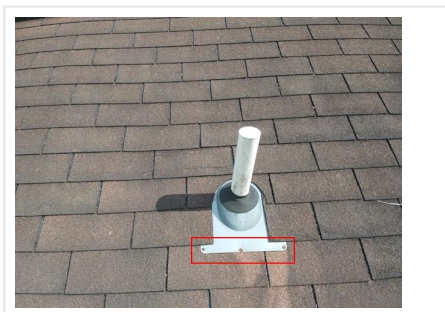
(5) Exposed nail heads were observed. Recommend caulking/sealing. Roof jack should be painted with UV protective paint to prevent premature deterioration.

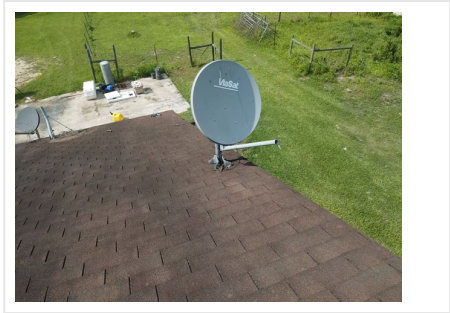
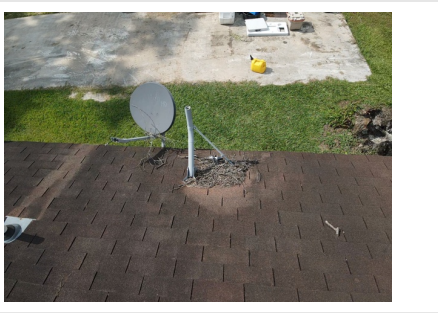
(6) Satellite dish mounted to roof surface. This presents the potential of roof leakage.

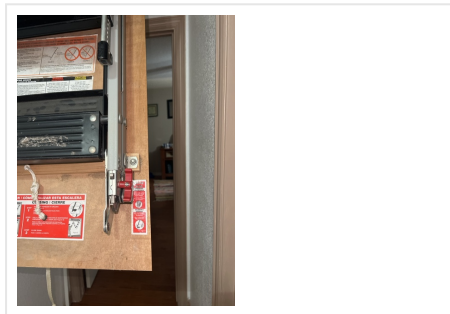
(2) Attic pulldown stairway is not weatherstripped.

****Weather stripping placed around attic door as required per inspection**

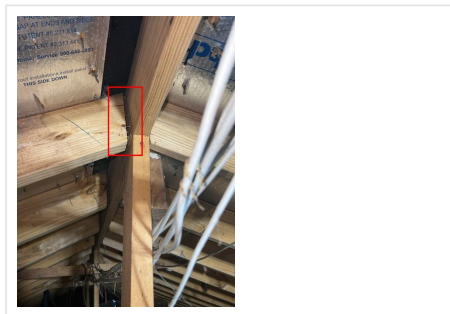
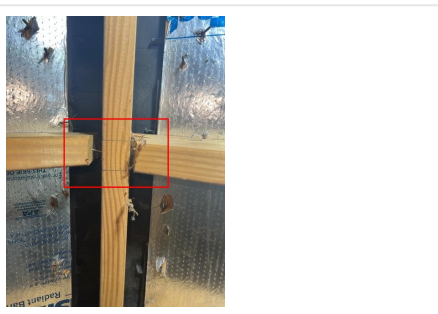
(3) Observed gaps between the rafter and ridge board.

**** June 2023
Repaired by Coburn roofing when roof replaced
Documentation available for review**

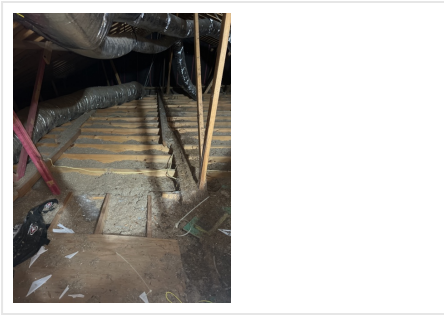
(4) Attic insulation level is well below the recommended 8" for cellulose.

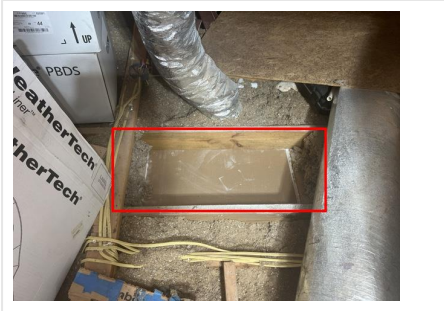
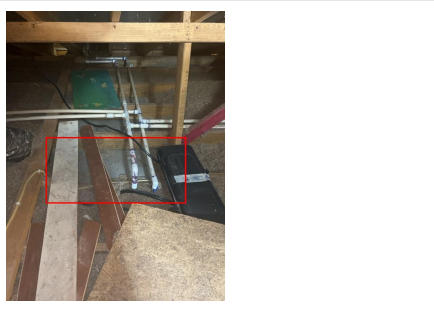
(5) Insulation is missing on attic floor at multiple locations.

****Fiberglass insulation replaced in deficient areas**

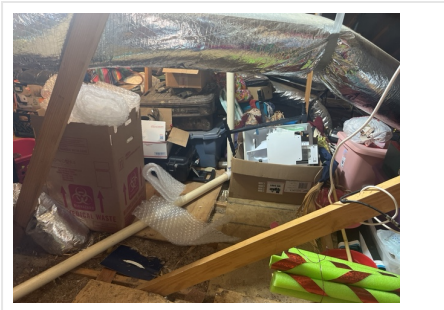
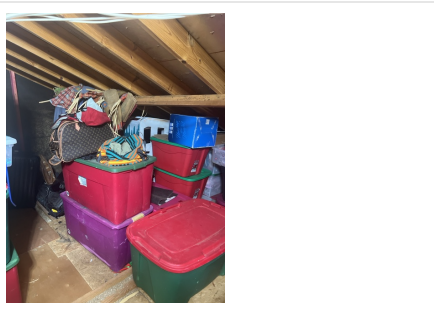
(6) Excess amount of debris was observed in attic. Not all areas of the attic were able to be visibly inspected.

****Attic was used as storage, all items will be removed at move out.**

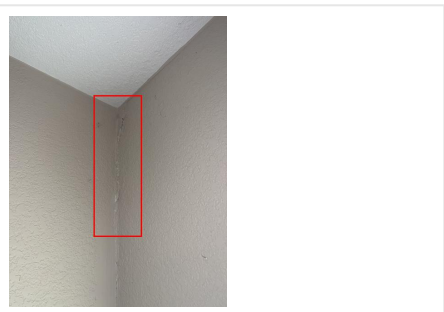
(2) Cracks in sheetrock observed at master bedroom.

****Cracks is from house being re-leveled, areas patched**

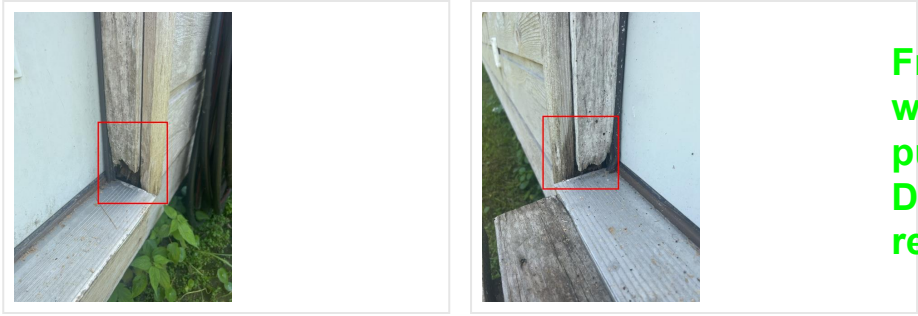
(3) Deteriorated or rotten wood observed at back door framing.

**French doors and surrounding wood replaced, door purchased at Lowes
Documentation available for review**

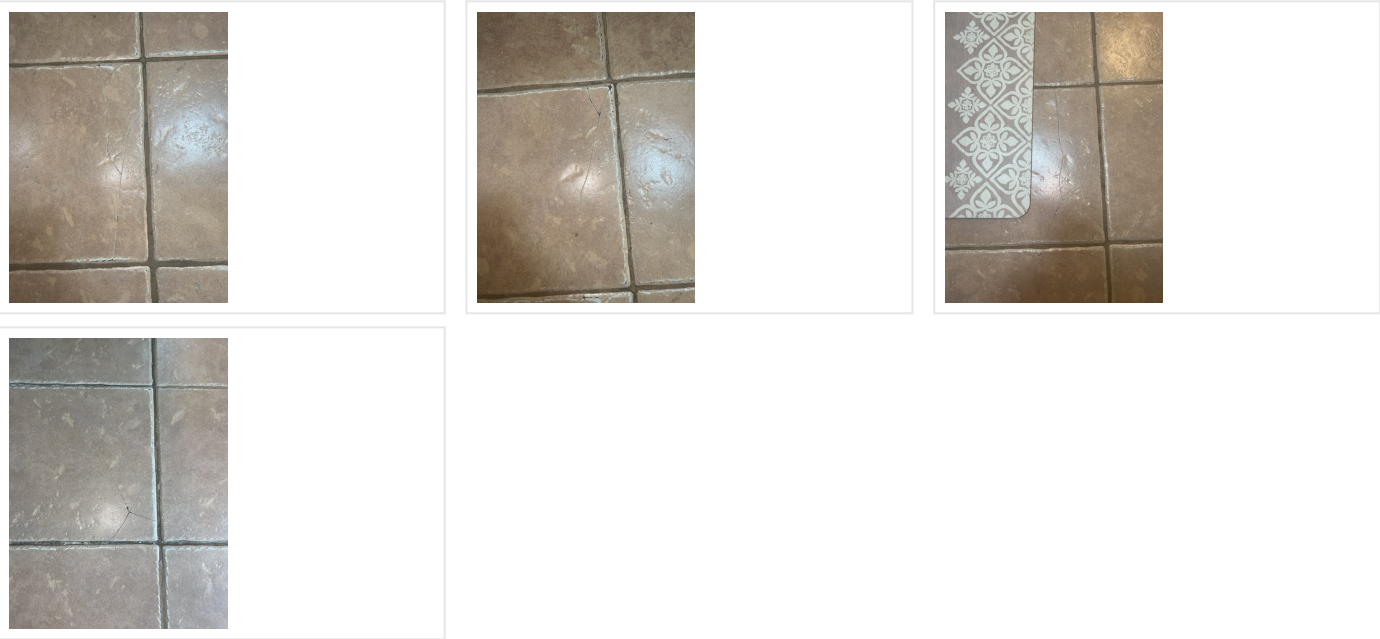
(2) Cracks in tile observed at multiple locations of the kitchen.

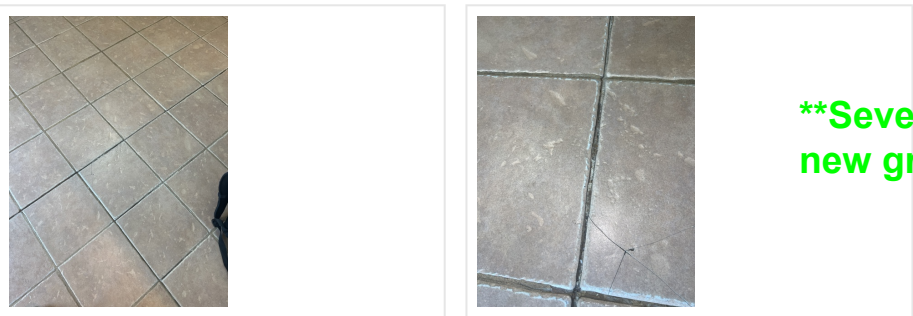
(3) Loose tiles on the floor at multiple locations in the kitchen. Missing grout observed.

****Severe cracked tiles replace, and new grout applied**

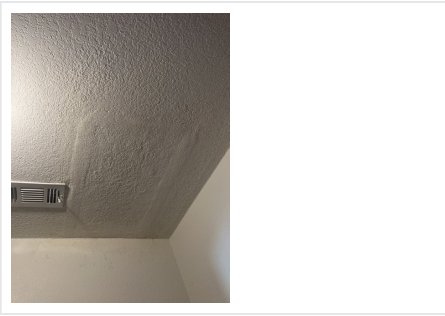
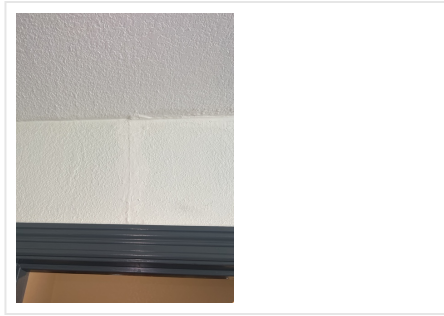
(4) Previously repaired sheetrock observed at multiple locations. **Area replaced due to someone stepped wrong through the attic.**

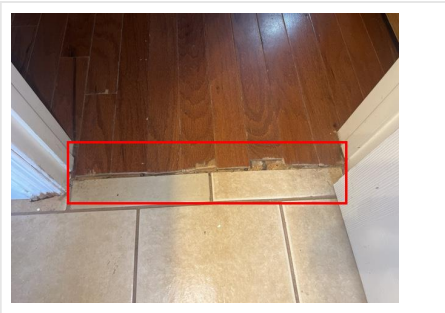
(5) Missing transition strip at master bath flooring.

Threshold transition strip replaced

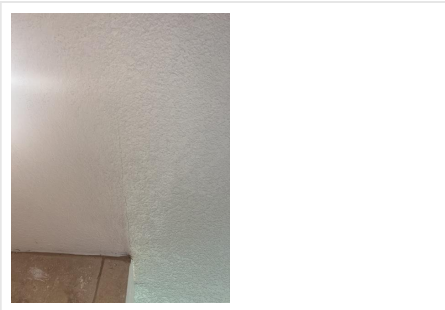
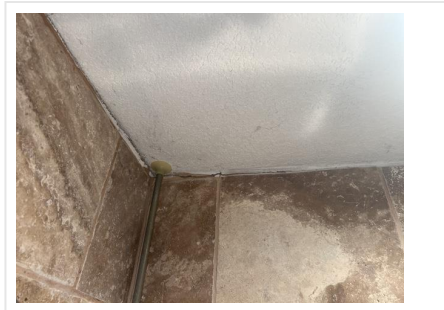
(6) Cracks in sheetrock observed at multiple locations in the master bath.

****Area repaired, tension shelf removed from master shower**

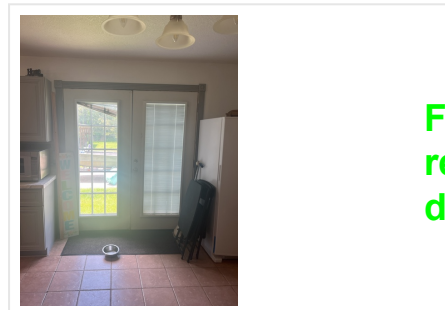
(2) French doors at kitchen do not open. Excessive force was used to try and open however doors did not operate.

**French doors, door facing, and surrounding wood replaced
door purchased at Lowes**

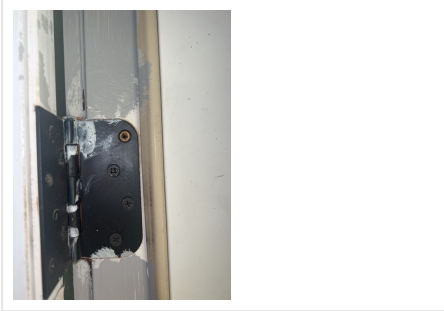
(3) Hinge screws missing at front door.

Screws replaced

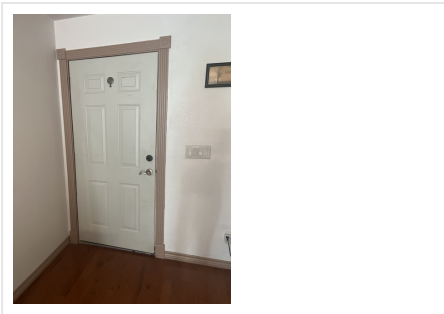
(4) Door does not latch properly at the front door.

Door properly closes and locks after house re-leveled. Documentation available for review

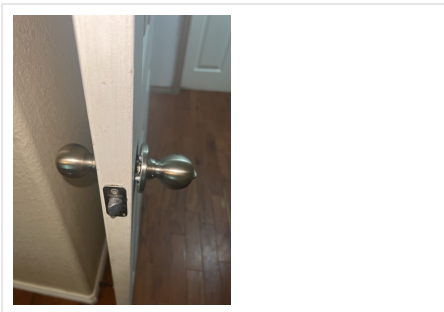
(5) Door handle hardware damaged/loose at middle bedroom door.

Handle properly installed, no longer loose, Documentation available for review

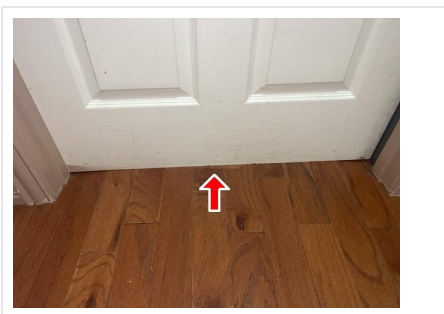
(6) Doors drag on flooring at middle back bedroom.

Doors open and shut without dragging since house re-leveled, Documentation available for review

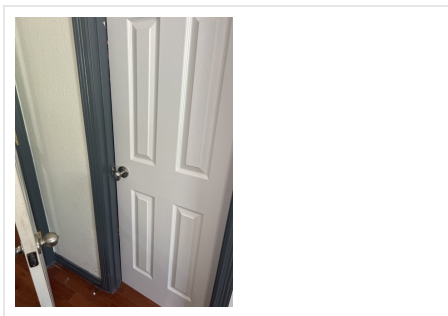
(7) Doors do not latch properly at middle bedroom closet.

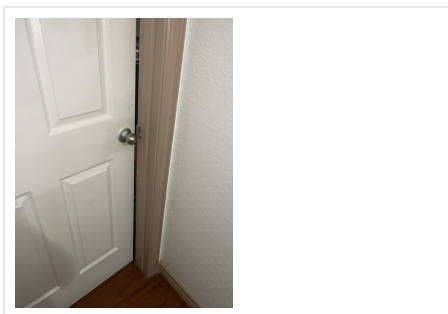
(8) Doors do not latch properly at master bedroom.

Doors open and shut without dragging since house re-leveled

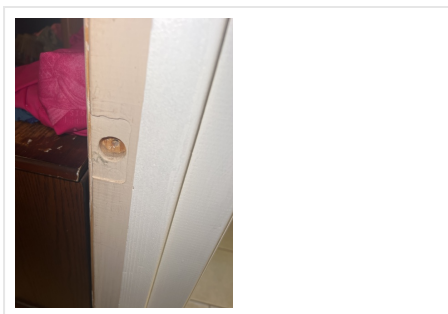
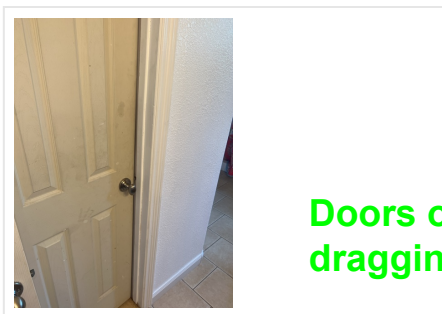
(10) Doors do not latch properly and striker plate is missing at master closet.

Doors open and shut without dragging since house re-leveled

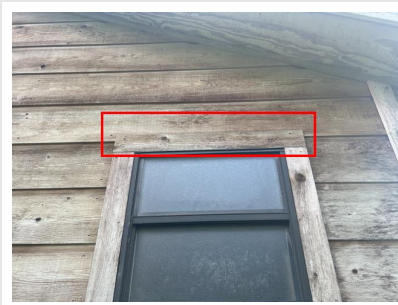
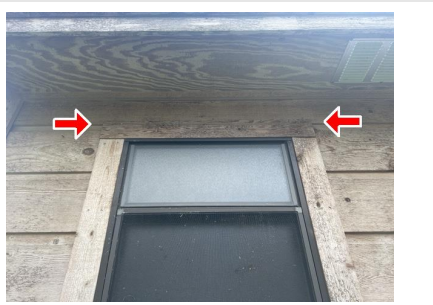
(3) Missing window flashing at all locations.

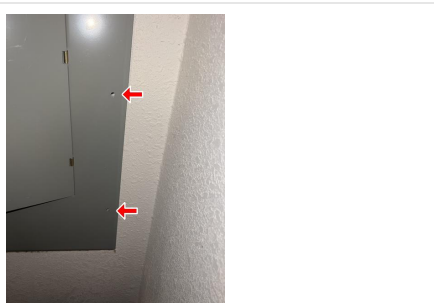
(4) Screws missing at the front of panel

Screws replaced

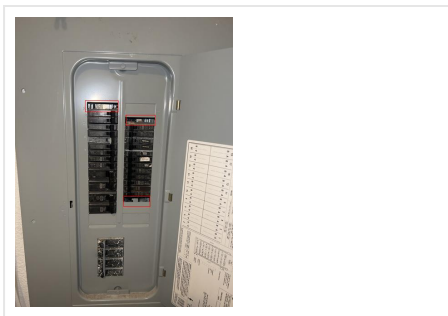
(5) Knockouts are missing

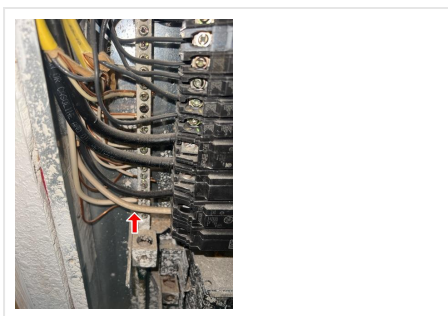
(8) White wires are being used as hot leads

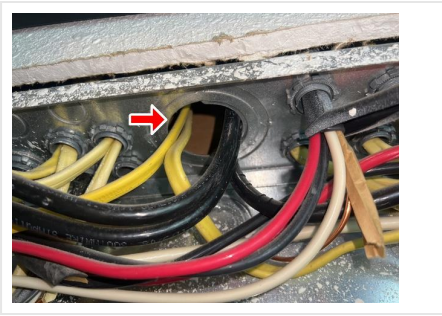
(10) Grommets or box connectors missing. Grommets or bushings are required at pass-through holes to prevent chaffing of the wiring. **Grommets replaced**

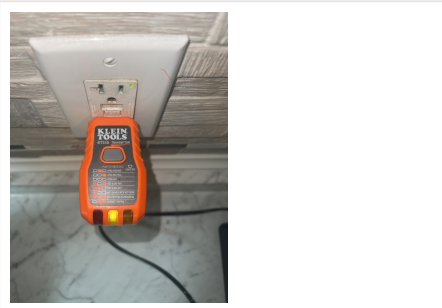
(3) Ungrounded outlets at kitchen.

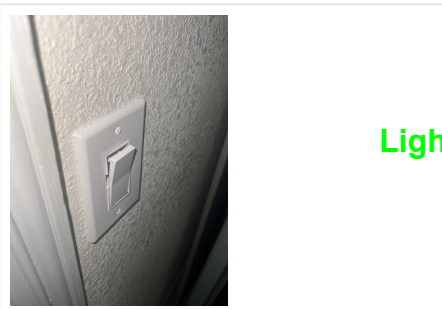
(4) Damaged light switch at laundry room.

Light switch replaced

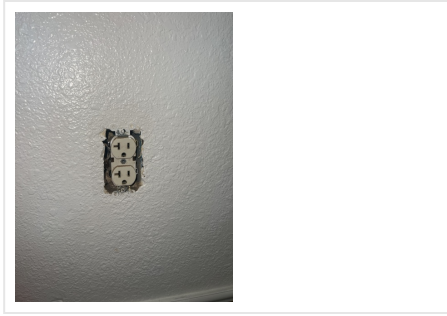
(5) Missing outlet covers at kitchen.

Switch replaced

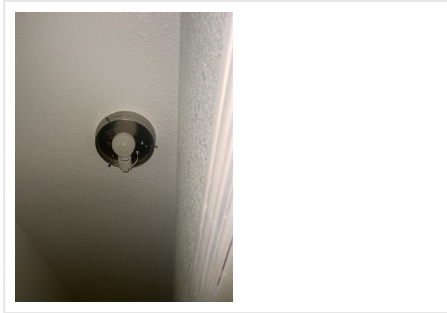
(6) Light fixture globes or covers are damaged / missing at middle bedroom closet.

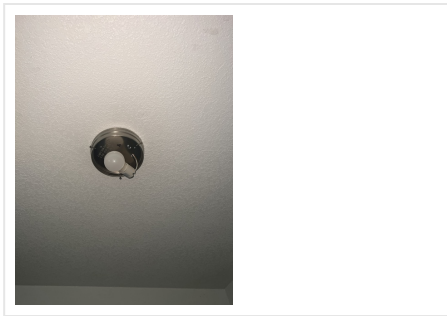
(7) Light fixture globes or covers are damaged / missing at middle rear bedroom closet.

Globes were on shelf, now placed on fixture

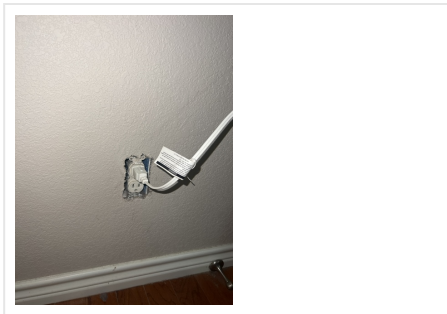
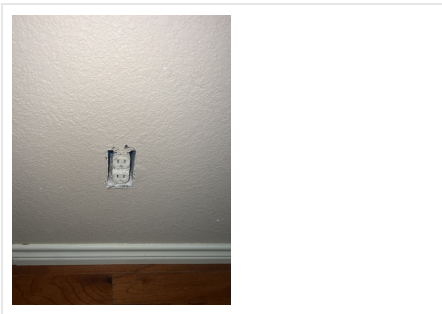
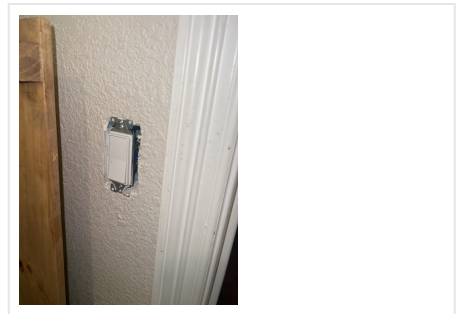
(9) Missing outlets covers at master bathroom. All covers placed on receptacles

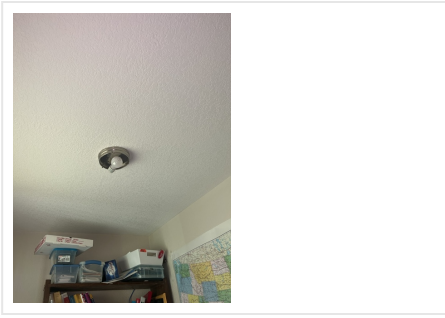
(10) Light fixture globes or covers are missing at office.

Globes now placed on fixture

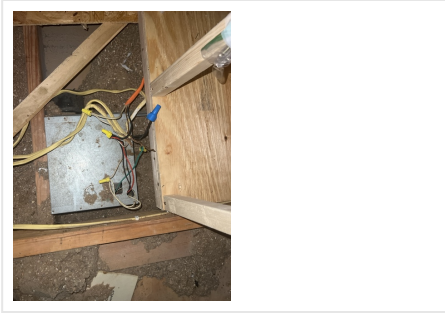
(11) Connections not in junction boxes at bathroom exhaust ventilators. **Junction box installed**

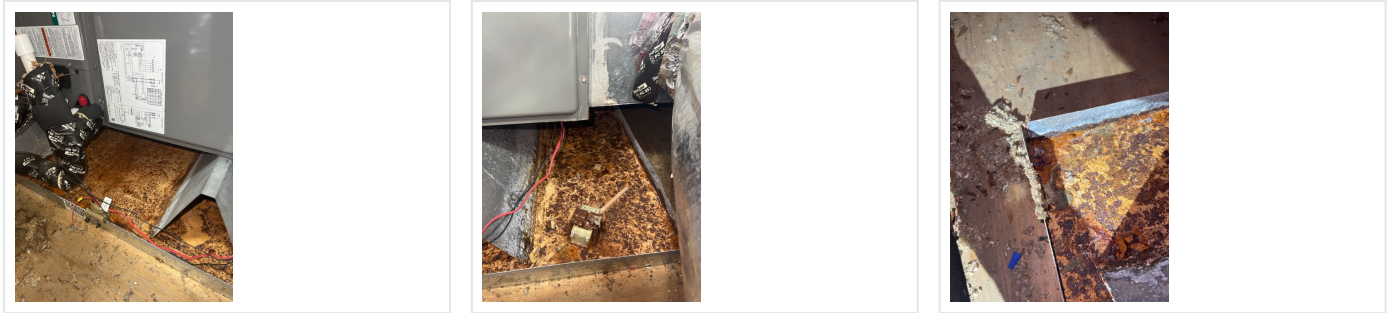
(2) Water in auxiliary/secondary drain pan. Secondary drain pan is rusted

Recommend cleaning, servicing, and further evaluation by a licensed professional

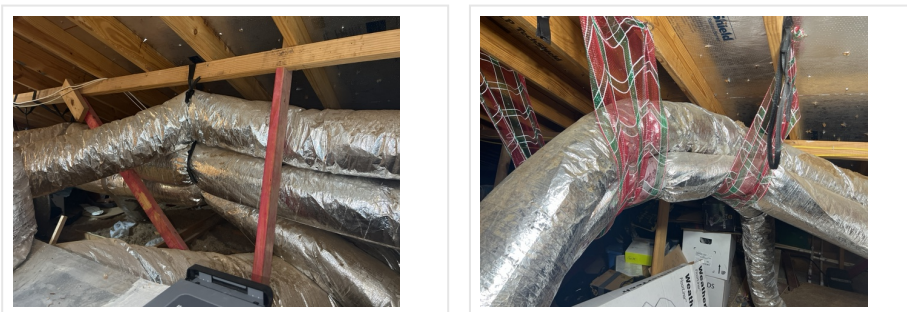
(2) Ductwork is in contact with each other - 1" clearance is required

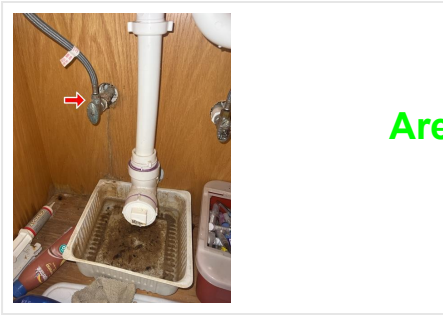
(3) Water supply line leaking at master bath sink.

Area repaired

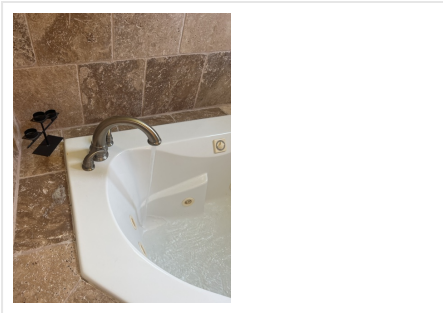
(4) Bath tub faucet is not securely mounted at master bath.

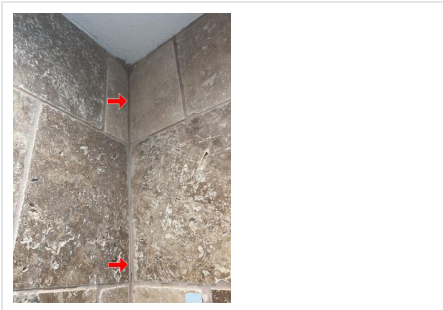
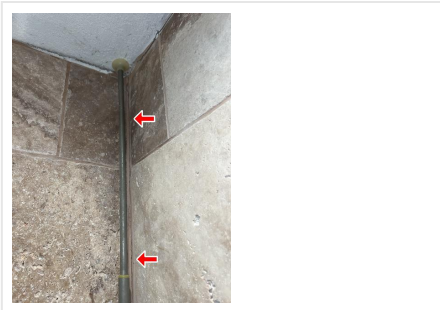
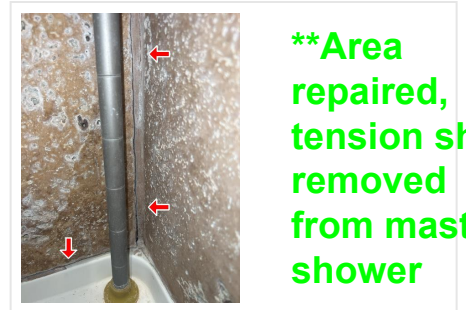
(5) Tub or shower requires caulking at the corners of shower walls and at the base of tiled shower.

** Area repaired, tension shelf removed from master shower

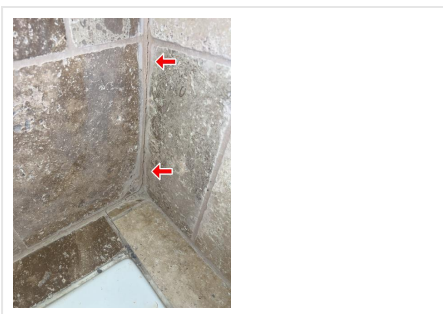
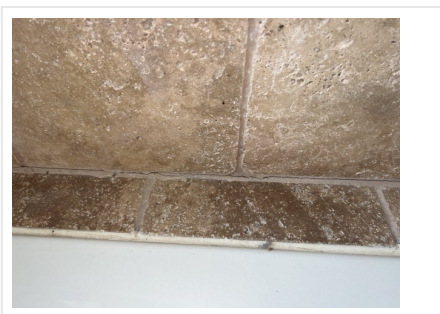
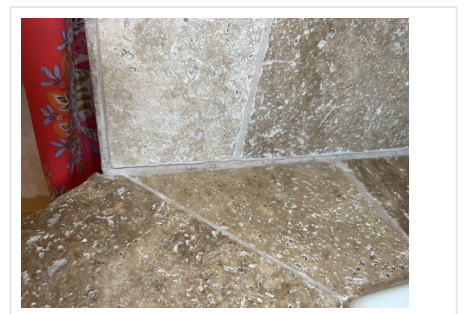
(6) Cracking grout observed near master bath tub.

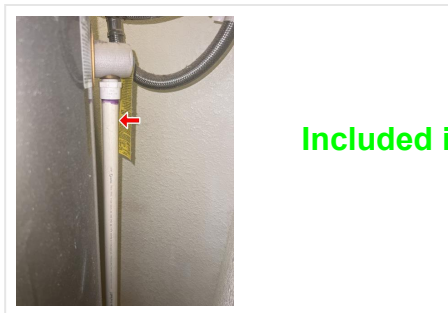
(4) Improper material used for T&P valve drain line. PVC is not an approved material.

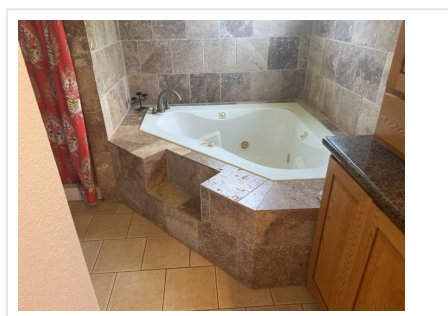
(2) No visible access panel to jacuzzi tub equipment - Jacuzzi tub motor was not viewed

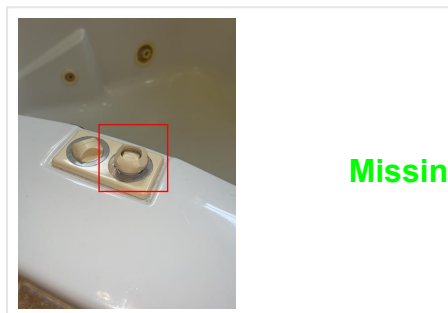
(3) Jacuzzi tub switch is broken.
