East Texas

HOME INSPECTION & PEST CONTROL

Michael & Theresa Huckabay
786 County Rd 308
Cleveland, TX 77327
November 17, 2023

PROPERTY INSPECTION REPORT FORM

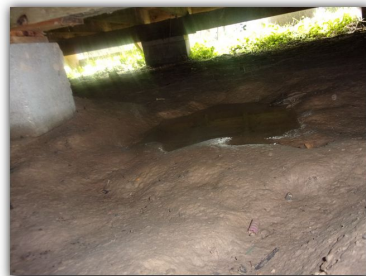
There was excessive moisture noted in the crawlspace at the time of inspection. This is a conducive condition for wood destroying insects.

Moister will also cause foundations to shift or move over time. I recommend maintaining a dryer climate under the structure.

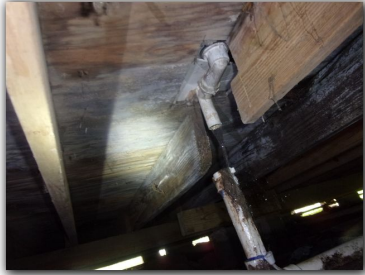
Floor joist noted under the hall tub that was improperly notched.

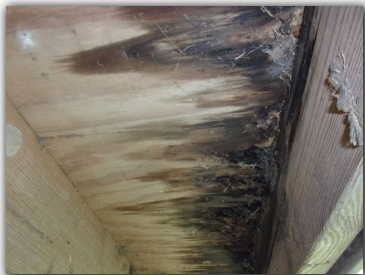
Previous moisture damage noted under the master tub

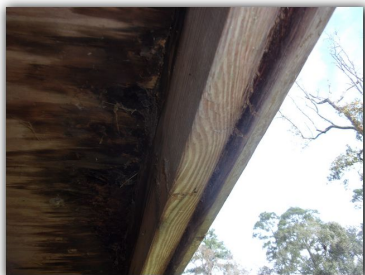
Note- one 2x6 noted for the exterior wall area along the east end.

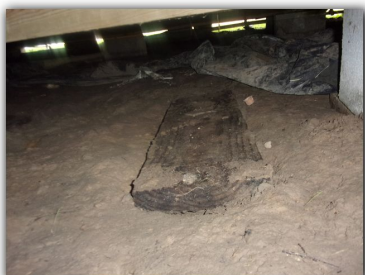
Crawl space has debris through out the crawl space. This debris allows rodents and other varmints to exist under structure. Debris should be removed and a clean environment maintained.

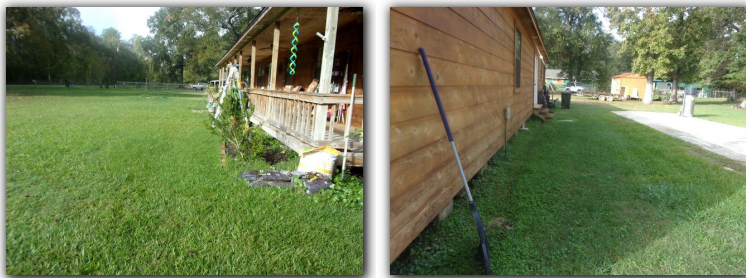
Foundation does not have positive grading. The drainage strategy of the foundation is important. Expansive soils can be very destructive to the foundation if the moisture content of the perimeter varies. Some improvement should be made to the grading of the yard.

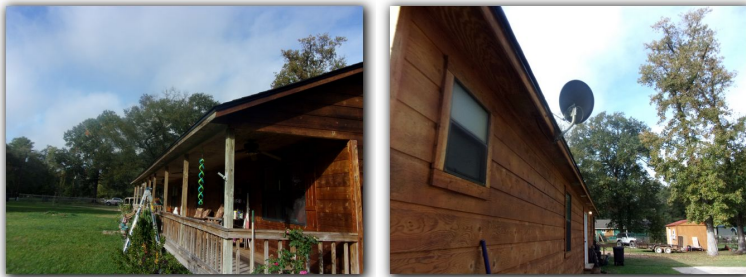
A complete guttering system with extensions is recommended on this structure. The gutter system is designed to expedite the drainage of water away from the property. Splash plates located under the downspouts can help direct water away from the foundation and reduce soil erosion, which can reduce the effectiveness of the termite chemicals placed in the soil. A properly installed gutter system is an important tool in maintaining even moisture content in the surrounding soil.

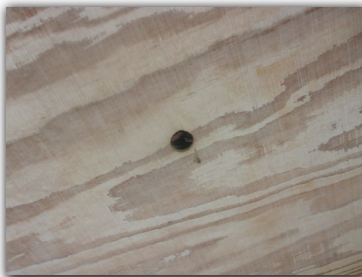
Small openings or gaps were noted in the roof structure (soffit & fascia). These gaps are recommended to be sealed with a silicone caulk. This helps prevent insect infestation such as ants, spiders, bees & wasps, and to keep wind driven rain from coming into contact with unpainted portions of the wood.

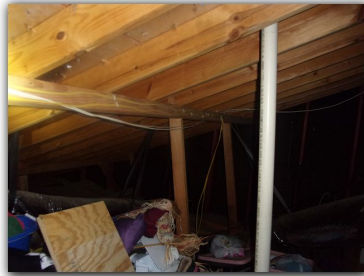
Purlins noted that were improper. Purlins shall be continuous and the same size as the rafters, and shall be supported by 2x4 braces installed to bearing walls at a slope of not less than 45 degrees from the horizontal. The braces shall be spaced not more than 4 feet on center and the length not to exceed 8 feet. And may not be cut or notched in any manner.

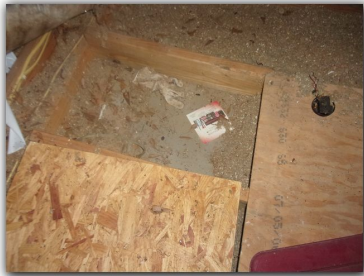
Missing insulation noted in various areas.

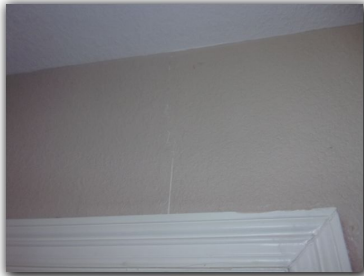
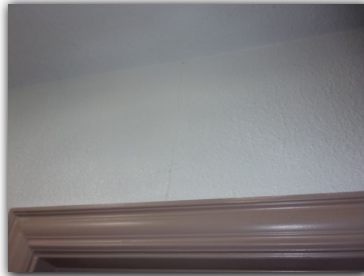
Common interior wall cracks up to 1/8" were noted in the interior gypsum wallboard. Cracks near the interior windows and doors are usually indications that there is some degree of movement occurring in the structure. (in any structure some degree of movement is normal and should not be of concern) the severity of the cracks can be an indication of the amount of movement in a structure.

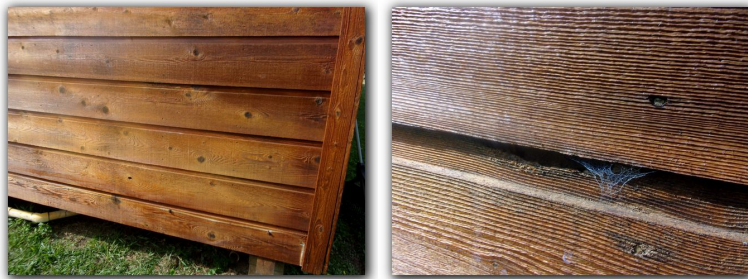
Moisture damage and openings noted on the east end

area.

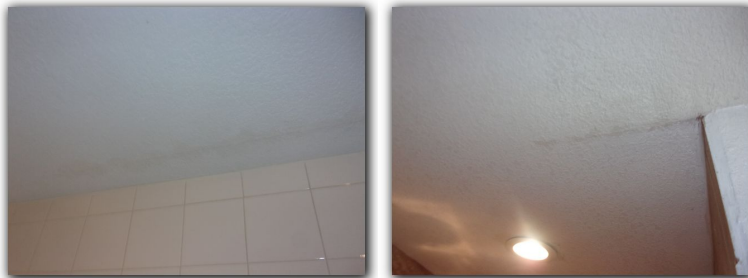
Common hairline wall cracks were noted in the

ceilings. Cracks are usually indications that there is some degree of movement occurring in the structure. The severity of the cracks can be an indication of the amount of movement in a structure.

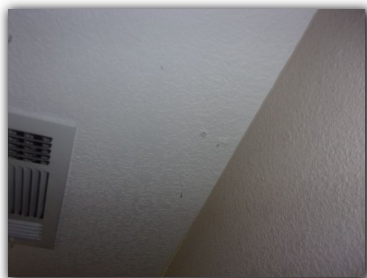
Nail pops noted in various areas.

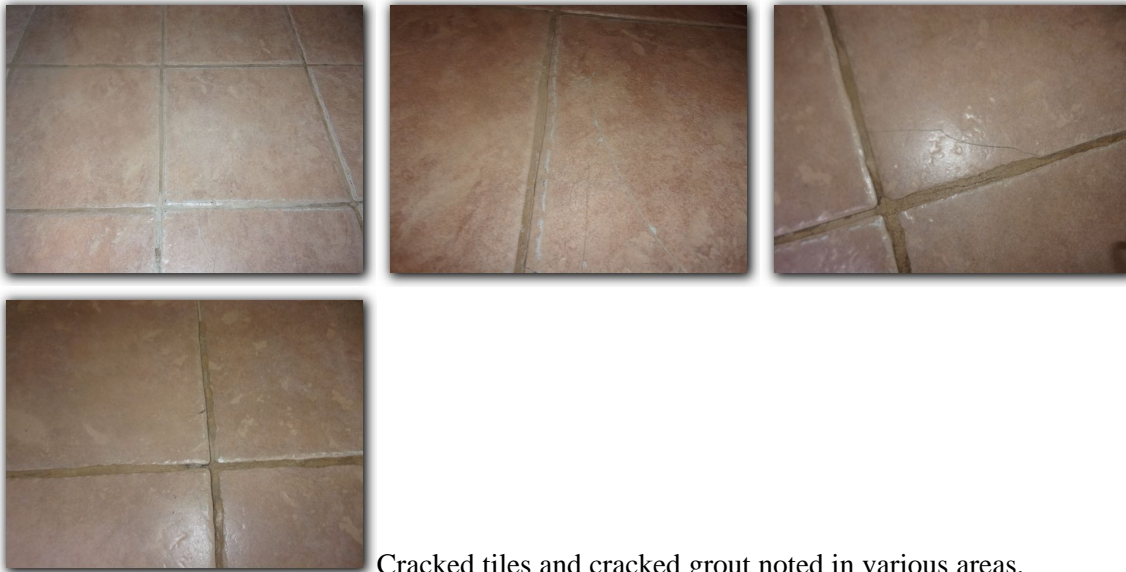
Cracked tiles and cracked grout noted in various areas.

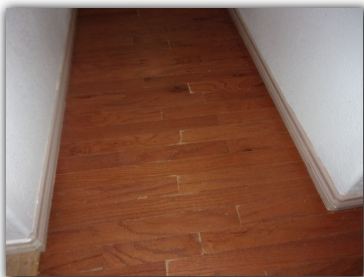
Note- some ware noted on the wood flooring.

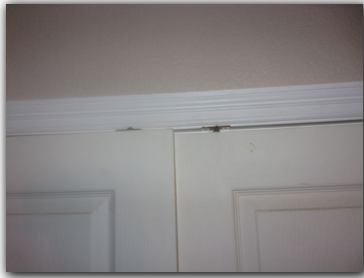
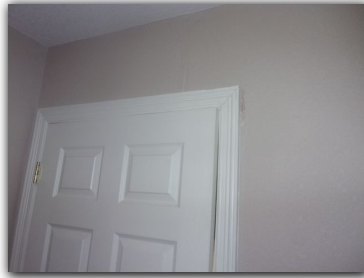
Doors are not square in the door frame or door trim

has gaps at the corners. Recommend having a qualified contractor inspect and repair door. Should problems persist with previously repaired doors, an effort should be made to maintain even moisture content in the soils surrounding a slab foundation.

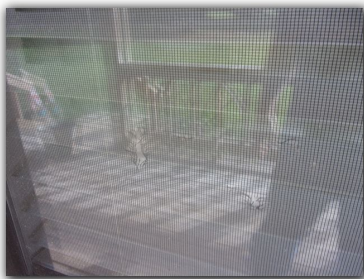
Various damaged screens noted.

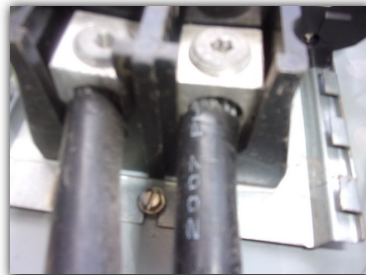
At the time of the inspection there was not any anti-oxidant paste on the lugs in the main panel where the aluminum main wires attach to the panel.

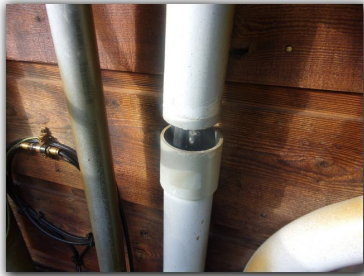
Loose conduit noted.

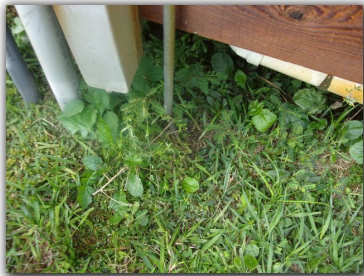
Buyers Note: The connection to the ground electrode rod is below finished grade. The connection should be made above finished grade or with an approved clamp listed for burial. The connector in place is inaccessible and cannot be determined for proper use at the time of this inspection.

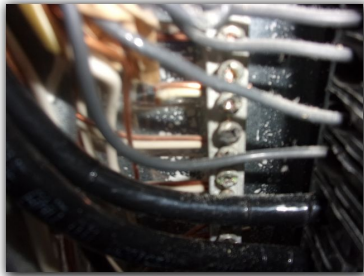
Ground and neutral wires should be separated in the sub panel area.

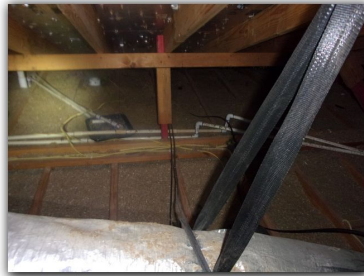
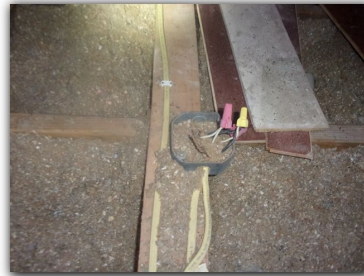
All junction boxes should be fitted with cover plates, in order to protect the wire connections.

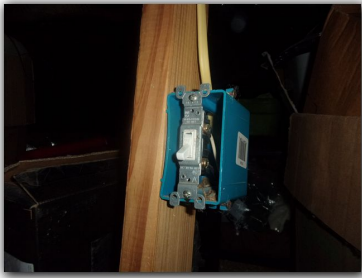
Missing cover plate noted.

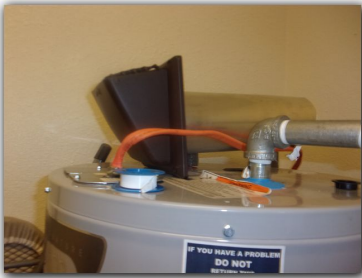
Wiring exposed on interior finishes is recommended to be relocated or protected by a rigid conduit.

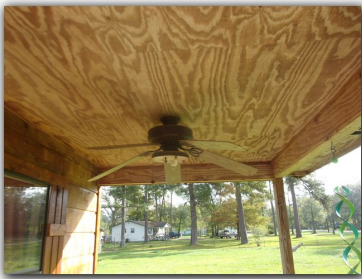
Warped fan blades noted.

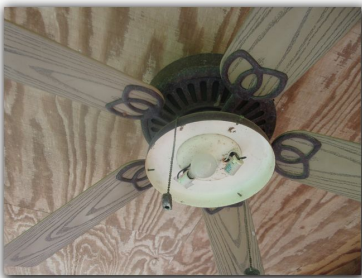
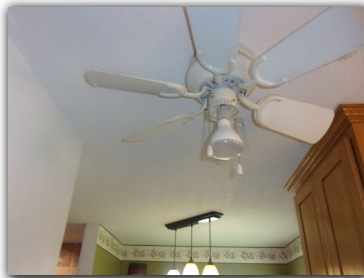
Missing globes noted.

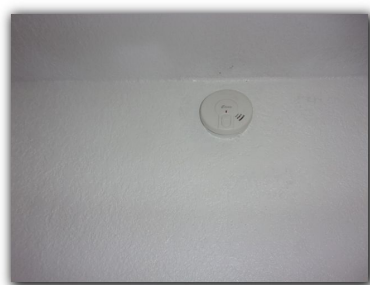
Your Smoke detectors are not installed to today's standards.

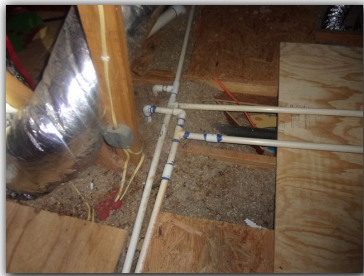
Note-Pvc pipes in the attic area are recommended to be insulated.

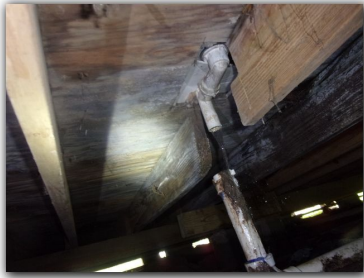
The drain line to the hall tub was disconnected. There did not appear to be a trap in the tub drain line.

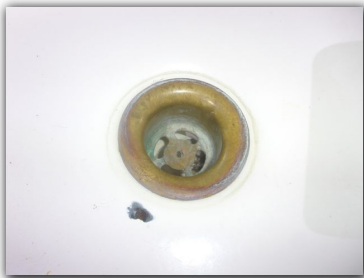
Missing drain stop noted.

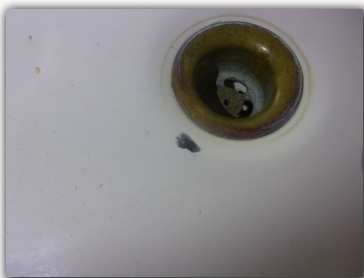
Chip noted in the hall tub area.

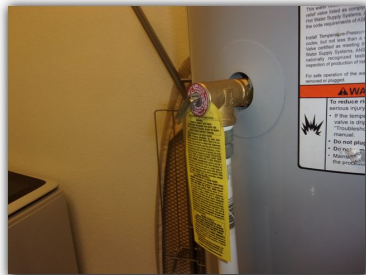
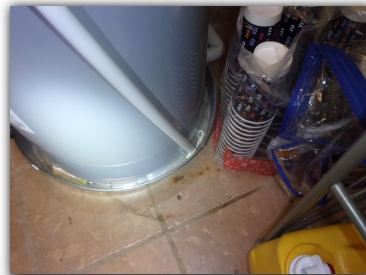
Temperature & pressure relief valve (TRP) should drain into a line that is plumbed horizontally or down, but cannot go back up. (this keeps debris from going back to the valve) this line can be 3/4 inch C.P.V.C. plastic (not reduced in size) and should terminate to the exterior and from 6 to 24 inches from the ground. Remember to test the valve and replace it if it leaks or does not operate or every 3 years.

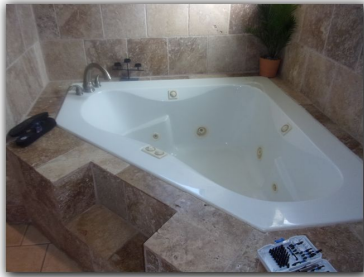
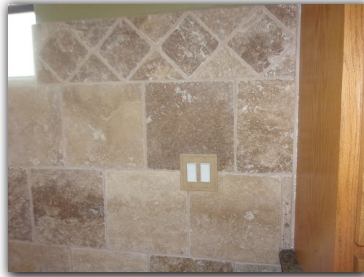
The unit did not have a proper switch.

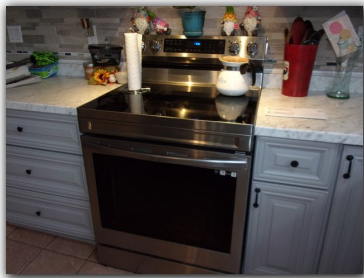
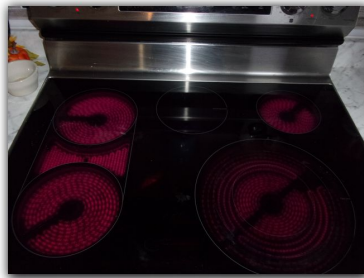
Range is not properly secured to the surrounding cabinet or wall. Children can tip the oven over if the door is used as a stepping stool. All ovens are now required to be secured in some fashion. An anti tip device should be installed.

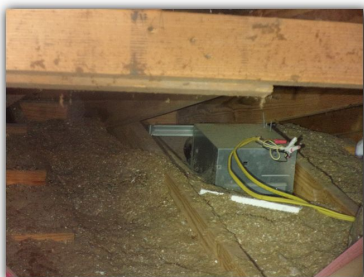
The bathroom exhaust fan terminates inside the attic. This could cause moisture damage to the attic area. These fans should terminate to the outside.
