PROPERTY INSPECTION REPORT FORM

04/26/2023

15531 Pensgate Street, Houston, TX 77062

Dean Finn

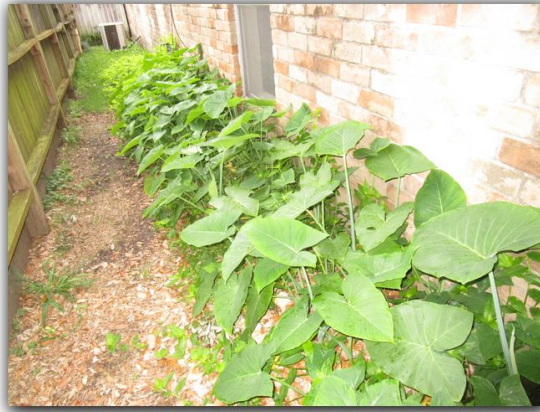
Heavy foliage is a conducive condition for Termites.

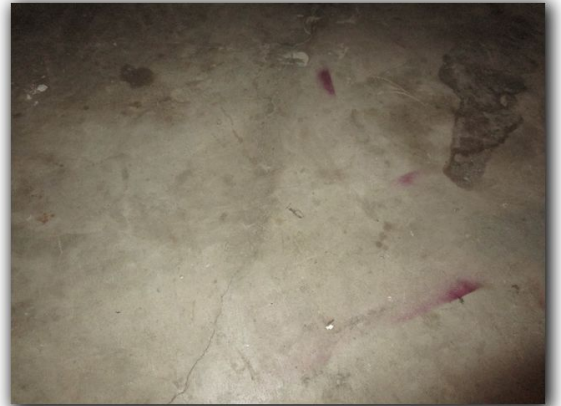
Multiple cracks in garage floor. Did not detect any displacement. Recommend these be monitored.

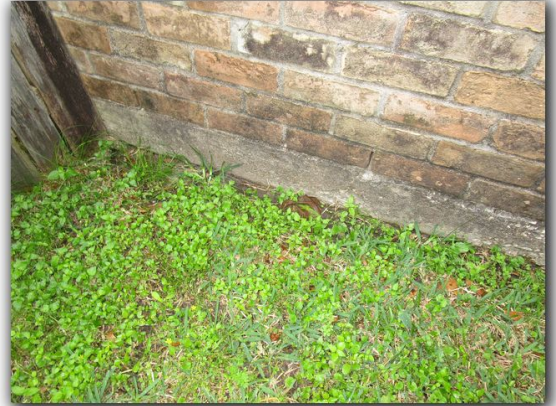
Negative drainage observed in multiple areas.

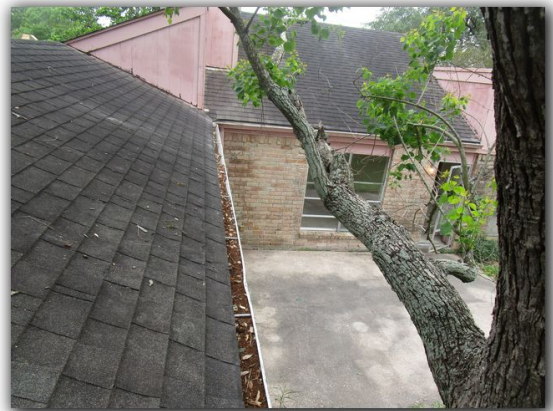
Gutters should be cleaned for proper drainage.

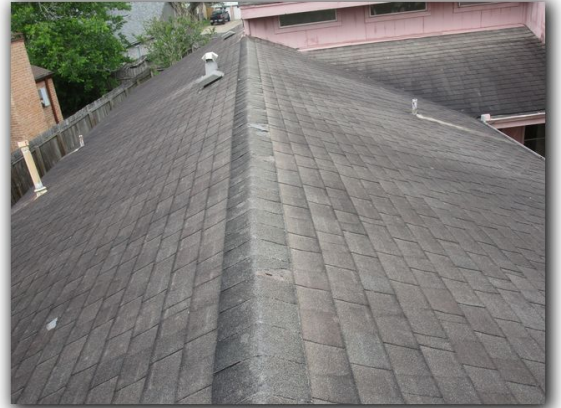
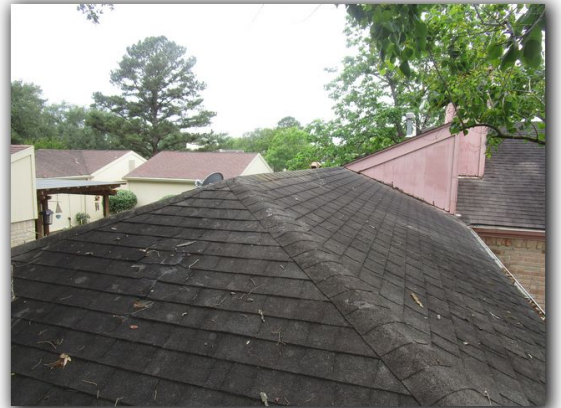
Shingles are damaged and worn in multiple areas. Roof should be considered to be in the end of its useful life.

Recommend a roofing professional to evaluate.

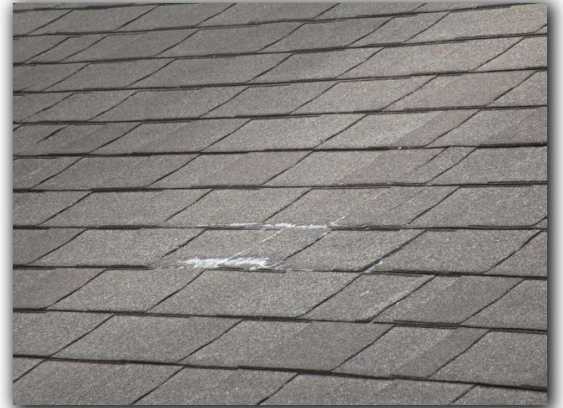
Uneven roof decking was observed in the rear of the house.

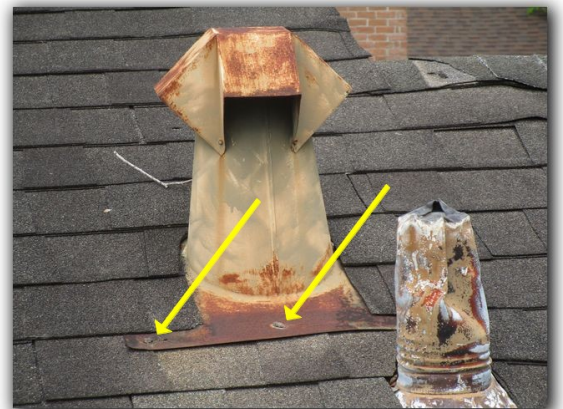
Unsealed nail penetrations were observed at flashing's and/or ridge shingles. Unsealed nail heads can allow water to penetrate past the roof covering over time. As the exposed portion of the nail rusts, more space will become available between the nail and the roofing material for water to penetrate. This condition can usually be remedied by sealing or caulking affected areas.

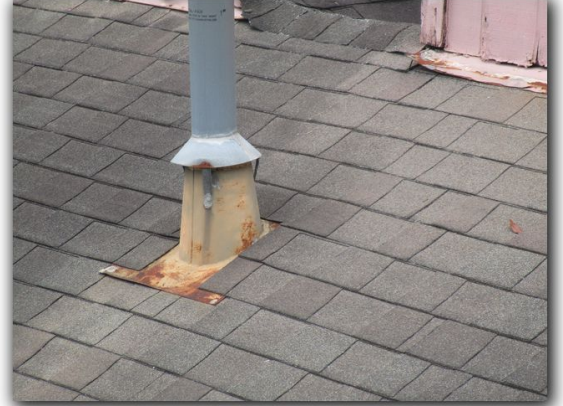
Multiple vent flashing's are rusted. Recommend these be painted with a rust inhibiting paint.

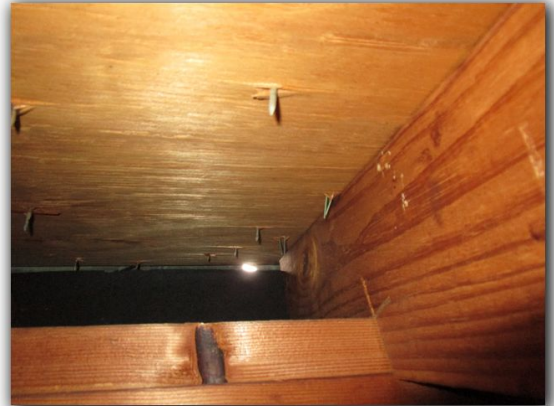
Evidence of prior water penetration in multiple locations.

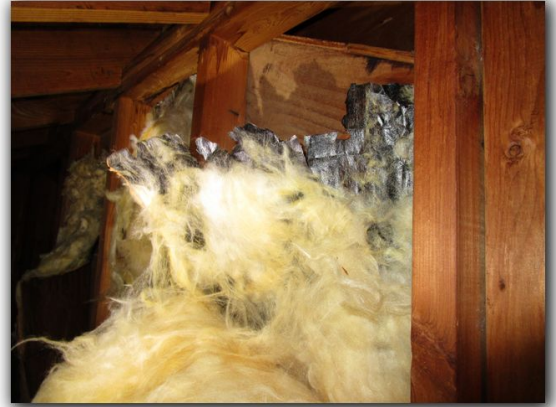
Batt insulation had fallen down from vertical attic walls. Recommend this be replace.

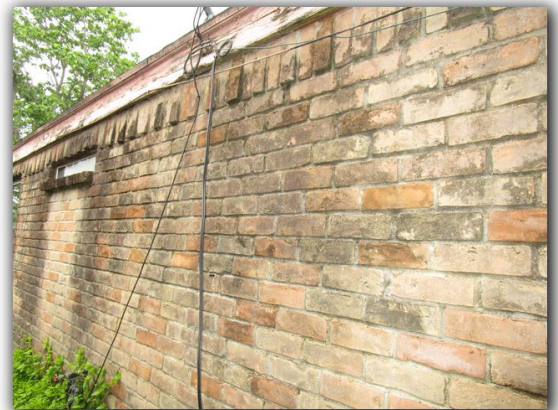
Evidence of excessive moisture in multiple areas. And siding should be cleaned to prevent deterioration.

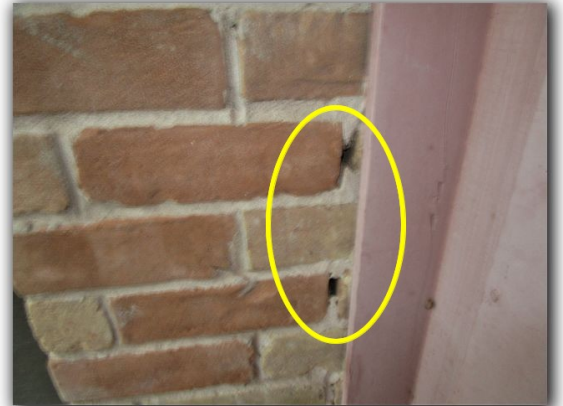
Areas around openings should be sealed to prevent moisture or insect intrusion.

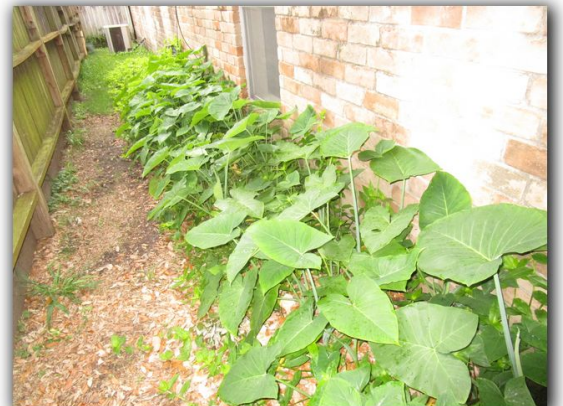
Recommend vegetation be kept away from the exterior walls. These hold moisture to the walls and can cause damage to the finish.

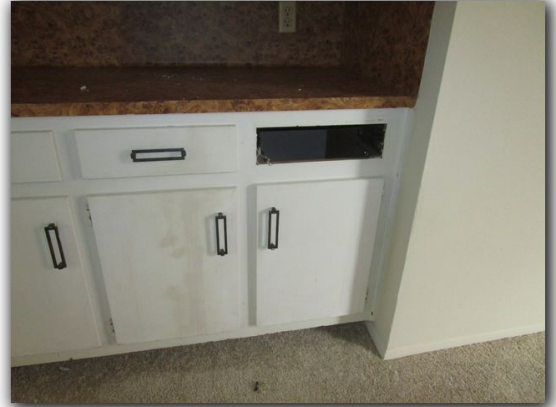
Multiple cabinets were missing parts and/or damaged.

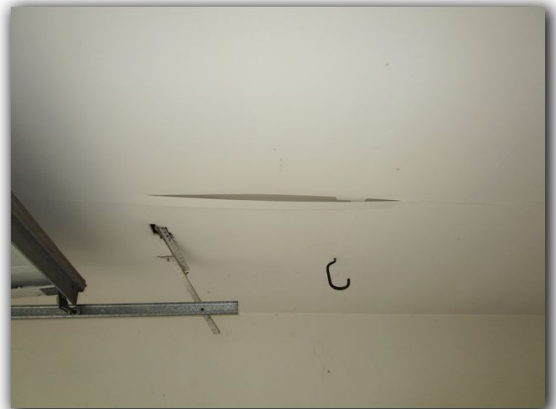
Sheet rock is missing/damaged in ceiling of garage. The garage must be separated from the living area of the structure by a fire break that includes the ceiling of the garage.

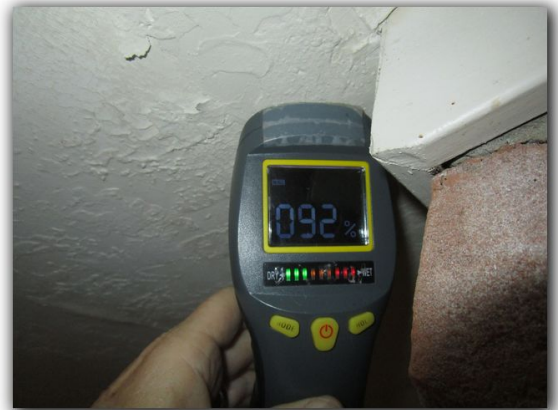
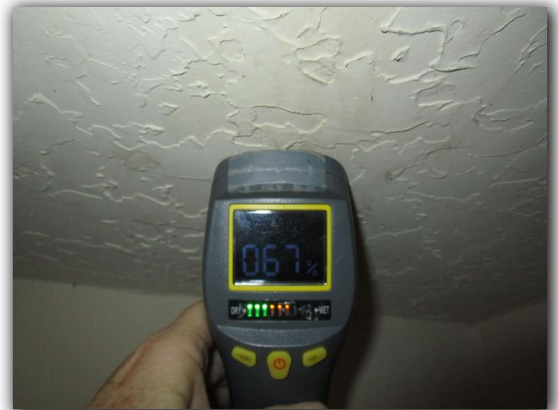
Multiple areas showed evidence of prior water penetration and at least 2, appear active based on moisture readings.

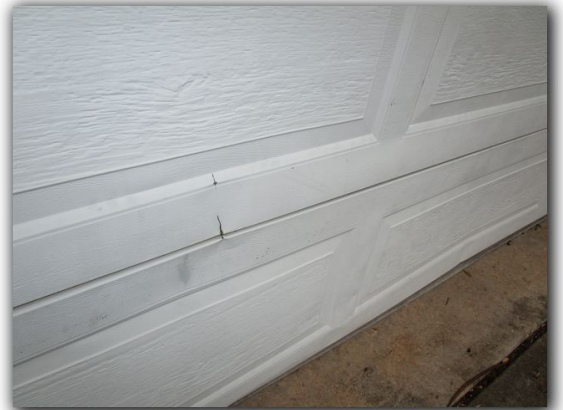
Overhead garage door has multiple dents/damage in panels.

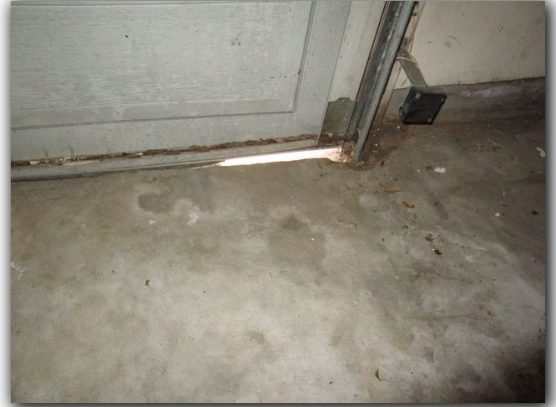
Overhead garage door was not flush to the frame and was missing weather stripping at the bottom.

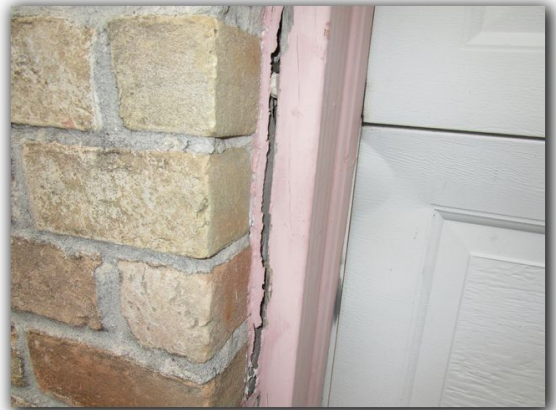
Overhead garage door frame shows evidence of prior water penetration and should be sealed to the bricks.

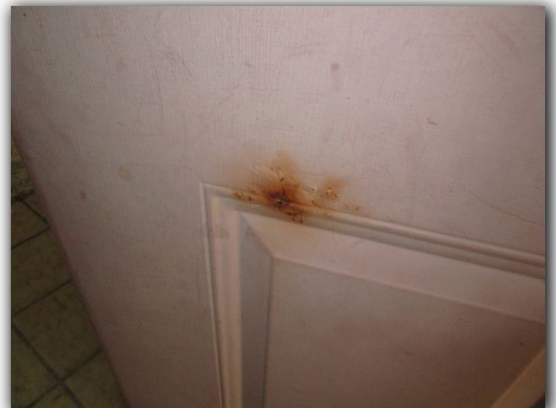
Multiple doors would not latch, were damaged, and/or were missing hardware.

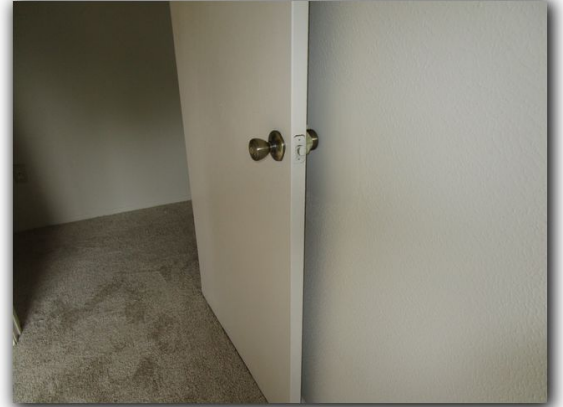
Multiple doors were missing door stops.

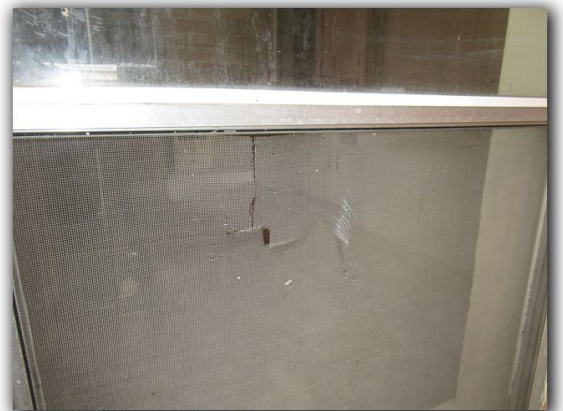
Multiple windows have missing and/or torn screens.

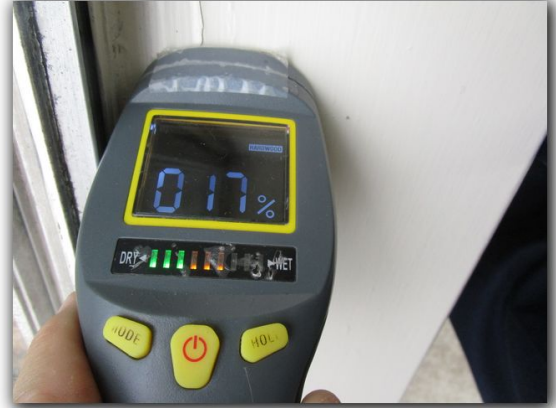
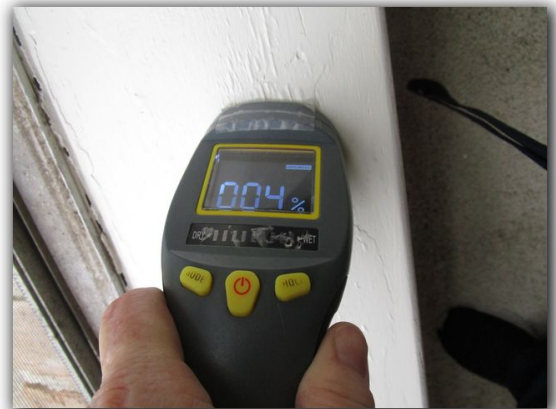
Multiple windows sills show evidence of prior water penetration. Although tested sills were within tolerance. Some had moisture levels at the higher end of the range.

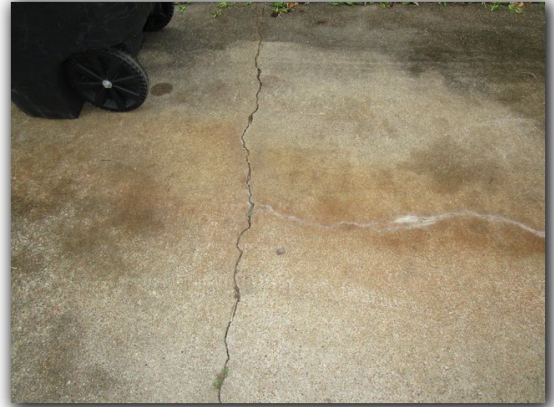
Driveway has multiple cracks.

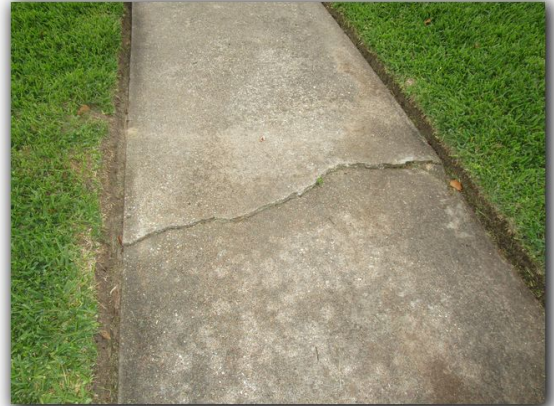
Front sidewalk/walkway had cracking resulting in possible tripping hazards.

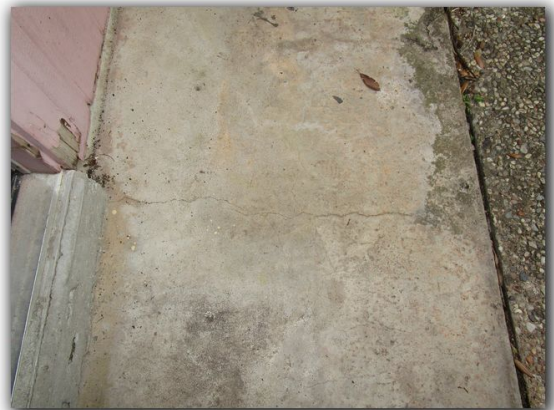
Shrinkage crack in porches. Shrinkage cracks are nonstructural.

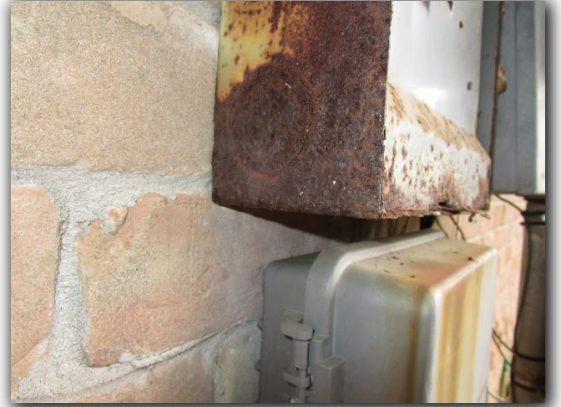
Service box has rust.

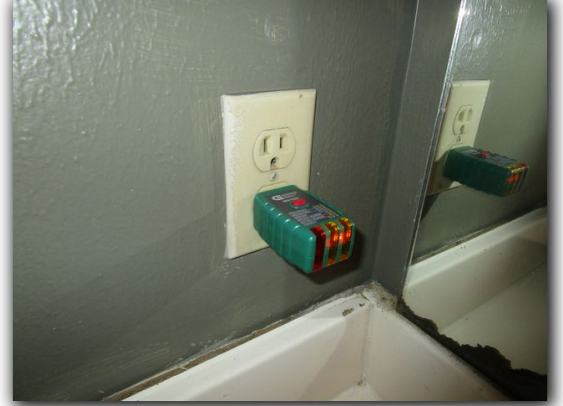
GFCI outlets were missing in multiple locations. These should be in all bathrooms, kitchens, garages and outdoors.

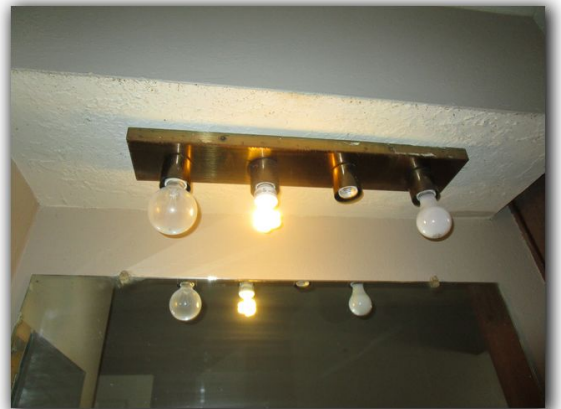
Multiple fixtures/lights were missing and/or nonfunctional.

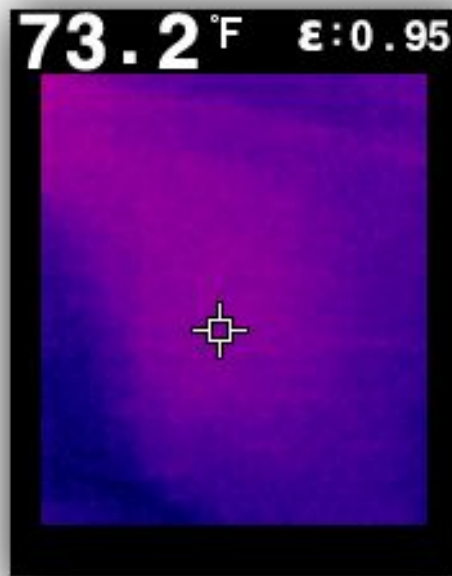
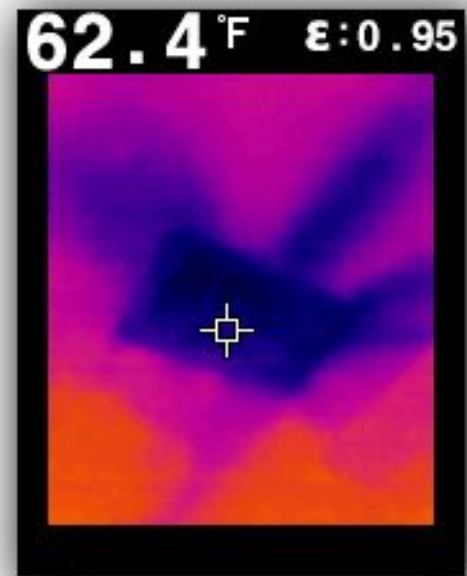
14 to 21 degree differential between intake and exchange allowed in Texas. Recorded only an 11 degree difference (73 to 62).

Recommend evaluation and repair by a HVAC professional.

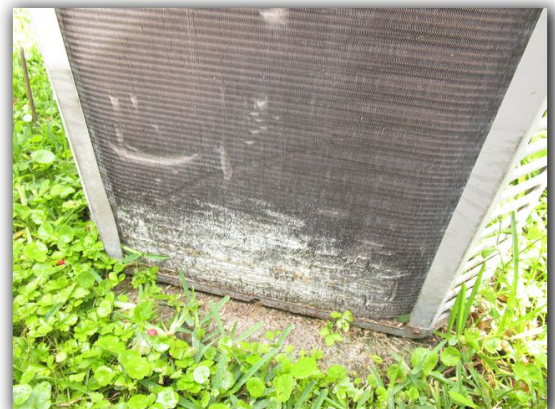
The fins of the outdoor portion of the air conditioning system were observed to be damaged and in need of repair. This condition can reduce the efficiency of the system.

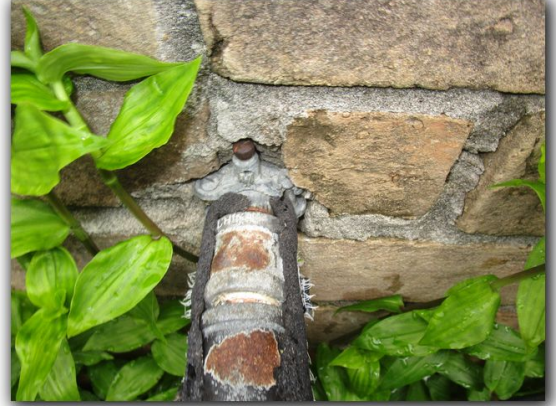
Type of supply piping material: Copper and Galvanized Pipe - Galvanized pipe rusts from the interior, can develop pin hole leaks, and can restrict flow causing low pressure.

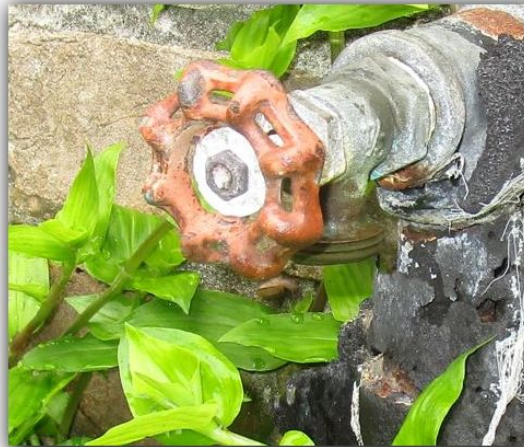
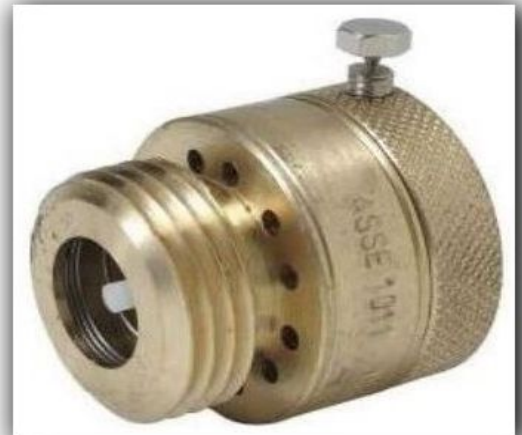
Anti-siphon devices missing. These devices are essentially one-way valves designed to stop the flow of potentially contaminated water back into the drinkable (potable) water supply.

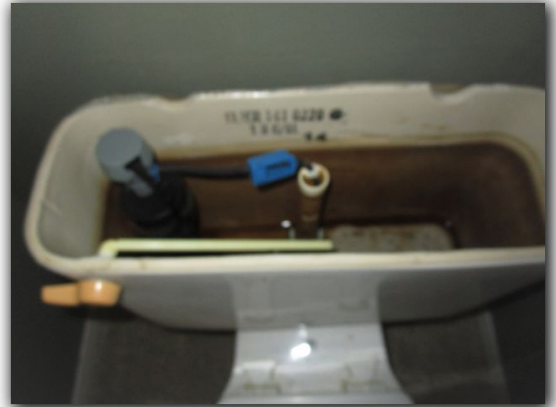
Both toilets were nonfunctional.

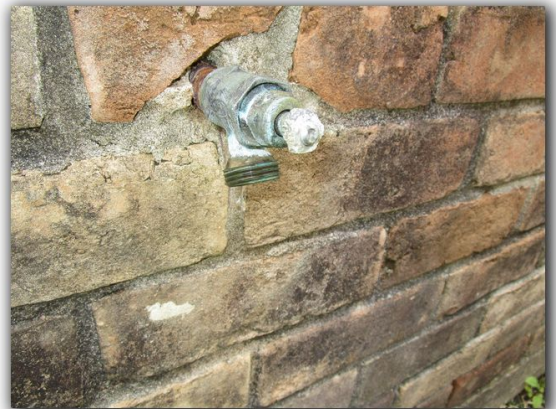
Water was leaking from both exterior faucets and left was missing the control handle.

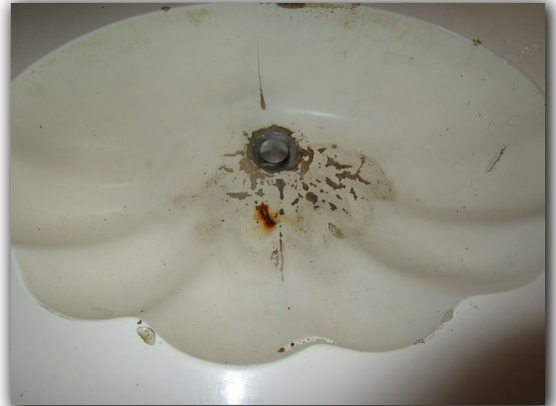
Damage to the finish of multiple fixtures.

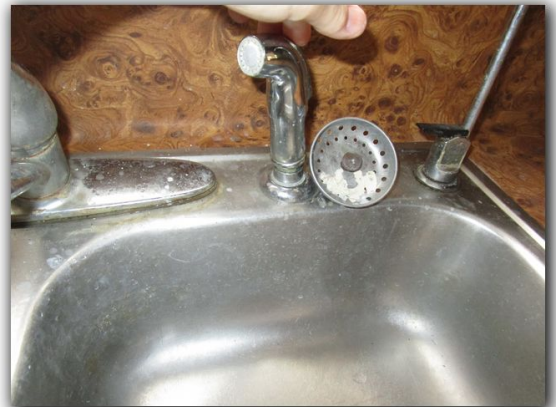
Kitchen sink fixtures were loose.

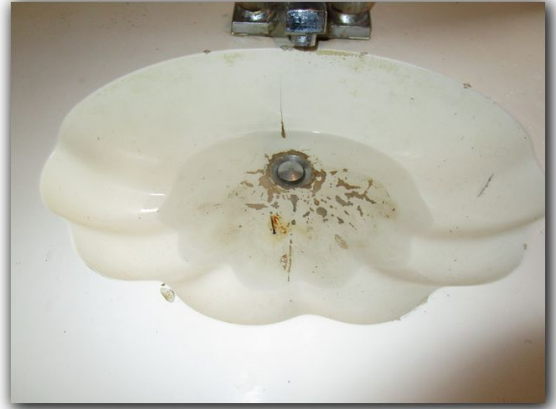
Slow drain at multiple fixtures..

Recommend a plumber to correct.

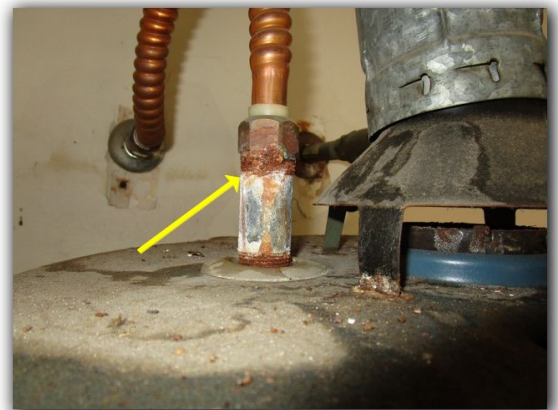
Missing dielectric union connectors on water line. Excessive corrosion was observed.

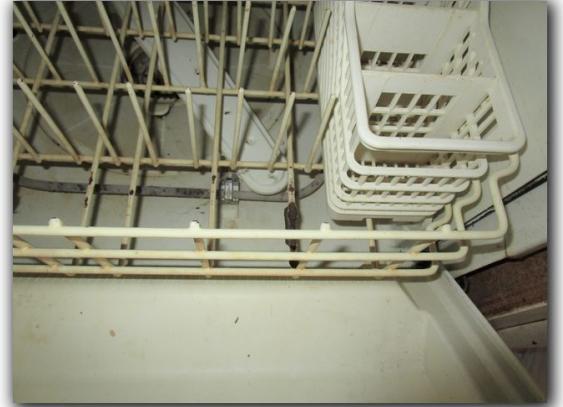
Racks were rusting through the plastic coating.

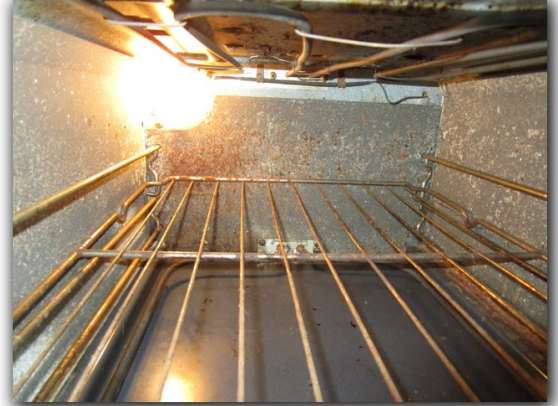
Rust was on the interior finish of both ovens.

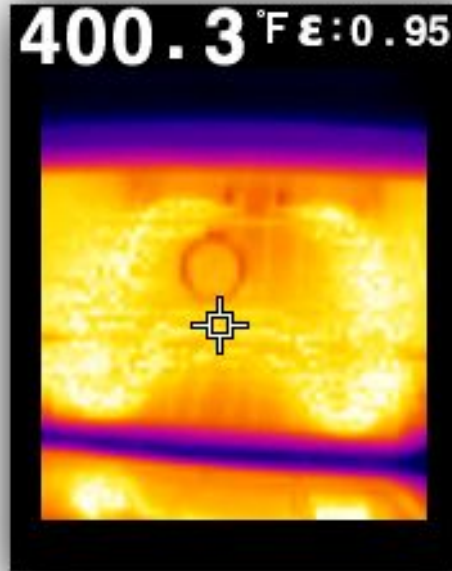
Lower Oven Temperature Exceeded Allowable Range:

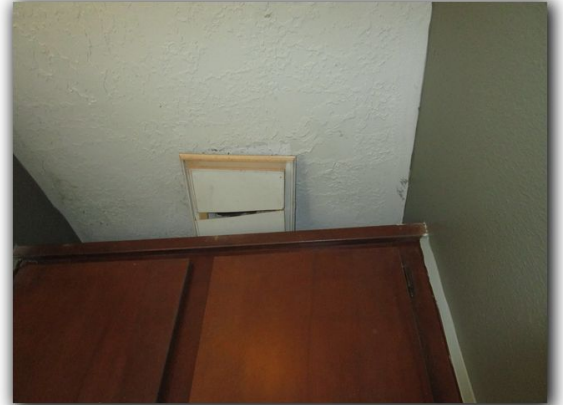
Both units were nonfunctional.
