Inspection Report

Property Address:
12053 Oak Forest Ln
Conroe TX 77385

PROPERTY INSPECTION REPORT

12053 Oak Forest Ln, Conroe, TX 77385

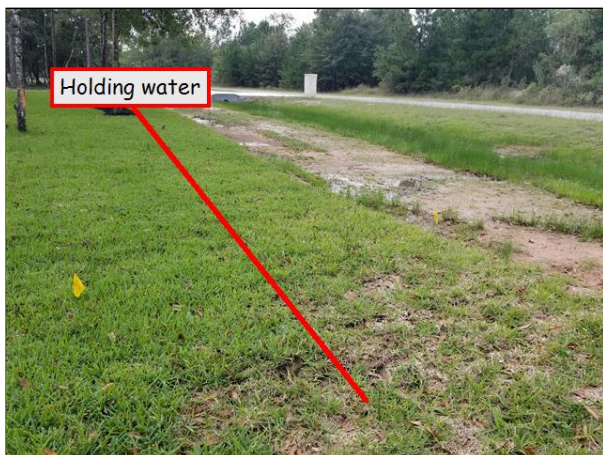
The home had negative/non-functional drainage around multiple areas of the home, which was causing water to stagnate/pond. Ponding water and stagnation overly saturate the soils adjacent to the home's foundation which can lead to adverse foundation conditions.

Front of home at road ditch

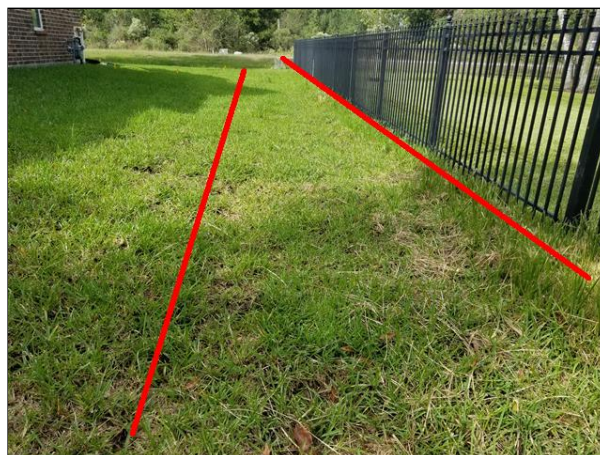
Across the left face lot line

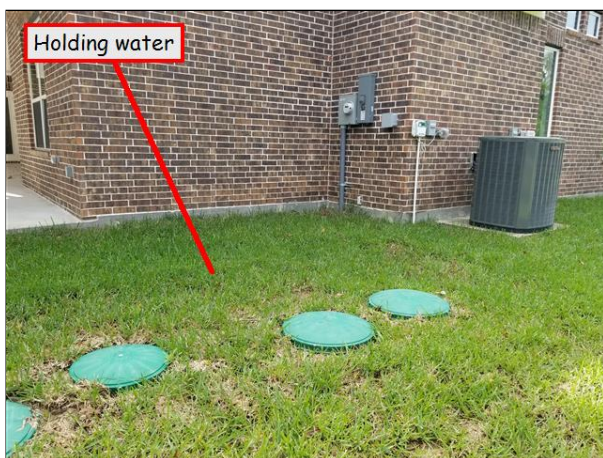
At the septic tanks

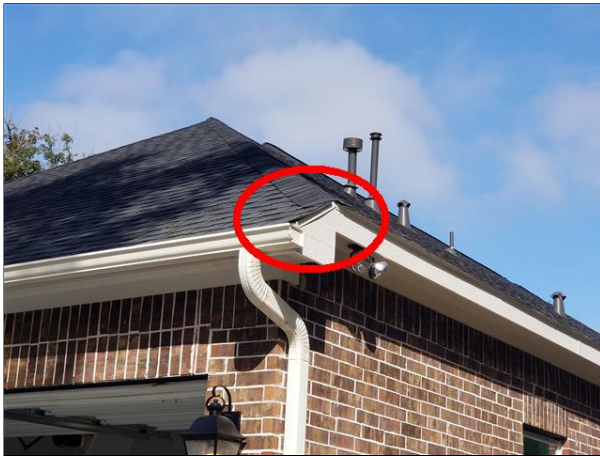
Location: Rear right corner

Observed shingles that uplifted at the rake edge of the roof, likely during the installation of the gutters.

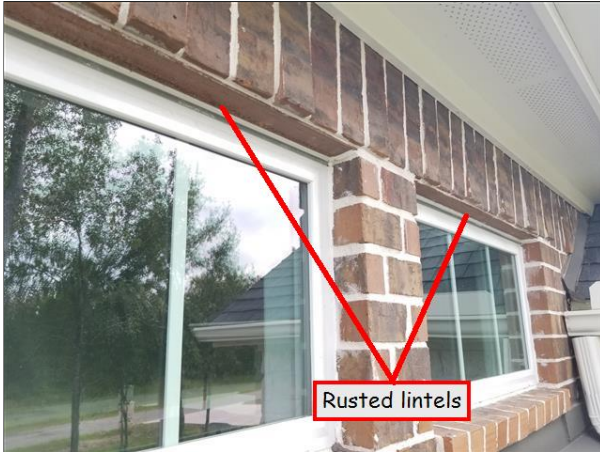
Observed steel lintels that were not primed and painted. It is recommended that the rusted lintels be properly treated to prevent exposure to the elements. If left untreated, the lintels can undergo increased thermal expansion, **which can cause the adjacent brick work to crack.**

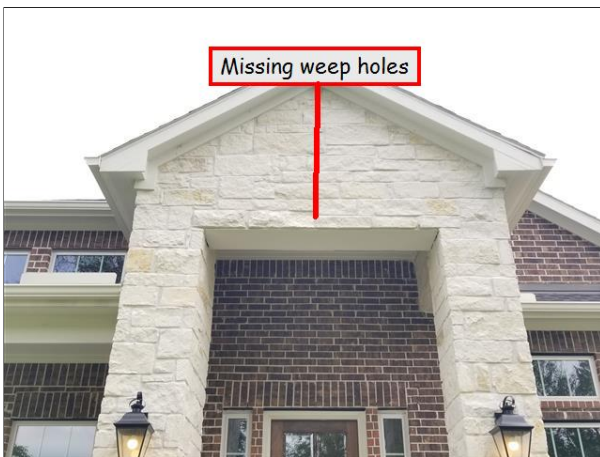
Location: Front of home

Observed a stone veneer above the front entry that did not incorporate weep holes. Weep holes are needed to prevent trapping water/moisture behind the wall system, which could have adverse affects on the structure (over time).

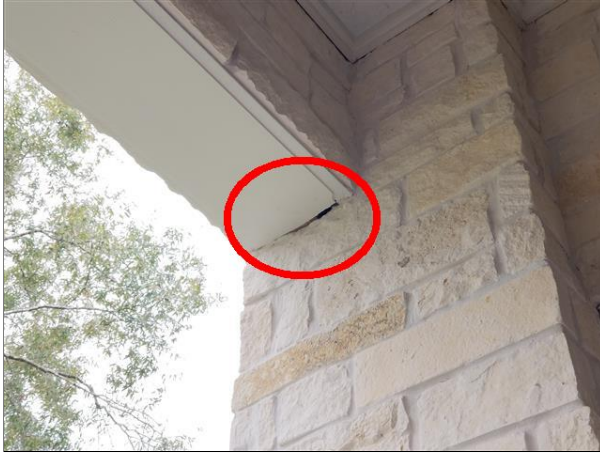
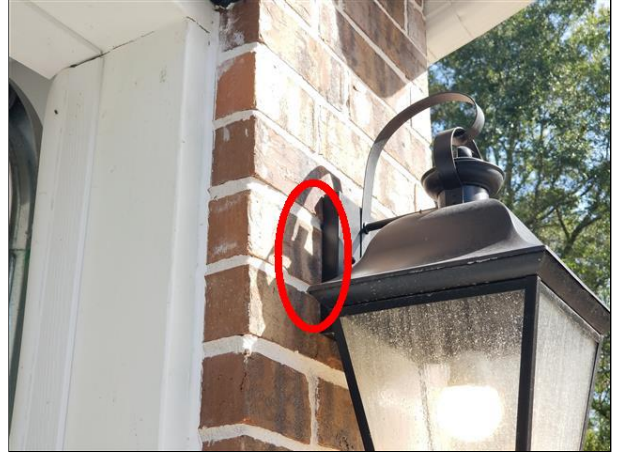
Location: Multiple locations

Observed penetrations and openings that were not durably sealed. Sealing penetrations and

openings that extend through the exterior drainage plane is done to prevent water and air infiltration into the home and/or to prevent water damage to sub-surface components.

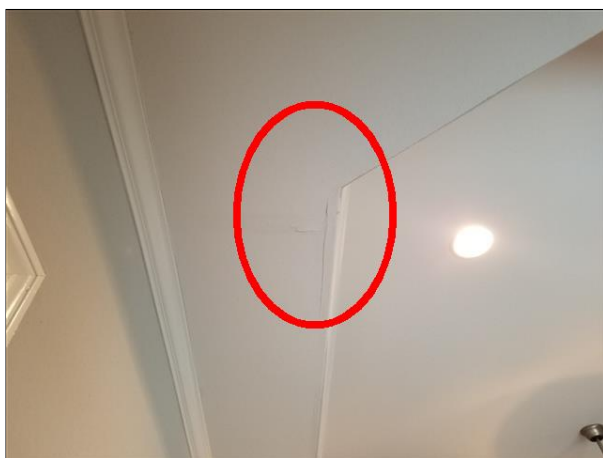
Location: Master bedroom

Observed active water damage on the master bedroom ceiling. It is recommended that a qualified roofing company evaluate and repair as necessary.

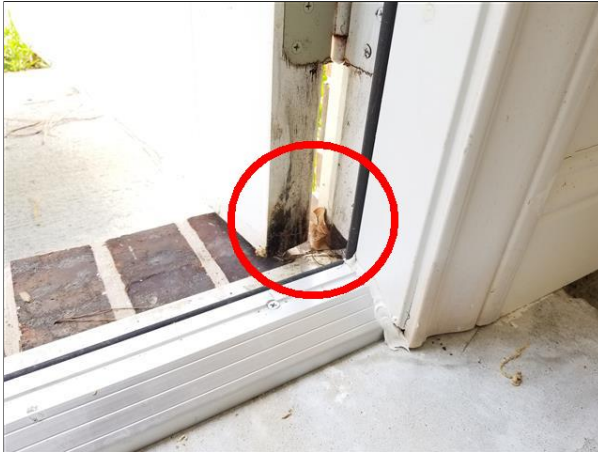
Observed an exterior door threshold and brick sill that did not slope away from the door. When exterior doors lack overhang protection from wind driven rain, they have a higher probability of developing water damage around the lower trim boards as well as allowing wind-driven rain infiltration into the garage. It is recommended that the brick sill be re-worked to provide an adequate slope, and the trim boards be raised to prevent water from wicking into the material causing damage.

Wood rot/water damage forming on base of door

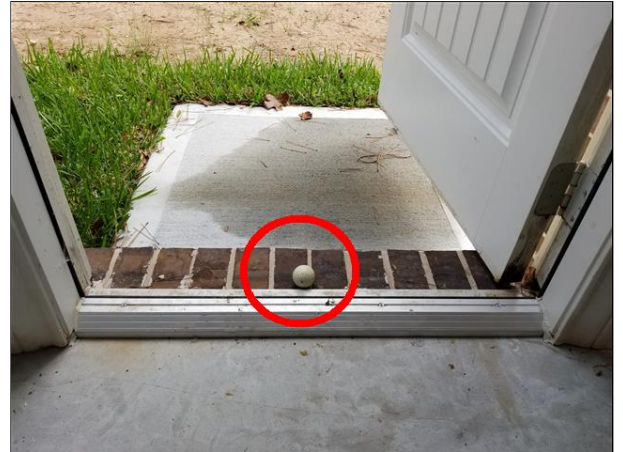
The brick sill did not slope away from the home

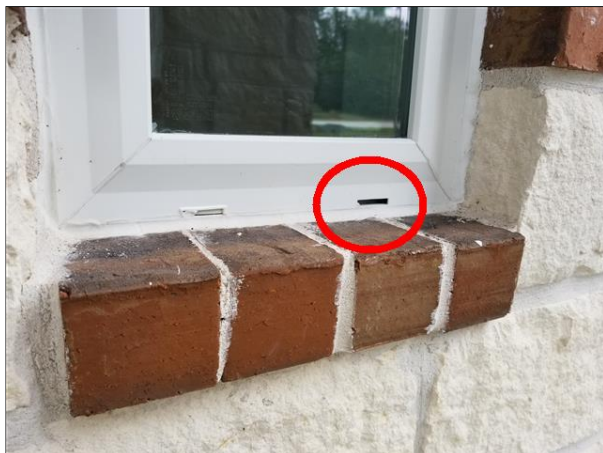
Observed vinyl windows that had missing weep hole inserts. The lower weep holes are designed to let water out of the window, while simultaneously preventing wind from infiltrating the home. When the weep hole inserts are missing, wind-driven rain can infiltrate the home causing water damage around the windows.

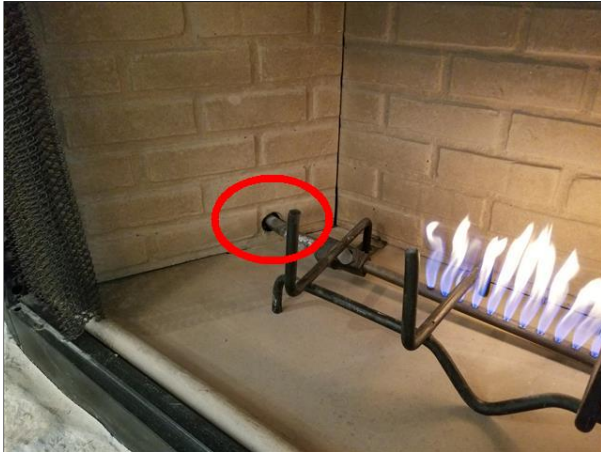
The gas line penetration through the refractory panel was not sealed. The opening in the refractory panel can provide access to areas outside of the fireplace by flames seeking combustion air; which is a potential fire hazard.

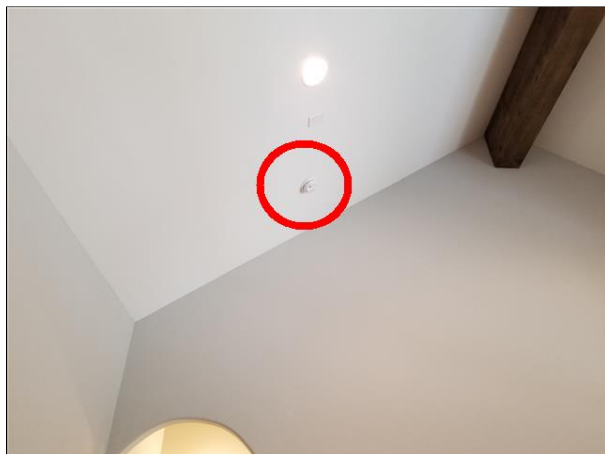
Observed a smoke alarm that was poorly located on the living room ceiling. Smoke alarms mounted on an A-frame ceiling typically need to be located 4 to 12 inches away from the peak of the ceiling to ensure that smoke gathering in the room will envelope and sound the alarm (heat and smoke rises).

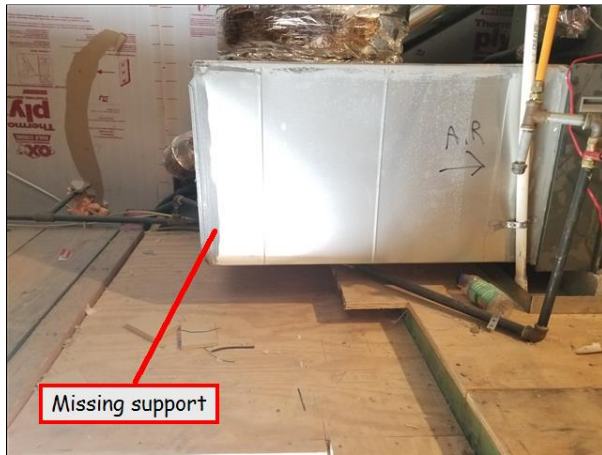
The return air plenum was missing blocking/strapping.

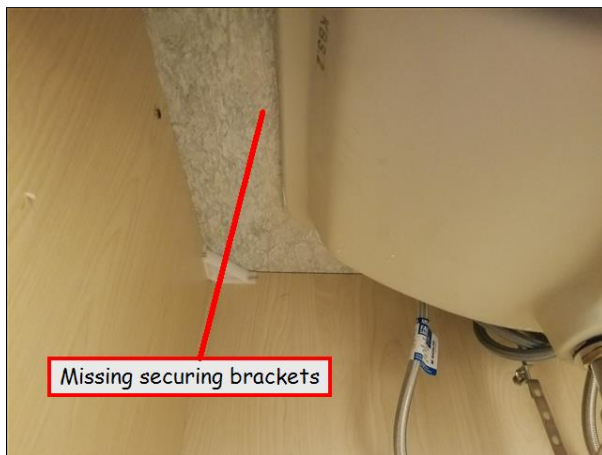
Location: Multiple locations

Observed multiple under-mount sinks that did not incorporate any securing mounts or brackets. The sinks were glued and caulked as the sole method of securing. It is recommended that a licensed plumber evaluate all of the under-mount sinks and repair as necessary.

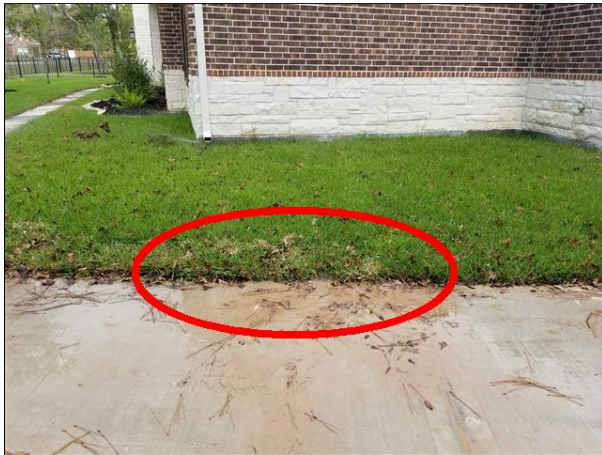
Location: Station #1

Observed an irrigation head/line that was damaged, which was causing a disruption in the delivery of water.

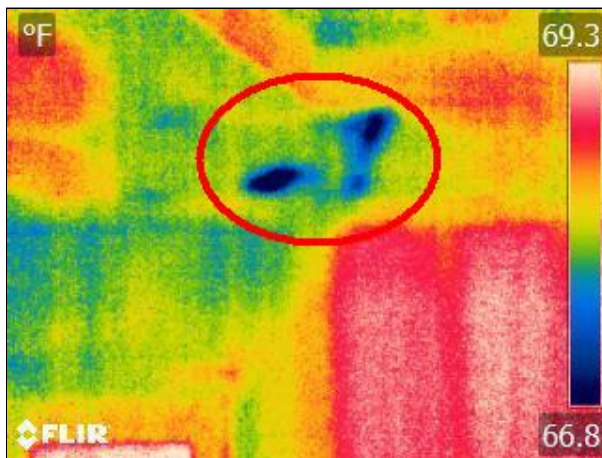
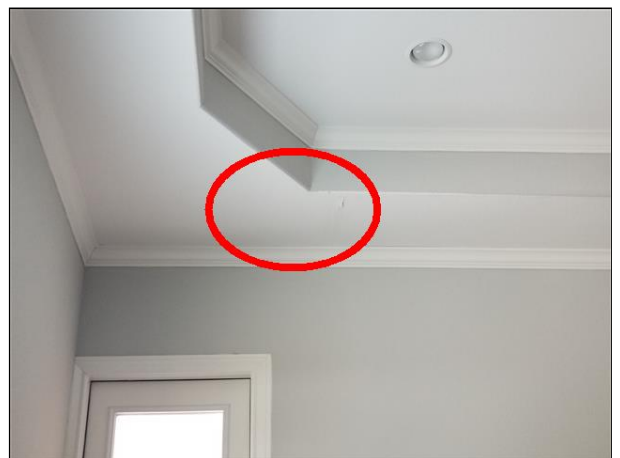
Location: Master bedroom

Observed an active water leak on the master bedroom ceiling. The blue circular spot in the thermal image shows the location of the water source, as confirmed by a non-contact moisture meter. It is recommended that a more invasive inspection be conducted to determine the origin of the water leak.

Thermal image showing the detected anomaly

Visible light image showing the general location of the detected anomaly

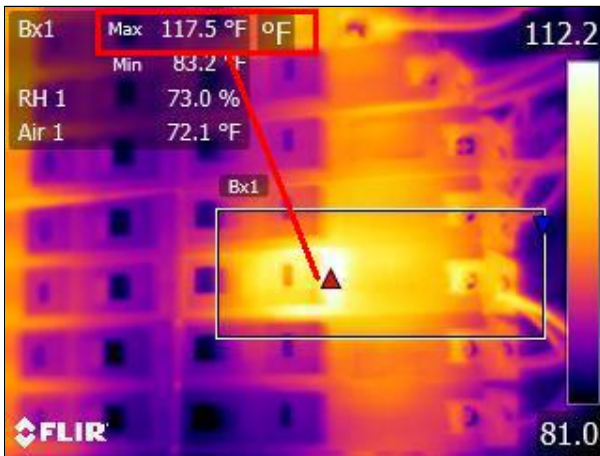
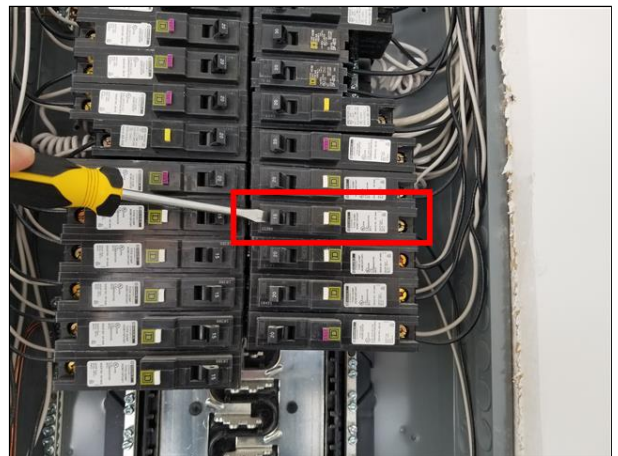
Location: Vent hood

Observed an arc-fault circuit interrupter (AFCI) breaker within the subpanel that had an elevated temperature, as compared to similar breakers with a similar load. The ampacity of the breaker was measured at 0.0 amperes with a max temperature of 117.5 degrees (approximate temperature). The origin of the over-heating may be located at a connection within the breaker itself, which could be a much higher temperature. It is recommended that a licensed electrician evaluate and repair as necessary.

Thermal image showing the detected anomaly

Visible light image showing the general location of the detected anomaly
