PROPERTY INSPECTION REPORT

Concerning: **227 Rose Gum Ct. Willis, TX 77318**

By: **Rodney Sims / Lic # 10271**

09/03/21 / 10:00

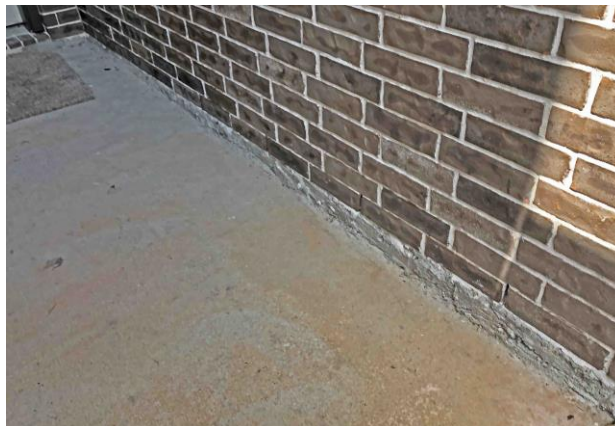
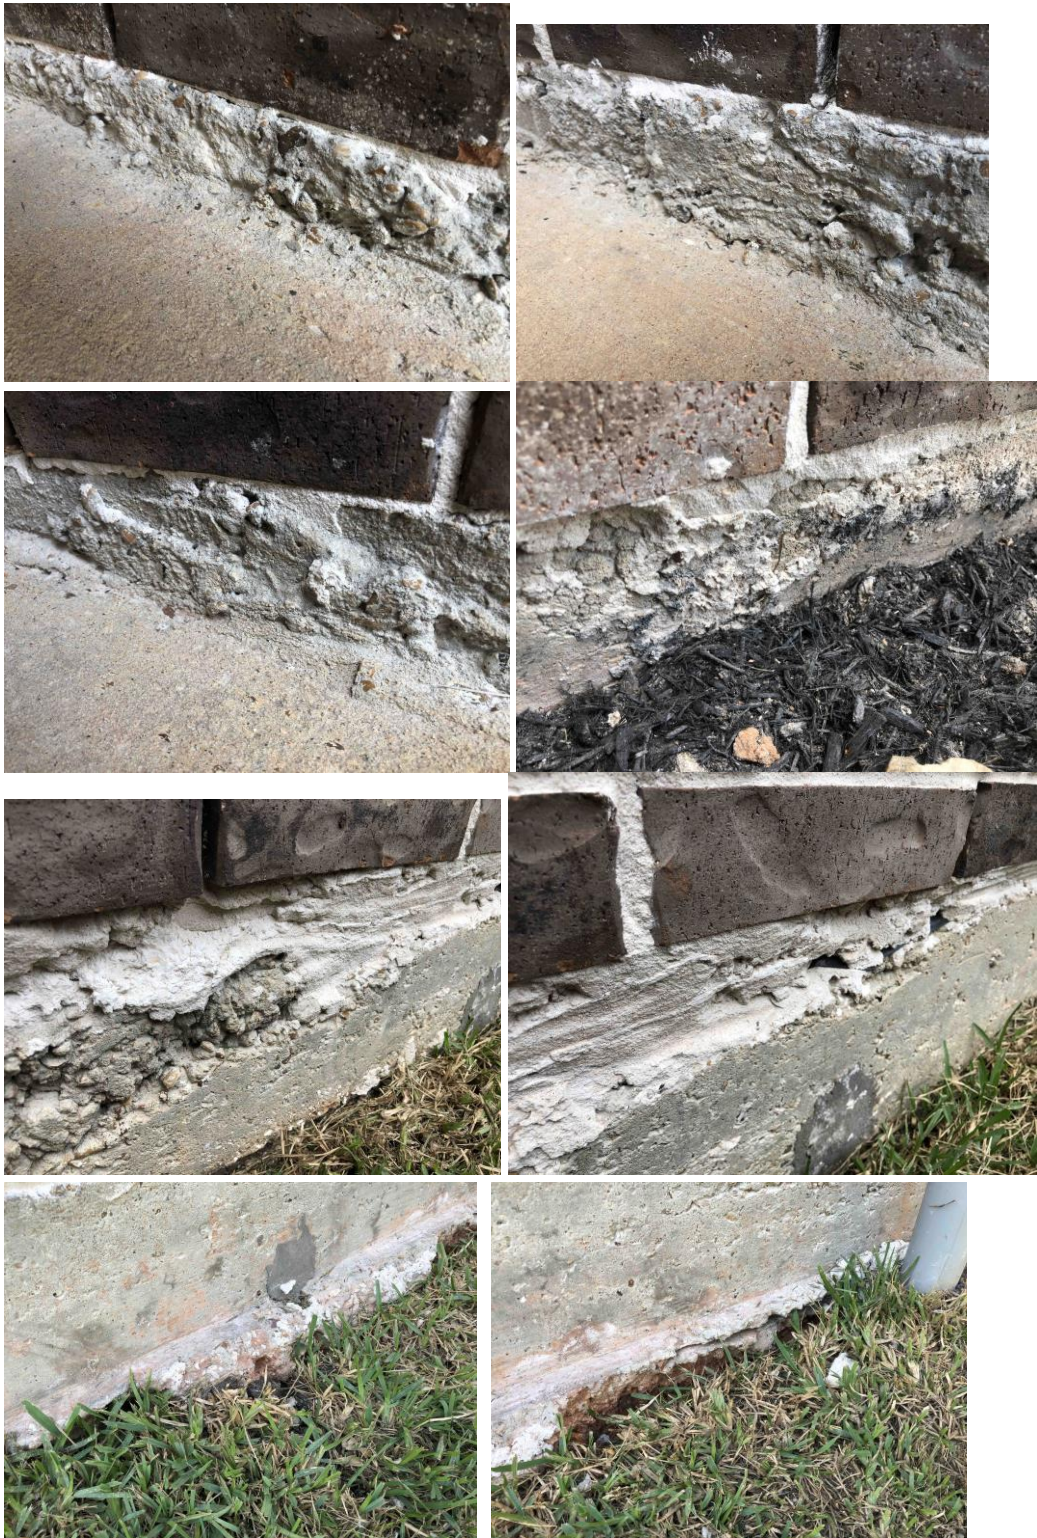
-The sides of the foundation were left unfinished, in a very rough unsightly manner in several locations.

-On the right side of the house the lower part of the foundation is visible where it protrudes outward a very notable amount and is very unsightly.

NOTE: -In the areas on the side of the foundation with the very rough unfinished appearance, the inspector highly recommends that a 'parge coat' or 'skim coat' of concrete is placed over the surface of those areas, as is commonly done by Chesmar Homes.

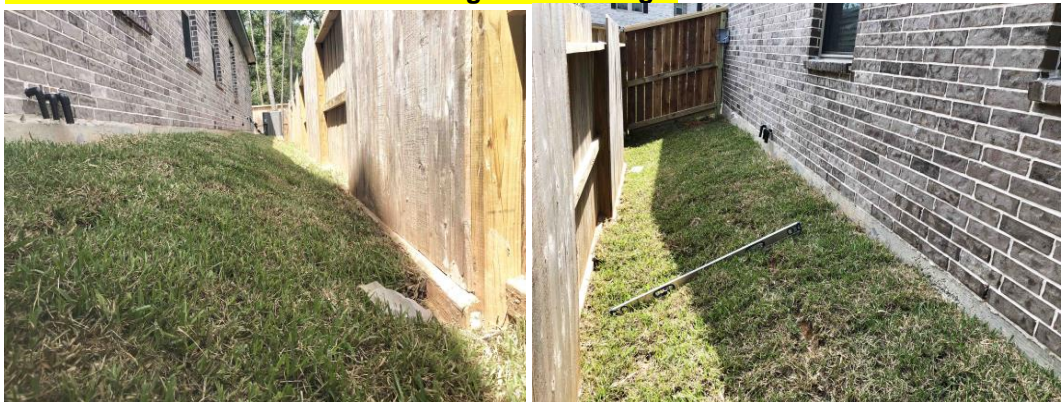
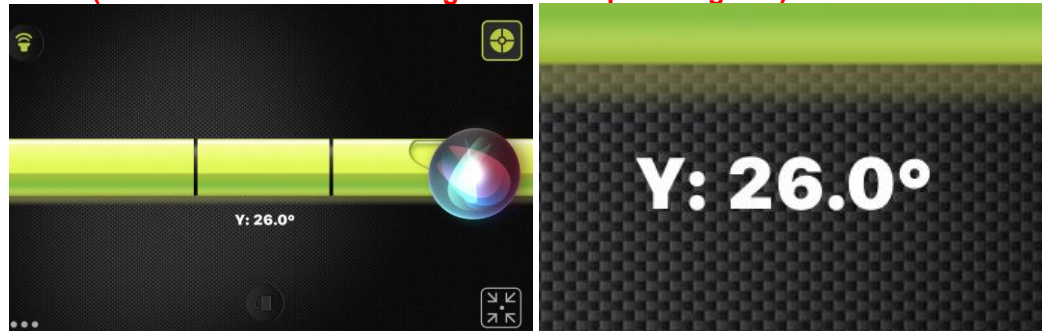
(Photos of the measured angle of the slope in degrees)

-On the right side of the property the slope of the grade was measured at 26.0 degrees (or 48.77 percent) which is considerably greater than 33.3 percent whereby building code requires an embedment and setback from the slope surface sufficient to provide vertical and lateral support for the footing without detrimental settlement, however no setback from the slope is present. Additionally, the inspector has no manner to determine whether the foundation footing adjacent to the slope surface is founded in material with an embedment, as required by code.

CODE REFERENCE: R403.1.7 Footings on or adjacent to slopes.
 "The placement of buildings and structures on or adjacent to slopes steeper than one unit vertical in three units horizontal (33.3-percent slope) shall conform to Sections R403.1.7.1 through R403.1.7.4."

CODE REFERENCE: R403.1.7.2 Footing setback from descending slope surfaces.
 "Footings on or adjacent to slope surfaces shall be founded in material with an embedment and setback from the slope surface sufficient to provide vertical and lateral support for the footing without detrimental settlement."

-This issue is required to be referred back to the Engineer of Record for the home to ensure that the foundation was engineered properly and adequately to meet all building code requirements for the slope present directly at the side of the foundation.

NOTE: -The inspector recommends that the Engineer of Record for the home provide a letter for the client stating that the foundation was engineered properly and adequately to meet all building code requirements for the slope present directly at the side of the foundation.

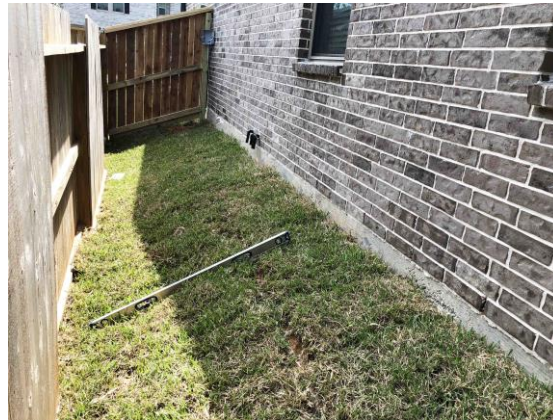
NOTE: -The inspector highly recommends that the client obtained the original Plot Plan from the builder to verify whether the slope on the right side of the property was designed and intended to be a 26 degree downward slope.

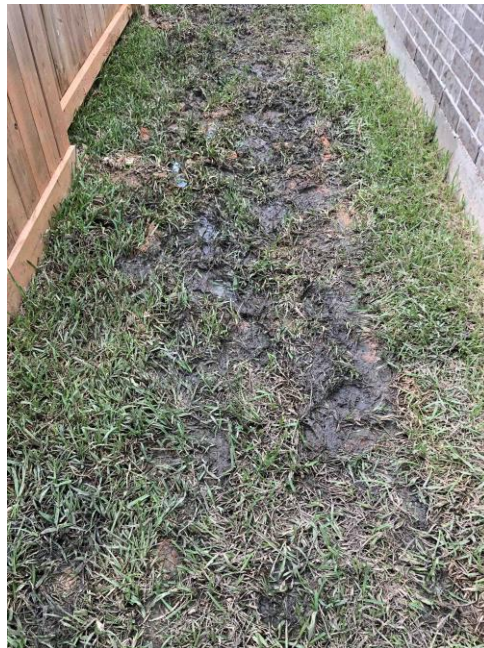
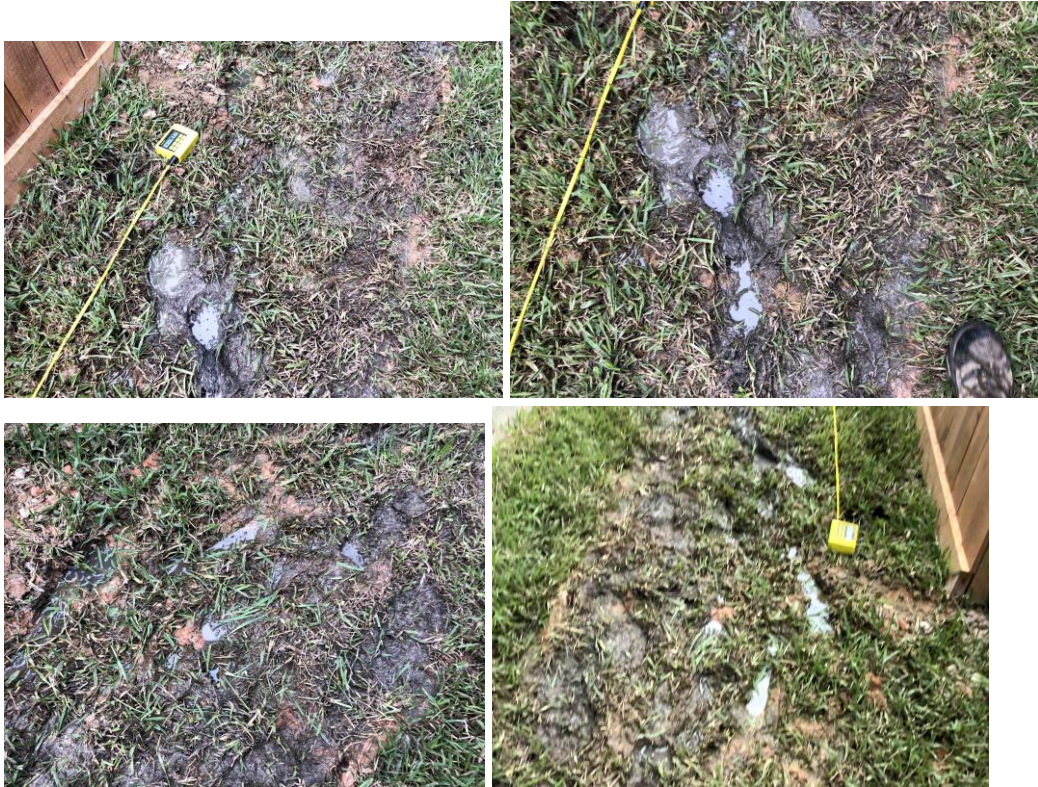
-On the left side of the property there was notable water ponding and mud present on the day of the inspection beginning roughly 43 feet behind the fence and extending to a point roughly 62 feet behind the fence, adjacent to the back left corner the house.

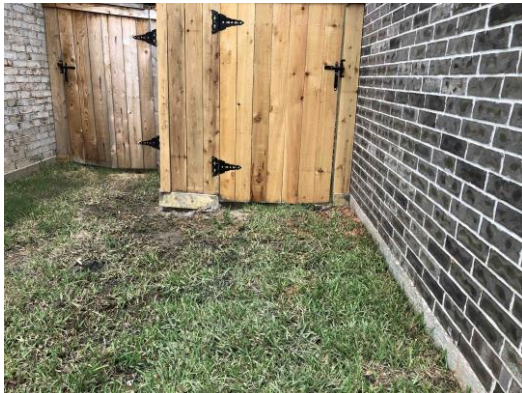
-On the left side of the property there was a very notable amount of mud and soggy soil in front of the side fence for a distance of roughly 7-8 feet.

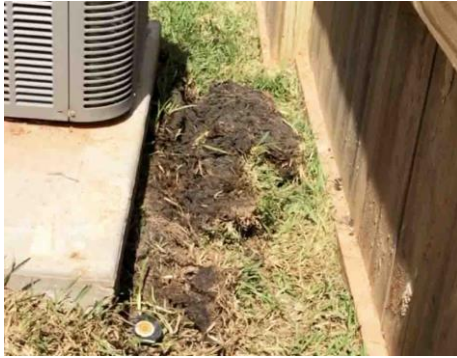
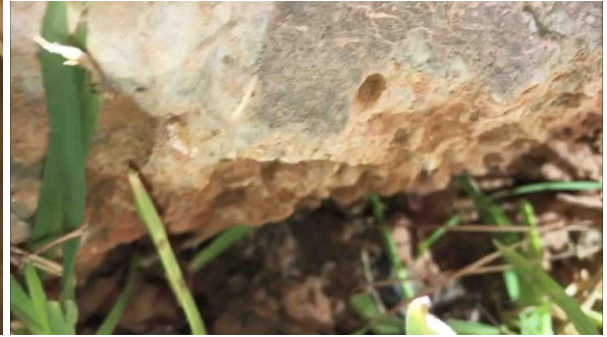
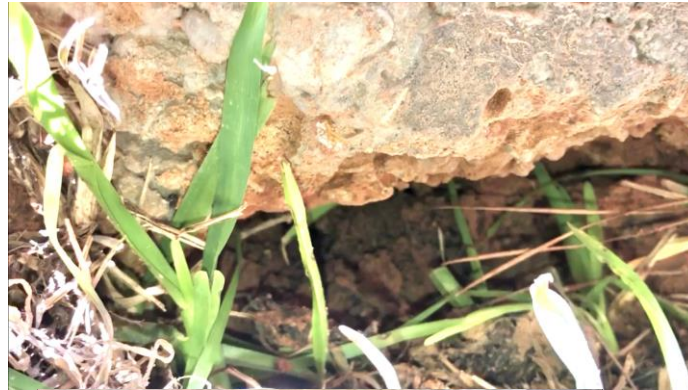
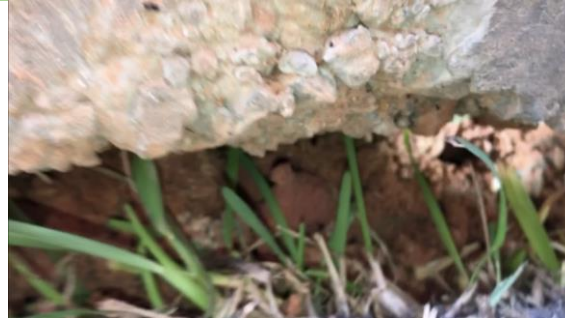
-There is a large amount of erosion under the outer portion of the air conditioner pad. This unstable condition may lead to the air conditioning condenser tilting, which is not allowed by the air conditioning condenser manufacturer.

NOTE: -Due to the extreme grade on the right side of the air conditioning condenser pad where the erosion is present, the inspector recommends filling that area with concrete.

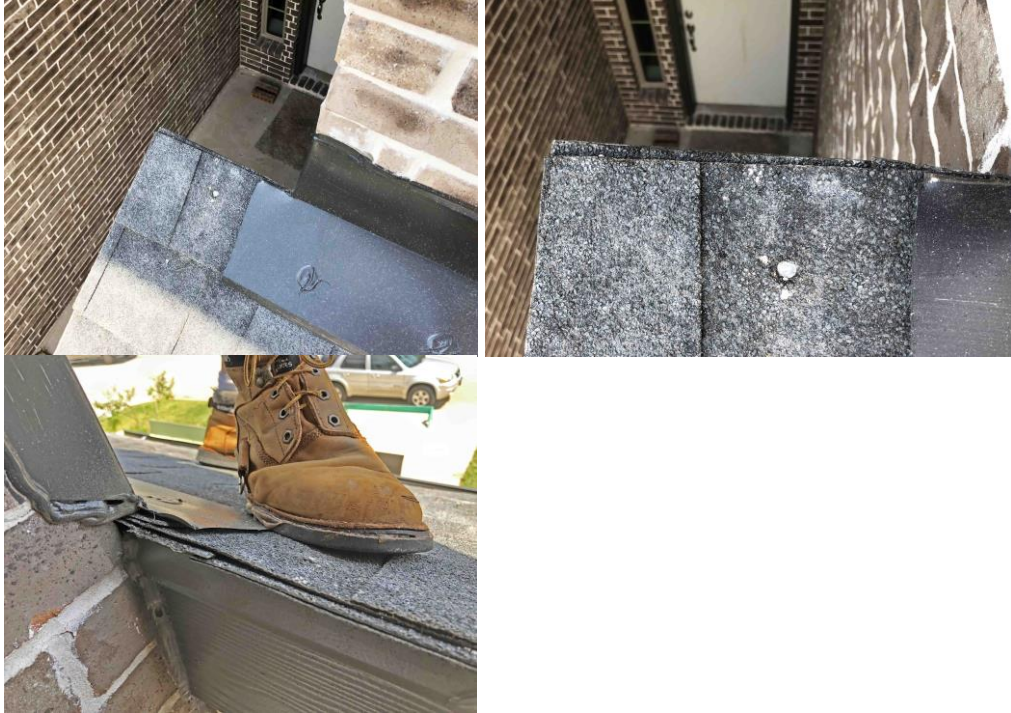
-At the roof rake on the right side of the front porch, at the portion of the roof rake that extends out roughly 8 inches past the wall, that area should have a flashing over the shingles that also turns down on the back of the fascia board.

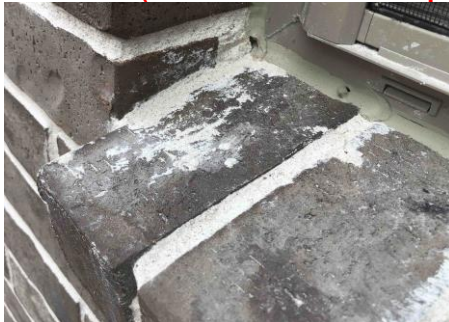
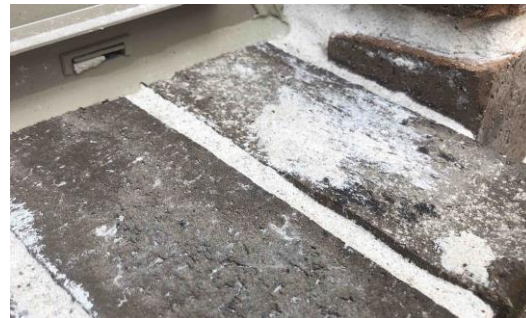
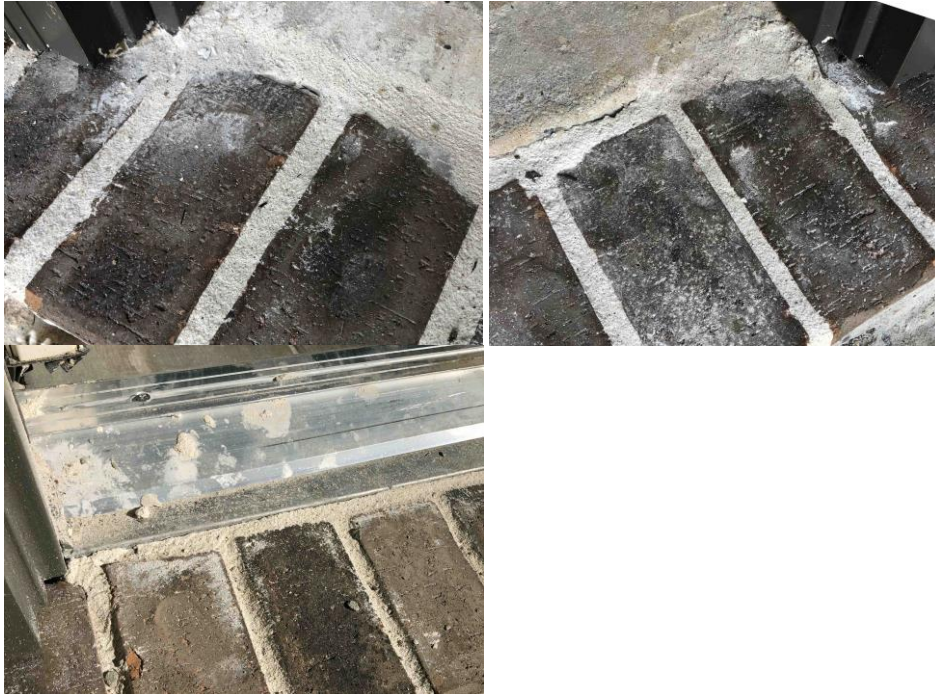
-At several/numerous locations there was brick mortar and brick mortar residue on the brick at the window sills and any other locations. (An acid wash may be required to remove the brick mortar residue.)

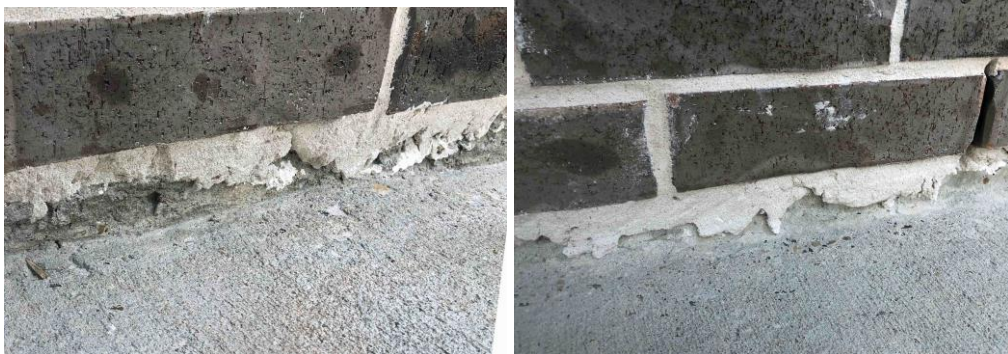
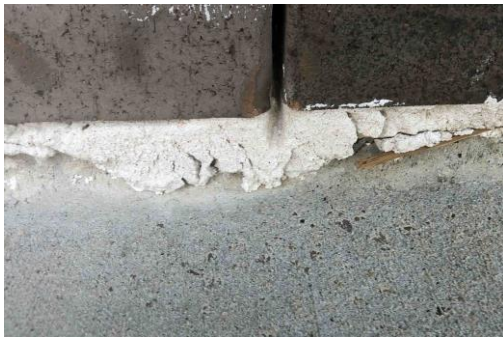
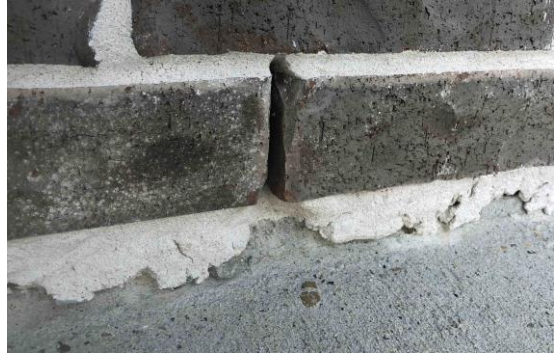
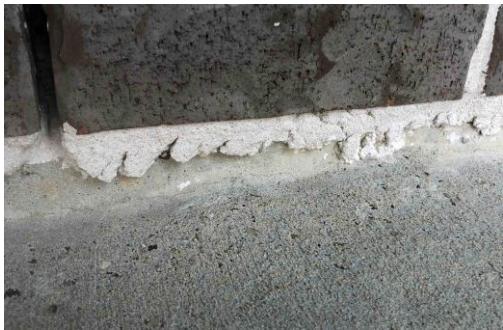
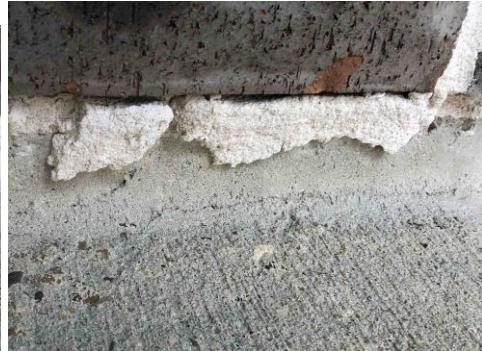
-At several/numerous locations at the bottom row of the brick, the brick mortar overlaps the side of the foundation a very considerable amount in a very unsightly manner.

-In the back of the home, behind the master bedroom area the brick mortar on the lowest course of brick overlaps the side of the foundation substantially and was never cleaned off or removed.

-Around the back patio in many locations.

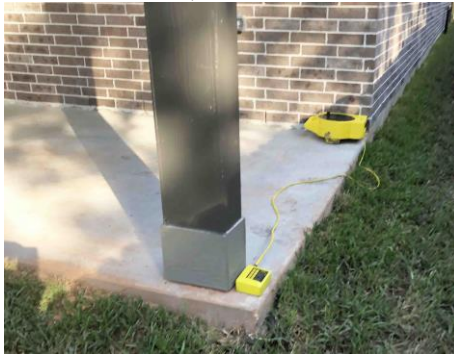
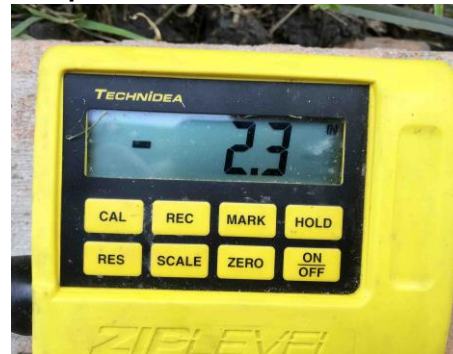
NOTE: -The maximum slope for a landing at an exterior door is 1/4 inch per foot.

-The patio is 7.5 feet deep, considering the allowed slope of 1/4 inch per foot, the maximum allowed drop over that distance is 1.875 inches.

NOTE: -The Right side of the back porch (the side where the back door is located) slopes downward toward the outer edge 1.8 inches over a distance of 7.5 feet, which is 'within' code requirements.

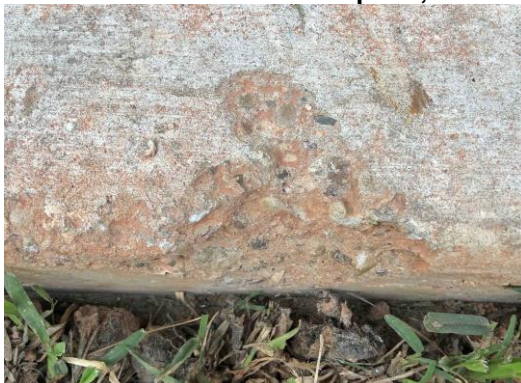
-On the left end of the back patio, there is a notable chunk out of the concrete.

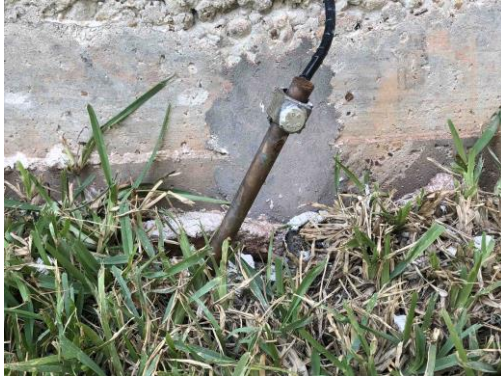
-The grounding electrode is not driven into the ground for the full eight feet length of the grounding rod, as required.

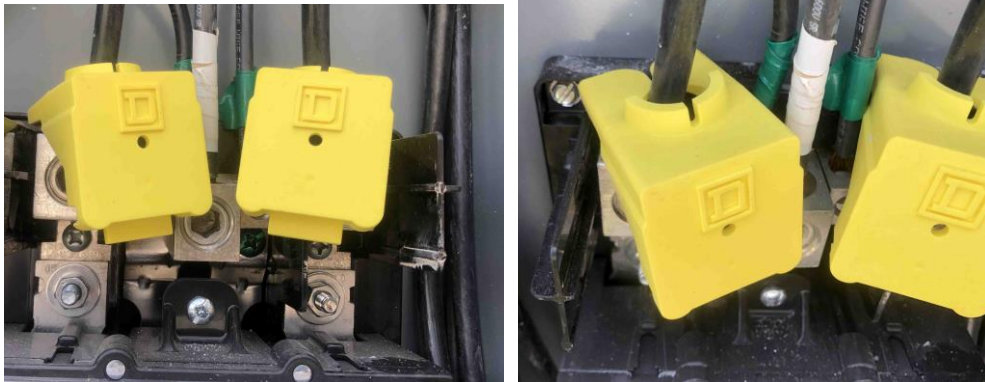
-The service entrance barriers are loose and crooked and not installed properly, as specified and required by the manufacturer.

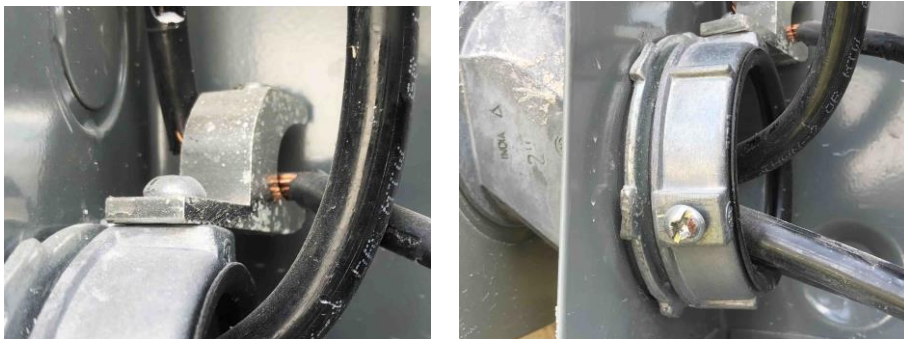
-The bonding clamp on the bonding bushing is extremely loose.

-The metal conduit between the meter can and the primary panel is very loose because the nut on the conduit inside the primary panel was not tight.

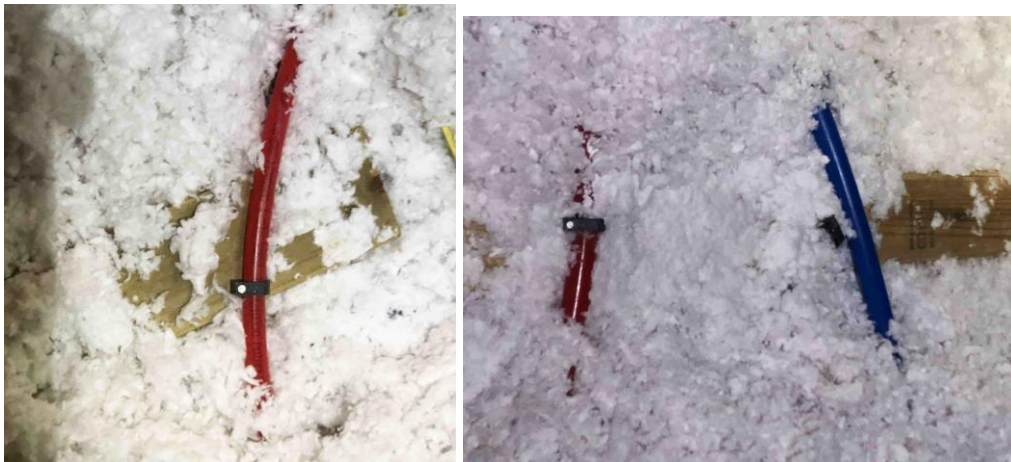
-In the attic, some of the Pex plumbing was not protected from freezing (insulated) as is required by the manufacturer.
