## **PRELIMINARY FOUNDATION INSPECTION REPORT: JOB NO. 23-LJ083**

**LOCATION:** 159 Corkwood  
Lake Jackson, TX

**DATE OF  
INSPECTION:** March 23, 2023

Proposed Foundation Repair  
159 Corkwood  
Lake Jackson, TX

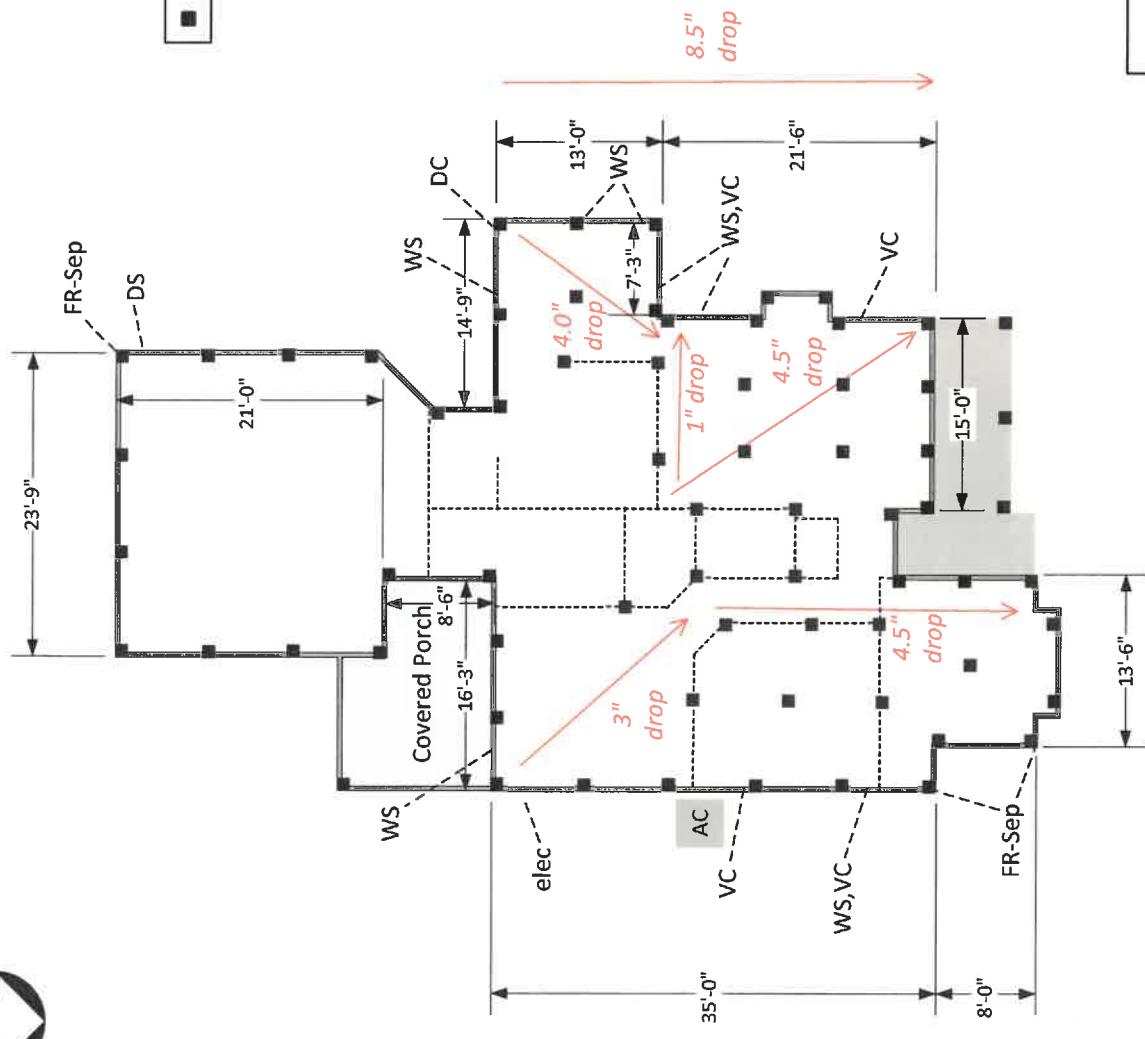
The entire perimeter of the structure shows settlement, with the front, left and right perimeter showing significant foundation movement. The interior of the structure shows over 8" of settlement when comparing the back perimeter to the front perimeter. Exterior deficiencies show multiple brick veneer cracks throughout and multiple windows show significant separation from the brick veneer. See the attached drawing showing deficiency locations in more detail. The interior of the structure shows significant floor slope with sheetrock cracks in the ceilings, above door frames and adjacent to windows. Door misalignment is present throughout the interior of the structure. The foundation movement is due to seasonal moisture changes in the expansive clay soil over the life of the structure. I recommend that pressed piles be installed as shown in the attached drawing both to stabilize the foundation and to aid the house in bearing in a soil zone of constant moisture and firmer stratum of soil.

I recommend the installation of 47 perimeter and 20 interior pressed piles. The intent of the repair plan is to stabilize the settlement and adjust as necessary to correct door frame misalignment while minimizing cosmetic deficiencies. Due to the amount of settlement, the likelihood that floor slope still exist after the repair is high. Pile locations should be added as noted on the attached drawing. All work should be in accordance with the details and specifications as shown. These repairs should stabilize this part of the foundation for the remaining life of the house. The engineer will not assume any liability for any cracks created during leveling or for any new cracks or damage to the structure which may appear during the leveling procedure. Please note that I shall not control or have charge of, and shall not be responsible for, construction means, methods, techniques, sequences, procedure of repair, health or safety programs or precautions contained with the work and shall not manage, supervise, control, or oversee construction. Further, I shall not be responsible for the acts or omissions of the contractor or other parties on the project. I have provided the service in a professional manner that meets generally accepted practices in residential construction. My entire warranty and liability will be limited to the payment received for my work performed.
