**TEXAS REAL ESTATE COMMISSION
PROPERTY INSPECTION REPORT**

**Prepared For: Diane and Micah Tomlinson
149 Waterstone, Montgomery, TX 77356**

August 20, 2020

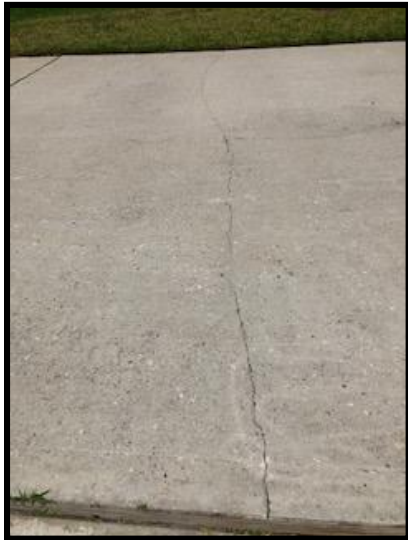
- The driveway is cracked.

Cracked driveway

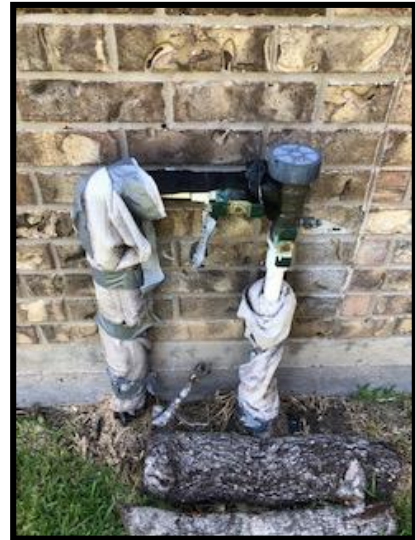
Not secure to wall

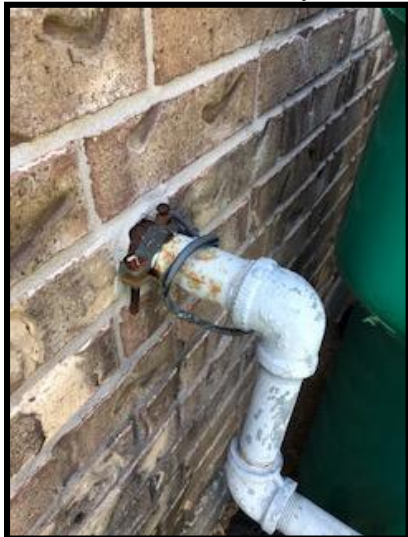
- A leak was detected at the powder bathroom commode.
- The gas line is not sleeved through the brick at the exterior gas meter; this may not have been required at the time of construction.

Not sleeved

▲ Recommend repairs and further evaluation by a qualified, licensed plumbing contractor.

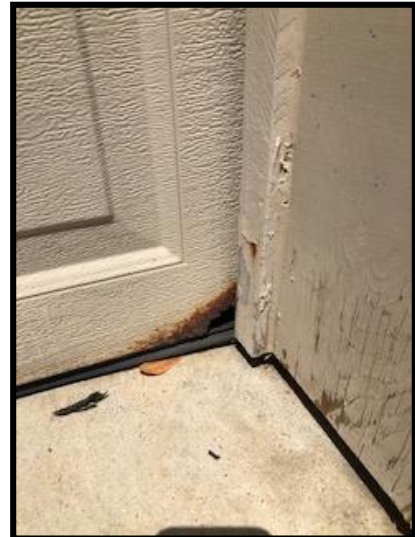
Damaged door

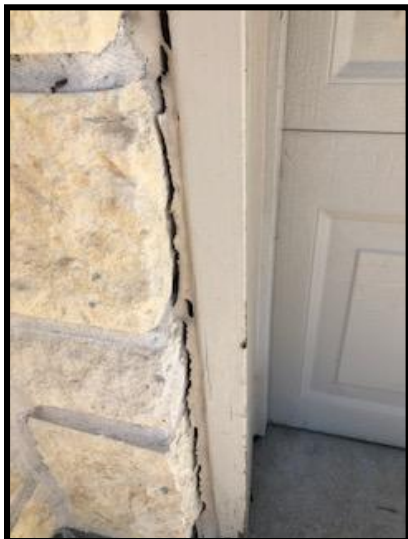
Trim separating from brick

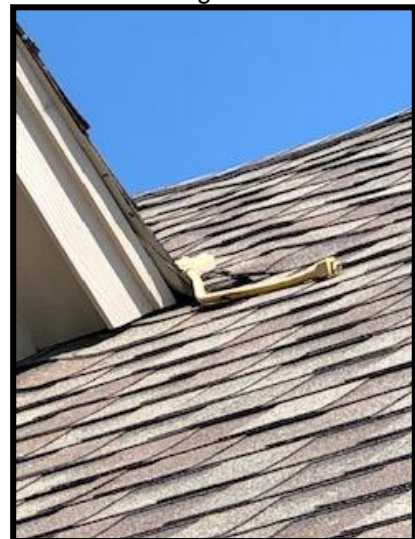
Extension cord

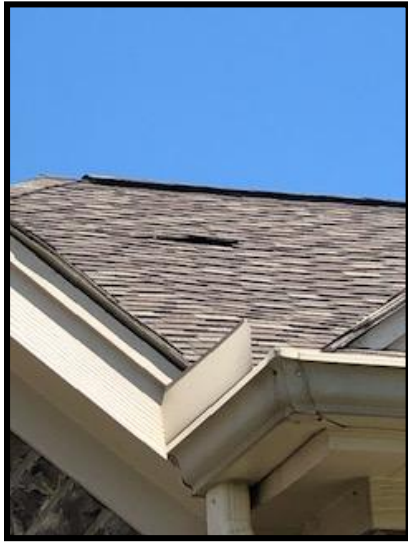
- Raised shingles at the front roof.
- Exposed nail heads at the roof jacks. Missing mastic.

Raised shingle

▲ A qualified roofing contractor is recommended for repairs and further evaluation.

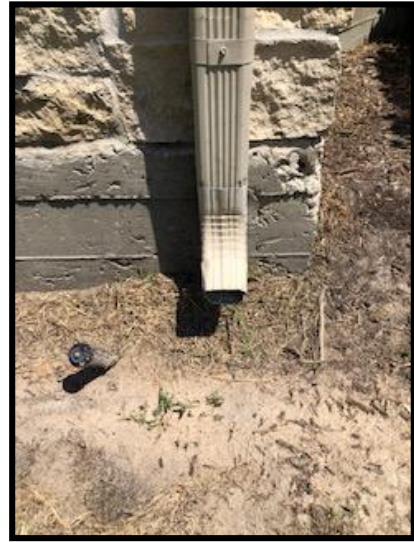
- The gutter/downspout is not secure at the rear porch.
- The downspout extension is missing at the rear porch.
- The gutter/downspouts are missing splash blocks.

Missing splash blocks

▲ A qualified contractor is recommended for repairs and further evaluation.

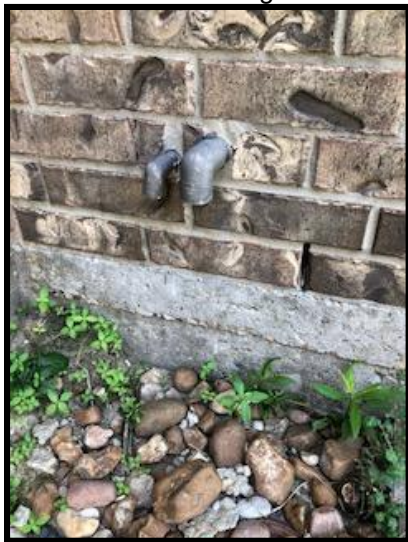
Drain too high

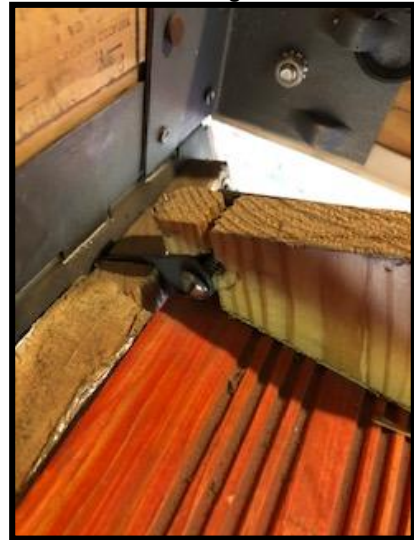
- The nuts and bolts are not secure at the attic access ladder.
- The attic access ladder is cracked/damaged at the upper section.
- The attic access frame is missing nails.
- The garage overhead door (single door) is damaged/corrosion at the lower section.
- The door(s) are damaged at the front bedroom and the garage/utility door.
- The door stops are missing at various doors.
- The garage door trimmer is separating from the brick.

Cracked attic ladder

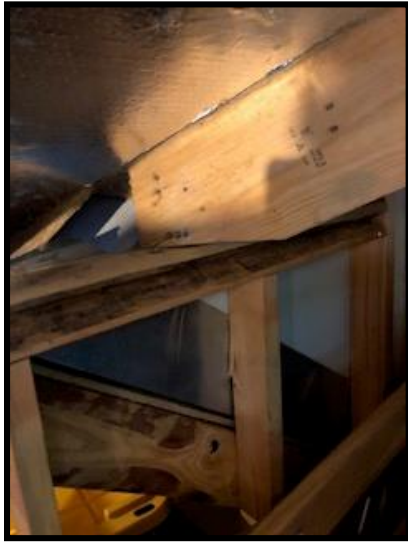
- Voids at the garage/entry roof.
- Missing studs under the garage valley.

Missing studs

▲ A qualified contractor is recommended for repairs and further evaluation.

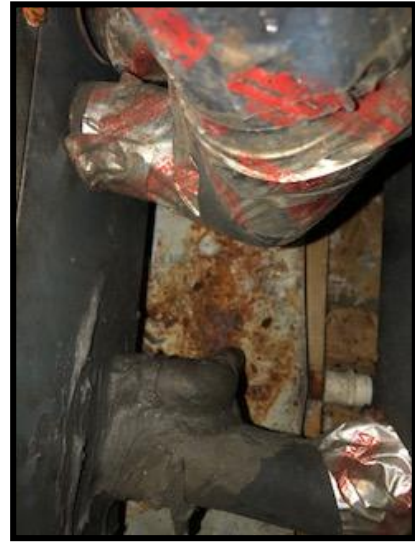
- The evaporator overflow pan shows evidence of corrosion.
- Improper air temperature in the powder bathroom.

Corrosion in AC pan

▲ Recommend repairs and further evaluation by a licensed, qualified H.V.A.C. contractor.

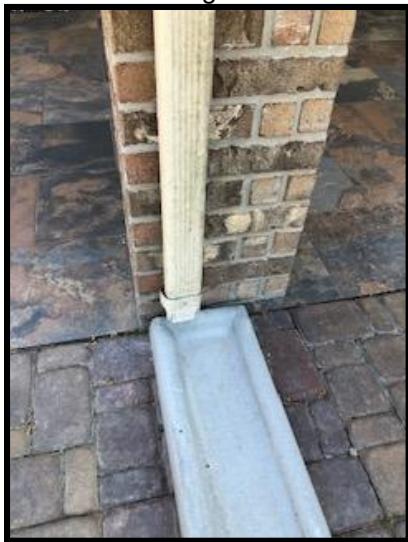
Missing extension

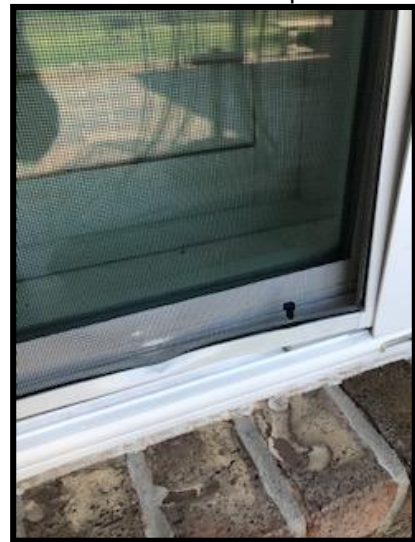
- The screens are damaged at the rear porch and right side windows.

Damaged screen

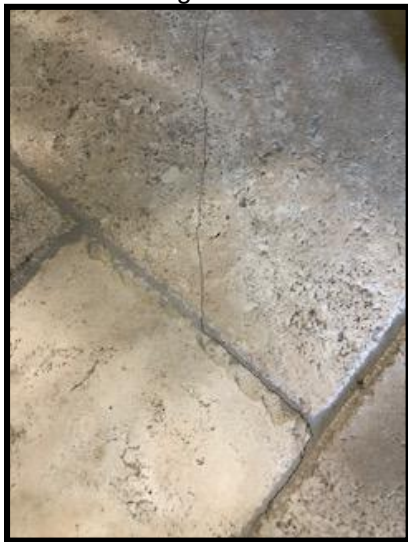
- The floor tiles are cracked in the breakfast, powder bathroom and foyer.
- Unknown stains to the second foyer ceiling.
- Repairs have been made to the floor tiles in the breakfast room.
- Small defects (nail holes, dents, etc.) in various areas of the ceiling drywall.
- It appears the interior ceilings have recently been painted; defects may not be detected in these areas.

Cracked floor tiles

▲ A qualified contractor is recommended for repairs and further evaluation.

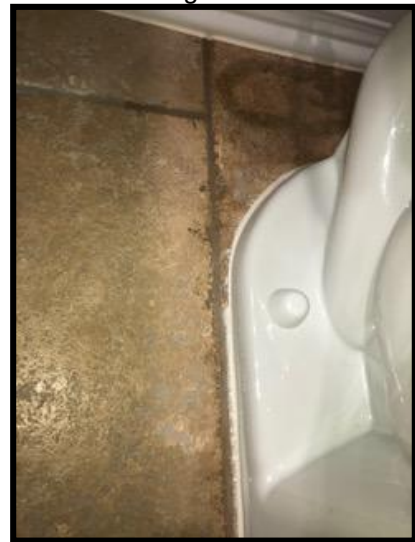
Leak at commode

▲ Recommend repairs and further evaluation by a qualified, licensed plumbing contractor.

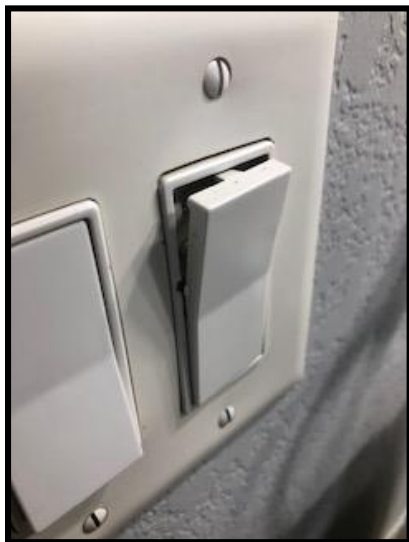
Voids at light switches

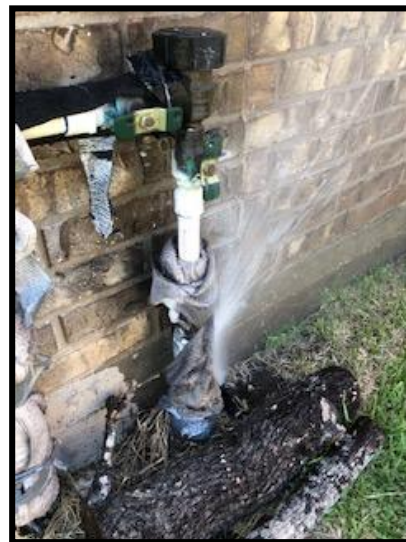
Sprinkler head

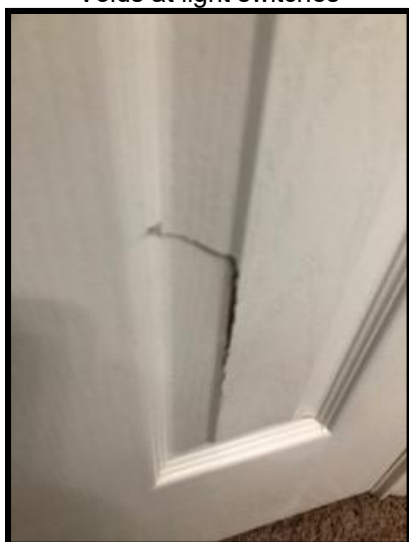
Damaged door

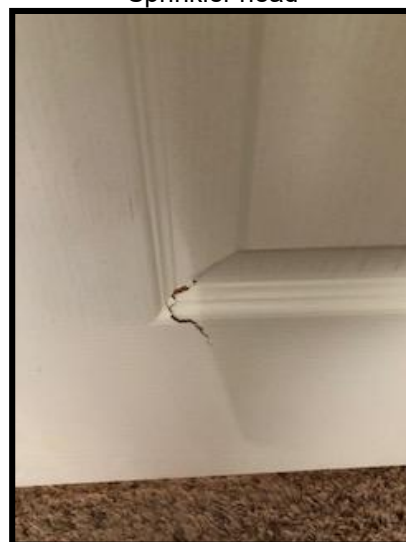
Damaged door

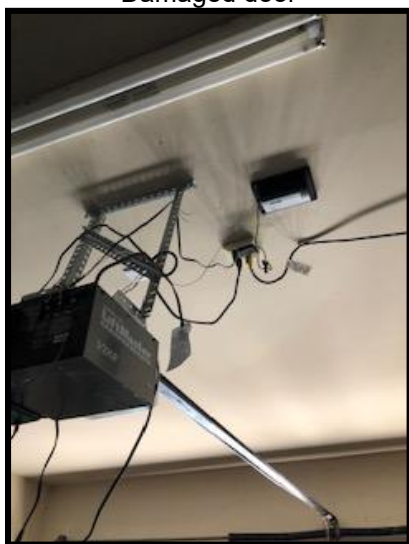
Extension cords

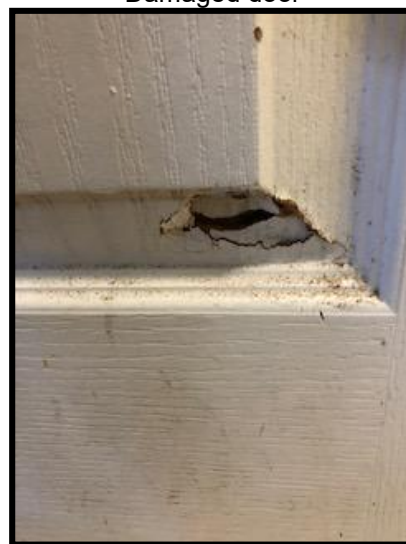
Damaged door
