Web Presentation

Property Address: 10303 Horsehose Bend Dr., Houston, TX 77064

American Dream Inspections TX, llc

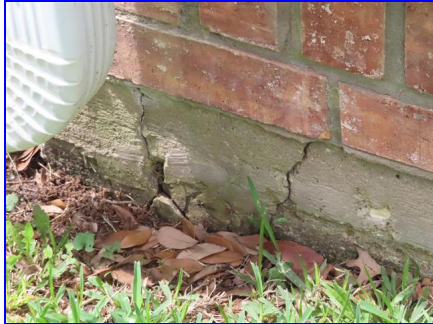
A. Item 1(Picture)

(1) Foundation was working as intended at time of inspection. All foundation penetrations, gaps and cracks should be sealed properly. Conducive to moisture and WDI (Wood Destroying Insect) intrusion.

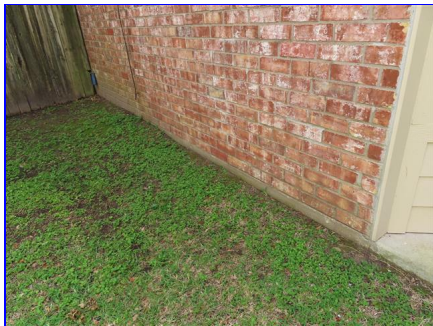
A. Item 2(Picture)

(2) Soil was too high and covering the foundation in several areas of the structure at time of inspection. Could not inspect foundation for any defects or deficiencies in these areas at time of inspection.

Foundation issues could be hidden and not visible at time of inspection. It's always recommended to have a professional inspect and further evaluate foundation for any defects or deficiencies.

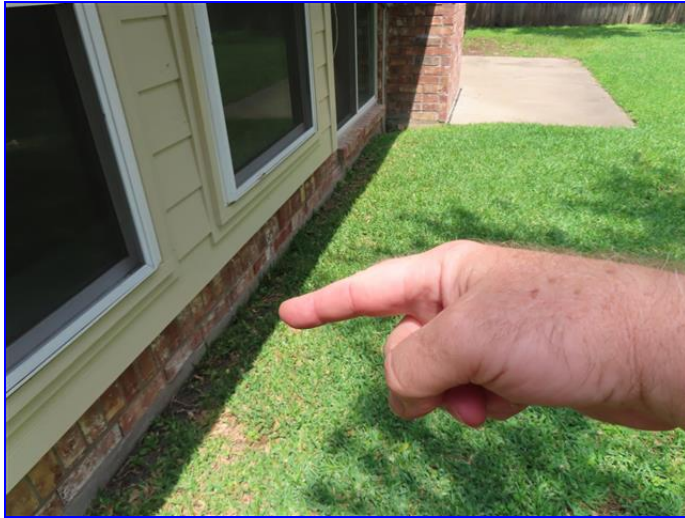
B. Item 1(Picture)

- 1) Rear grading is sloped toward the foundation at time of inspection. Soil was too high to the foundation and siding in several areas at time of inspection. Soil should be graded 6" in 10' away from the foundation. Soil should be at least 4" from bottom of brick and 6" from bottom of siding. Conducive to moisture intrusion and causing possible damage.

Rear grading is sloped toward the foundation at time of inspection. Soil was too high to the foundation and siding in several areas at time of inspection. Soil should be graded 6" in 10' away from the foundation. Soil should be at least 4" from bottom of brick and 6" from bottom of

siding. Conducive to moisture intrusion and causing possible damage.

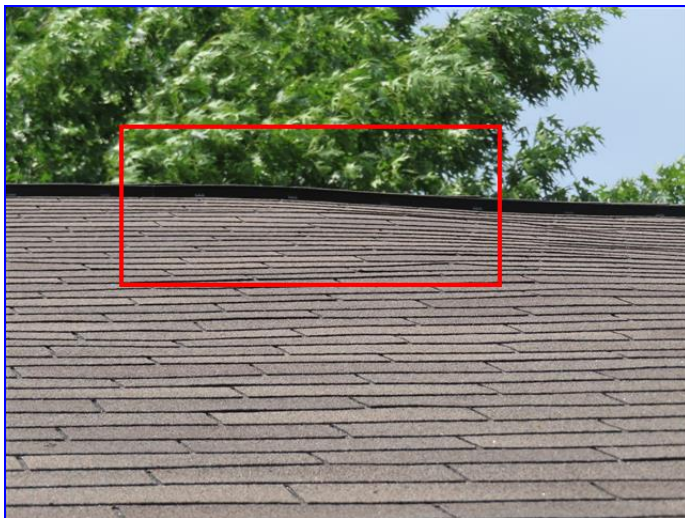
C. Item 3(Picture)

- 2) Roofing has deflections and lifting at ridge in several areas at time of inspection. Should have a professional roofer evaluate.
- 3) All lifted roof shingles should be corrected and sealed properly by a professional roofer. Conducive to moisture intrusion and causing possible damage. Should have a professional roofer inspect and evaluate roofing.

(1) Roofing has deflections and lifting at ridge in several areas at time of inspection. Should have a professional roofer evaluate.

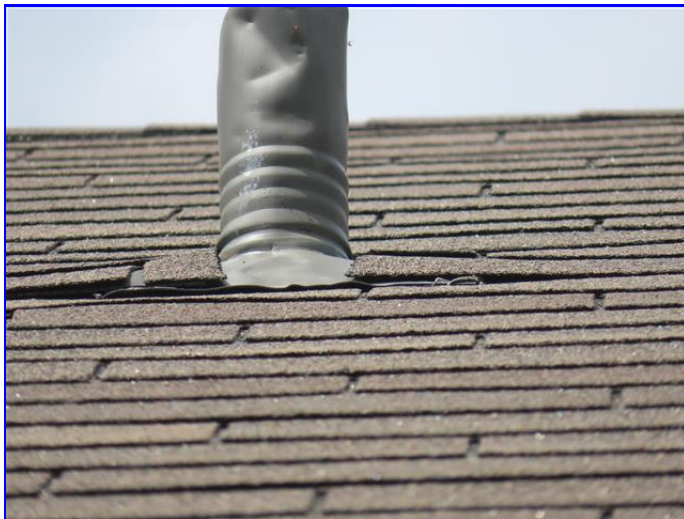
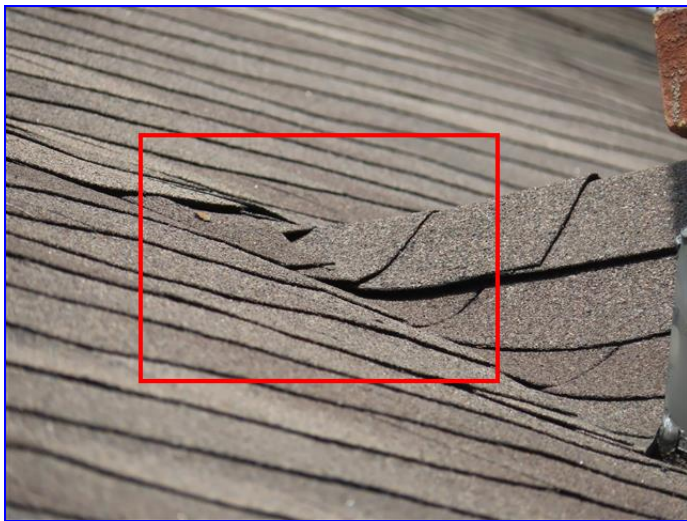
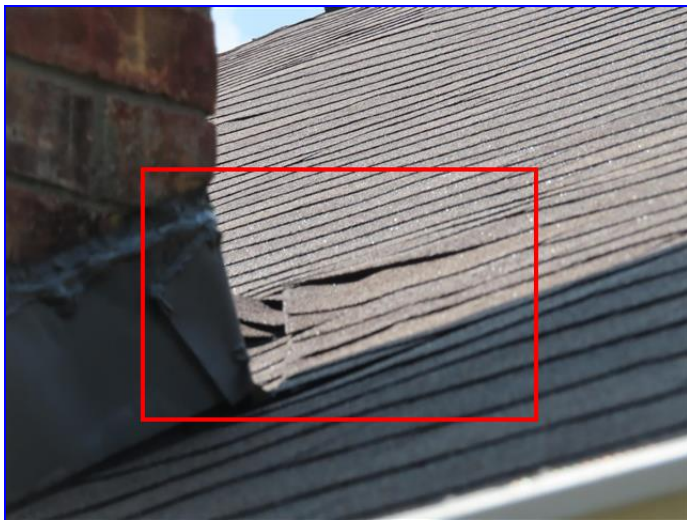
(2) All lifted roof shingles should be corrected and sealed properly by a professional roofer. Conducive to moisture intrusion and causing possible damage. Should have a professional roofer inspect and evaluate roofing.

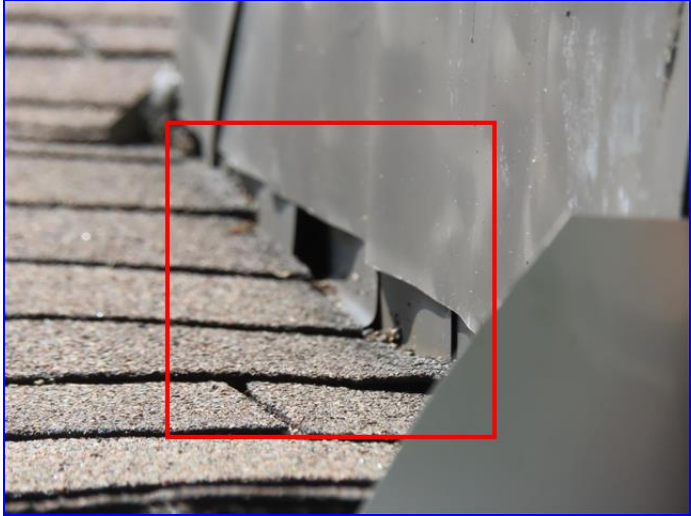
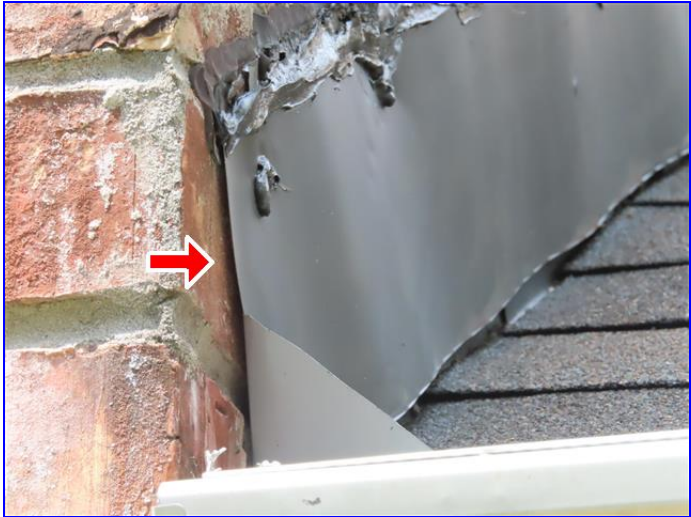
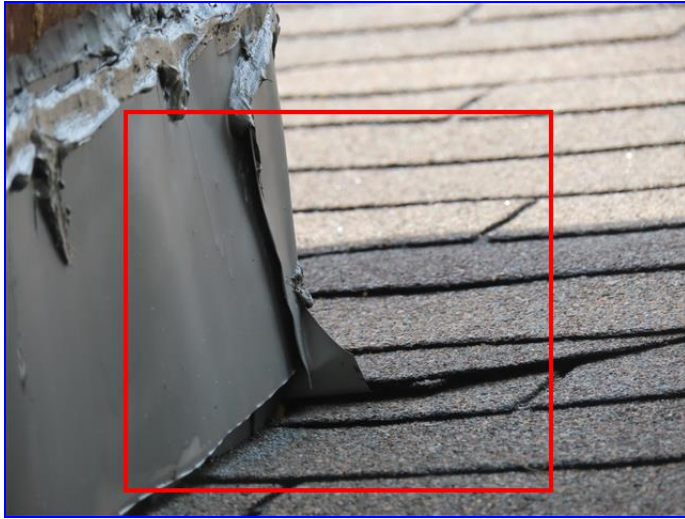
- 4) All lifted roof flashing should be corrected and sealed properly. Conducive to leaking and causing possible damage. Should have a professional roofer inspect and evaluate roofing.

(3) All lifted roof flashing should be corrected and sealed properly. Conducive to leaking and causing possible damage. Should have a professional roofer inspect and evaluate roofing.

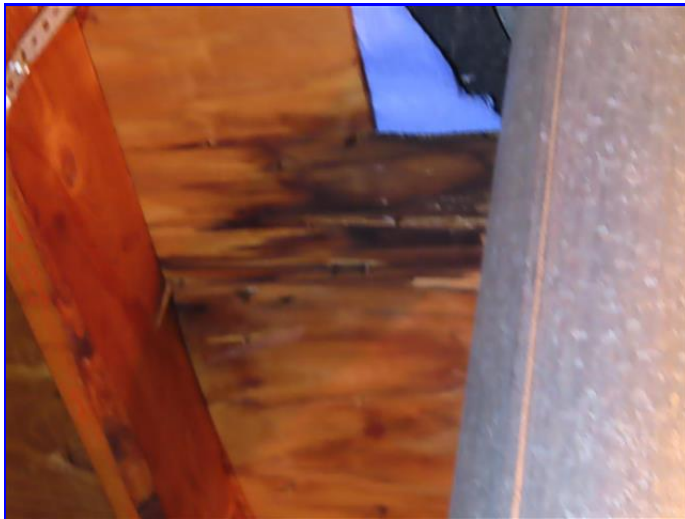
C. Item 11(Picture)

- 5) Roof sheathing at furnace exhaust has moisture staining, damage and rot at time of inspection. Should have a professional roofer inspect and correct properly.

(4) Roof sheathing at furnace exhaust has moisture staining, damage and rot at time of inspection. Should have a professional roofer inspect and correct properly.

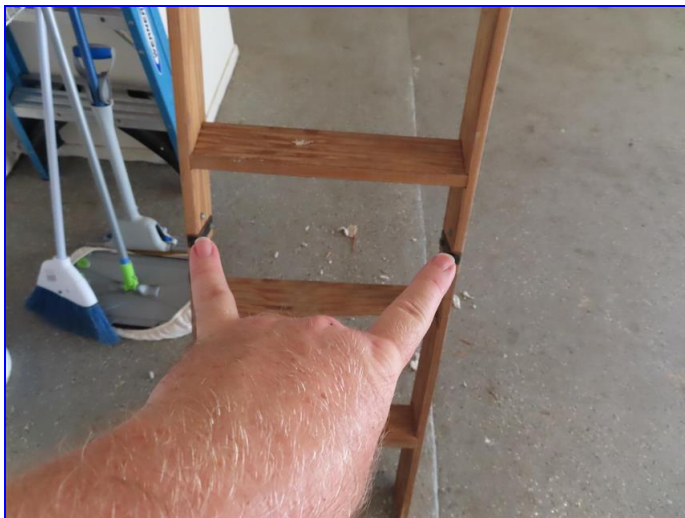
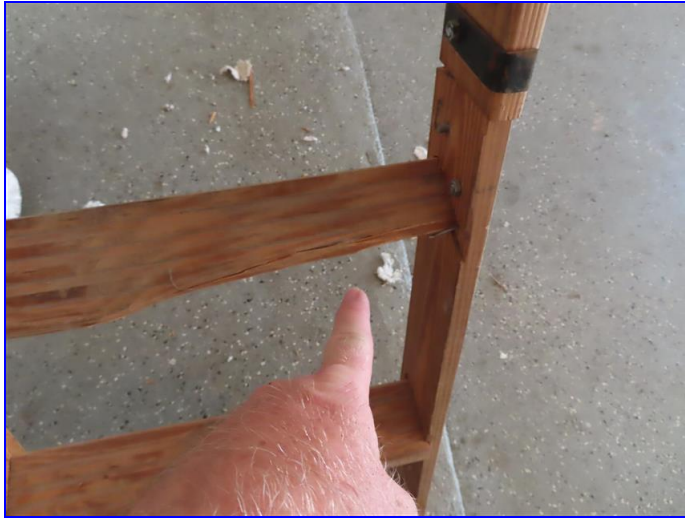
- 6) Attic ladder and hardware were loose and step was damaged at time of inspection. Should have a professional correct properly. This is a possible safety hazard.

(1) Attic ladder and hardware were loose and step was damaged at time of inspection. Should have a professional correct properly. This is a possible safety hazard.

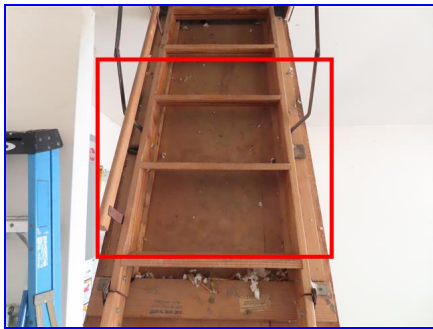
D. Item 3(Picture)

- 7) Attic door access in the garage should be sealed and insulated properly. Conducive to leaking Carbon Monoxide into attic and into living space. Possible safety hazard.

(2) Attic door access in the garage should be sealed and insulated properly. Conducive to leaking Carbon Monoxide into attic and into living space. Possible safety hazard.

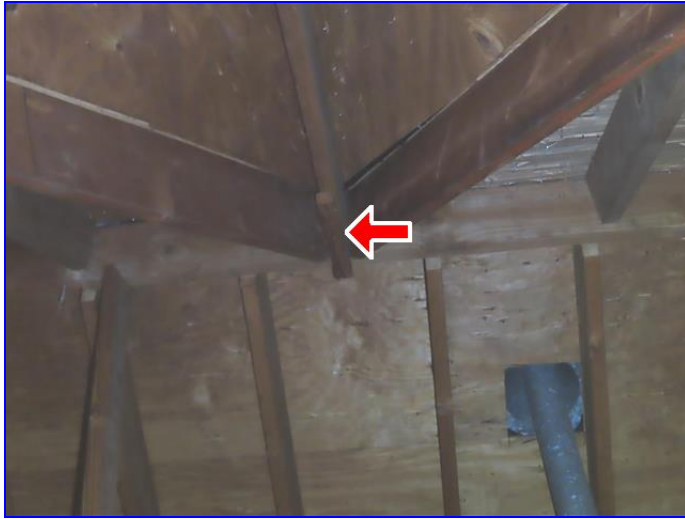
D. Item 4(Picture)

- 8) Roofing structure in garage attic was missing vertical support at time of inspection. Should have a professional correct properly. This is a possible structural issue.

(3) Roofing structure in garage attic was missing vertical support at time of inspection. Should have a professional correct properly. This is a possible structural issue.

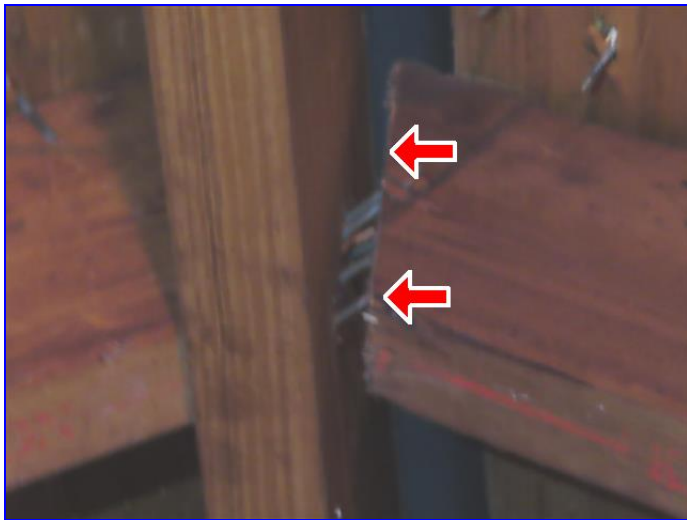
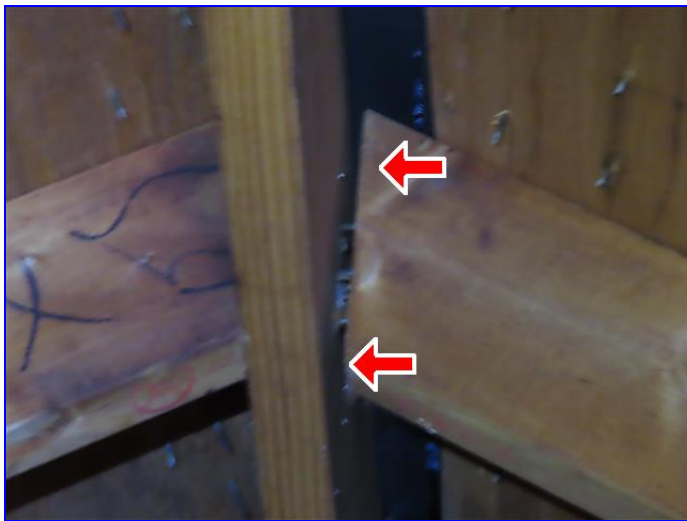
- 9) Rafters in the attic were separating in several areas at time of inspection. Should have a professional correct properly. This is a possible structural issue.

(4) Rafters in the attic were separating in several areas at time of inspection. Should have a professional correct properly. This is a possible structural issue.

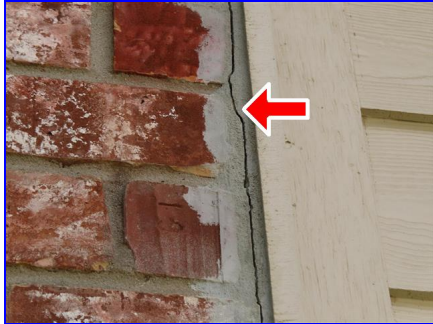
E. Item 1(Picture)

(1) All exterior brick wall penetrations, gaps or cracks should be sealed properly. Conducive to moisture and WDI (Wood Destroying Insects) intrusion.

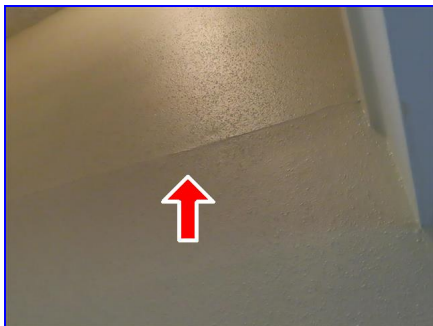
E. Item 2(Picture)

(2) Interior wall is cracked at time of inspection. Possibly due from settling of the structure.

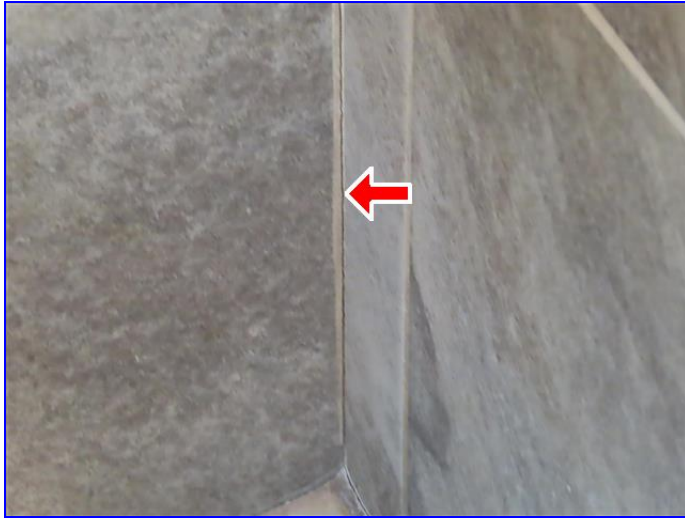
E. Item 3(Picture)

(3) All bathroom tile wall penetrations, gaps or cracks should be sealed properly. Conducive to moisture intrusion.

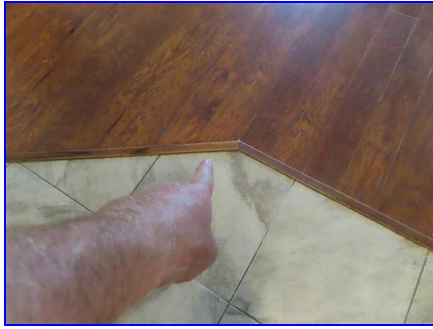
F. Item 1(Picture)

(1) Floor transition trim was loose at time of inspection. Should correct properly.

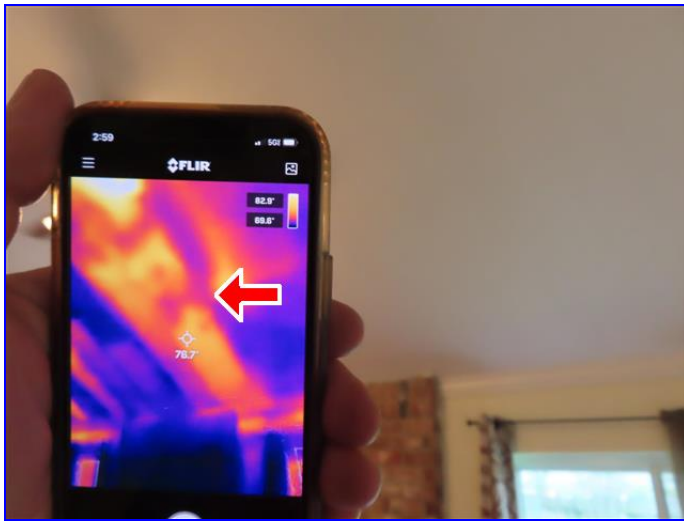
F. Item 2(Picture)

(2) Ceilings have lack and missing insulation in several areas at time of inspection. Should have a professional correct properly.

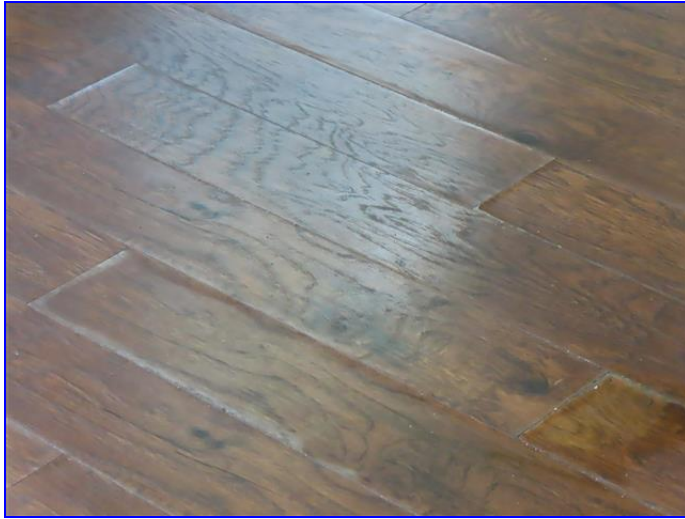
F. Item 3(Picture)

(3) Master bedroom laminate flooring has signs of moisture damage at time of inspection. Should have a professional correct properly.

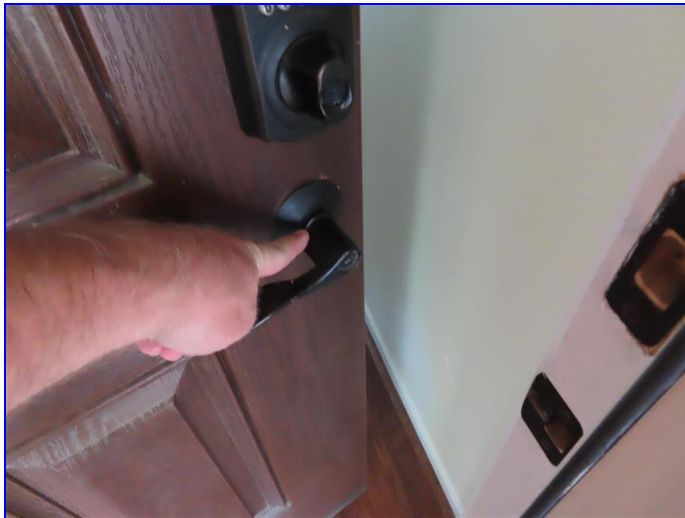
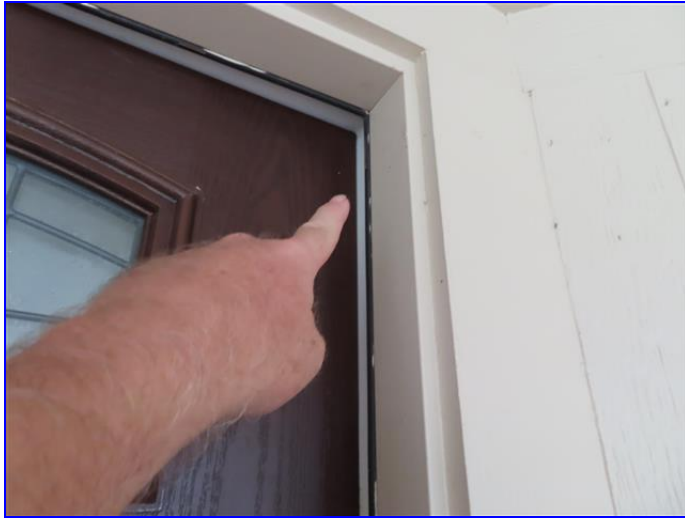
(1) Front exterior door was catching door frame and handle was loose at time of inspection. Should have a professional correct properly.

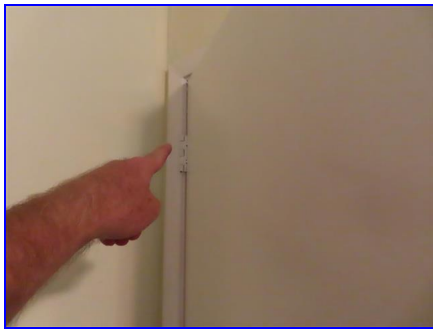
G. Item 3(Picture)

(2) Interior garage door was missing self closing hinges at time of inspection. Should have a professional correct properly.

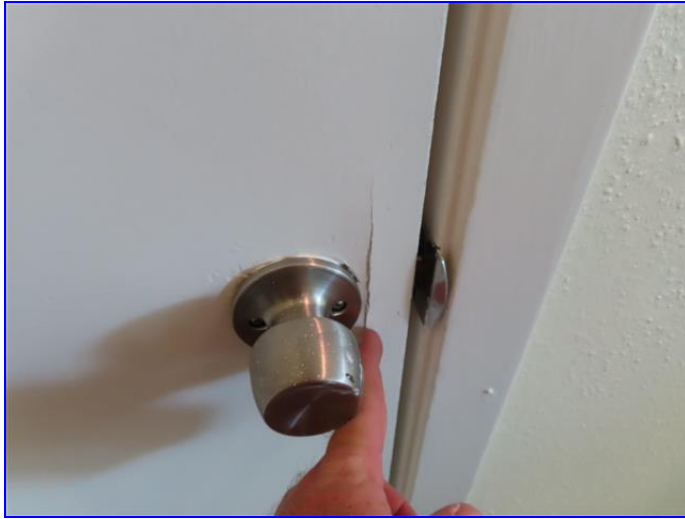
G. Item 4(Picture)

(3) Master bedroom door is damaged at time of inspection. Should have a professional correct properly.

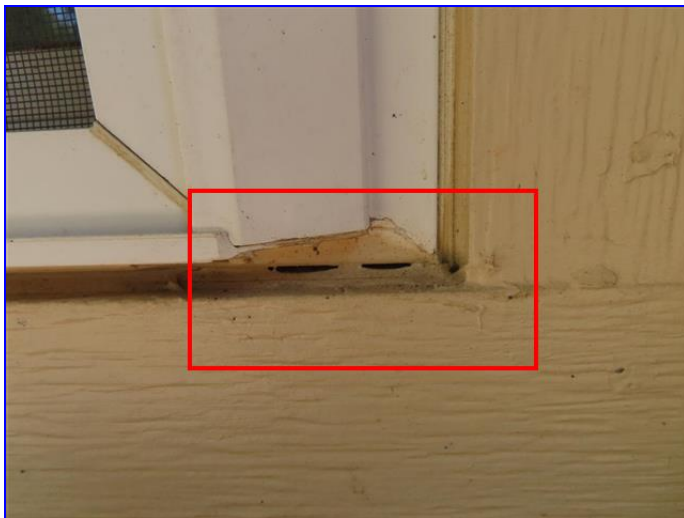
H. Item 1(Picture)

All exterior and interior window penetrations should be sealed properly. Conducive to moisture and WDI (Wood Destroying Insects) intrusion.

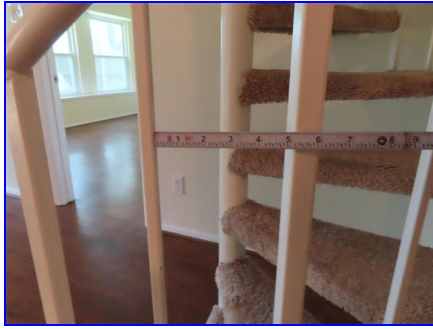
I. Item 1(Picture)

Stair railing balusters should be no more than 4" apart per code. This is a possible safety hazard.

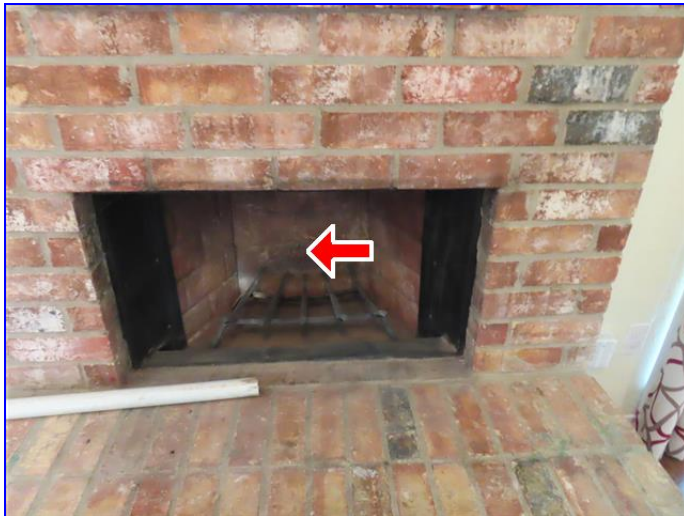
J. Item 1(Picture)

Fireplace was only visually inspected for defects or deficiencies at time of inspection. Did not inspect operation of fireplace at time of inspection. Fireplace front screen was missing at time of inspection. Should correct before use of the fireplace. Inspection of fireplace is not part of home inspection per TREC Standards of Practice. Recommend having a professional Fireplace Tech further evaluate unit.

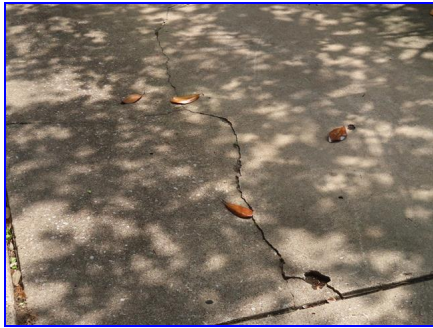
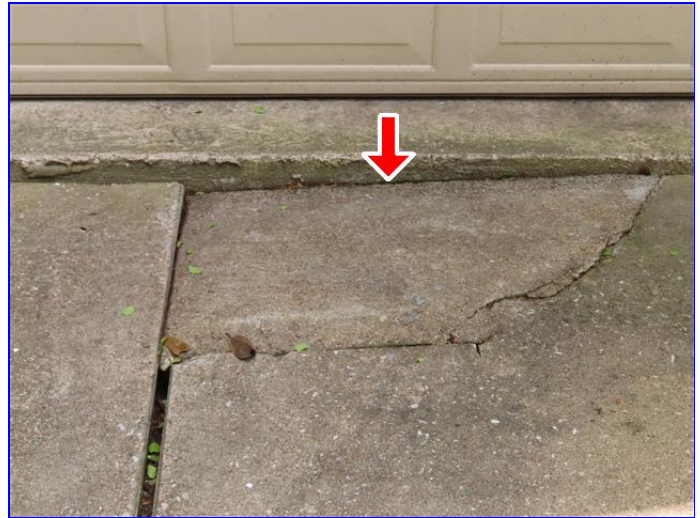
(1) Driveway has large cracking and small section is damaged and sinking at time of inspection. Should have a professional correct properly.

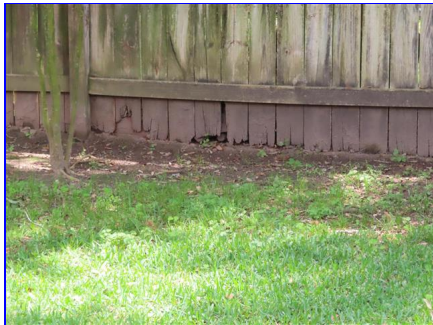
K. Item 3(Picture)

(2) Wood fencing has wear, tear and rot in several areas at time of inspection.

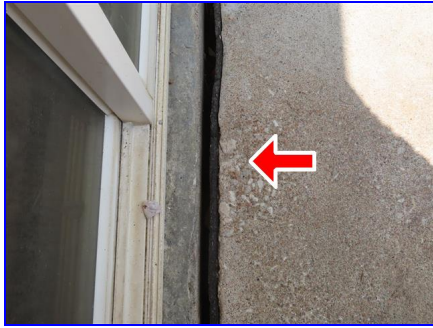
K. Item 4(Picture)

(3) Rear patio gas large gap from foundation at time of inspection. Should have a professional

correct and seal properly.

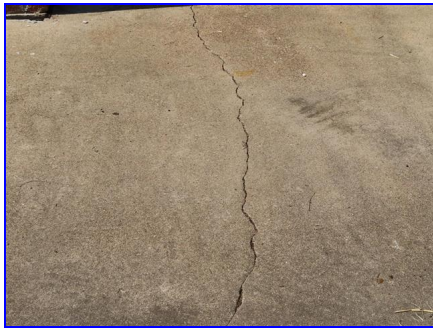
K. Item 5(Picture)

(4) Rear patio has large crack at time of inspection.

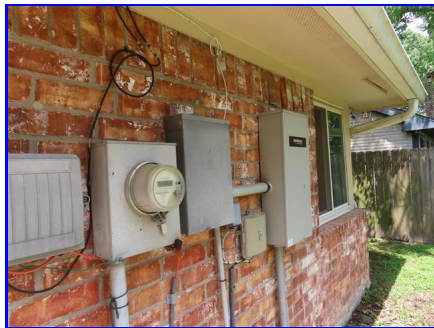
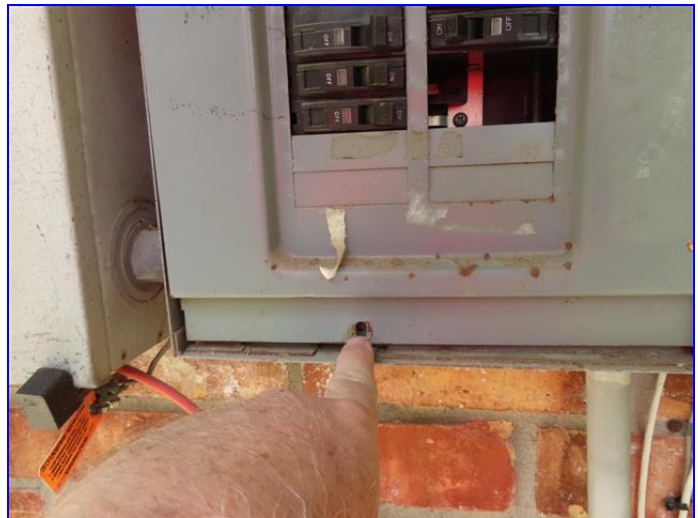
(1) Electric meter and main breaker box. Dead front cover was missing fasteners and was loose at time of inspection. Should have a professional electrician correct properly.

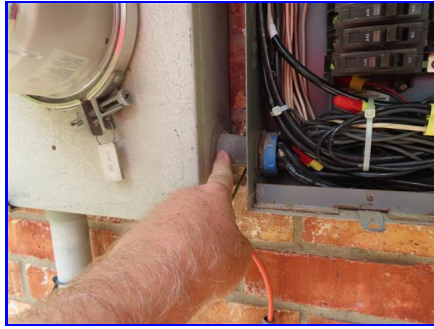
A. Item 4(Picture)

(3) Connector between meter and breaker box was missing electrical bonding at time of inspection. Should have a professional electrician correct.

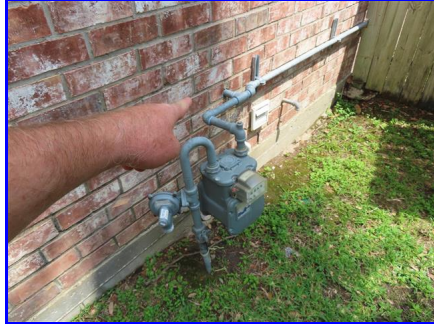
B. Item 3(Picture)

(2) Gas meter plumbing was missing electrical bonding at time of inspection. Should have a professional electrician inspect and correct properly.

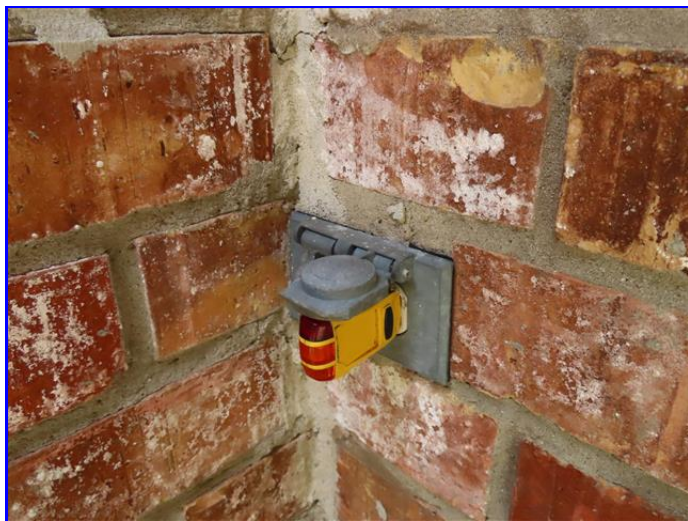
B. Item 4(Picture)

(3) All exterior electrical outlets should be GFCI protected and sealed to the structure properly. Outlets should be installed in exterior boxes with covers. Should have a professional electrician inspect and correct properly.

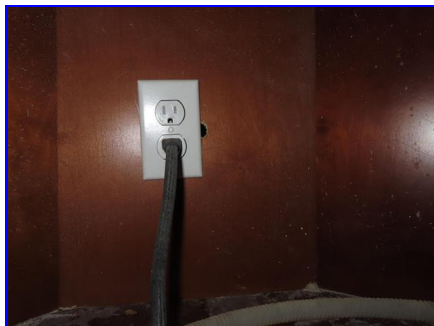
B. Item 5(Picture)

(4) Electrical outlet under kitchen sink should be GFCI protected outlet. Should have a professional electrician correct properly.

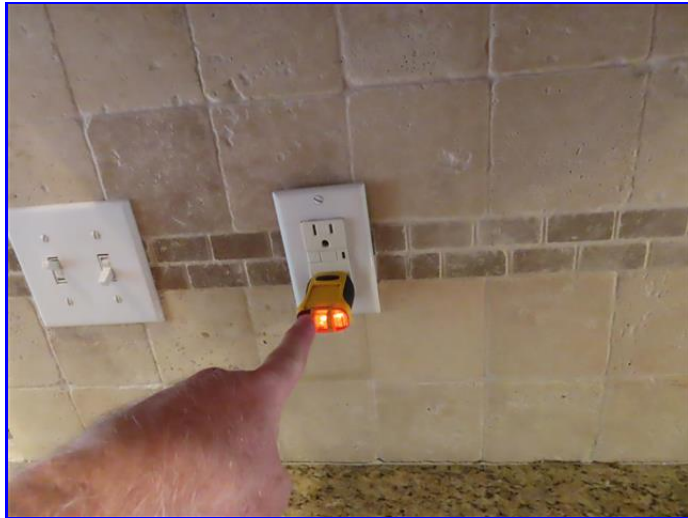
B. Item 6(Picture)

(5) Several interior electrical outlets were loose to the wall at time of inspection. Should a professional electrician secure properly.

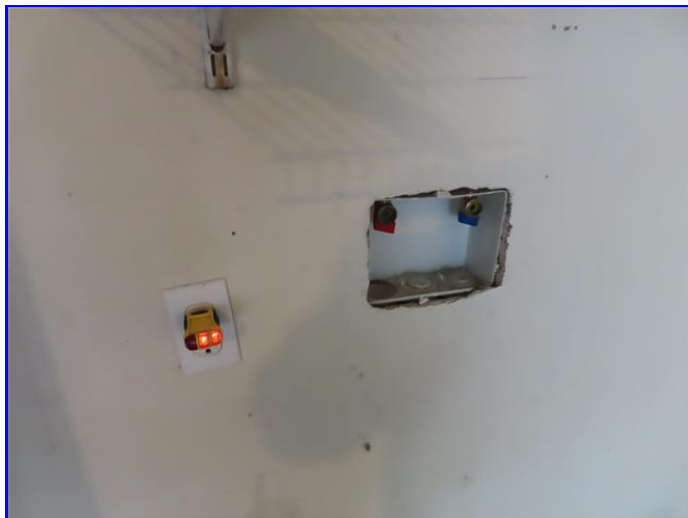
B. Item 7(Picture)

(6) All garage electrical outlets should be GFCI protected. Electrical covers were missing GFCI protected label at time of inspection. Should have a professional electrician inspect and correct.

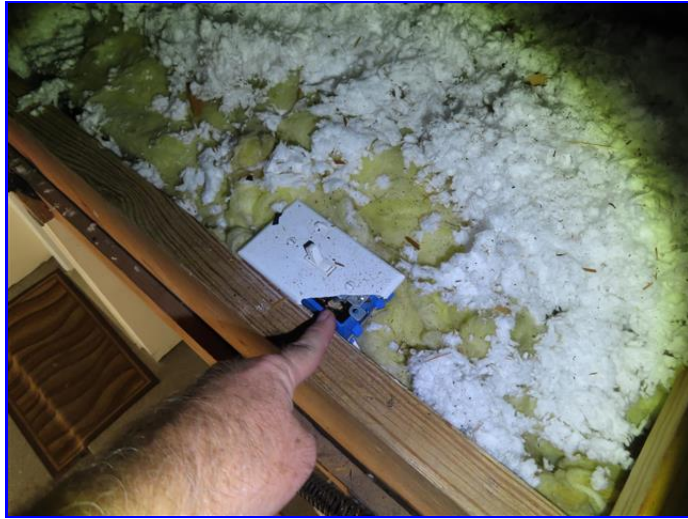
B. Item 8(Picture)

(7) Attic light switch cover was damaged at time of inspection. Should have a professional electrician replace properly.

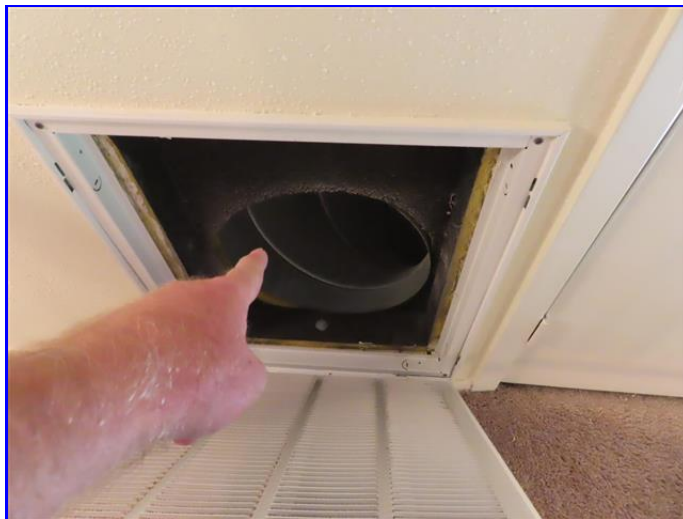
C. Item 1(Picture)

HVAC return was missing filter at time of inspection. Should correct properly.

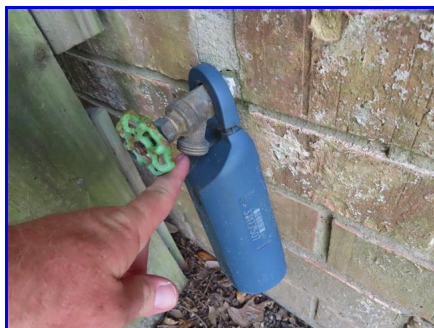
A. Item 2(Picture)

(2) Exterior faucets were missing hose bibbs at time of inspection. Should have a professional plumber correct.

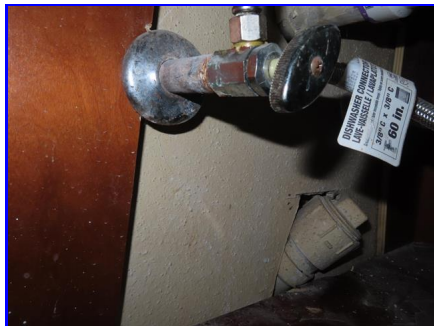
A. Item 4(Picture)

(4) Structure has galvanized plumbing that will rust, corrode, leak and have calcium build up that reduces water pressure. These issues could of been hidden at time of inspection. Recommend replacing all galvanized plumbing by a professional plumber.

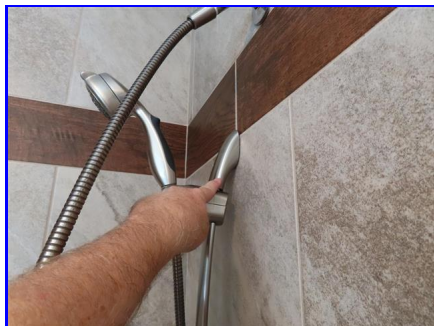
A. Item 5(Picture)

(5) Several plumbing fixtures were loose at time of inspection. Should have a professional plumber correct properly.

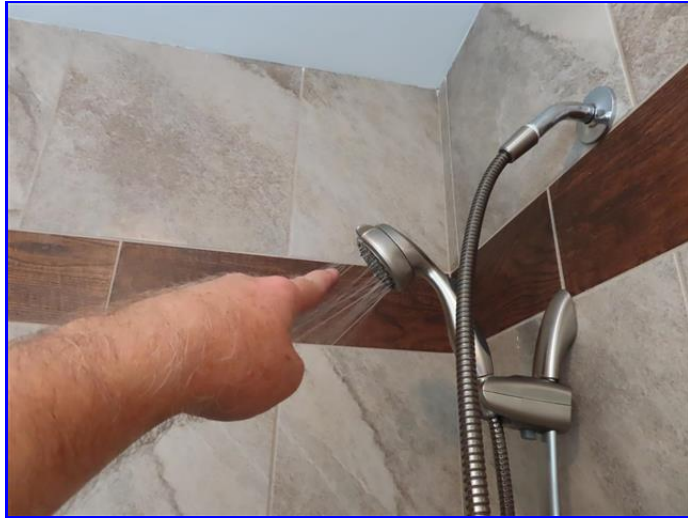
A. Item 6(Picture)

(6) Showerhead was not flowing properly at time of inspection. Should have a professional plumber inspect and correct properly.

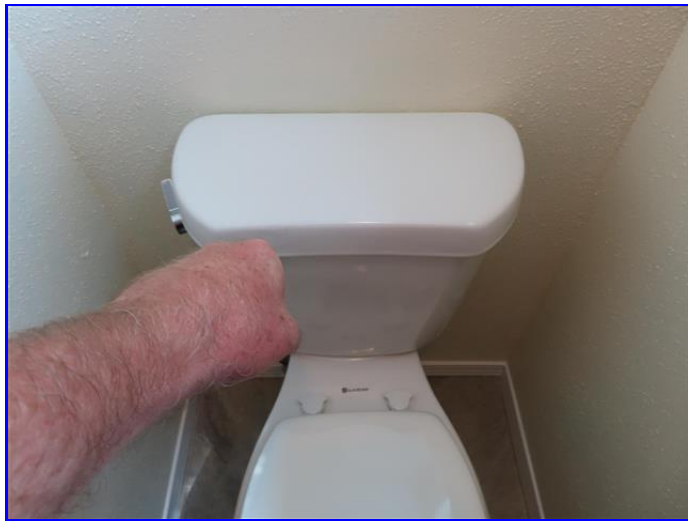
A. Item 7(Picture)

(7) Master toilet was not operating properly at time of inspection. Should have a professional plumber inspect and correct properly.

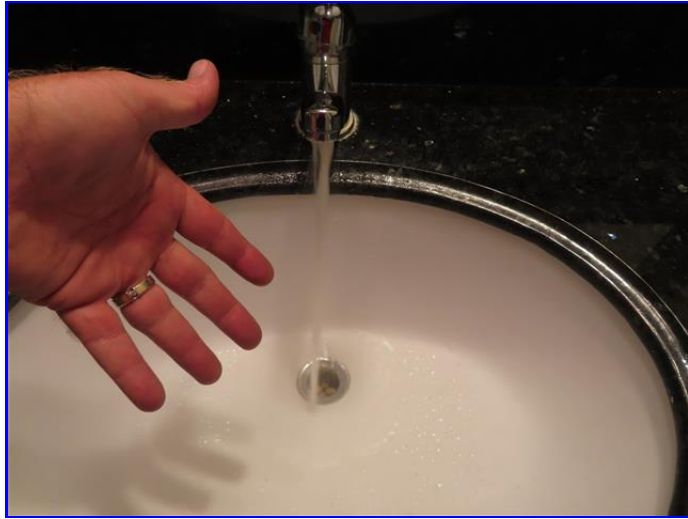
A. Item 8(Picture)

(8) Bathroom faucet was not flowing properly at time of inspection. Should have a professional plumber inspect and correct properly.

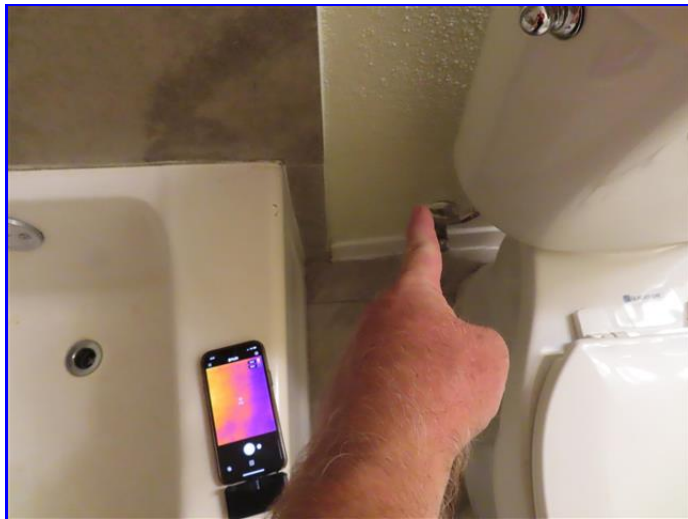
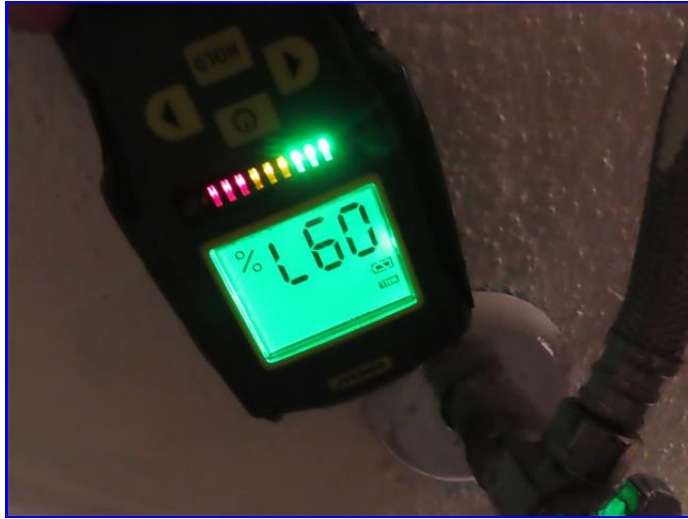
(9) 1st floor wall at toilet shut off valve has high levels of moisture from possible leak at time of inspection. Should have a professional plumber inspect and correct properly.

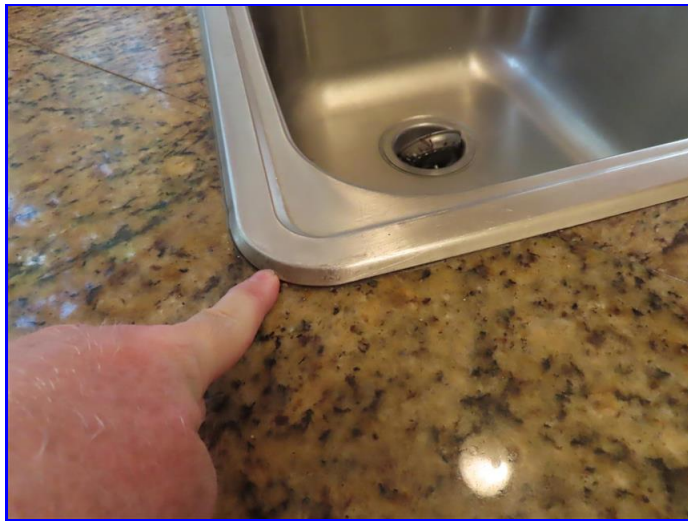
A. Item 11(Picture)

(10) Kitchen sink should be sealed properly to the countertop. Conducive to leaking and causing possible damage.

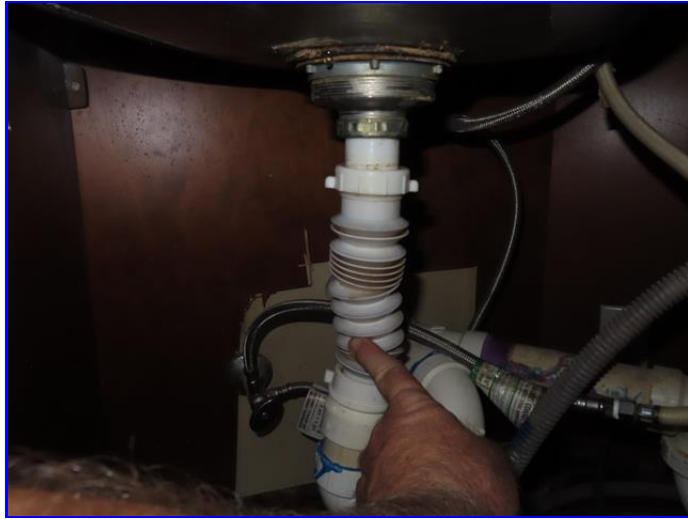
B. Item 1(Picture)

(1) Kitchen sink drain was loose, installed with improper flex piping and leaking at time of inspection. Should have a professional plumber inspect and correct properly.

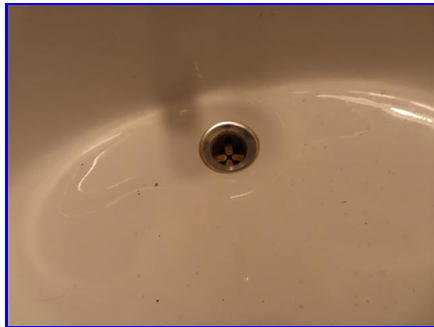
B. Item 2(Picture)

(2) Bathroom sinks were missing drain stoppers at time of inspection. Should correct properly.

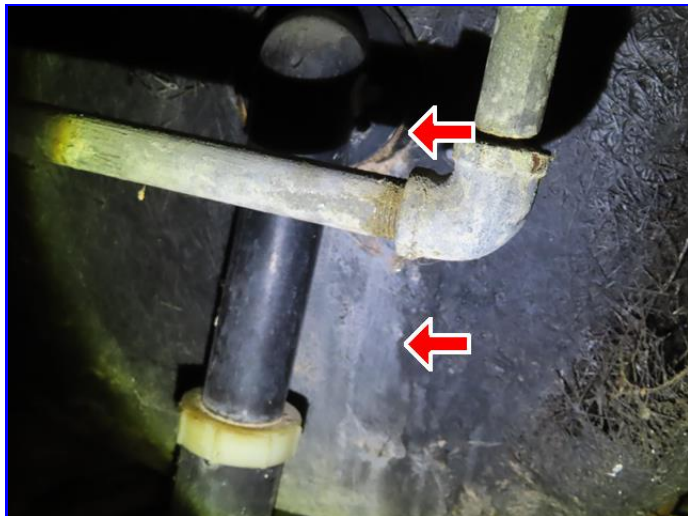
B. Item 3(Picture)

(3) Bathtub overflow has signs of leaking at time of inspection. Should have a professional plumber inspect and correct properly.

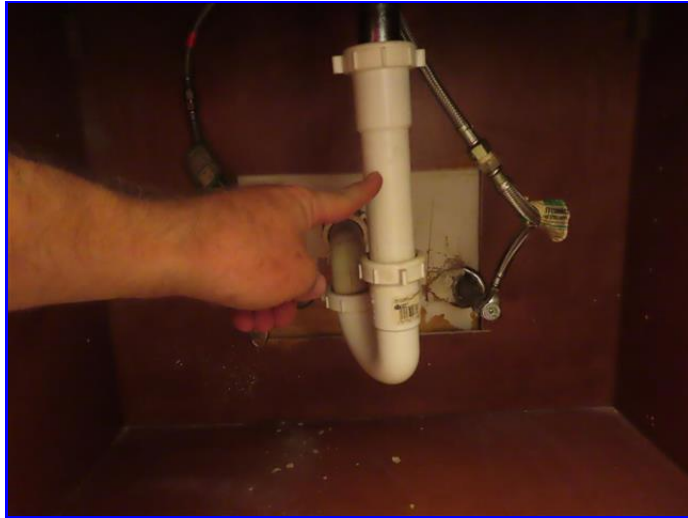
B. Item 4(Picture)

(4) Several bathrooms sink drain plumbing were loose at time of inspection. Conducive to leaking and causing possible damage. Should have a professional plumber correct.

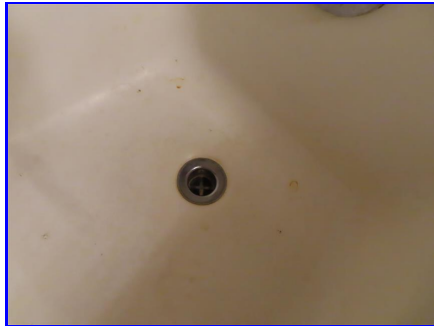
B. Item 5(Picture)

(5) Bathtub was missing drain stopper at time of inspection. Should have a professional plumber inspect and correct properly.

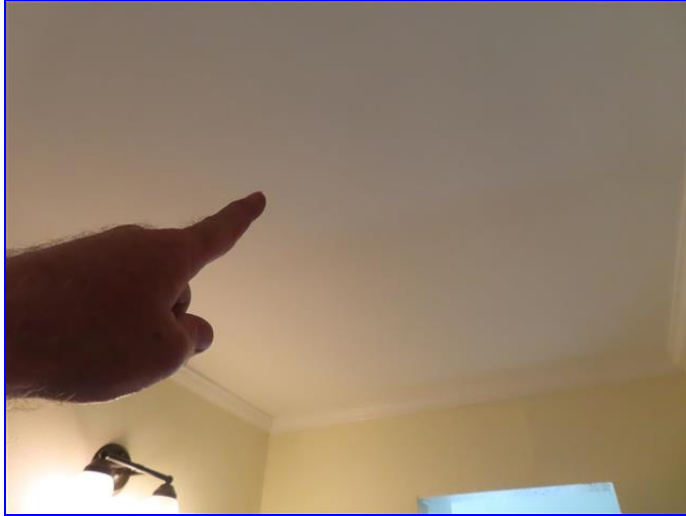
F. Item 1(Picture)

(1) Several bathrooms were missing exhaust fans at time of inspection. Should have a professional correct properly.

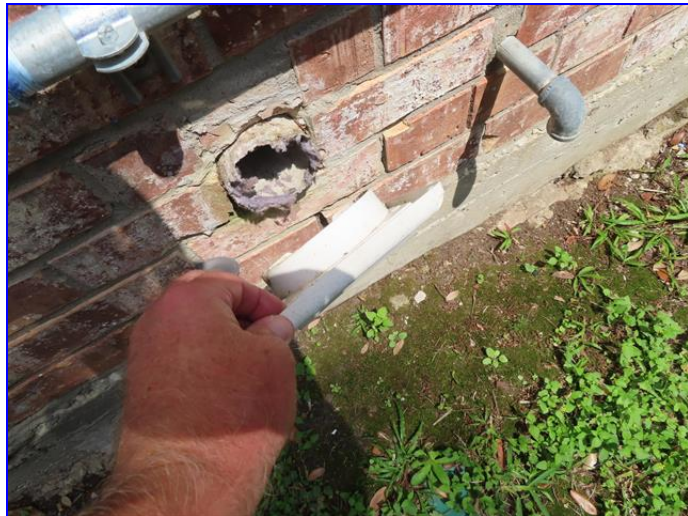
H. Item 1(Picture)

Exterior dryer vent was loose from structure at time of inspection. Should be secured and sealed properly to structure. Conducive to leaking moisture into structure.
