SUNBELT INSPECTIONS

Inspection Report

Property Address:
150 Waterford Way
Montgomery TX 77356

PROPERTY INSPECTION REPORT FORM

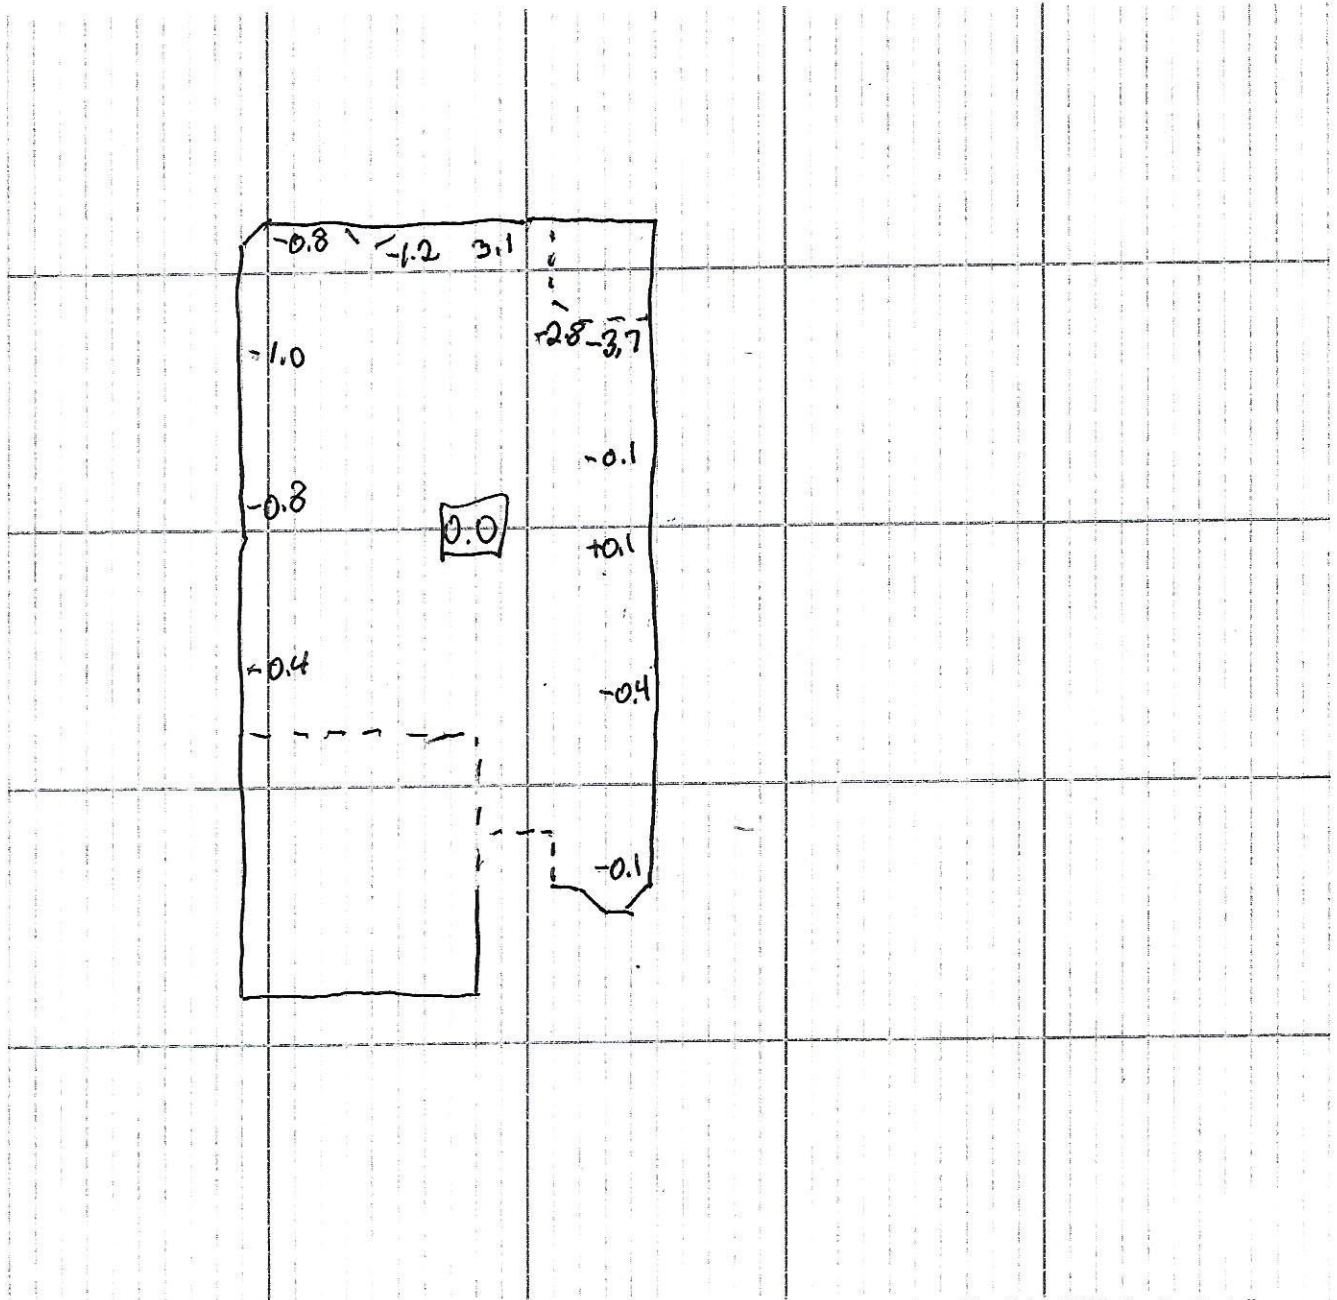
Foundation Elevation Drawing

*NOT TO SCALE - The above drawing is a rough sketch of the foundation. The elevation measurements were taken with a Zipline 2000. Construction tolerance for foundations is + or - 1.5" for 20' of measurement away from center. This drawing also serves as a benchmark of current foundation elevations.

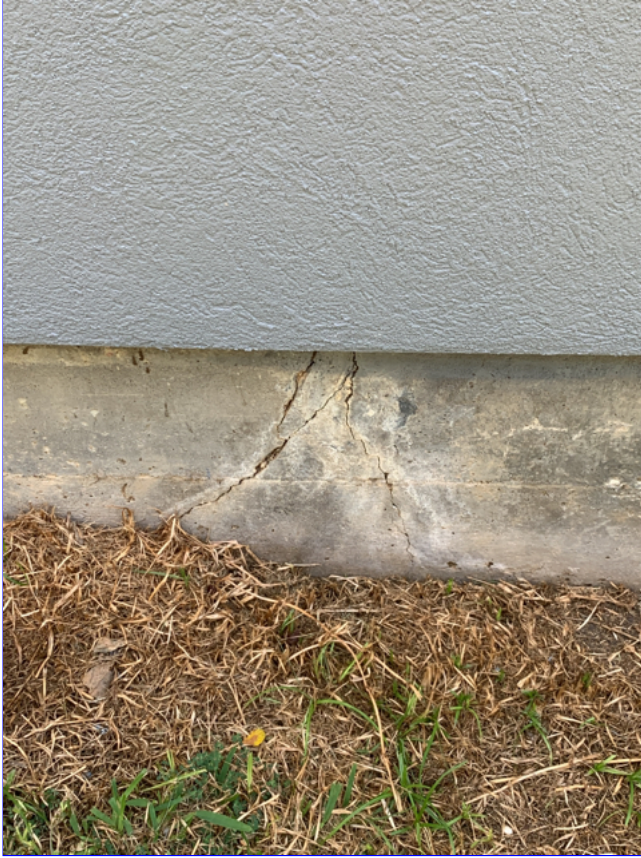
(1) There is some slab edge cracking.

A. Item 1(Picture) There is some slab edge cracking.

(2) It is the opinion of the inspector that the foundation is not functioning as intended, and is in need of repair. I recommend that you consult a licensed and qualified foundation contractor, who utilizes the services of a registered structural engineer to design repairs, to determine the best method for repair, estimate cost, and to perform the designed repairs.

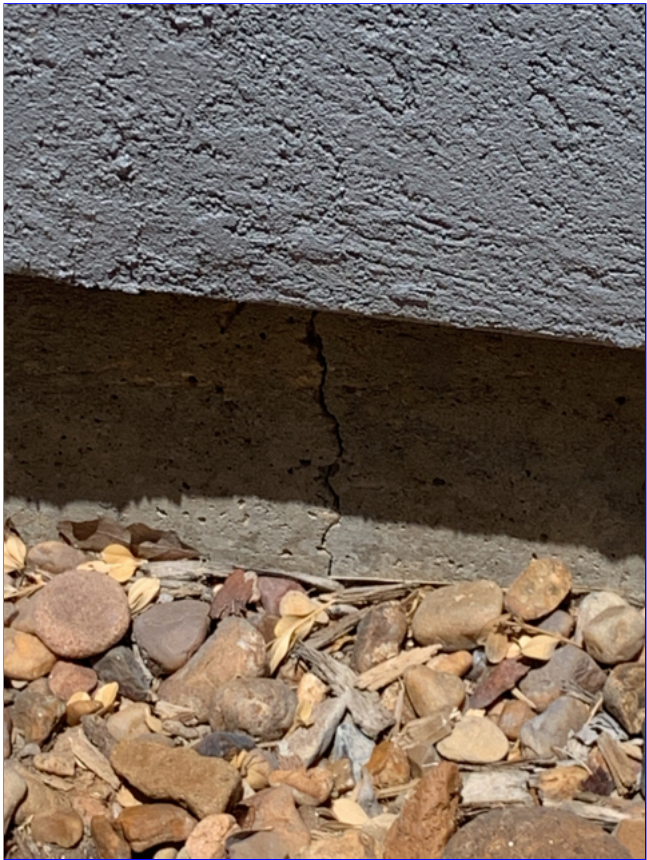
A. Item 2(Picture) There is some slab edge cracking.

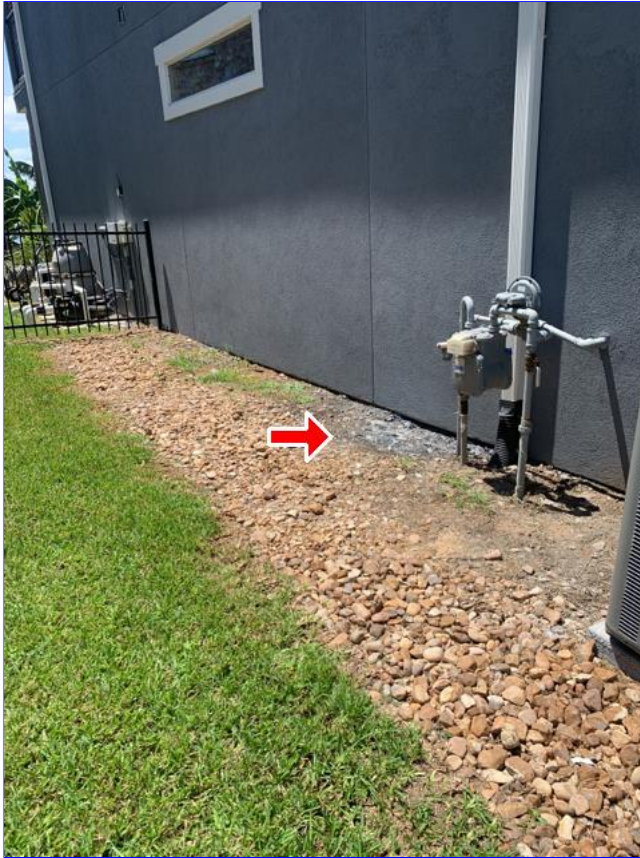
B. Item 1(Picture) Drainage swales at the sides of home appears to have low spots.

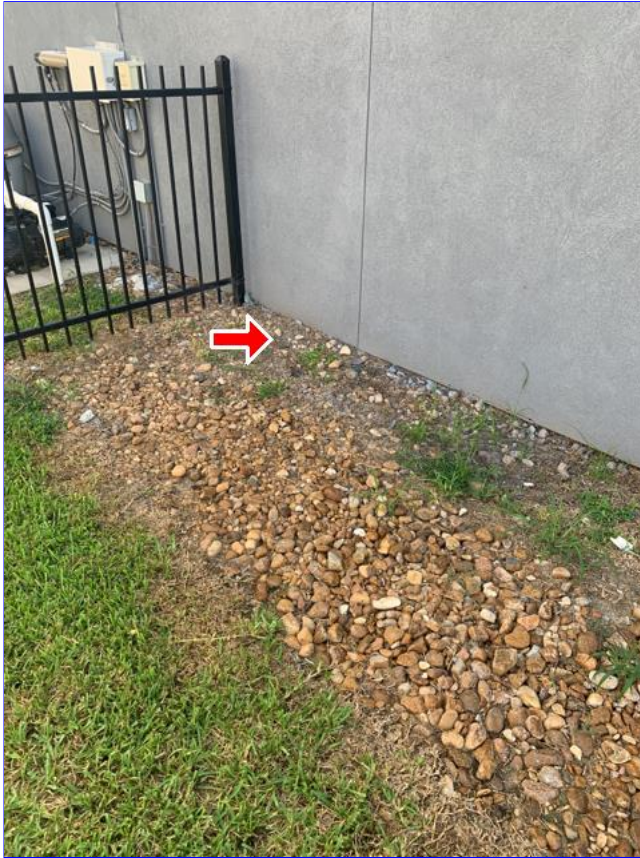
(2) High soil conditions observed at left side (facing front). High soil conditions are conducive to wood destroying insects and should be avoided. I recommend a minimum six inch foundation side wall exposure around the entire perimeter of the foundation. High soil levels prevent a quality Termite inspection. Recommend correction.

B. Item 2(Picture) High soil conditions observed at left side (facing front).

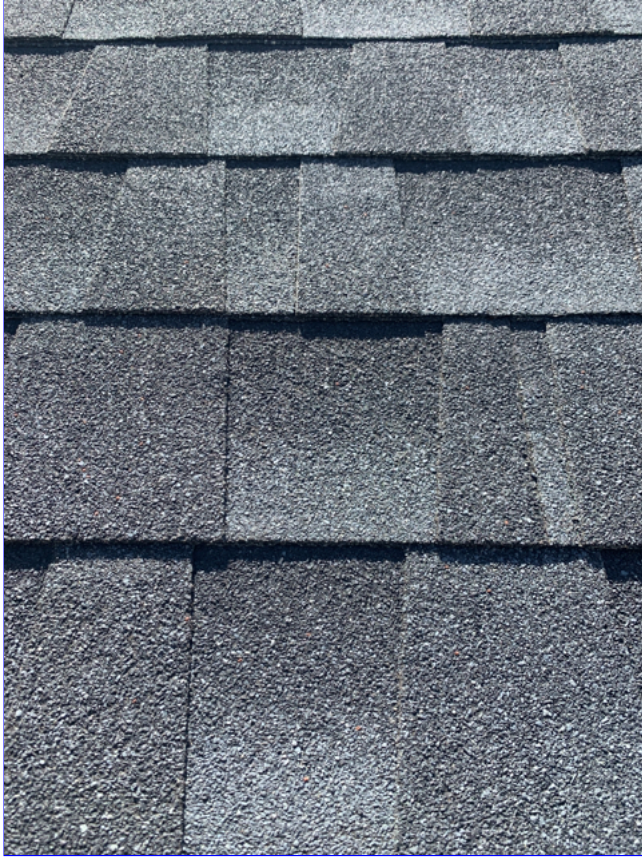
The roof covering, is not new and shows signs of wear consistent with its age. The overall condition of the roof covering appears to be acceptable and no signs of any current moisture penetration into the structure were observed. This roof covering is probably around 2 to 4 years old. This type of architectural style composition shingles typically lasts about 20 years in this climate.

C. Item 1(Picture) The roof covering, is not new and shows signs of wear consistent with its age.

A general seal up of roof penetrations, exposed nail heads and flashings is recommended as routine maintenance.

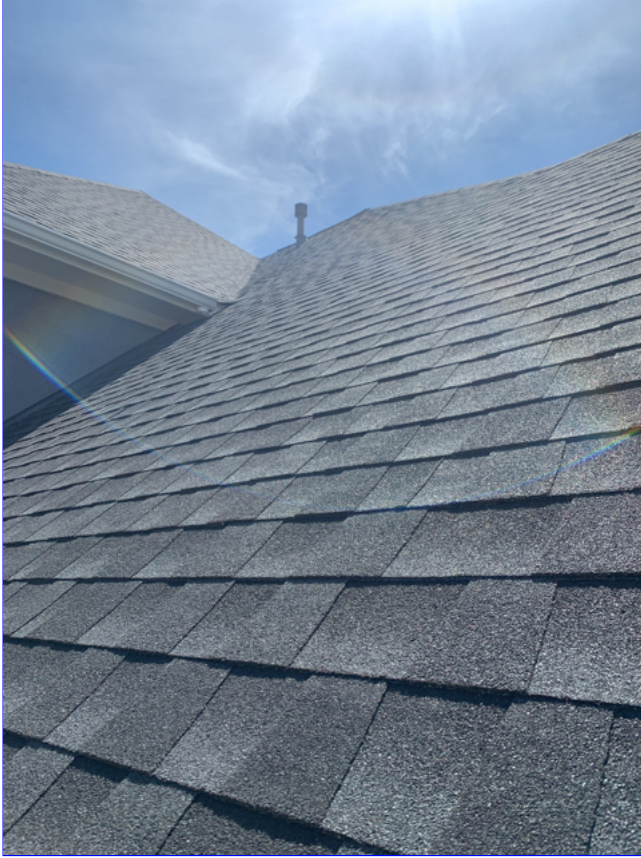
C. Item 2(Picture) The roof covering, is not new and shows signs of wear consistent with its age.

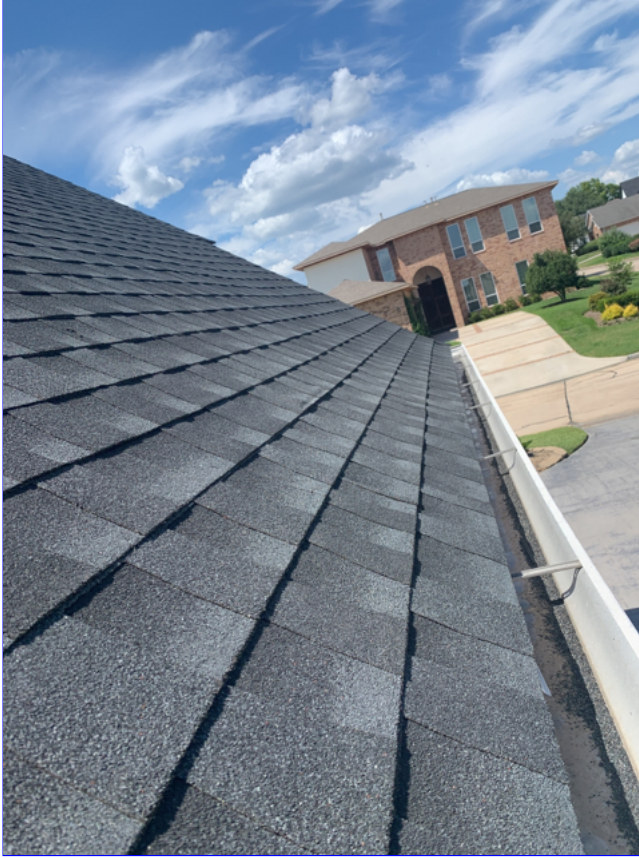
C. Item 3(Picture) The roof covering, is not new and shows signs of wear consistent with its age.

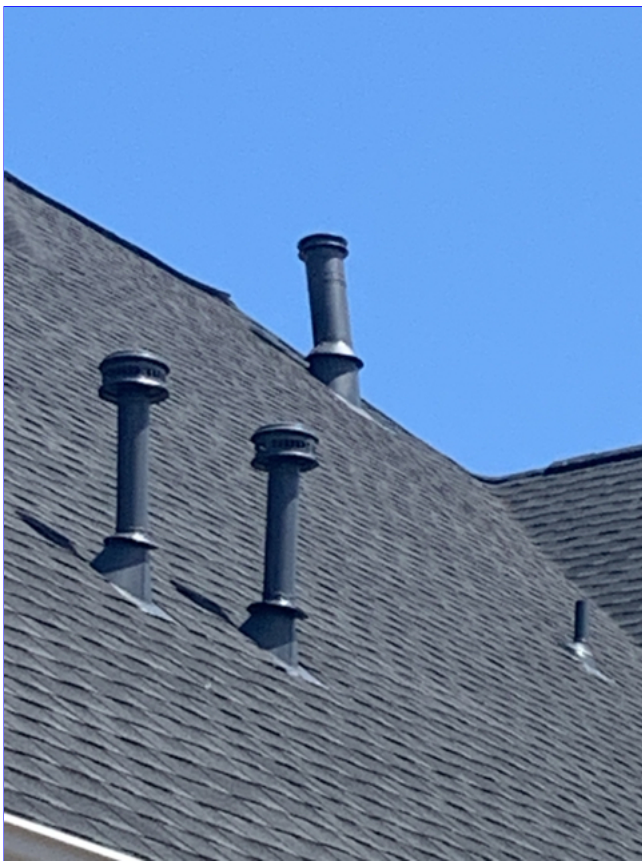
C. Item 4(Picture) The roof covering, is not new and shows signs of wear consistent with its age.

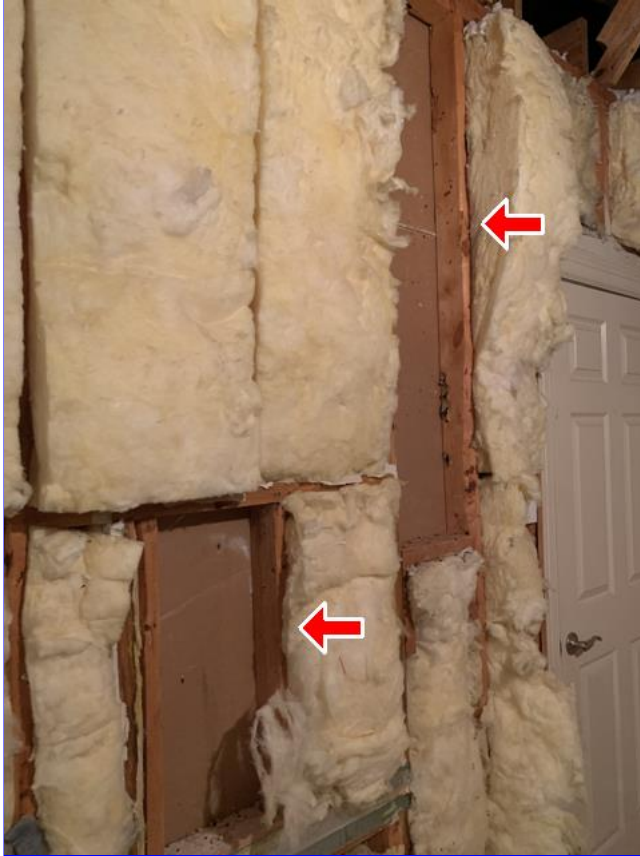
(1) Insulation is displaced at walls, viewed from the attic space. I recommend correction for energy efficiency reasons.

D. Item 1(Picture) Insulation is displaced at walls, viewed from the attic space. I recommend correction for energy efficiency reasons.

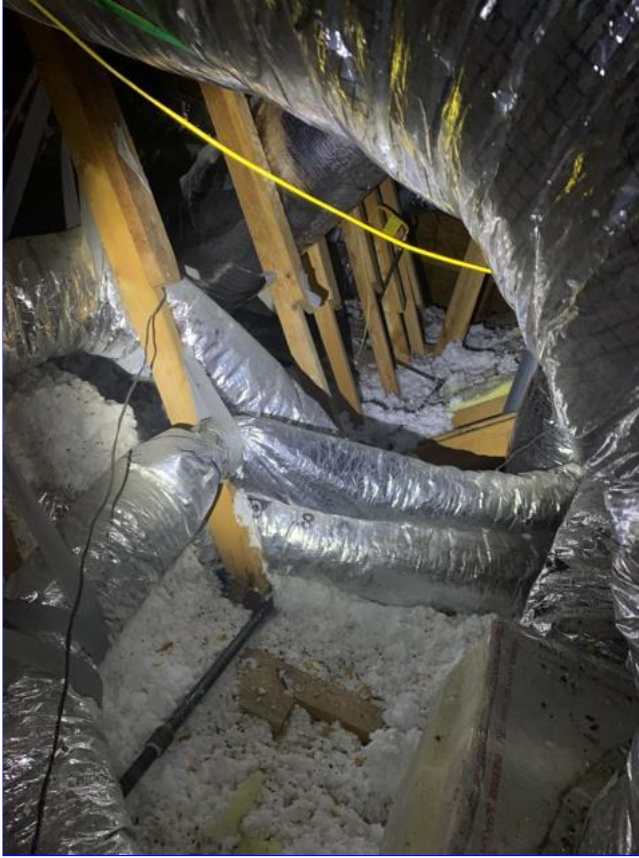
(2) Walkways and/or service platform(s) not installed to access mechanical equipment in the attic. Proper walkways and platforms should be in place to provide safe access to service and inspect equipment.

D. Item 2(Picture) Walkways and/or service platform(s) not installed to access mechanical equipment in the attic.

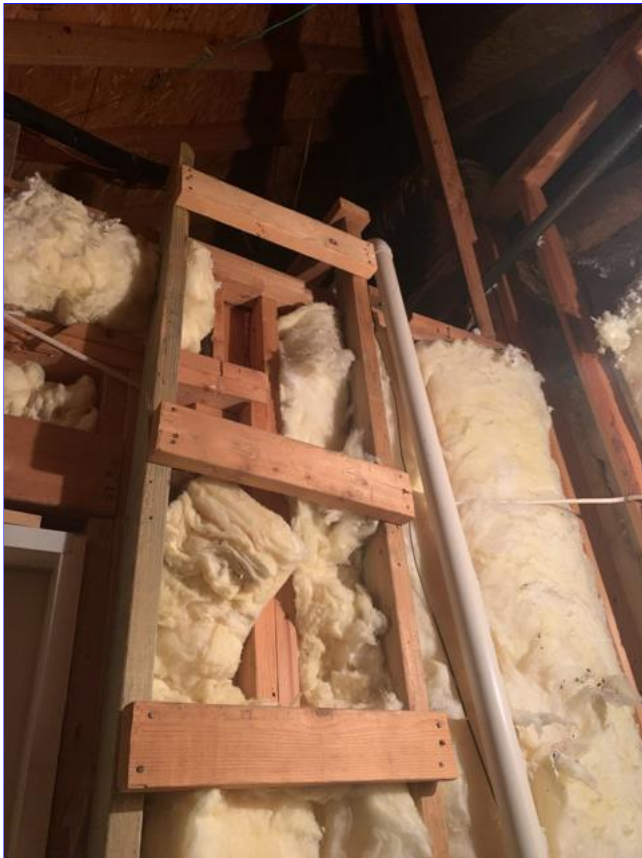
D. Item 3(Picture) Walkways and/or service platform(s) not installed to access mechanical equipment in the attic.

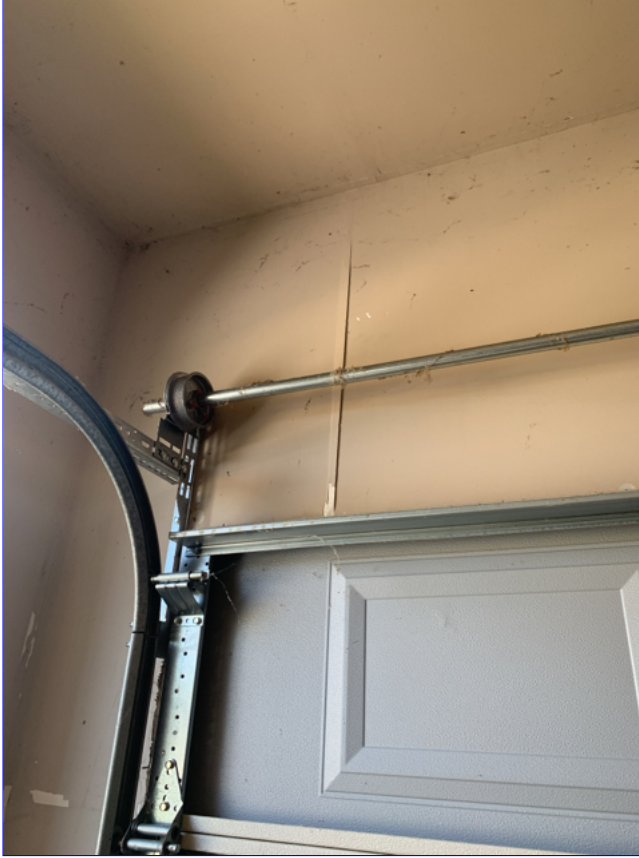
(1) Drywall tape joint cracks and/or nail pops were observed around the home. These are cosmetic in nature, and can be repaired as needed.

E. Item 1(Picture) Drywall tape joint cracks and/or nail pops were observed around the home.

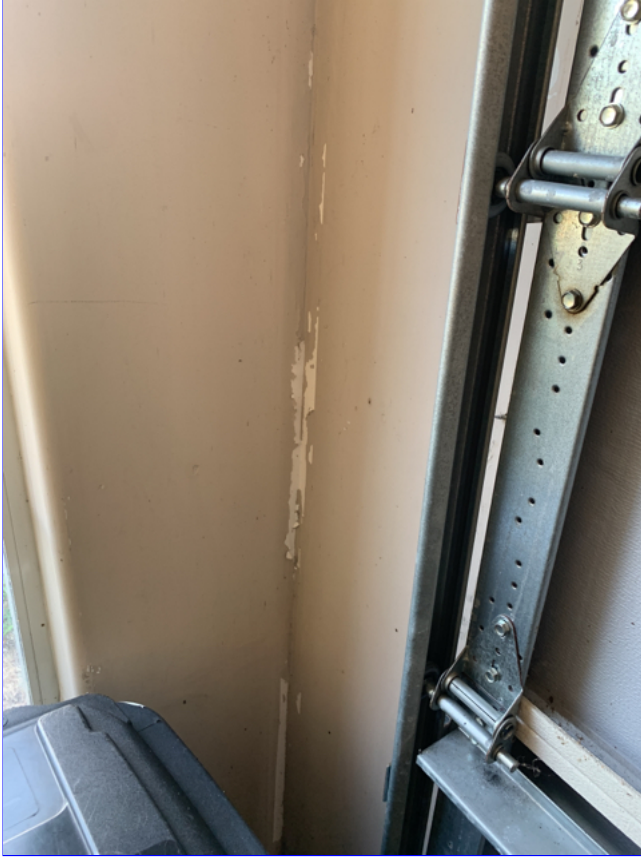
E. Item 2(Picture) Drywall tape joint cracks and/or nail pops were observed around the home.

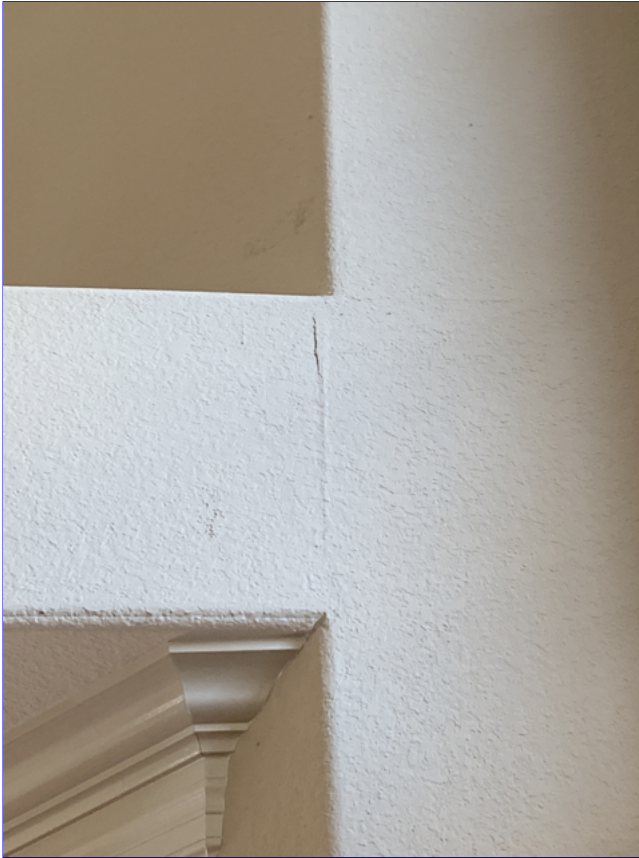
E. Item 3(Picture) Drywall tape joint cracks and/or nail pops were observed around the home.

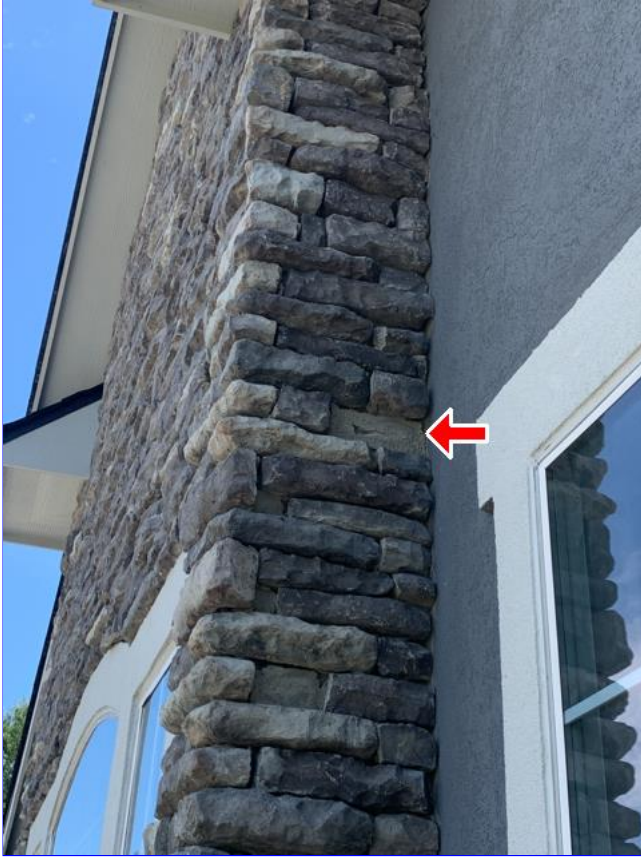
(2) Missing stones was observed at the front of the home. Recommend correction.

E. Item 4(Picture) Missing stones was observed at the front of the home. Recommend correction.

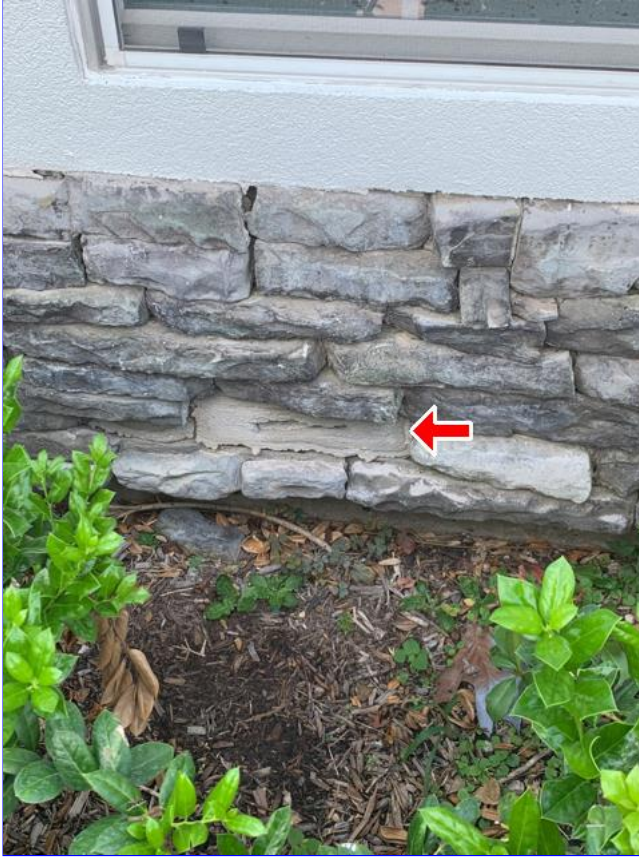
E. Item 5(Picture) Missing stones was observed at the front of the home. Recommend correction.

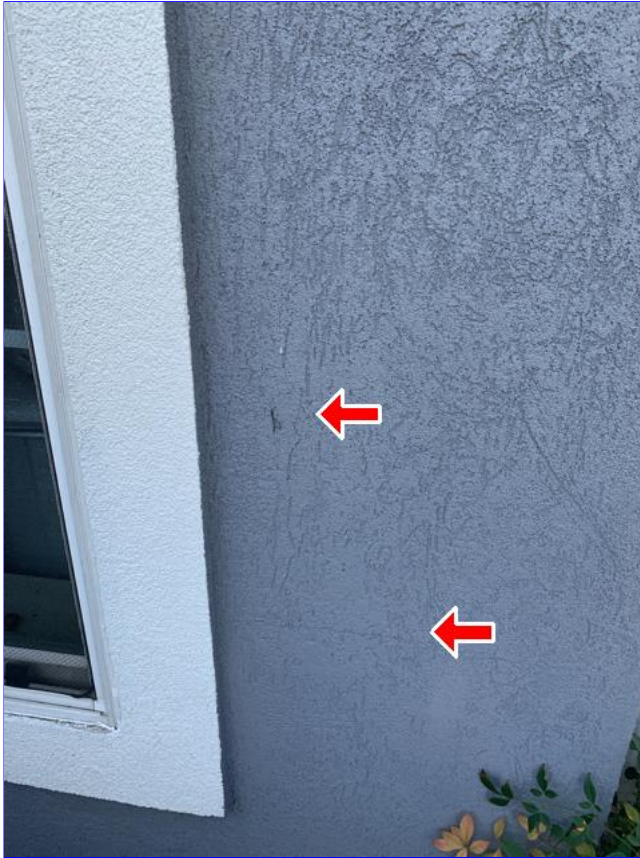
(3) Stucco damage and cracks or repaired cracks observed. Recommend having second stucco inspection to test for moisture.

E. Item 6(Picture) Stucco damage and cracks or repaired cracks observed.

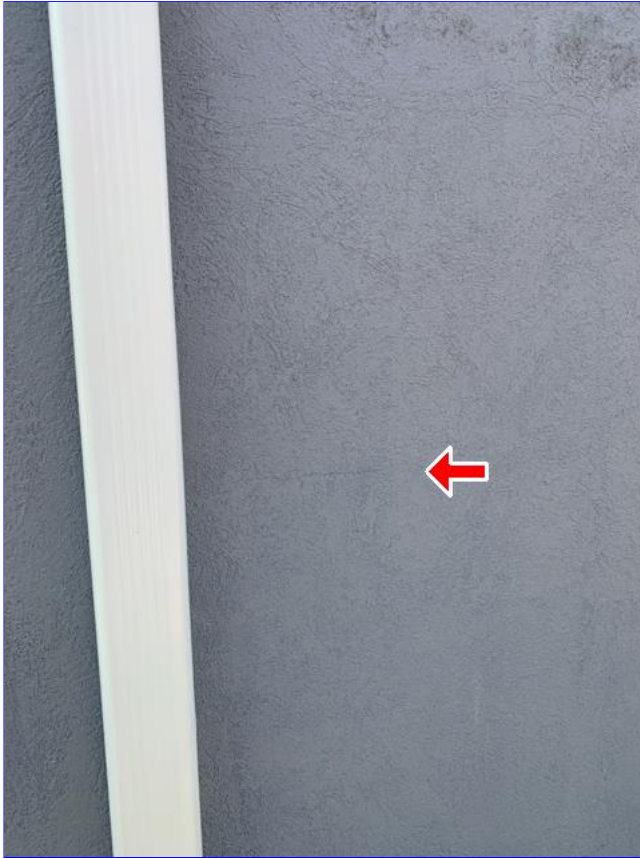
E. Item 7(Picture) Stucco damage and cracks or repaired cracks observed.

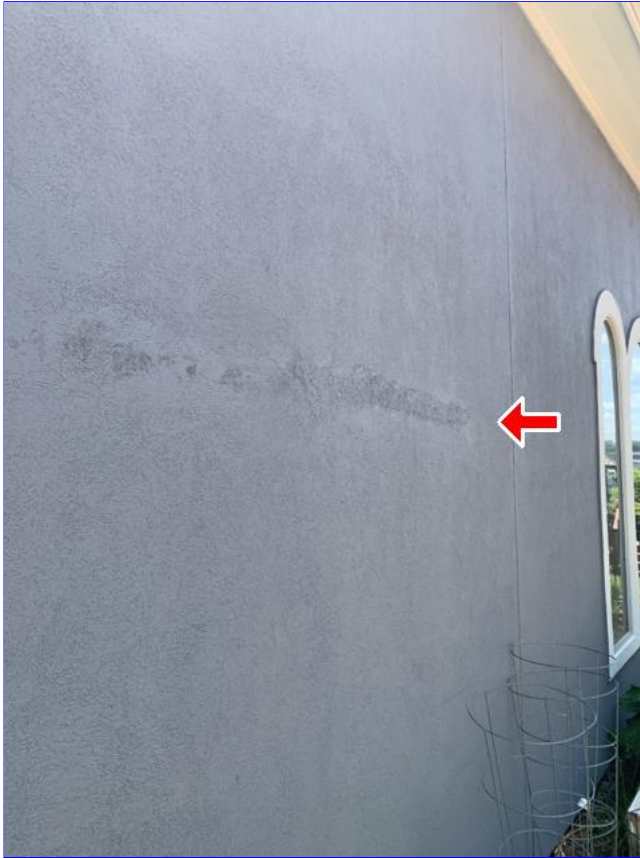
E. Item 8(Picture) Stucco damage and cracks or repaired cracks observed.

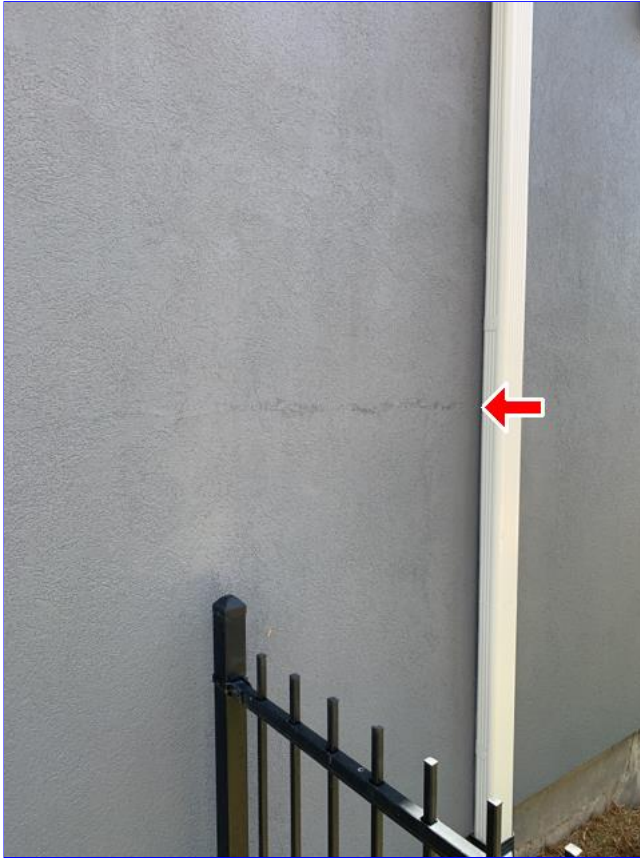
E. Item 9(Picture) Stucco damage and cracks or repaired cracks observed.

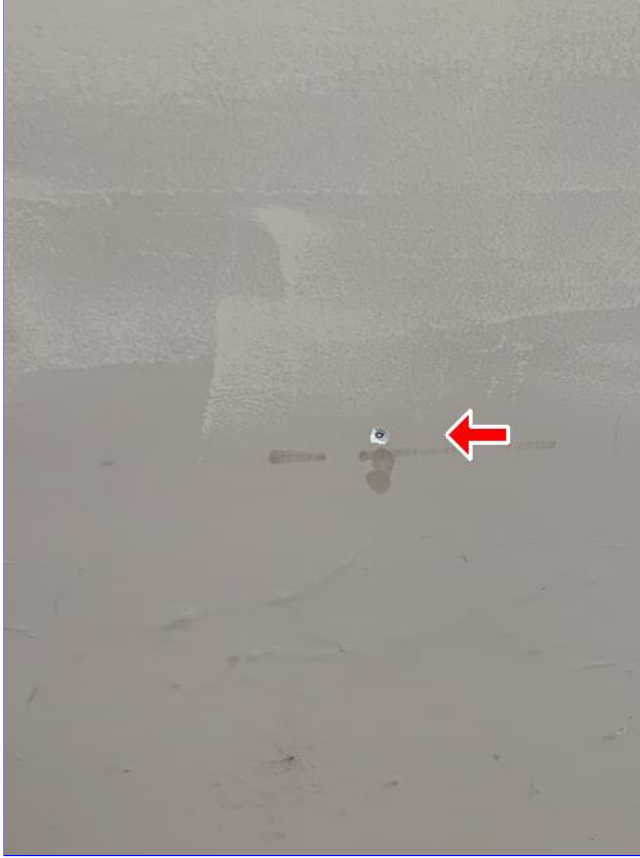
(1) Drywall tape joint cracks and/or nail pops were observed around the home. These are cosmetic in nature, and can be repaired as needed.

F. Item 1(Picture) Drywall tape joint cracks and/or nail pops were observed around the home. These are cosmetic in nature, and can be repaired as needed.

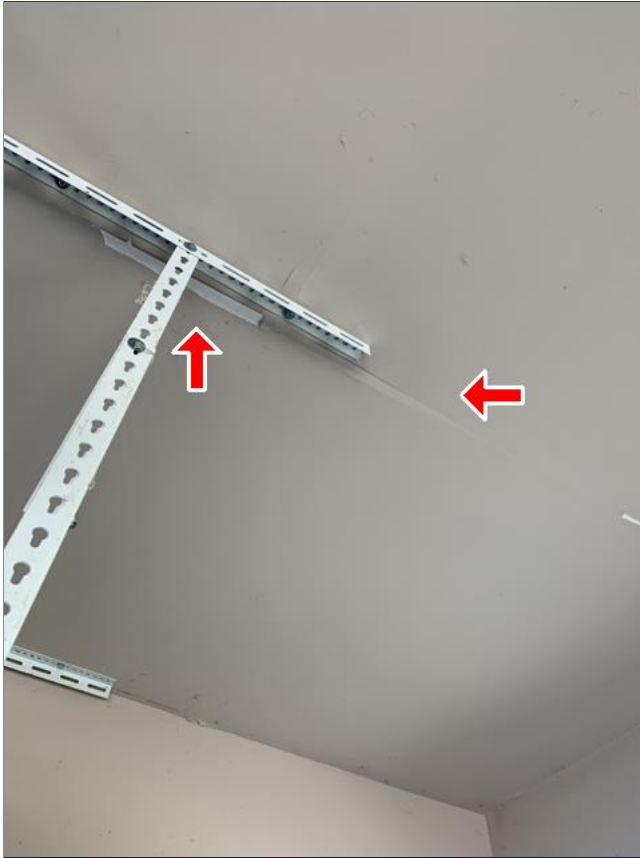
F. Item 2(Picture) Drywall tape joint cracks and/or nail pops were observed around the home.

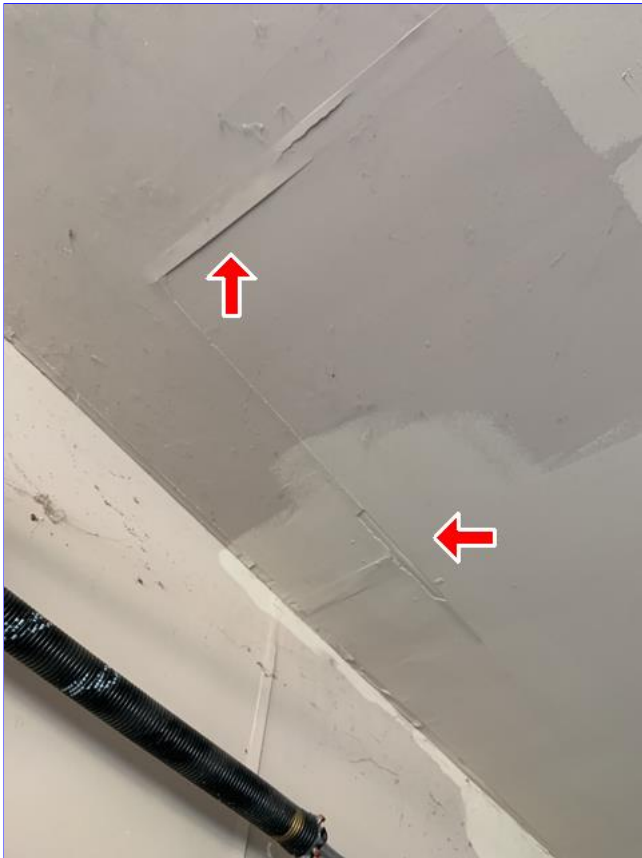
F. Item 3(Picture) Drywall tape joint cracks and/or nail pops were observed around the home.

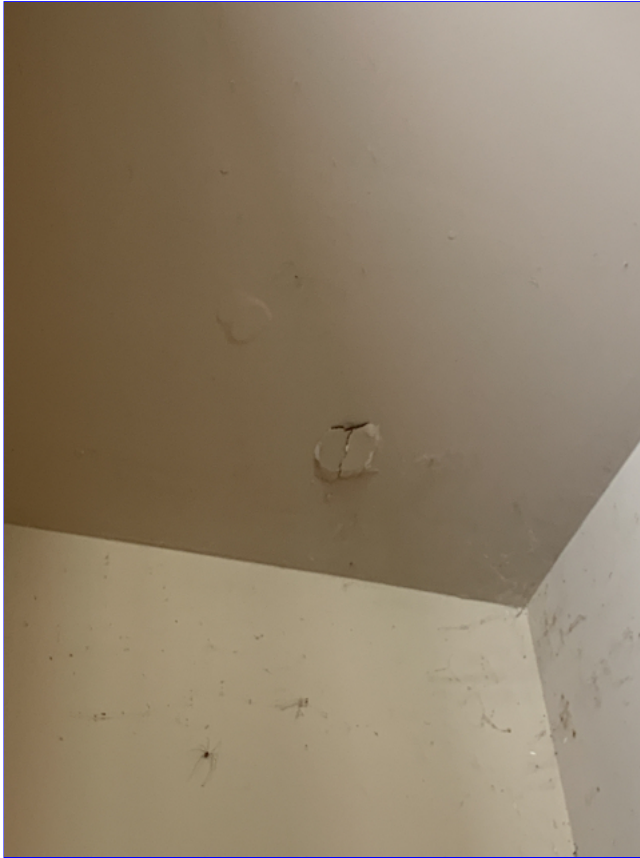
(2) Damage was observed to be to the ceiling in the garage. Recommend repair.

F. Item 4(Picture) Damage was observed to be to the ceiling in the garage. Recommend repair.

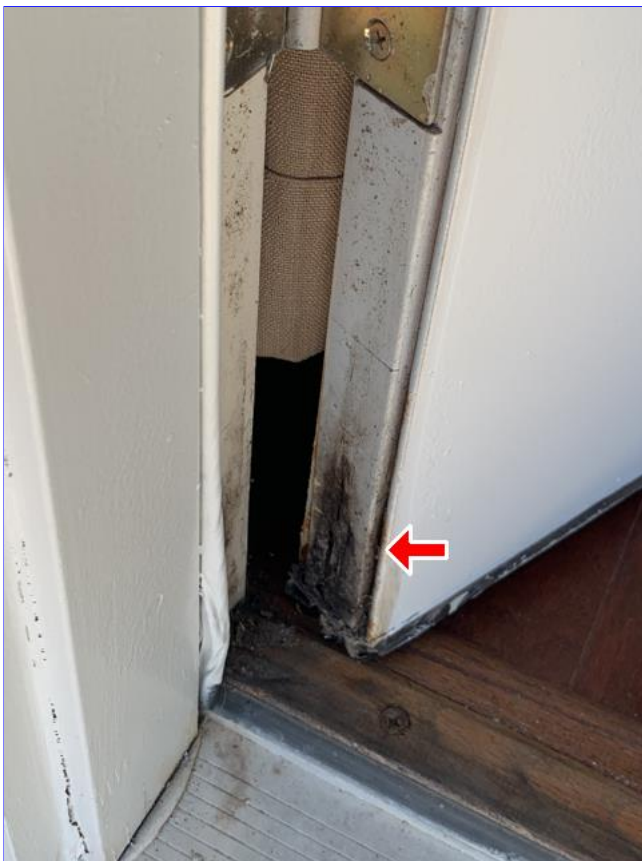
Wood rot was observed on the patio door to the master bedroom. Recommend replacing.

G. Item 1(Picture) Wood rot was observed on the patio door to the master bedroom. Recommend replacing.

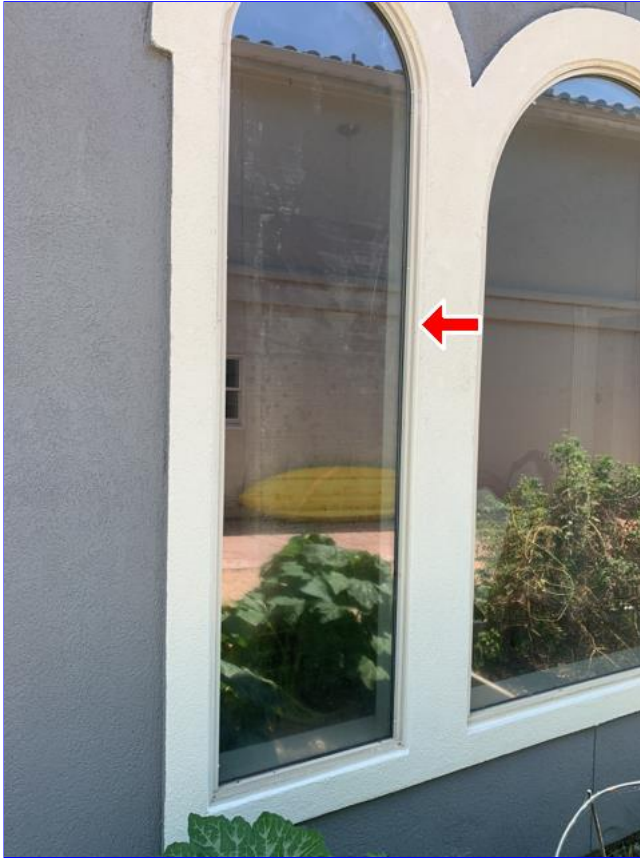
H. Item 1(Picture) Window seals appear to be compromised, as suggested by condensate and mineral deposits built up between the double panes of glass.

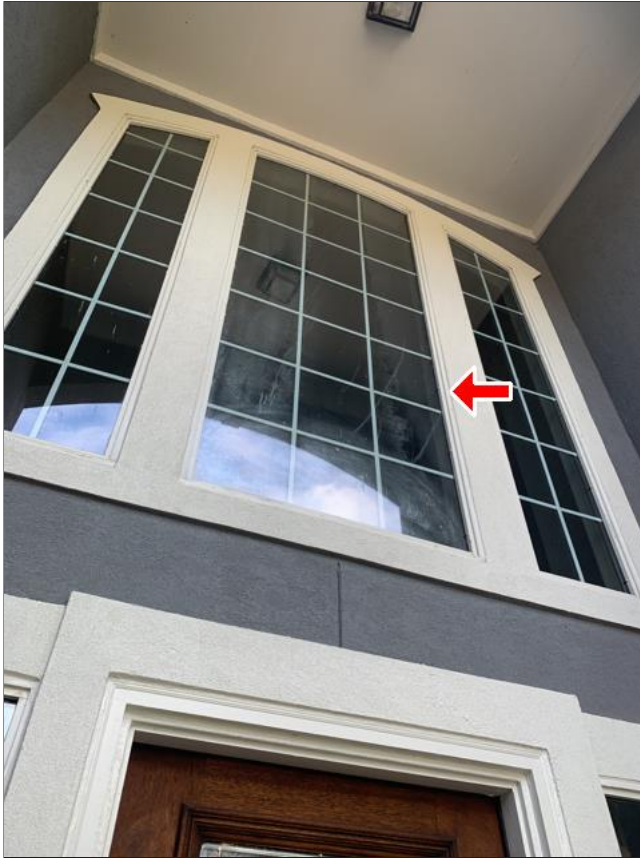
H. Item 2(Picture) Window seals appear to be compromised, as suggested by condensate and mineral deposits built up between the double panes of glass.

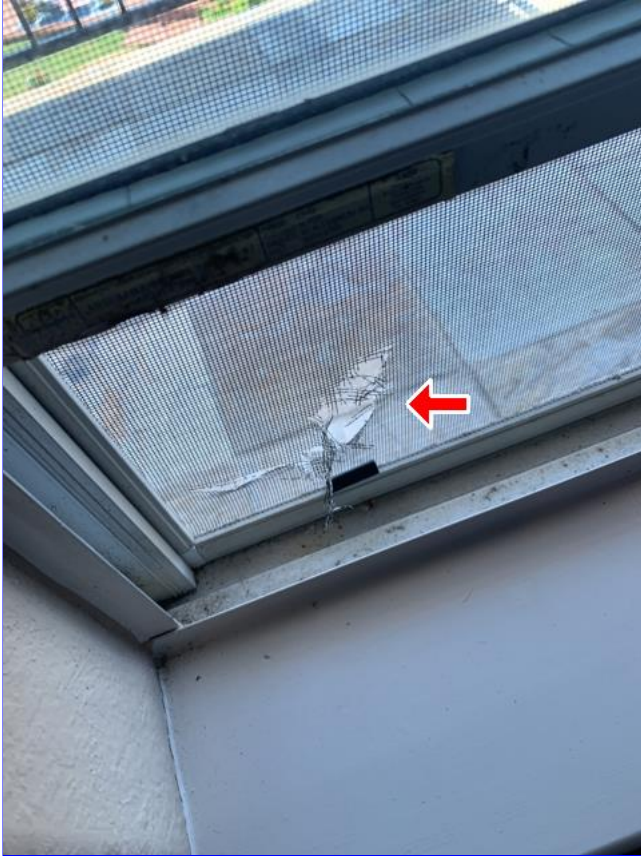
(2) There are damaged screens. Recommend repair.

H. Item 3(Picture) There are damaged screens. Recommend repair.

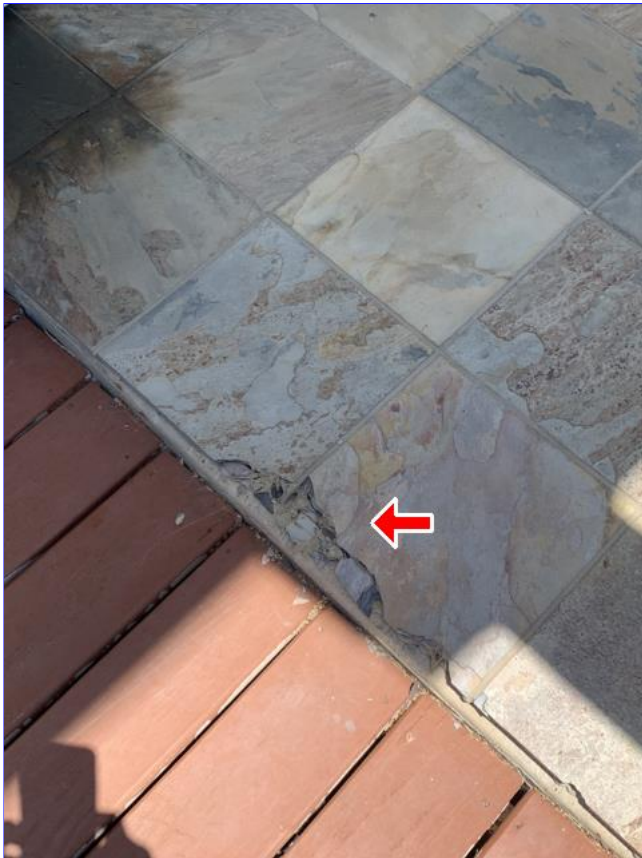
(1) Damage to the floor covering at the back patio was observed. Recommend repair.

K. Item 1(Picture) Damage to the floor covering at the back patio was observed. Recommend repair.

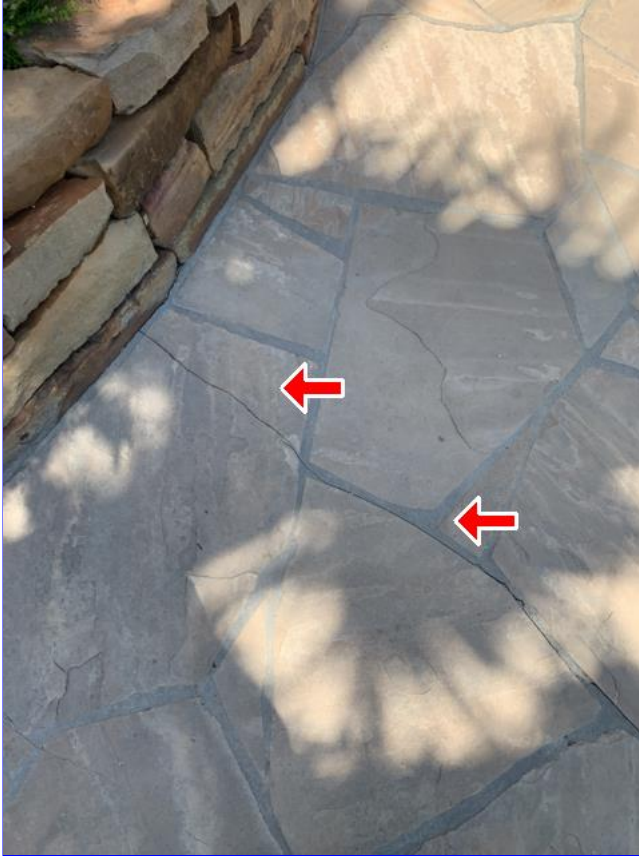
(2) Cracks where observed at the deck. Recommend repair.

K. Item 2(Picture) Cracks where observed at the deck. Recommend repair.

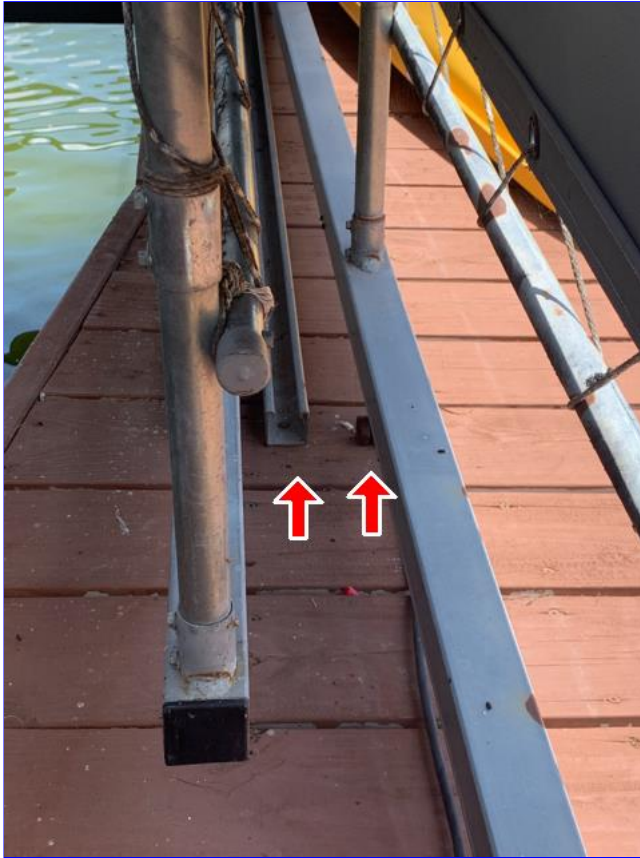
(3) One of the canopies for the boat cover is not on track. And some of the track is uneven. Recommend repair.

K. Item 3(Picture) One of the canopies for the boat cover is not on track. And some of the track is uneven. Recommend repair.

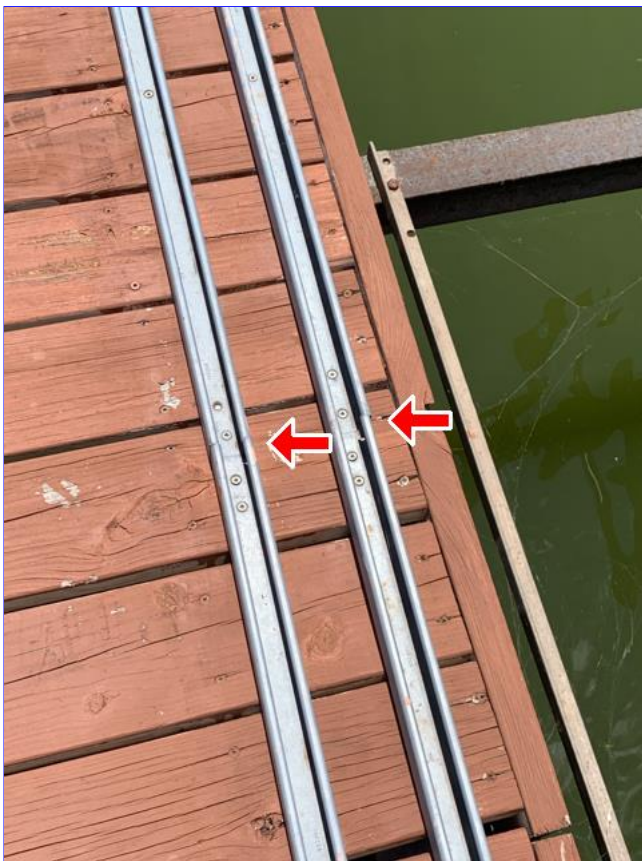
K. Item 4(Picture) One of the canopies for the boat cover is not on track. And some of the track is uneven. Recommend repair.

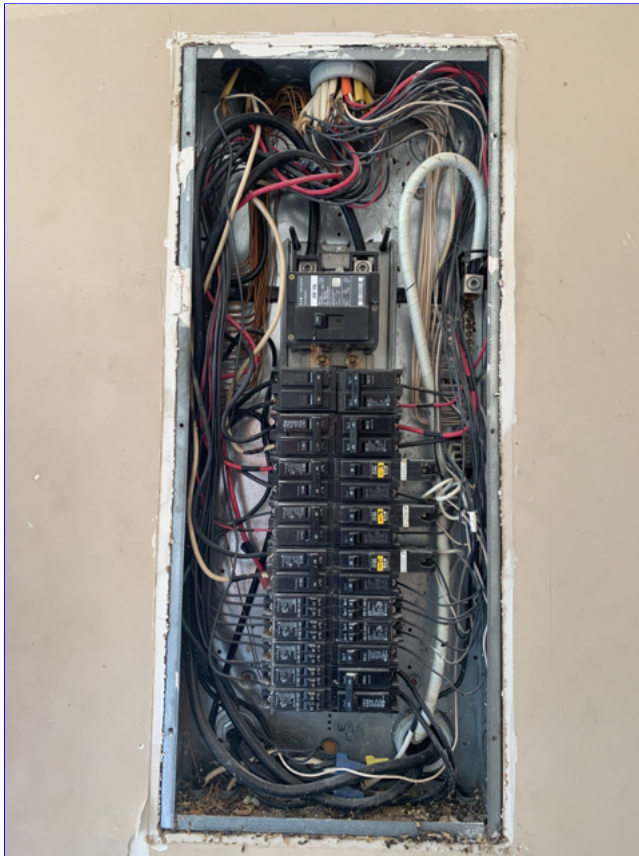
The main electrical service panel, shown with dead front cover removed for inspection purposes. The panel inspected okay.

A. Item 1(Picture) The main electrical service panel, shown with dead front cover removed for inspection purposes. The panel inspected okay.

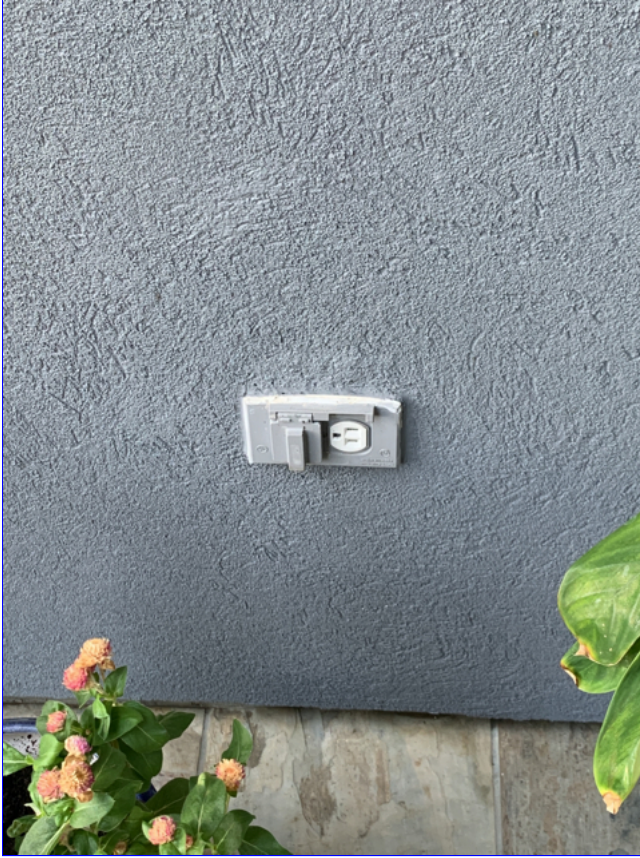
(4) Cover is missing for an outside outlet. Recommend replacing.

B. Item 1(Picture) Cover is missing for an outside outlet. Recommend replacing.

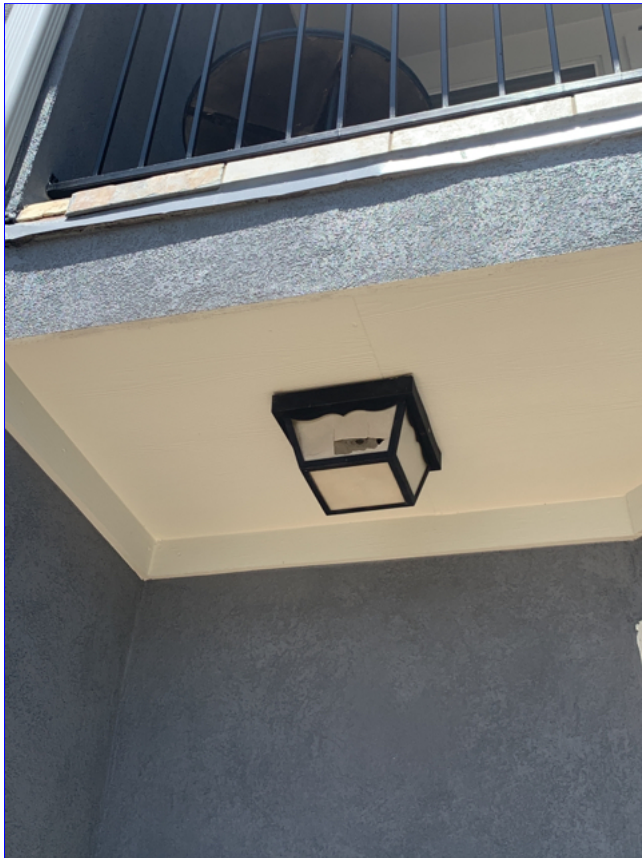
- (5) The exterior outlets such as outlets on boat dock and on back porch, are not all GFCI protected.
- (6) The light cover is broken at the back porch. Recommend replacing.

B. Item 2(Picture) The light cover is broken at the back porch. Recommend replacing.
