SUNBELT INSPECTIONS

Inspection Report

Property Address:
150 Waterford Way
Montgomery TX 77356

PROPERTY INSPECTION REPORT FORM

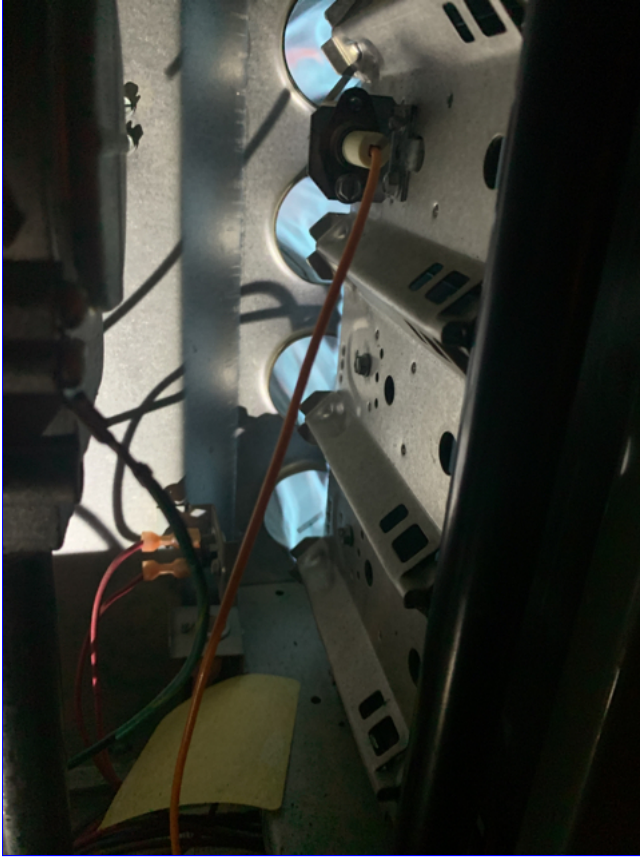
(1) The unit appeared to operate normally using the standard controls. I could not determine if the heat exchanger is cracked or not without dismantling the furnace. Dismantling of components is outside of the scope of a standard home inspection. Manufacture date 2004.

A. Item 1(Picture) Furnace burners

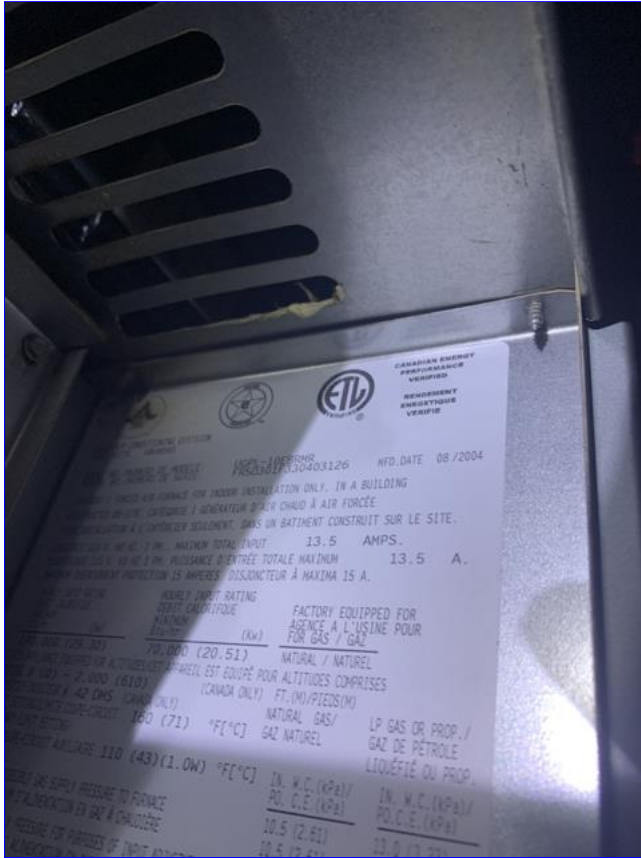
A. Item 2(Picture) Furnace service tag

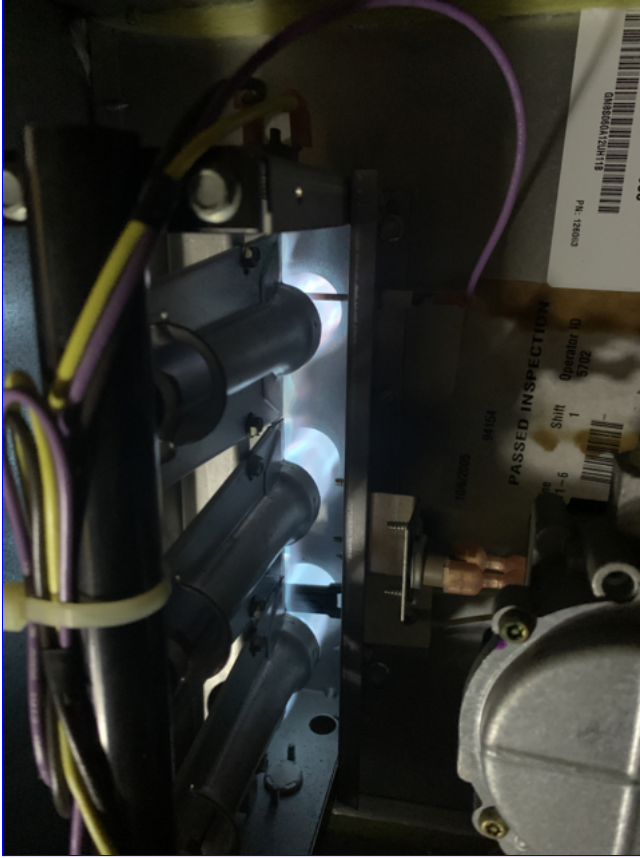
A. Item 3(Picture) Furnace burners

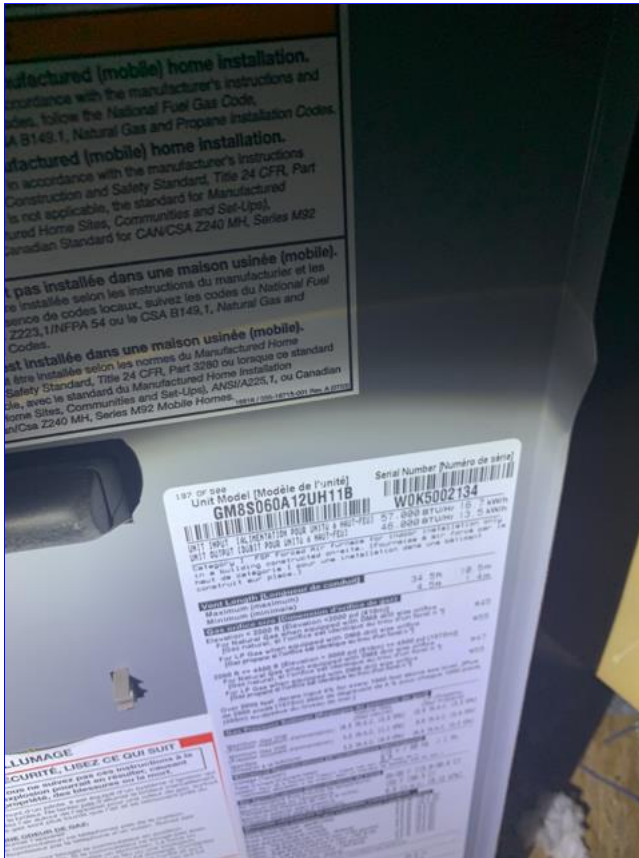
A. Item 4(Picture) Furnace service tag

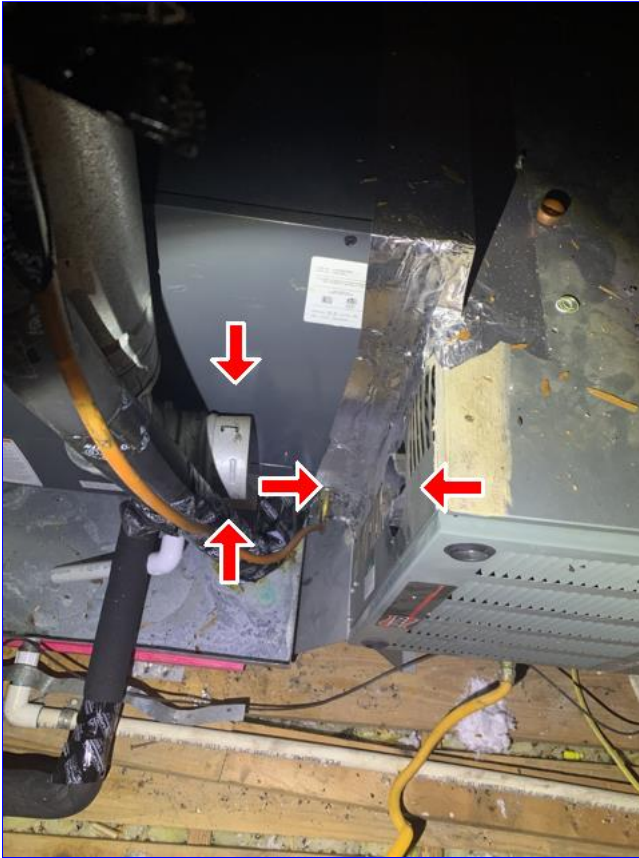
(2) The exhaust flue for the furnace is not connected. Exhaust fumes are going into the attic space. Recommend correction.

A. Item 5(Picture) The exhaust flue for the furnace is not connected. Exhaust fumes are going into the attic space. Recommend correction.

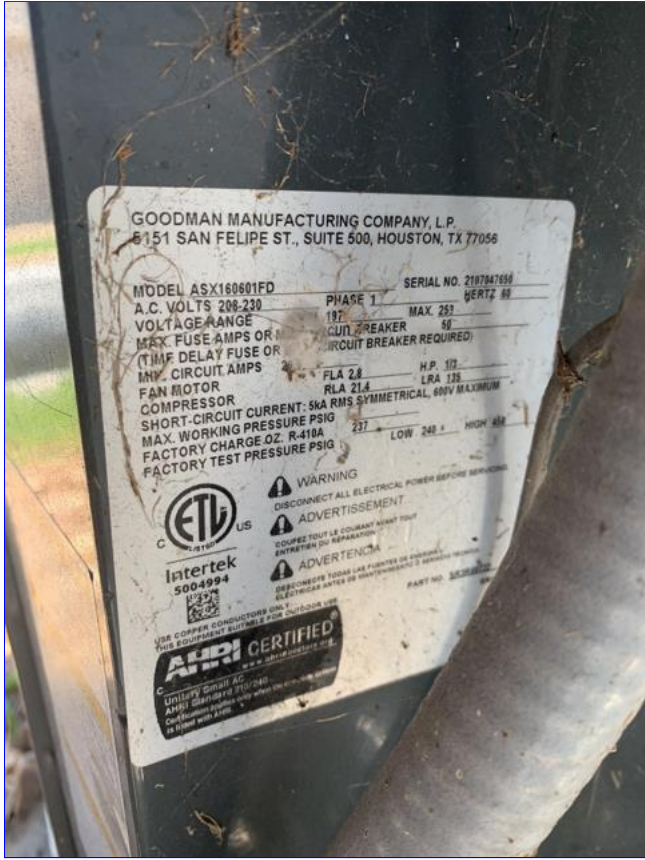
These conditions indicate that both systems are currently NOT cooling normally. Manufacture date 2021 and 2016.

B. Item 1(Picture) AC service tag

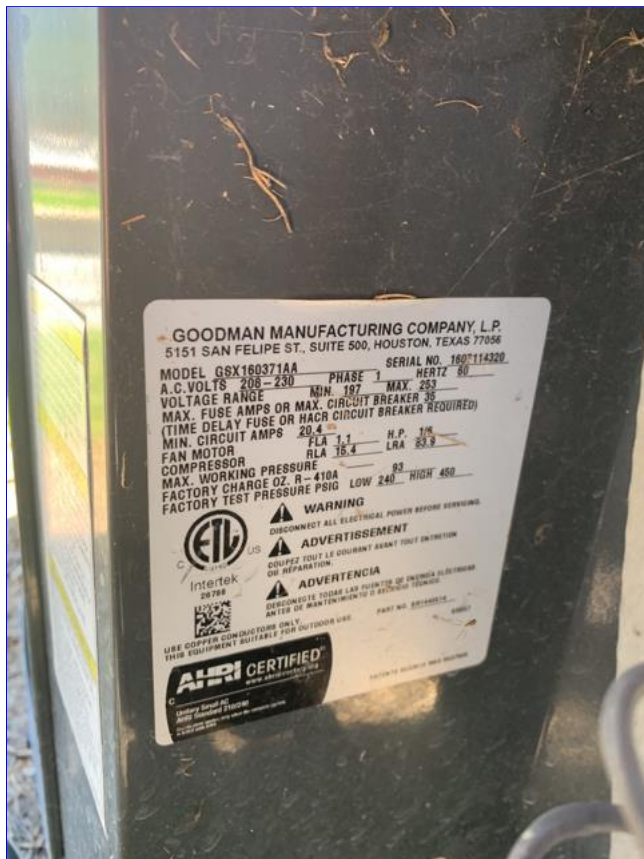
B. Item 2(Picture) AC service tag

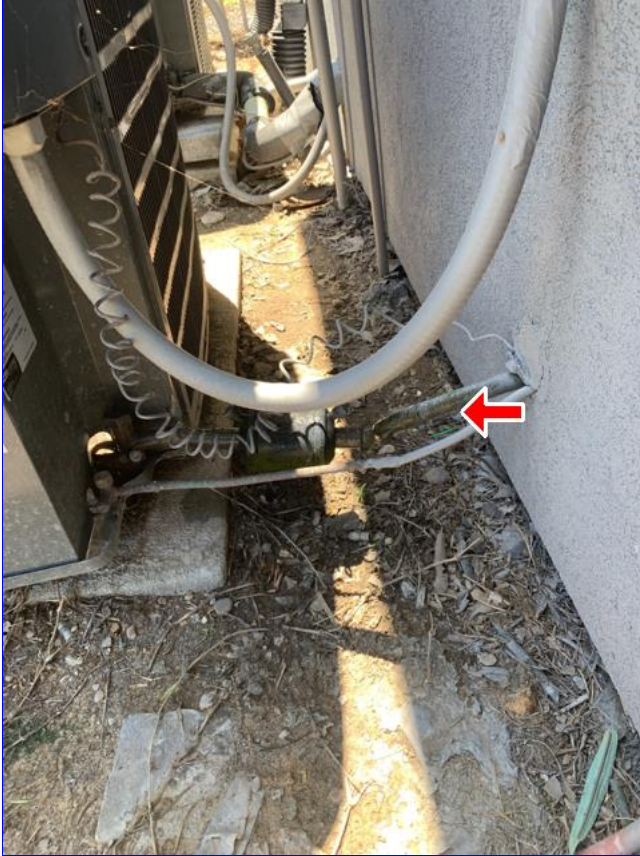
(2) The insulation, on the refrigeration line(s) is deteriorated. I recommend it be repaired or replaced.

B. Item 3(Picture) The insulation, on the refrigeration line(s) is deteriorated. I recommend it be repaired or replaced.

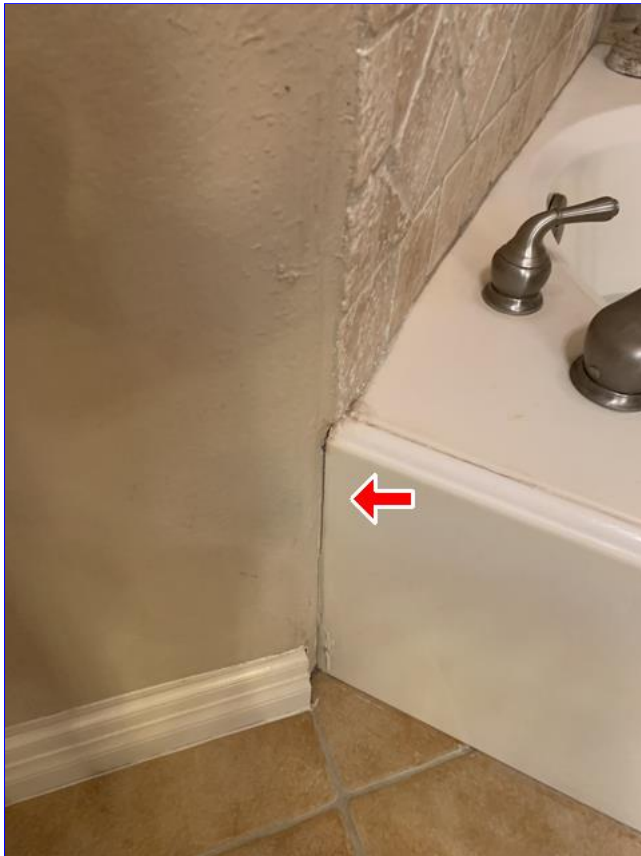
(1) Areas around the master tub need to be caulked. Recommend caulking.

A. Item 1(Picture) Areas around the master tub need to be caulked. Recommend caulking.

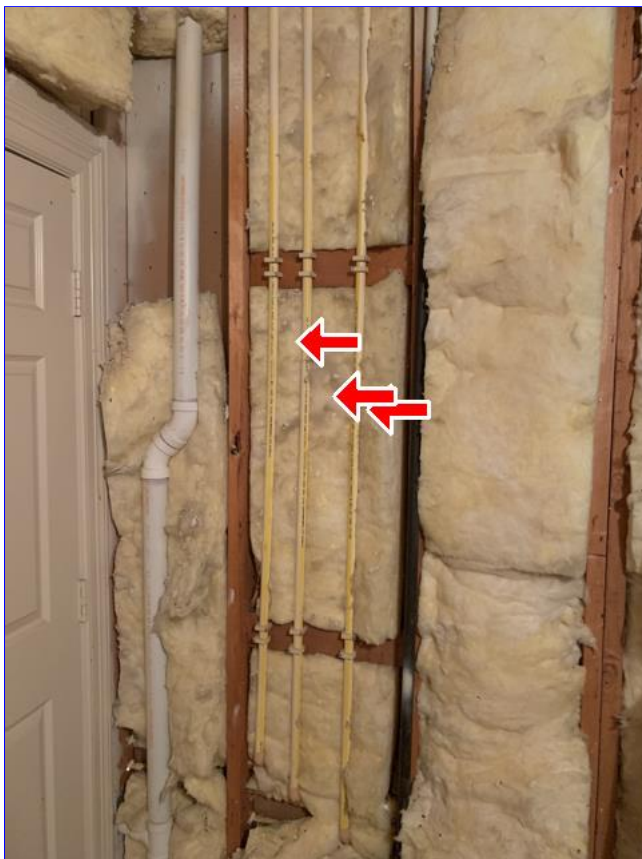
(3) Exposed water pipes observed in the attic space are not properly protected from freezing. Water pipes should be buried under the insulation or properly wrapped to prevent breakage from freezing.

A. Item 2(Picture) Exposed water pipes observed in the attic space are not properly protected from freezing. Water pipes should be buried under the insulation or properly wrapped to prevent breakage from freezing.

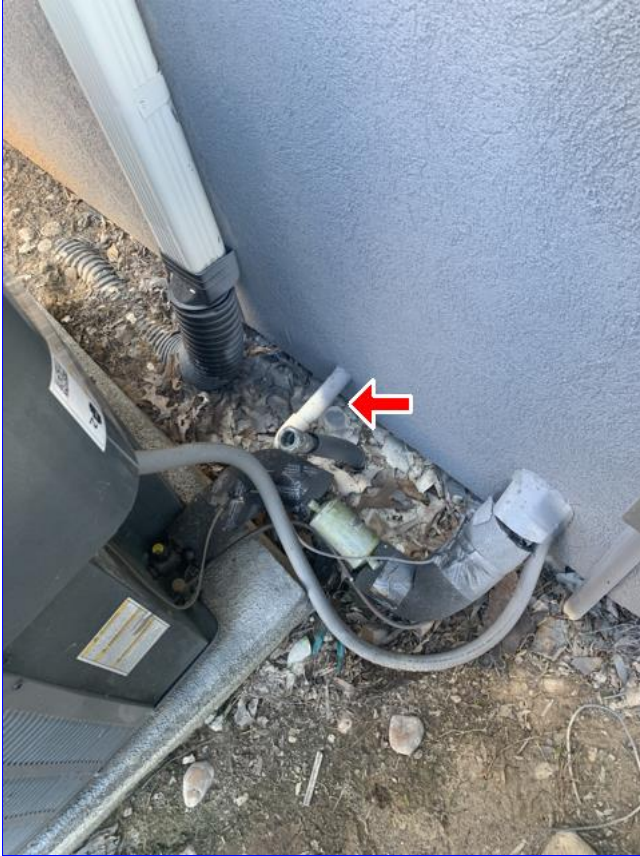
(4) The main water supply line at the exterior, is not properly protected from freezing.

A. Item 3(Picture) The main water supply line at the exterior, is not properly protected from freezing.

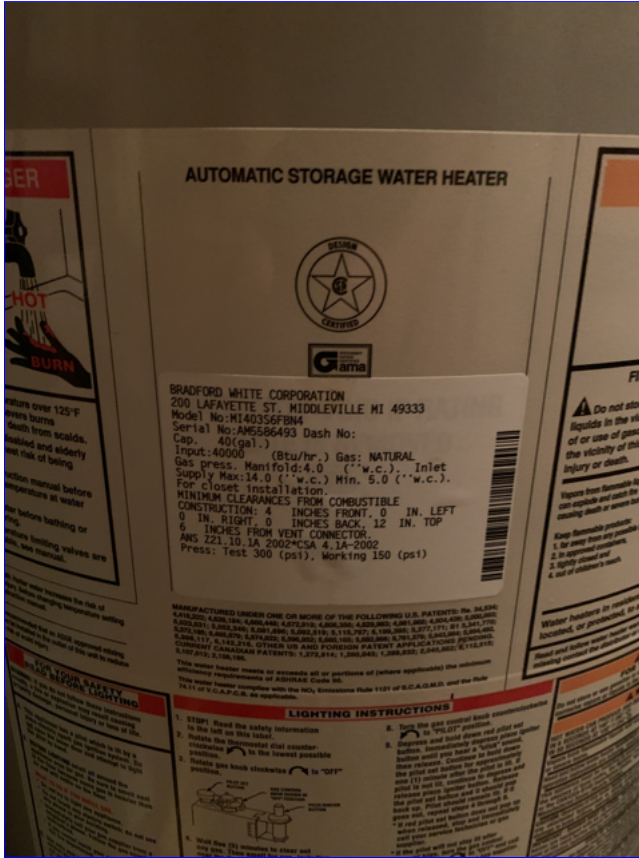
C. Item 1(Picture) Water heater service tag. Manufacture date 2004.

(2) **NOTE:** The water heater is old. Although the heater appears to be currently operating, it is nearing, or has exceeded, the end of the average useful service life of typical gas fired water heater (about 15 years). The heater may last a few years longer or may not. I cannot determine how long the unit will continue to operate. I recommend that you budget for replacement.

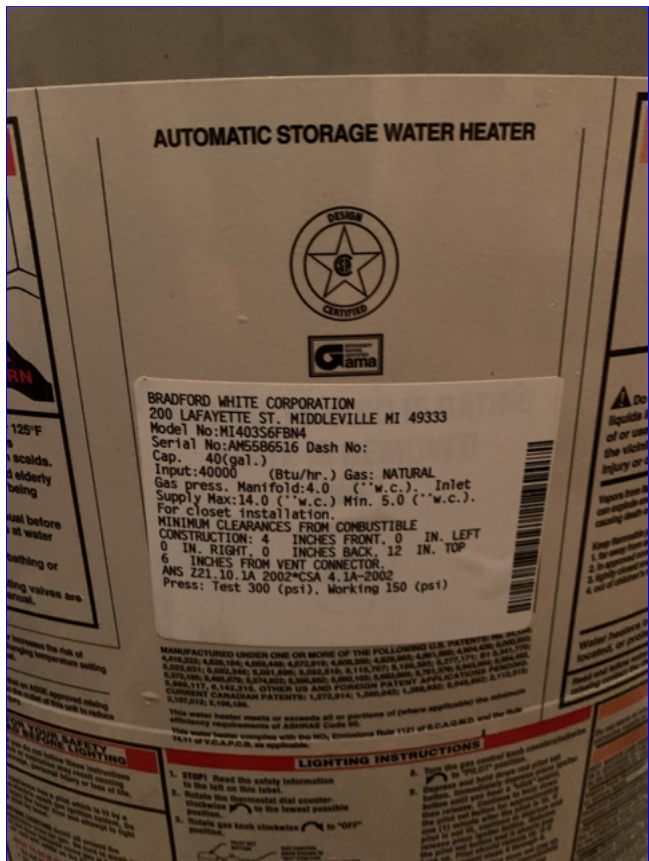
C. Item 2(Picture) Water heater service tag. Manufacture date 2004.

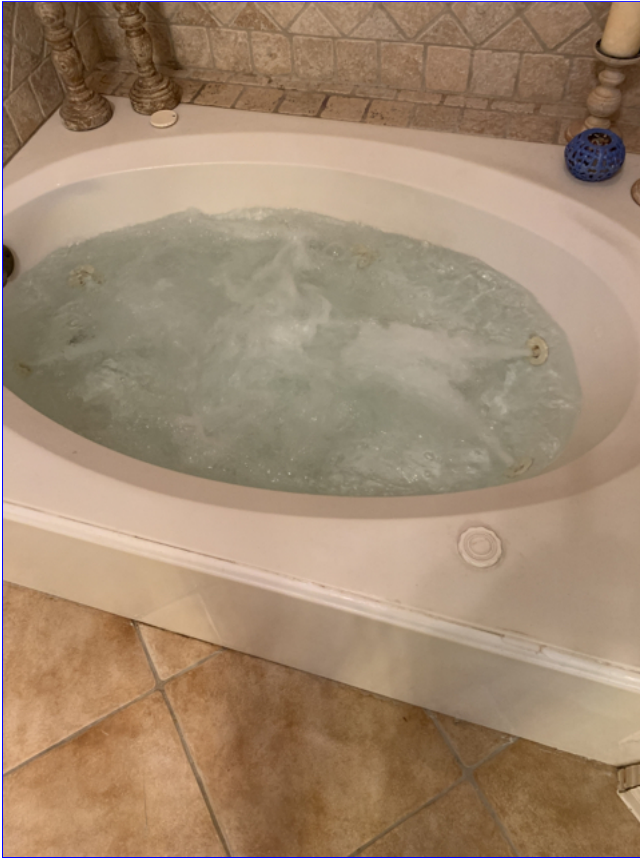
D. Item 1(Picture) A readily accessible inspection port is not available.

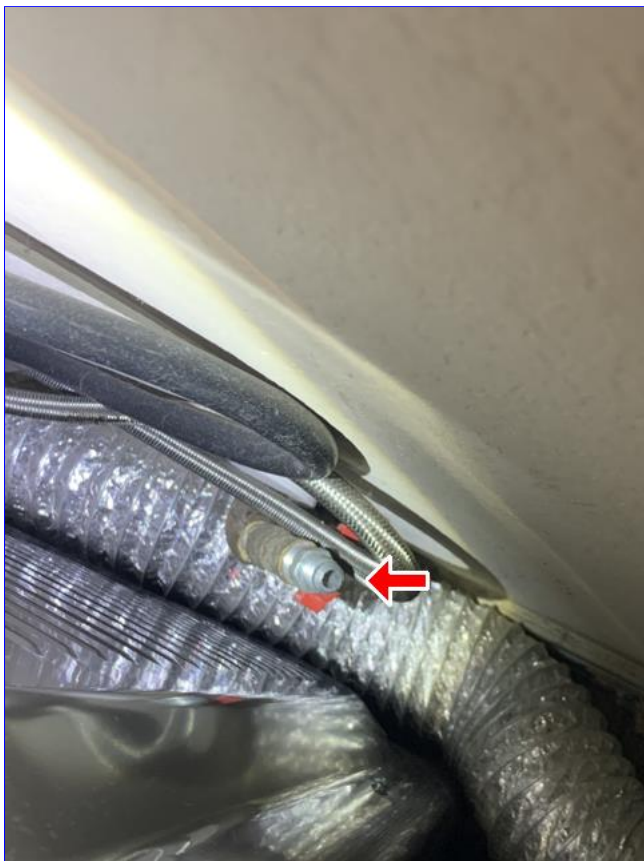
E. Item 1(Picture) The gas line at the clothes dryer location should be properly capped if not in use.

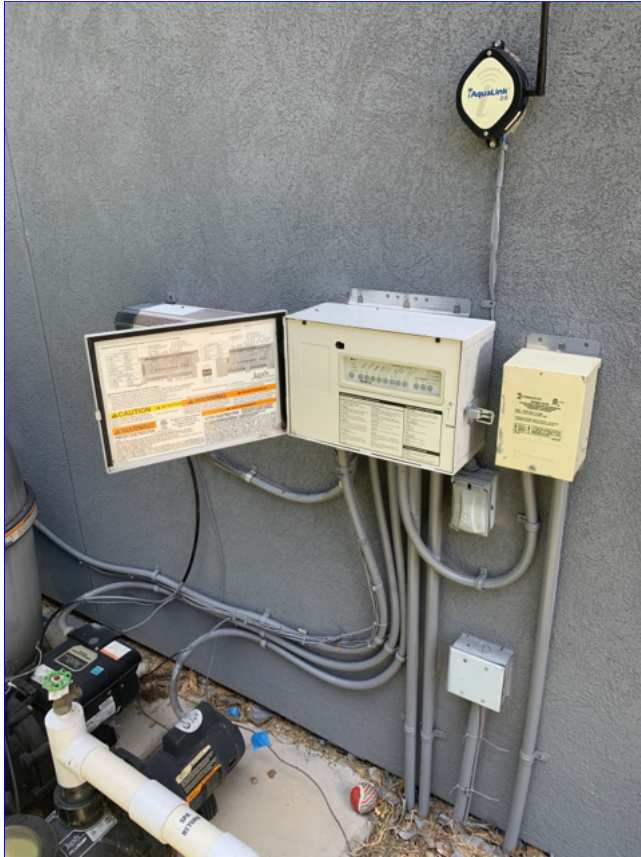
Pool control observed at the pump. A remote or control panel was not observed in the home or at the pool. A phone application might be used. Contact sellers or pool company for instructions.

A. Item 1(Picture) Pool control observed at the pump.
