INVASIVE STUCCO INSPECTION

2302 Brun Street
Houston TX 77019

APRIL 27, 2021

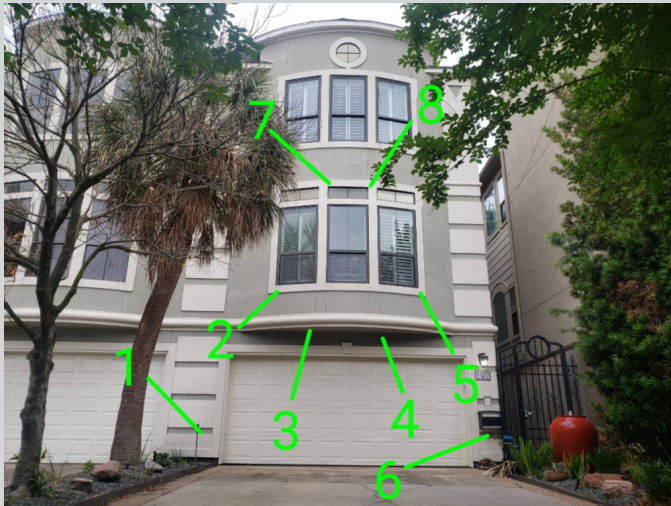
General: East Elevation

Probe	%	Moisture	Substrate	Note
1	12	Low	Firm	Some minor softness at bottom of wall, probed above and firm
2	11	Low	Firm	
3	11	Low	Firm	
4	12	Low	Firm	
5	11	Low	Firm	
6	12	Low	Firm	Some minor softness at bottom of wall, probed above and firm
7	8	Low	Firm	
8	9	Low	Firm

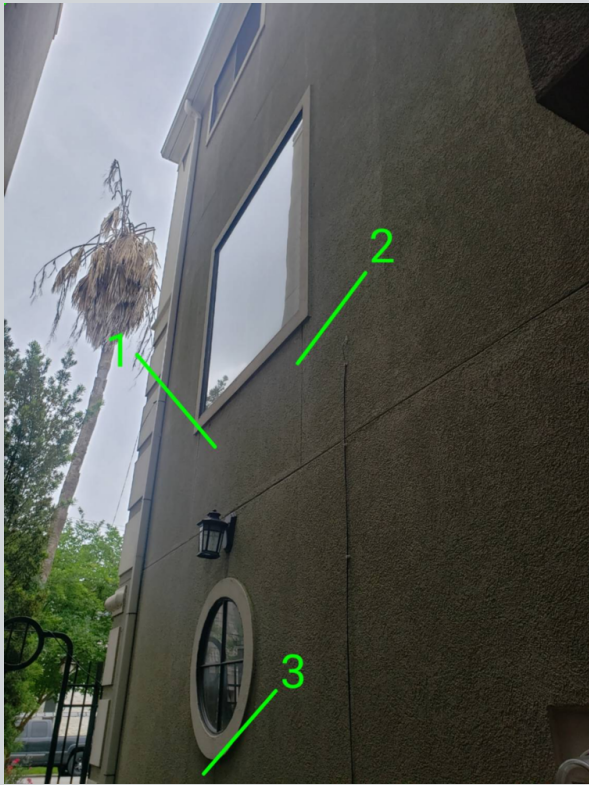
General: North Elevation 1

Probe	%	Moisture	Substrate	Note
1	11	Low	Firm	
2	12	Low	Firm	
3	14	Low	Firm

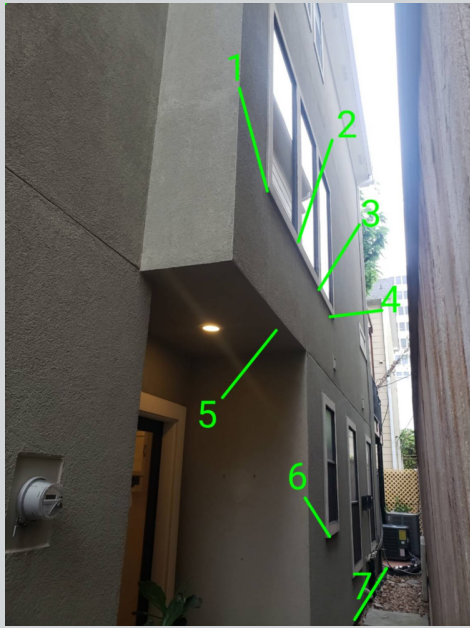
General: North Elevation 2

Probe	%	Moisture	Substrate	Note
1	11	Low	Firm	
2	12	Low	Firm	
3	12	Low	Firm	
4	11	Low	Firm	
5	11	Low	Firm	
6	10	Low	Firm	
7		No Reading	Firm	Substrate firm to touch along bottom of wall

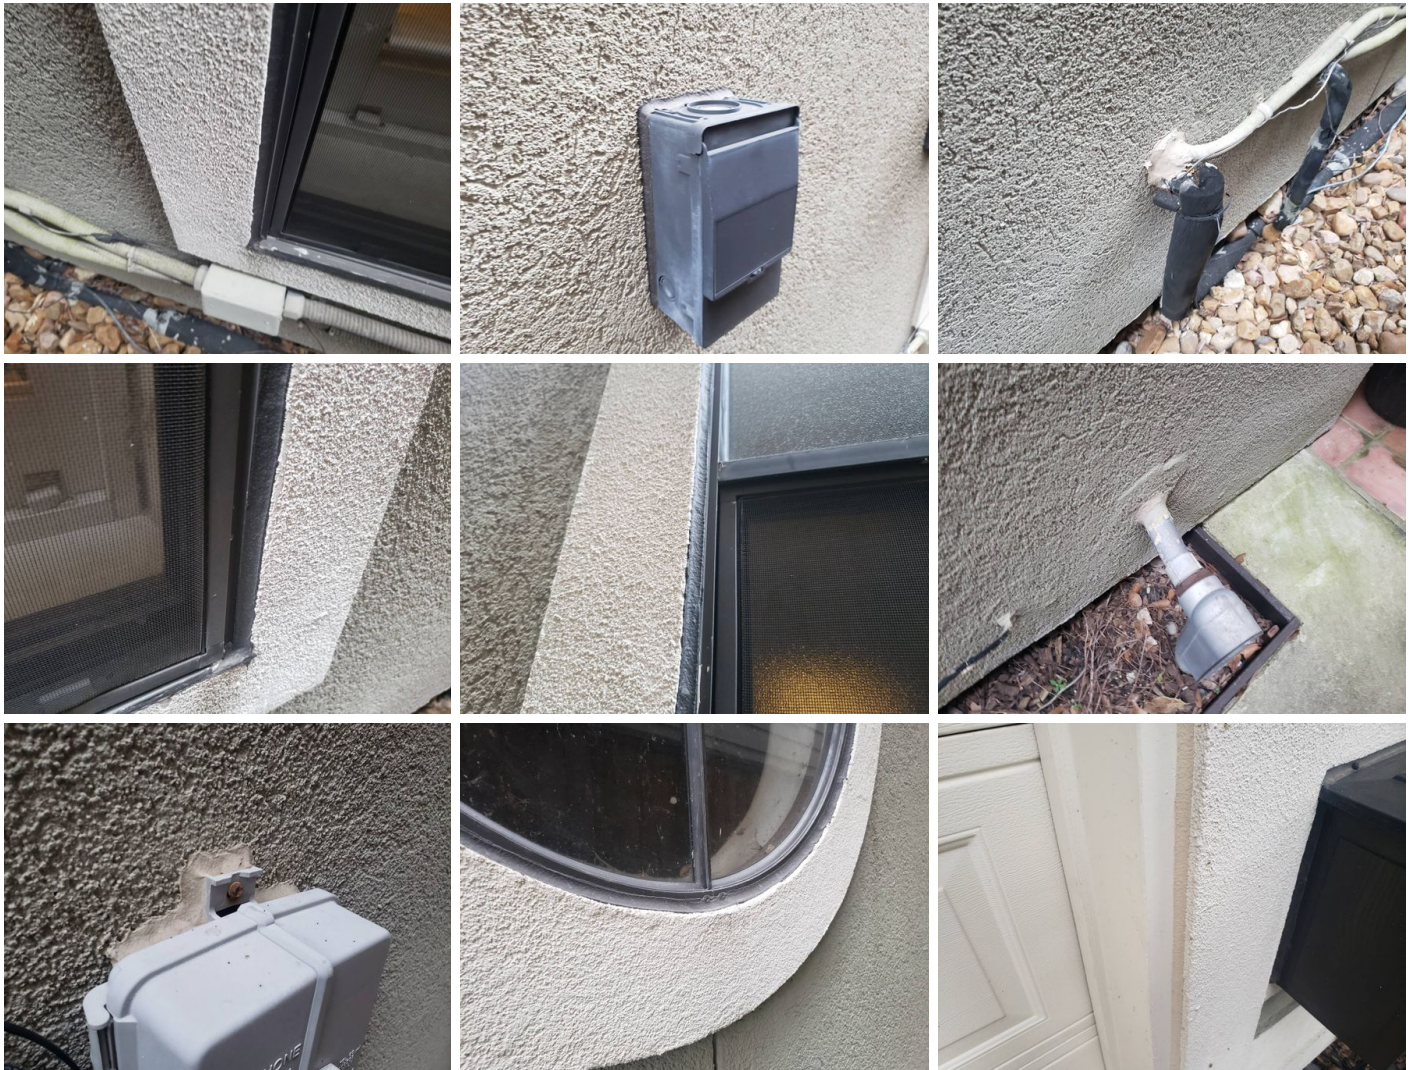
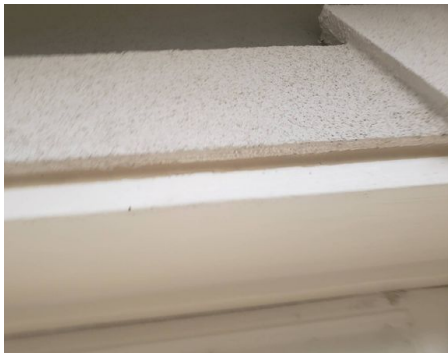
Sealants: Sealants - Generally good condition

The sealants in the stucco appeared to be in generally good condition at the time of the inspection, including at windows, doors, ascents, flashings, and wall penetrations. It is stressed that exterior sealants play a key role in preventing water intrusion. It is recommended that all sealants be maintained routinely.

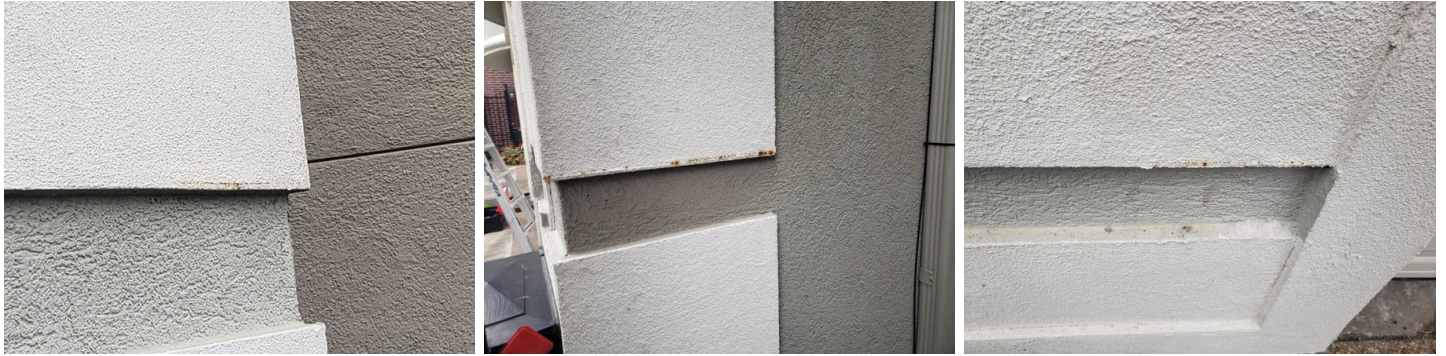
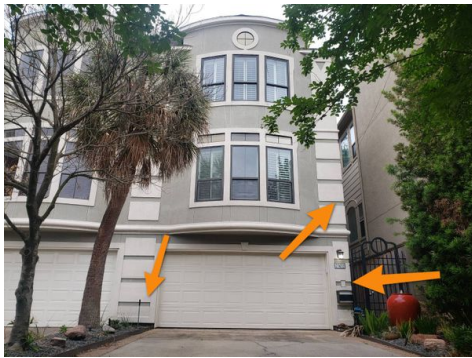
10.6.1 Metal Accessories Rusted

METAL ACCESSORIES RUSTED

Trim bands

Rust was observed on the metal stucco assemblies. Stucco is constructed with metal accessories, and rust is evidence of excessive moisture in the stucco veneer. It is recommended that a stucco contractor be contacted to repair the rusted accessories and to repair any other secondary damage.

Obtain Cost Estimate

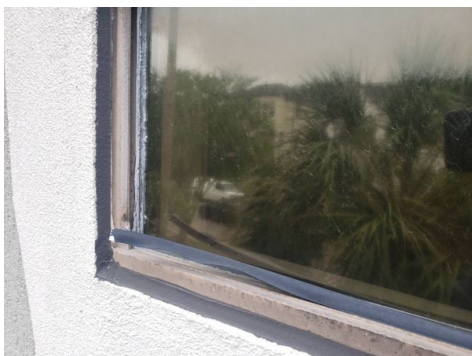
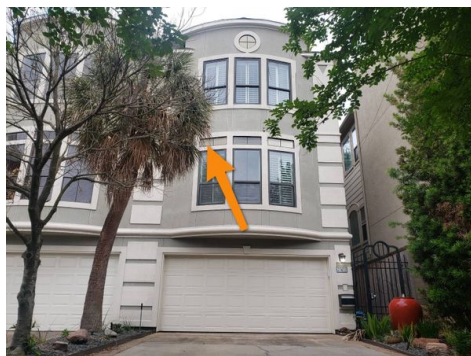
10.7.1 Other Conditions of Note

WINDOW GASKETS

Window gasket was loose and missing at the transom window at the front of the house. Have a window company replace and or seal window as needed.

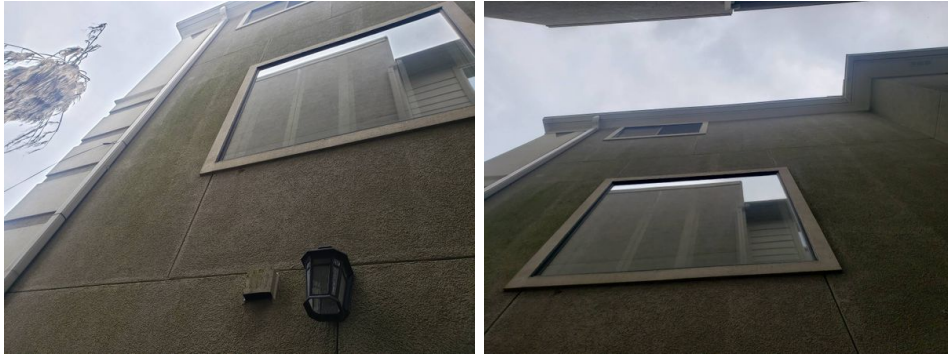
10.8.1 Paint Condition

MICROBIAL GROWTH PRESENT

Microbial growth / algae was observed on the stucco surface. The substance should be removed and the stucco should be cleaned as necessary.

Obtain Cost Estimate
