KEENEYE INSPECTIONS LLC

COMPREHENSIVE HOME INSPECTION REPORT (7-6)

7714 Atwood Manor Ct
Richmond, TX 77407

| Nazir Ahmad <i>Name of Client</i> | 05/08/2023 9:00 am <i>Date of Inspection</i> |

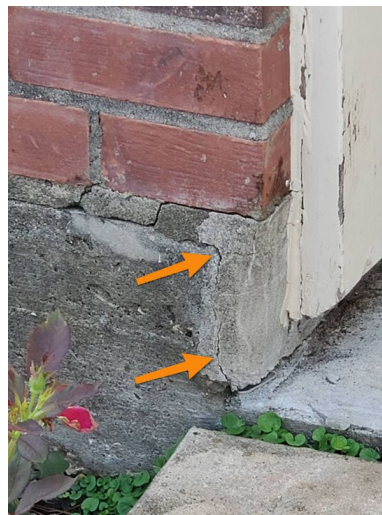
1: Foundation perimeter beam - corner pop

Observed foundation corner pop / cracked. This is a common condition in slab on grade foundations, and usually cosmetic.

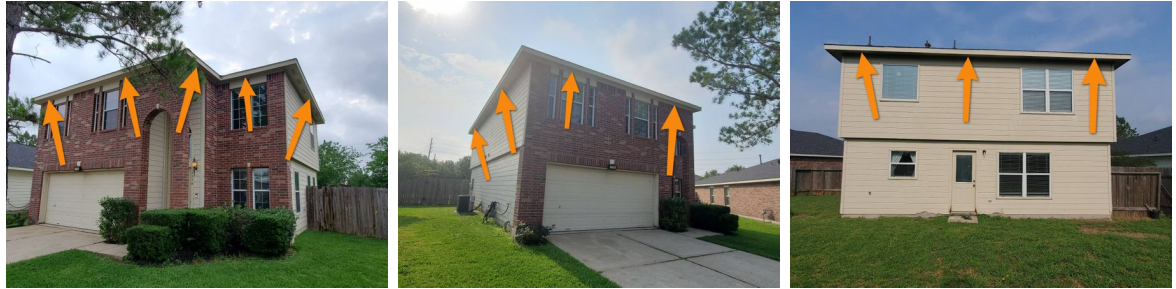
1: Gutters - recommended

Grading and drainage could be improved with the installation of rain gutters. Properly installed rain gutters can prevent erosion and water ponding and help direct water away from the foundation.

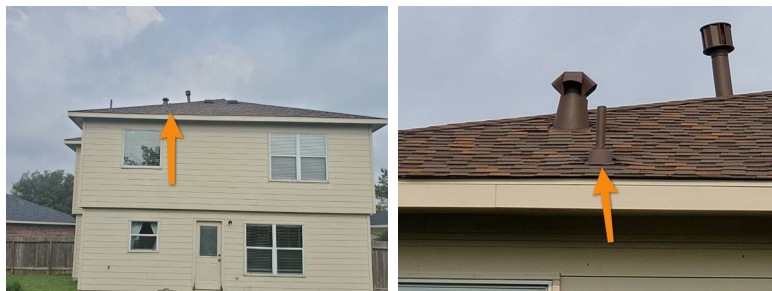
Back

Roof covering flashings were observed to be lifting / buckled. The flashing was damaged or improperly installed and were in need of repair or replacement. Lifting, damaged or improperly installed flashings may allow water penetration.

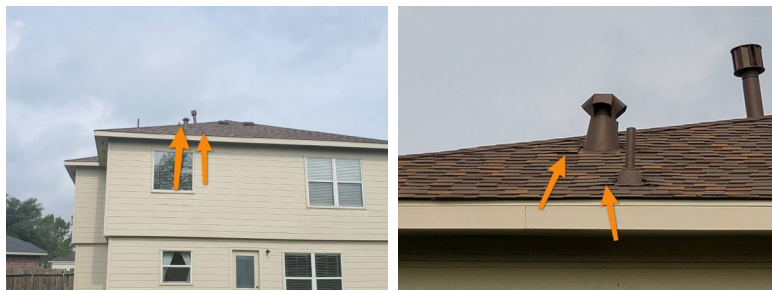
Back

Observed roof shingles lifting and in need of further evaluation and repair.

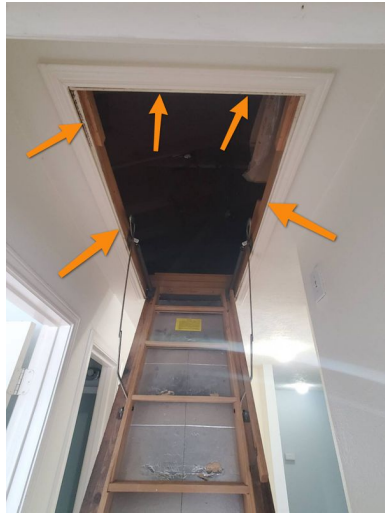
Observed lack of weatherstripping around door frame at attic access.

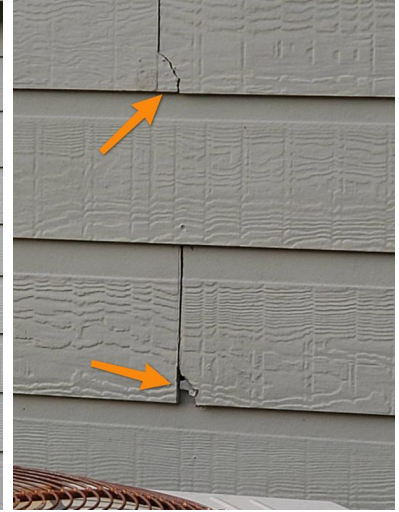
Left

Observed broken or damaged of cement board siding. Recommend repair.

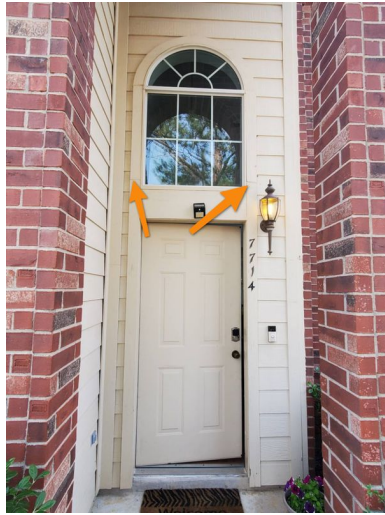
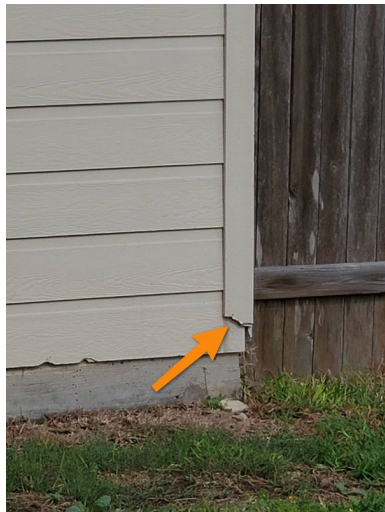
The exterior siding trim was observed to have some deterioration and/or damage. Damaged and deteriorated exterior siding trim should be repaired to prevent wall damage, moisture penetration.

Some trims around the windows appear to be replaced over time, but having fasteners backing out, lacking proper paint etc.

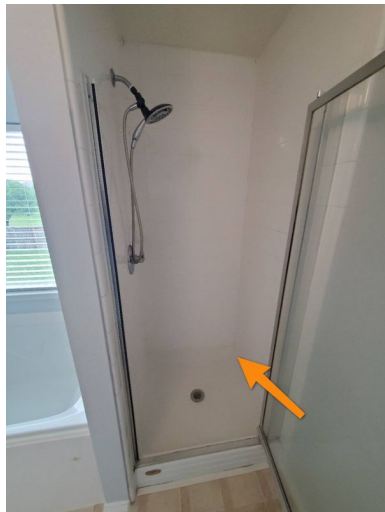
Master bath

Observed crack(s) at bathroom wall tile(s)

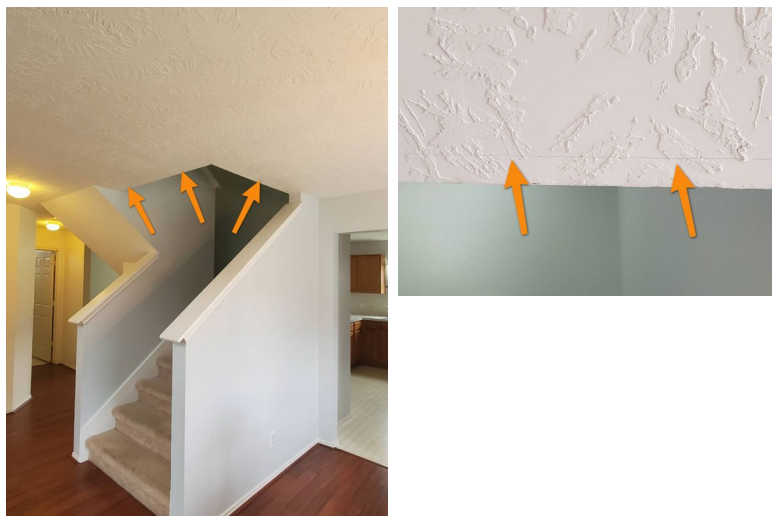
1: Ceiling(s) - Drywall contraction cracks

Observed drywall corner cracks which are typically contraction cracks resulting from thermal reaction to weather changes or framing movement. Recommend repair and periodic monitoring.

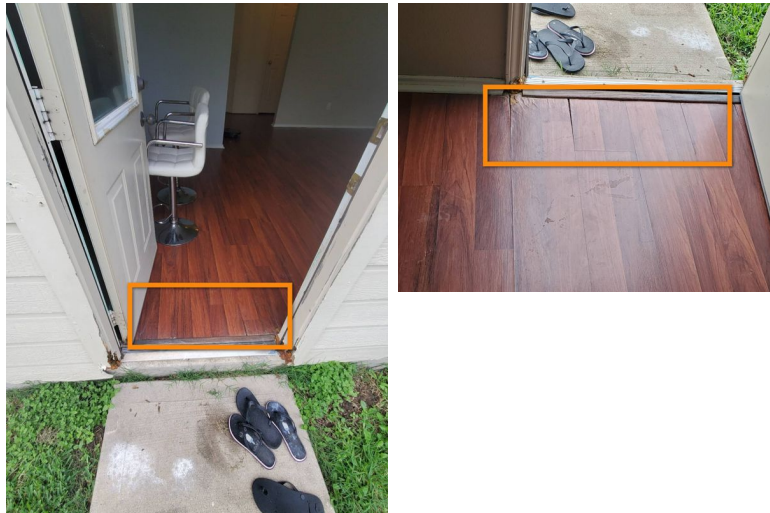
Back

Observed damage at flooring due to presence of moisture. This may be due to on-going moisture problem from high soils on the outside, or previous moisture intrusion. Recommend further evaluation and repair as needed.

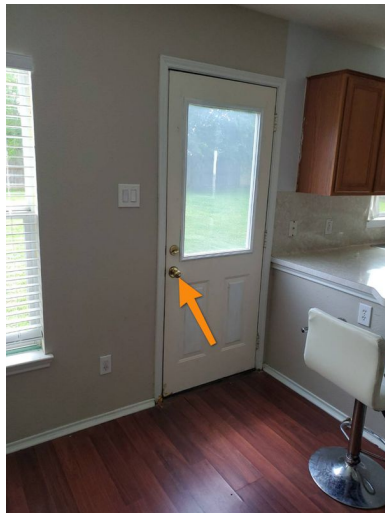
Back door

Observed exterior door hardware faulty or defective, and not performing as intended.

Front door latch was observed to stick, and require multiple attempts to open the door. Recommend replacing the hardware.

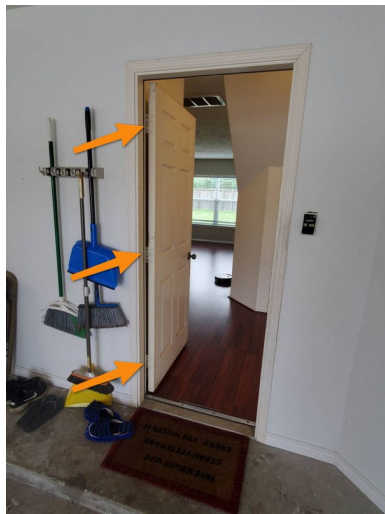
As per Texas Standards of Practice, garage entry door lacking self-closing hinger is a deficiency, which is no longer an accepted building standard.

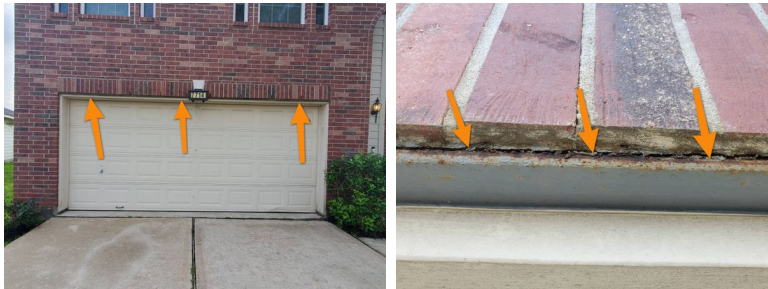
8: Garage Vehicle Door(s) - Steel lintel(s) need paint

The steel garage door lintel is in need of cleaning and paint to prevent rusting and corrosion. Steel garage door lintels are the support for exterior brick veneer siding and should be maintained to prevent deterioration and damage.

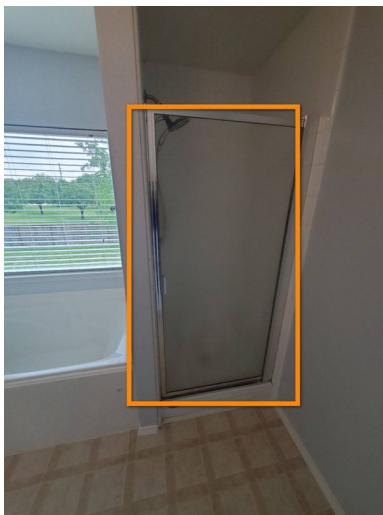
9: Interior Door(s) - Tempered glass at shower - Lack of

Observed lack of tempered glass at shower enclosure which is a SAFETY HAZARD and should be corrected.

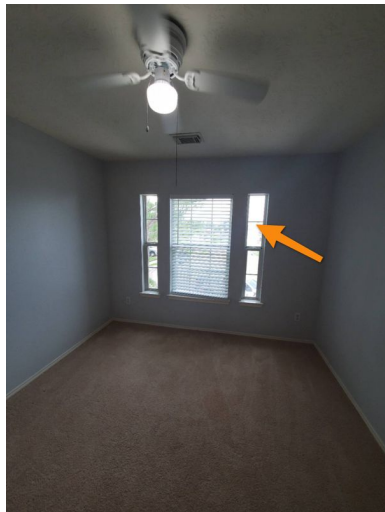
2nd Floor 1st Bedroom

Moisture and or discoloration is present between window glass panes. This has resulted in condensation or a fog like film to develop between the panes of glass. The thermal pane windows no longer function as designed when they loose their seal and repair or replacement is needed.

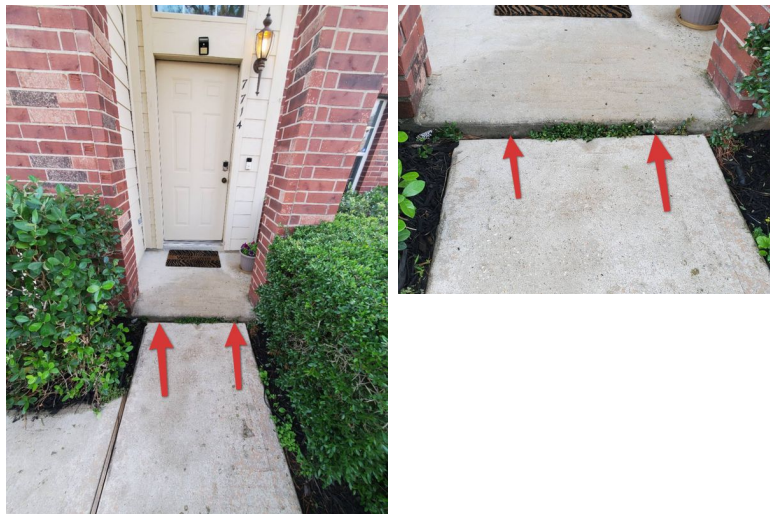
Observed tripping hazard at exterior concrete pavement due to movement in soil over time. Recommend periodic monitoring and repair as needed.

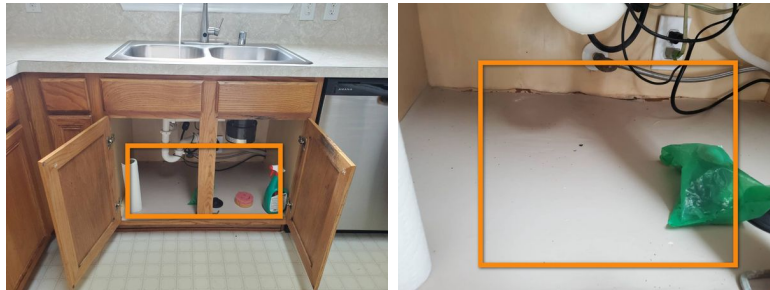
Observed water damage at kitchen cabinet which appear to be from an old leak.

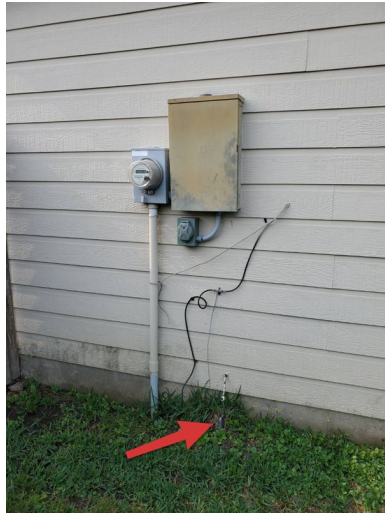
Wrong clamp

1: Grounding wire to rod - improper connection

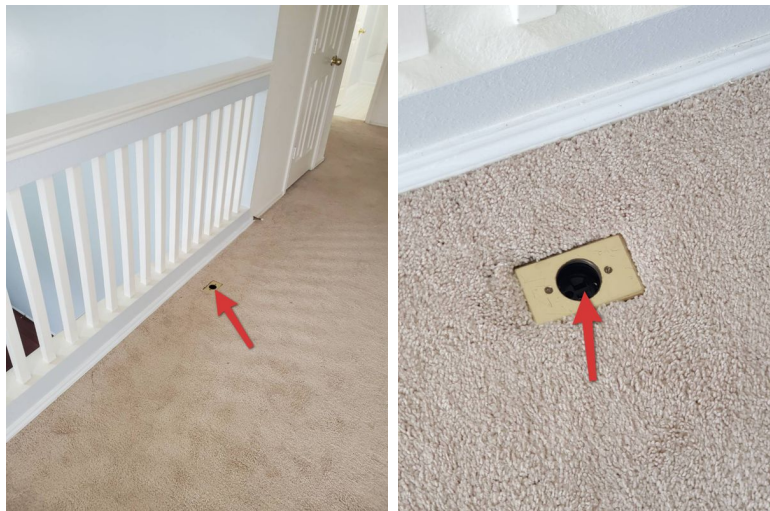
2nd Floor

In-floor receptacle box lack of cover and is a safety hazard.

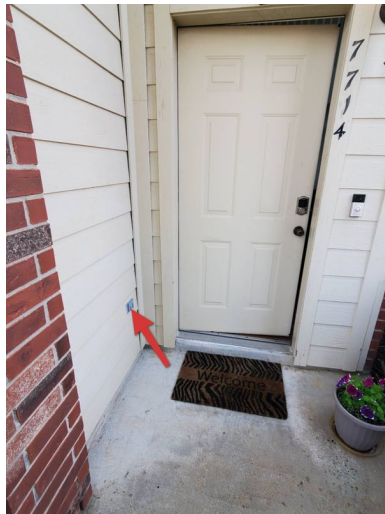
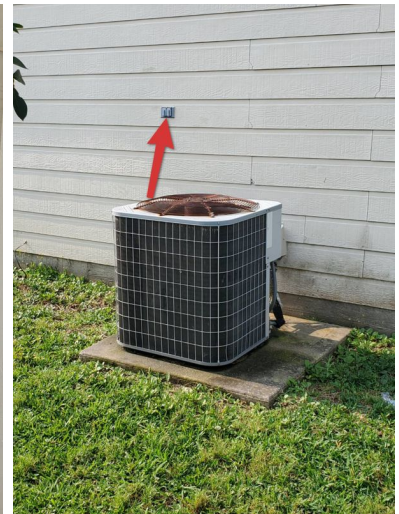
4: Receptacles (EXTERIOR) - lacking weather tight bubble covers

Lack of weather proof bubble covers at electrical receptacles in wet locations is a SAFETY HAZARD and should be repaired by a certified, licensed electrical specialist.

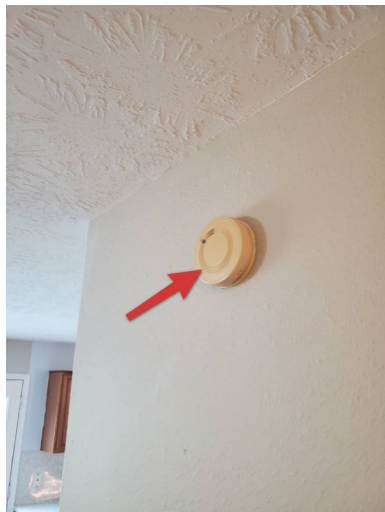
Loose, missing, expired, missing batteries or damaged smoke alarms are a SAFETY HAZARD. Under current building standards, there should be a smoke alarm located in each sleeping room, outside each separate sleeping area in the immediate vicinity of the sleeping rooms, and on each additional story of the dwelling, including basements but excluding crawl spaces and uninhabitable attics (in dwellings with split levels and without an intervening door between the levels, a smoke alarm installed on the upper level and the adjacent lower level shall suffice provided that the lower level is less than one full story below the upper level).

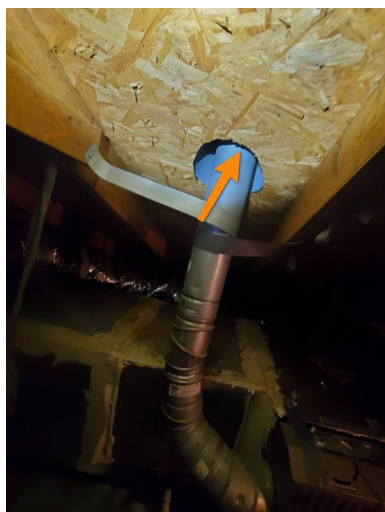
Also, due to lack of seal, there may be water intrusion from rain during heavy or windy rain conditions..

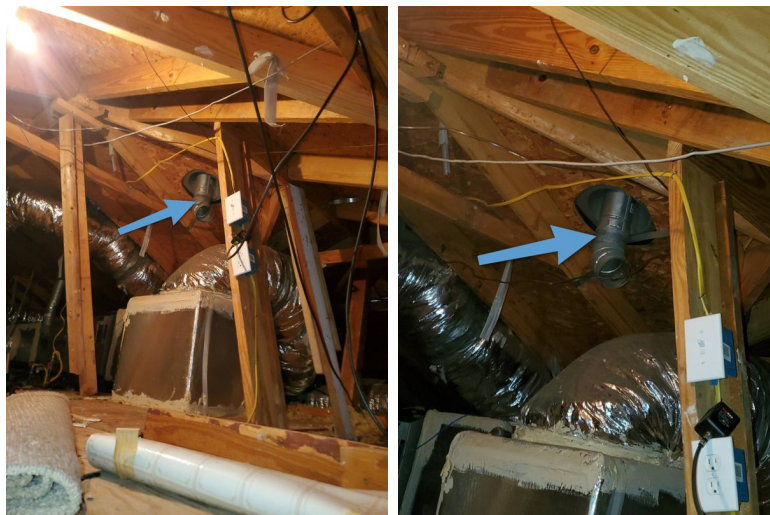
4: Furnace unused vent

Furnace unused vent observed at the time of the inspection. May be it was from previous unit. Recommend removing if not in used.

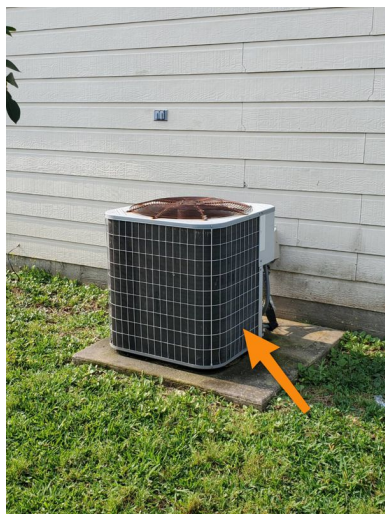
Average life expectancy of cooling equipment is 12 to 14 years. The cooling equipment has passed average life expectancy. Recommend periodic service and maintenance in accordance with manufacturer's recommendation, and budget for replacement.

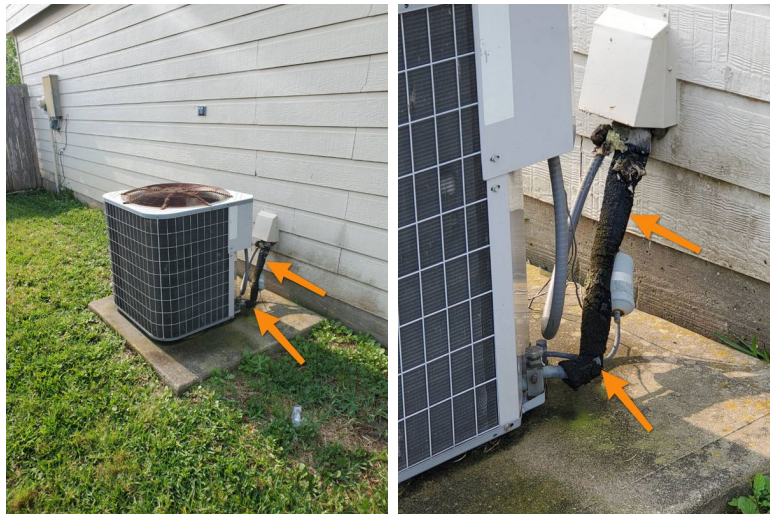
The HVAC refrigerant lines were not properly insulated or the insulation was damaged and in need of replacement at the exterior equipment. Inadequate cooling line insulation at the exterior HVAC equipment may result in equipment damage, inadequate performance, reduced equipment life or other defects.

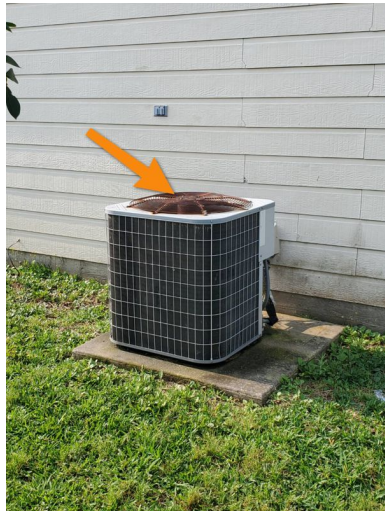
6: Rust/ Corrosion at Exterior condenser unit

During inspection Inspector observed Rust/Corrosion at Outside condenser unit.

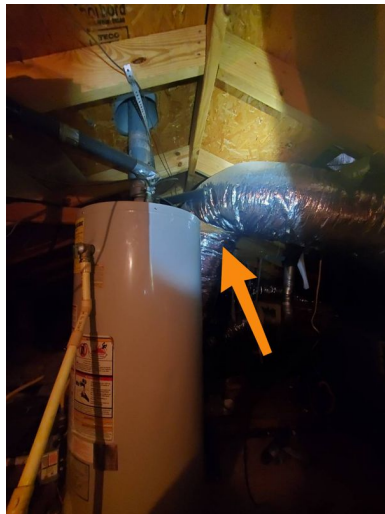
The ductwork was observed to be kinked, restricted or improperly routed. Improperly installed HVAC ductwork may limit air flow or create other defects and should be repaired. Duct over front HVAC unit

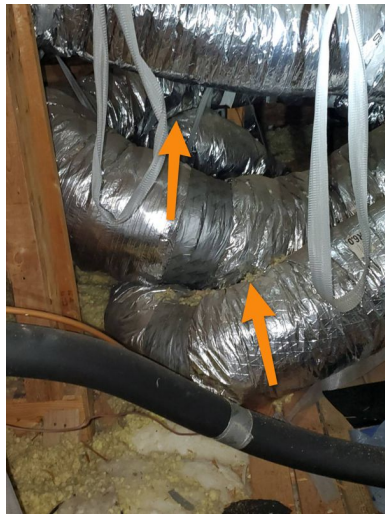
4: Lack of adequate spacing between ducts

Observed lack of adequate spacing or clearance between ducts which are in contact with each other. This may lead to possible condensation leading to water damage to finished ceiling below. Highly recommend proper correction to this defect. See pictures in other comment in this section.

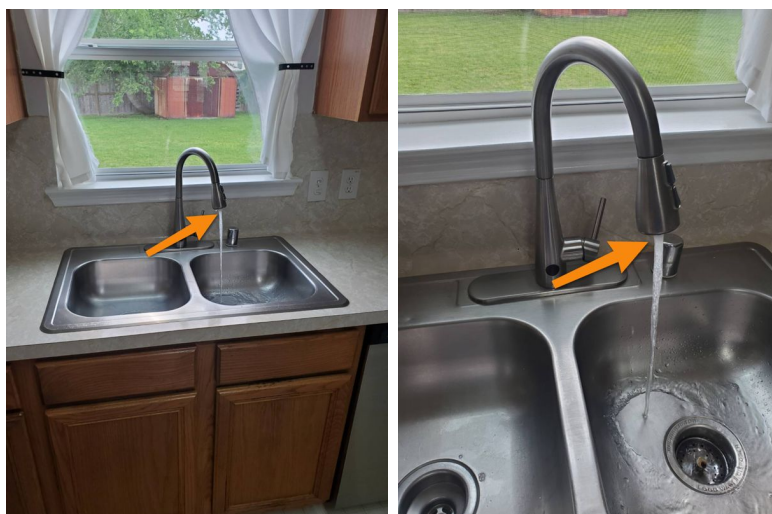
Low water pressure was observed at the kitchen sink. The cause of low water pressure should be determined and should be repaired as needed.

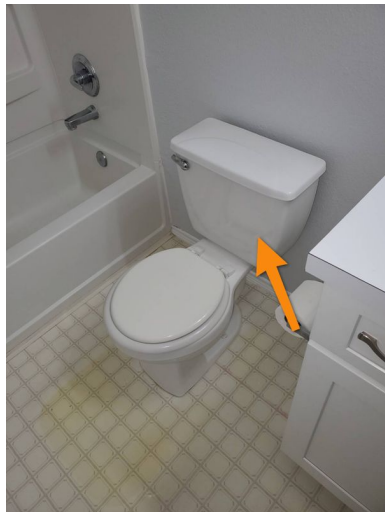
2nd Floor

Toilet tank filler noisy.

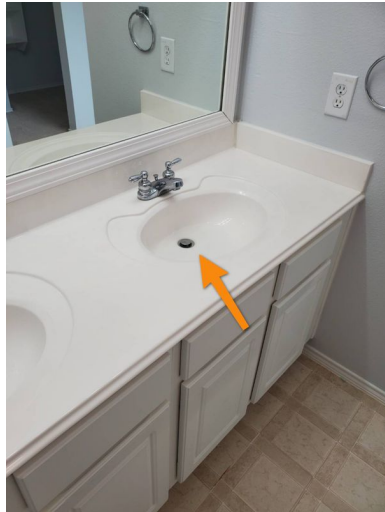
Master bath

Observed bathroom sink bowl draining slower than normal. Corrugated plumbing pipe installed under sink and leaking. Recommend plumber assess and make necessary repairs

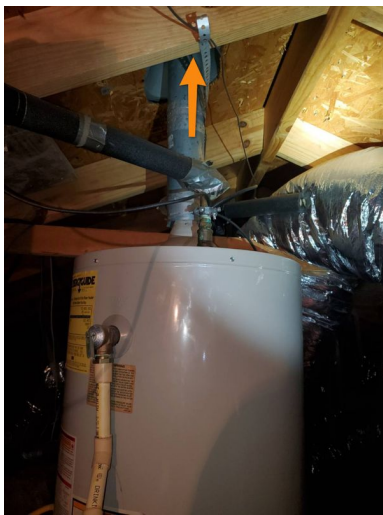
3: Water Heater - Exhaust flue to roof jack - lack of sealant

Observed day light at exhaust flue to roof jack connection, which is an indication of lack of sealant to prevent occasional water penetration.

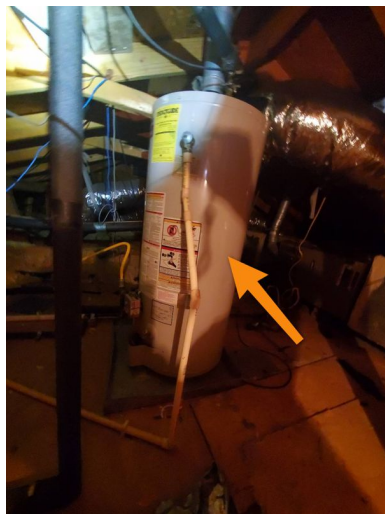
Gargling sound observed at water heater unit. Recommend further evaluation by specialists.

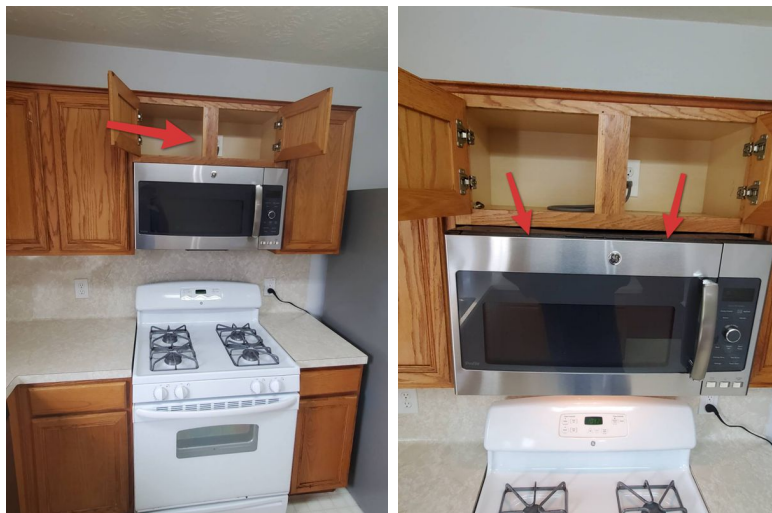
A gas oven, gas range or gas cooktop was installed with a range hood exhaust system which was not vented to the exterior. All gas appliances should be vented to the exterior of the structure. Lack of ventilation to the exterior of the structure is considered a SAFETY HAZARD and may allow harmful vapors to accumulate in the living area. There may be appliance manufacturer's guidelines that allow alternative ventilation of gas cooktops, ovens or ranges. Further evaluation is recommended.

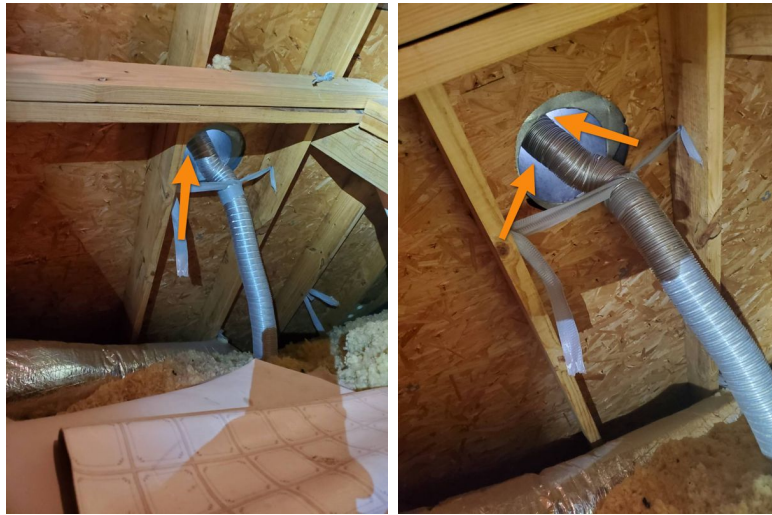
Also, due to lack of seal, there may be water intrusion from rain during heavy or windy rain conditions..

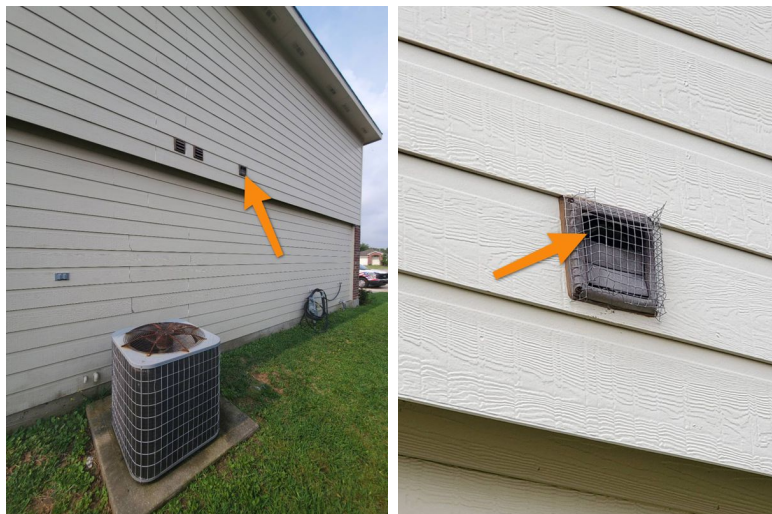
2: Exhaust fins at exterior wall damage

Observed exhaust fins at exterior wall damage during inspection. Recommend repair or replace.
