## DOMESTIC/CAUSE & ORIGIN LEAK INVESTIGATION

Homeowner's Name	Mariann Porter
Work Order #	32062
Testing Address	119 Dover Grace, New Braunfels, Tx 78130
Date of Service	Sep 7, 2022
Homeowner's Phone #	(830) 708-1075
Work Performed by:	Sonny Osborne By JT
Payment Type	Check
Pictures of Home

## POOL LEAK DETECTION

Homeowner's Name	Mariann Porter
Work Order #	33383
Date of Testing	Nov 2, 2022
Testing Address	119 Dover Grace, New Braunfels, Tx 78130
Homeowner's Phone Number	830-708-1075
Payment Type	Credit Card
Technician's Name	Carlos Gutierrez By JT

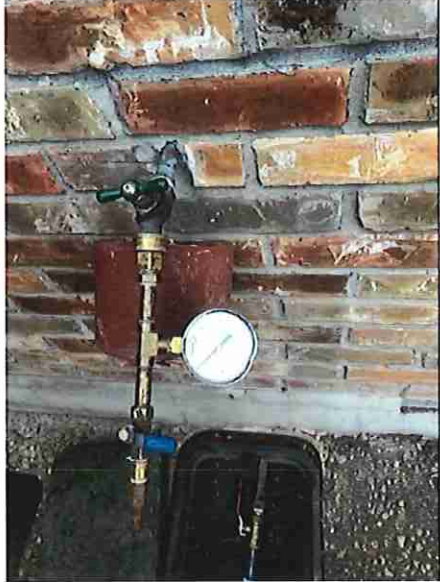
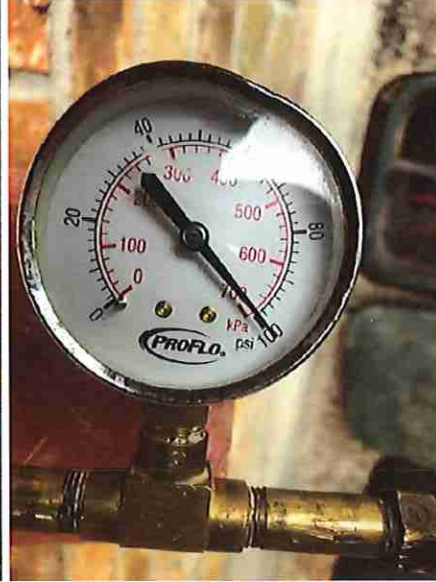
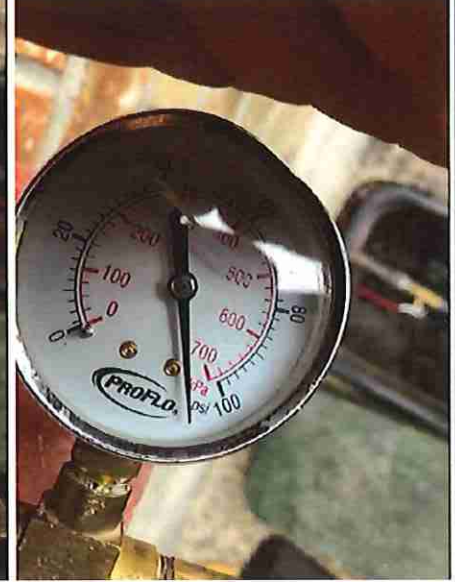
Picture of the Incoming Pressure

100 PSI

106 PSI

A Test Gauge was installed onto the Domestic Water System and a pressure test was performed. The Domestic Water System held pressure for 30 minutes, indicating that there are no leaks on the Domestic Water System at this time.

- ◆ The incoming pressure is too high and needs to be reduced.

We recommend keeping the incoming pressure between 60 – 80 PSI. Installing a PRV (pressure reducing valve) is recommended to avoid future damage and future leaks.

We recommend considering contacting a professional servicing plumbing company to address this issue.

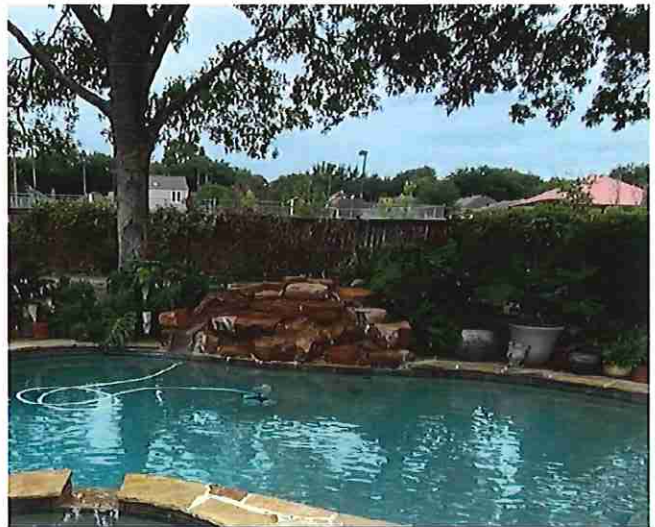
Pictures of Features

We inspected the Water Features Structure and Found the Following	There were some areas where the mortar allowed water to seep out, rather than into the pool. The Water Feature does not get used daily.
--	--

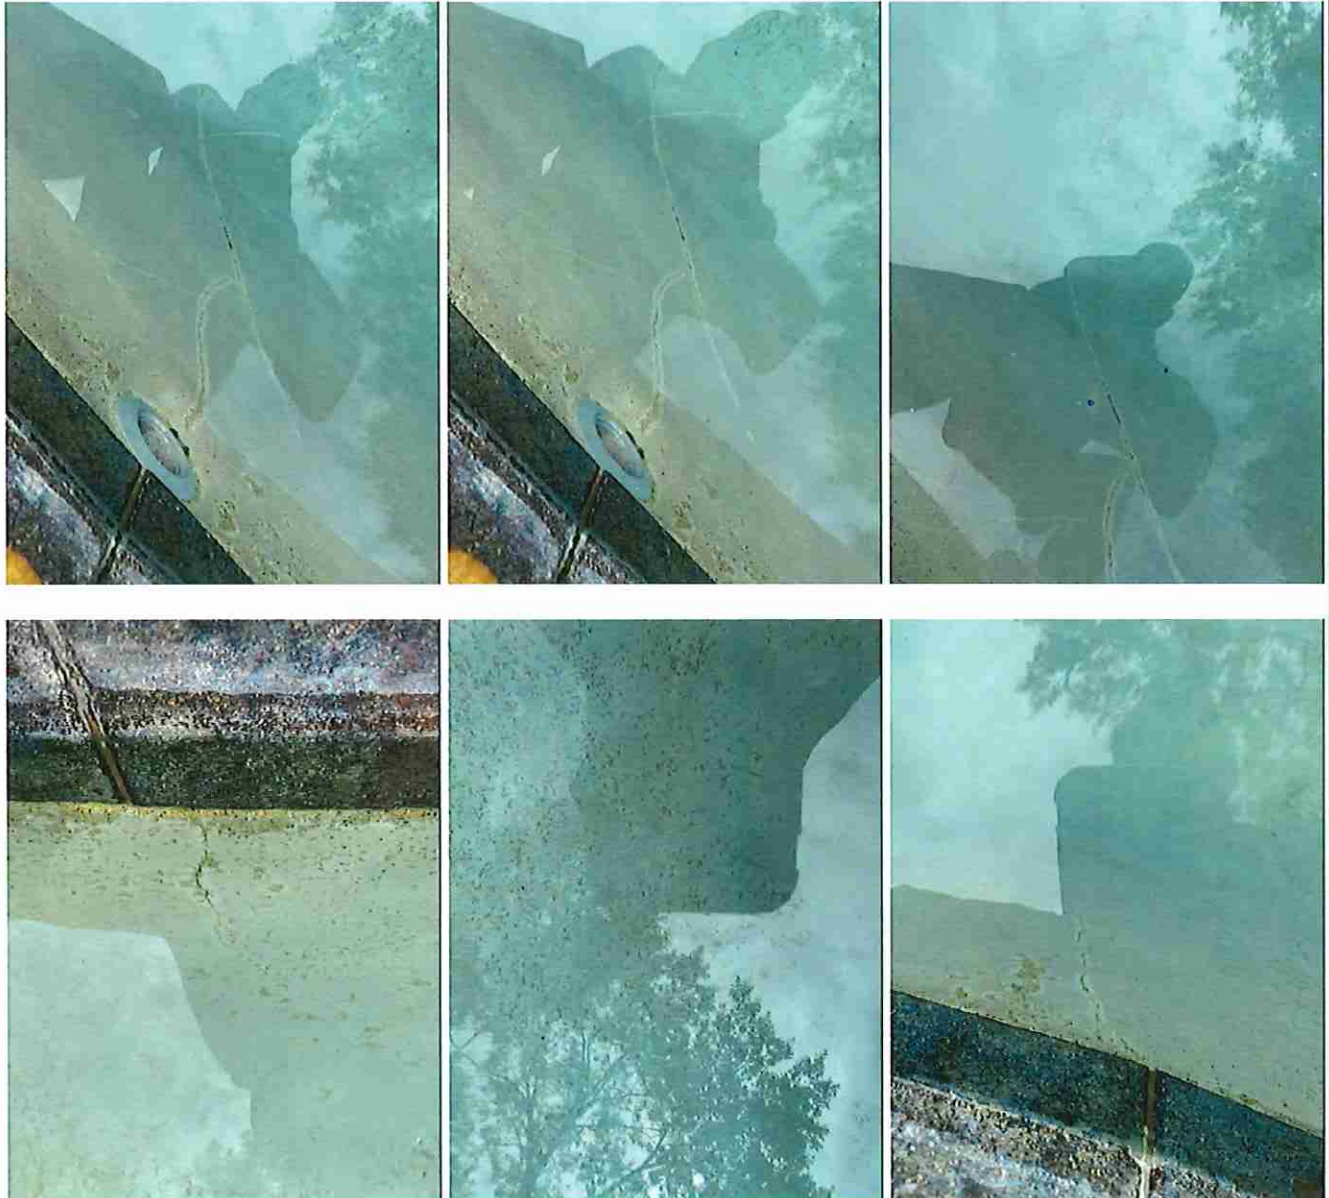
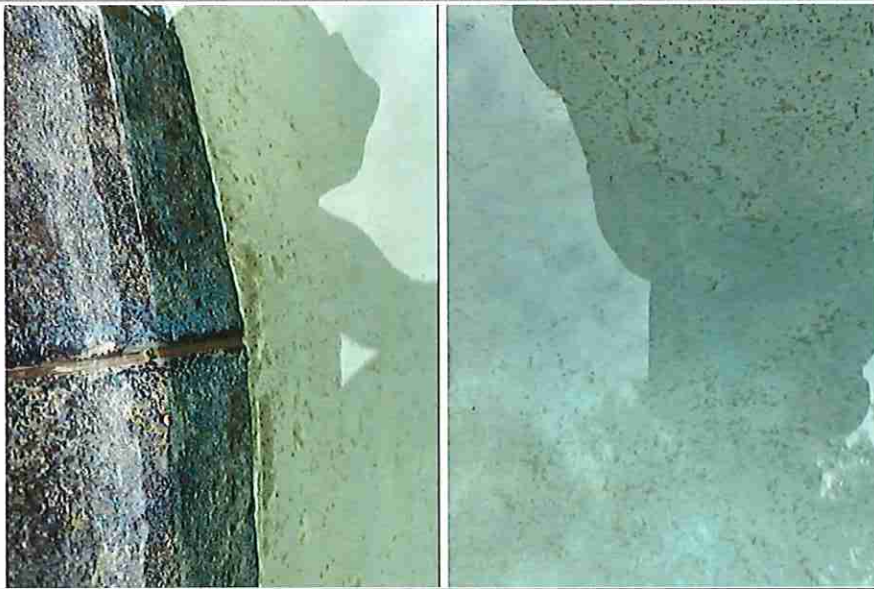
Pictures of Leak Location

The pool has structural cracks that are causing water loss. These cracks run along the pool's wall and some go down to the floor of the pool. There is approximately 30+ of cracks.

The water feature appears to leak some when in use. This is due to areas along the mortar joints that allow water to leak out.

We Inspected the Structural Body of the System and Found the Following Pictures of Structural Leak	<b>We inspected the structure and found leaking cracks.</b> See pics above
--	---

The water feature is not run every day and is not the main reason of water loss, the structural cracks are.  
Crack repair would be recommended for the 30+' of cracks.

We recommend contacting either the original pool builder or a professional pool remodeling company such as Canyon Creek Pools (210) 492-7946 or Sunray Pools (210) 637-0044 to address these cracks.  
ALD is not offering repairs at this time.
