18527 Haughland Dr Cypress, TX 77433 April McGee

## PROPERTY INSPECTION REPORT

Prepared For:	April McGee
•	(Name of Client)
Concerning:	18527 Haughland Dr, Cypress, TX 77433 (Address or Other Identification of Inspected Property)
By:	Kelly M Herbert, Lic #TREC21822 06/05/2019 (Name and License Number of Inspector) (Date)
	(Name, License Number of Sponsoring Inspector)

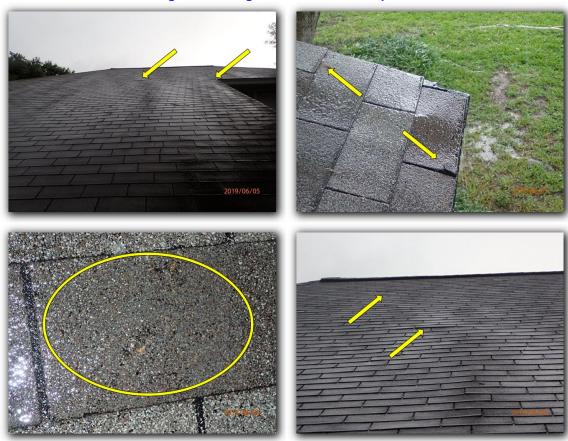
nspector observed lifted shingles and grit loss. Seller's disclosure indicates roof is 1 year old. Recommend contacting the Roofing Contractor to re-inspect roof material for defects.

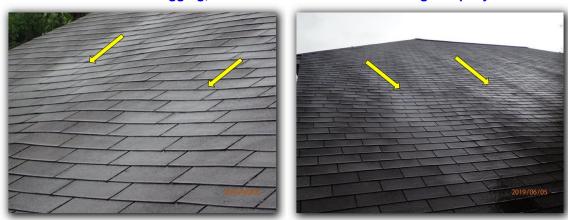
Roof shows evidence of sagging; recommend estimate from roofing company.

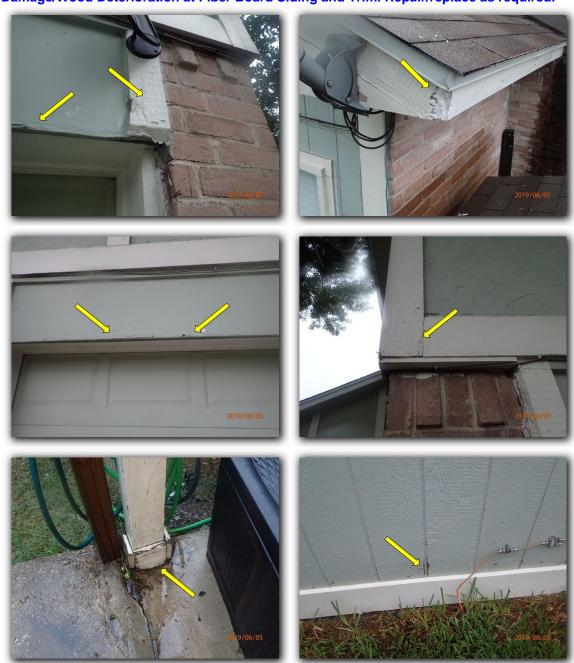
Damage/Wood Deterioration at Fiber Board Siding and Trim. Repair/replace as required.
