Inspection Report

Property Address:
18527 Haughland Drive
Cypress TX 77433

Sandstone Inspections

PROPERTY INSPECTION REPORT FORM

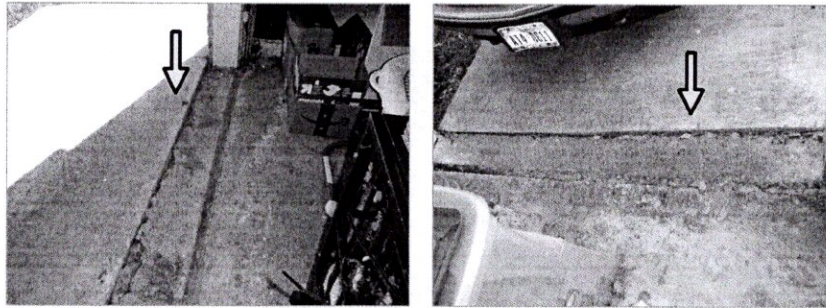
Significant differential movement / settlement observed: indicated by elevation readings, cracks in brick veneer and/or foundation, cracks in sheetrock over doors and windows, uneven floors, and doors that are not square in jamb.

In my opinion the foundation is not performing its intended function; the distress patterns observed at the time of the inspection are/were severe enough to recommend further evaluation and/or repair by a licensed engineer/foundation company.

Observed uneven driveway; the driveway is higher than the garage slab; rain may pond against th garage doors.

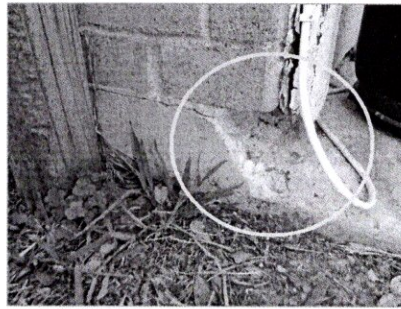
Spalling (i.e., corner pops) at one or more corner(s). Corner spalling is common to slab foundations, it is caused by expansion and contraction of building materials, and does not affect the structural integrity of the foundation.

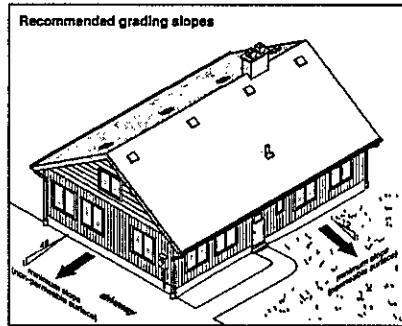
Soil grade and drainage patterns around some areas of the house do not appear to properly direct water away from the foundation to aid in controlling run off water. Water may pond/accumulate against the foundation. This condition may cause differential movement of the foundation and/or water penetration during heavy rains. Recommend filling in yard with soil to reach a grade slope away from the foundation of at least one inch per foot, and/or creating a drainage swale to help divert water away from the foundation.

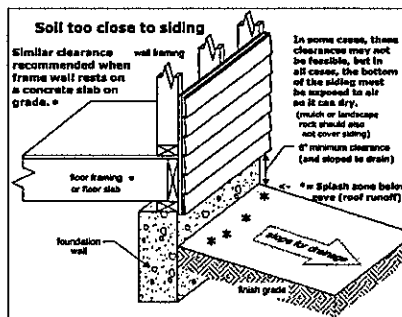
Soil level too high around areas with brick and/or cement board siding. Common industry practice requires a clearance of at least 4 inches from bottom of brick/stone veneer to soil and at least 6 inches to siding. High soil level near brick/ siding promotes wood rot and is considered a conducive condition to termite activity and water penetration.

Recommend addition of rain gutters to help improve drainage and/or prevent wood rot around the house.

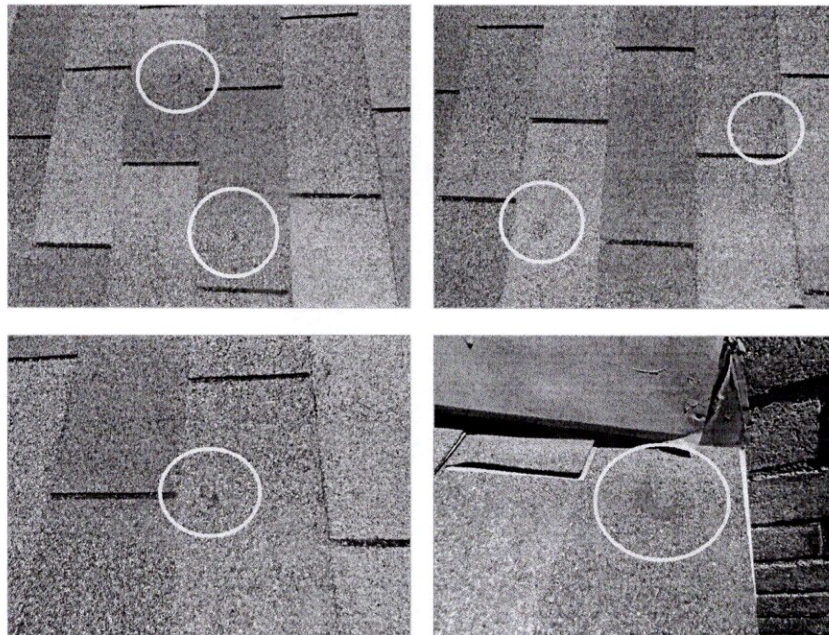
Marks on the roof observed at various locations suggest slight ice impact damage or similar damage.

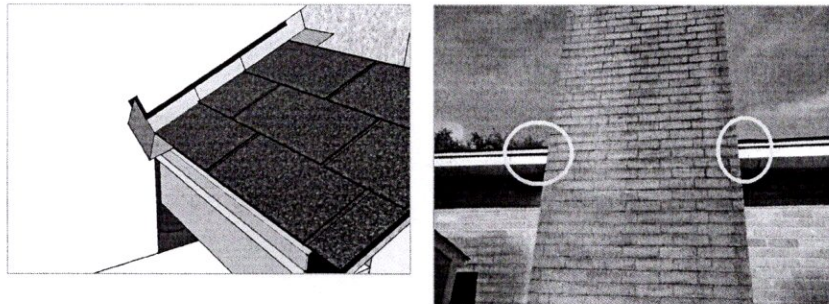
No "kick out" flashing observed where a roof terminates along a vertical wall. Kick out flashing is needed to encourage rain water running down roof to be diverted / "kicked out" away from vertical wall and reduce water running down vertical wall.

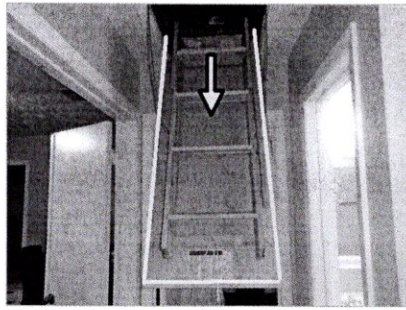
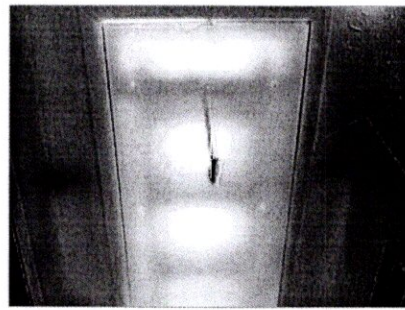
No fire rated label observed at attic access door. Attic access doors from living areas should be fire rated to maintain code fire rated separation between the attic to the house.

The attic access stairway is not sealed with weather stripping to prevent loss of conditioned air to the attic and/or sucking attic air into the house and/or is missing insulation on stairway. The infrared image to the right reveals area of energy loss. Recommend repair to save on energy bills.

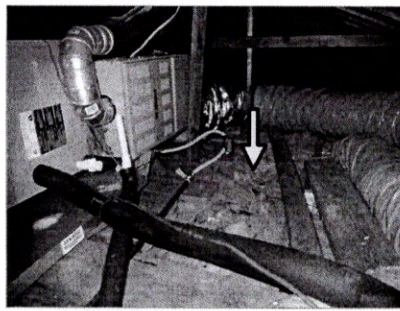
Inadequate attic walkway and/or platform to mechanical equipment in attic. Current standards require 30 inch head clearance and a minimum 24 inch wide SOLID (no gaps or obstructions), floor to equipment for servicing and a 30 inch deep solid platform in front of equipment.

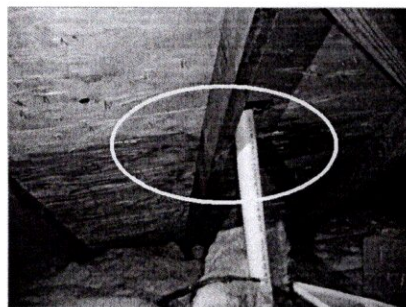
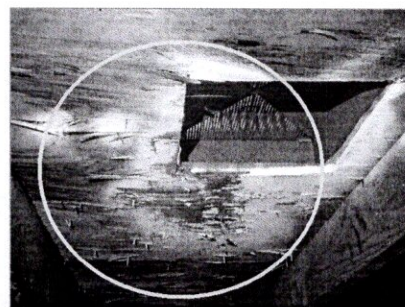
Water damaged roof decking and uneven roof decking observed at various locations in the attic is an indication of previous water penetration.

Uneven roof decking may cause sagging of exterior roof shingles.

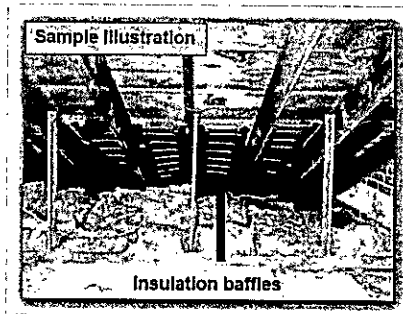
Observed inadequate amount of soffit venting to allow proper ventilation of attic, appears soffit vents are covered with attic insulation, owner incurs larger utility bills as well as shortened roof life with poor attic ventilation. Recommend installing insulation baffles. Whenever possible, attics should have ventilation openings high and low on the roof.

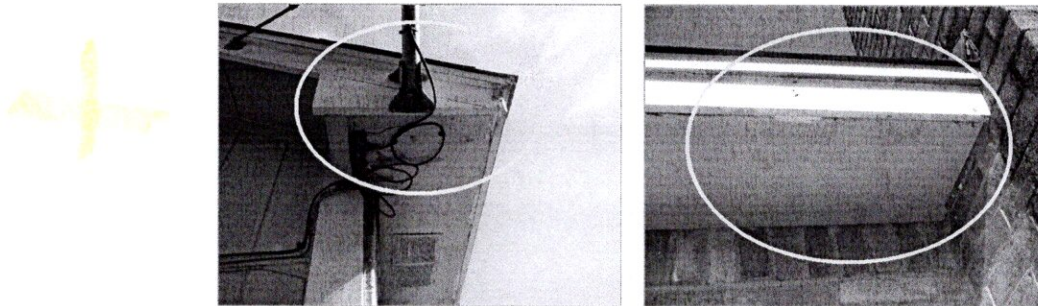
Wood damage observed around exterior fascia and/or soffit at various locations.

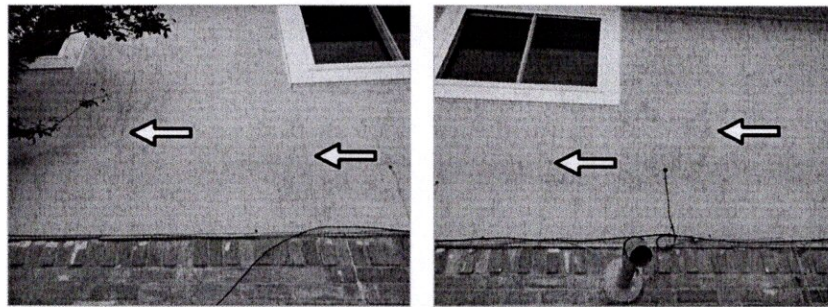
Sealing/caulking missing and/or deficient at vertical trim boards and at vertical joints in siding; causes siding damage and may allow wind driven rain entry. The inspector can not determine the condition of wood structural members behind the wall covered by building materials.

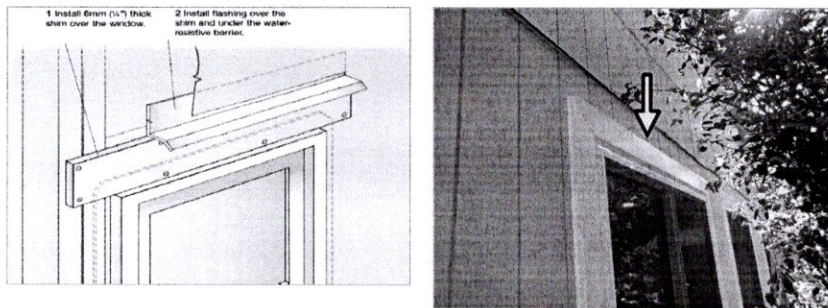
Head flashing missing over exterior windows. Head flashing helps prevent water penetration. Without head flashing windows/ sealing must be maintained as the only defense against water penetration.

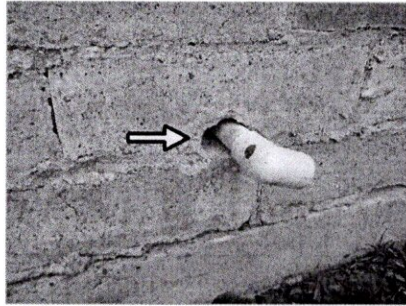
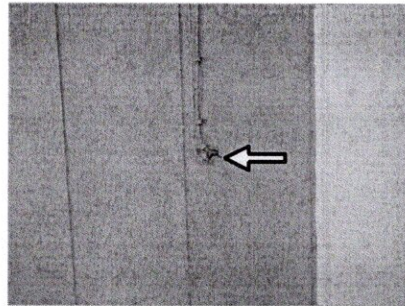
Sealing/caulking needed around all holes and exterior siding penetrations on top and both sides. (leave bottom open) to prevent water entry. including but not limited to light fixtures, electrical outlets/disconnects, service panels, dryer, bath vents, etc.

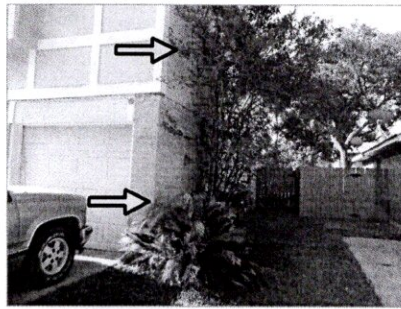
Bushes / trees / foliage should not contact siding of house to prevent wood rot, insect access and excessive moisture. Recommend removing tree stumps/roots close to the house foundation as they represent a source of wood destroying insect activity.

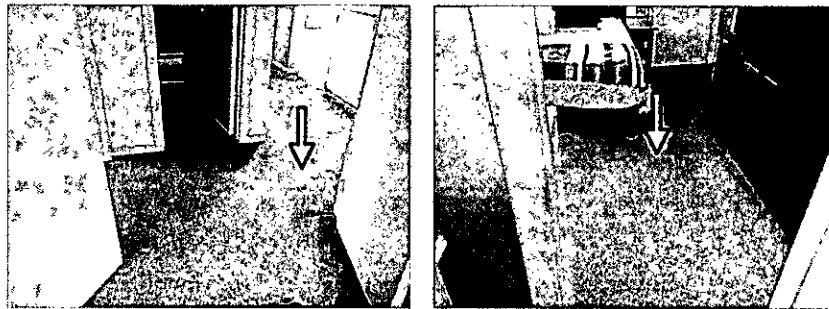
Floor squeaks observed at various locations throughout the second floor; the subfloor is probably loose.

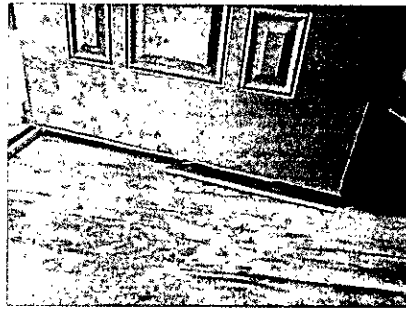
Observed lower weather stripping torn/damaged at front door.

The garage pedestrian door weather stripping is damaged.

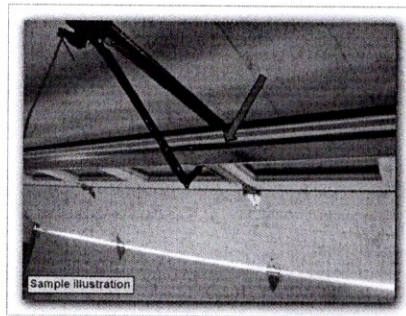
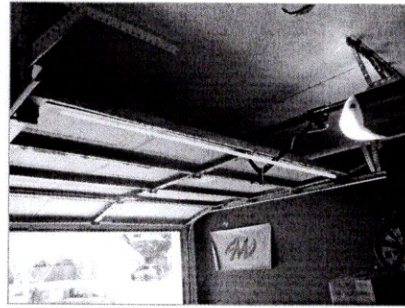
Observed wood rot at lower section of garage door vertical frame and/or trim board(s).

The garage door is missing additional bracing at the top. When a garage door operator is installed, the door should have the manufacture's required additional bracing at the top installed to prevent damage to the door from the automatic opener.

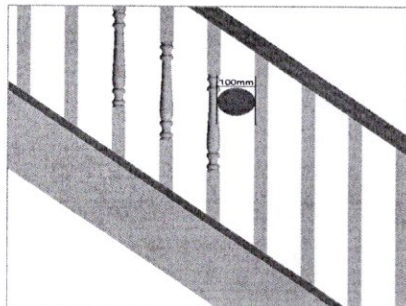
Space between railings does not comply with current industry standard, (code) UBC 421.1.1 & CABO D105.2.1. Requires spacing between intermediate rails do not allow passage of an object four inches in diameter. Recommend covering large openings in stair rails with temporary type nylon netting if small children are present in house to prevent injury.

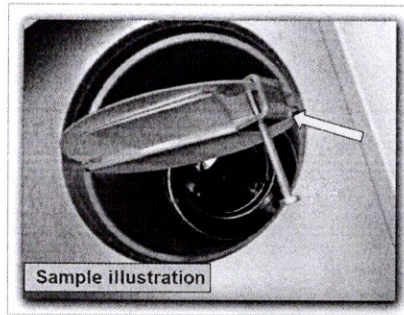
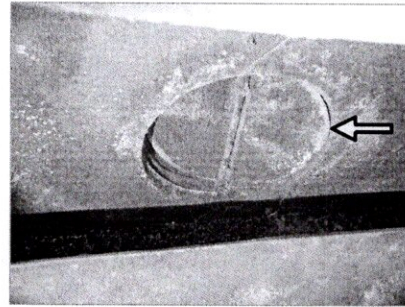
Cracks observed at the back wall of the fireplace hearth need to be repaired as a safety measure to prevent sparkles from reaching the wood behind the fireplace.

Observed fireplace damper is missing the required bracket/weight to keep the damper from fully closing when the fireplace is equipped with fire logs to prevent combustion gasses from entering the residence.

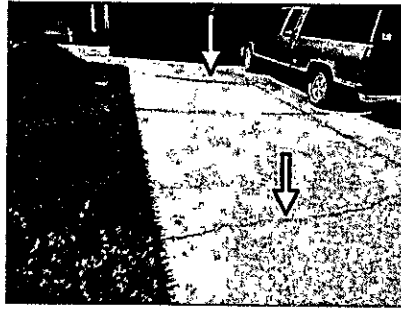
Cracks in walkways, driveway and/or garage concrete observed. This type of cracks are typical and not related to foundation movement.

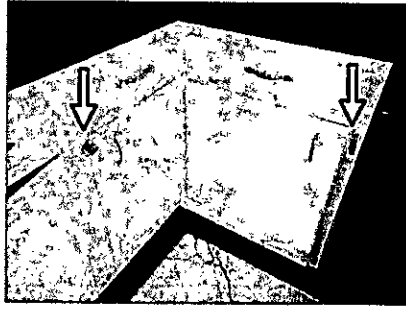
Observed kitchen cabinet to the left of the cooking range and second floor secondary bathroom vanity were locked (with padlocks). Plumbing, drainage, and other items not accessible for inspection.

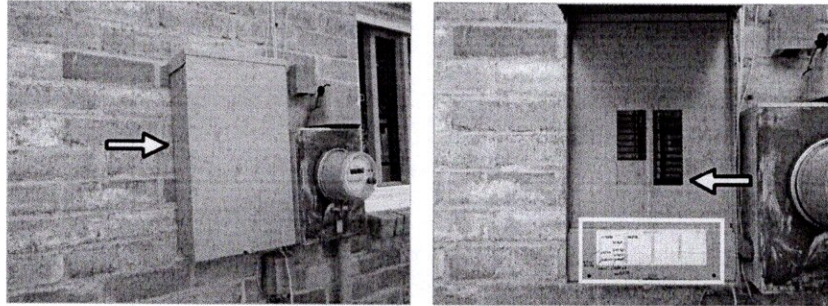
The electrical panel is missing a bushings/knock out cover.

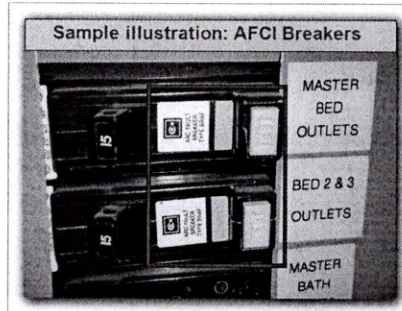
Observed no Arc Fault Circuit Interrupter (AFCI) device protection for all 15 and 20 amp receptacle outlets at family rooms, dinning rooms, living rooms, dens, bedrooms, sun rooms, recreation rooms, closets, hallways, or similar rooms around the house. AFCI devices are intended to protect against fires caused by electrical arcing faults in the house wiring. Current TREC Standards of Practice requires inspectors to indicate that a hazardous or deficient condition exists regardless of the time the house was constructed.

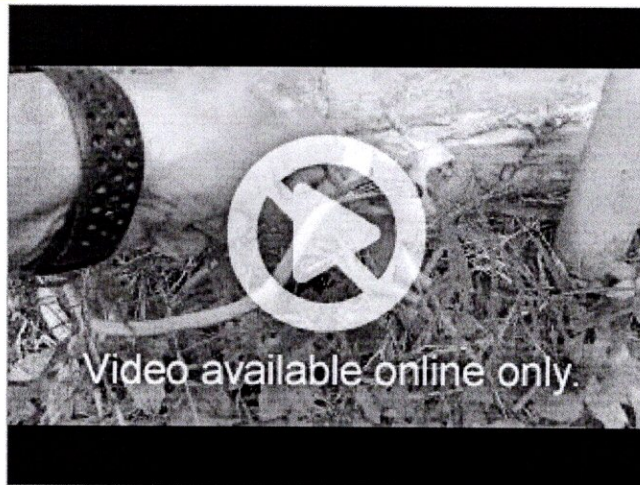
The ground wire/wire clamp is loose from the ground rod; this condition represents a safety hazard: recommend repair.

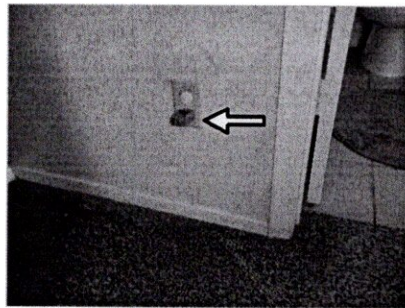
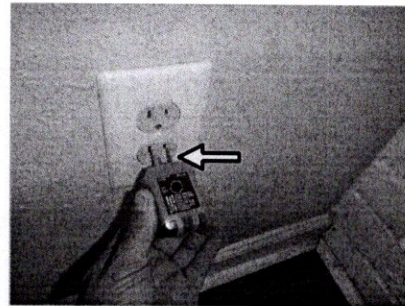
Older style 3-prong outlet for dryer observed. Will not fit newer 4 prong corded electric dryer (NEC requirement since 1996).

Outlet not working/with no power observed in the primary bedroom.

The electrical outlet in the living room (by the fireplace) is damaged: can not be plugged in.

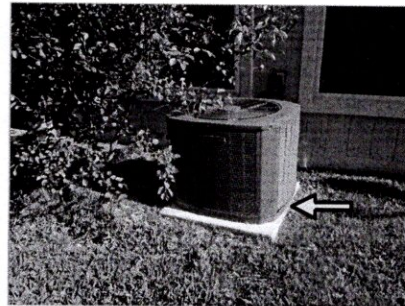
The condensing unit is too close to the ground. Equipment and appliances supported from the ground shall be level and firmly supported on a concrete slab or other approved material extending not less than three inches above the adjoining ground (CODE M1305.1.4.1).

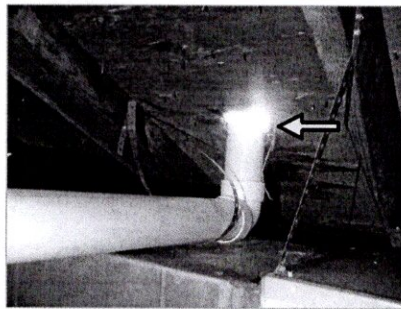
Observed bathroom plumbing waste vent not properly connected to vent to the exterior.

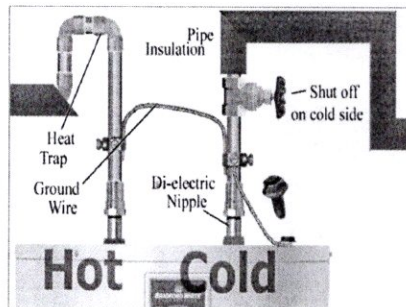
Observed gas line and hot/cold water lines are not properly bonded near water heater. The inspector was unable to verify proper bonding of metal water pipe lines.

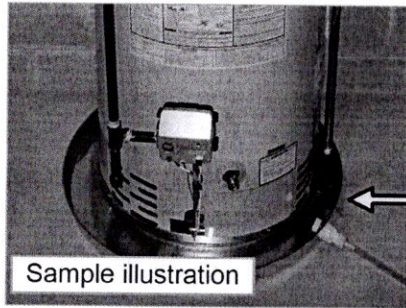
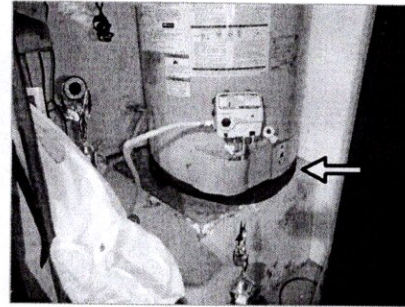
Rust and leakage was observed at water heater tank and plumbing connections.

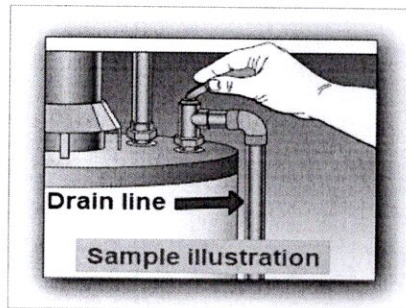
Water heater temperature and pressure relief valves should be installed in a way that flows by gravity (IRC CODE P2804)

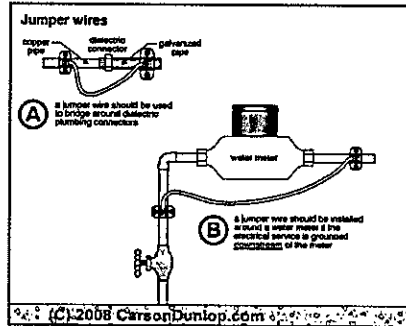
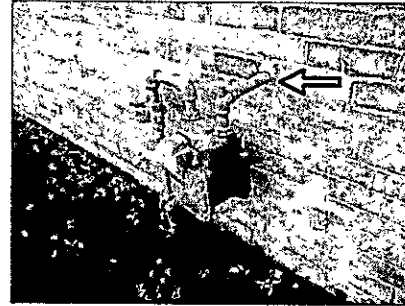
Observed ground rod/wire is missing at gas meter. The inspector did not see/could not verify proper bonding of gas lines CSST (corrugated stainless steel tubing). Current standards require CSST to be bonded to minimize the risk of damage to the building materials from a nearby lightning strike.

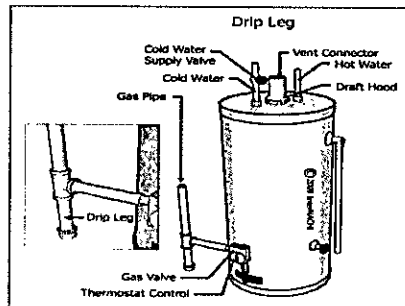
No drip leg observed on house heater and/or gas water heater. A drip leg is called for in the manufactures installation instructions.

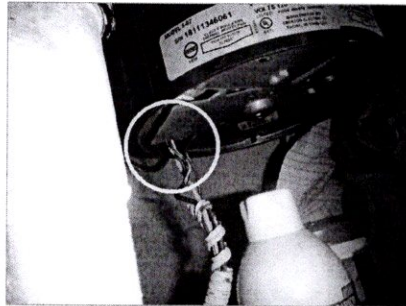
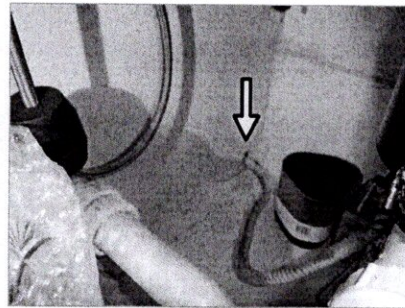
The garbage disposal unit is hardwired/ can not be plugged or unplugged from an outlet for easy access by service personnel.

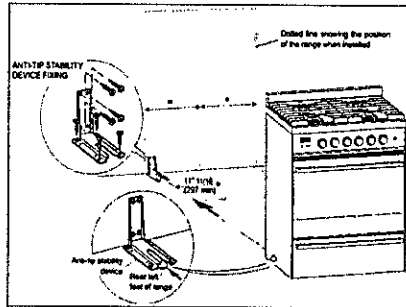
Observed cooking range is missing an anti-tip device, which is recommended as a safety measure to prevent the the appliance from tipping over when being used.

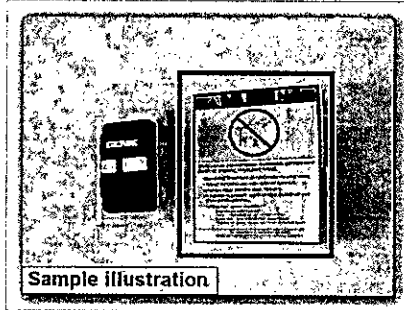
The equipped safety sticker / decal next to operator button is missing.
