PROPERTY INSPECTION REPORT

Age of Home: 2013 Size: 1,643
Structure Type: Structure is a wood framed structure on a concrete slab foundation.

| Matt Messer Name of Client 5626 That Way, Kingwood, Texas 77339 | 5/3/2023 Date of Inspection | |

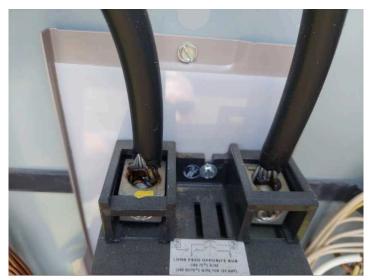
- Service entrance wiring is underground
- The aluminum wiring in the service panel noted to be missing anti-oxidant grease.

Aluminum service conductors missing anti-oxidant grease

| ELECTRICAL SYSTEMS | | | |
|---|---|--|--|
| Page 8 Item: A | Service Entrance and Panels | • The aluminum wiring in the service panel noted to be missing anti-oxidant grease. | |

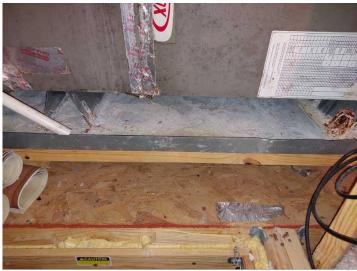
Evaporator overflow pan has corrosion and should be monitored for further degradation

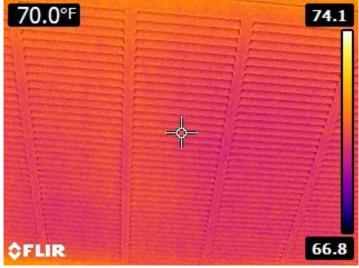
- The temperature difference between Return Air and Supply Air is 11.7 deg F.
- The air temperature measurements will be taken at the return air vent and at several supply air vents. The temperature drop / differential is required to be between 15 22 degrees. In the event the air temperature differential measures below 15 degs F, the AC unit will be noted defective and recommended to be evaluated by a reputable HVAC contractor.
- Rust and/or corrosion was noted in the condensate drip pan
- Temperature drop/differential was not observed between 15-22 degrees. (taken between interior return and supply air).

Air temperature measured at return air vent 70

This is considered a defective system and should be serviced by a licensed HVAC contractor.

• The HVAC system should be further evaluated by a Qualified Licensed HVAC contractor

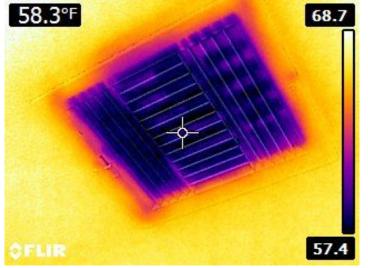
Air temperature measured at supply air vent 58.3

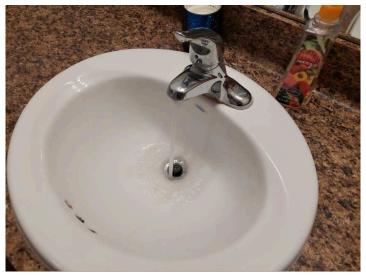
- Type of Drain Piping Material: PVC
- Drain stoppers were either damaged, or non-functional at one or more sinks in the home

Drain stop does not function properly

| ELECTRICAL SYSTEMS | | | |
|---|---|--|--|
| Page 15 Item: B | Drains, Wastes, and Vents | • Drain stoppers were either damaged, or non-functional at one or more sinks in the home | |

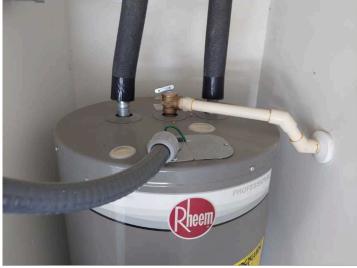
| Rheem Manufacturing Co Water Heating Division | | |
|--|--|--|
| 100 | Water heater data tag (2013) | Water heater temperature and pressure relief valve is damage did not trip |
