PROPERTY INSPECTION REPORT

“AROUND THE HOUSE” HOME INSPECTIONS

Concerning: 13106 Sierra National Drive, Atascocita, TX 77346

By: David J. Stiles Inspector Lic. #7308 11/10/2019

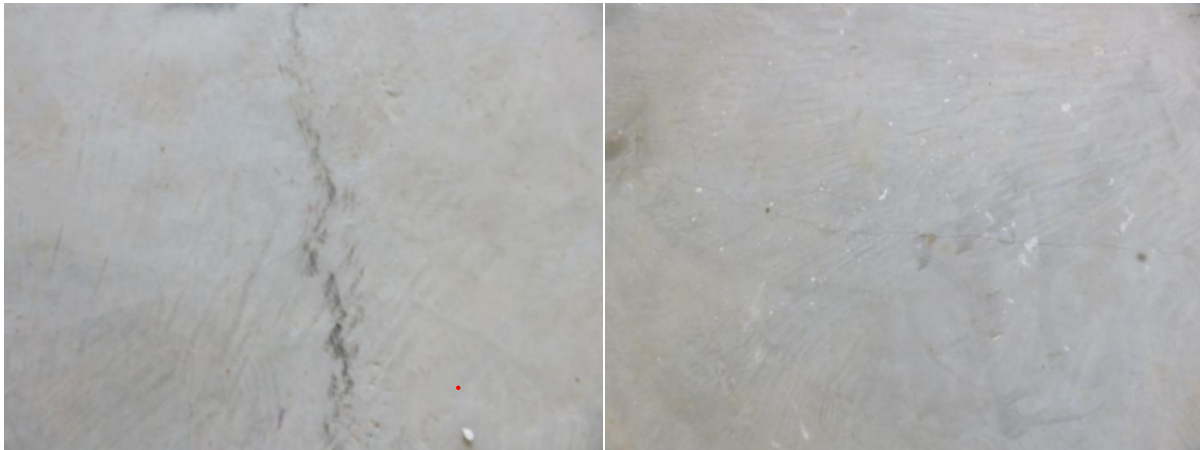
- Floor/foundation cracks are displayed in the 2 – car and 1 – car garage.

Examples **No Repair Needed - Shrinkage Cracks**

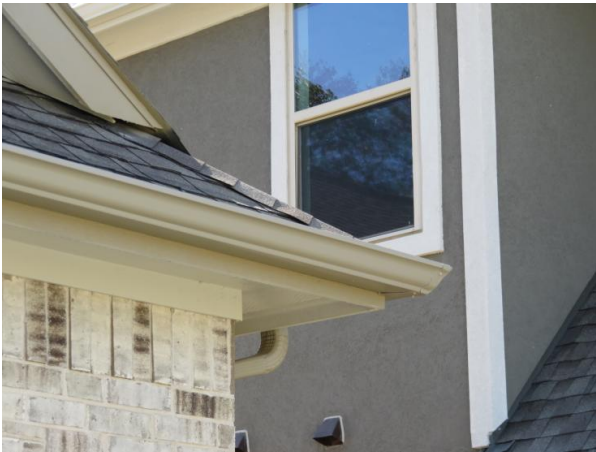
- Shingle(s) are elevated at the front right corner of the garage.

} Repaired
11/13

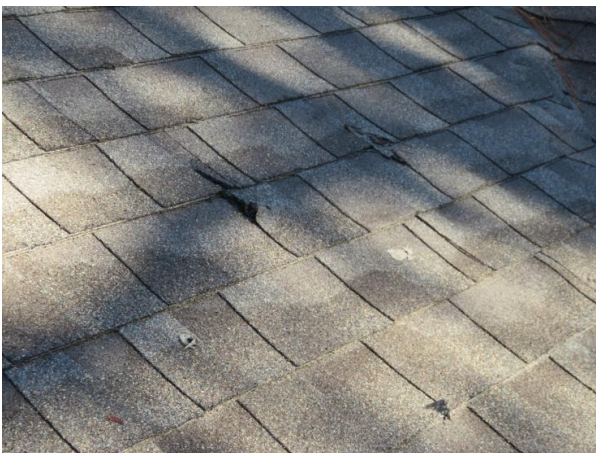
- At the rear lower roof shingles are scuffed/damaged.

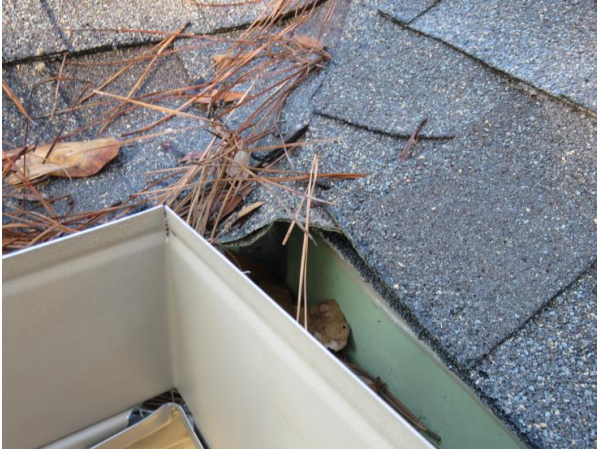
- At the rear patio the right side valley at the rain gutter is bunched/elevated.

Repaired
11/13

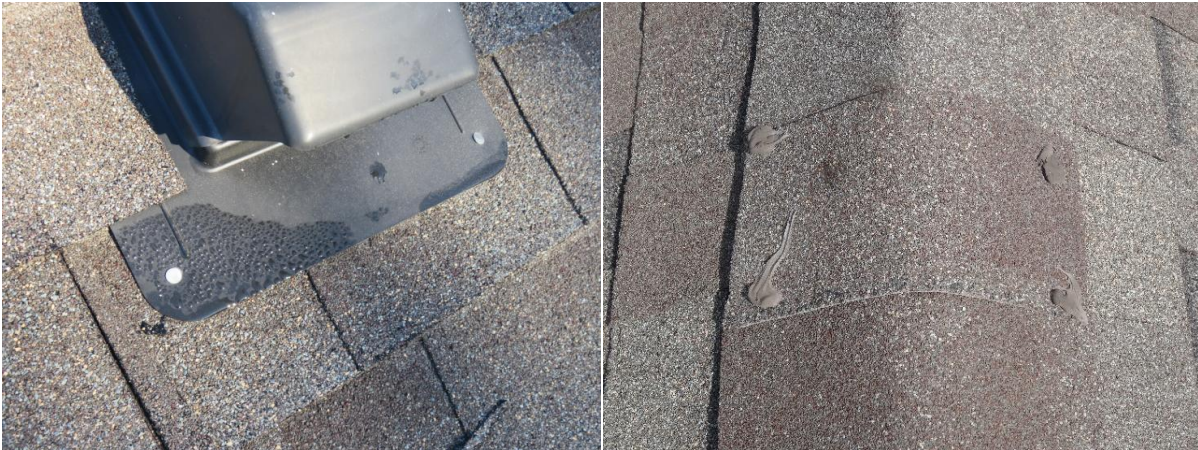
- Nails exposed to weather and moisture will rust and fail prematurely creating the potential for shingle elevation and movement. Weather protective caulk or other appropriate roofing material should be applied to the nails.

Current example at the right rear roof and required application

Repaired 11/13

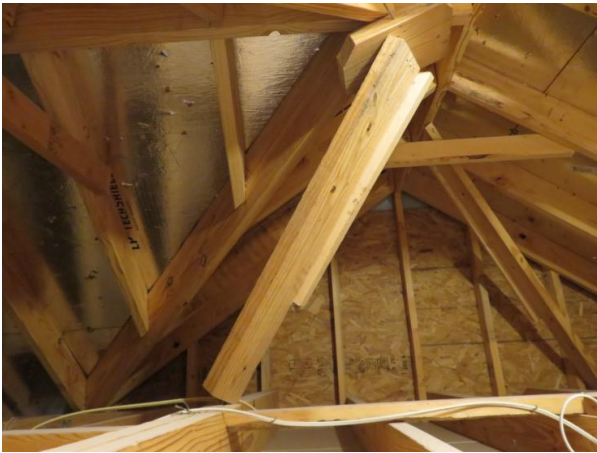
- In the attic area above the 1 – car garage s roof support post appears to be leaning to a greater degree and secured at top and bottom in a manner that should be further inspected by the builder/professional roofer.

Repaired
11/13

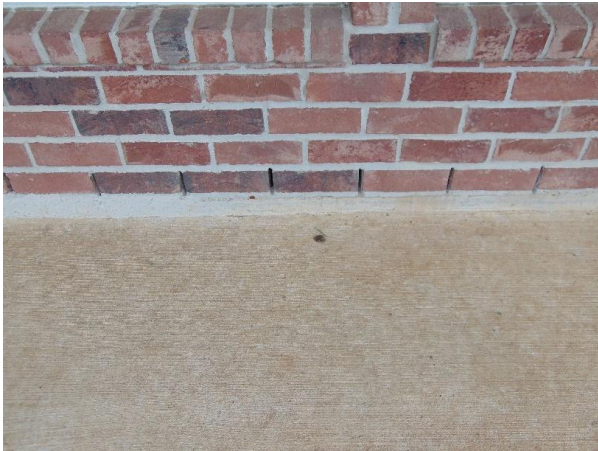
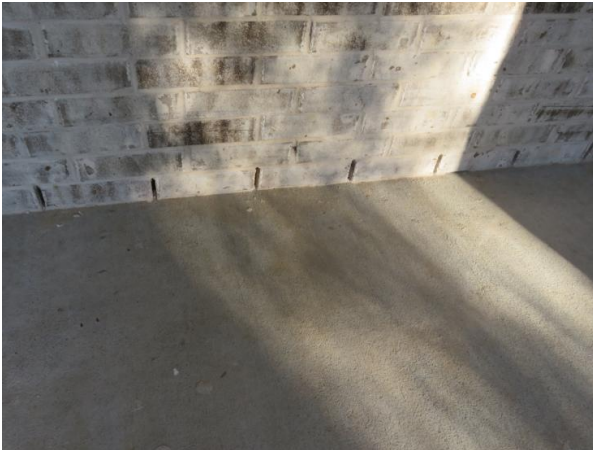
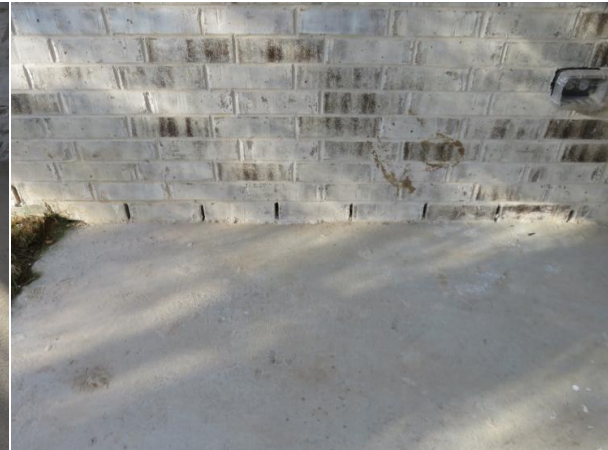
- Weeps holes at the front porch and/or rear patio are installed in a manner that can allow water to flow into the weep holes. Elevation of the first row of bricks should be at least 2" above the finished floor to assist in preventing water flow into the weep holes. There is not likely to be method of improvement or repair but it is not recommended that the weep holes be filled, sealed or covered.

Example of a favorable foundation with an elevated floor/foundation and current installation(s) at the rear patio

No Repair Needed.
Patios are sloped for
rain to run off.

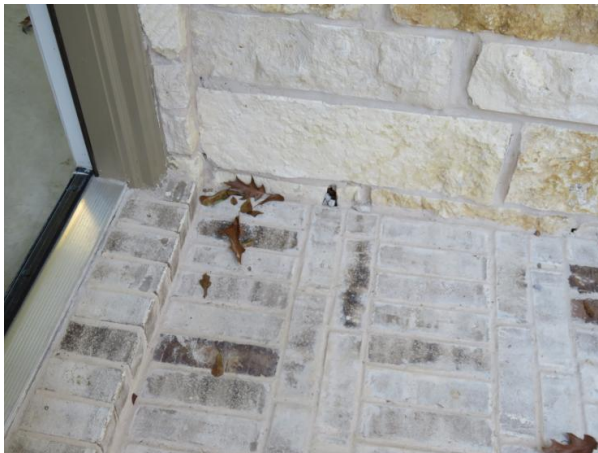
- The wall outside the 1 – car garage displays a hole.

To be repaired 11/20

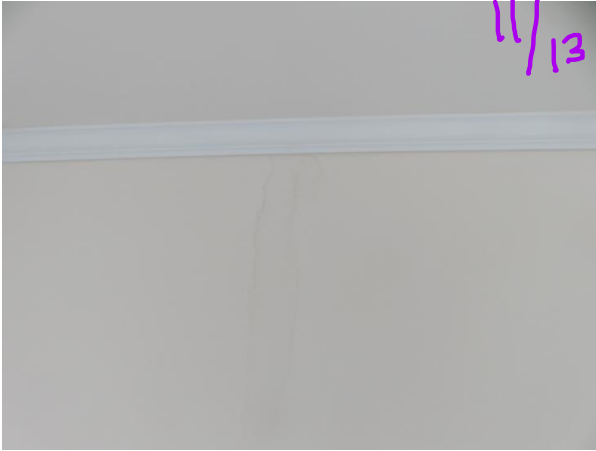
- The left wall in the Master bedroom (right rear) displays a water penetration stain. Dry at the time of the inspection.

Confirmed to be an old leak, previously repaired

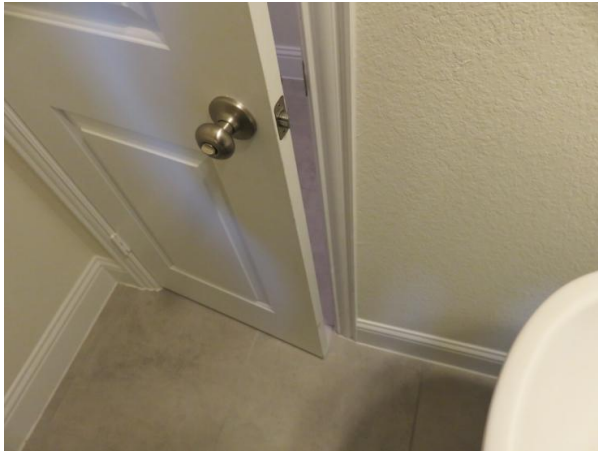
- The 1st floor half-bath door does not latch.

Repaired 11/14

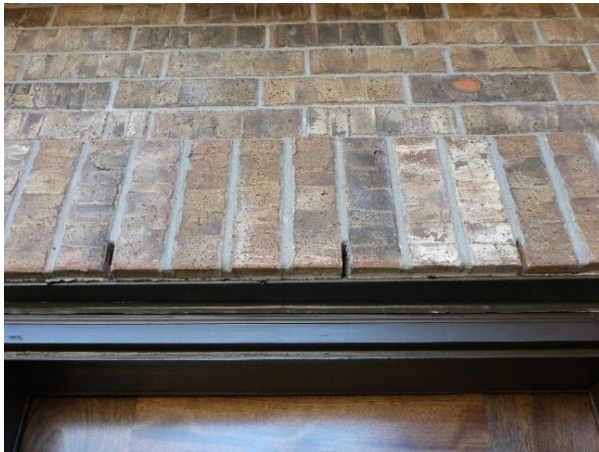
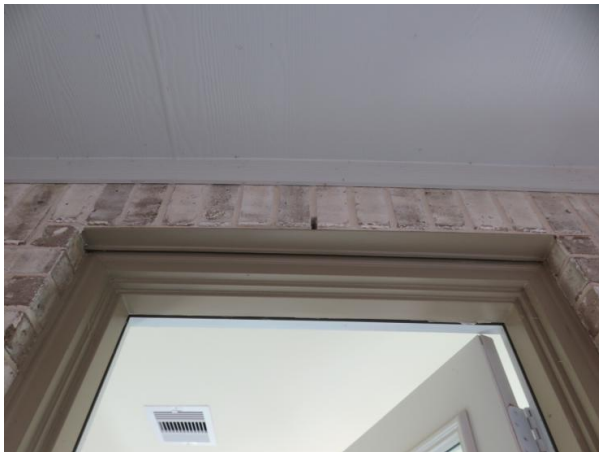
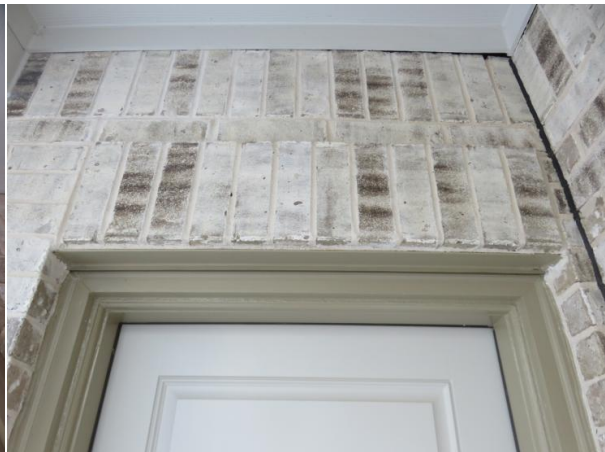
- Doors with brick walls supported by steel lintels will rust if condensation/water is allowed to accumulate or penetrate behind the wall of brick. The top of the lintel should be installed with flashing between the bottom of the first row of brick and the lintel. [IRC - 703.7.5]. It could not be ascertained to what degree, if any, flashing is installed in this manner. Weep holes can be provided by drilling/removing a portion of the mortar between bricks at the top of the lintel. **Weep holes are required to be 3/16" in width and installed in pairs above a door and/or at least within 33" of each other.** [IRC - 703.7.6].

Weep hole example and current installation examples at the rear patio and 1 – car garage

To be repaired
11/20

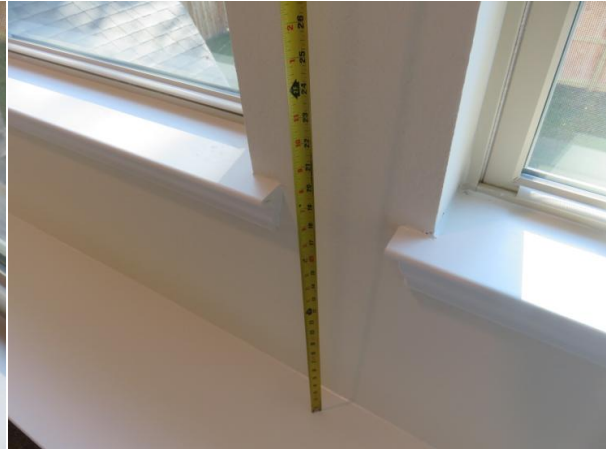
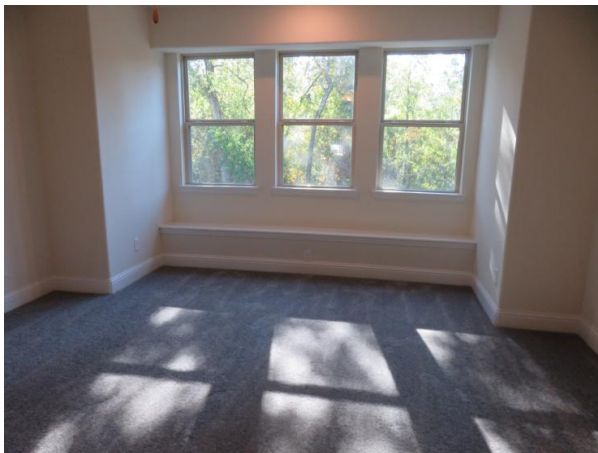
Current installations in the 2nd floor game room. The shelf below the windows makes the window accessible/height above the shelf less than 24".

Installing Angel locks
11/18

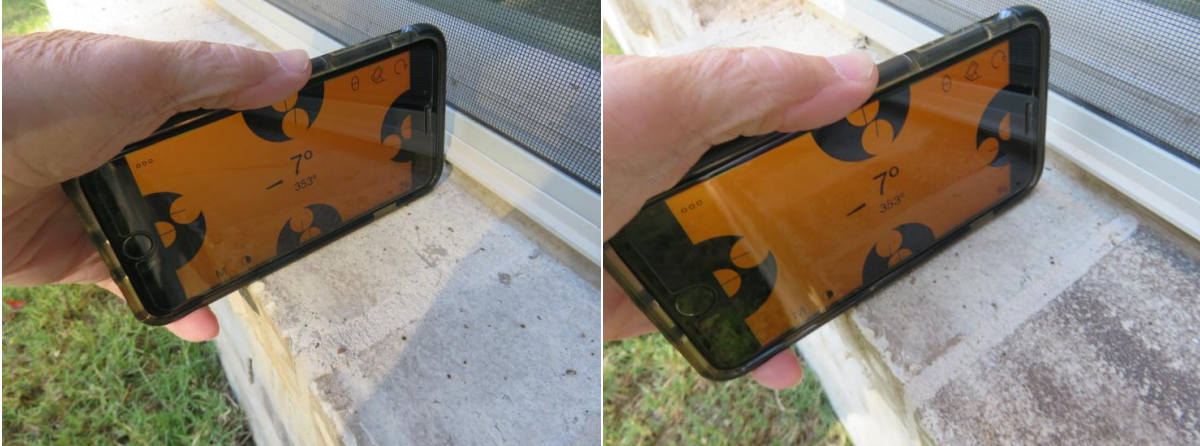
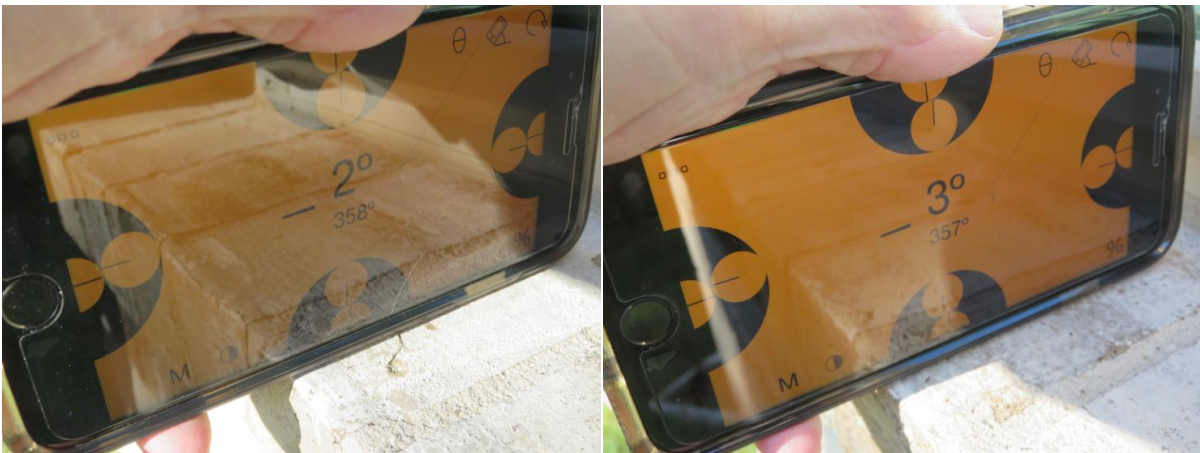
- Exterior window sills are required to be installed to slope at least at a 15* angle away from the home/window to properly drain/shed water away from the home. Maintain window caulk/sealant to assist in preventing window leakage.

Repairing all window sills
< 7° / To be repaired 11/20

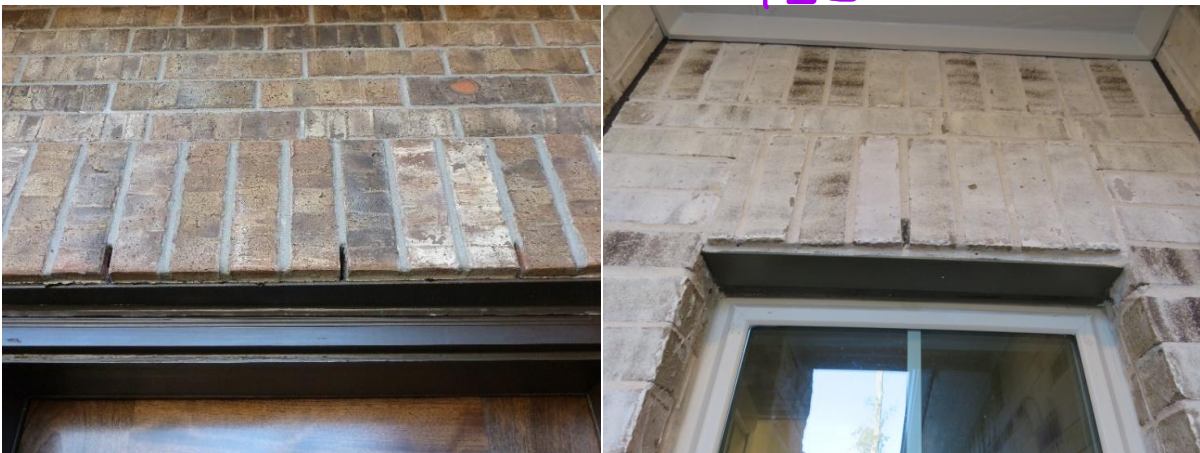
- Windows with brick walls supported by steel lintels will rust if condensation/water is allowed to accumulate or penetrate behind the wall of brick. The top of the lintel should be installed with flashing between the bottom of the first row of brick and the lintel. [IRC - 703.7.5]. It could not be ascertained to what degree, if any, flashing is installed in this manner. Weep holes can be provided by drilling/removing a portion of the mortar between bricks at the top of the lintel. **Weep holes are required to be 3/16" in width and installed in pairs above a window and/or at least within 33" of each other. [IRC - 703.7.6].**

Weep hole example and current installation examples

To Be Repaired 11/20

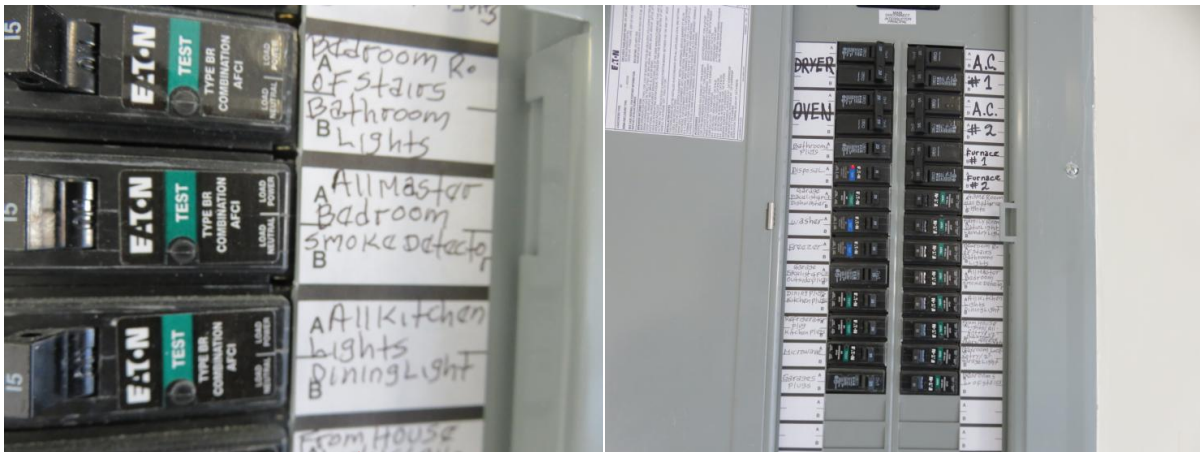
- The smoke/CO detectors are co-mingled with another branch circuit breaker in the home. Smoke and CO detectors should remain powered at all times. Co-mingling exposes the smoke and CO detectors to extinguishment if the breaker of the co-mingled area(s) trip. It is preferred that smoke and CO detectors be wired to a dedicated circuit breaker. Additionally, smoke/CO detector circuit breakers are required to be labeled in the panel.

Not required to be seperated but we will label.

Labeling 11/15.

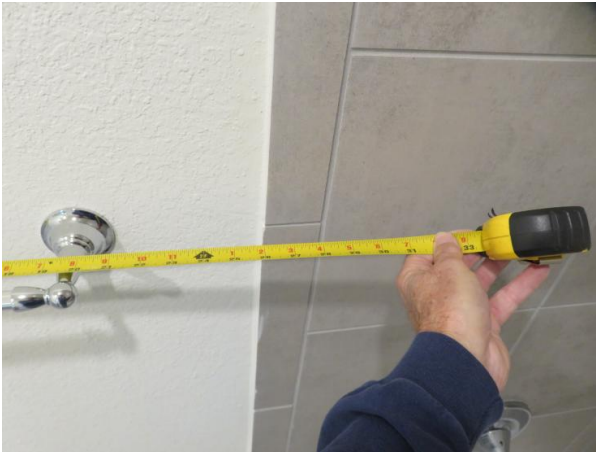
- The light switch adjacent to the 2nd floor right side bathroom shower is too close and poses an electrical safety hazard. This switch is required to be out of reach while standing in the shower and at least 3' from the shower stall. {IRC 4003.10 NEC 410.10D}

Example at the 2nd floor right side bathroom bathtub/shower

Electrician to inspect 11/15

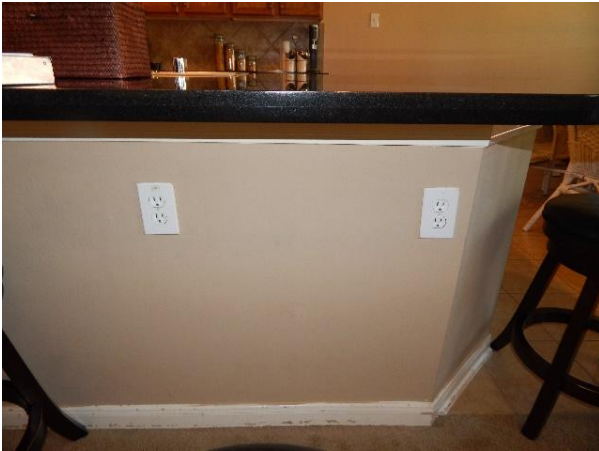
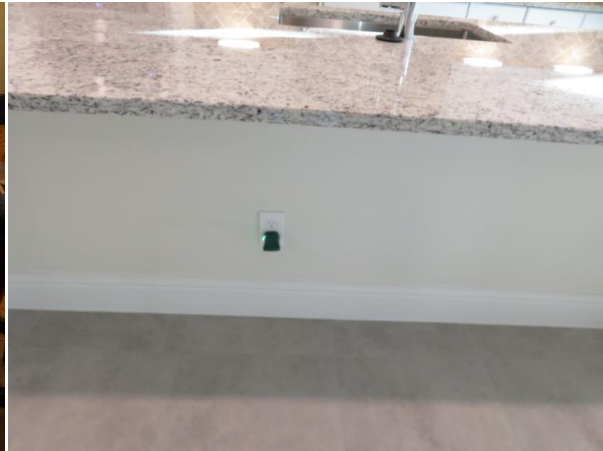
- The outlet(s) on the family room side/dining side of the kitchen sink countertop are required to be GFCI safety rated and no lower than 12" beneath the countertop for safety of crawling toddlers and smaller children. (IRC 3901.4.5X). While not specifically intended for use at the countertop the outlet is GFCI protected and would undoubtedly be used at the countertop and electrical cords may not reach the outlet of an appliance creating a safety hazard.

Required and current installation *Cannot move but is GFCI*

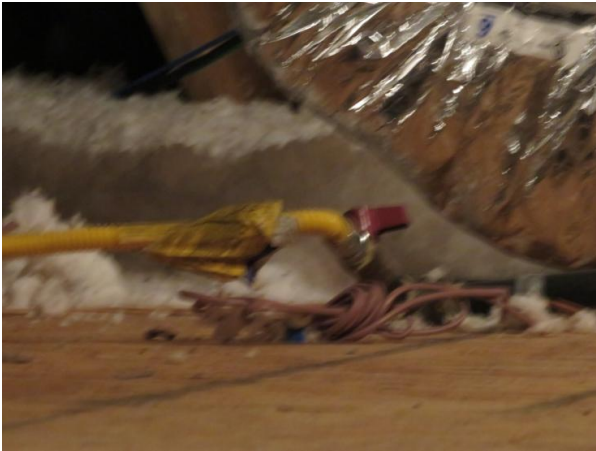
- The 1st floor furnace natural gas supply was OFF at the time of the inspection. The furnace was not tested/operated. Verification of a working appliance should be displayed at the time of the builder walk-through.

To be repaired
11/15

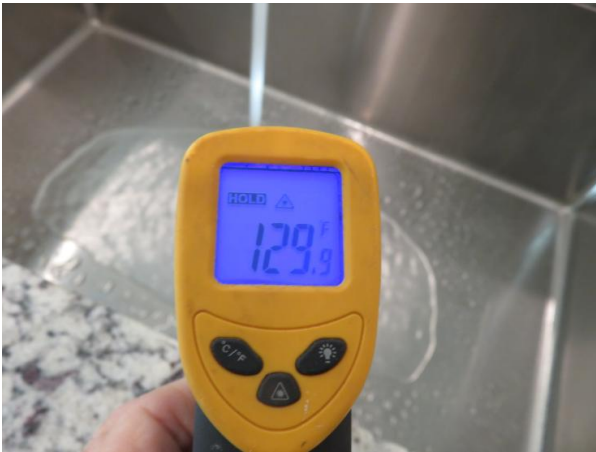
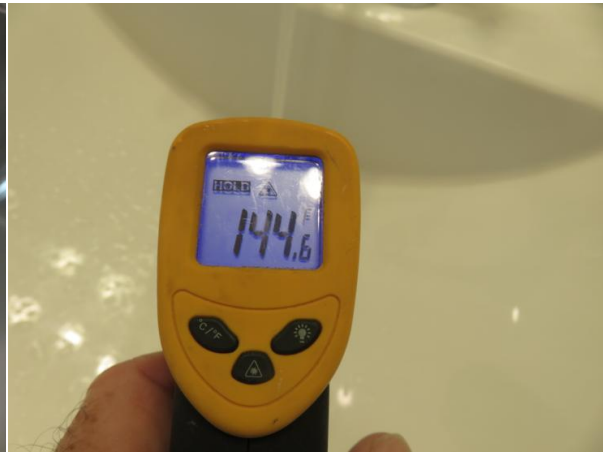
- The water temperature as recorded at sinks in the house was too hot. Temperatures in excess of 120°F can cause severe burns and scalding.

Examples *per discussion w/buyer:
Do not reduce temperature*

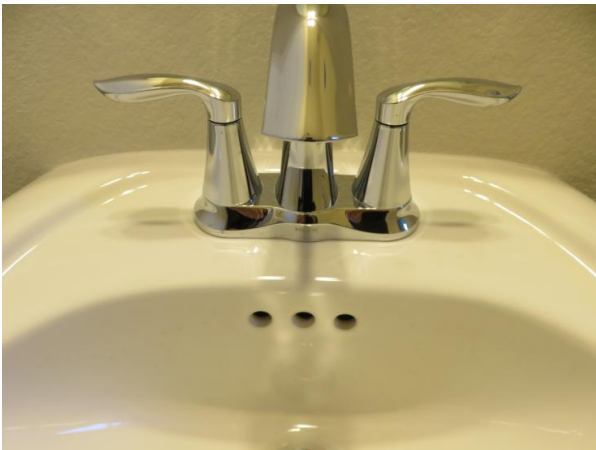
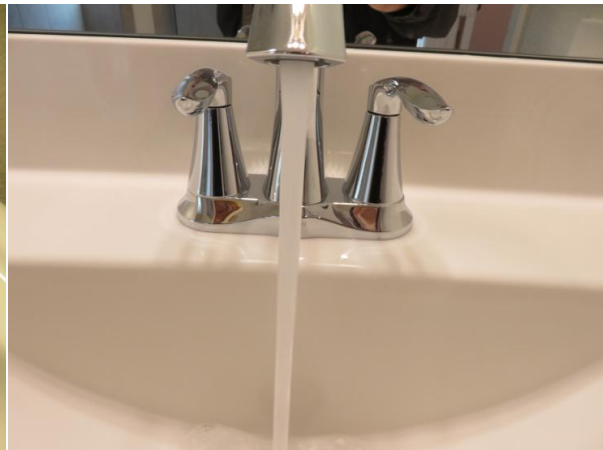
- All water supply faucets should be marked by color coding, engraving or other means to identify each handle for water temperature orientation. This includes the washing machine faucets handles.

Current installation examples and example of labeling *Not required by code*

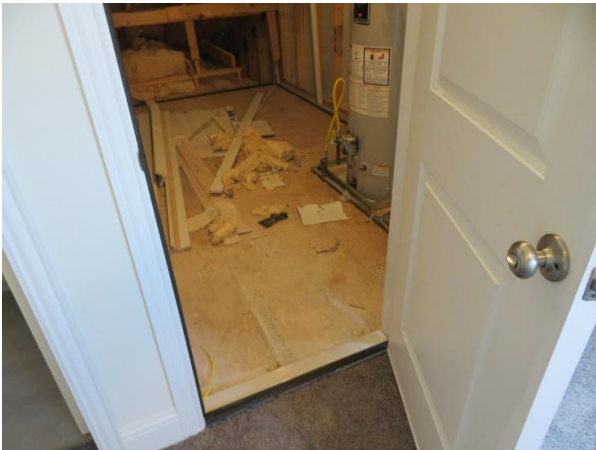
- The water heaters are located in the attic directly accessible to a bedroom/sleeping area. Gas leaks and/or CO detection devices should be installed in the attic area.

Not required per code
but as customer courtesy
we will change bedroom
smoke detector to a combo
detector.
Completed 4/14

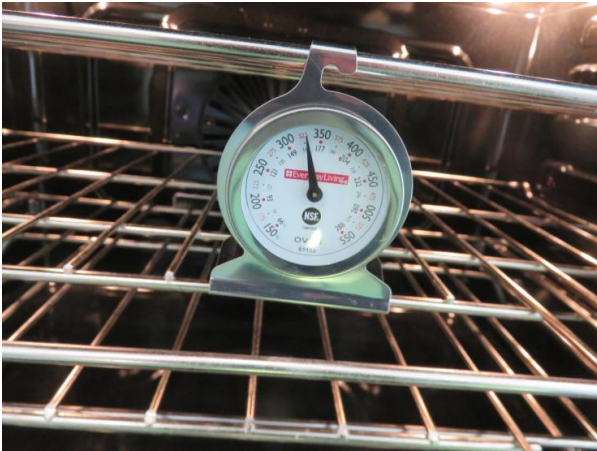
- The oven set at 350°F failed to achieve this temperature.

Repaired 11/14
