Property Inspection Report

Habib Othman 22007
Bullseye Engineering Inspection, LLC

3615 Windy Drift Ln
Inspection Prepared For: Krishnamoorthy Gopal
Agent: -

Date of Inspection: 6/7/2023
Year Built: 2007 Size: 2973
Weather:

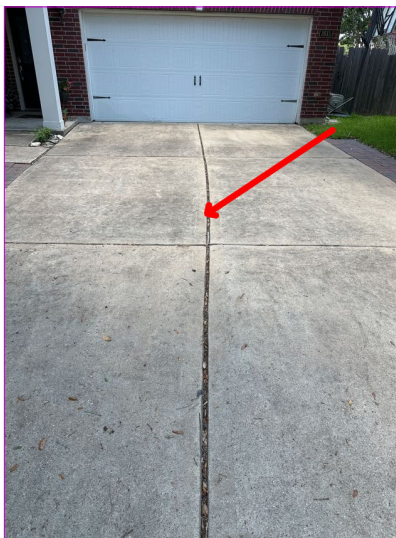
- At the time of the inspection, the Inspector observed no deficiencies in the condition of the home walkways at the time of the inspection.
- Driveway expansion joint were missing caulking. Keeping your joints watertight will prevent moisture from seeping under concrete pads and causing them to heave or sink.

Expansion joint missing caulking

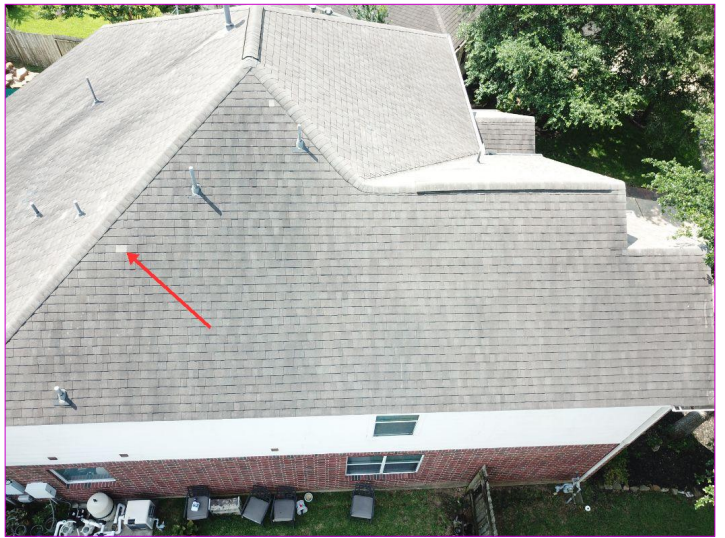
Damaged shingle

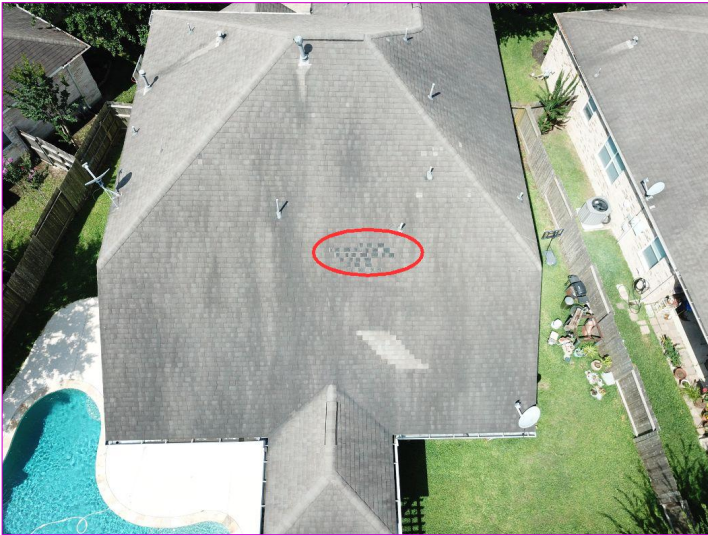
- Observed some missing shingles on the roof plane. Recommend replacing missing shingles to avoid further damage.

Missing shingles

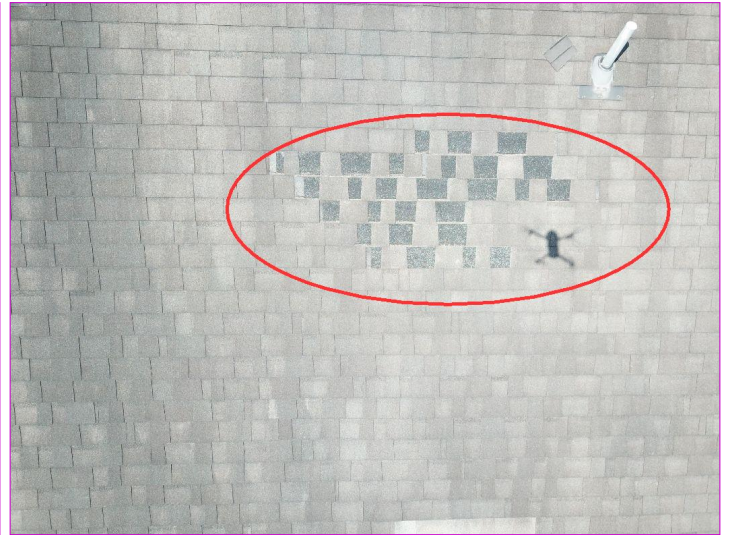
Missing shingles (zoomed view)

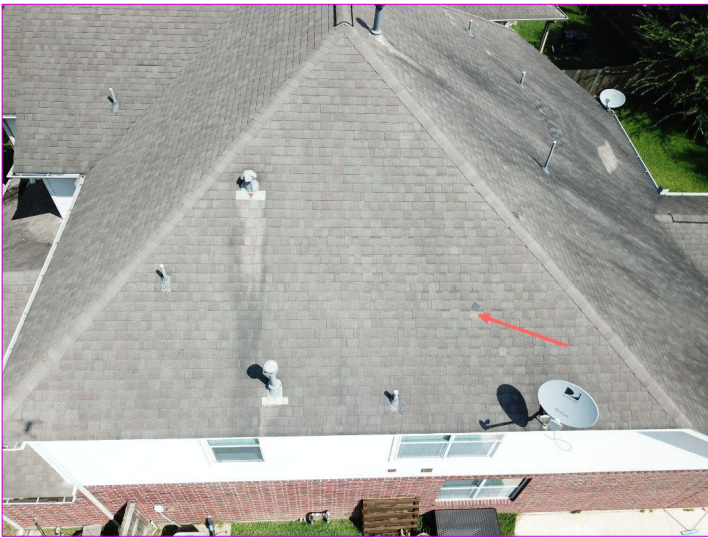
Damaged shingle

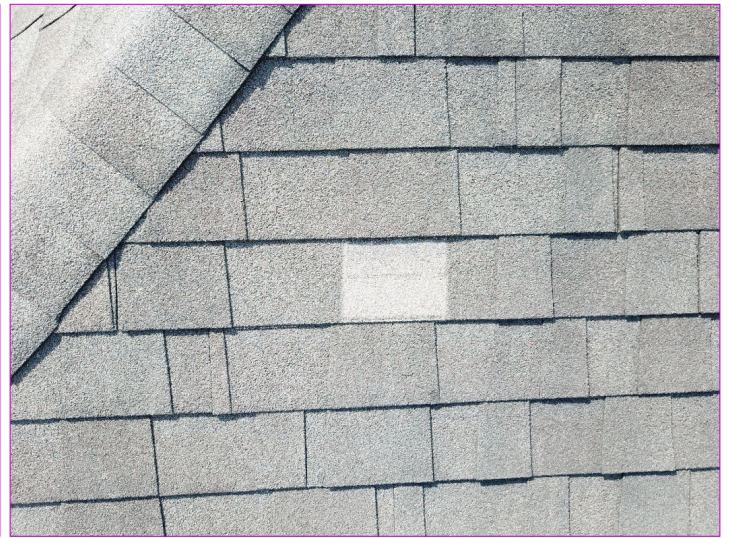
Damaged shingle

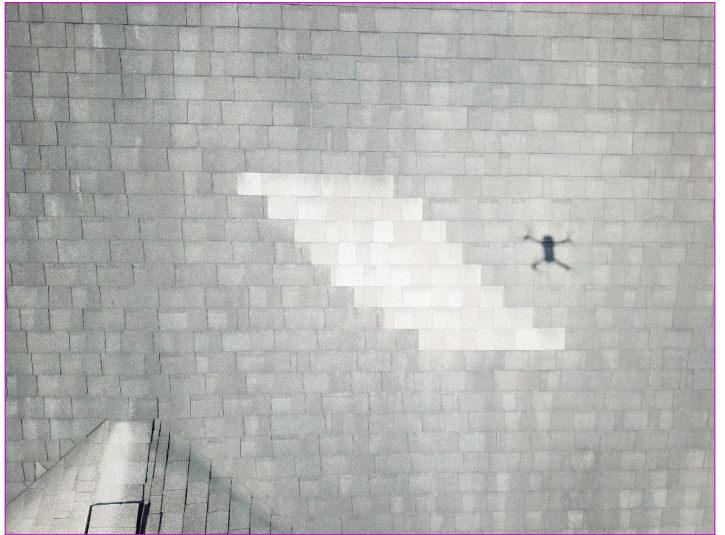
- Repair have been made to the shingles. No damage or water entry has been found during the attic inspection. Verify with owner that there is no ongoing problem,

Signs of previous repair

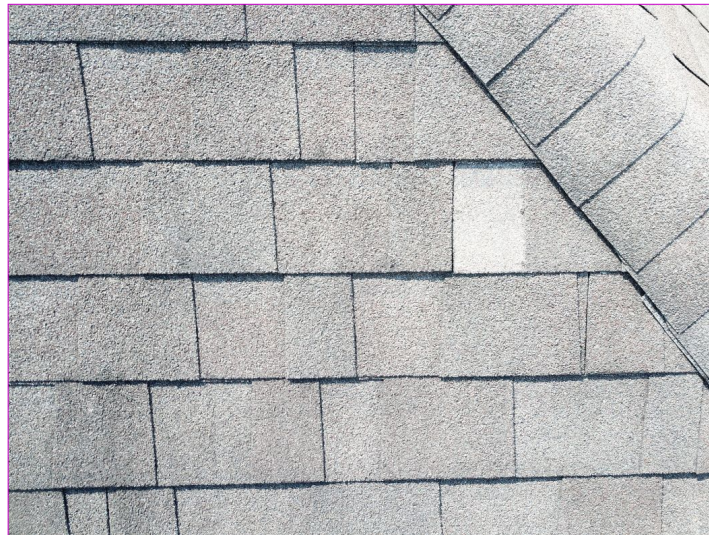
Damaged shingle

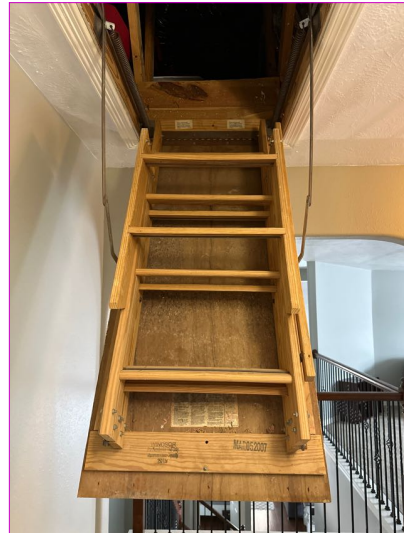
• The attic access ladder cover was not insulated.
The Inspector recommends insulating the attic access ladder cover to reduce unwanted heat loss/gain.

Attic ladder missing insulation

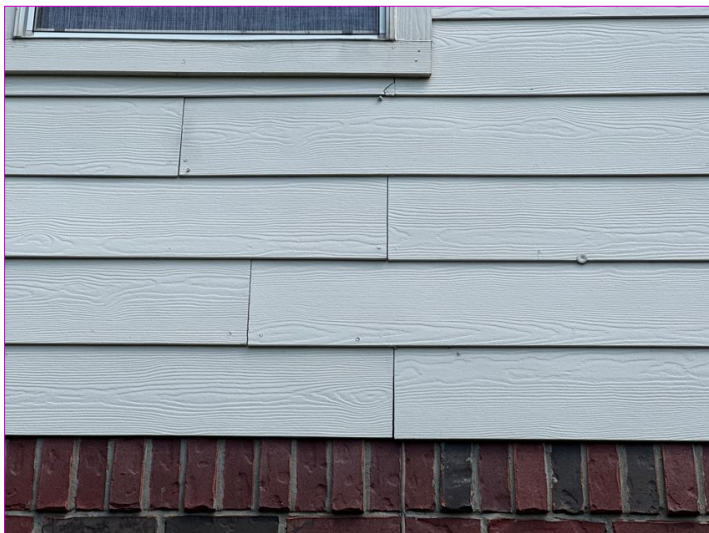
• The exterior cementitious siding had gaps in the edges at one or more location. Improving the caulking and painting to weatherproof these areas is recommended.

Siding gaps (right side)

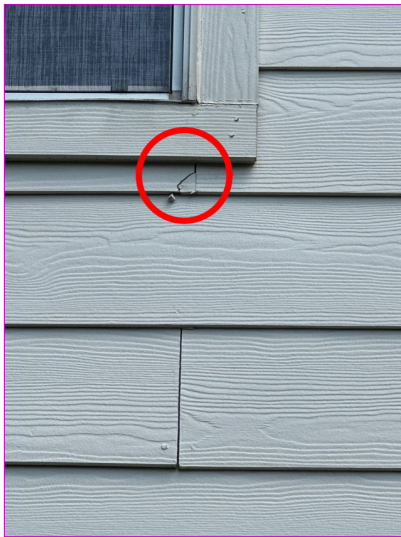
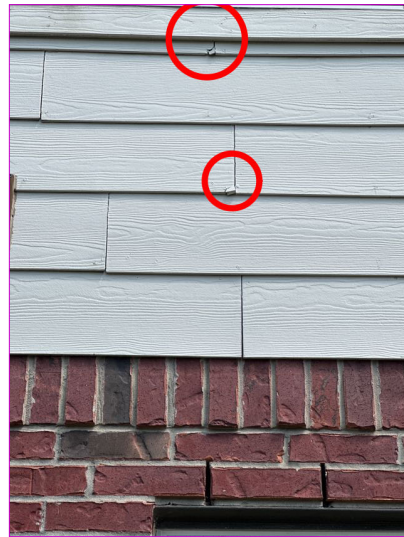
• The cementitious lapped siding had localized areas of damage. To prevent damage to home materials or the wall structure from moisture intrusion the Inspector recommends repair by a qualified contractor.

Localized siding damage (right side)

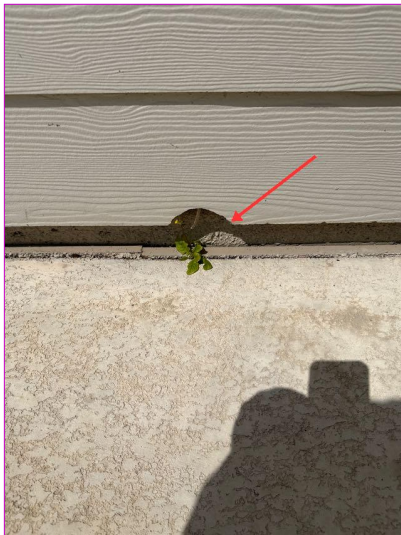
Localized siding damage (rear side)

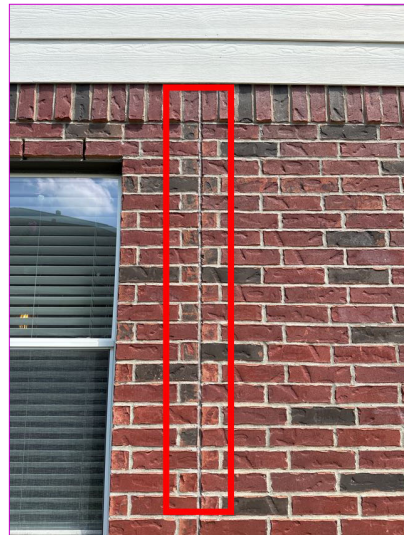
• Expansion joint(s) had visible gap widening at the top. This condition is a sign of a foundation settlement. Recommend sealing the gap and monitoring.

Expansion joint gap widening at the top (right side)

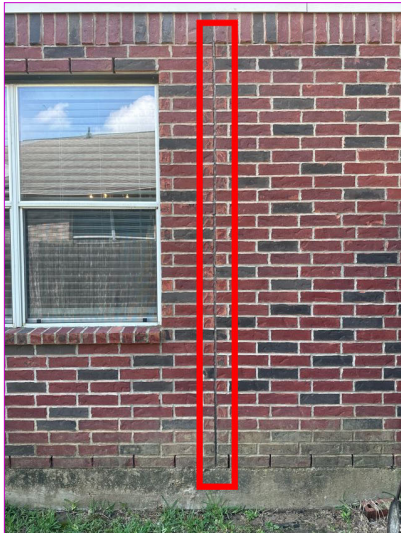
Expansion joint gap widening at the top (left side)

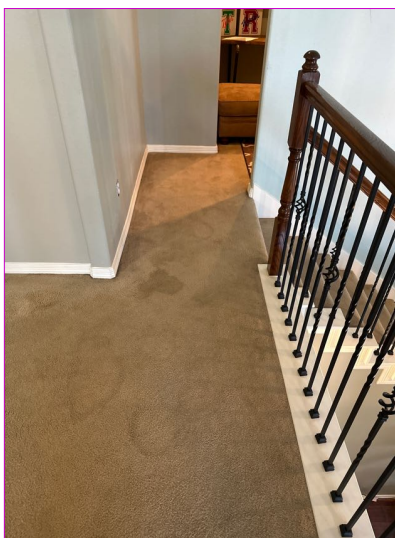
• Carpet in the upstairs hallway had areas of staining or discoloration. Before the expiration of your Inspection Option Period you may wish to consult with a qualified contractor to discuss options and costs for repair or replacement.

Carpet stain (2nd floor)

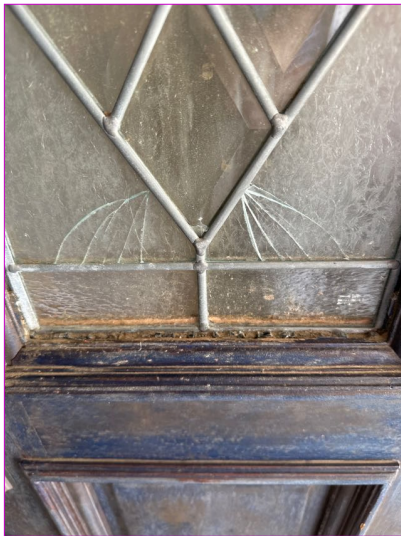
Cracked pane (entry door)

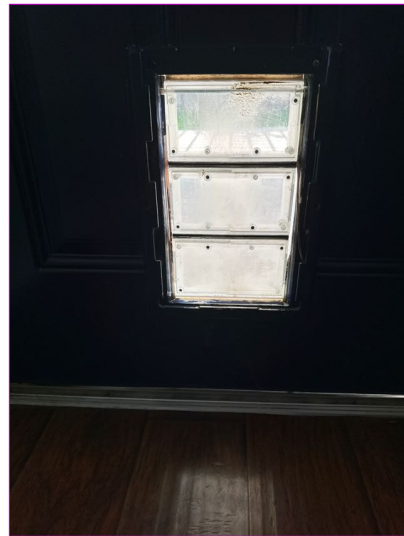
Exterior door lost integrity with dog access

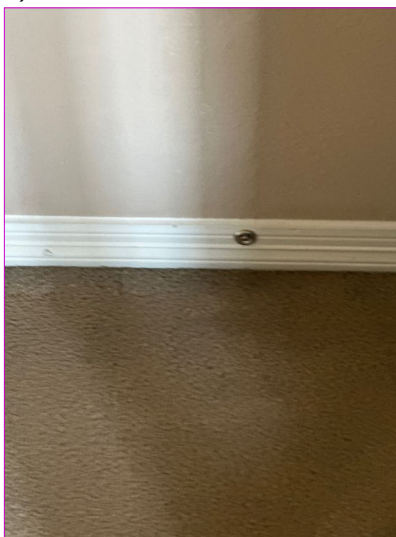
Missing door stop (upstairs bedroom)

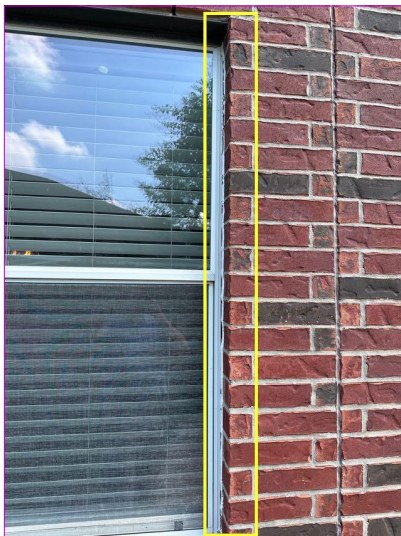
Window frame wall separation (right side)

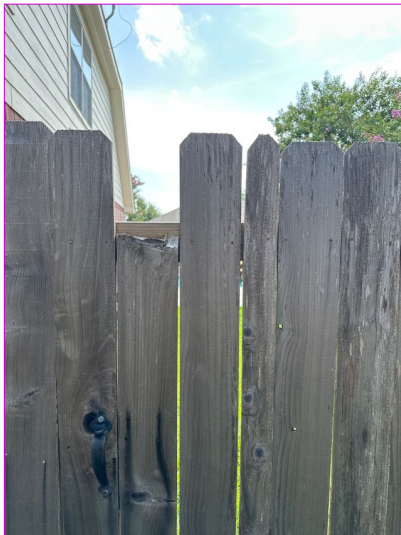
Damaged fence picket

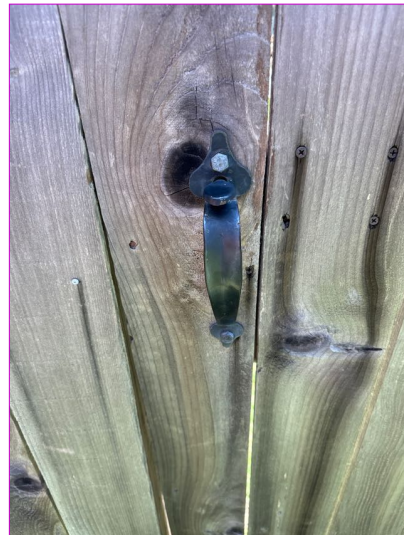
• The gate had a latch that needed adjusting at the time of the inspection.

Gate lock needs adjusting

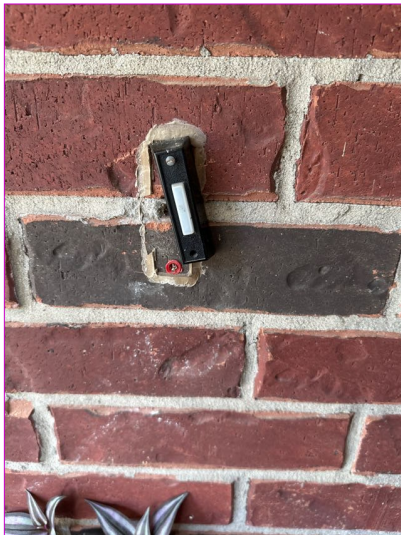
- At the time of the inspection, the bell ring button was loose at the wall. Recommend repair by a handyman.

Loose bell ring

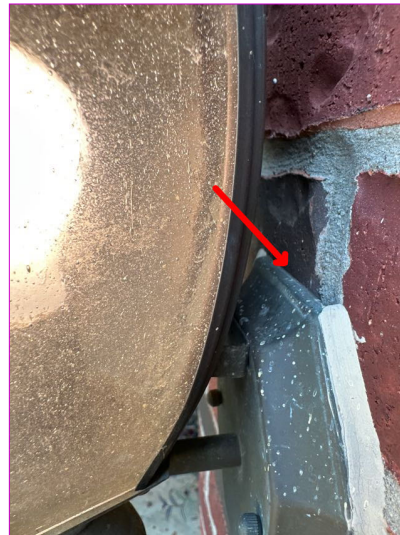
- Exterior lighting was installed in a manner that left energized electrical components exposed moisture intrusion. This condition will deteriorate electrical connections and is a potential fire hazard. The inspector recommends correction by a qualified electrical contractor.

Missing sealant around exterior light fixture (entry)

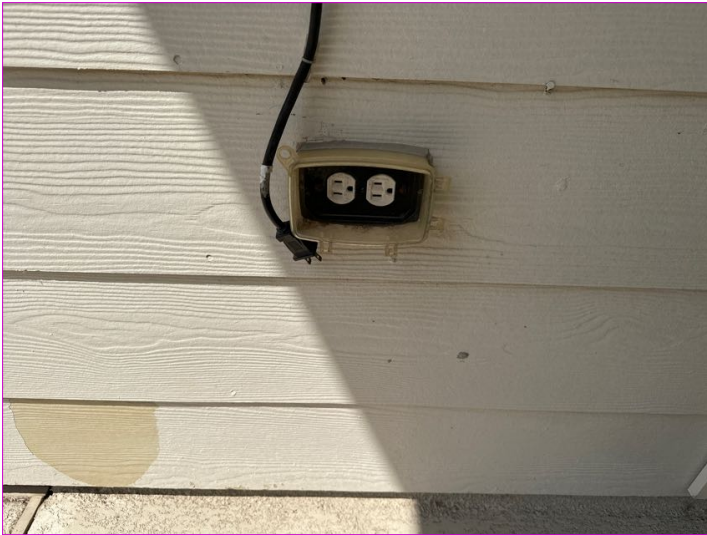
- Exterior receptacle at the home at the rear had a missing cover and may allow water entry. Inspector recommend repair and caulking.

Exterior receptacle missing cover (rear side)

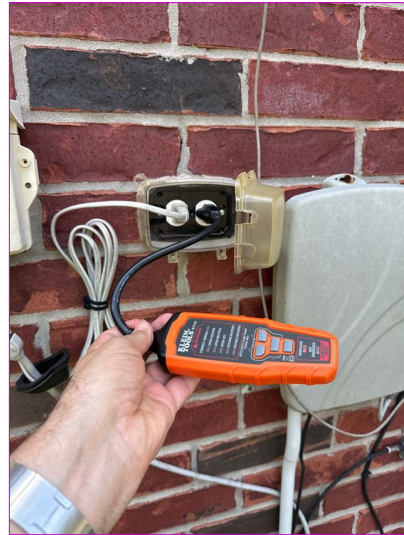
Faulty GFCI receptacle (right side)

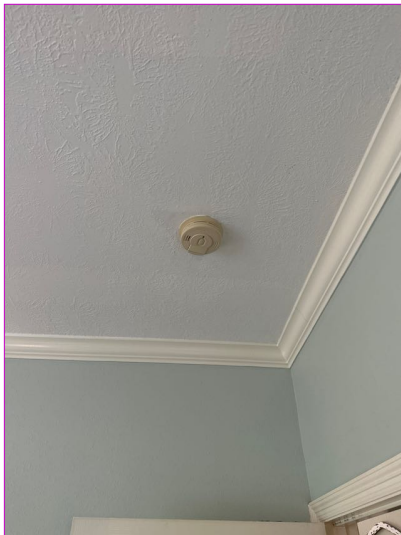
Replace old smoke detectors

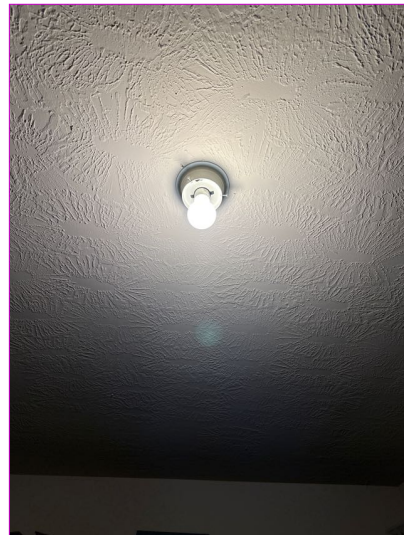
Damaged light fixture (master bedroom closet)

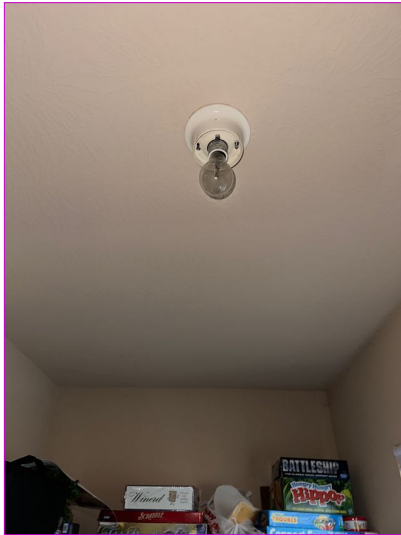
Damaged light fixture (upstairs bedroom closet)

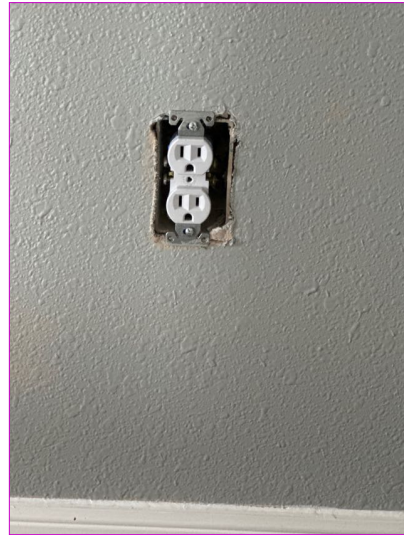
- At the time of the inspection, one or more electrical receptacle cover plate was missing. This condition left energized electrical components exposed to touch, a shock/electrocution hazard. The Inspector recommends a cover plate be installed by a qualified electrical contractor.

Receptacle missing cover (upstairs hallway)

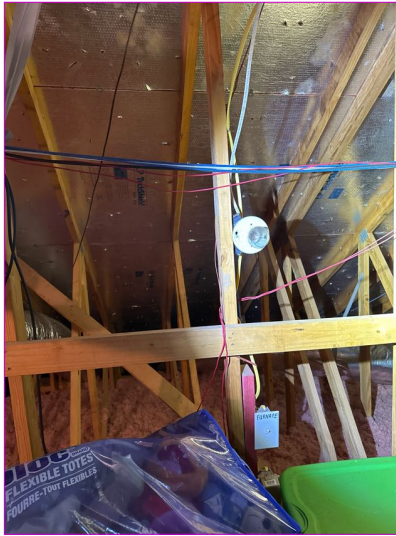
Inoperative light fixture (attic)

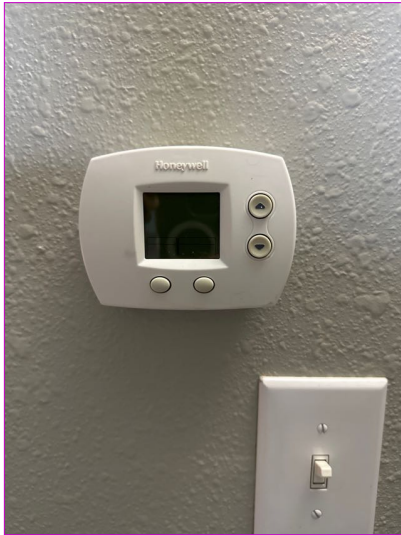
Inoperative thermostat (upstairs hallway)

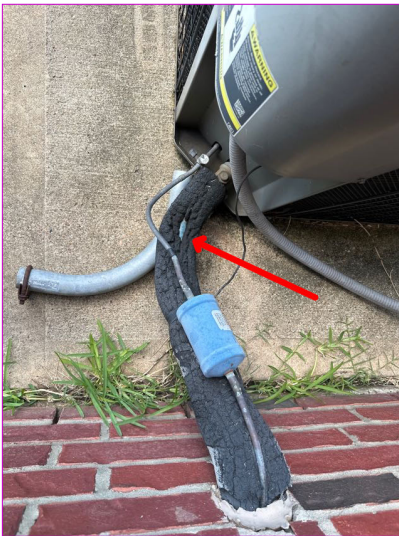
• Insulation on the air-conditioning suction (large, insulated) line was damaged or missing at areas and should be replaced by a qualified HVAC contractor..

Damaged AC line insulation

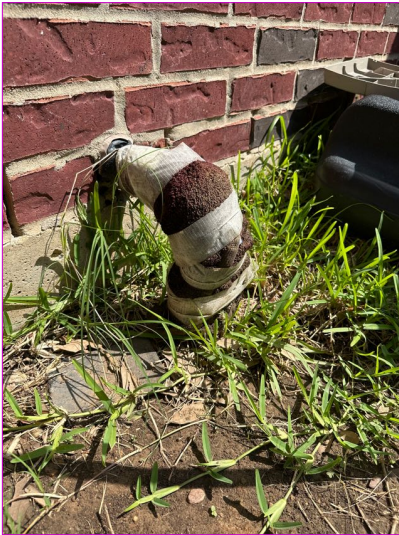
Unable to operate main water shut off valve (right side)

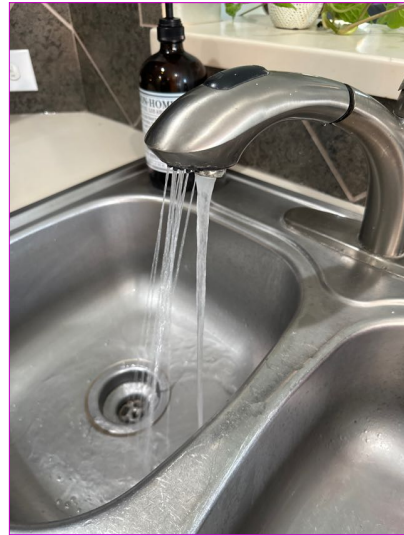
Wand needs repair (kitchen)

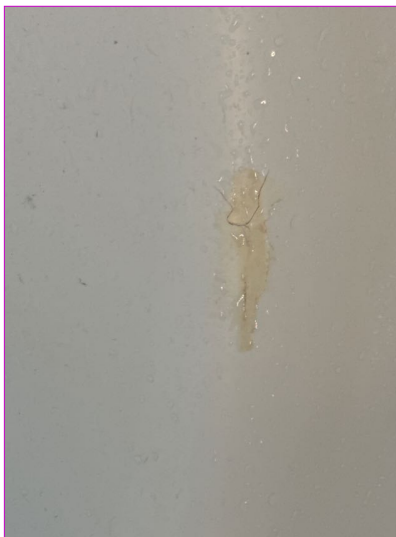
Tub cosmetic damage (master bathroom)

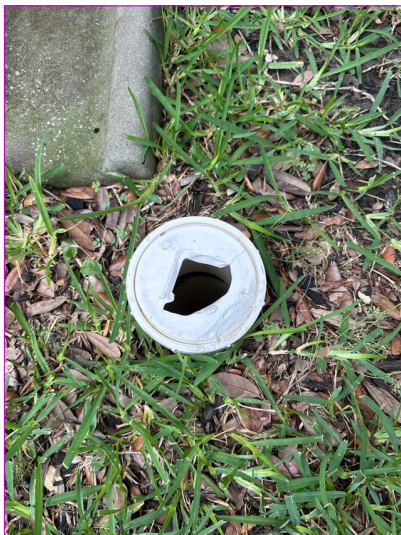
Damaged clean out cover (left side)

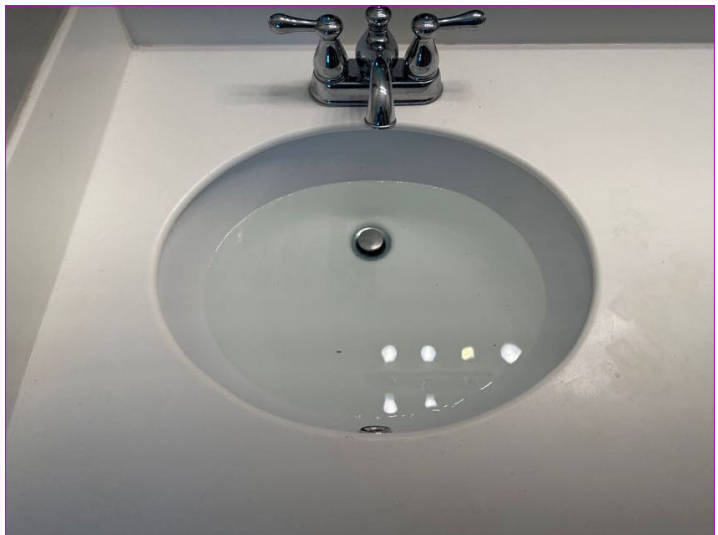
Slow sink drain (master bathroom)

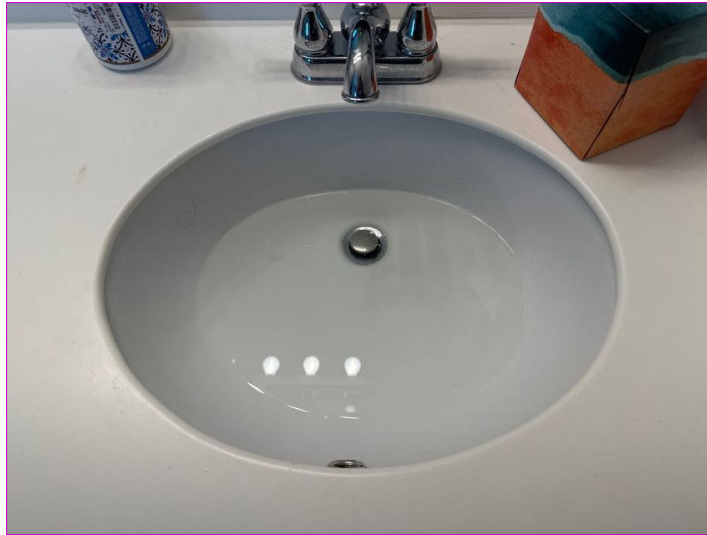
Slow sink drain (master bathroom)

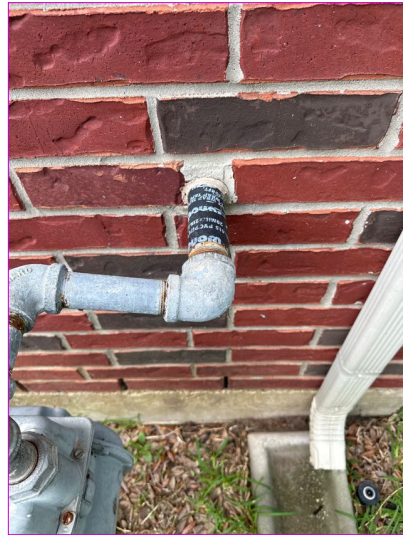
Missing bonding

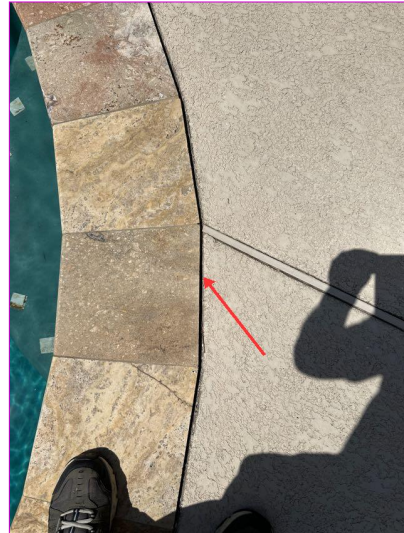
Missing caulking

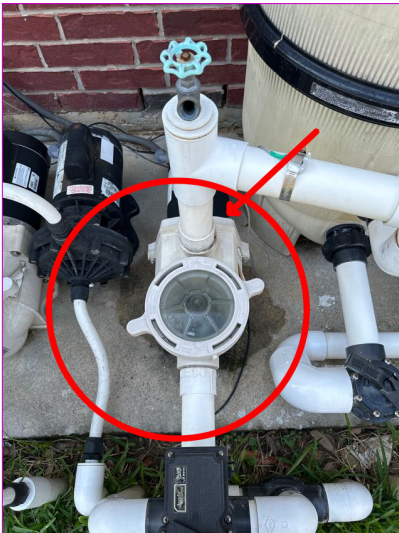
Signs of leakage below filter pump

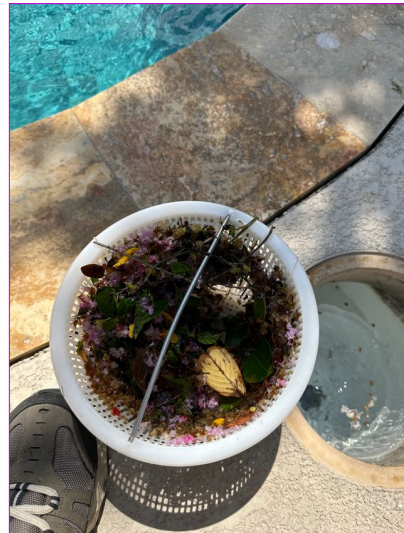
Basket needs cleaning
