BPG Inspection, LLC

**21839 Hannover Village Drive
Spring TX 77388**

Client(s): White
Inspection Date: 6/1/2020
Inspector: Murray Campbell , TREC #22455

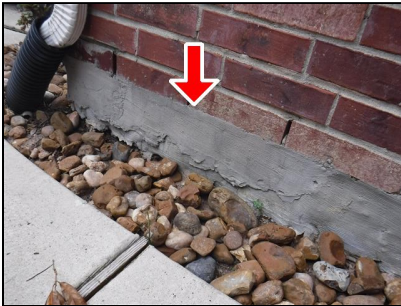
Parging is flaking off of the foundation in various areas. Parging is the mortar coat applied to the exterior of slab foundations. Flaking or "spalling" is common, and not typically related to any structural deficiencies. Consult with a mason for repair alternatives.

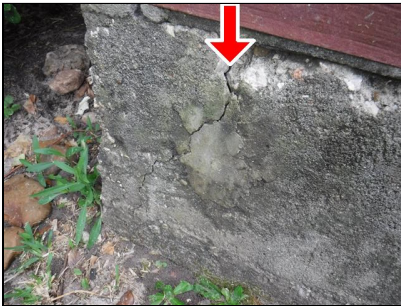
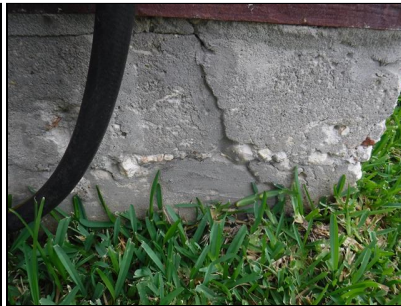
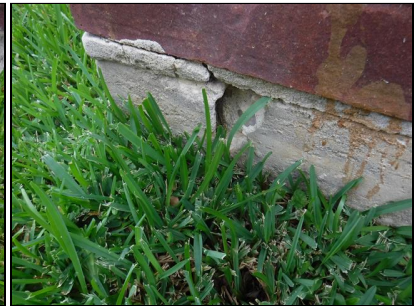
Corner cracks were observed at the corners of the slab foundation. Cracks of this nature are typical and occur when the exterior veneer is warmed by the sun and the wall expands. This condition is also a conducive condition for termite infestations. I recommend you contract foundation expert to repair mortar as needed to prevent further separation. Sidewalk repair caulking is the typical product used for this repair.

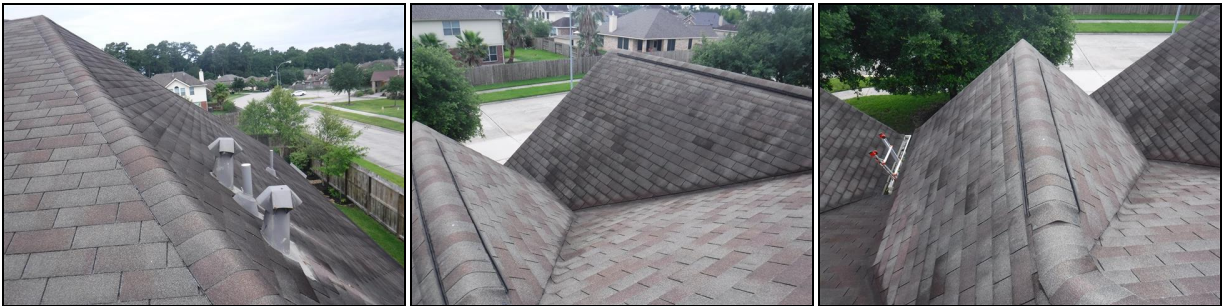
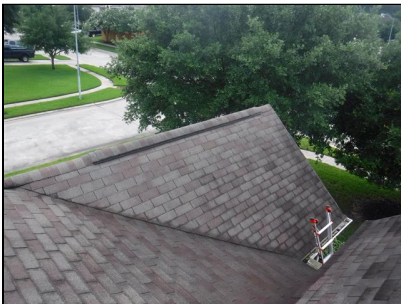
There were several roofing fasteners observed to be improperly sealed or exposed. Left unsealed the fastener penetrations could present a point of water penetration into the roof structure. Seal (caulk) all exposed roofing fasteners (i.e. plumbing vents, flue pipe roof jacks, flashings, and ridges lines).

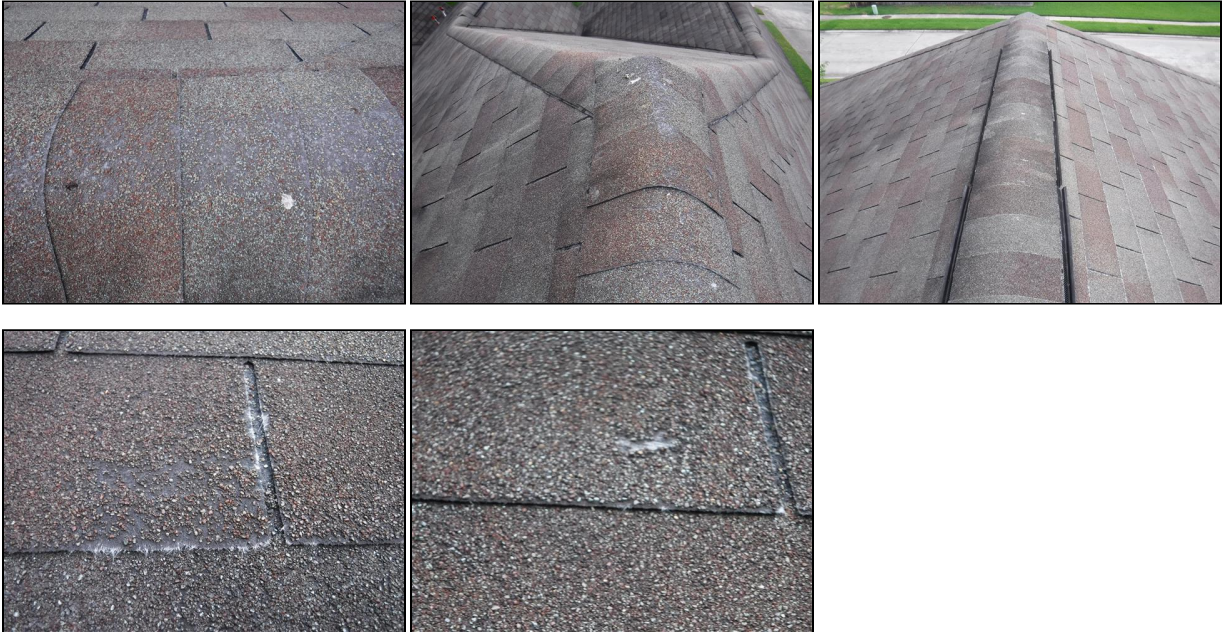
There are signs of previous hail strikes.

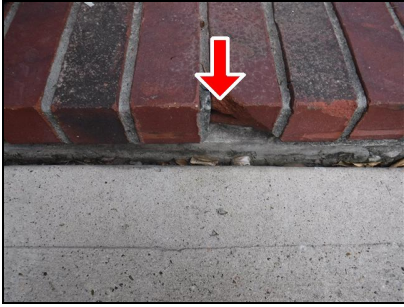
Noted areas of siding trim and edges that have missing or deteriorated caulking. These areas can be a point of water infiltration if not addressed. Noted no evidence at interior sides of home areas with previous water infiltration at time of inspection. Recommend fully and properly sealing all areas affected.

There is a brick damaged at front entrance. Repair as needed.

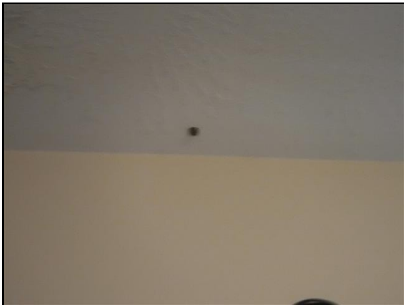
There are some nail heads "popping" through the ceiling/wall surface. Nail pops are typically cosmetic and not of any structural significance. A handy person can simply reset the nail head and fill the depressions with a patching material such as drywall or spackling compound.

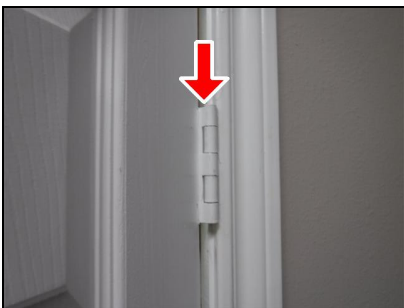
The occupant door leading from the attached garage into the house is not self closing. I recommend installing/adjusting self closing hinges on the door leading from the garage to the living space as a safety feature to prevent exhaust gases (car, appliance) from entering the house.

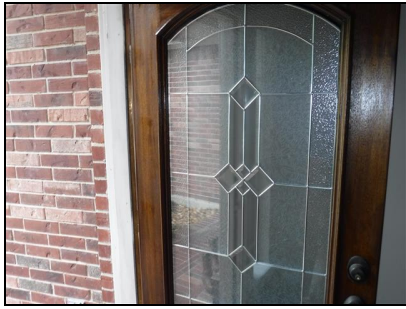
Noted at the front entry door is not plumb. Door attempts to close with no assistance and has door wedge currently holding door open. Recommend having door properly re-hung and aligned to operate as designed.

Recommend replacing all missing door stops.

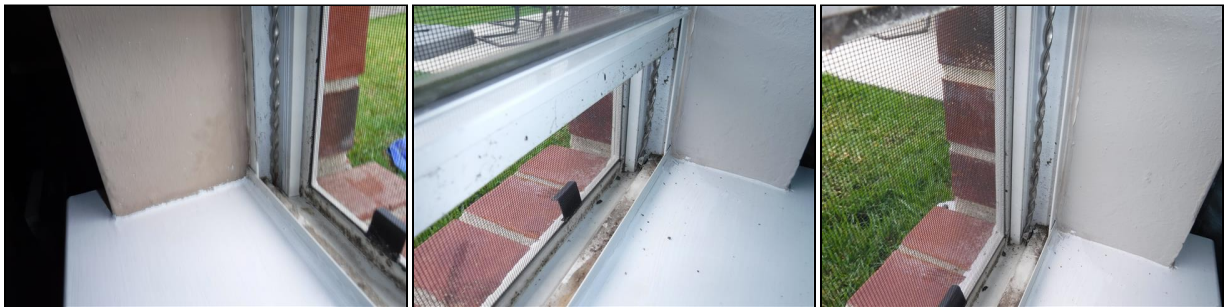
Window sash springs need adjustment or repair to allow windows to remain completely open, Located Master bedroom (1), Living room (1), and front guest bedroom (1).

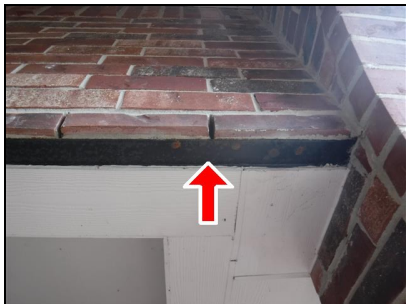
Window lintels are rusted in areas. Recommend remediation of rust, application of rust prohibitive paint.

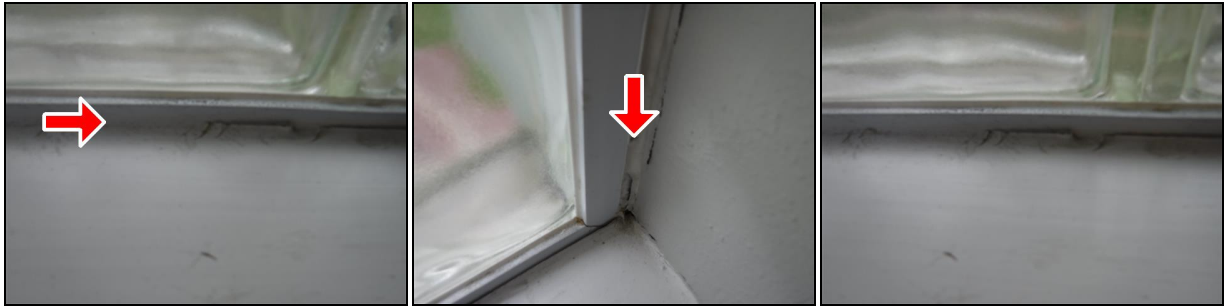
Noted several window sills at interior of home with deteriorated caulking at various sides of window frames. Deteriorated caulking at area can potentially subject framing under and behind window sill to future moisture collection concerns. Recommend having all window sills affected re-sealed with caulking. Important to check all 4 sides of window frames for deteriorated caulking concerns.

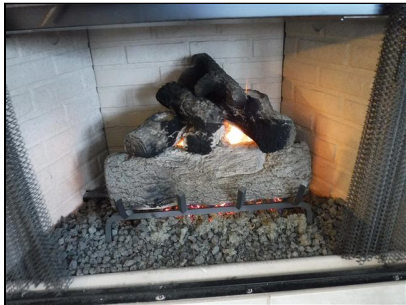
Fireplace does not have a damper blocking device installed as called for by today's standards in fireplaces with gas log systems. <http://damperclamp.com/installation.php>

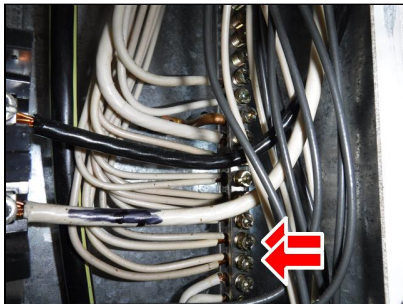
Neutral wires are not individually lugged to the panel neutral bus bar as called for by today's standards.

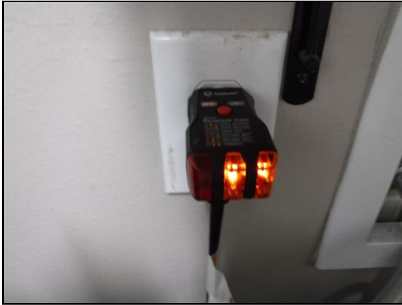
There are no GFCI (Ground Fault Circuit Interrupt) protected outlets in locations called for by today's standards: laundry,. I recommend updating to current standards.

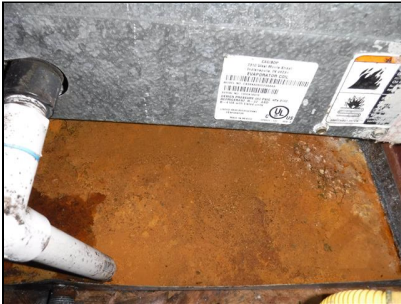
Rust noted in the secondary drain pan. The rust may extend to the bottom of the pan, which may result in water leaking onto the surrounding area. This is typically from excess condensation, most times produced from a soiled evaporator coil. I recommend replacing or repairing pan as needed. I also recommend that the system be serviced by a licensed HVAC technician to address the cause of excess condensate before closing.

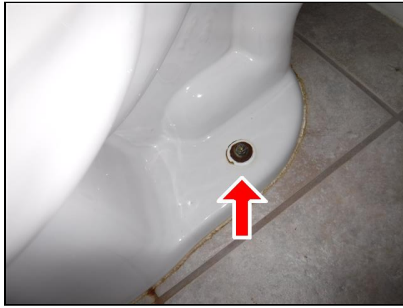
☒ The toilet(s) is loose at floor in the guest bath. A plumber should perform repairs. Repairs may involve re-setting the toilet on a new wax seal.

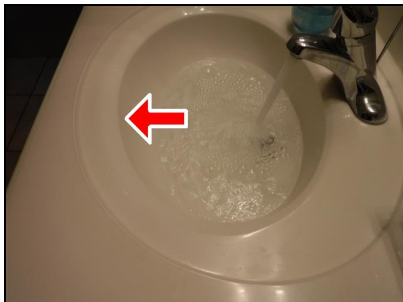
The master bath guest bath sink does not have an over-flow drain and there is a drain stopper present. Client should ensure that the sink is never left unattended during filling. Suggested recommendation is to remove stopper assembly from sink.

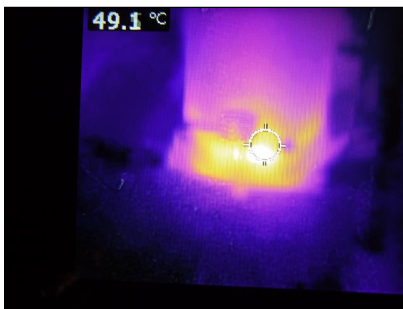
Temperature readings at sinks were measured at a higher than suggested setting. The U.S. Consumer Product Safety Commission (CPSC) urges all users to lower their water heaters to 120 degrees Fahrenheit. In addition to preventing accidents, this decrease in temperature will conserve energy and save money. Most adults will suffer third-degree burns if exposed to 150 degree water for two seconds. Burns will also occur with a six-second exposure to 140 degree water or with a thirty second exposure to 130 degree water. Even if the temperature is 120 degrees, a five minute exposure could result in third-degree burns. Consumers should consider lowering the thermostat to the lowest settings that will satisfy hot water needs for all clothing and dish washing machines.

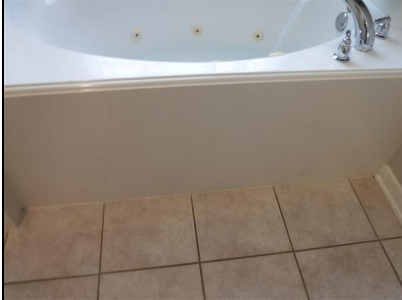
There is no visible Jacuzzi equipment access panel installed that would allow repairs/replacement in case of failure.
