## INVASIVE STUCCO INSPECTION

1301 Milford St  
Houston, TX 77006

MARCH 7, 2022

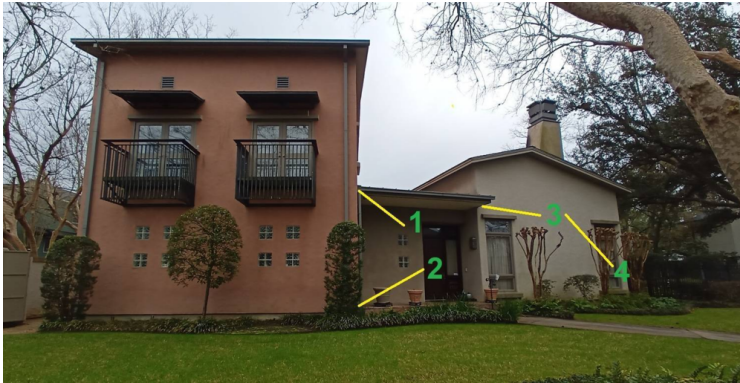
### General: ELEVATION 1

#	%	Level	Substrate	Notes
1	12	Low	Firm	
2	10	Low	Firm	
3	10	Low	Firm	
4	12	Low	Firm

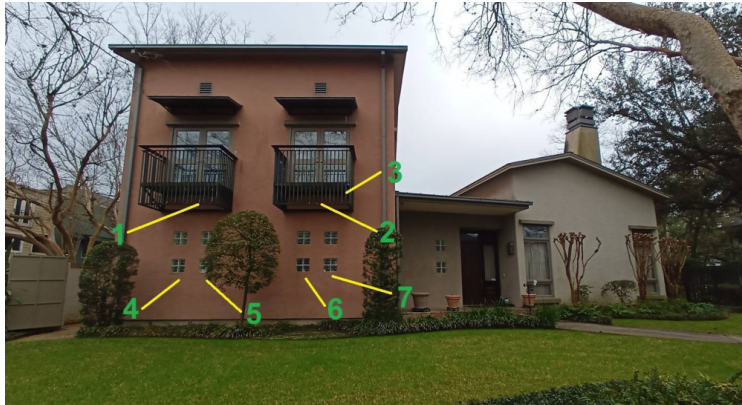
### General: ELEVATION 2

#	%	Level	Substrate	Notes
1	13	Low	Firm	
2	10	Low	Firm	
3	12	Low	Firm	
4	10	Low	Firm	
5	9	Low	Firm	
6	12	Low	Firm	
7	14	Low	Firm

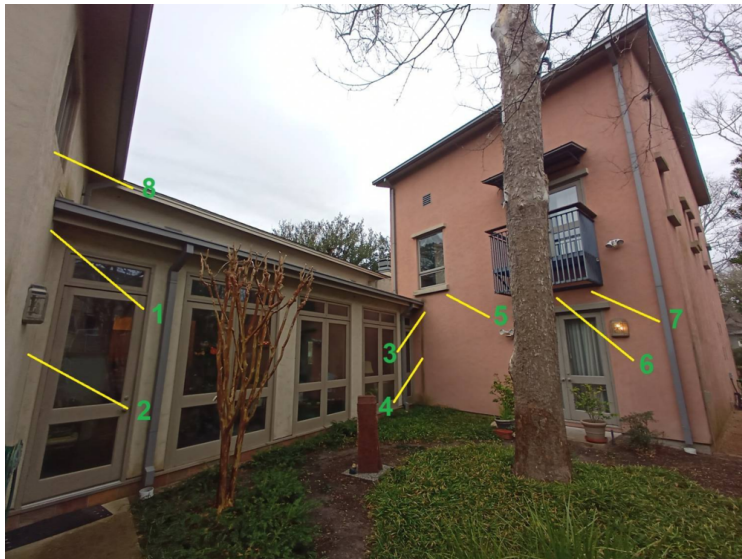
General: ELEVATION 3

#	%	Level	Substrate	Notes
1	12	Low	Firm	
2	10	Low	Firm	
3	14	Low	Firm	
4	12	Low	Firm	
5	9	Low	Firm	
6	11	Low	Firm	
7	10	Low	Firm	
8	10	Low	Firm

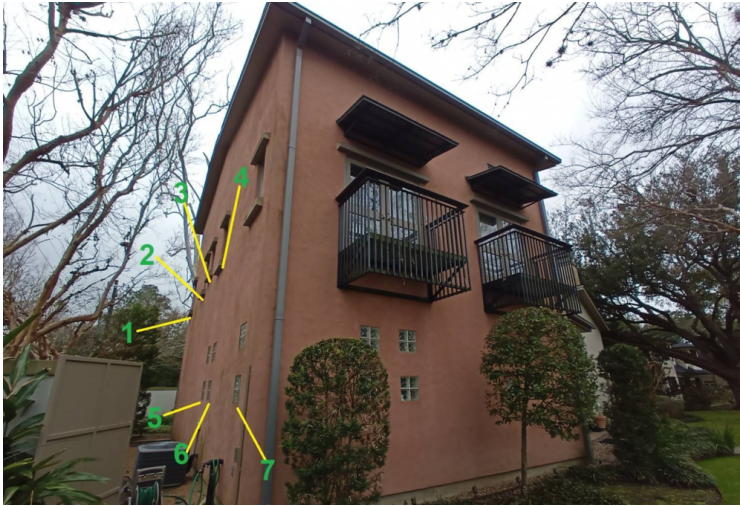
### General: ELEVATION 4

#	%	Level	Substrate	Notes
1	10	Low	Firm	
2	9	Low	Firm	
3	13	Low	Firm	
4	10	Low	Firm	
5	12	Low	Firm	
6	10	Low	Firm	
7	11	Low	Firm

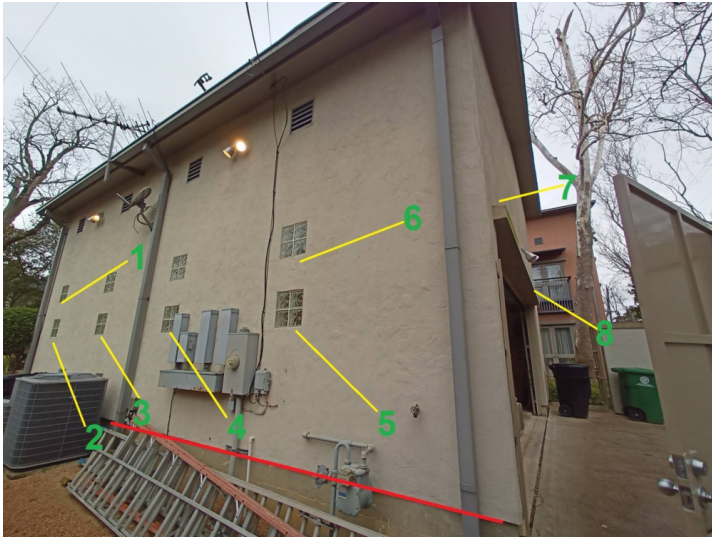
### General: ELEVATION 5

#	%	Level	Substrate	Notes
1	12	Low	Firm	
2	12	Low	Firm	
3	13	Low	Firm	
4	14	Low	Firm	
5	12	Low	Firm	
6	11	Low	Firm	
7	12	Low	Firm	
8	13	Low	Firm	
<b>Red Lin</b>	N/A	N/A	Deteriorated	Back wrapping present

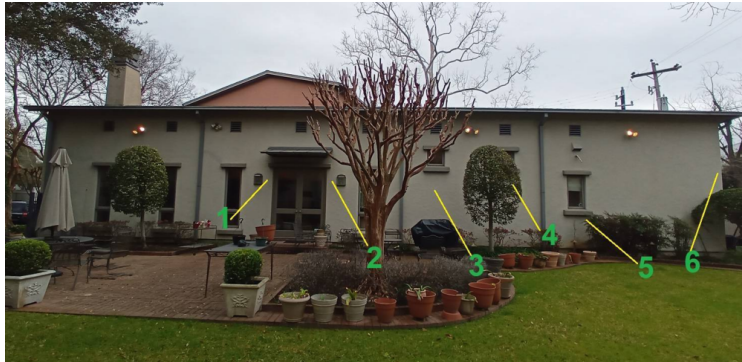
General: ELEVATION 6

#	%	Level	Substrate	Notes
1	10	Low	Firm	
2	10	Low	Firm	
3	12	Low	Firm	
4	11	Low	Firm	
5	12	Low	Firm	
6	10	Low	Firm

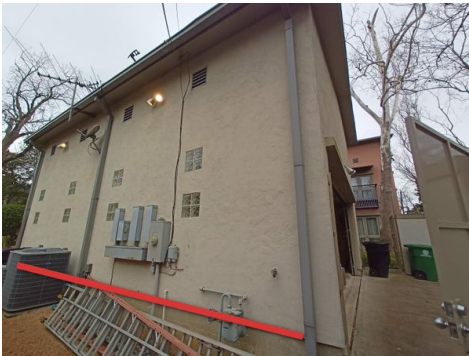
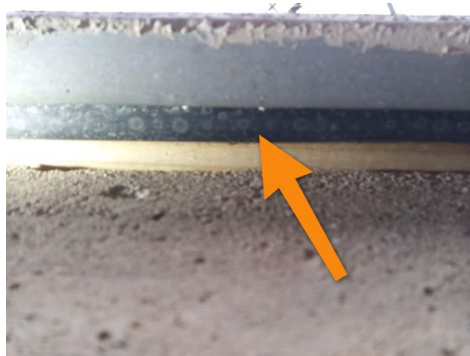
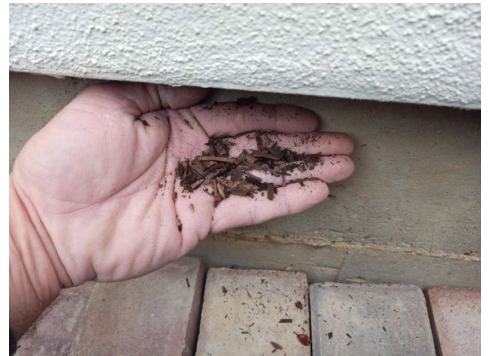
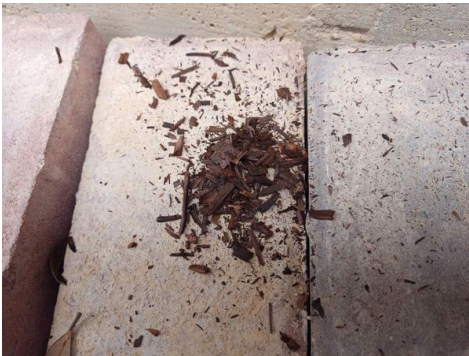
### 12.1.1 Substrate Integrity

#### BACK-WRAPPING PRESENT - SUBSTRATE DAMAGED

Back wrapping of the vapor barrier material was observed at the bottom of the stucco. Back wrapping can prevent moisture from draining from the bottom of the stucco system, thus leading to water damage at the substrate. It is recommended that the vapor barrier be cut along the bottom of the walls to allow for proper drainage. It is pointed out that damage was observed at several locations around the house where we could reach behind the stucco.

#### Obtain Cost Estimate

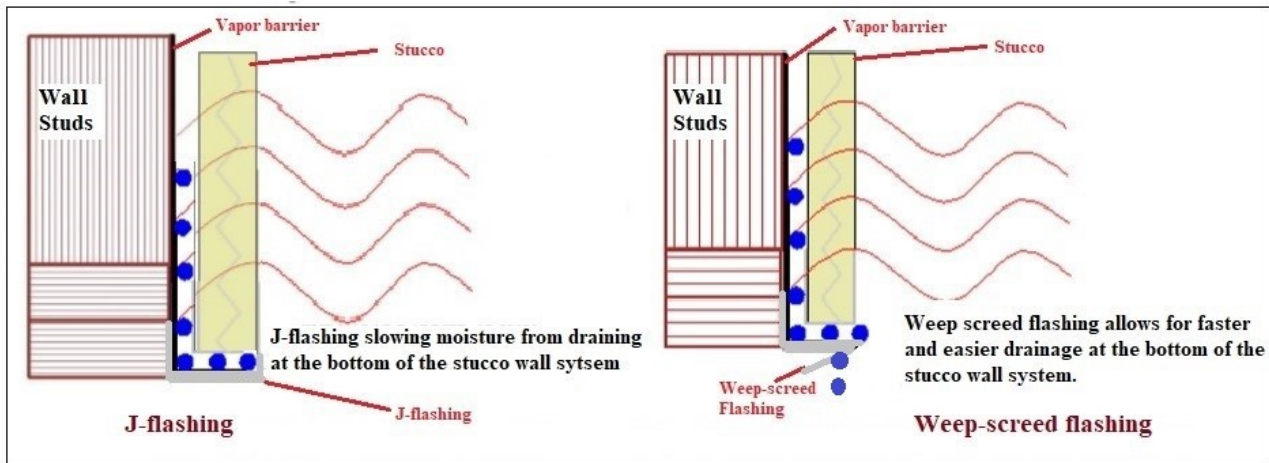
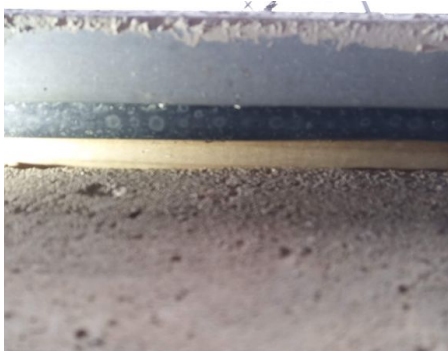
### Flashings : J-Flashing Present

The stucco system was equipped with the older style J-flashing along the bottom of the exterior walls, rather than the current standard weepscreed flashing. It is pointed out that J-flashing does not have holes/openings in the material to allow moisture to drain out of the stucco/wall. A weepscreed has holes in the bottom to promote moisture in the stucco/wall to exit. Restrictions in the drainage path can lead to mold, mildew, or other moisture related problems.

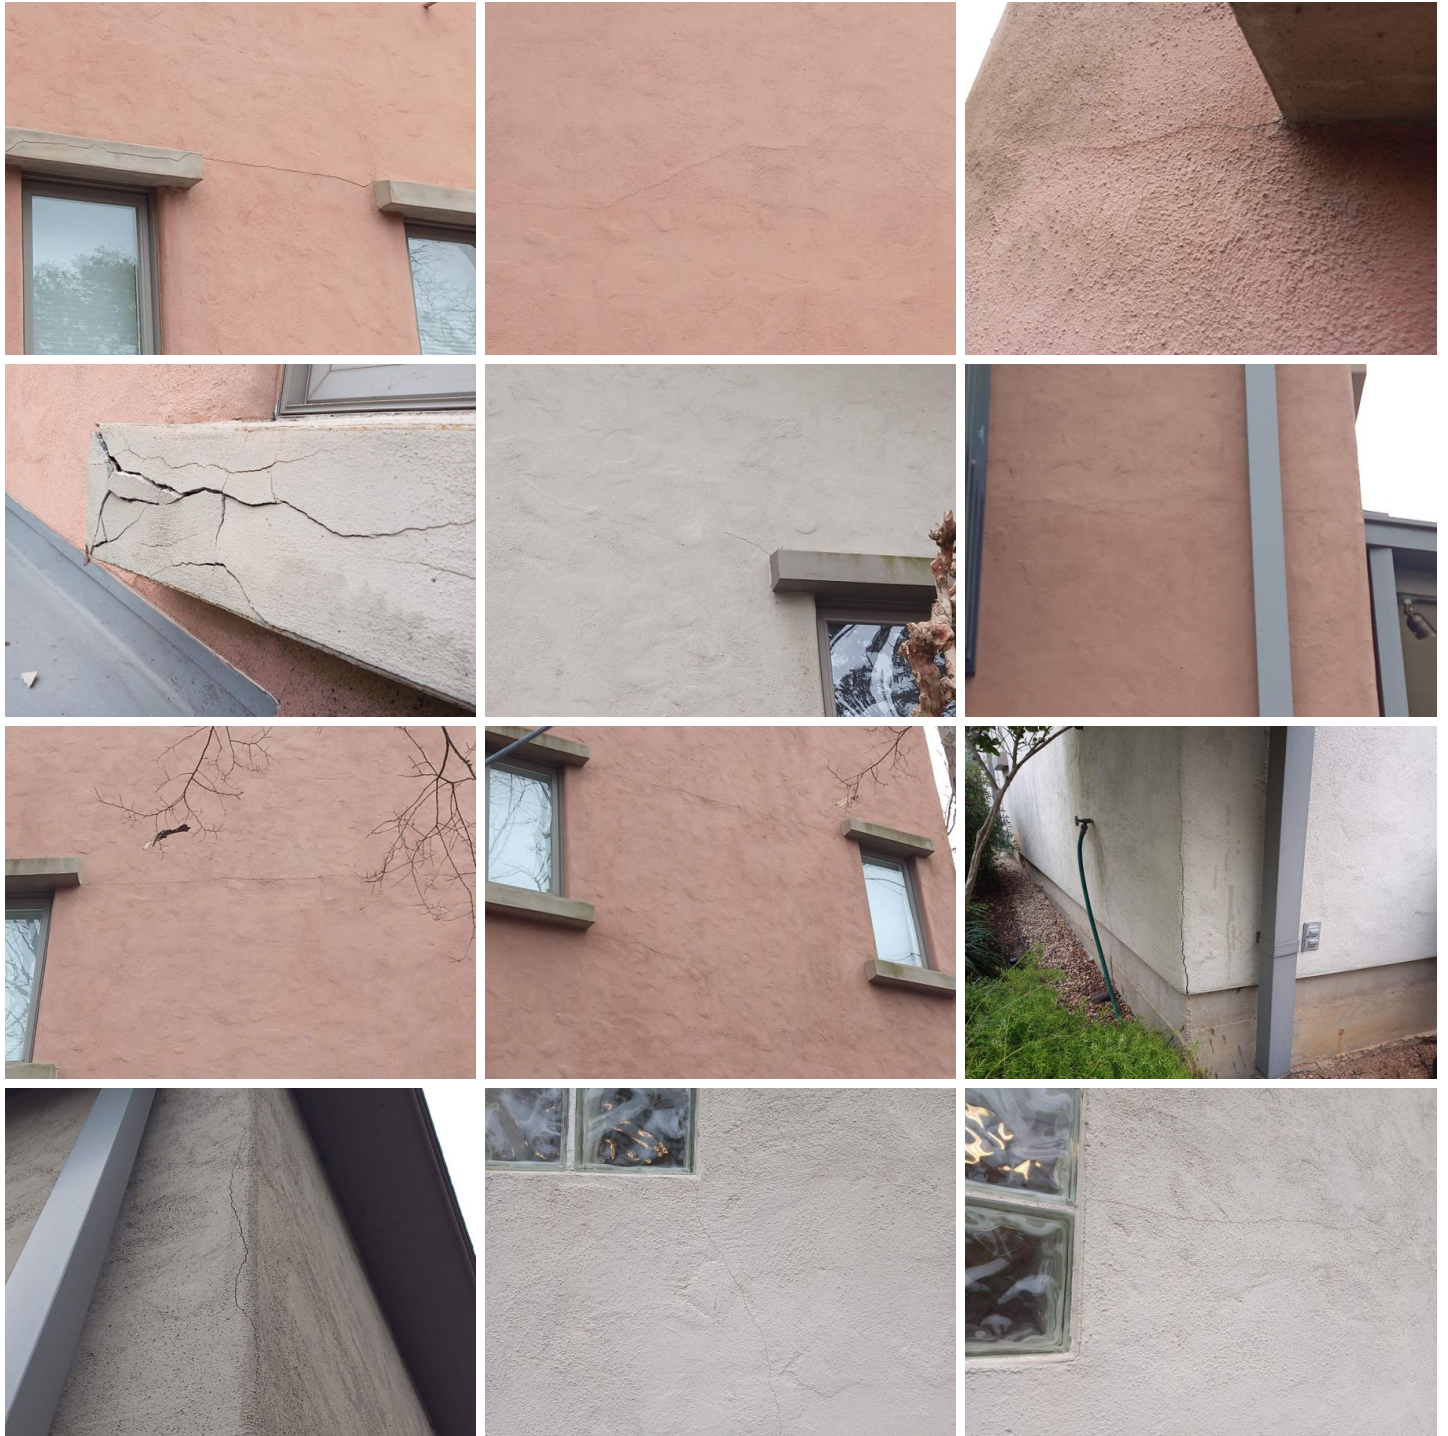
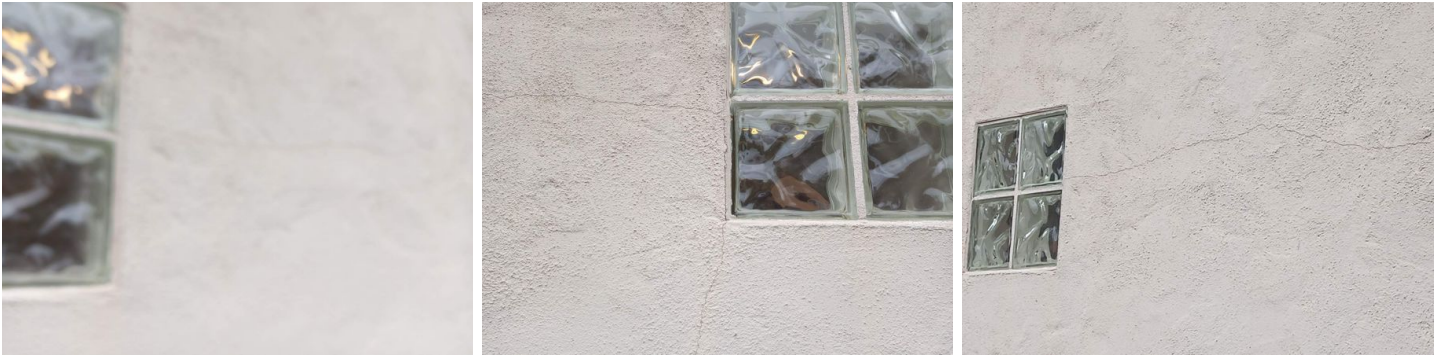
13.1.1 Stucco Cracks

**EXTENSIVE CRACKING OBSERVED**

We observed extensive hairline cracks, large cracks and spalling in the stucco veneer. It is recommended that you consult a qualified waterproofing contractor to repair all cracks and spalling. In addition, the contractor should determine what repair measures are needed. It is pointed out that smaller cracks may only require an elastomeric type paint, however larger cracks may need to be grinded, filled, and retextured. The finish coat or additional coats may need to be removed and refinished at the areas that are spalled. It is recommended that you consult a qualified stucco waterproofing contractor to seal all the cracks.

**Obtain Cost Estimate**

**Repairs made 2023**

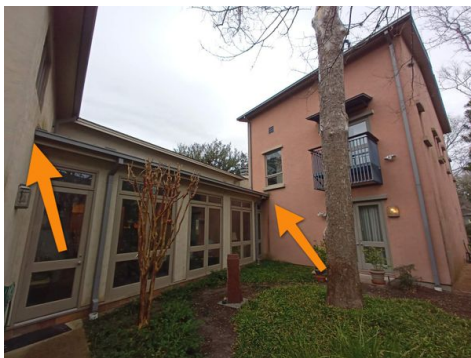
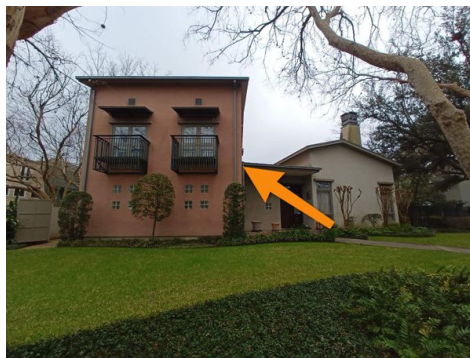
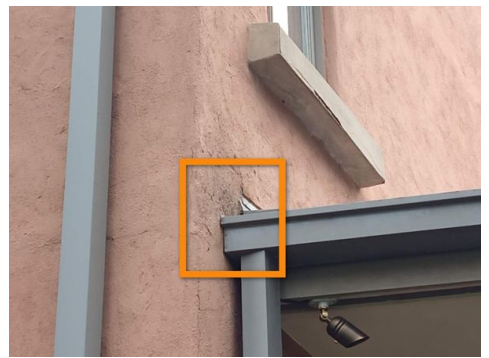
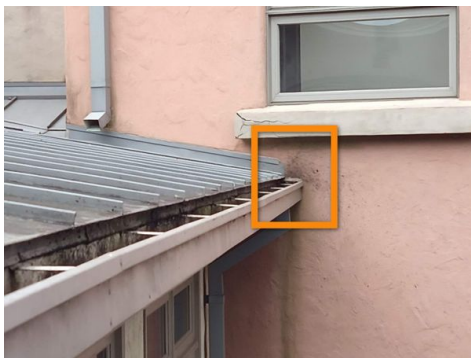
13.2.1 Flashings

**KICKOUT FLASHING MISSING - NO DAMAGE OBSERVED**

Kickout flashing was not present at the roof to wall intersection. A lack of kickout flashing can possibly allow water run off from the roof to be routed into the wall cavity. This condition is known to lead to wood rot, mold, and other moisture related problems. When the area was probed no damage or elevated moisture was observed. Consideration should be given to having a water proofing specialist install this flashing detail or at a minimum the sealants for this area be routinely maintained.

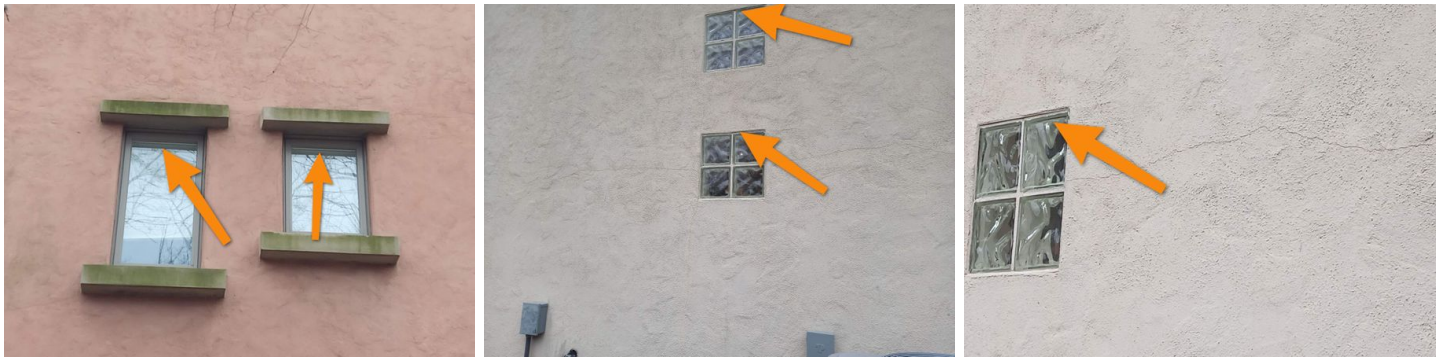
## 13.2.2 Flashings

**HEAD FLASHING NOT PRESENT - MAINTAIN SEALANTS**

## ALL WINDOWS

Head flashing was not installed at the top of one or more doors or windows. Head flashing is intended to prevent water that runs down the wall from entering into wall cavity through the joint between the stucco and the top of the window/door. No evidence or damage or elevated moisture were observed due to the missing flashing, and since the window/door appears to be performing adequately since the time of construction, we do not recommend that the flashing be installed at this time. It is recommended that the sealants around the window/door be maintained routinely.

**Obtain Cost Estimate**

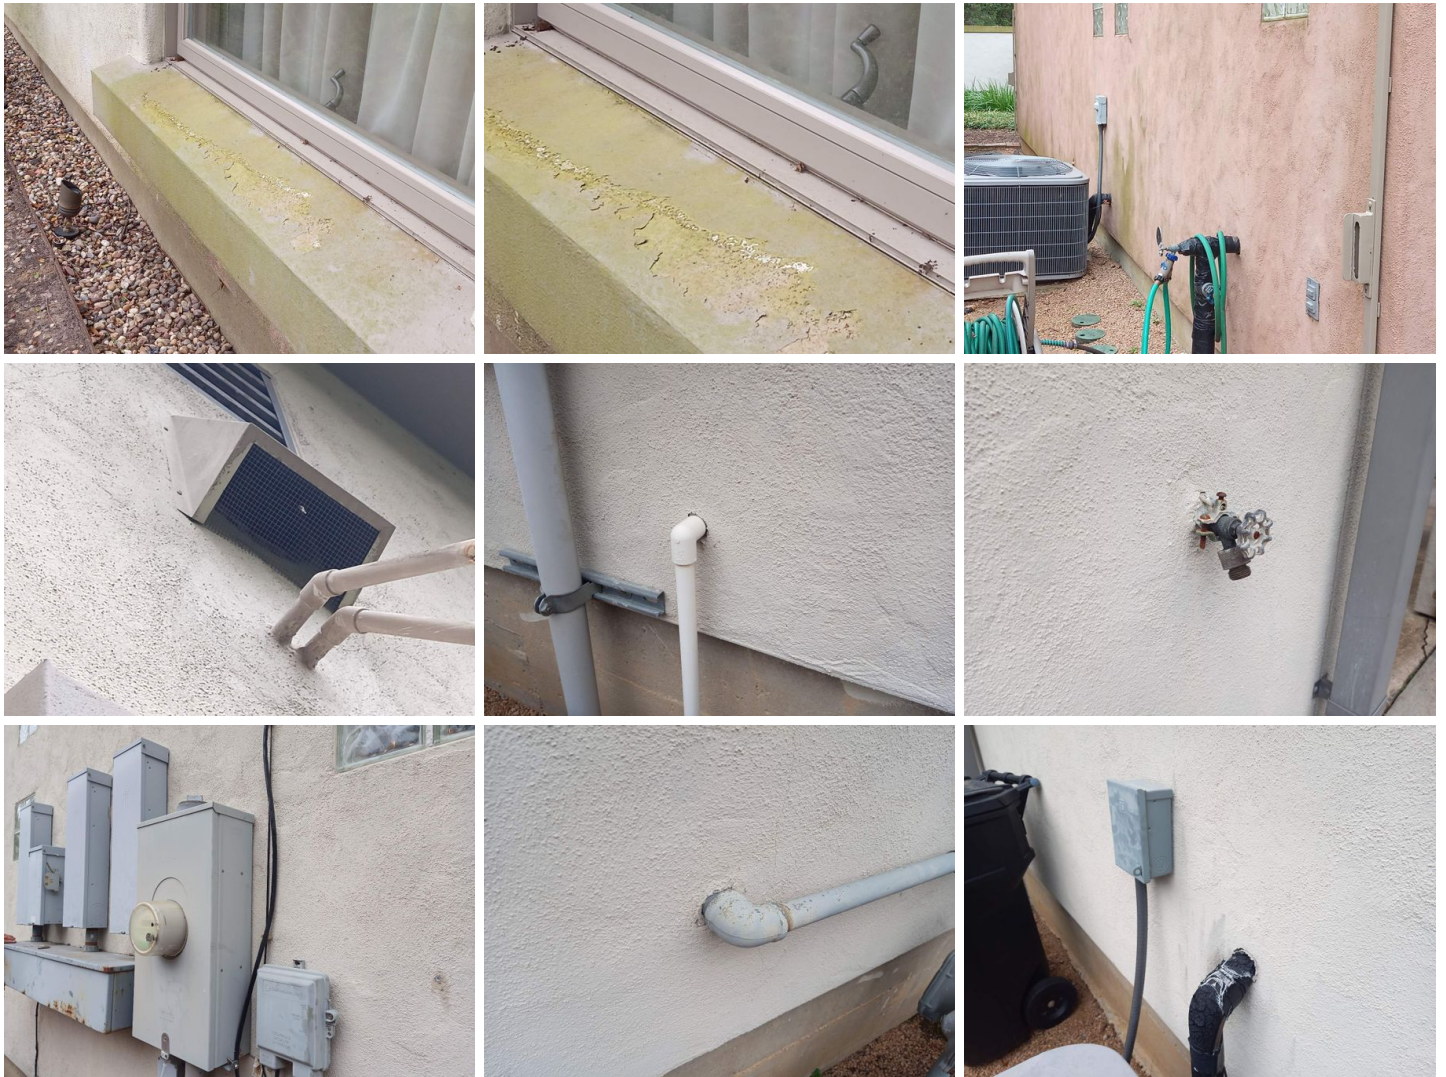
## 13.3.1 Sealants

**VULNERABILITIES TO WATER INTRUSION**

Light fixtures, Water piping, Vent caps, Gas piping, Windows, Doors, Electrical boxes, Wall penetrations, Accent details

A substantial vulnerability to water penetration was observed at openings through the exterior building envelope, and it is recommended that all penetrations/openings be sealed against water penetration. Below is a representative sample of photographs showing some, but not necessarily all, locations where there is a vulnerability to water penetration. Have a contractor provide a cost estimate to seal all vulnerable areas on the exterior building envelope against water penetration.

**Obtain Cost Estimate**

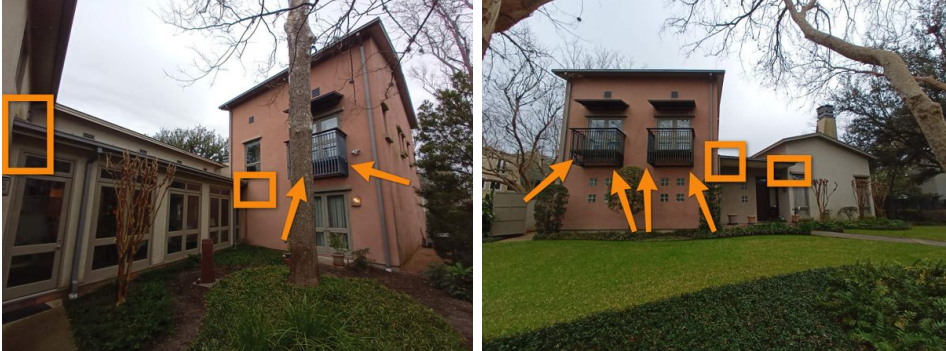
13.3.3 Sealants

**SEAL FLASHINGS**

ROOF TO WALL INTERSECTIONS, SECOND FLOOR EXTERIOR DOORS

The sealants were inadequate at the metal flashings. It is recommended that the flashings be resealed with a high quality exterior sealant by a water proofing specialist to prevent water intrusion.

**Obtain Cost Estimate**

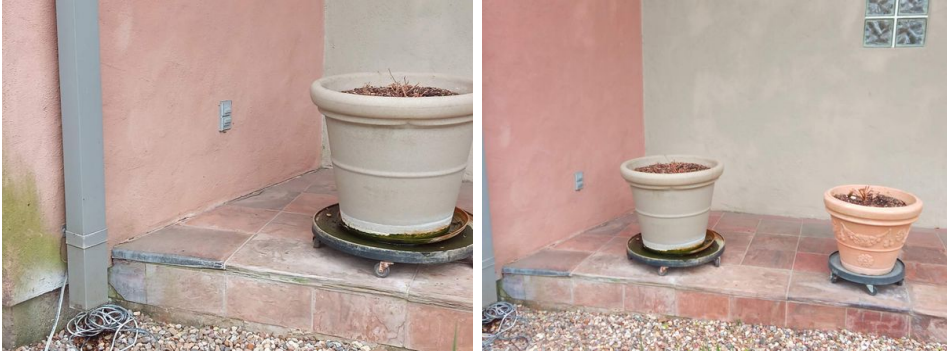
## 13.5.1 Clearance

**INADEQUATE CLEARANCE - 1-2 INCHES NEEDED**

## Porch

The stucco veneer did not have adequate clearance along the bottom of the wall. It is currently recommended for new construction that there be a minimum distance of one to two inches clearance along the bottom of the stucco to prevent water wicking into the bottom of the stucco and to allow the stucco wall to drain properly.

**Obtain Cost Estimate**

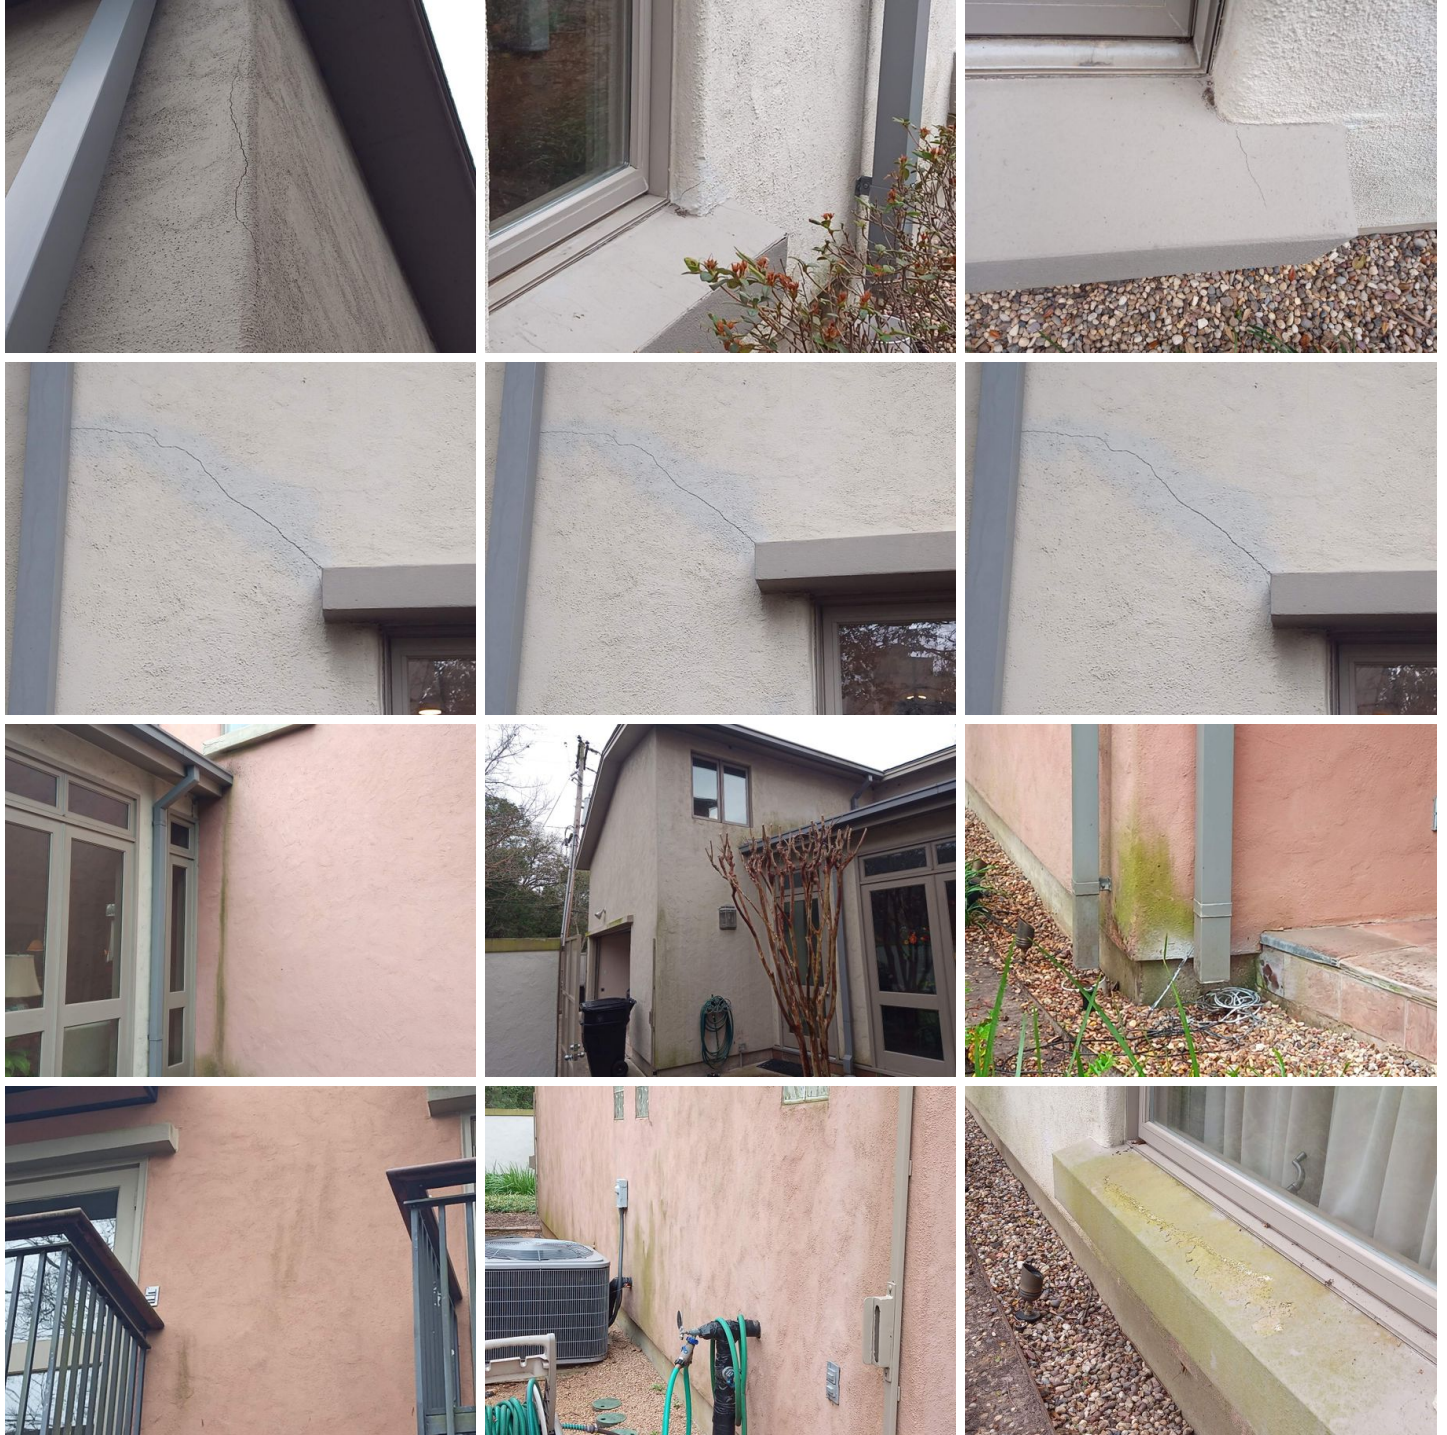
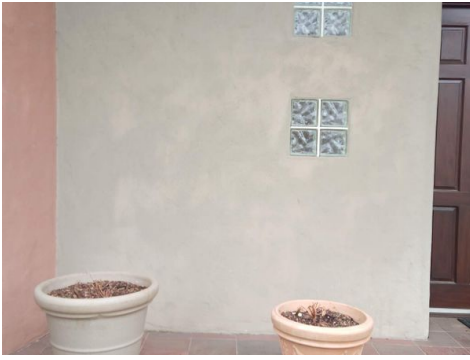
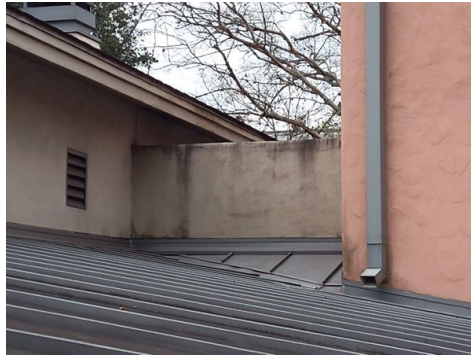
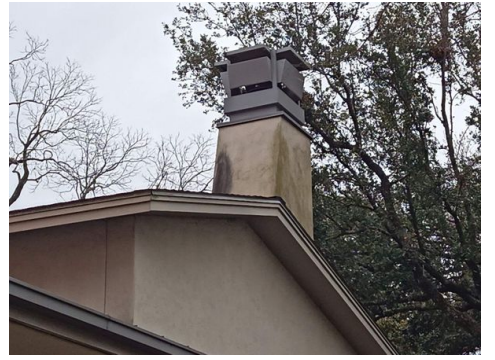
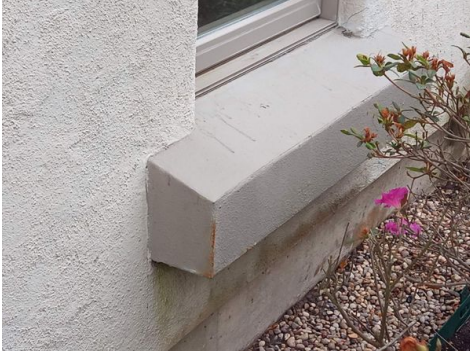
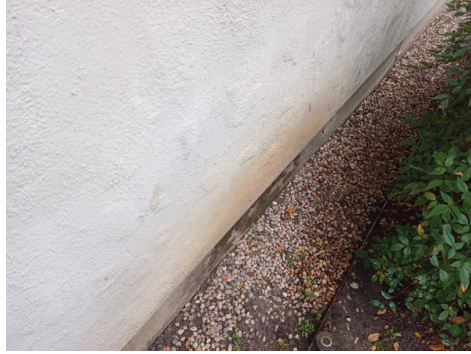
13.6.1 Paint Condition

**RECOMMEND - PAINT, SEALANT, CRACK REPAIR**

It is recommended that the house be sealed and painted by a water proofing specialist/stucco contractor at this time. It is recommended that all cracks be repaired throughout the exterior of the structure at this time. Any large cracks should be grinded out and retextured. It is pointed out that painting the exterior veneer is typically recommended as needed.

**Obtain Cost Estimate**

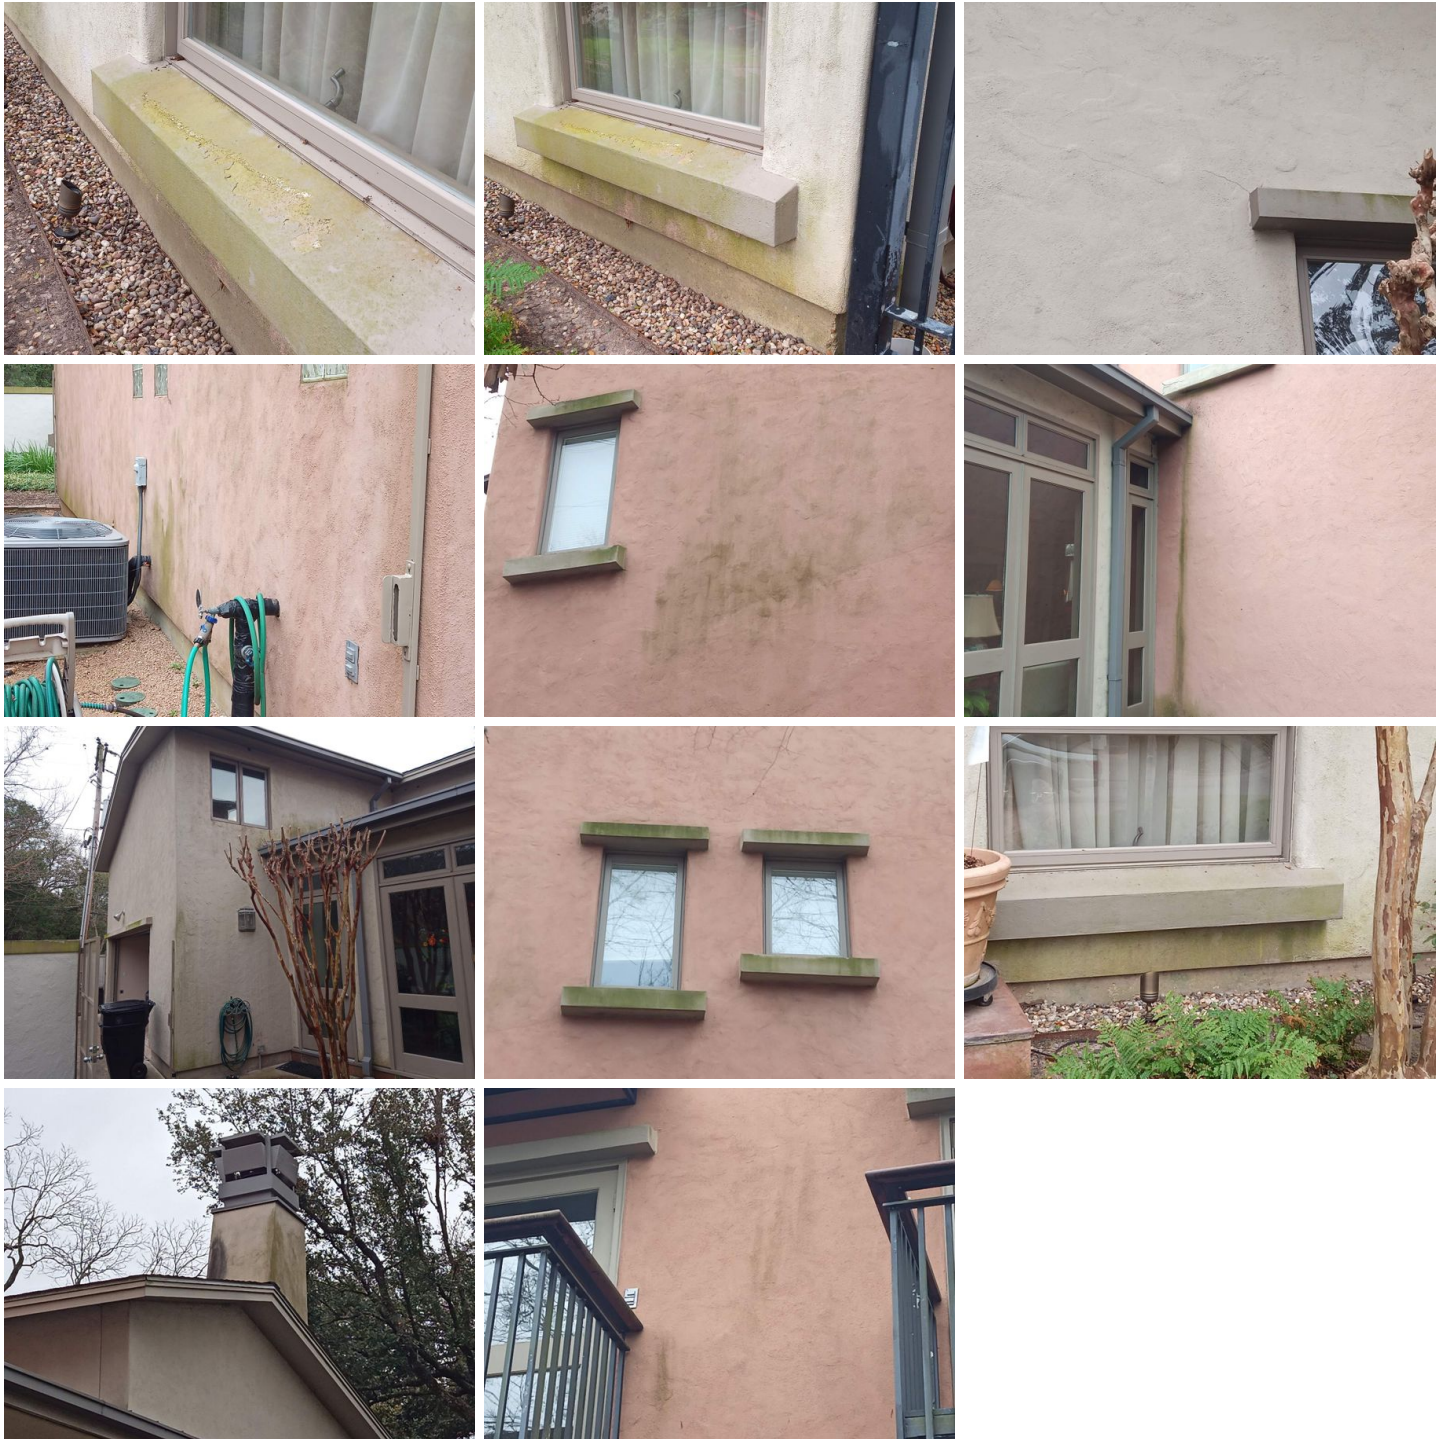
13.6.2 Paint Condition

**MICROBIAL GROWTH PRESENT - EXTENSIVE**

Microbial growth / mildew was observed on the stucco surface at many locations around the house. The substance should be removed and the stucco should be cleaned and painted as necessary.

**Obtain Cost Estimate**

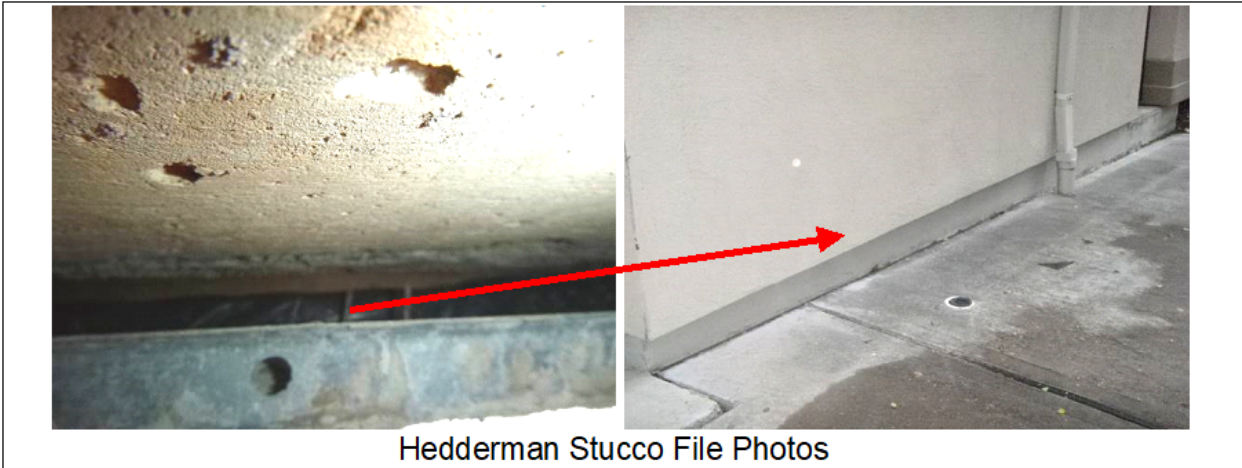
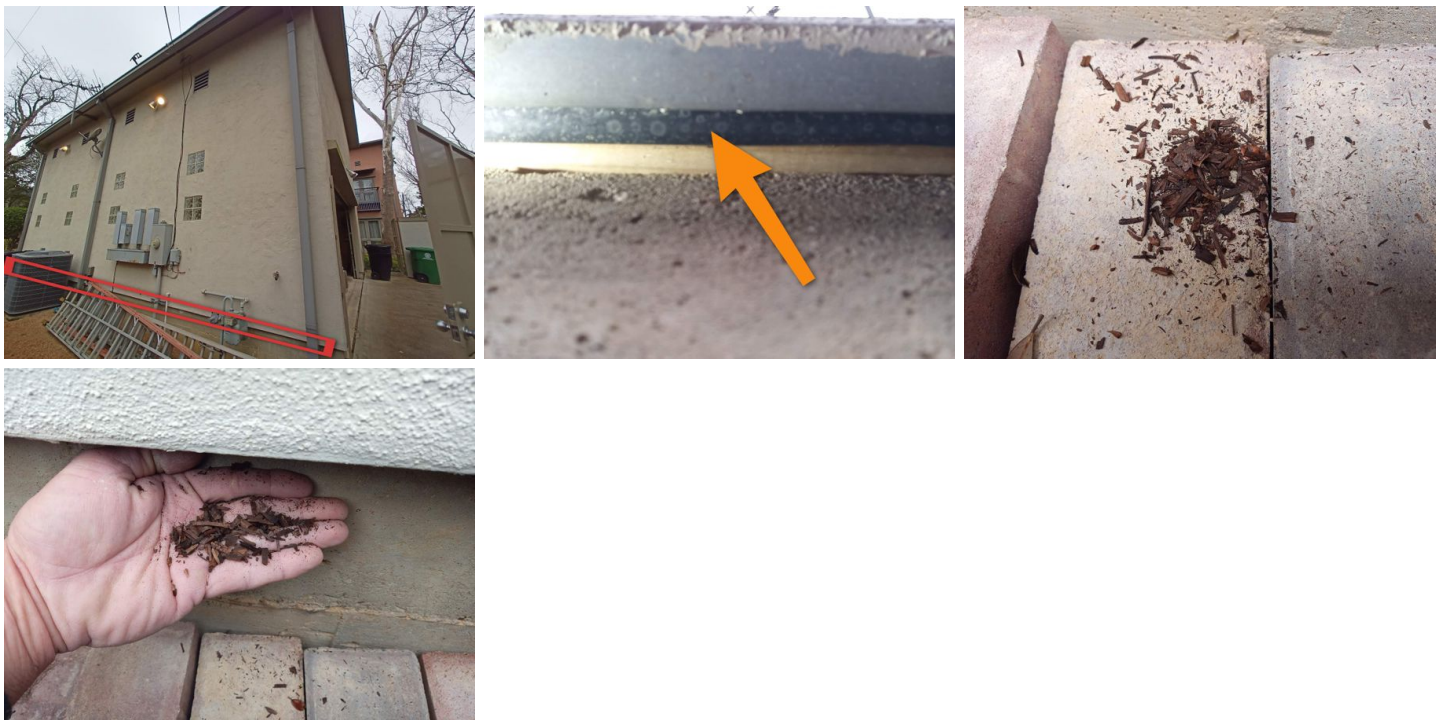
13.7.1 Back-Wrapping

**BACK-WRAPPING PRESENT - SUBSTRATE DAMAGE OBSERVED**

Back wrapping of the vapor barrier material was observed at the bottom of the stucco. Back wrapping can prevent moisture from draining from the bottom of the stucco system, thus leading to water damage at the substrate. It is recommended that the vapor barrier be cut along the bottom of the walls to allow for proper drainage. It is pointed out that damage was observed at several locations around the house where we could reach behind the stucco.

**Obtain Cost Estimate**

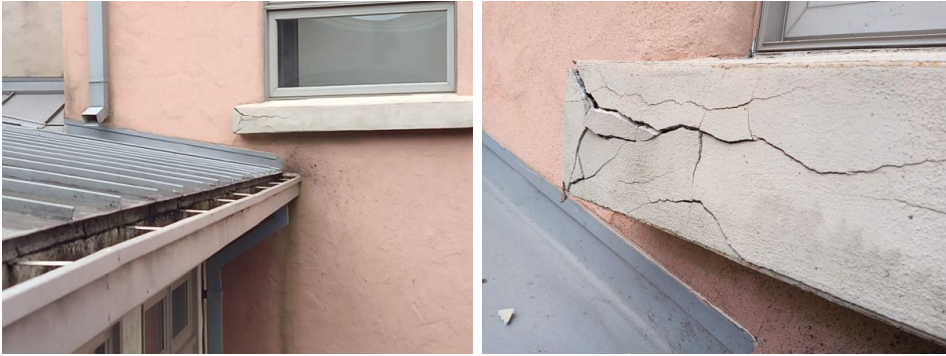
13.8.1 Stucco Damaged

**STUCCO DAMAGED**

The stucco was observed to be damaged and needs to be repaired.

**Obtain cost estimate**
