HEDDERMAN SERVICES

MECHANICAL INSPECTION

1301 Milford St
Houston, TX 77006

PROPERTY INSPECTION REPORT FORM

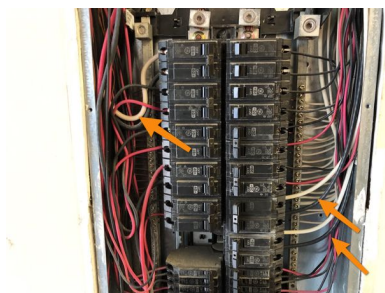
We observed one or more white wires that were used as a power wires, and were connected to a circuit breaker. Typically, the white wires are the grounded/neutral conductors, and if they are used as a power conductor, they must be permanently marked or wrapped with black or red tape to identify them as a “hot” ungrounded conductor.

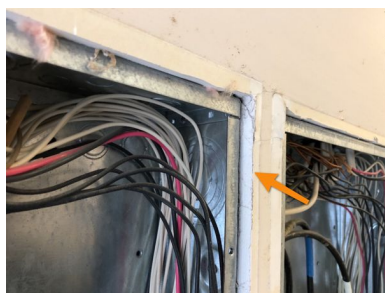
2: Breaker Panel - Not flush with wall

The breaker panel was not flush with the finished surface of the wall as required but was recessed into the wall. Further investigation with an electrician concerning this condition is recommended.

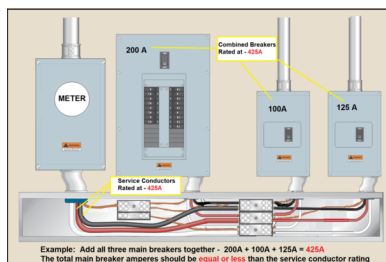
3: Breakers Oversized - A/C condensing unit

The circuit breakers for air conditioning condensing unit was rated higher than the maximum size allowed by the manufacturer of the condensing unit. The breakers should be replaced by the size listed on the manufacturer's nameplates located on the condensing unit.

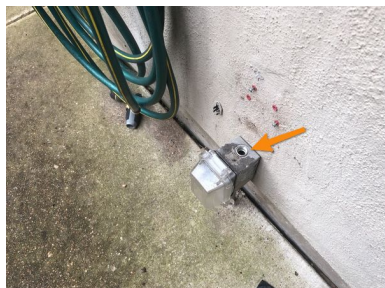
East exterior

An electrical junction box was damaged and/or rusted and the wiring inside was exposed. The damaged components need to be repaired.

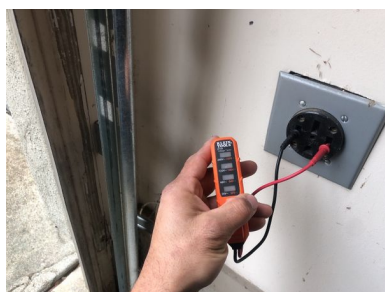
Garage

An outlet was observed that was nonfunctional at the time of the inspection. The reason for the condition was not determined with certainty. Have an electrician find the source of the problem, and make any necessary repairs.

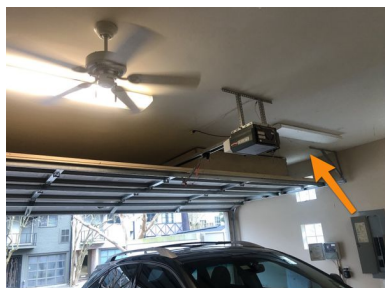
Garage

A light fixture that was non-functional when the switch was on was observed. The problem may be a burned out bulb, defective light fixture, or defective switch.

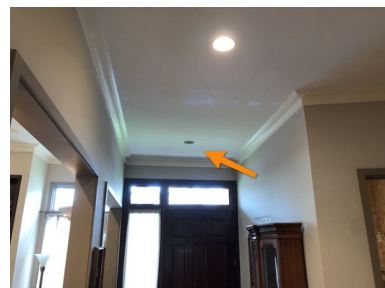
North entry

The doorbell equipment or button was missing.

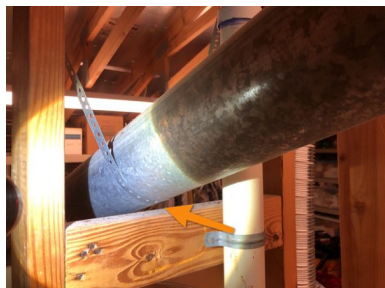
North

Inadequate clearance -

The vent pipe was not installed properly and is in need of repair. It is pointed out that an improperly installed vent pipe is a safety hazard.

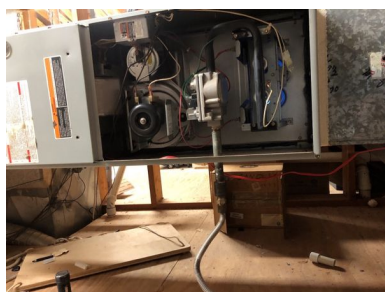
All units

The furnace was hanging by straps, rather than being properly supported from the underside of the furnace. This can be a hazardous condition, should any of the straps break. It is recommended that a service company be contacted to provide positive support under the furnace.

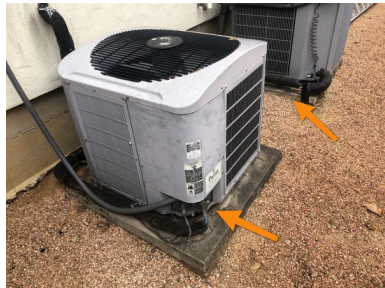
The insulation for the low pressure refrigerant line is partially missing and needs to be replaced to prevent condensation from dripping from the line and to promote proper refrigeration cycling.

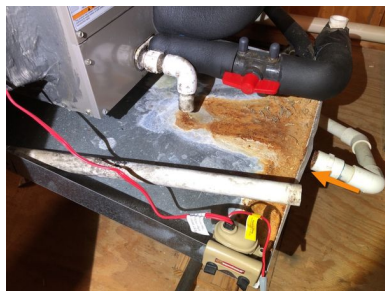
North

Rust was observed in the overflow pan under the coil, apparently due to water backing up at the primary drain line and overflowing into the pan. No water was observed in the overflow pan at the time of the inspection, however since the equipment was only operated for a short time during the inspection, It is recommended that the primary drain line and the coil be checked by an air conditioning service company.

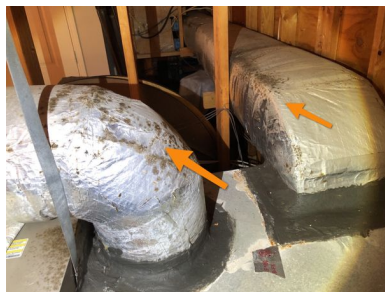
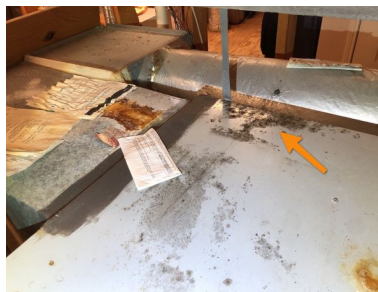
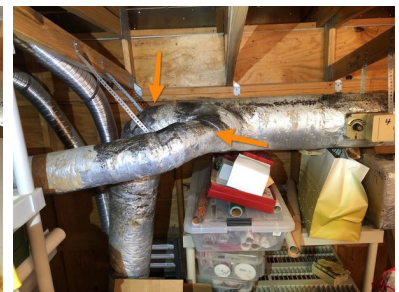
Microbial growth was observed on the outside of the equipment and/or ductwork. This condition is indicative of a moisture/condensation problem, possibly due to air leaks at the equipment and/or a lack of adequate attic ventilation. Further investigation is recommended with a service company to determine the source of the growth and to determine if the growth is present inside the equipment and/or air ducts. It is recommended that you obtain a cost estimate for any needed repairs.

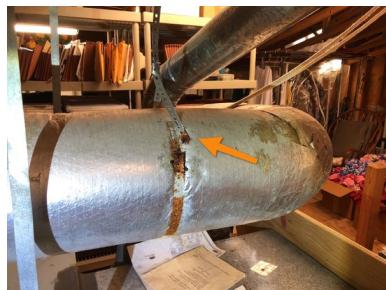
North

The ducts support straps were observed to be damaged . The ducts should be supported in accordance with the manufacturer’s installation instructions, which typically includes hanging the ducts from the rafters supported by 1 ½ inch straps spaced approximately every four feet. Have a service company make the necessary repairs.

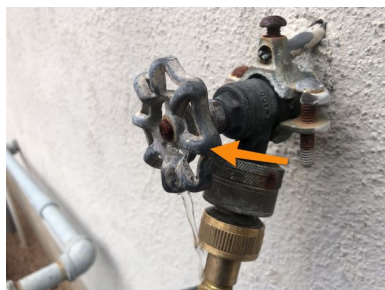
Throughout exterior

A leak was observed at a hose bibb around the valve stem.

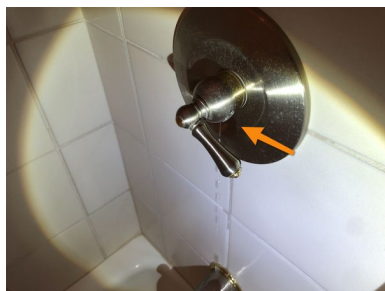
2nd Floor North West Bathroom

The water valve was leaking around the valve stem at a faucet.

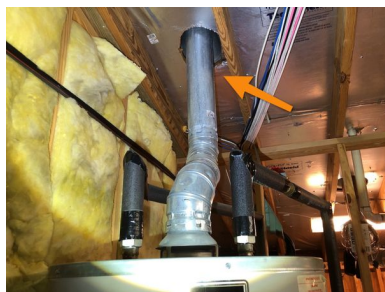
Support straps missing -

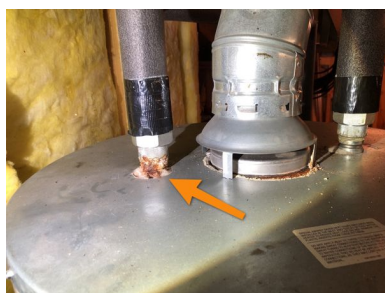
The piping at the top of the water heater was severely corroded at the fittings and is in need of repair.

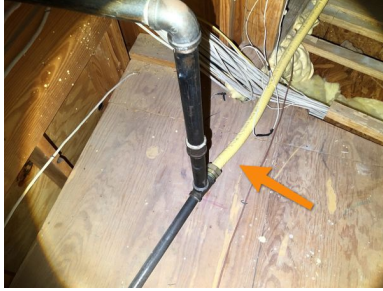
Corrugated stainless steel tubing (CSST) was installed at the gas distribution piping system. The CSST piping did not appear to be electrically bonded properly on one or both ends of the piping. CSST piping is required to be electrically bonded to help prevent the piping from incurring damage, possibly leading to a fire, should an electrical arc or lightning strike occur. It is recommended that a plumber be contacted for

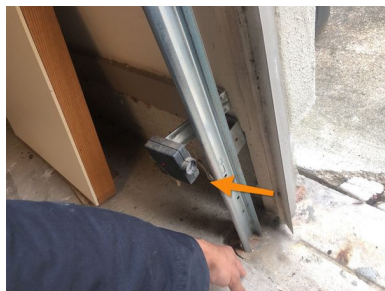
The infrared device was located too high on the garage door, and should be located no more than six inches above the floor. It is recommended that the device be lowered.
