## STRUCTURAL INSPECTION

1301 Milford St  
Houston, TX 77006

KRAUSE MANAGEMENT TRUST c/o Greg Krause

MARCH 7, 2022

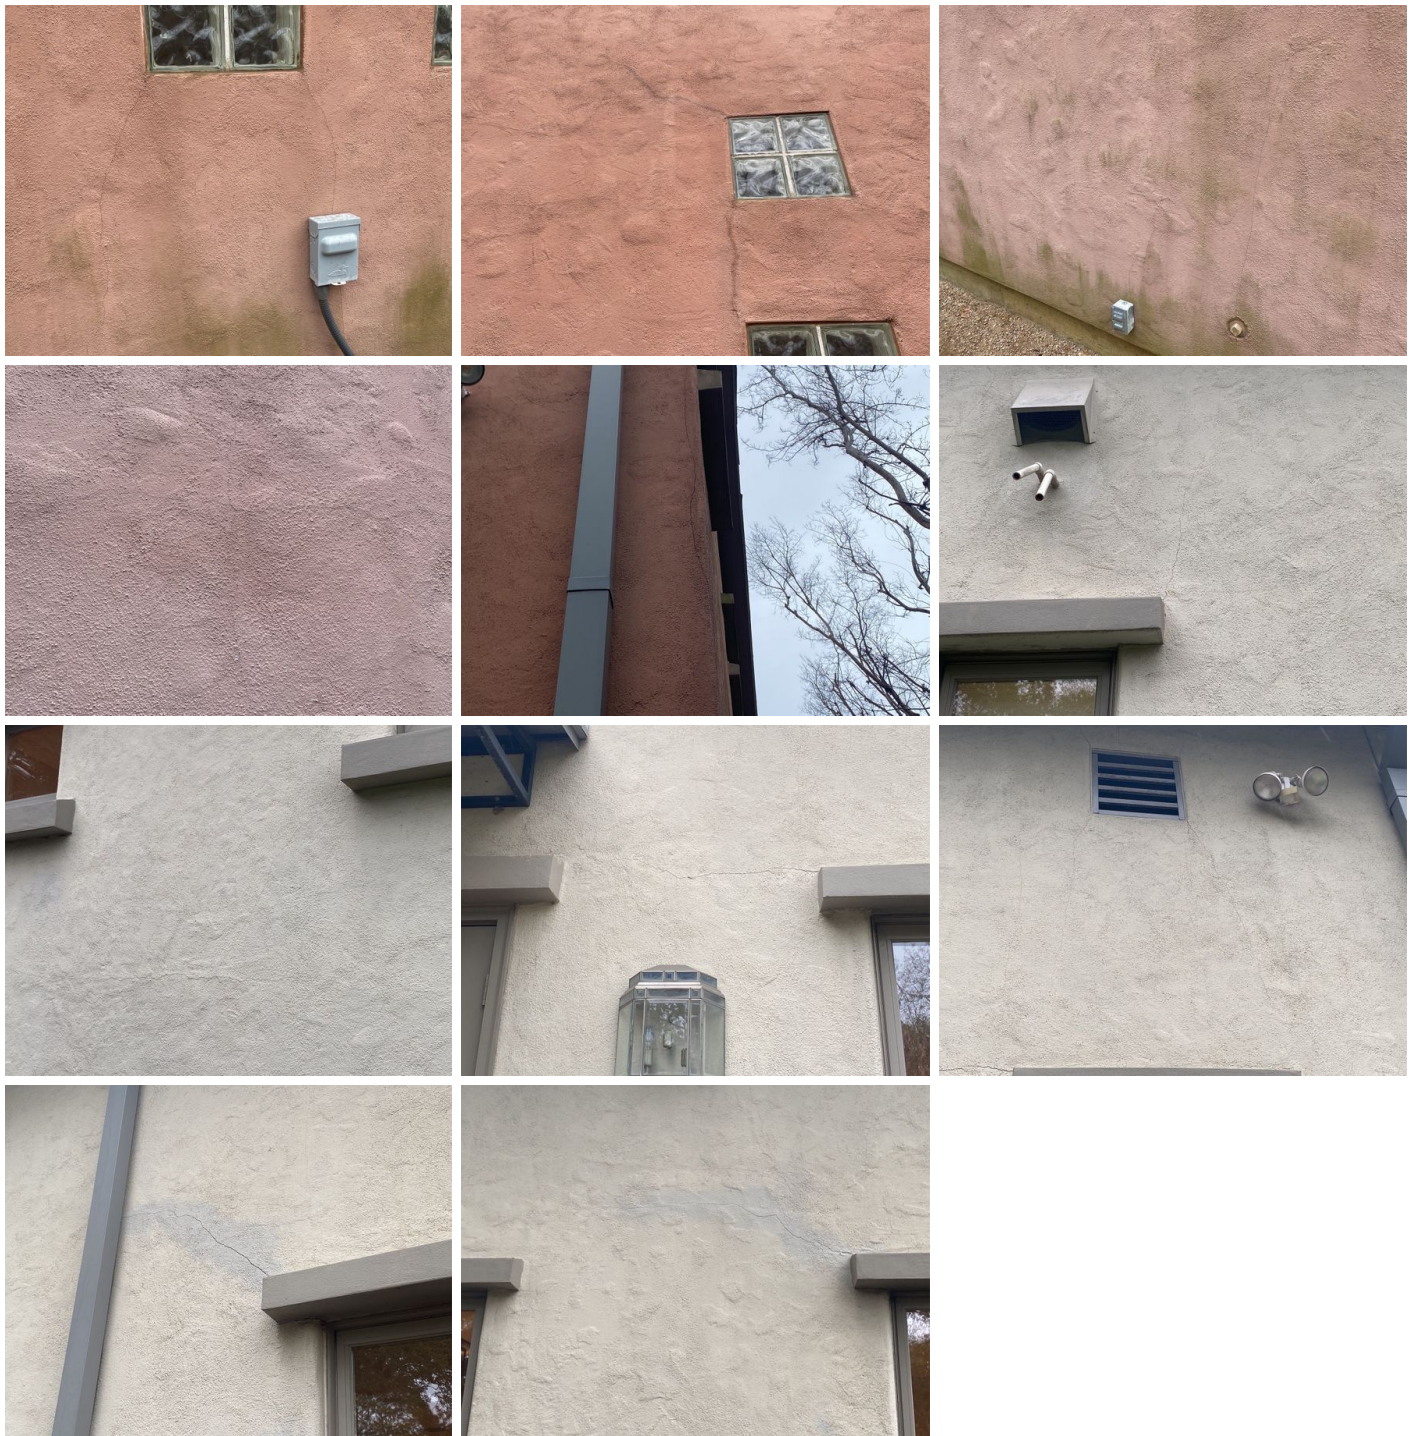
**Veneer - Stucco Cracks-OK**

Cracks and/or patches were observed in the exterior stucco veneer at the time of the inspection, including at the above locations. It appears that the cracks are related to the normal drying/shrinking/cracking of a cementuous

**All cracks have been repaired.**

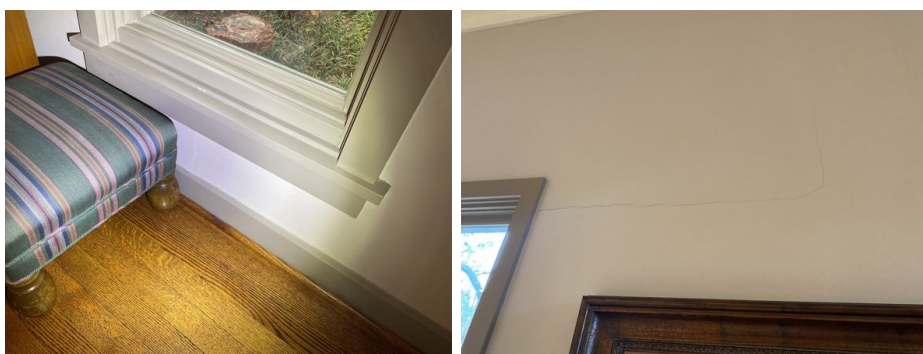
Living Room

**Sheetrock Cracks/Patches/Compression ridges**

Sheetrock cracks, patches, and/or compression ridges were observed in the house during the inspection, including at the specified locations. It is recommended that the cracks be repaired for cosmetic purposes.

**All cracks repaired.**

**Obtain Cost Estimate**

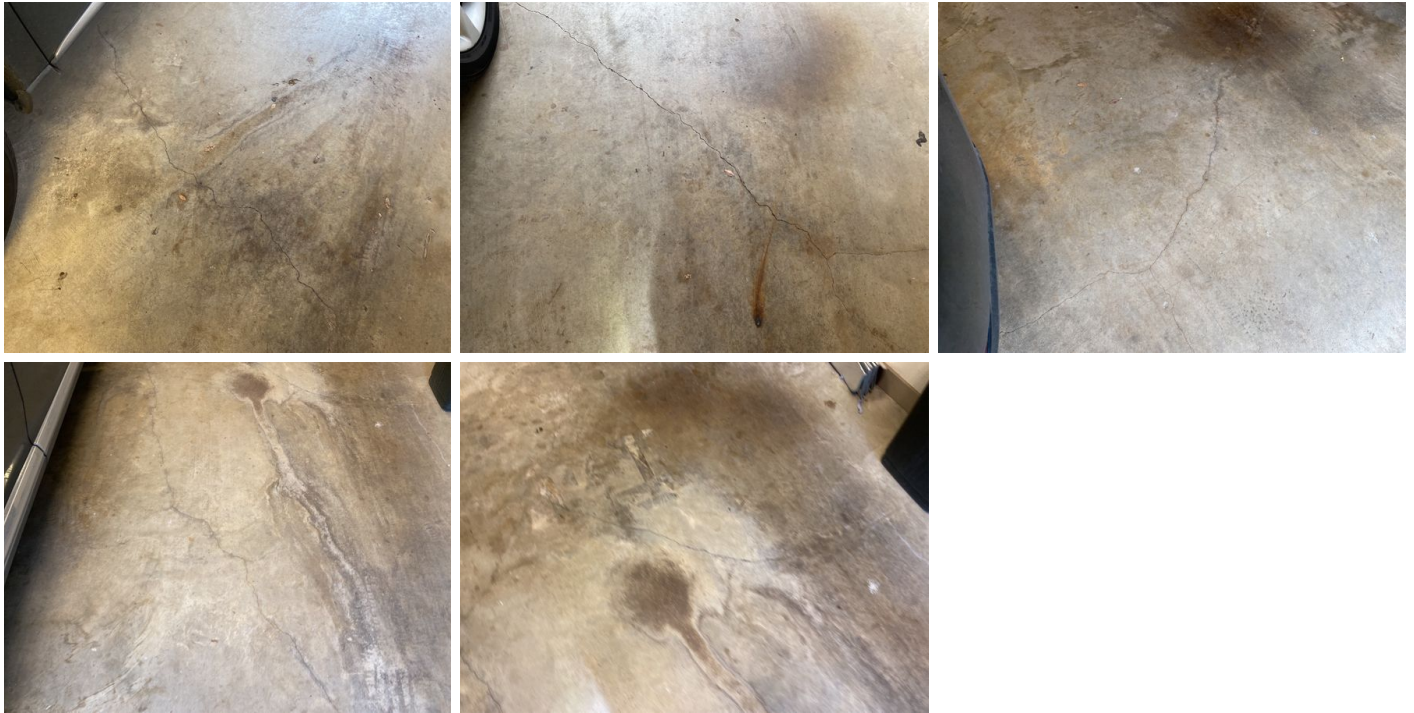
**Concrete Cracks - Garage**

Cracking of the foundation concrete exists in virtually all foundations. It is pointed out that cracking is a normal property of concrete and other brittle materials, and Hedderman Engineering, Inc. assumes no responsibility should cracks be found that are not mentioned in this report. Some cracking was observed in this concrete foundation, including at the garage floor.

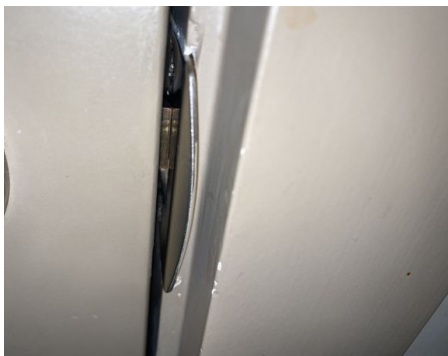
Utility Room

**Separation of Materials: Non latching doors**

Doors that would not latch due to misalignment of the striker plate and the locking mechanism were observed.

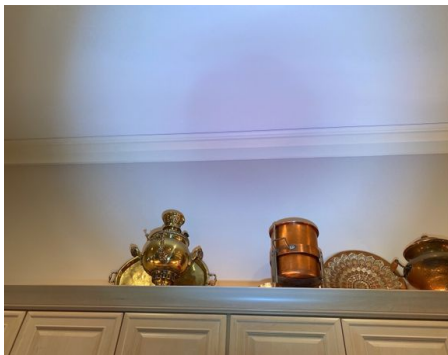
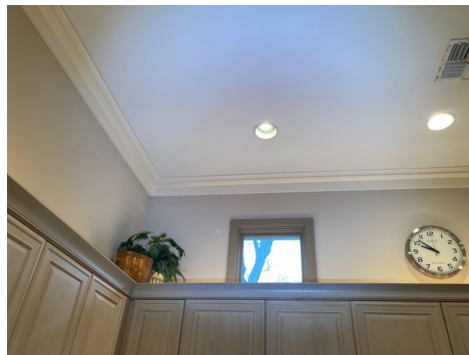
Kitchen

**Separation of Materials: Crown molding separation**

The crown molding was observed to be separated at the ceiling which is typically related to movement in the house.

**Crown molding has been repaired.**

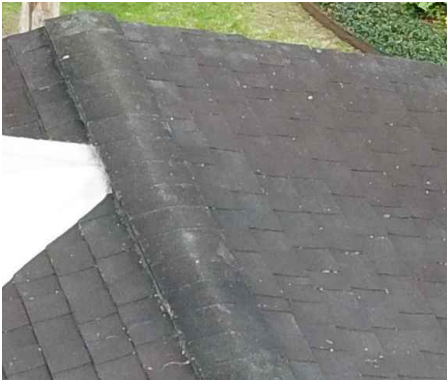
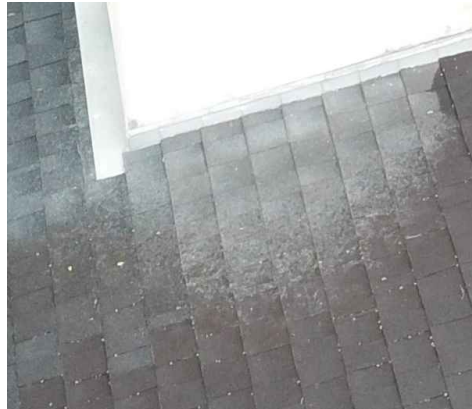
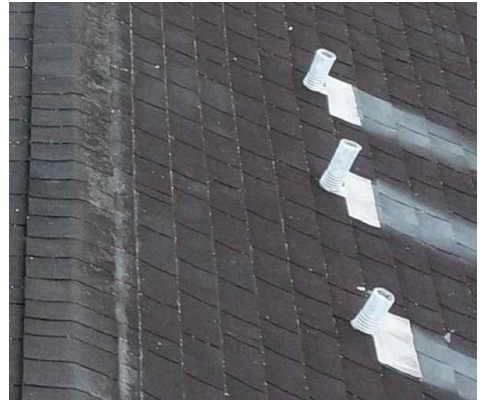
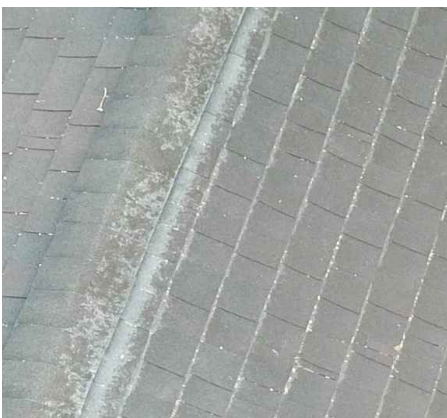
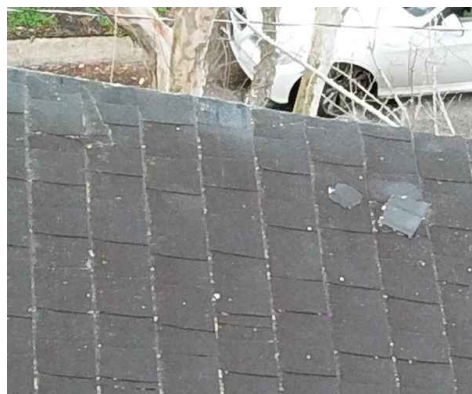
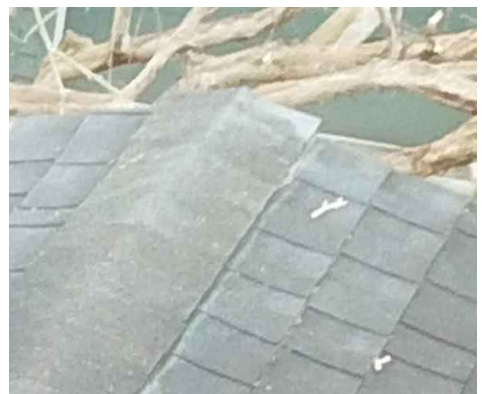
**Wear and Deterioration: Composition - Advanced**

Discolored, Aggregate Missing, Broken Corners/Tabs, Shingle Loose/Missing, Deteriorated Ridge Shingles

The composition roof surface was showing evidences of advanced deterioration of the roof surface as described above and shown below.

**New roof June 2022.**

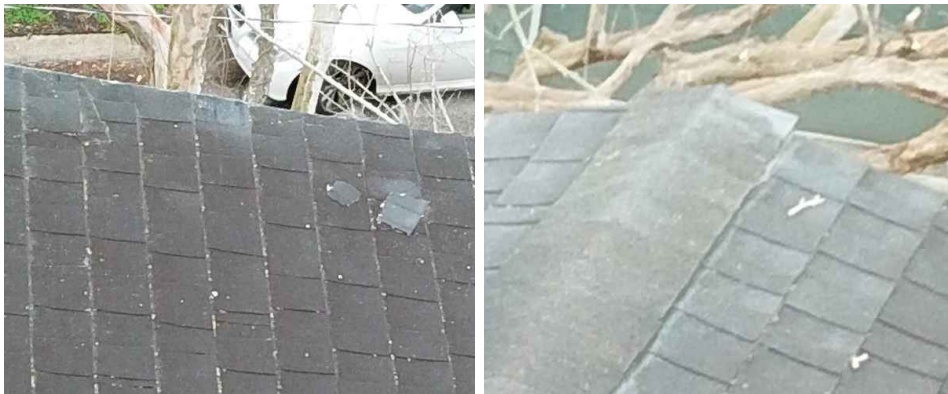
### SHINGLES DAMAGED

Shingles were observed to be damaged and the roof is in need of repair. Contact a roofing contractor to obtain a cost estimate for repairs.

**JUST SERVICEABLE CONDITION - REPLACE IN APPROXIMATELY 1-2 YEARS**

After observing the condition of the roof surface, it is my opinion that the roof surface appears to be in just serviceable condition at this time and has only a little life remaining, with some repairs needed at this time. Have a roofing contractor provide a cost estimate to make all necessary repairs to bring the roof into a completely serviceable condition.

**Obtain Cost Estimate**

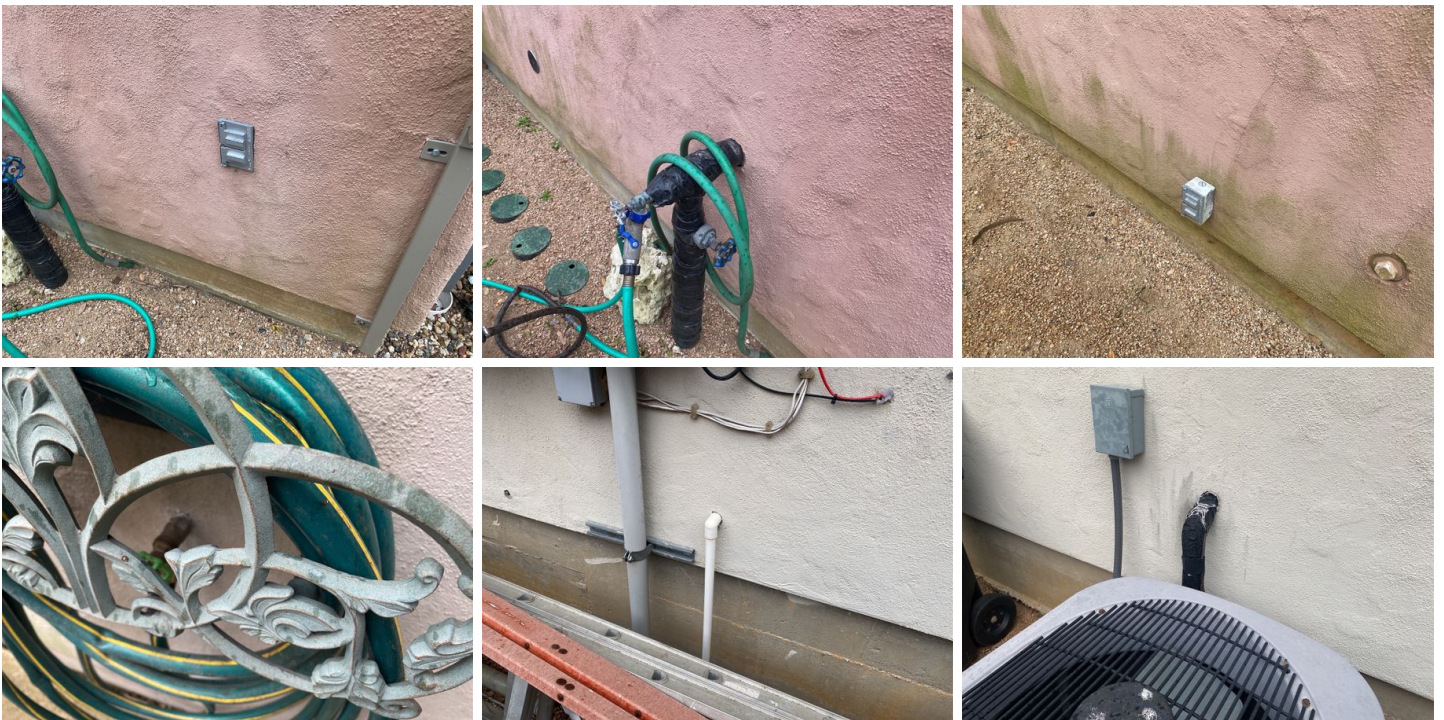
A substantial vulnerability to water penetration was observed at penetrations/openings through the exterior building envelope, and it is recommended that all penetrations/openings be sealed against water penetration. Typical examples on a structure may include light fixtures, air conditioning refrigerant lines, water piping, gas piping, vent caps, windows, doors, expansion joints, etc. Below is a representative sample of locations and/or photographs showing some, but not necessarily all, locations where there is a vulnerability to water penetration. Have a contractor provide a cost estimate to seal all vulnerable areas on the exterior building envelope against water penetration and/or open up any clogged weepholes in the veneer.

**Obtain Cost Estimate**

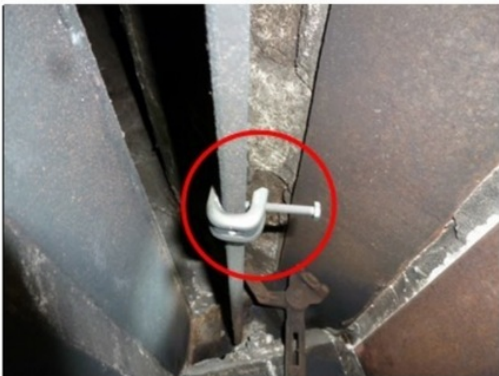
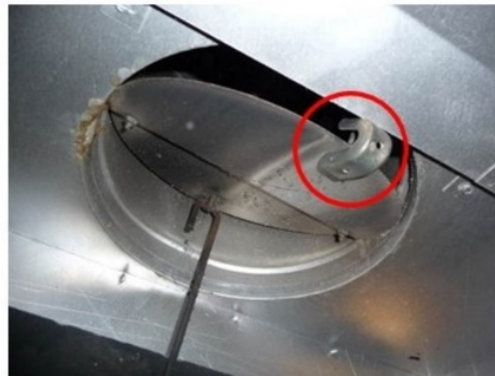
#### **DAMPER C CLAMP MISSING**

The fireplace was equipped with a ceramic gas log. The smoke chamber and flue pipe were free from built-up soot, the damper was operational, and the firebox was properly sealed. While the draw of the chimney was not able to be checked, no evidences of poor draw were visible, and no repairs were needed to the fireplace. It is pointed out that the damper was not equipped with a spacer device to prevent the damper from closing completely. This device keeps the damper open slightly, even when it is in the closed position, to prevent combustion gases from building up in the living space should the gas log be operated when the damper is closed. It is recommended that the clamp be installed for safety purposes.

**Obtain Cost Estimate**

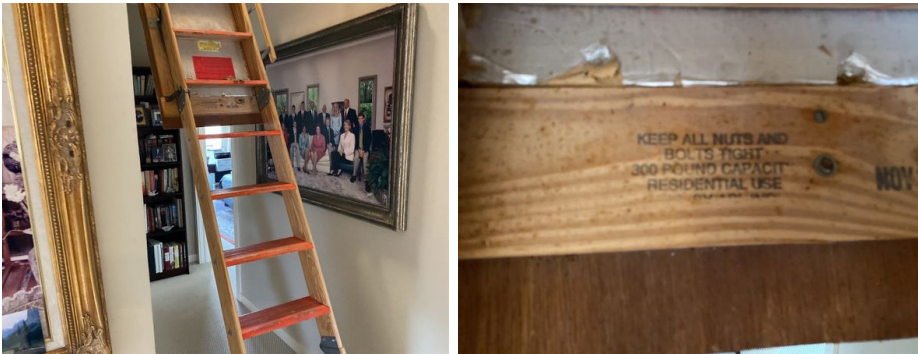
##### Ladder: Ladder - 300 Lb. rating

The rated capacity of the access ladder into the attic is 300 pounds. The ladder does not meet current code requirements for ladders into attics. Consideration should be given to replacing the ladder with a ladder that meets current code requirements.

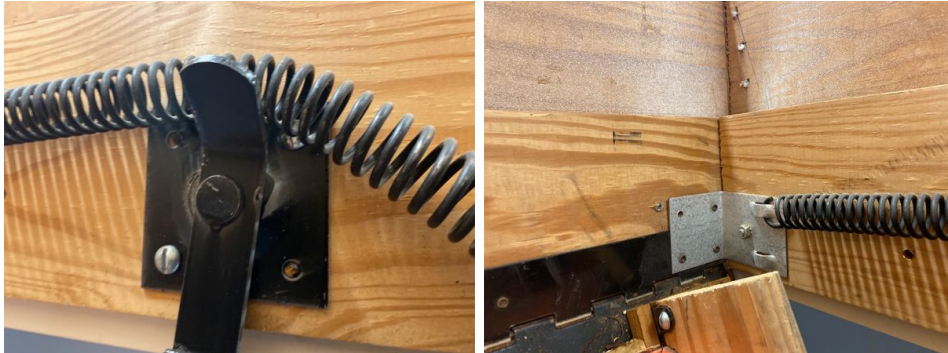
### LADDER ATTACHMENT IMPROPER

Nail(s) missing in spring arm pivot(s), Nail(s) missing in corner bracket(s)

The stair assembly was not properly installed or secured to the framing members, and repair is needed for safety purposes. The condition(s) can be a safety hazard, and repair is needed, as an improperly installed stair assembly can possibly collapse.

**Obtain Cost Estimate**

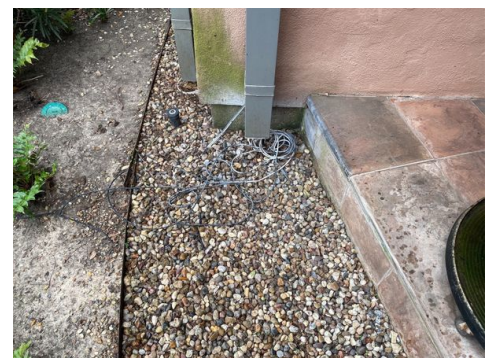
The downspout was missing a splash block.

**Obtain Cost Estimate**

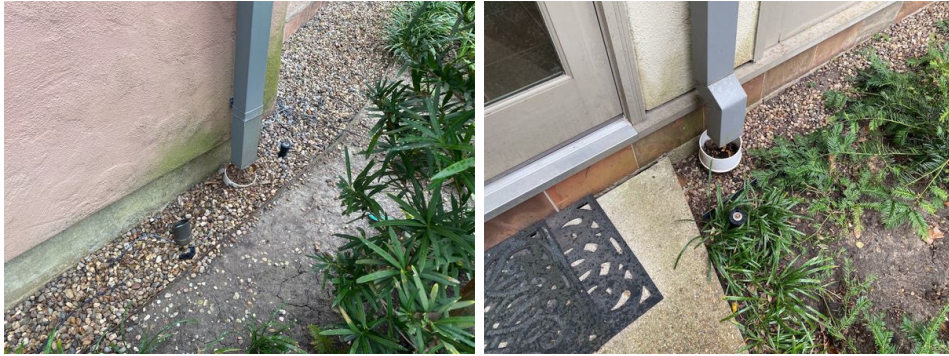
**DS DRAIN CLOGGED**

The drain to the downspout was clogged and in need of repair.

**Obtain Cost Estimate**

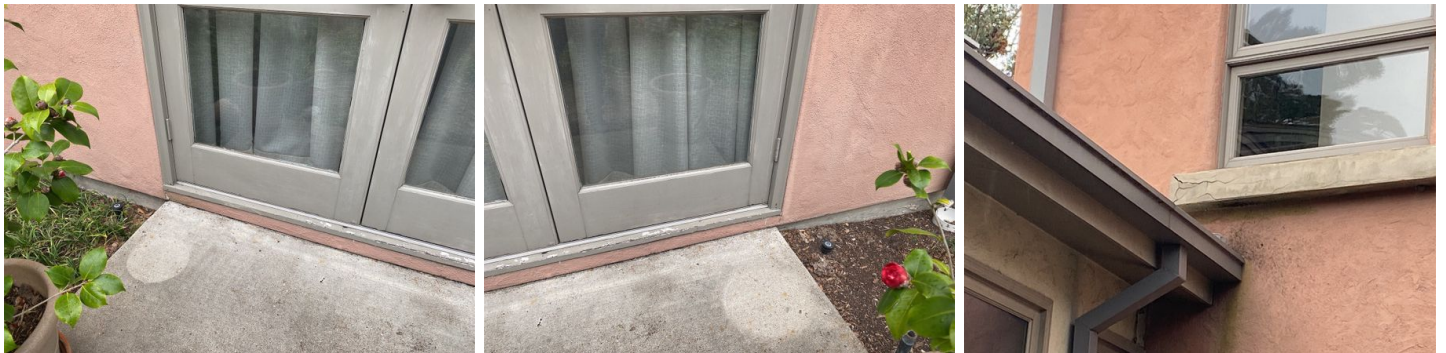
**WOOD ROT**

We observed evidences of wood rot and it is recommended that all rotted wood be replaced. Have a contractor provide a cost estimate to determine the entire scope of the wood rot, and provide a cost estimate to replace all rotted wood in the house.

**All areas of wood rot have been repaired.**

**Obtain Cost Estimate**

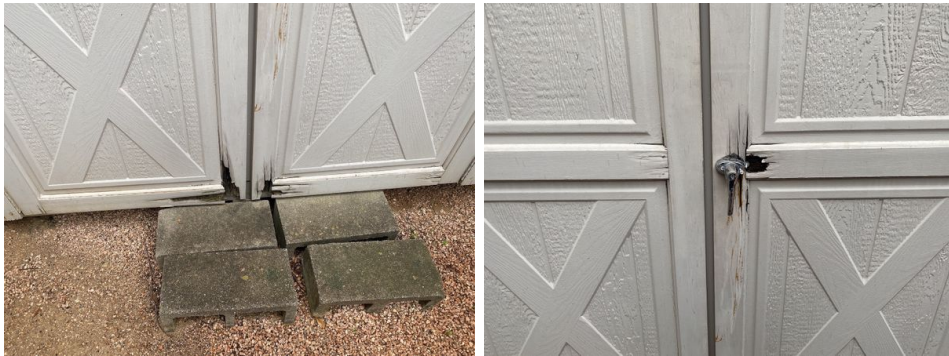
**SHED**

The shed was in need of some repairs.

**Obtain Cost Estimate**

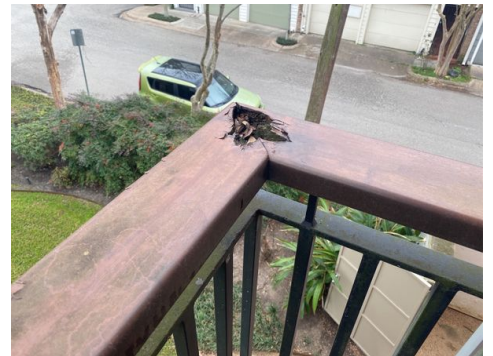
**WOOD RAILING - REPAIR**

The wood guardrail was damaged at the balcony and is in need of repair. Further investigation with a service company is recommended to obtain a cost estimate for all needed repairs.

**Obtain Cost Estimate**

**Wood railings have been repaired.**

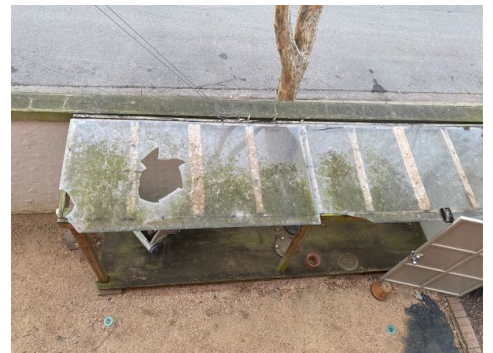
**GREENHOUSE ROOF DAMAGED**

The greenhouse roof was observed to be damaged and needs to be repaired.

**Obtain Cost Estimate**

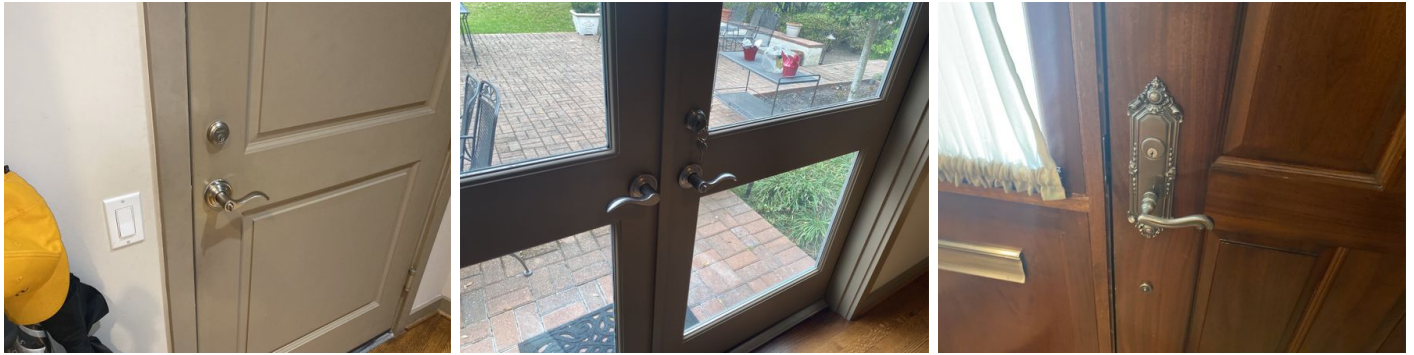
We observed exterior doors that were equipped with keyed deadbolts, rather than thumbed deadbolts. In case of emergency, you would have to find a key to unlock the door, which could be hazardous. It is recommended that the keyed deadbolts be replaced with thumbed deadbolts. It is pointed out for informational purposes that current code requirements prohibit the use of keyed deadbolts.

**R311.4.4**

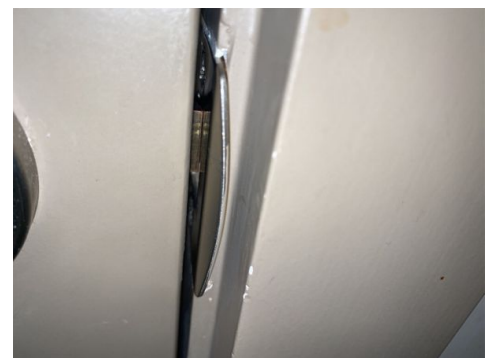
Utility Room

We observed non-latching doors that were in need of adjustment to the striker plate on the door frame.

**Obtain Cost Estimate**

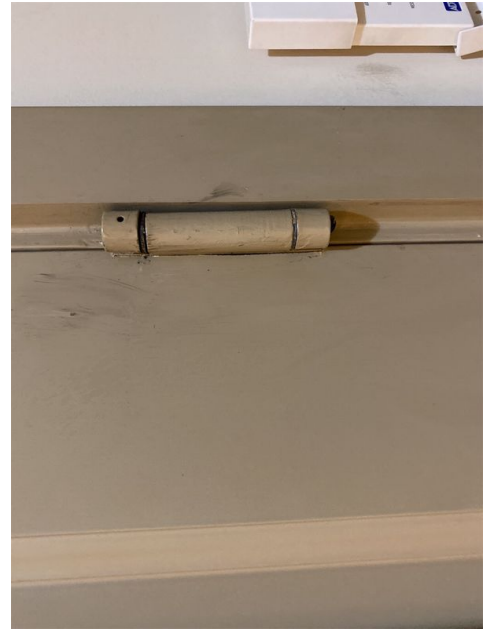
The self-closing hinges on the door to the garage were non-functional, and need to be repaired. Contact a service company to make the needed repairs.

**R302.5.1**

**Obtain Cost Estimate**

**This has been repaired.**

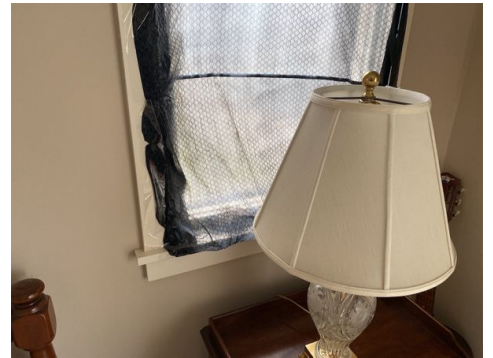
North West Bedroom

**CASEMENT - INOPERABLE DUE TO WOOD ROT**

The casement window was inoperable due to wood rot and needs to be replaced.

**Obtain Cost Estimate**

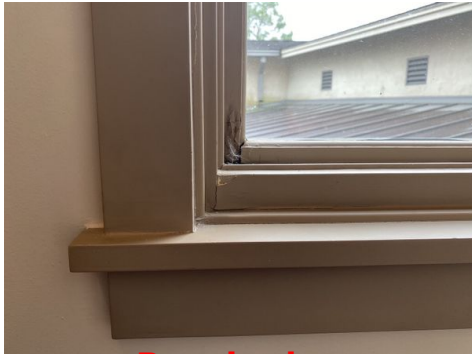
Stairwell **Repaired**

Wood rot was observed and it is recommended that the damaged wood be replaced. It is pointed out that additional damage could be present under the rotted material that will not be visible until the outer rotted materials are removed. Have a service company determine the entire scope of wood rot throughout the house, and provide a cost estimate to replace all rotted wood, including at the above locations.

**Obtain Cost Estimate**

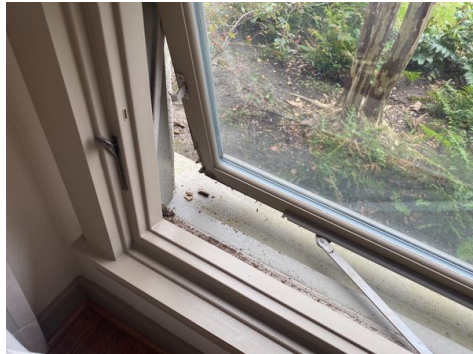
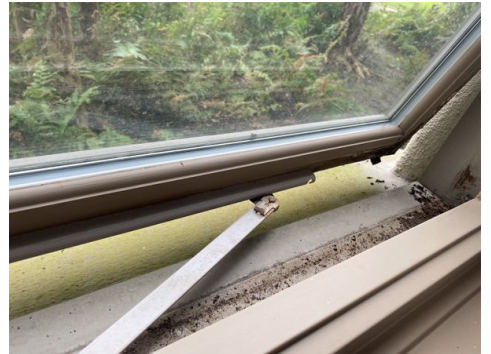
Living Room

**Living room wood rot repaired  
but window is NOT OPERABLE.**
