Wood Destroying Insect Report

Inspection Performed by Andrew Dabbs TPCL #0828555 3/7/2022

1301 Milford St

TEXAS OFFICIAL WOOD DESTROYING INSECT REPORT

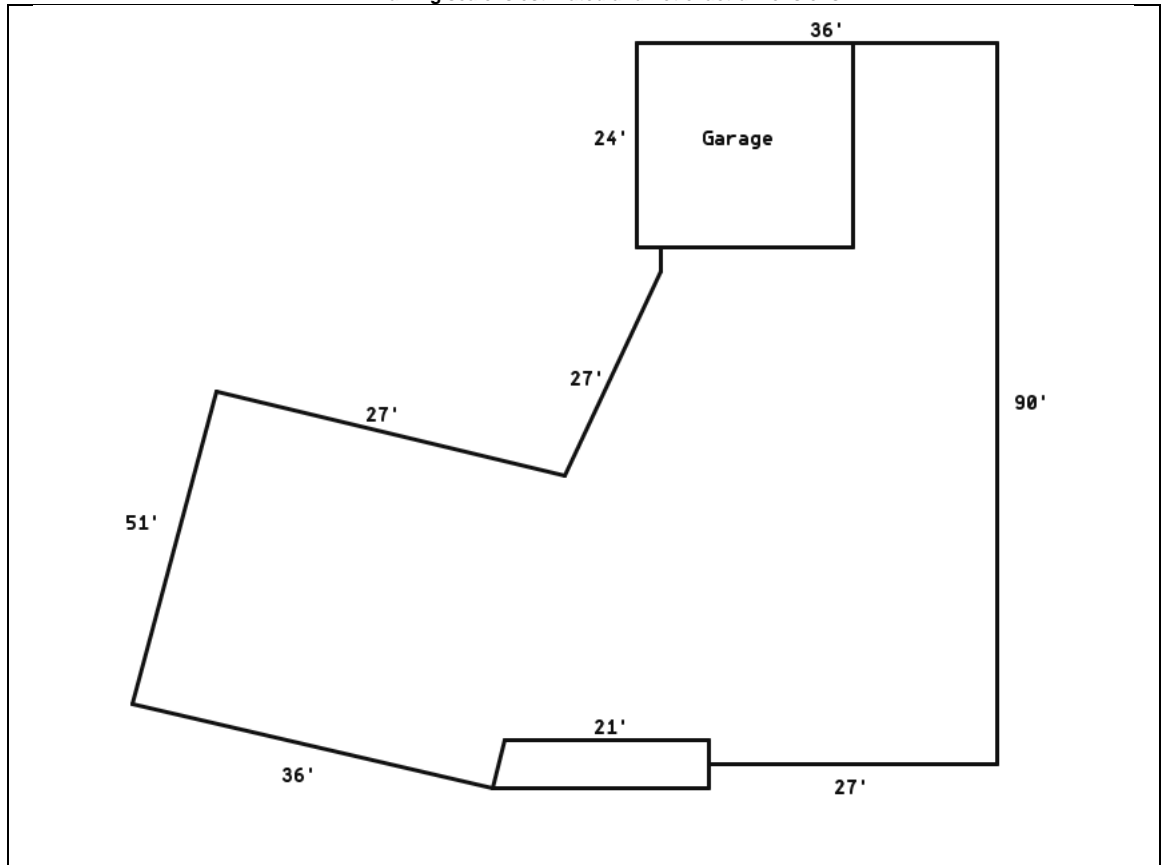
Diagram of Structure(s) Inspected

Additional Comments: **Bait stations for subterranean termites were present in the yard. Further investigation is recommended to determine if a contract is active with a pest control company.**

Conducive conditions obstruct visibility and limit the inspection for wood destroying insects. It is recommended that all conducive conditions be corrected and the obstructed areas be reinspected once the work is complete.

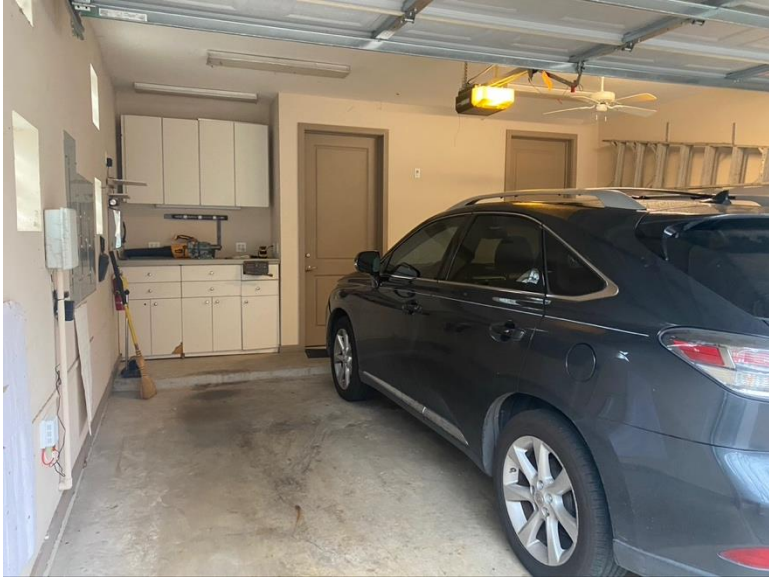
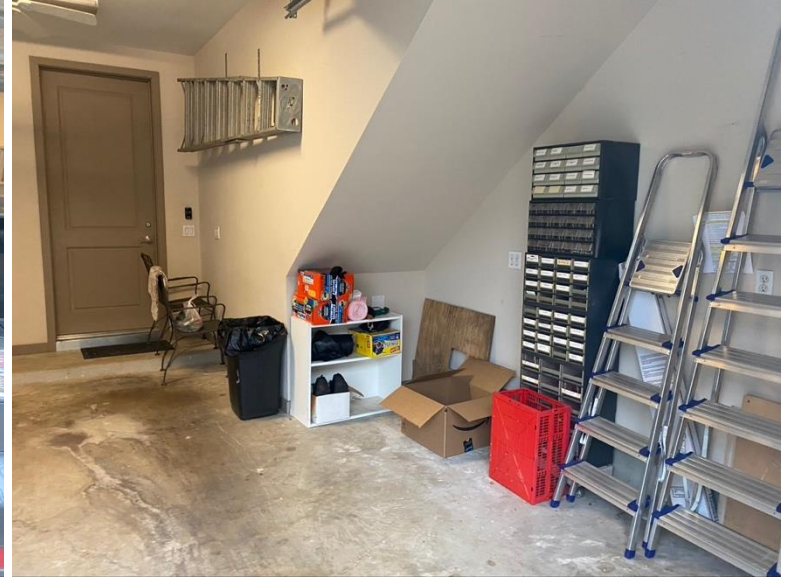
Obstructed view in the garage.

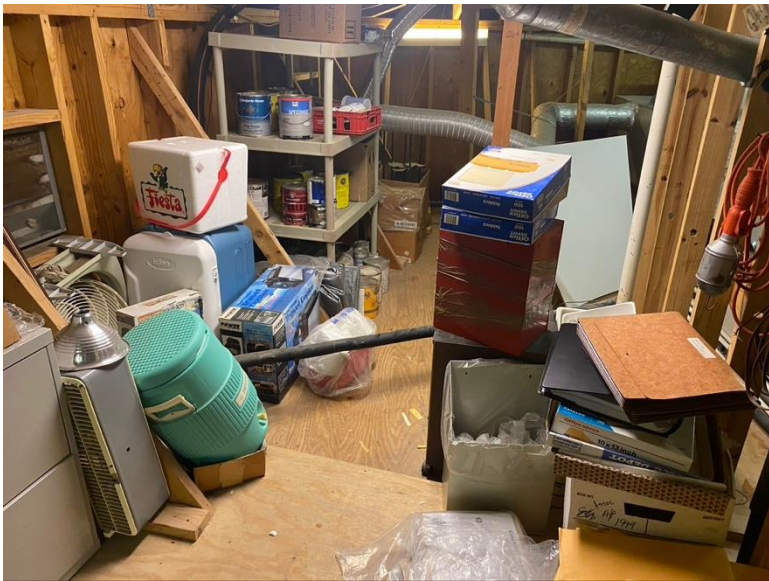
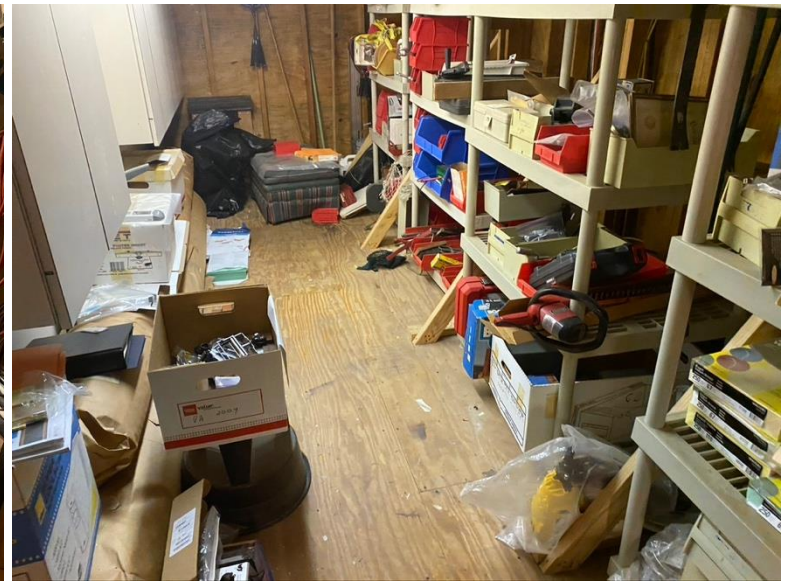
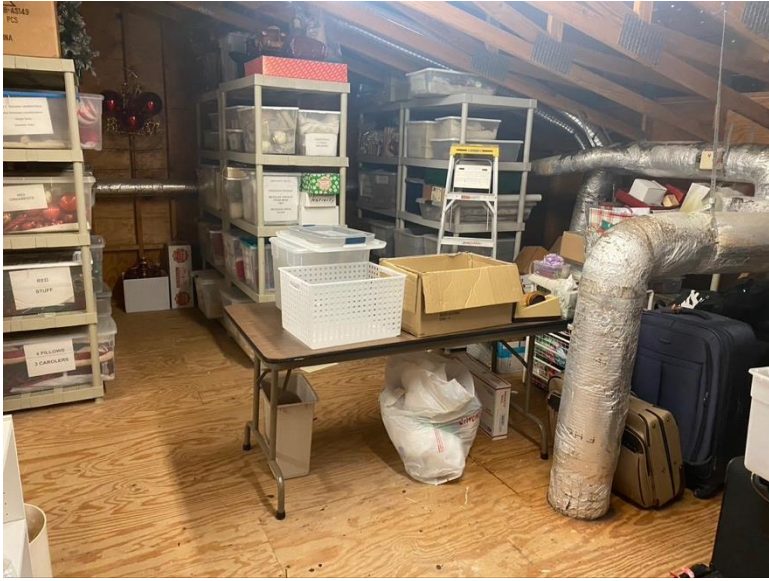
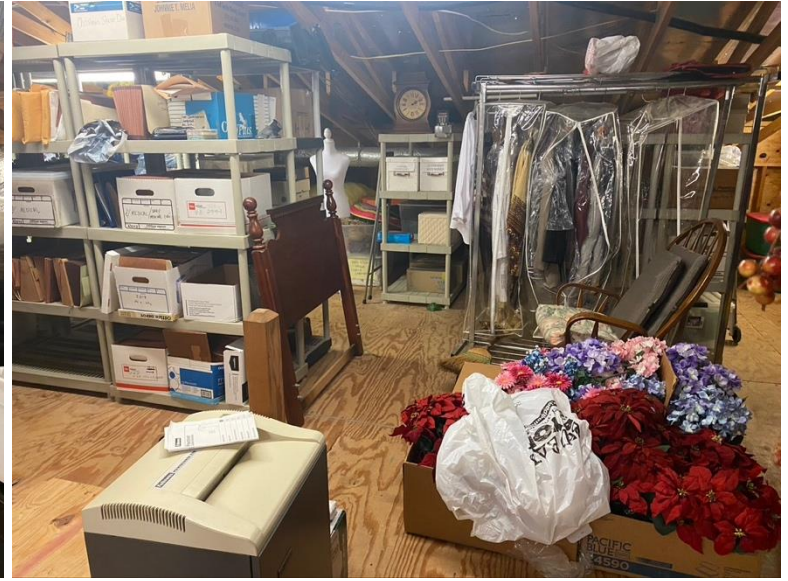
Obstructed view in the attic.

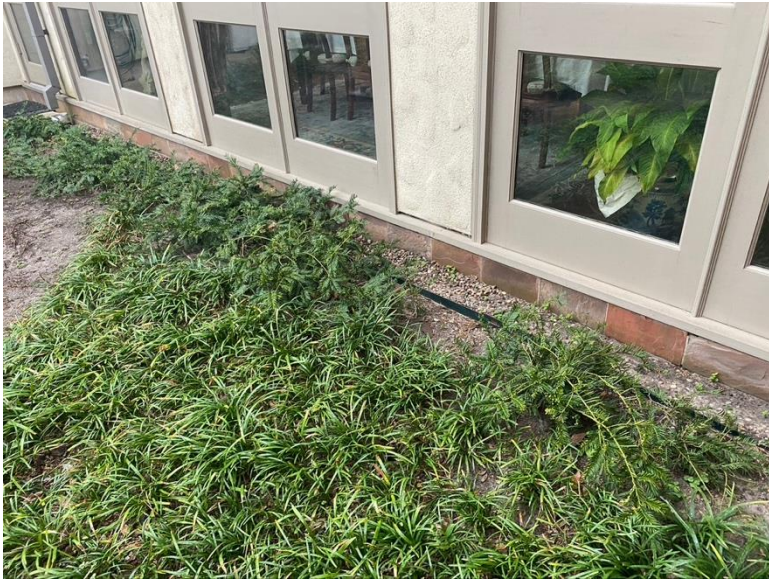
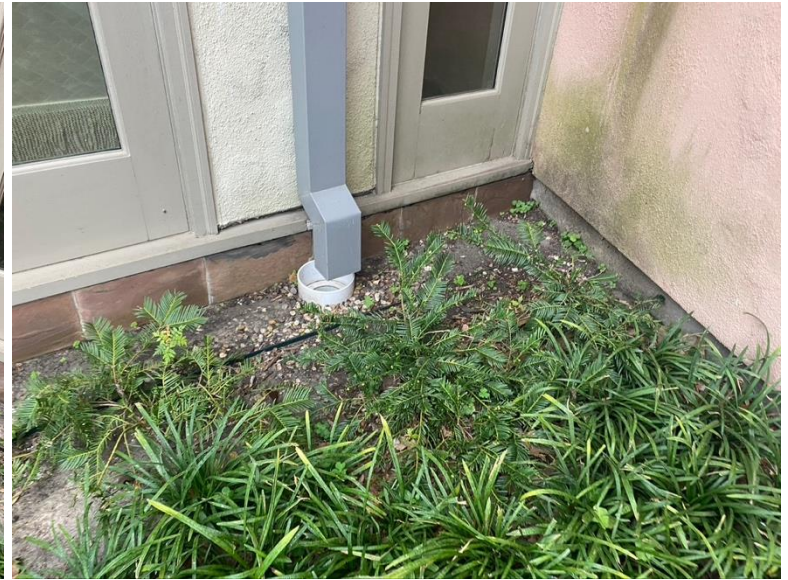
Obstructed view of the foundation.

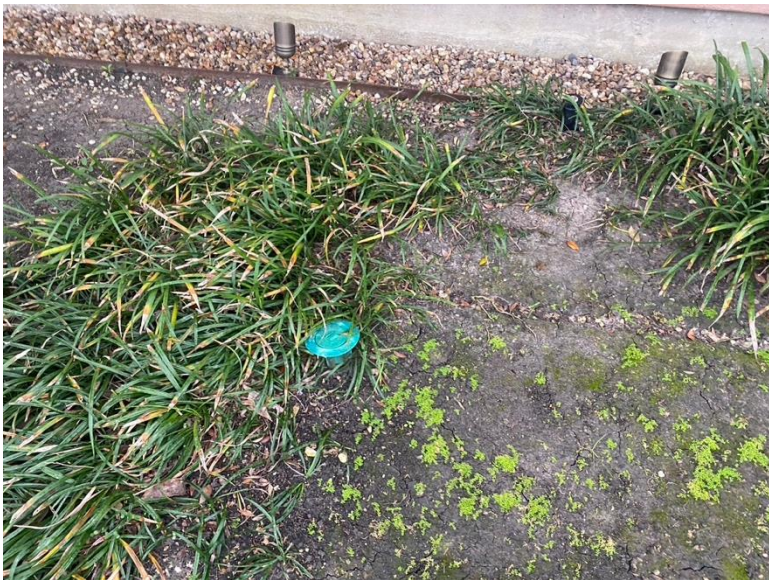
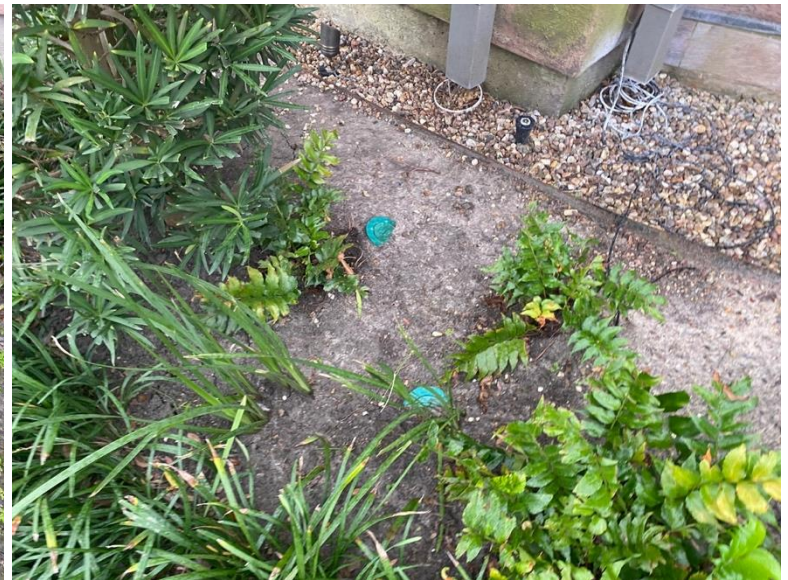
Bait stations present in yard. Further investigation recommended to determine if contract is active with pest company.

Bait stations observed around the structure.
