18615 Sweetjasmine Ln  
Spring, TX 77379  
Matt & Jenny Sneller

## PROPERTY INSPECTION REPORT

**Concerning:** 18615 Sweetjasmine Ln, Spring, TX 77379  
(Address or Other Identification of Inspected Property)

**By:** Mathew Blossom, Lic #21230 11/29/2021  
(Name and License Number of Inspector) (Date)

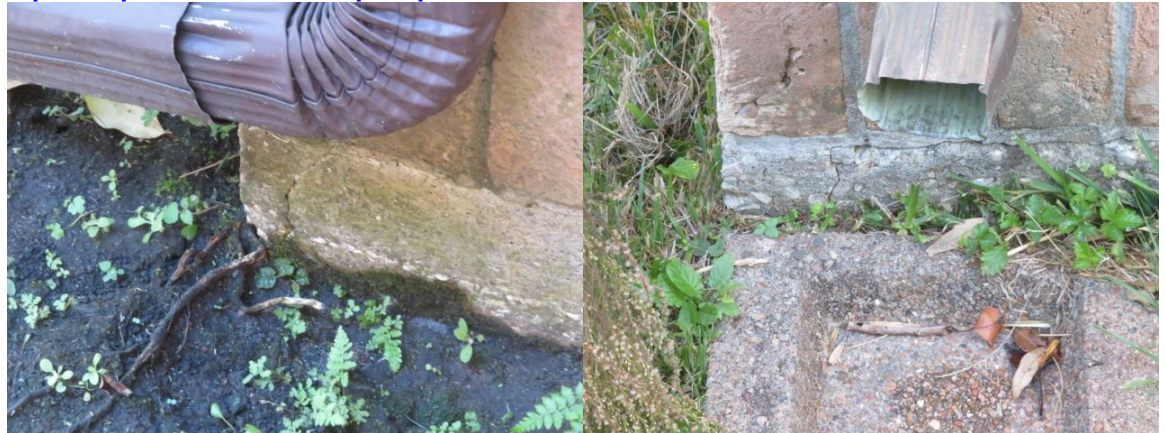
**There are cracks at the corners of the foundation. Corner cracks are commonly found on slab foundations. They are generally cosmetic in nature, however, they may require minor repair to prevent water and pest penetration.**

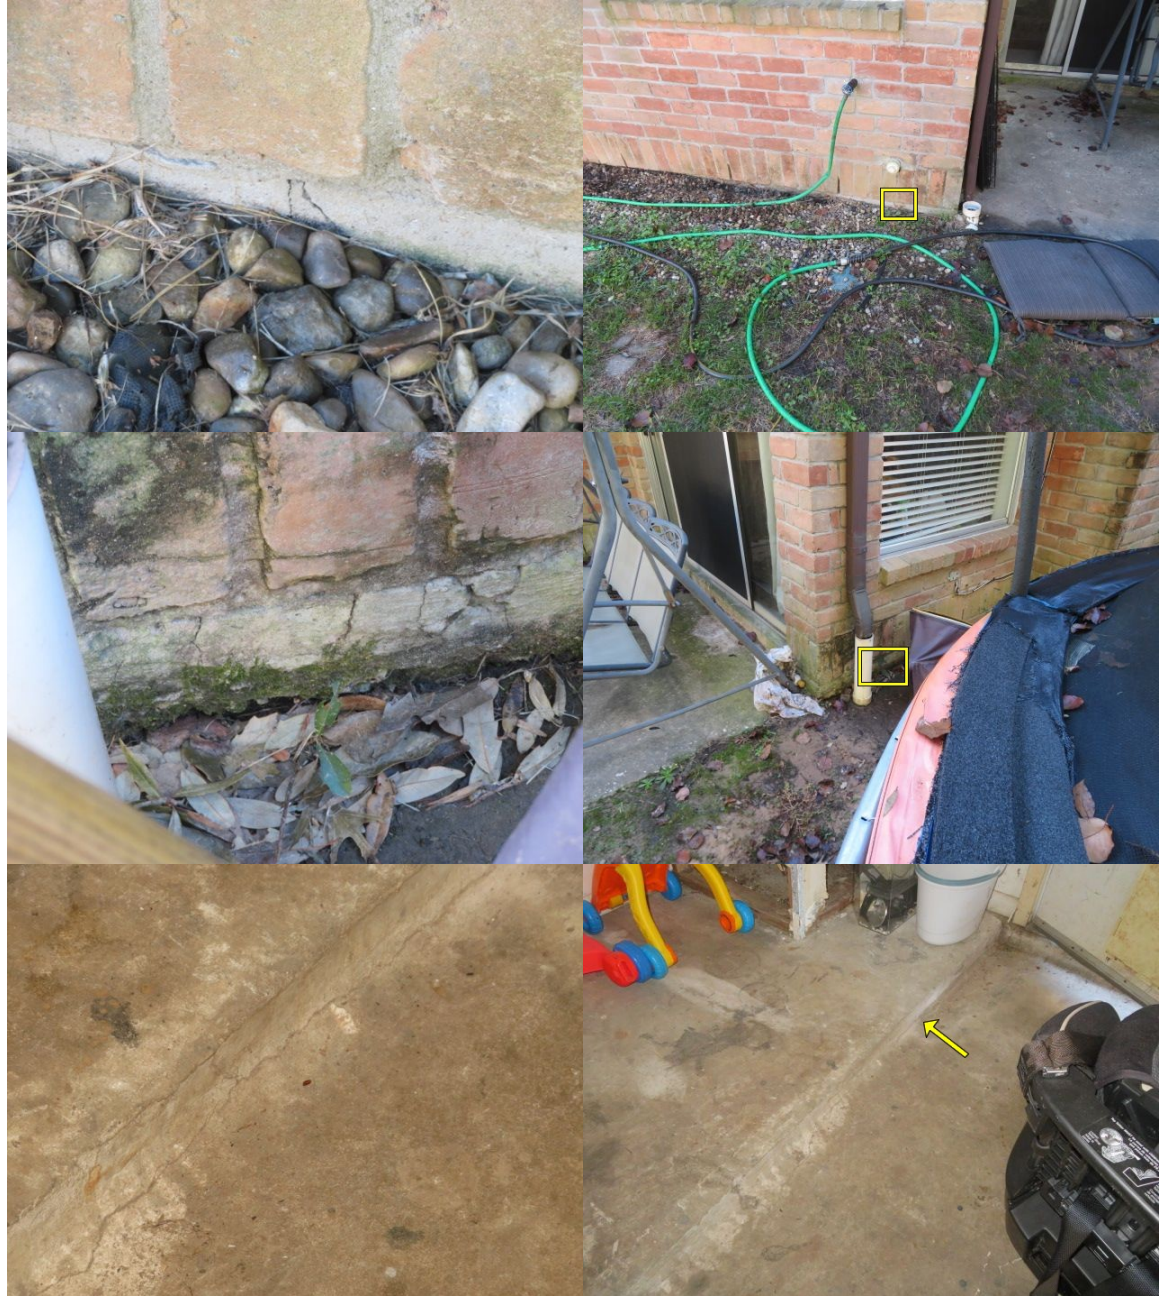
There are hairline cracks in the foundation on the right side of the house, the back side as well as the slab in the garage.

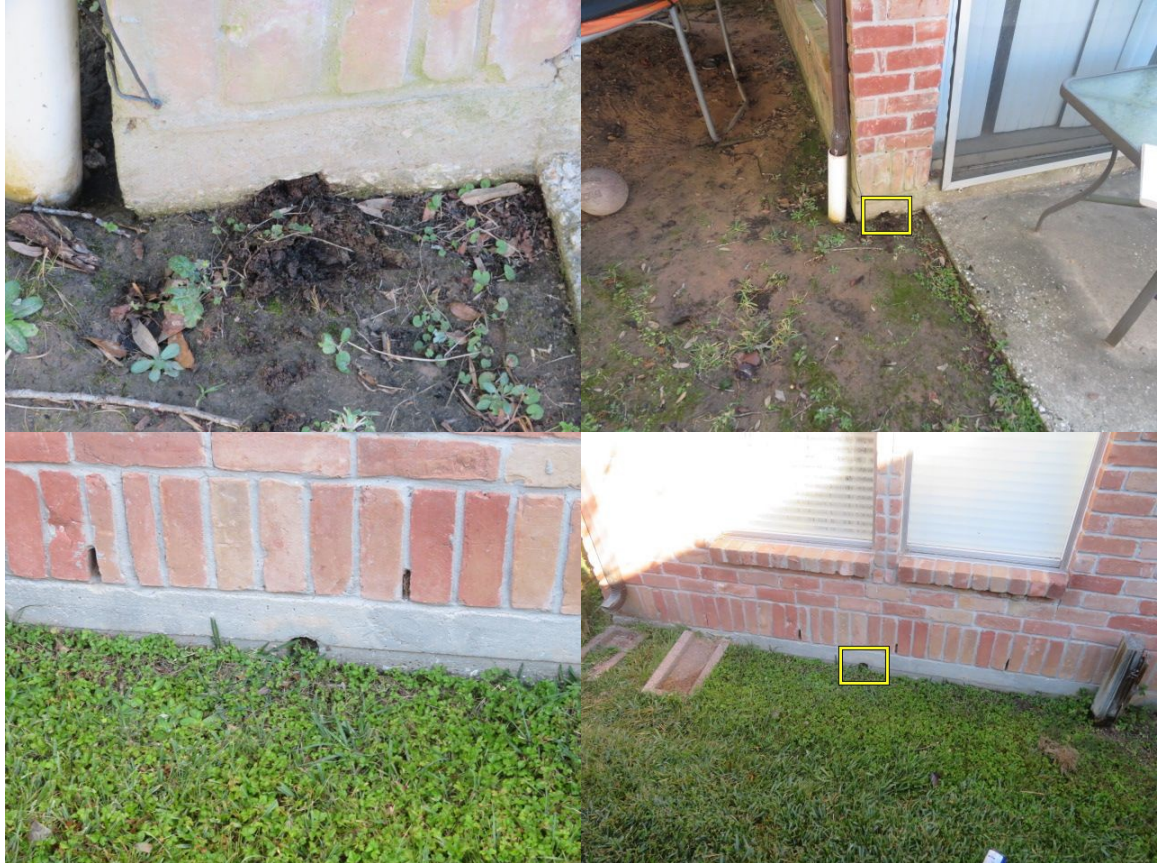
There are exposed cable ends on the back and left sides of the home. These cable ends should be sealed to help prevent oxidation/rusting of the cable into the foundation.

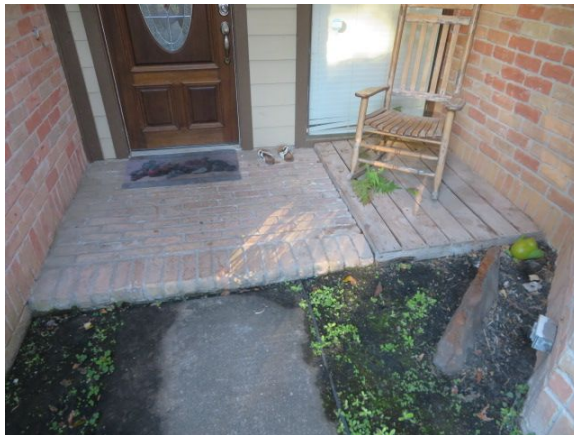
NOTE: The foundation is obstructed from view at the front porch.

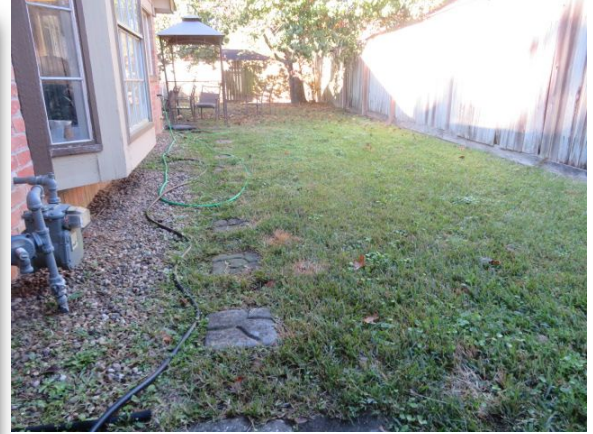
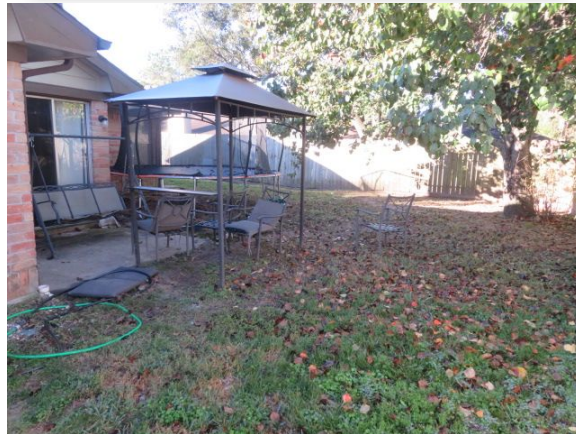
The lot did not appear to have the proper slope for drainage at all points around the perimeter of the home. The grading should slope at least 6" in the first 10' around the home. Inadequate slope may allow water to stand against the foundation and may lead to excess foundation movement.

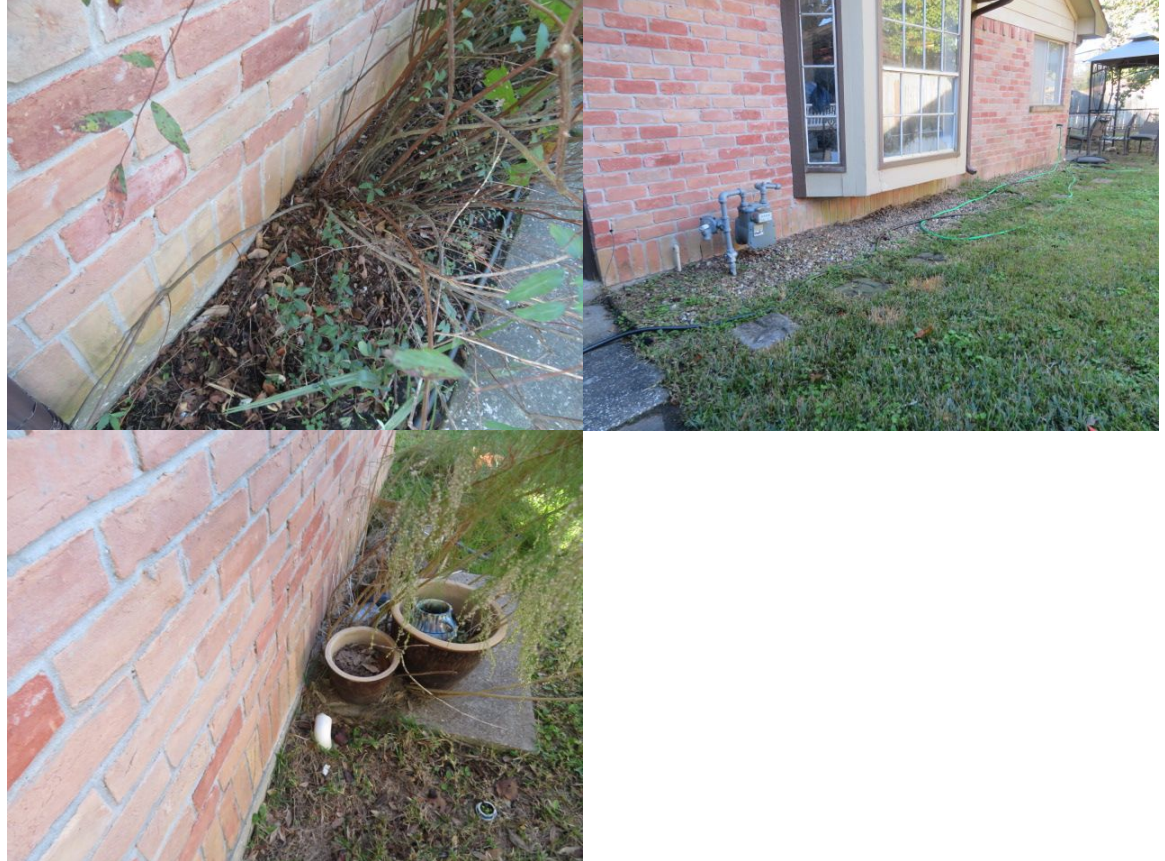
There are high soil areas against the foundation at multiple locations covering the base of the walls. High soil could allow wood destroying insects to enter the wall cavity and could allow reverse flow of water into the weep holes and into the wall cavities.

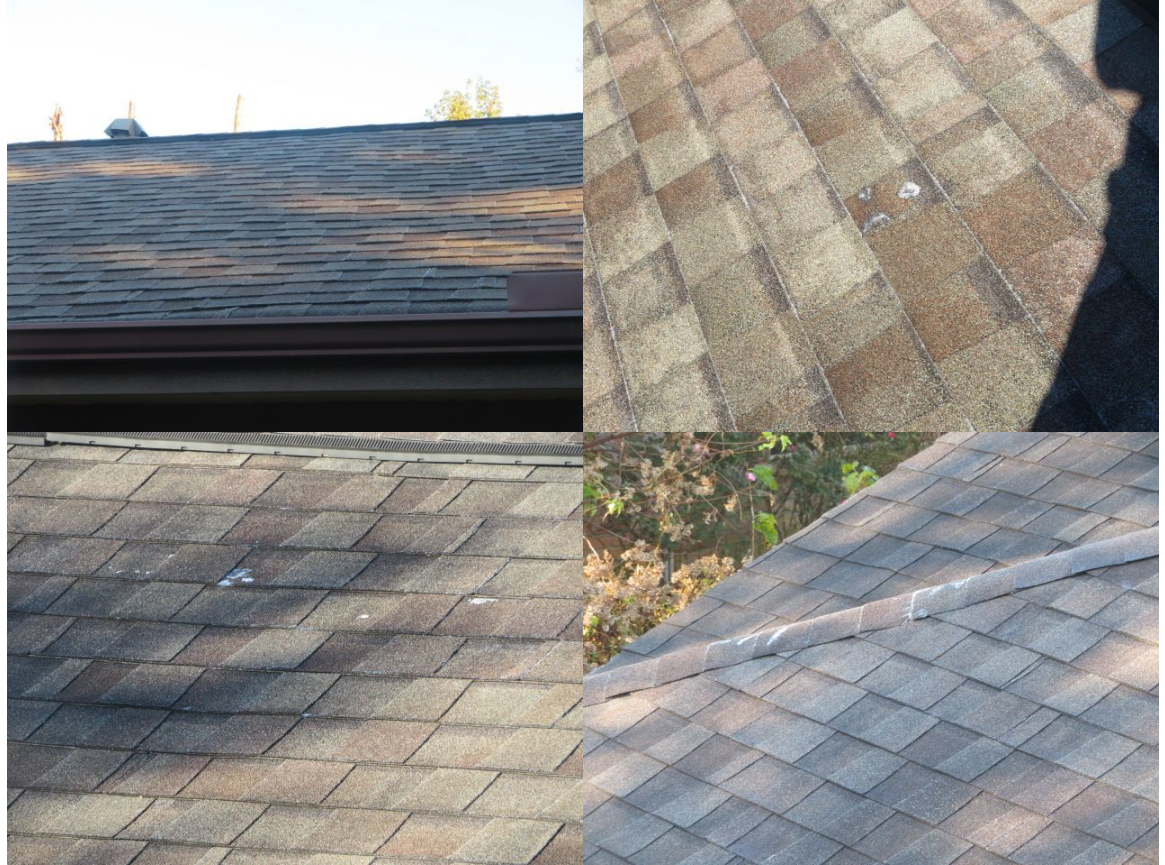
The shingles are showing signs of age / wear, including loss of granular material.

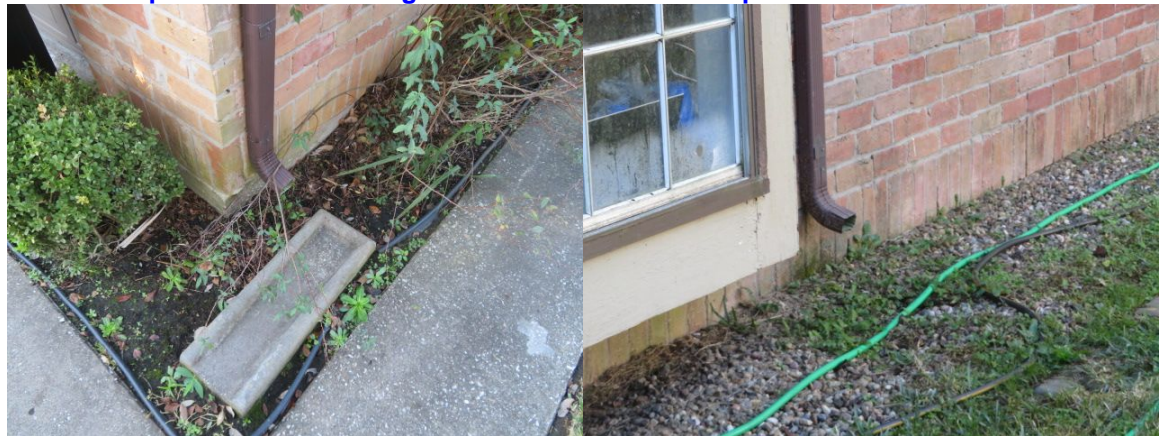
There are splash blocks missing at the base of the down spouts around the home.

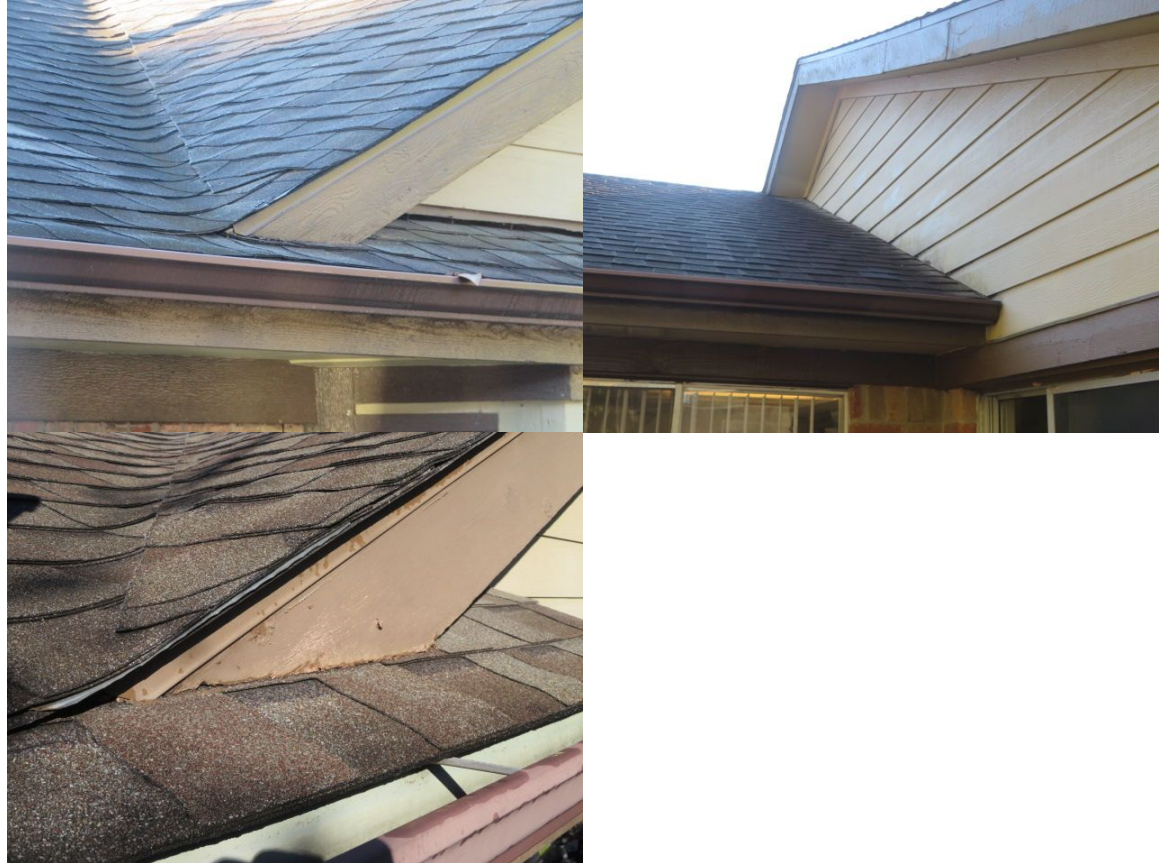
There are some places where the siding comes in contact with the roof covering. Ideally there should be about a 1" to 2" gap between the roof and siding to help prevent excessive contact with water and eventual water damage to the siding.

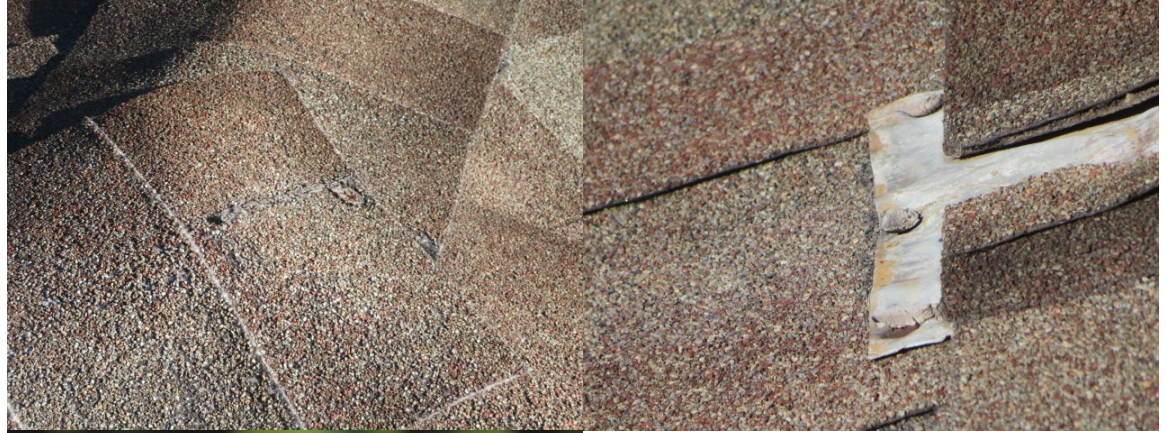
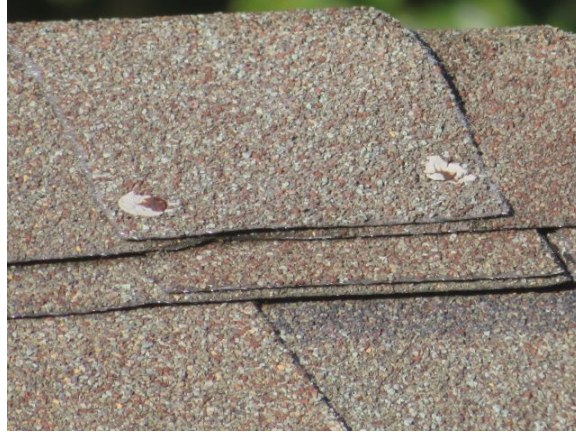
There are exposed nail heads on the roof. Nail heads should be sealed with roof caulking material. Over time, water may penetrate the roof around a rusted nail if they are not properly sealed.

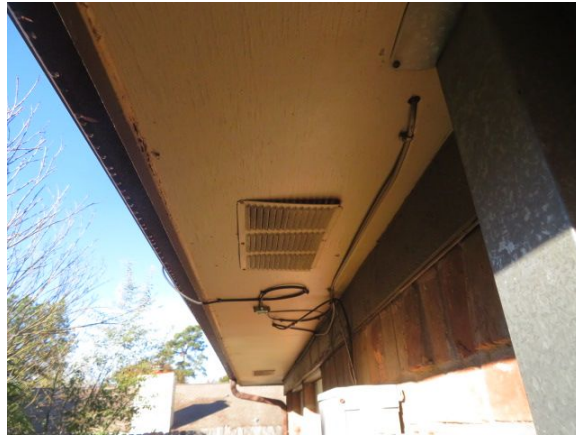
**There is a loose soffit vent cover on the left side of the house.**

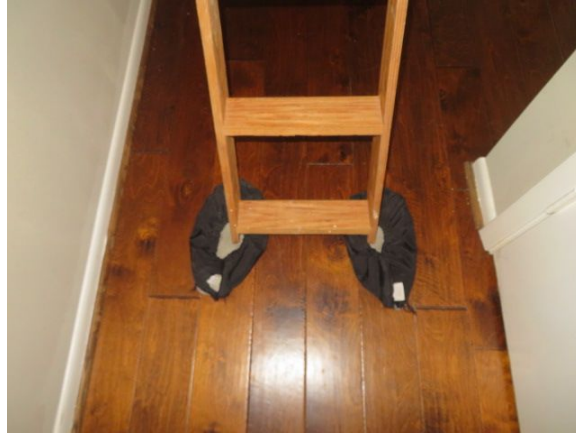
There is no protection for the floor from the attic ladder.

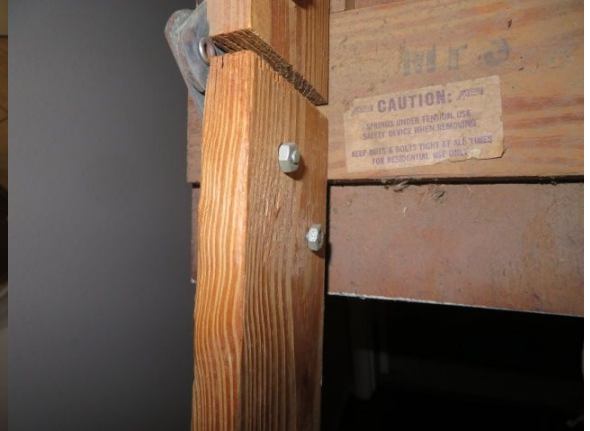
There are loose / missing bolts on the attic access ladder. I recommend tightening all bolts periodically.

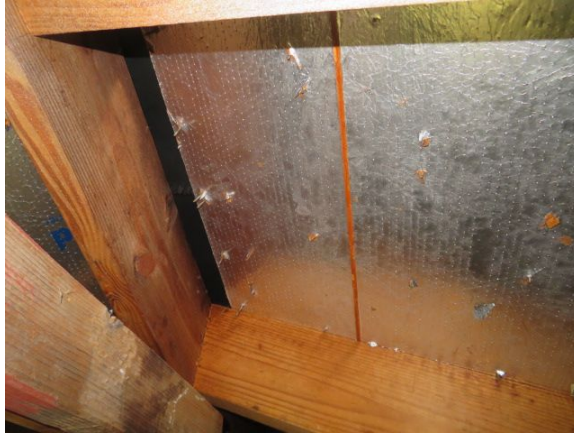
The roof decking material is less than 2' in width from the ridge beam. This is a potential hazard for anyone that may be walking on the roof near the ridge.

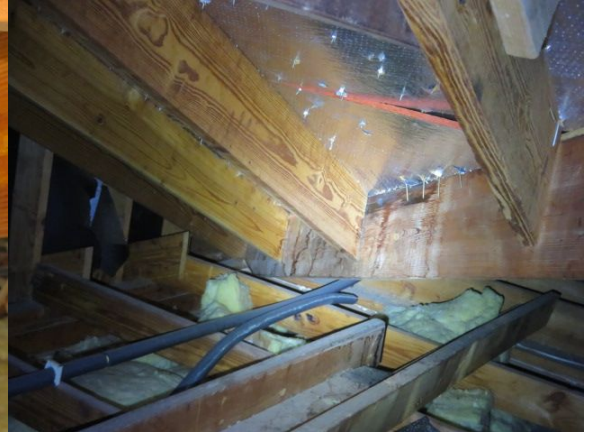
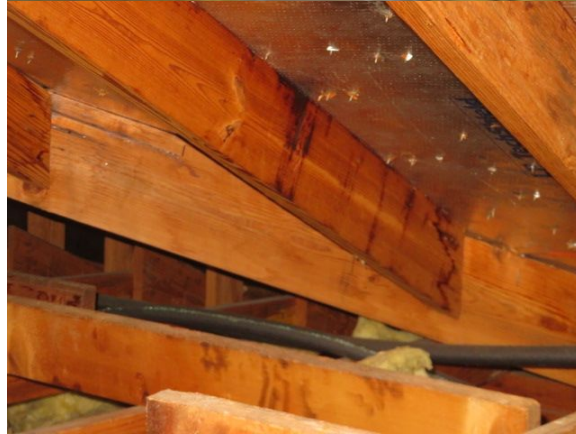
There is evidence of moisture penetration in the attic.

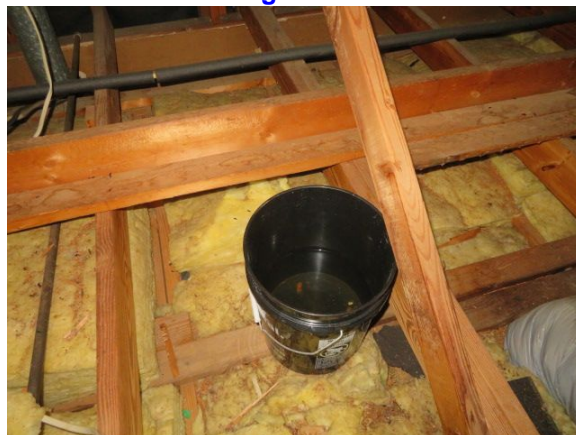
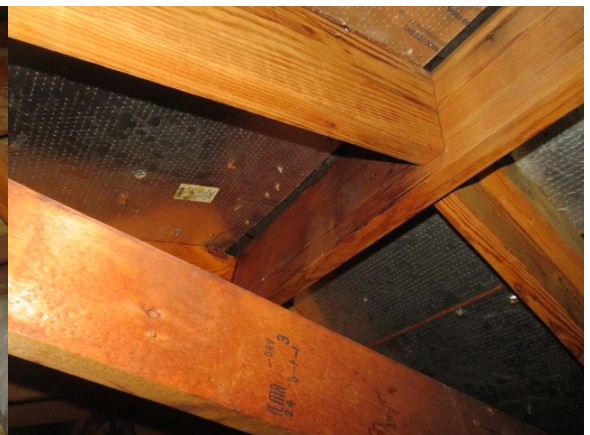
There is a bucket that is half full of water in the attic over the kitchen. It is likely there is an active leak at the ridge beam in this area.

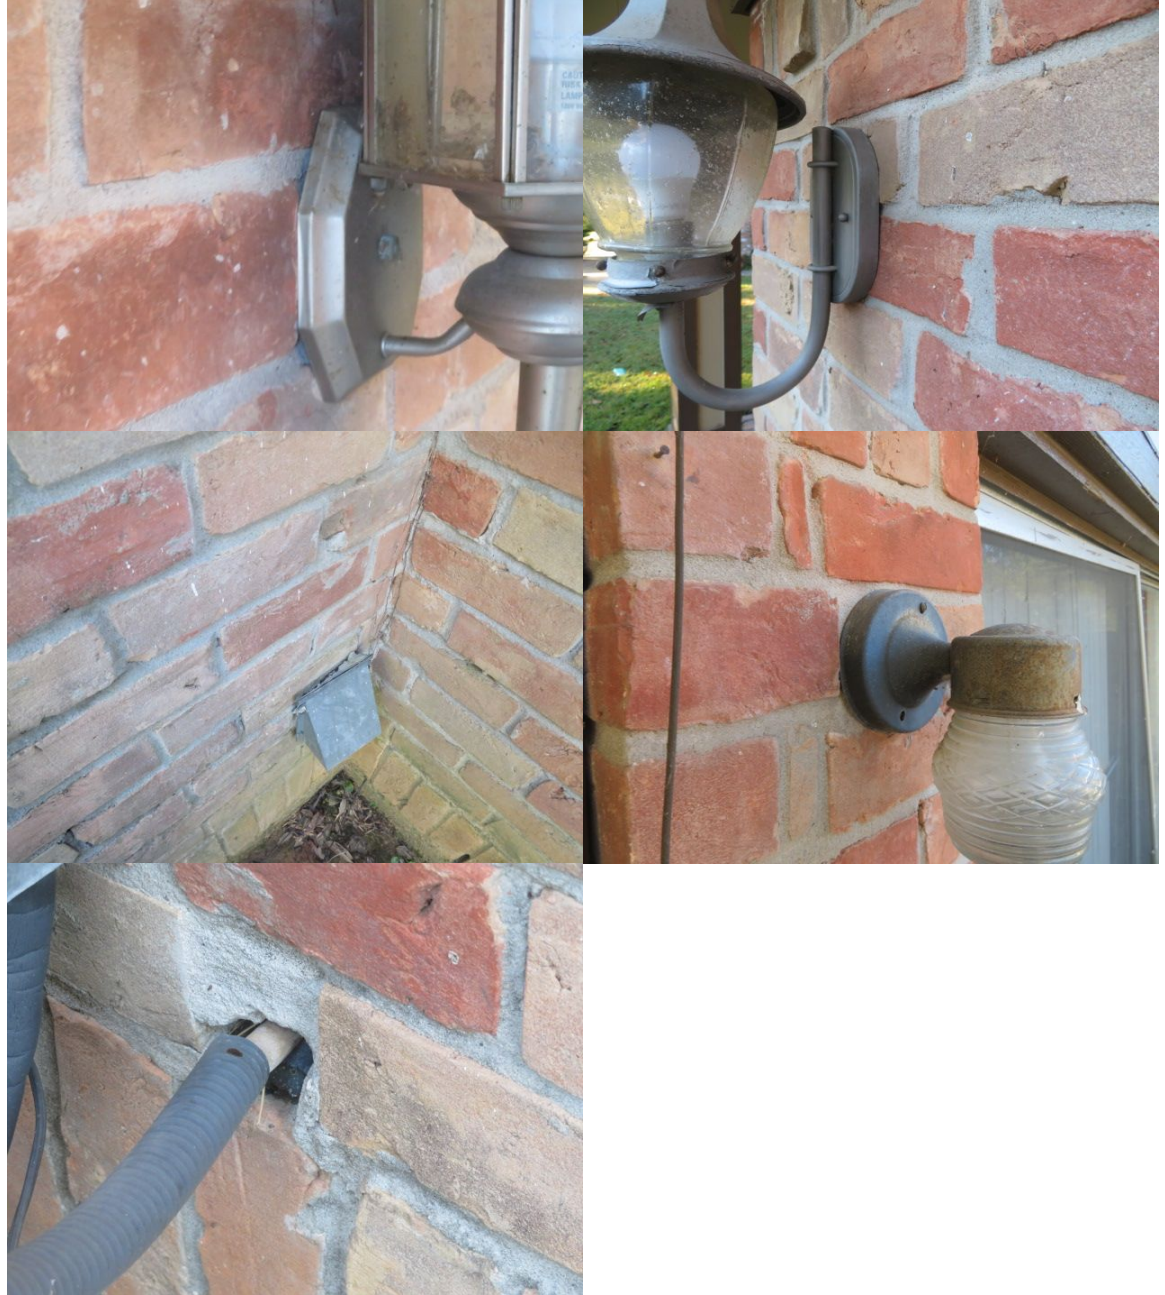
All wall penetrations and exposed openings should be sealed to help prevent pest and moisture penetration into the wall cavity including areas such as electrical outlets, exterior light fixtures, window and door frames, and water and gas supply lines.

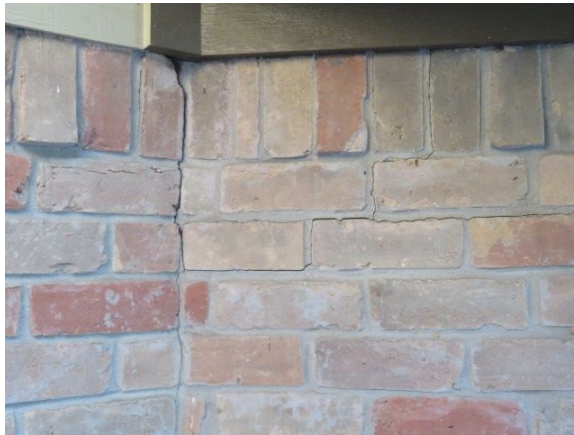
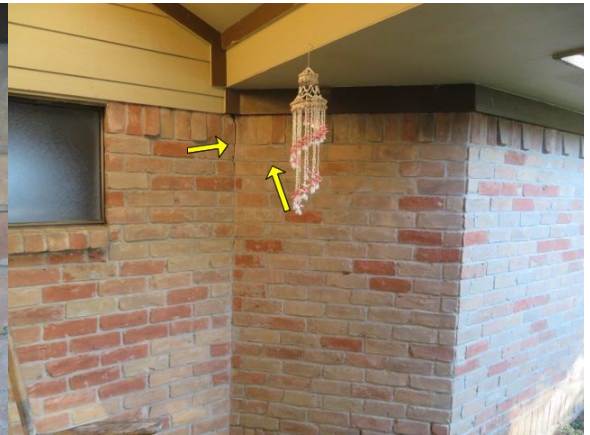
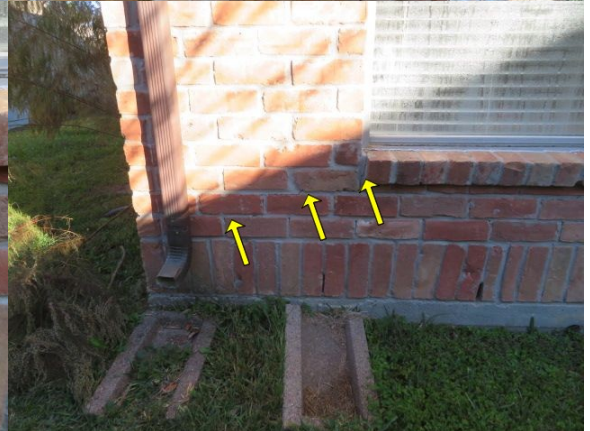
There are mortar joint cracks in areas such as the front entry and the back left corner of the house.

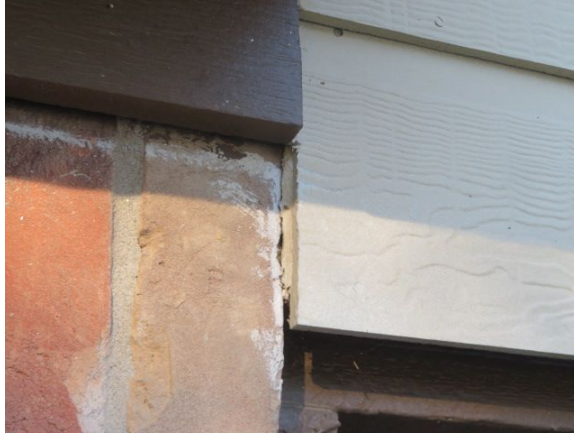
There is deteriorated caulking material at the brick / trim intersections.

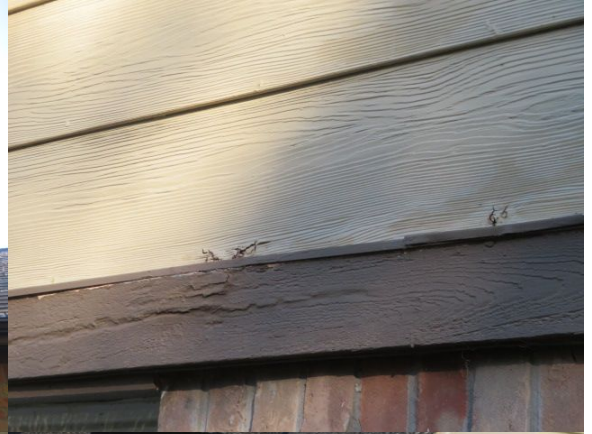
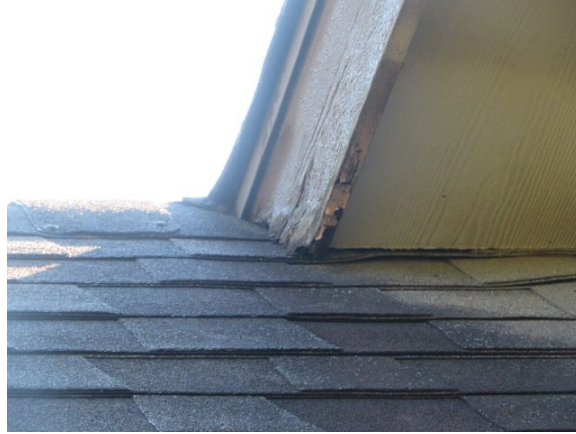
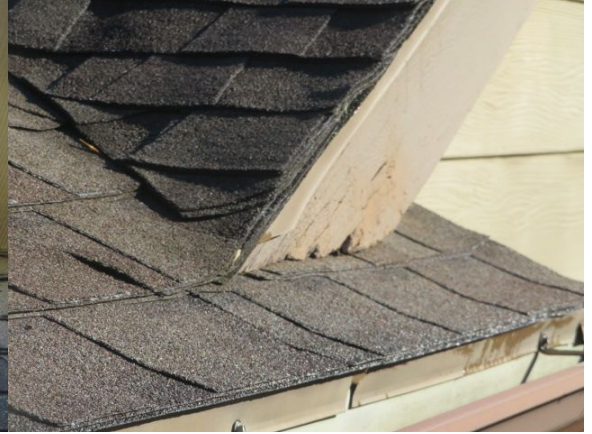
There is wood rot in the fascia in multiple locations.

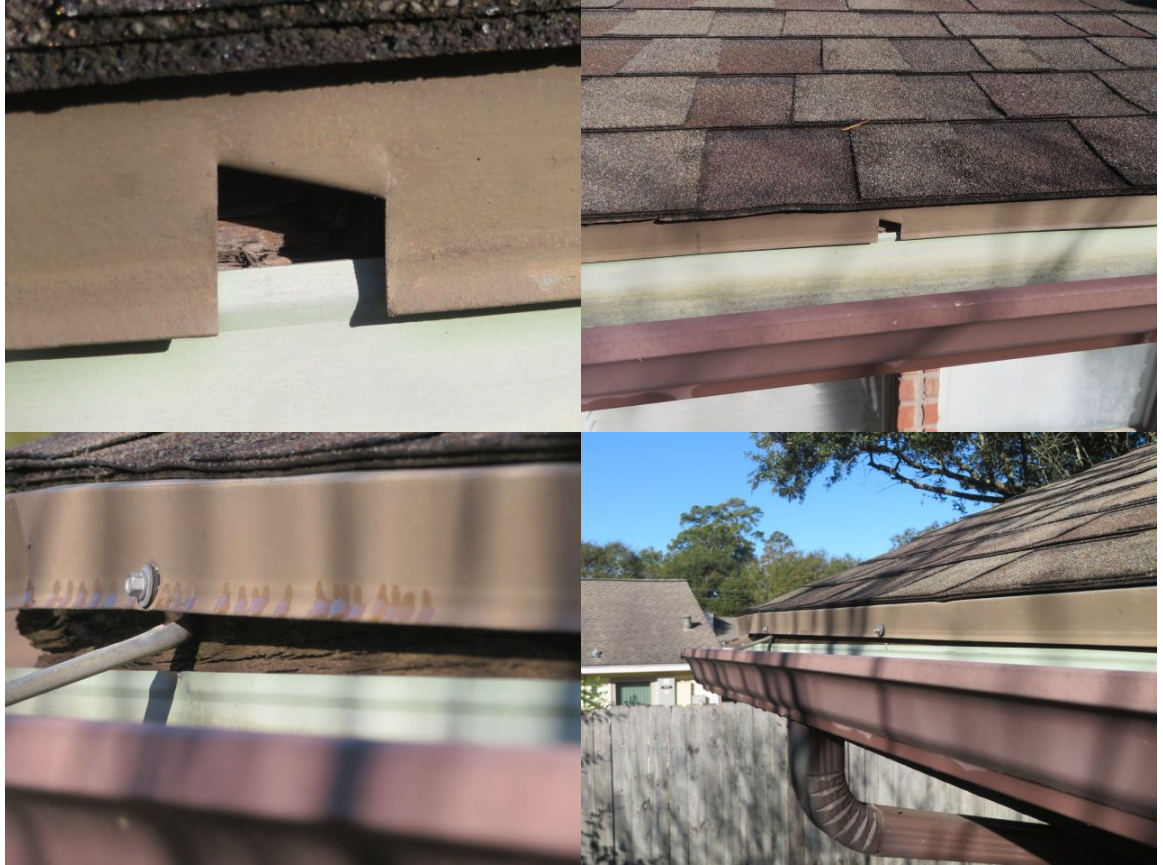
There is wood rot in the fascia behind the rain gutters on the back left side of the house.

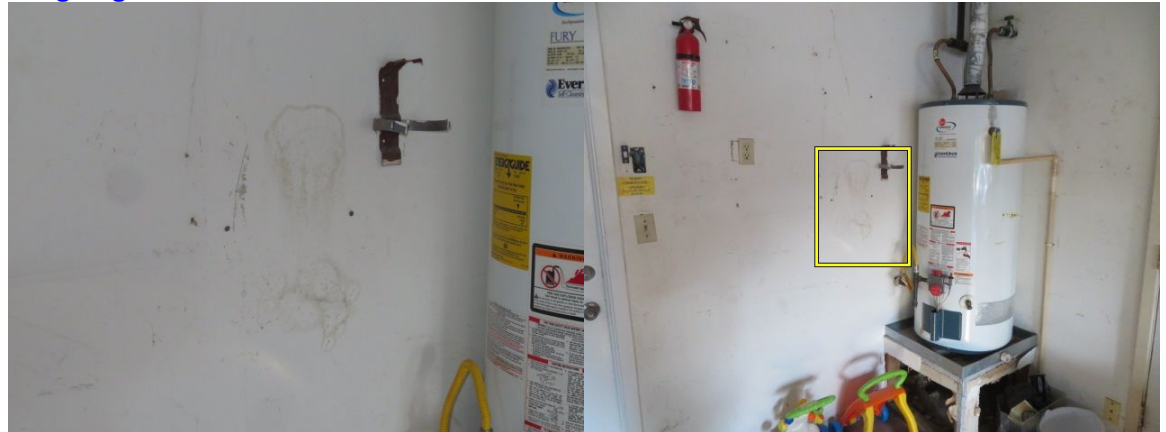
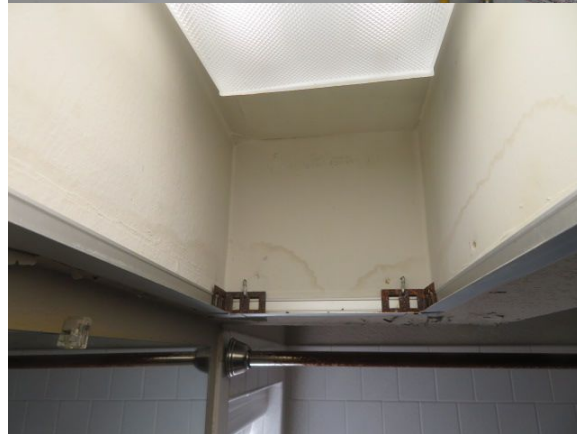
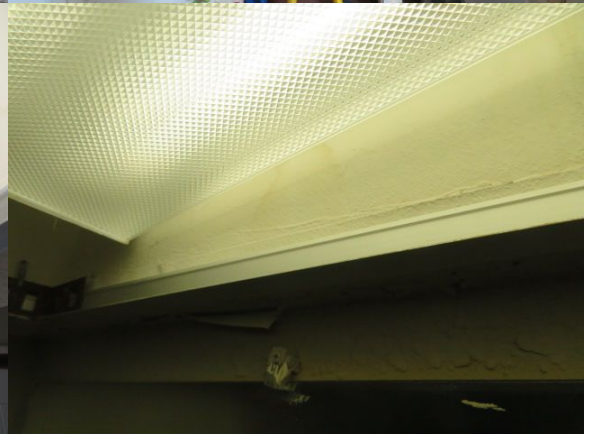
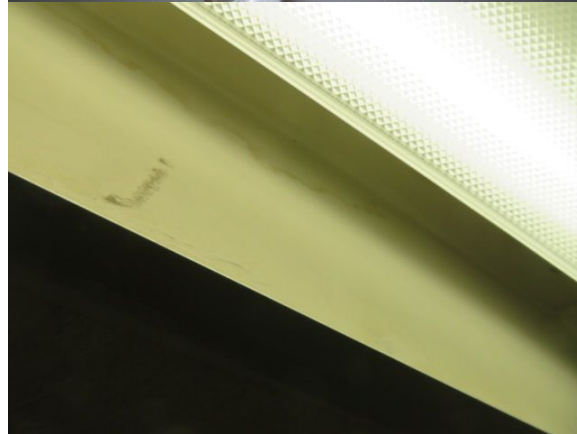
There are moisture stains and evidence of water damage to the sheet rock in areas such as the garage and the hall bathroom.

**NOTE:** I recommend further investigation at areas where moisture stains are present as I cannot see into the wall or behind the sheet rock. I cannot determine what may be present inside the wall.

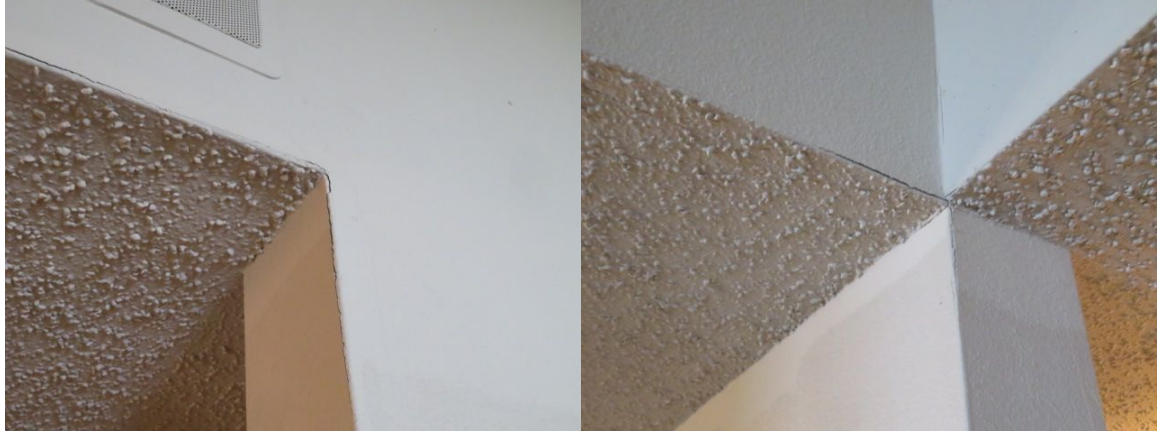
There are cracks in the drywall in areas such as the living room.

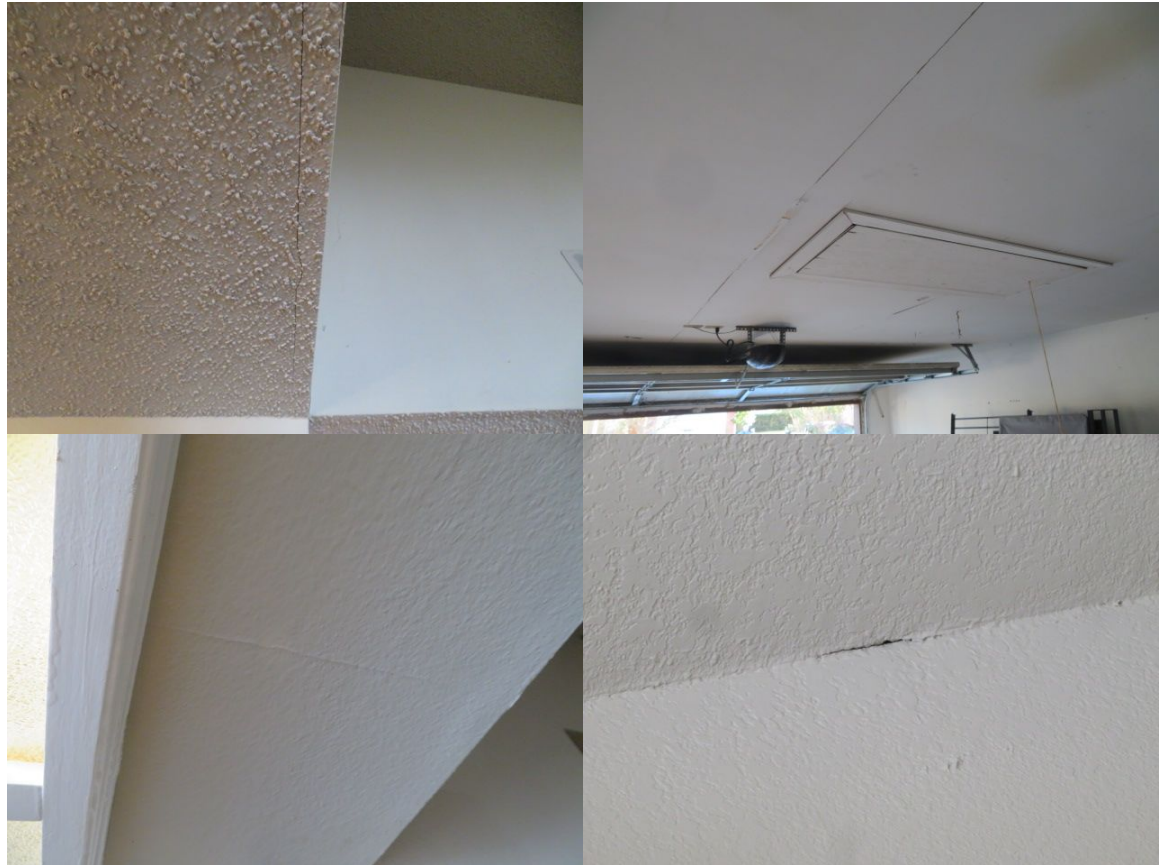
There are cracks in the ceiling in areas such as the living room, garage, master bathroom and kitchen.

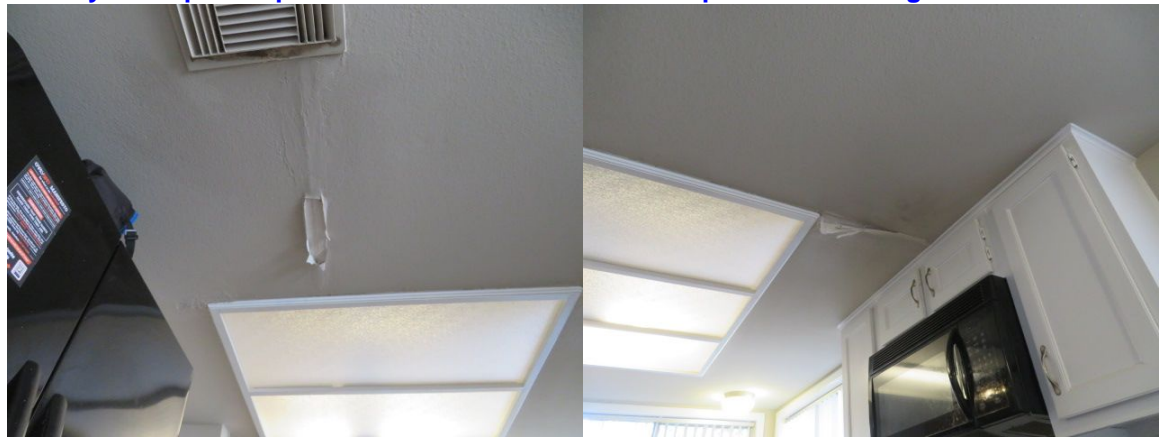
The drywall tape has peeled and there is evidence of repair to the ceiling in the kitchen.

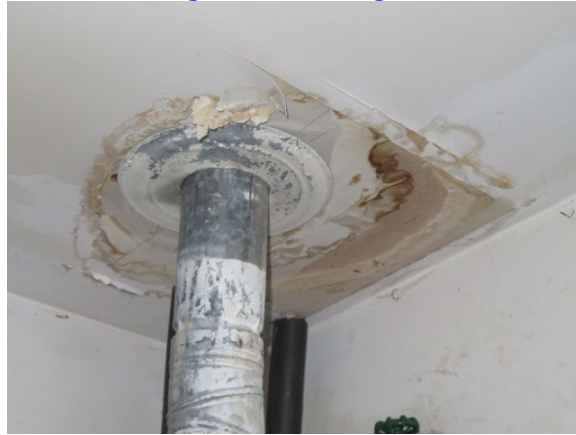
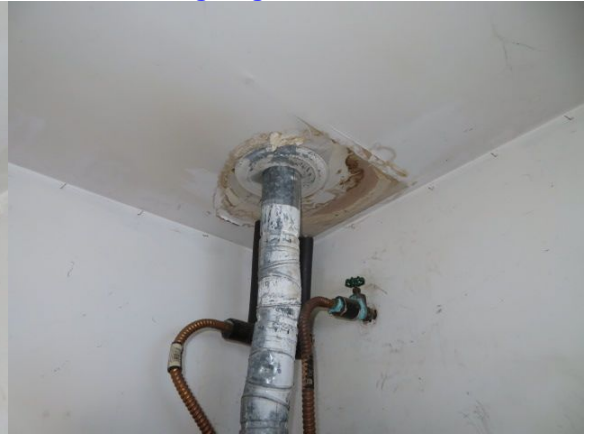
There is damage to the ceiling above the water heater in the garage.

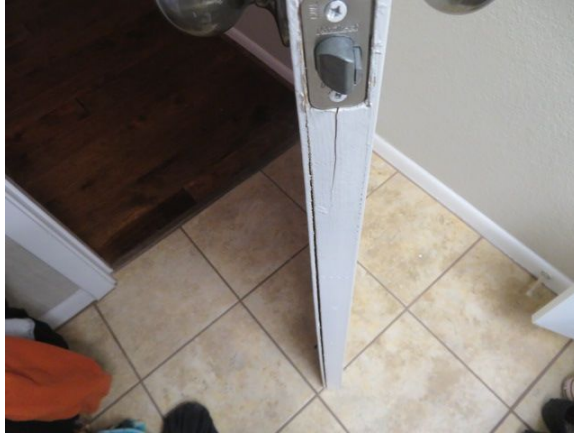
The door to the hall bathroom is delaminating.

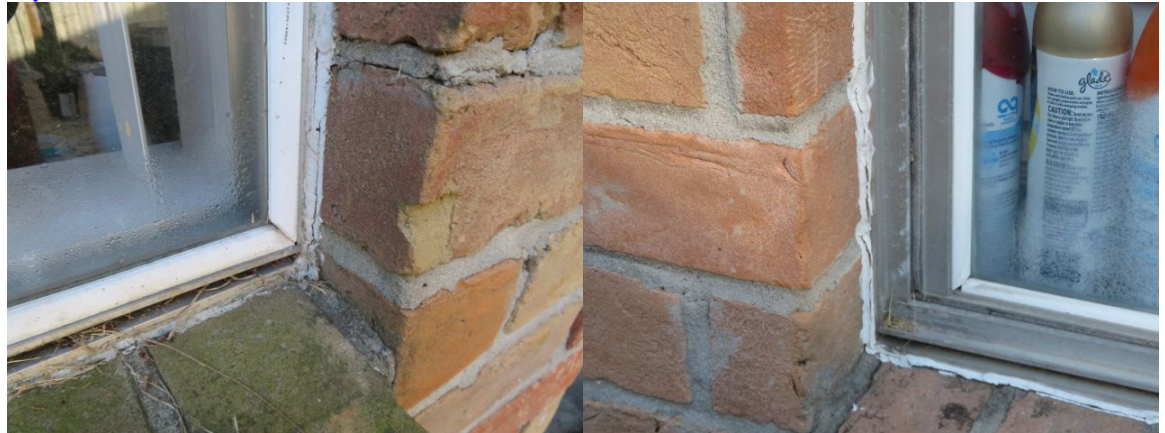
The caulking around the windows is showing signs of deterioration and may need to be replaced.

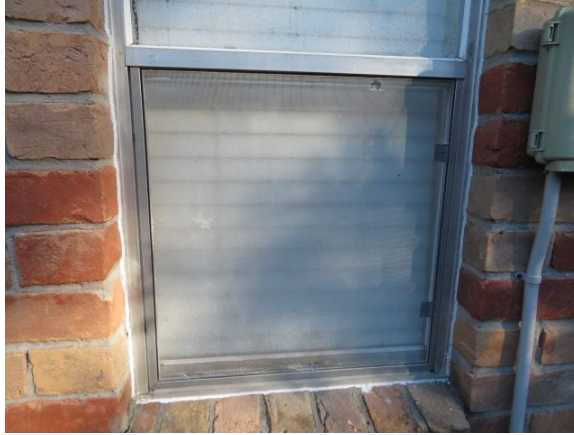
There are damaged window screens around the home.

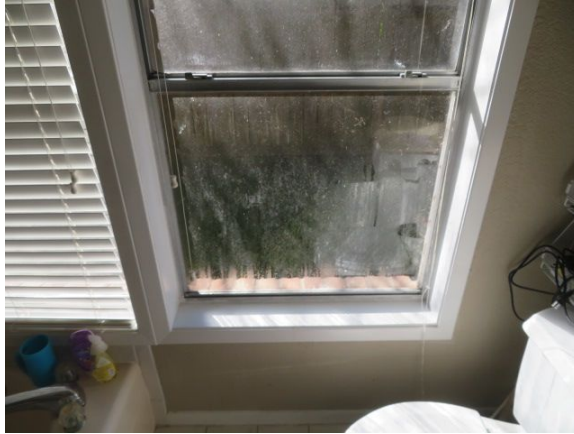
There are some locations where safety glass is required, such as in wet areas by bathtubs. Safety glass is identified by an etching in the corner of the glass. This etching was not found on the glass where safety glass should be in the master bathroom.

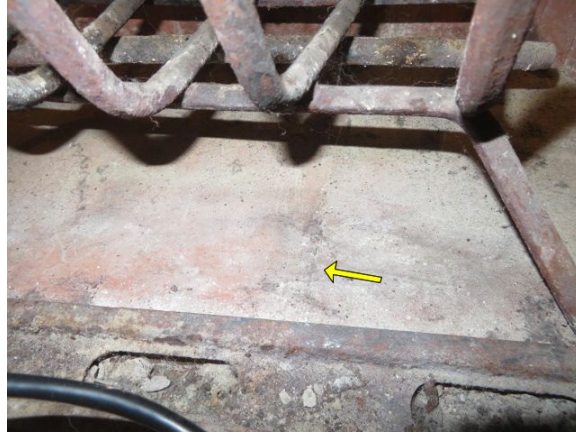
There are cracks in the bottom of the fireplace.

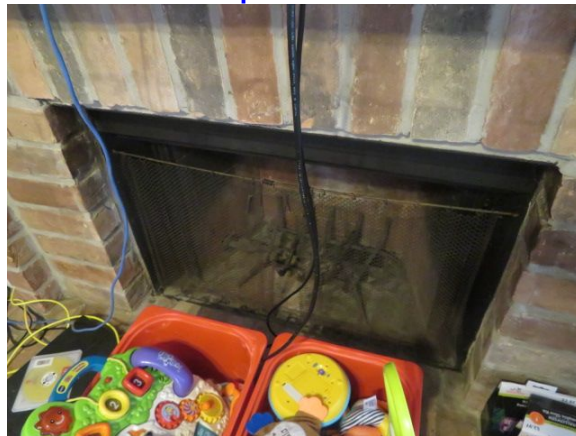
The rail for the fireplace screen is loose.

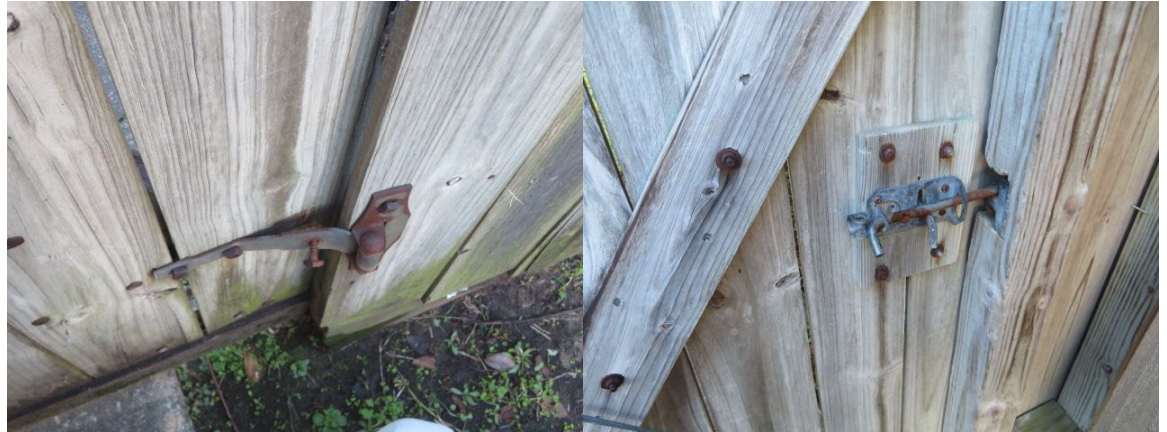
**The fence is not normally part of the routine home inspection. However, during the inspection, I observed the fence and gate on the right side of the home are damaged / deteriorated and could not be opened.**

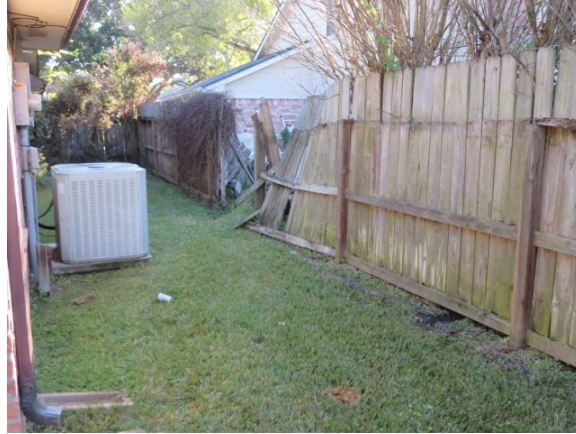
The fence is deteriorated and there is a large gap in the fence on the left side of the house.

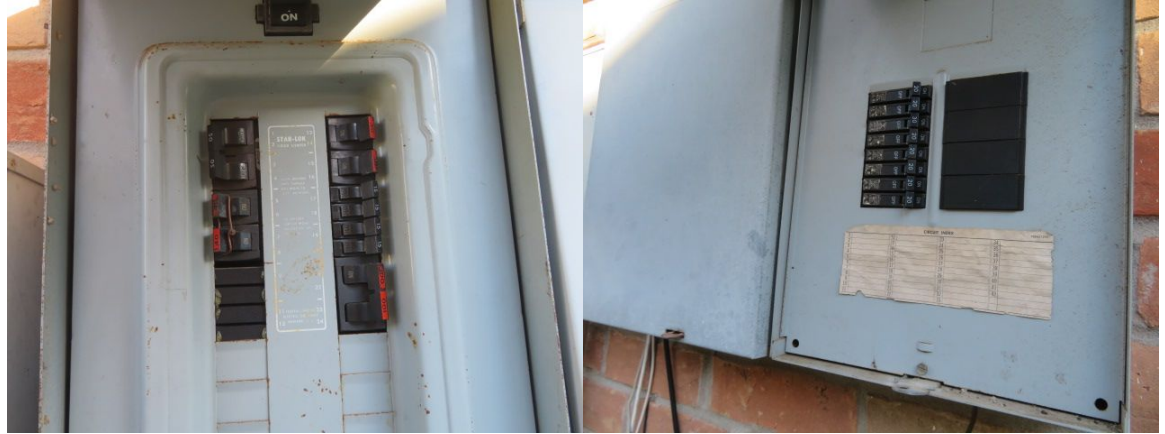
There is inadequate labeling in the service panel.

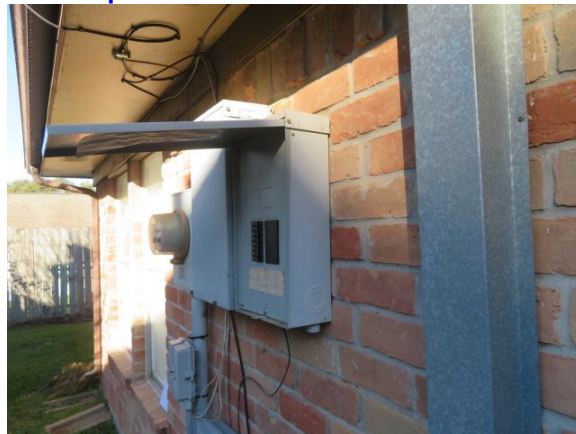
The GE panel box is loose on the wall.

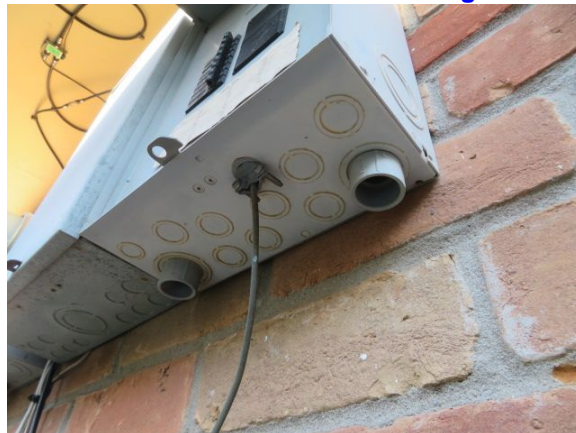
There are unused knockouts missing in the GE panel box.
