18615 Sweetjasmine Ln  
Spring, TX 77379  
Matt & Jenny Sneller

## PROPERTY INSPECTION REPORT

**Concerning:** 18615 Sweetjasmine Ln, Spring, TX 77379  
(Address or Other Identification of Inspected Property)

**By:** Mathew Blossom, Lic #21230 11/29/2021  
(Name and License Number of Inspector) (Date)

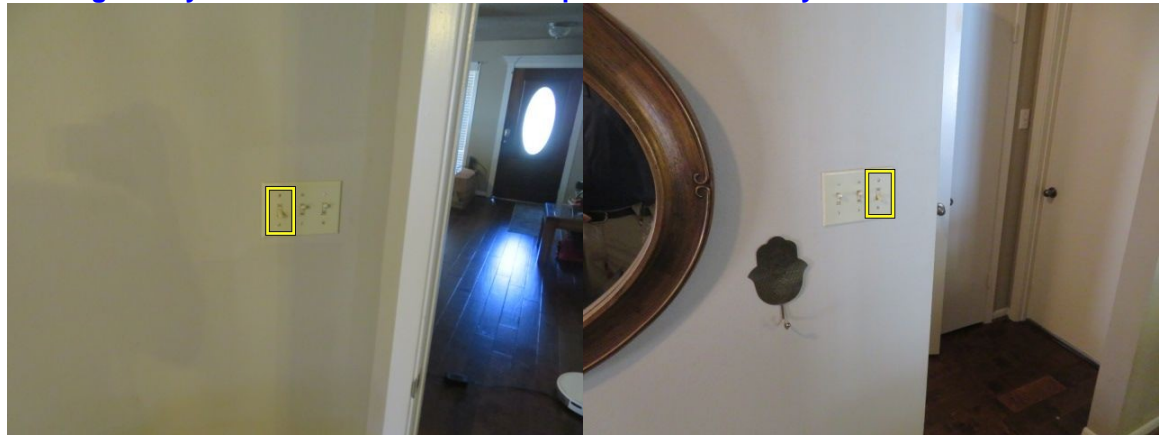
**There are switches that do not appear to operate any circuits in some places such as the master bedroom and living room. If the bulbs are not blown, the circuit/fixture should be investigated by a licensed electrician and repaired as necessary.**

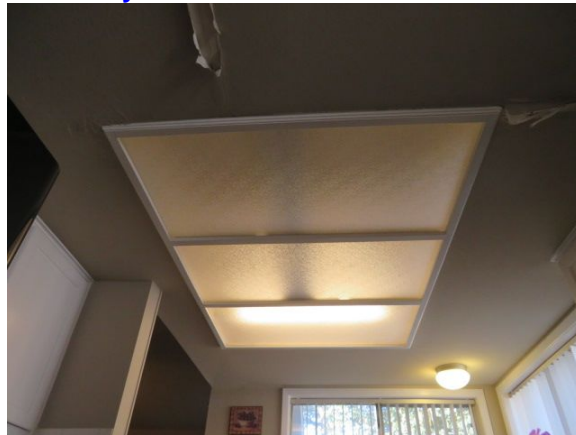
**Some of the lights in the fixture in the kitchen did not turn on. If the bulbs are not blown, the circuit/fixture should be investigated by a licensed electrician and repaired as necessary.**

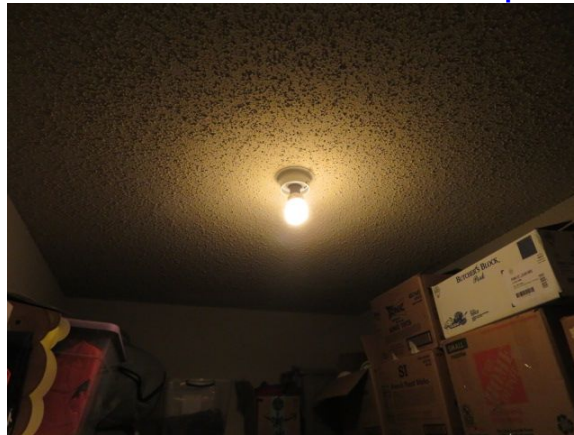
The bedroom closet light fixtures are now required to have a protective globe and be a minimum of 12 inches away from any combustible materials. The closet light fixtures in the home do not meet this minimum requirement.

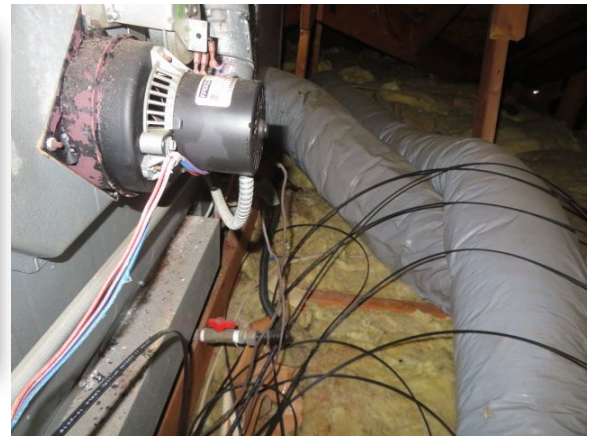
There is no sediment trap on the gas supply line. The below diagram is an example of a sediment trap.

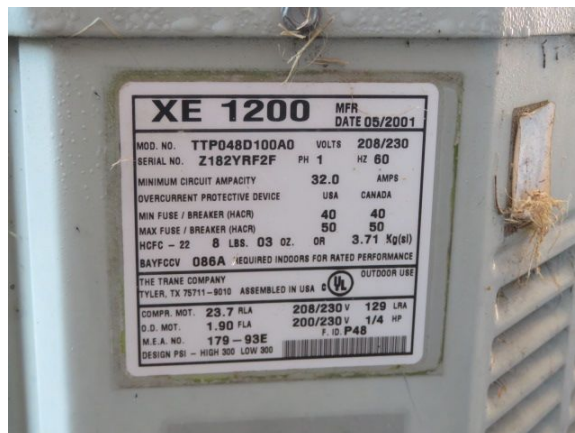
Unit 1      Supply Temp: **39.9**      Return Temp: **65.8**      Difference: **25.9**

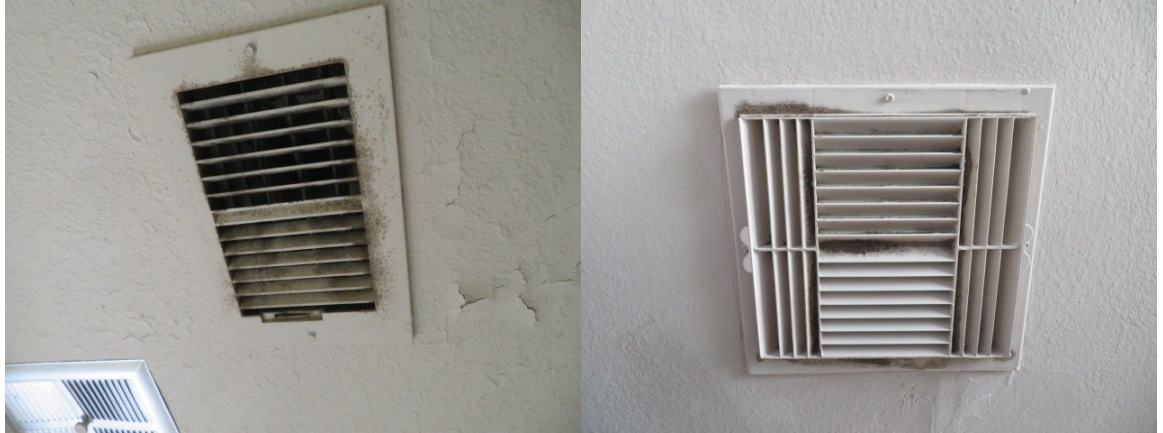
**There is microbial growth on some of the supply register covers.**

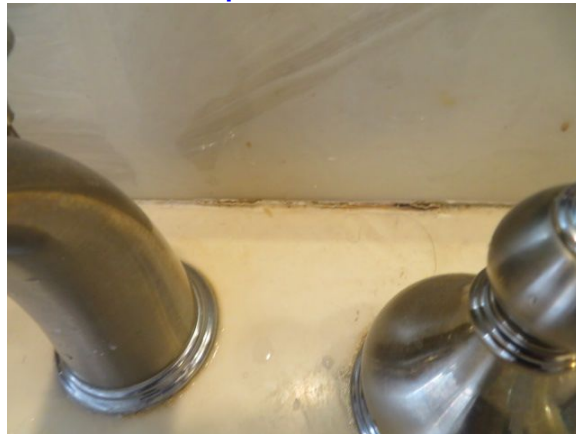
**The silicone seal at the sink backsplash is deteriorated. This may allow moisture to leak into the cabinet space below.**

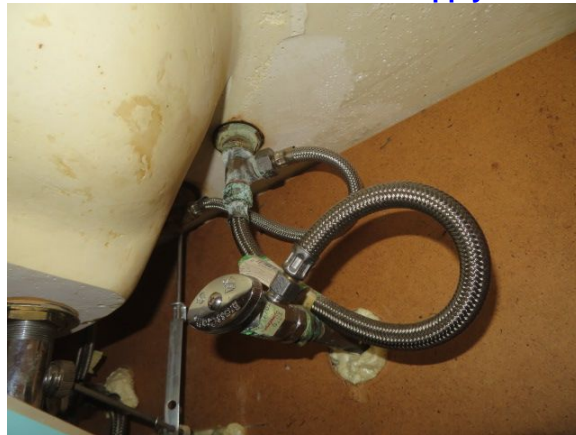
**There is corrosion at the water supply lines at the sink connections.**

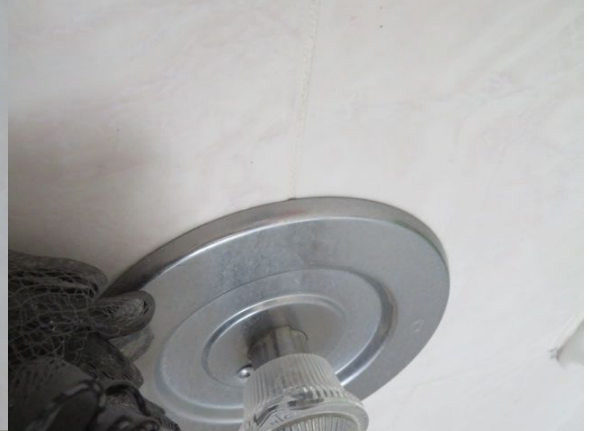
All bathtub wall penetrations and corners should be silicone sealed to help prevent water penetration into the wall cavity. The silicone is missing / deteriorated at the control knob and shower head as well as at the shower wall corners and edges in the master bathroom.

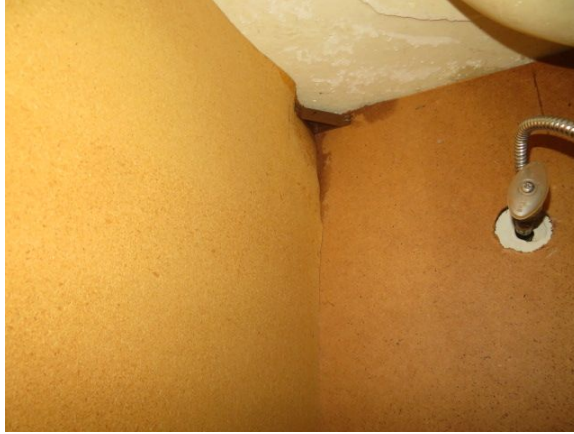
There are moisture stains in the wall of the cabinet under the sink.

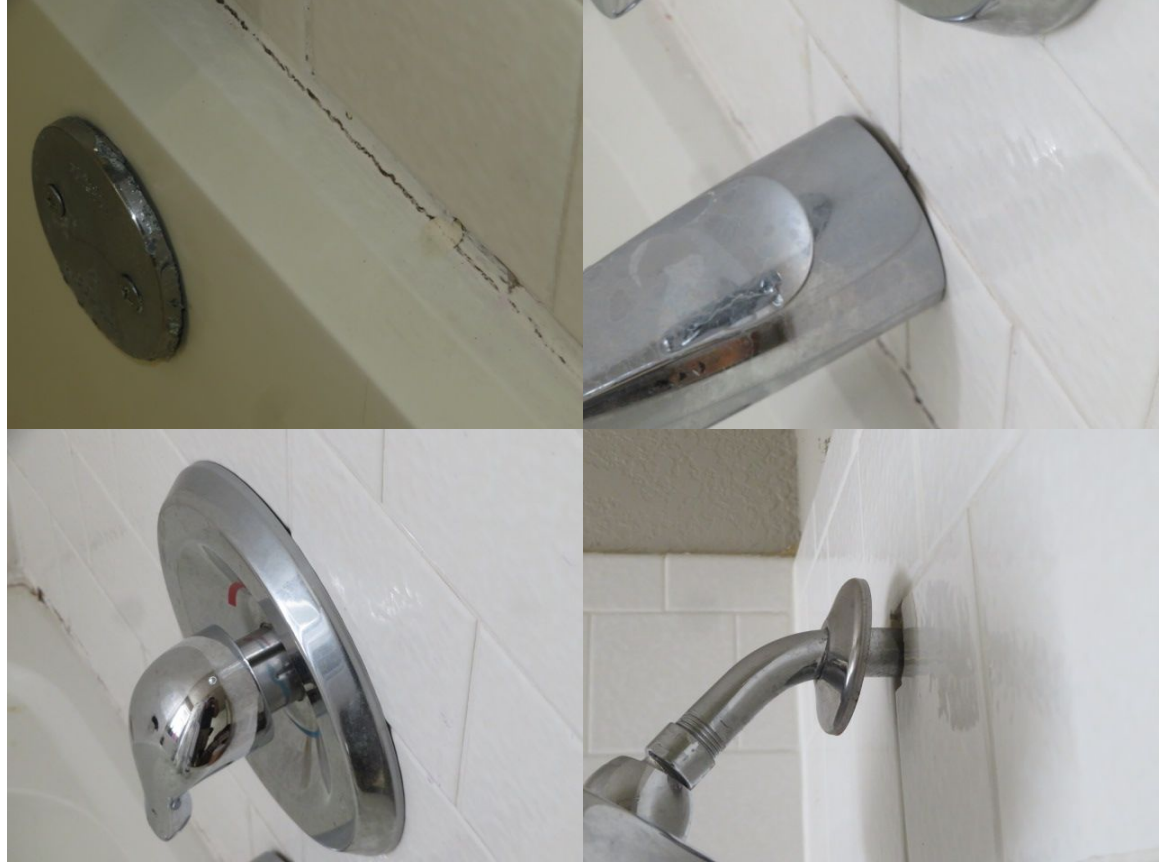
All bathtub wall penetrations and corners should be silicone sealed to help prevent water penetration into the wall cavity. The silicone is missing / deteriorated at the control knob, the tub faucet, and shower head as well as at the shower wall corners and tub edges in the hall bathroom.

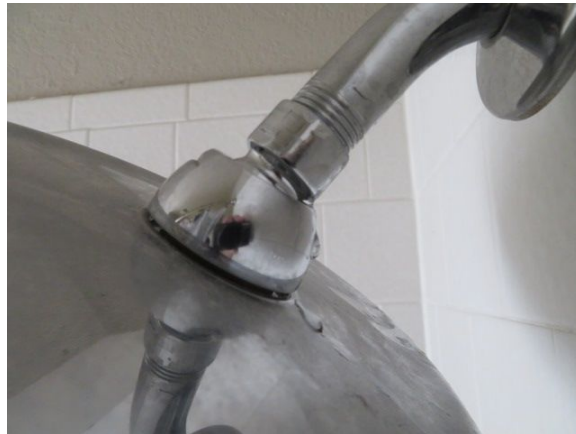
There is a leak at the shower head connection.

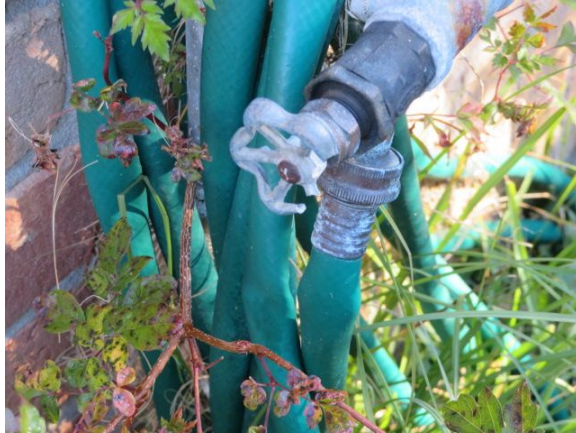
**There is a broken handle on the left side of the house.**

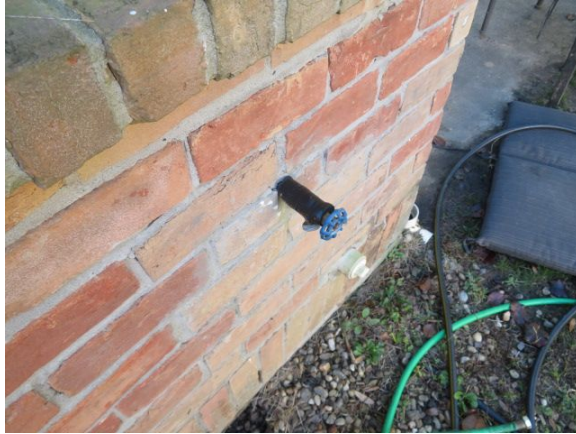
**There are hose bibs that are loose in the wall.**

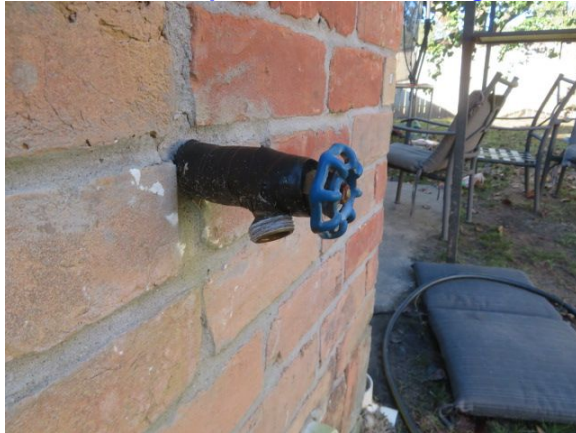
**There are anti siphon devices missing at the hose bibs around the home.**

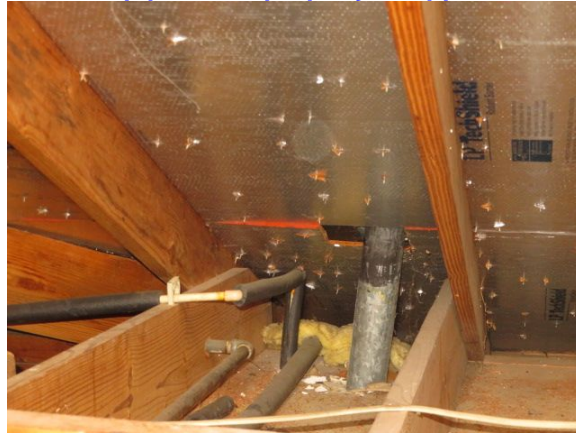
The vent pipe is not properly strapped at the roof penetration.

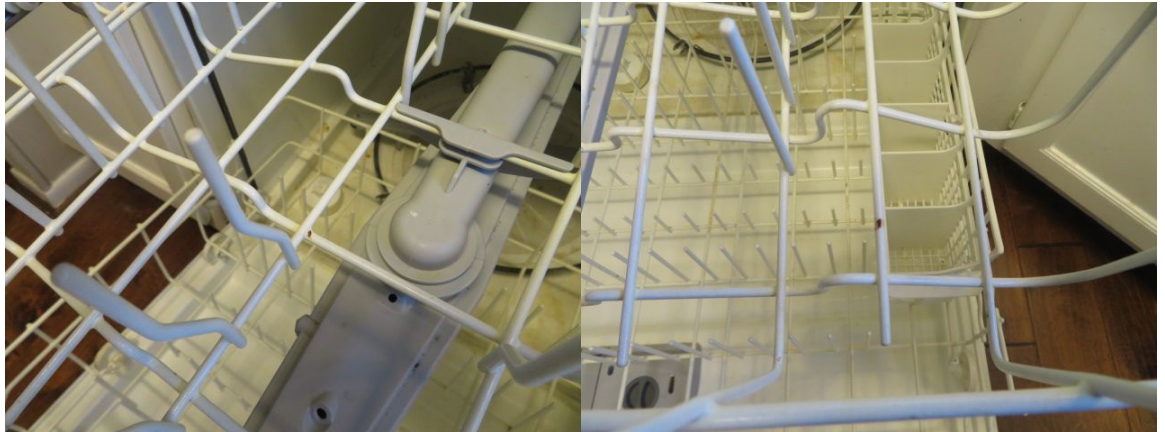
**There is rust on the dishwasher racks inside the unit.**

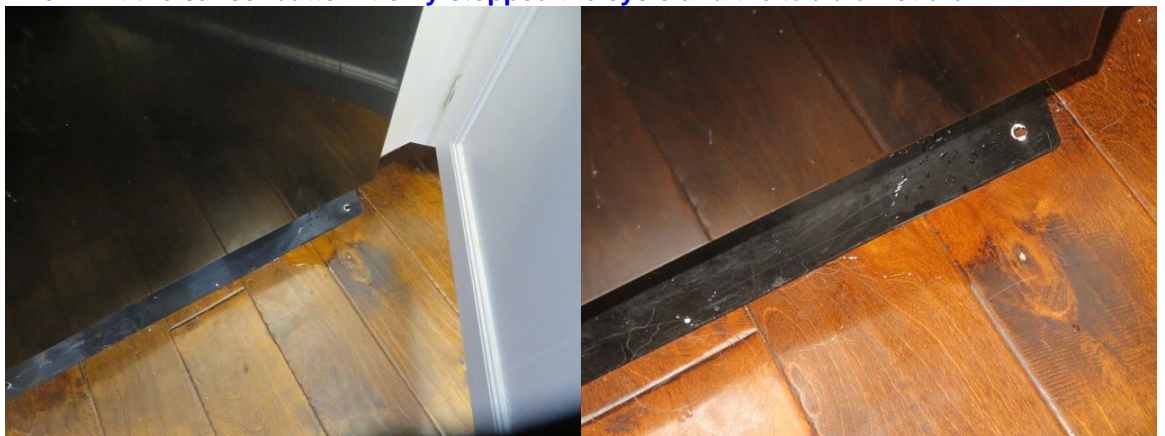
**The dishwasher leaked during operation. I tried to cancel the cycle and drain the tub but when I hit the cancel button it only stopped the cycle and the tub did not drain.**

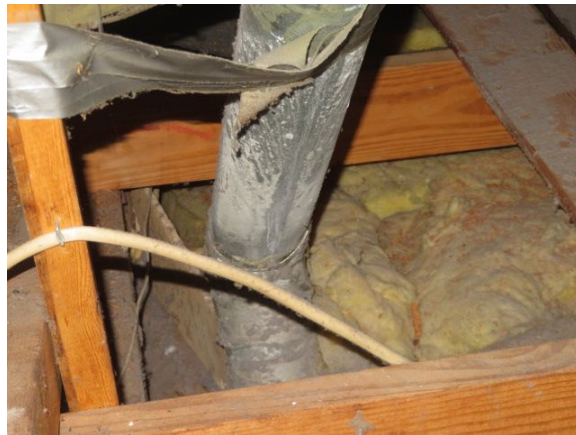
**The dryer vent is not venting completely to the exterior. There is lint accumulating in the attic. Lint is highly flammable and should be removed and the vent properly vented to the exterior.**
