Home Inspection Report

Property Address:
502 Pearl View Ln
Pinehurst TX 77362

PROPERTY INSPECTION REPORT

By: Jonathan Dooley TREC # 22163 / Dooley Inspections LLC 9/2/2020
(Name and License Number of Inspector) (Date)

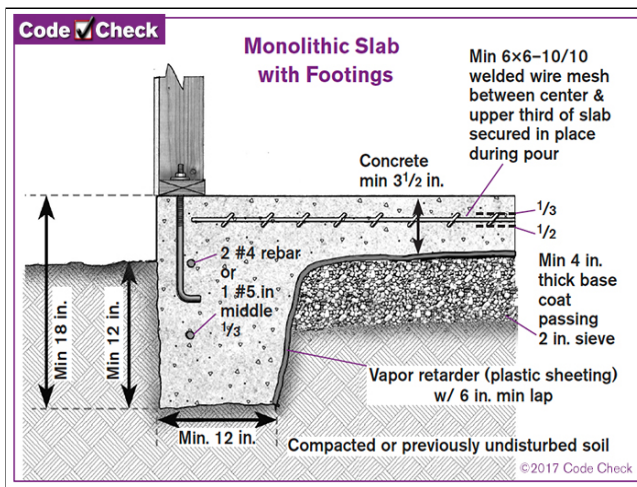
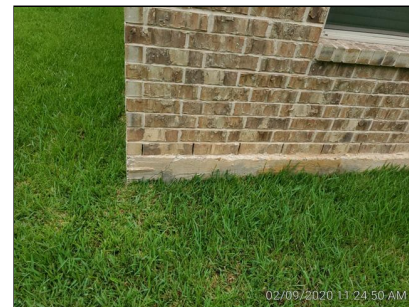
Rear: Corner Pop, non structural crack

In my opinion, the slab foundation appeared to be performing adequately even though it showed some signs of prior movement/settlement. Based on a limited visual observation today, the structure did not appear to exhibit evidence of significant deflection or cracking. I perceived the foundation to contain no significant unlevelness after walking the floors.

Maintenance Advice - Due to the expansive nature of the soil in the this area, a frequent foundation-watering program during summer months is advised. Consistent watering at the entire perimeter of the slab during summer months can help prevent further and/or future settlement and damage.

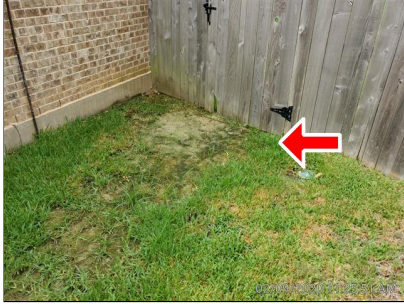
Right Side

Muddy Area

Storm water didn't appear to drain well at right side (near front). A rut has formed creating muddy areas in yard. Consider back filling low areas to promote drainage to french drain and prevent ponding of water in yard.

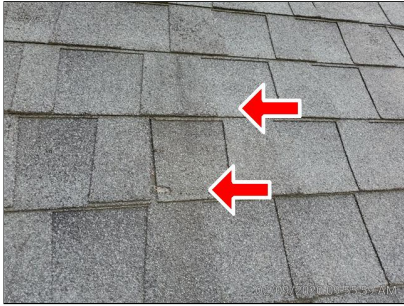
Exposed nail head and Small Cuts/Tears at sides. Functional damage from roofing tools that reduces the ability of the roof to shed water and significantly shorten the shingle's long term service life. This is a sign of poor workmanship. Consider having damaged shingles replaced by the installer to prevent a future leak.

Right Side: small tears

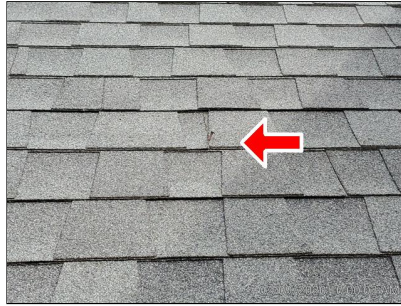
Left Side: Nail Sticking Up

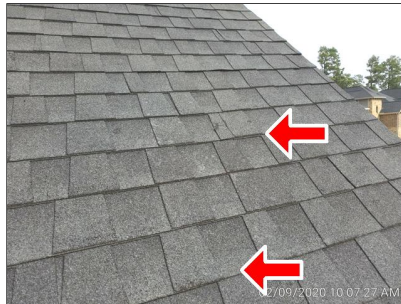
Front: Worn Shingles

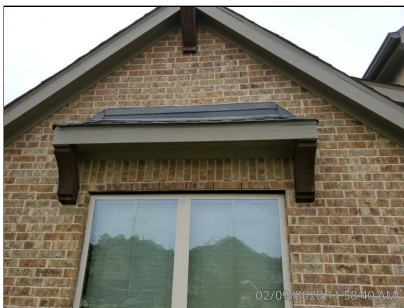
The cap flashing around small porch roof in front was not notched into the mortar joint, but was caulked against brick. This may area may eventually leak down wall due to shrinking/weathering of caulking.

Poorly Flashed Overhang

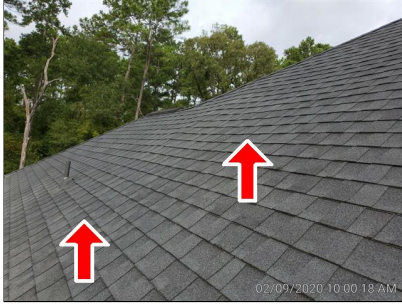
Rear Left Corner

Rafter Humps

Some minor deflection was observed at the roof surface. This condition is not uncommon and generally does not necessarily indicate structural issues and may be more visible with certain types of roof covering. This condition should be monitored and a qualified, verified roofing contractor should be contacted if the condition worsens.

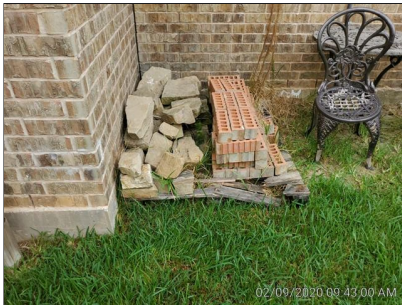
Wood pallet abutting house is considered a conducive condition for potential insect activity. Recommend having a pest control apply a preventative WDI treatment around perimeter of house for added peace of mind.

Wood to Ground Contact

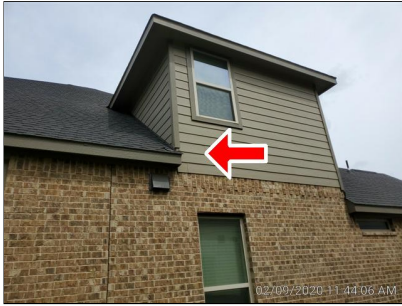
Left Side

A gap between the fascia and roof sheathing exists which allows insects or bees to enter attic. Recommend sealing all gaps in siding.

Small Gap in Roof Flashing

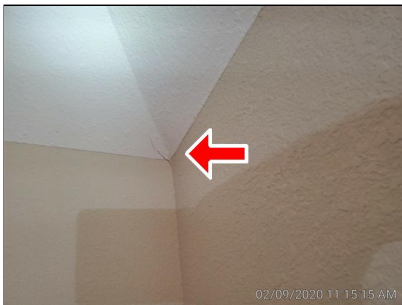
Media Room

Minor Drywall Cracking

Vertical hairline settlement cracks in drywall noted at 2nd story cathedral ceiling; Tape line cracks are typical of this age house and should not be cause for alarm. Recommend sealing cracks and monitoring areas. The rate of movement cannot be predicted during a one-time inspection. If further movement is noticed, contact a foundation expert for evaluation and possible remedies.

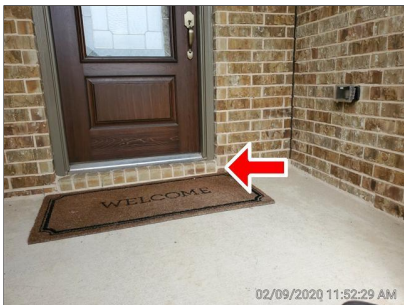
Small gap at bottom of threshold

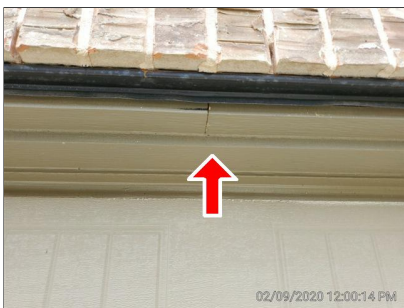
No Caulk at Butt Joint

There was a small gap at top of garage opening that needs sealed with caulking. This will prevent warping from moisture.

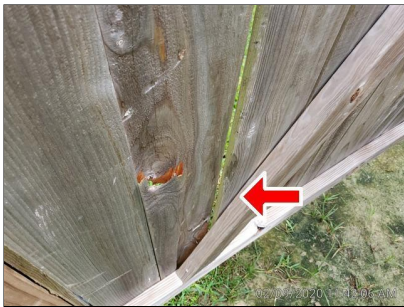
Damaged/Loose pickets noted at fence gate right side. I recommend preplacing broken pickets with nails to prevent injury.

Damaged Gate

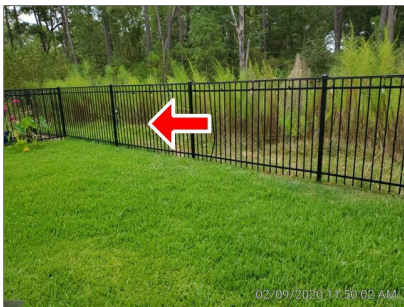
There was a bent vertical member (spire) at rear. This spire should be replaced to prevent unwanted vermins in back yard.

Bent Iron Fence Spire

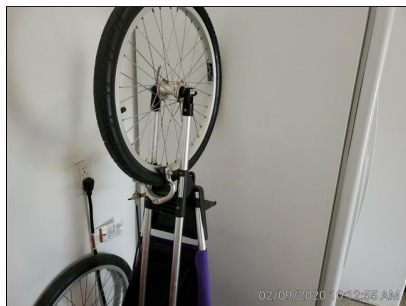
All the outlets in garage were GFCI protected on 1 circuit meaning that if once tripped, your garage freezer will lose power. I recommend replacing one of the outlets with dedicated non-gfci outlet to prevent food going back in freezer due to a trip.

Freezer on GFCI outlet

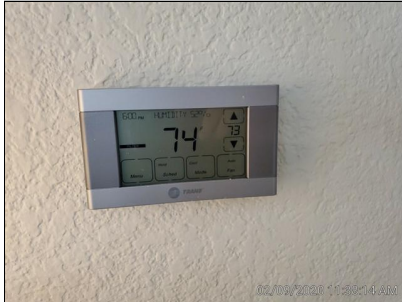
Thermostat is different brand (Trane) than units (Lennox)

At time of inspection, cooling system appeared to be functioning as intended. The ambient air test was performed by using infrared thermometer on the air vents to determine if the difference in temperatures of the supply and return air vents

Return-75 Average at vents-60 = 15 degrees Delta T (Temperature drop was normal at vents)

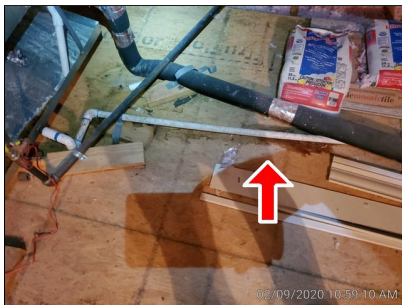
Missing insulation on 2ndary Condensate Drain pipe

Due to it being in the middle of summer, I highly recommend a seasonal service of the AC equipment using the following checklist:

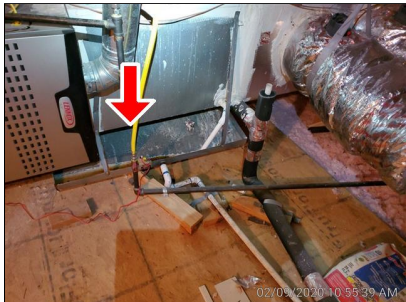
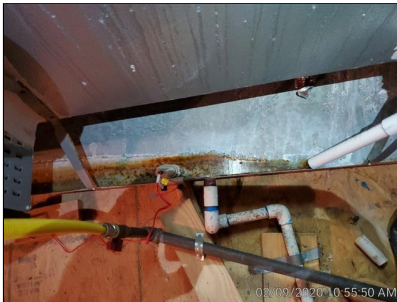
At time of inspection, a condensation drain line appeared to be clogged due to algae build-up inside. This condition may cause failure of unit and water damage of ceiling. The Inspector recommends cleaning out line by having an HVAC specialist service unit.

1" Water in Drip Pan

Clogged Condensate Drain Line

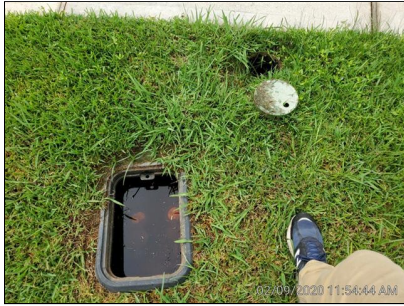
Limited Inspection: Main Water Line and Shut-Off Valve Was Not Fully Visible

I was unable to see most of the main water line and water shut-off due to excessive water in meter box.

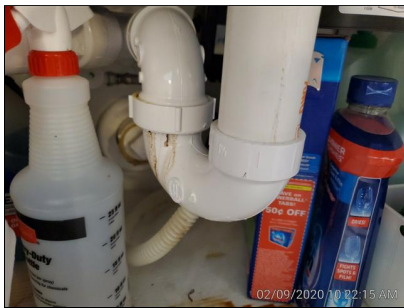
Previous Clog

The p-trap on waste line had water stains at connection indicating it had leaked and corrected itself for the time being at the Kitchen sink. . No apparent problems were found.

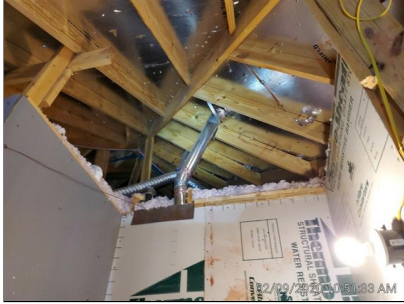
Attic

14 Potential Fire Hazard-

The dryer vent piping is long and vertical which can trap lint at elbow. Vent pipes should be cleaned regularly if they are vented vertically. I recommend cleaning this vent pipe out before use and consider moving exhaust discharge to the side wall so that you don't have to remember to clean them out every year or so.

Potential Fire Hazard-
