**BPG Inspection, LLC**

Client(s): Wiede  
Inspection Date: 1/13/2022  
Inspector: JB Atterberry , 24834

**Concerning:** 1523 Pine Gap Drive, Houston, TX 77090

**By:** JB Atterberry 24834 / BPG Inspection, LLC 1/13/2022

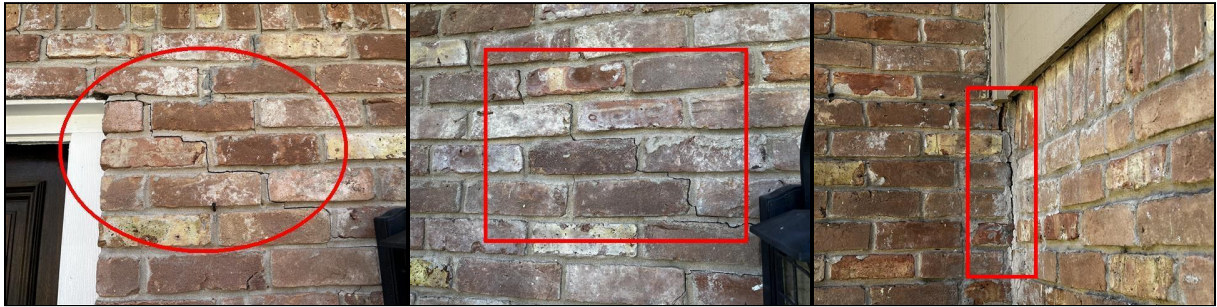
Minor differential movement/settlement observed as indicated by exterior mortar crack(s) and interior sheetrock ceiling and/or wall crack(s), door(s) that are not square in the jamb, and/or bind, etc. Movement appeared to be minimal at time of inspection.

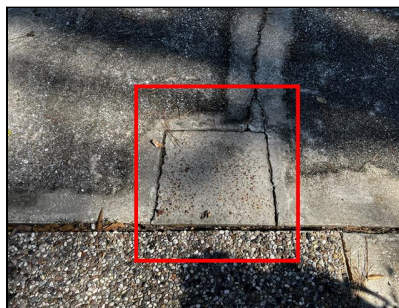
Previous repairs to the foundation have been disclosed and/or were detected. Refer to the seller for any documentation and possible warranties for further information.

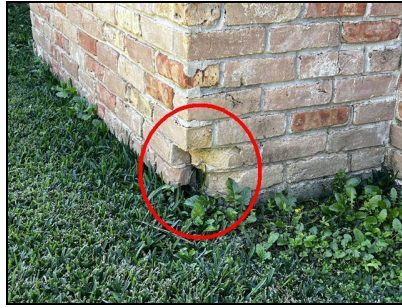
Brick was broken/missing at the exterior of the fireplace, at time of inspection. Recommend repair by a qualified Mason.

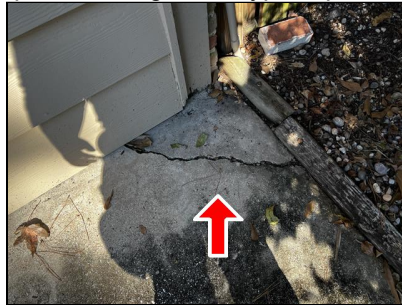
Rear of home

Corner cracks were observed at the corners of the slab foundation. Cracks of this nature are typical and occur when the exterior veneer is warmed by the sun and the wall expands. This condition is also a conducive condition for termite infestations. I recommend you contract foundation expert to repair mortar as needed to prevent further separation. Sidewalk repair caulking is the typical product used for this repair.

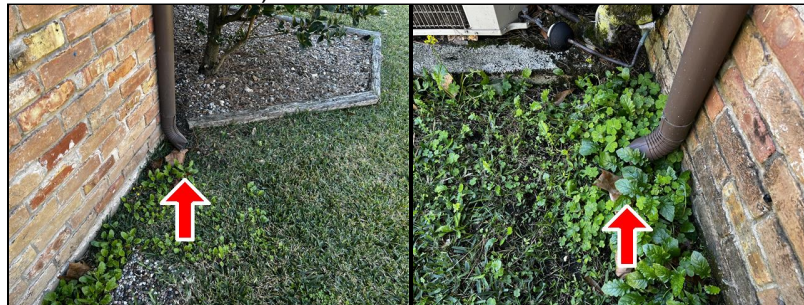
Gutter downspouts should discharge water at least 36 inches away from the foundation. Storm water should flow freely away from structure at points of discharge. (Discharging roof water next to the structure has the potential of causing foundation movement)

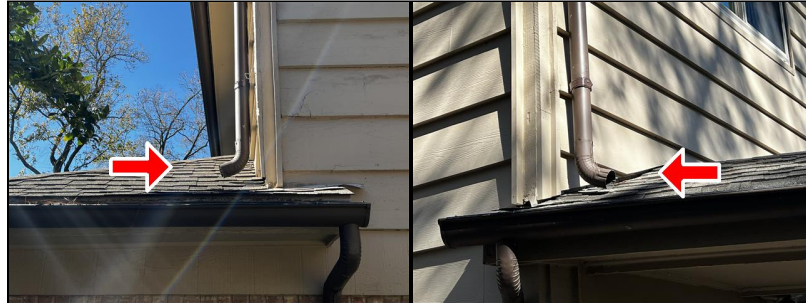
Recommend that upper story gutter downspouts extend down into lower gutters, or directly down to grade.

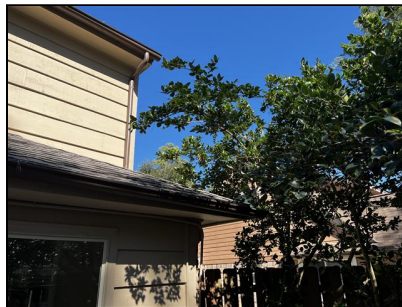
Tree limbs that are in contact with roof or hanging near roof should be trimmed back 3-5' to prevent any damage to the roof covering.

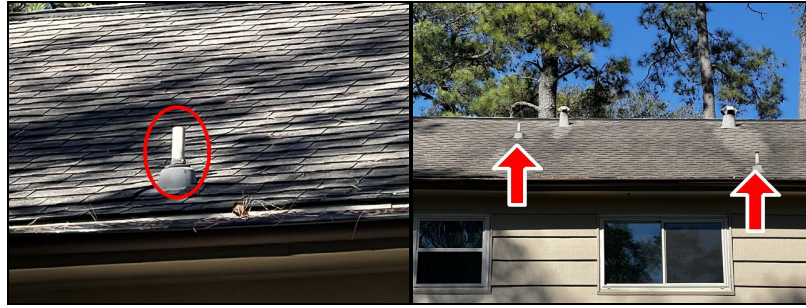
Paint is needed on bare metal flashing, vents or PVC pipes. This will prevent rust and also UV damage to the pipes.

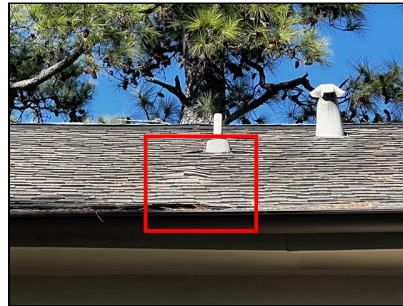
Noted areas of roof with buckling shingles. Buckling shingles can quickly lead to leaks. Buckling shingles can sometimes be traced back to mistakes made during roof installation. Recommend having a qualified roofing contractor fully evaluate and recommend corrective actions and if needed.

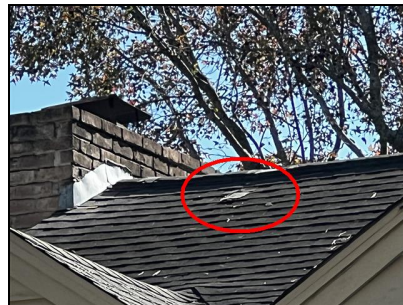
Noted an area on the front left side of the roof that missing/deteriorated shingles. Recommend having a qualified roofing contractor repair/replace affected area.

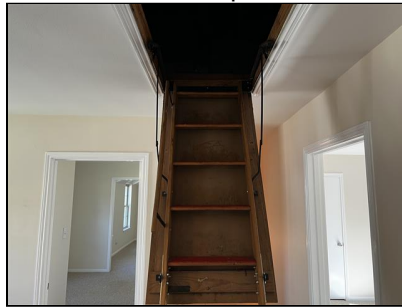
Observed the attic pull down ladder/hatch is not insulated completely, nor does it have weather stripping installed at edge of door that meets ceiling framing. Recommend fully insulating the attic stairway to keep the house more energy efficient. On average the insulation R-value for the entire attic area will drop approx. 27% when the attic stairs/hatch is not fully and properly insulated. The reason for this is that, although the attic stairs/hatch account for only 1% of the total attic area, the rate that heat flows through them by conduction (per square foot) is 38 times higher than in the insulated part of the attic.

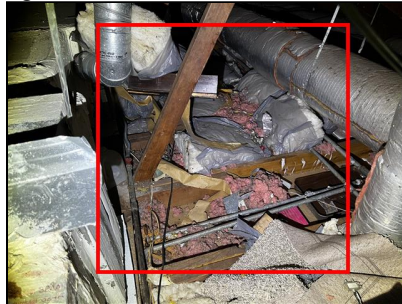
30 inch work space/platform missing in front of HVAC unit.

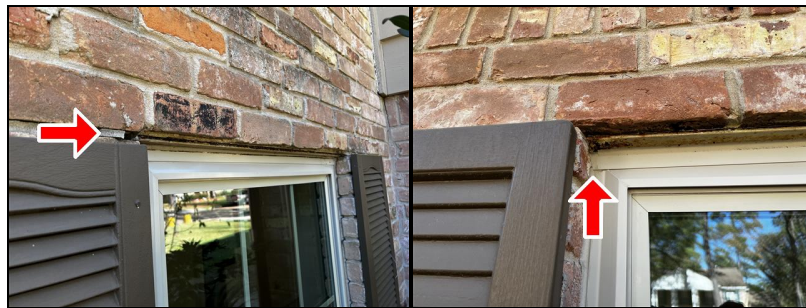
Lintels/headers above doorways, windows are rusting. Recommend remediation of rust, application of rust prohibitive paint.

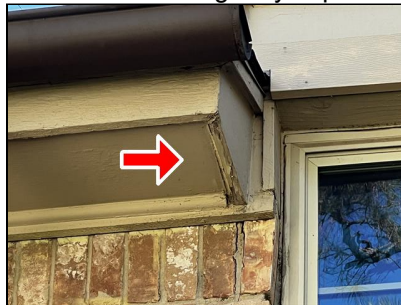
Paint appears weathered on exterior. Power washing may improve look, but paint may be necessary.

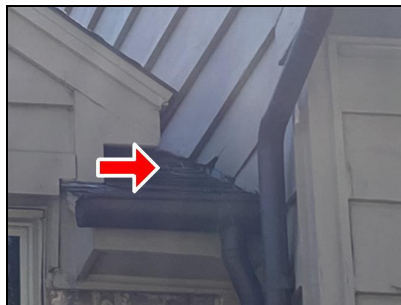
There are areas of the front of home exterior wood siding, trim, fascia, drip edge, door jambs, etc. that have sustained varying levels of water (rot) damage and is in need of repair. Recommend further investigation to determine if any further hidden areas need attention or repair.

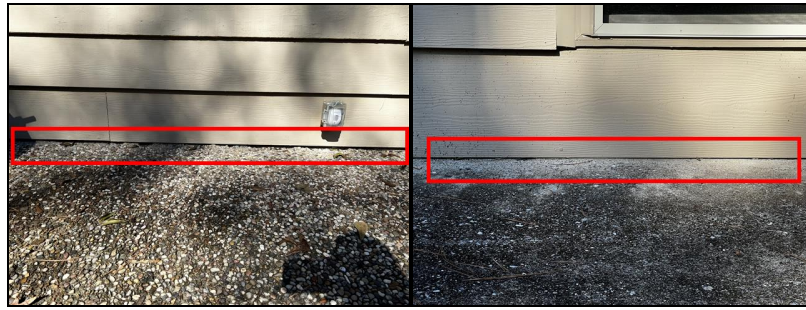
Rear siding has been run all way down to slab covering cold joint between patio and foundation slabs. This hidden area is a known conducive area for termite infestations. I recommend a pest control maintenance program that includes monitoring and treatments as needed.

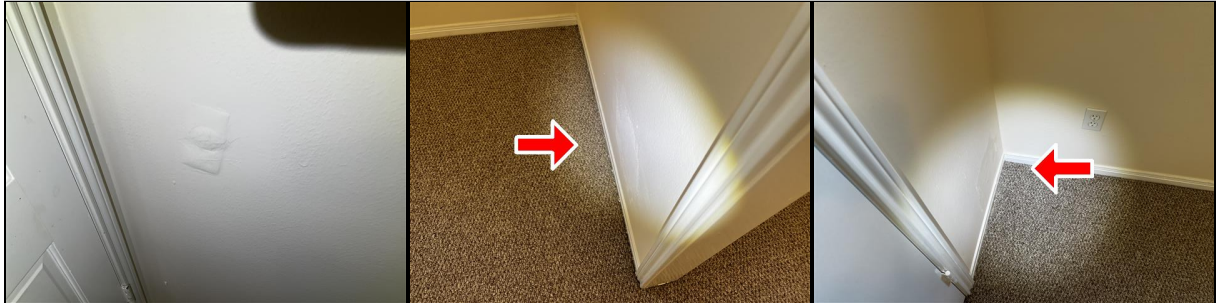
Noted areas of the walls that have prior repair.

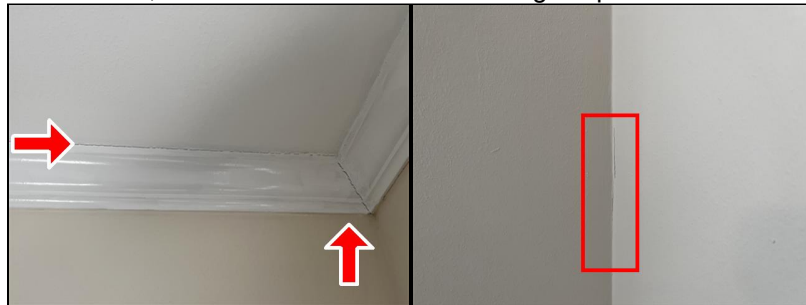
Cracks on walls in various areas, consistent with structural settling. Repair as needed.

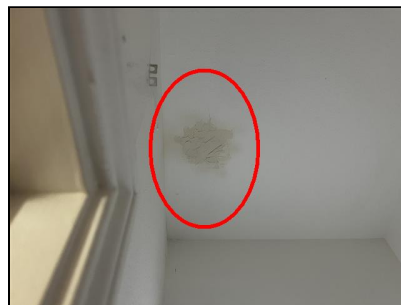
There is evidence of previous repairs on the ceiling in the master bedroom (sitting room closet). There was no prior disclosure of this repair, and no evidence of damage in the attic. I recommend you query the owner for the history on this area.

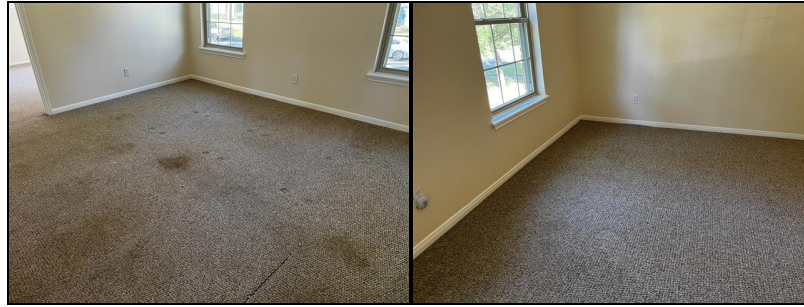
Found at various places at 2nd floor where the floor squeaks and pops when foot pressure is applied. This is

usually caused by improper fasteners applied to the wood decking. After original installation and a period of time elapses the improper fasteners have a tendency of backing out causing the sub-floor to loosen, thus causing floors to squeak/pop. Recommend properly repair floor with the appropriate fasteners.

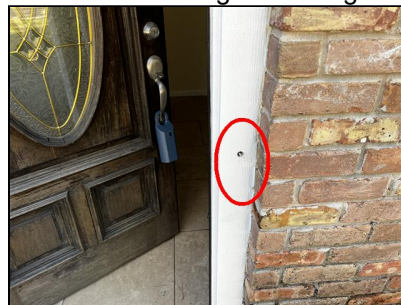
The door bell switch is loose from the wall and/or damaged/missing. Repair is advised.

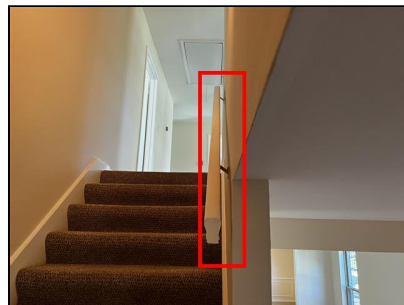
Staircase handrailing does not turn back into the wall as called for by today's standards

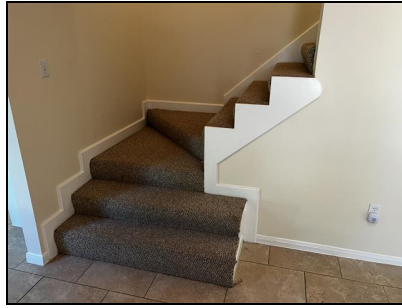
Spiral staircases are typically not safe as they do not conform to current building safety standards (narrow treads, open risers, railing/balusters improperly spaced). Use them with caution, and consider having a contractor upgrade structure to current safety standards.

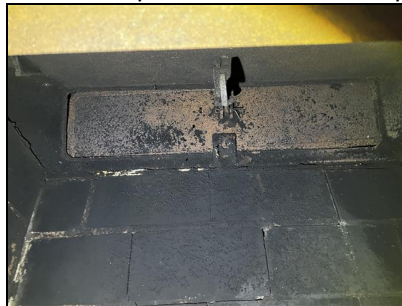
Fireplace does not have a damper blocking device installed as called for by today's standards in fireplaces with gas log systems. <http://damperclamp.com/installation.php>

The damper for fireplace at the same location is rusted tight or "seized" (non-operational). Repairs should be made so unit works properly. Recommend a qualified contractor inspect and repair as needed.

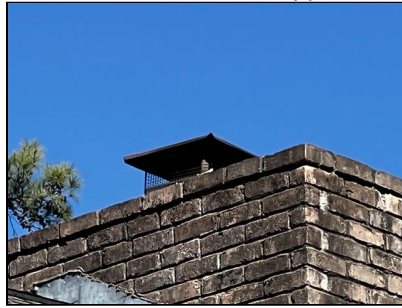
Chimney cap is rusted. Recommend remediation of rust, application of rust prohibitive paint.

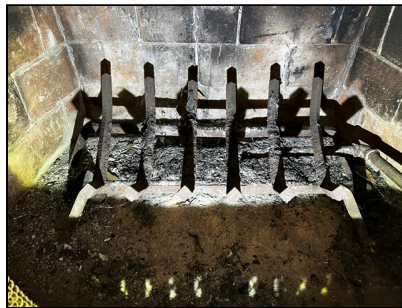
The fireplace firebox and flue are dirty, which restricted my visibility. Recommend having the firebox and flue cleaned by a qualified chimney sweep and evaluated at that time. Clean every 200 fires (every 100 fires for a wood burning stove or insert).

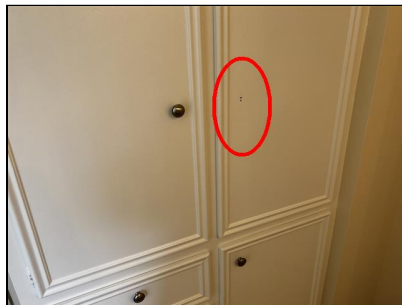
Cabinet pull knobs missing in areas of the master bathroom.

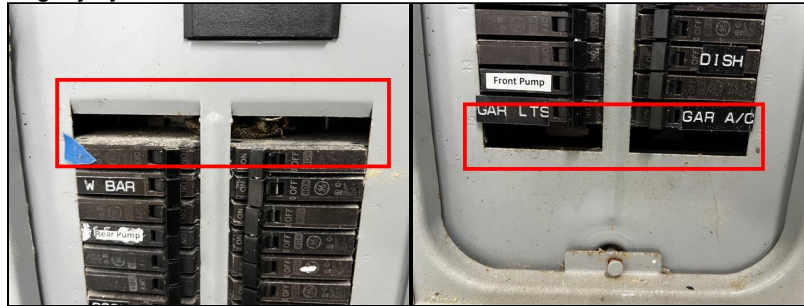
Knockout covers are missing in main panel. These should be replaced to prevent access to live electrical components, preventing injury.

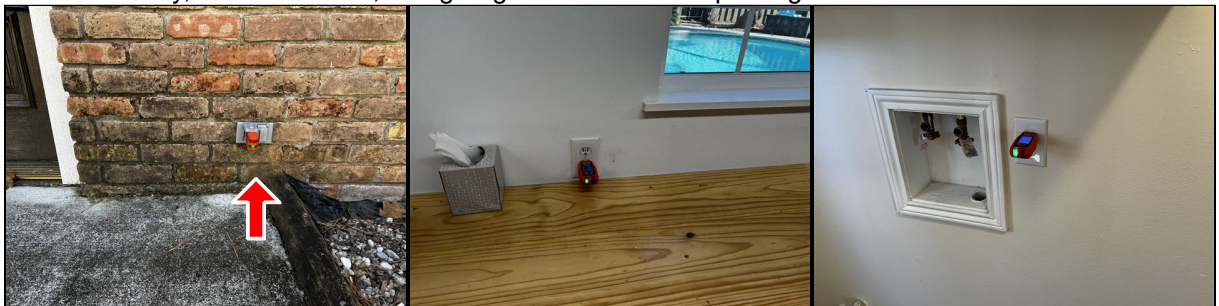
There are no GFCI (Ground Fault Circuit Interrupt) protected outlets in locations called for by today's standards: laundry, exterior outlets, and garage. I recommend updating to current standards.

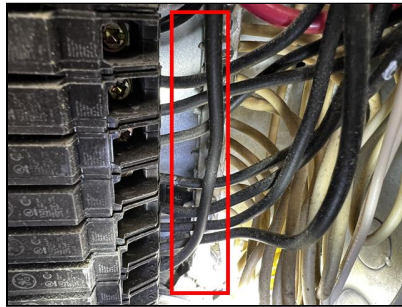
Aluminum wire is installed on 120 VAC branch electrical circuits in the subject house. These single strand, branch circuit aluminum wires were used widely in houses during the mid 1960s and 1970s. According to the U.S. Consumer Product Safety Commission, problems due to expansion can cause overheating at connections between the wire and devices (switches and outlets) or at splices, which has resulted in fires. For further information on aluminum wiring contact the U.S. Consumer Product Safety Commission via the Internet at <http://www.cpsc.gov/>. It is recommended that the electrical system be evaluated by a licensed electrician.

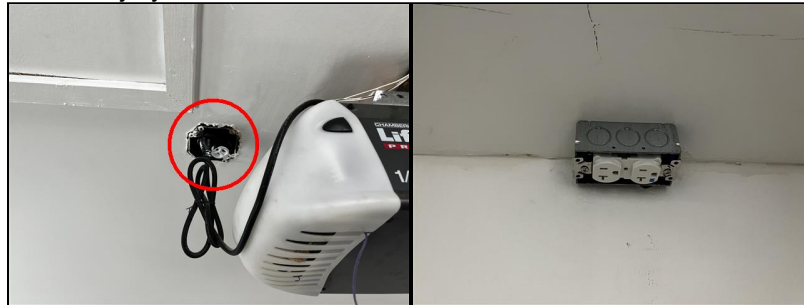
Located in the garage

Replace missing/damaged cover plates on various outlets and switches. Prevent access to live components that can cause injury or electrocution.

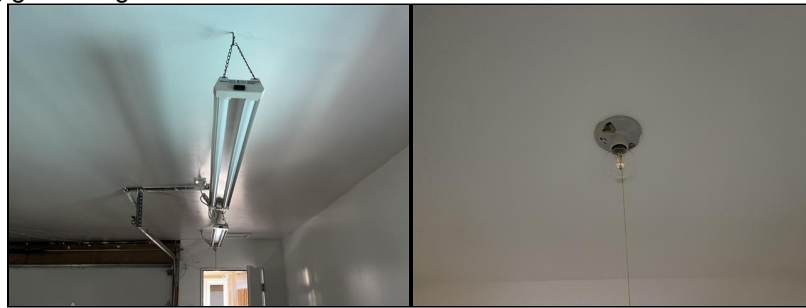
Noted light fixtures at closets, attic area, and garage that are not properly protected by globe or guard. Recommend having globe or guard installed at affected fixtures.

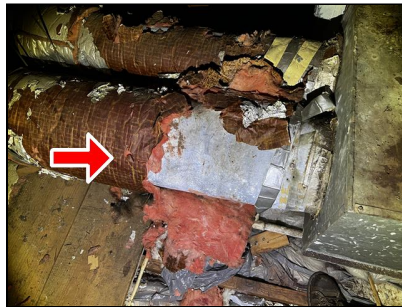
Ducts/duct insulation are damaged in areas of the attic. HVAC technician should repair as necessary.

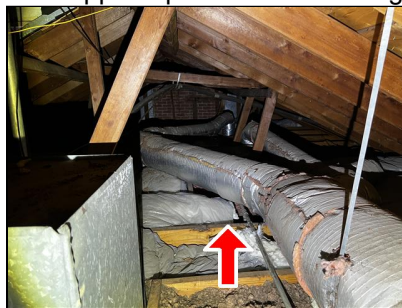
There are several duct runs that are not strapped up to the roof framing as called for by today's standards

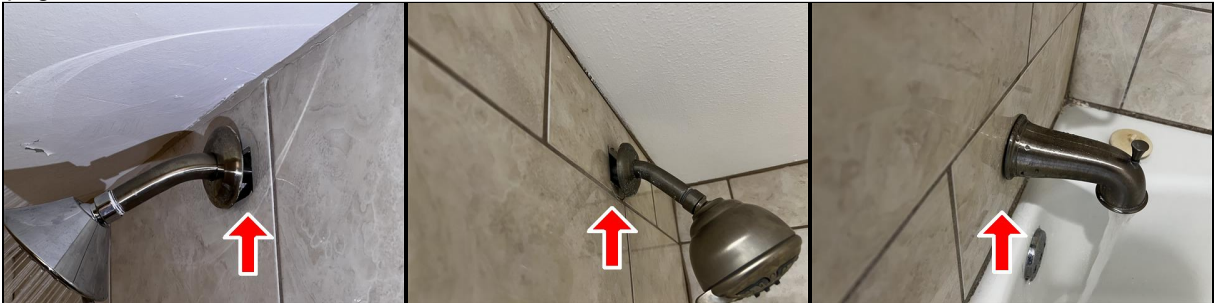
The bathtub fill spouts and/or controls need to be reseated and sealed (caulked) to prevent moisture seepage into tub surround.

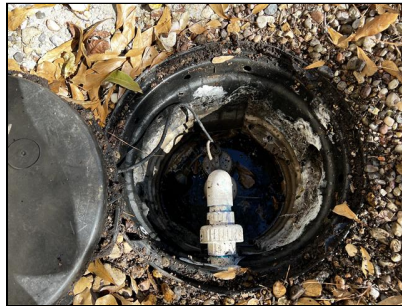
Property did have a sump pump, located on the rear of the garage. Sump pump was functional at time of inspection.

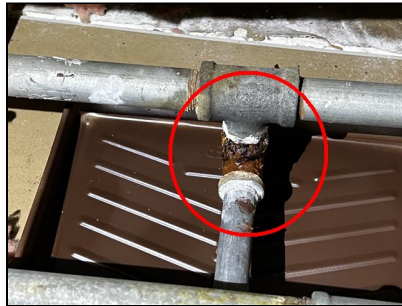
Noted a galvanized water supply pipe that is rusted. No leaking was noted at time of inspection. Recommend repair/replacement by a licensed plumber.

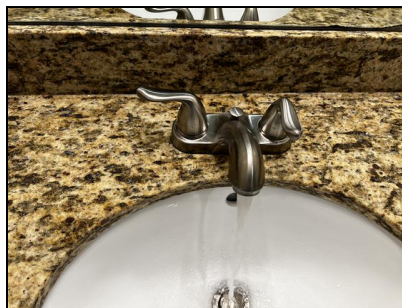
Noted faucet in the upstairs shared bathroom was loose. Recommend repair by a licensed plumber.

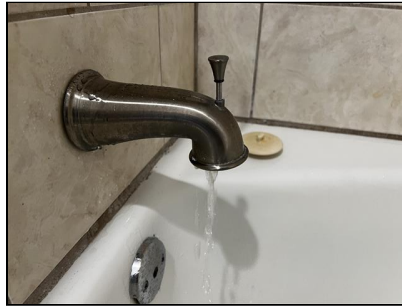
The water at upstairs tub nozzle would not terminate when showerhead was activate over the tub. Each is to dispense water independently of each other at 100%. Recommend properly repair/replace the shower diverter at the tub.

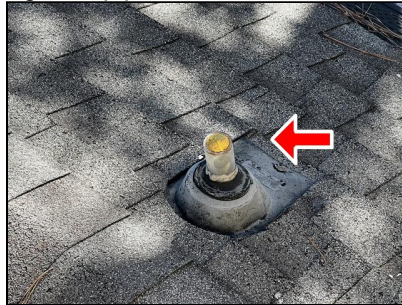
❌ There is foam in one of the plumbing vent pipe on the roof and should be removed.

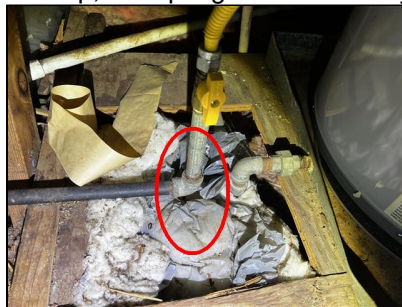
Gas supply to unit is missing a sediment trap, or drip leg as called for by current standards.

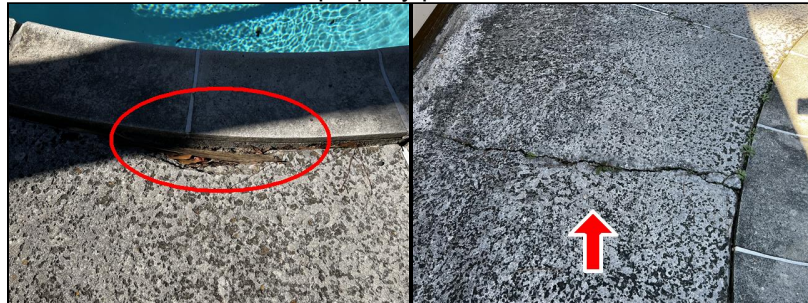
Noted some cracking, movement or missing or aged sealant around areas of walking deck. Recommend having area repaired and sealed as needed to properly protect.
