74 E Kentwick Pl  
The Woodlands, TX 77384

# PROPERTY INSPECTION REPORT FORM

<u>Annette Agafon</u> <i>Name of Client</i>	<u>04/27/2023</u> <i>Date of Inspection</i>
<u>74 E Kentwick Pl, The Woodlands, TX 77384</u> <i>Address of Inspected Property</i>	
<u>Sean Salinas</u> <i>Name of Inspector</i>	<u>21192</u> <i>TREC License #</i>
<u>Chris Stull</u> <i>Name of Sponsor (if applicable)</i>	<u>20945</u> <i>TREC License #</i>

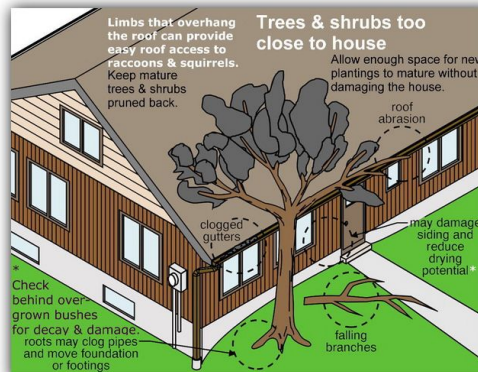
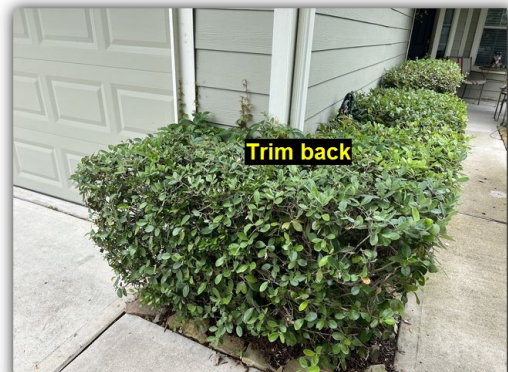
Spalling (i.e., corner pops) at one or more corner(s), Corner spalling is common to slab foundations and does not affect the structural integrity of the foundation.

Observed a surface crack on the foundation at the rear side of the house.

Recommend vegetation be cut back away from exterior of home to prevent damage.

Buyer's note: Ensure flower bed soil does not rise above foundation or brick weep holes to prevent water and wood destroying insect entry into house.

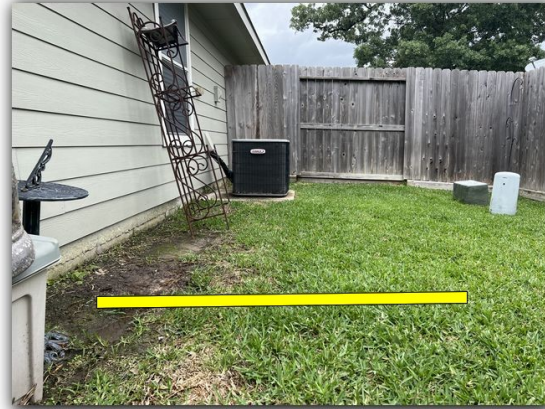
Observed the grading did not slope away from the home in one or more areas around the exterior. Current standards call for the grading to slope away from the home at least 6 inches per 10 feet. This is to prevent water from pooling close to the foundation which can cause damage. Remedies may include adding rain gutters, French drains or re-grading around the home.

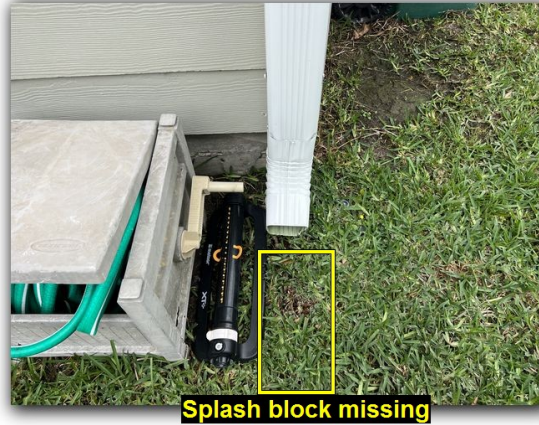
*One or more splash blocks missing. Recommend adding splash blocks to divert water away from the foundation.*

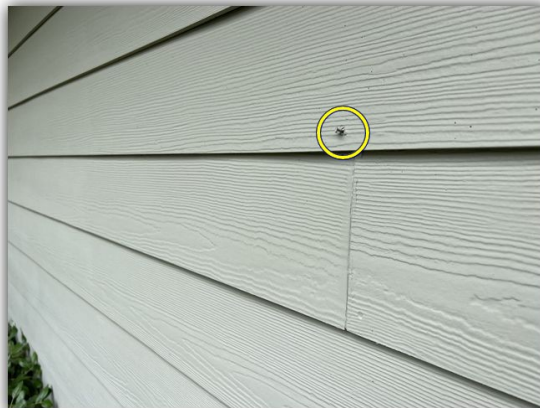
*Observed a loose nail on cement board siding at the front walkway.*

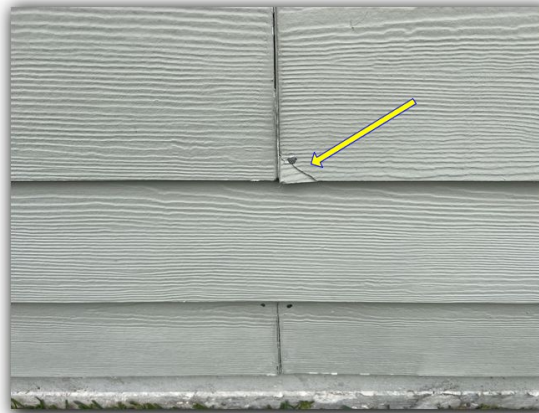
*Observed cracked / damaged corners on Hardy siding. Commonly caused during construction by over driven nails.*

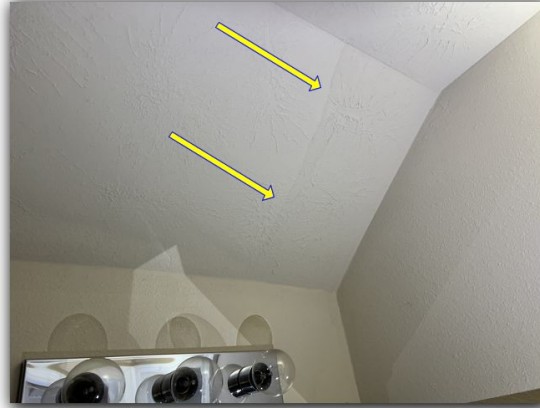
Observed water stains on the ceiling in the second floor bathroom. Moisture readings were low at time of inspection which usually indicates the stains are from a previous leak, but I could not be certain. Recommend asking the seller about a previous leak that may have been repaired or having further evaluation by a contractor.

*Observed water stains on the ceiling in the second floor bathroom. Moisture readings were low at time of inspection which usually indicates the stains are from a previous leak, but I could not be certain. Recommend asking the seller about a previous leak that may have been repaired or having further evaluation by a contractor.*

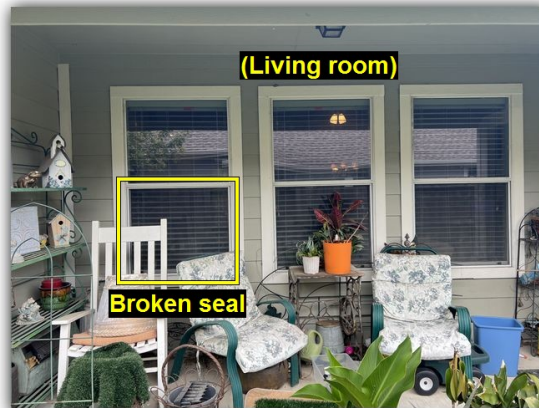
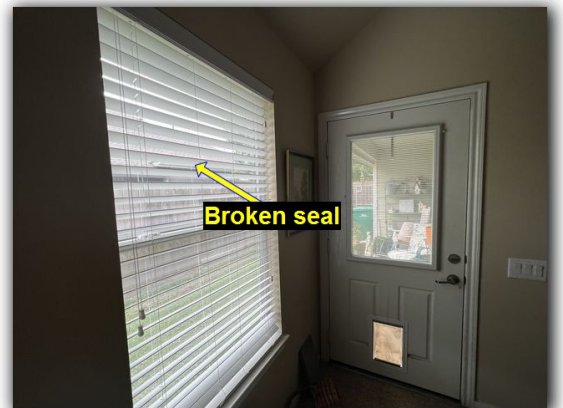
Observed the thermal seal was broken on two or more windows (including but not limited to: living room & near rear patio door). A broken seal allows condensation to form between the panes which causes a cloudy film to develop. This cloudiness can continue to get worse until it is difficult to see out of the window. Recommend further evaluation by a qualified window repair company.

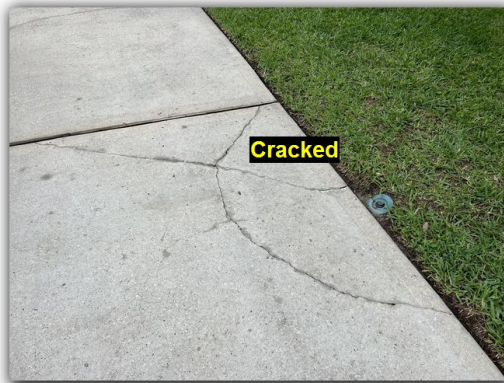
*Cracks in walkways, driveway and/or garage concrete observed, typical.*

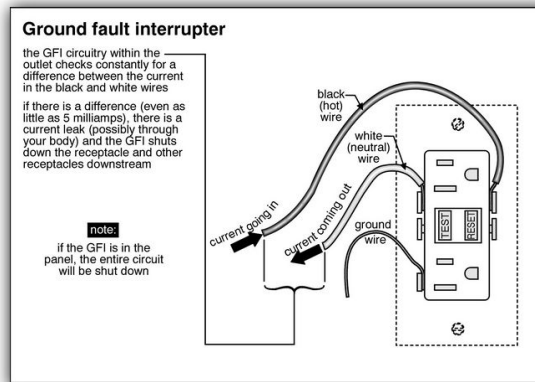
Did not observe GFCI protection for all outlets in required locations, including but not limited to; all laundry room, living room side of kitchen bar. Current standards call for GFCI protection for all outlets in the kitchen, bathrooms, laundry room, garage, exterior and any outlet that is within 6 feet of a water source. This condition is a recognized safety hazard.

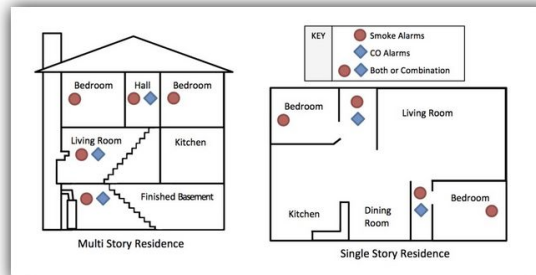
Inadequate number and/or improper location of smoke detectors in home. Smoke detectors should be located on each level of the home AND inside AND outside of all sleeping rooms. Consult the smoke detector manufacturer's instructions regarding specific placement of detectors.

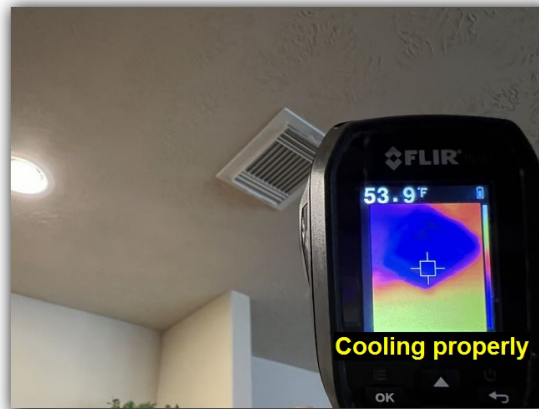
A thermal image of the air vents show the air conditioning unit(s) cooling properly at time of inspection.

TEMPERATURE DIFFERENTIAL: 18 degrees (72, 54) **GOOD**

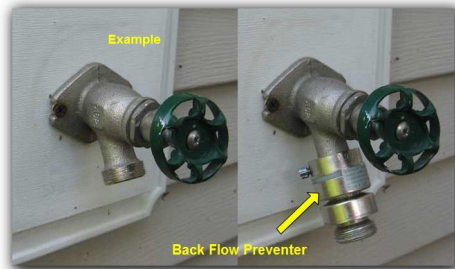
*Some exterior hose spigot(s) do not have code approved anti-back flow devices installed. Note: Back flow preventers cost approximately \$5.00 and are easy to install.*

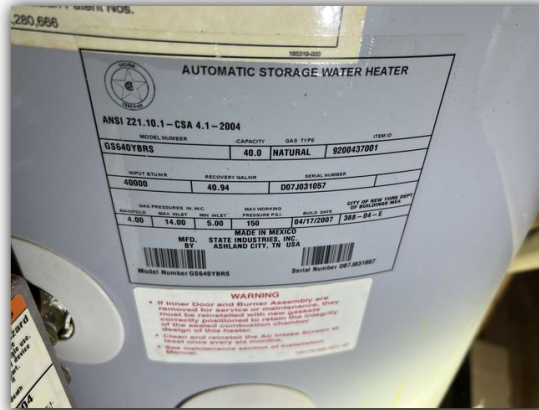
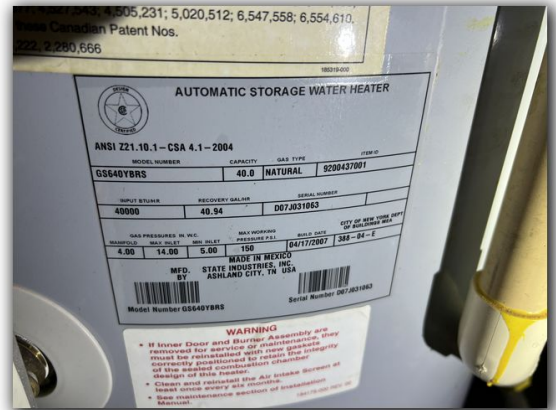
WATER HEATING UNIT(S): STATE (2007), 2 UNITS

*Rust / corrosion observed at connections on top of water heater, corrosion can eventually lead to leaks.*

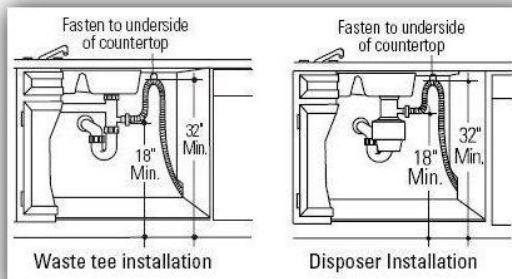
Did not observe a high loop or air gap installed for the dishwasher. The high loop or air gap prevents gray (dirty) water from backing into the dishwasher if the disposal or drain becomes clogged.

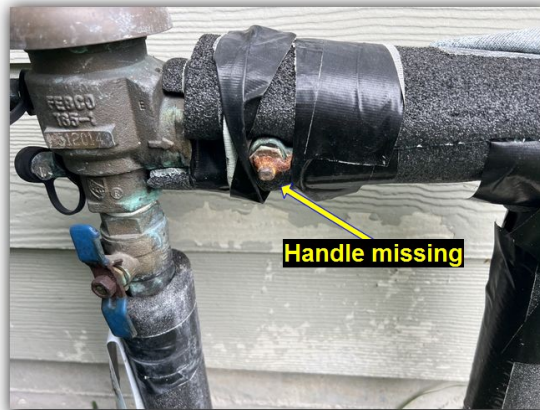
Observed a missing shutoff handle at the backflow preventer. Recommend replacing the handle.
