DEAVERS ENGINEERING LLC

Reference: 3323 Kentwood Drive

Foundation Inspection

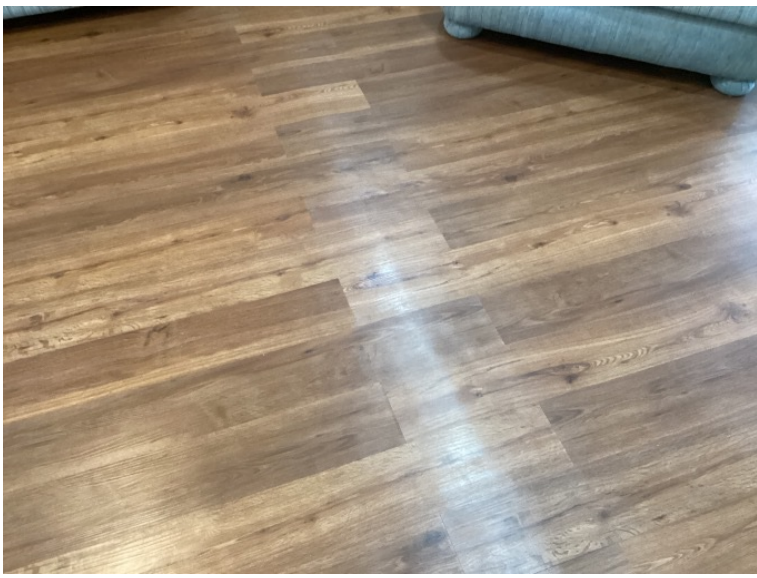
Hump noted between initial foundation and 1st addition. Appears to be larger than it is due to light and flooring layout. Hump appears to be at its maximum .5". 1st addition section appears to be slightly raised from original slab.

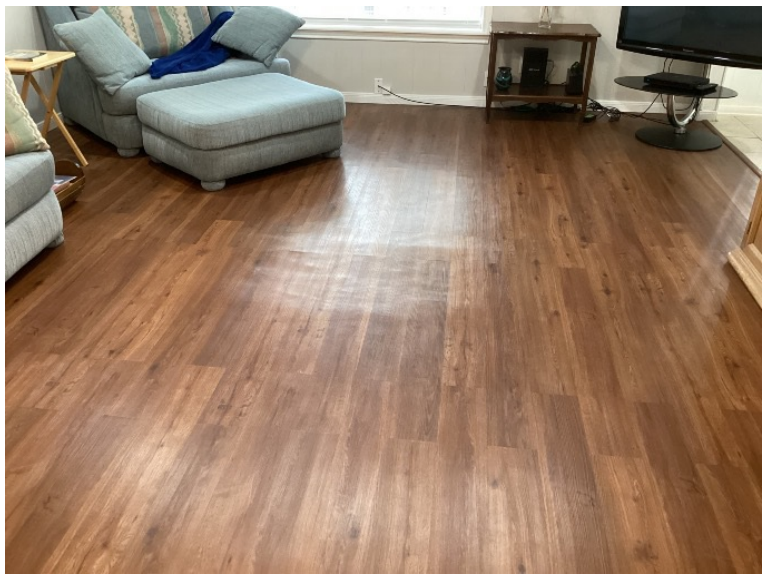
Hump and 1st addition section as seen from living room, facing rear.

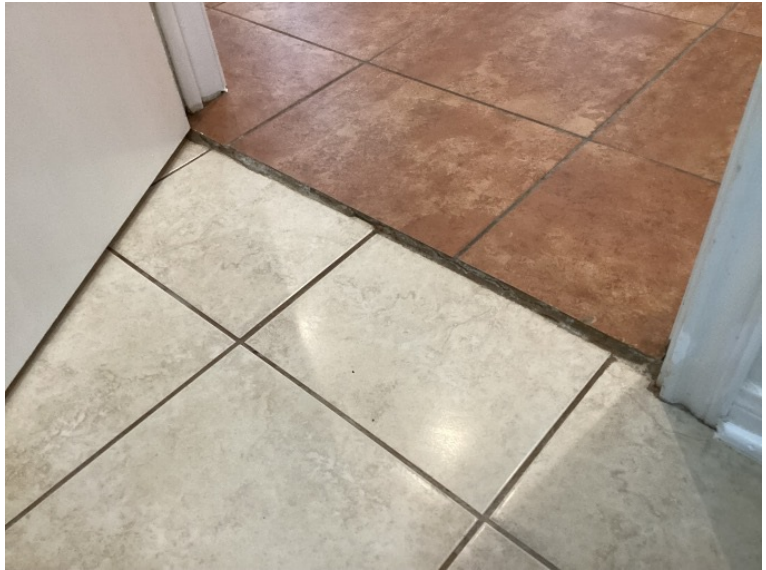
Threshold between kitchen (1st addition/white) and 2nd addition (red). Approximately .5" variation between the two flooring types.

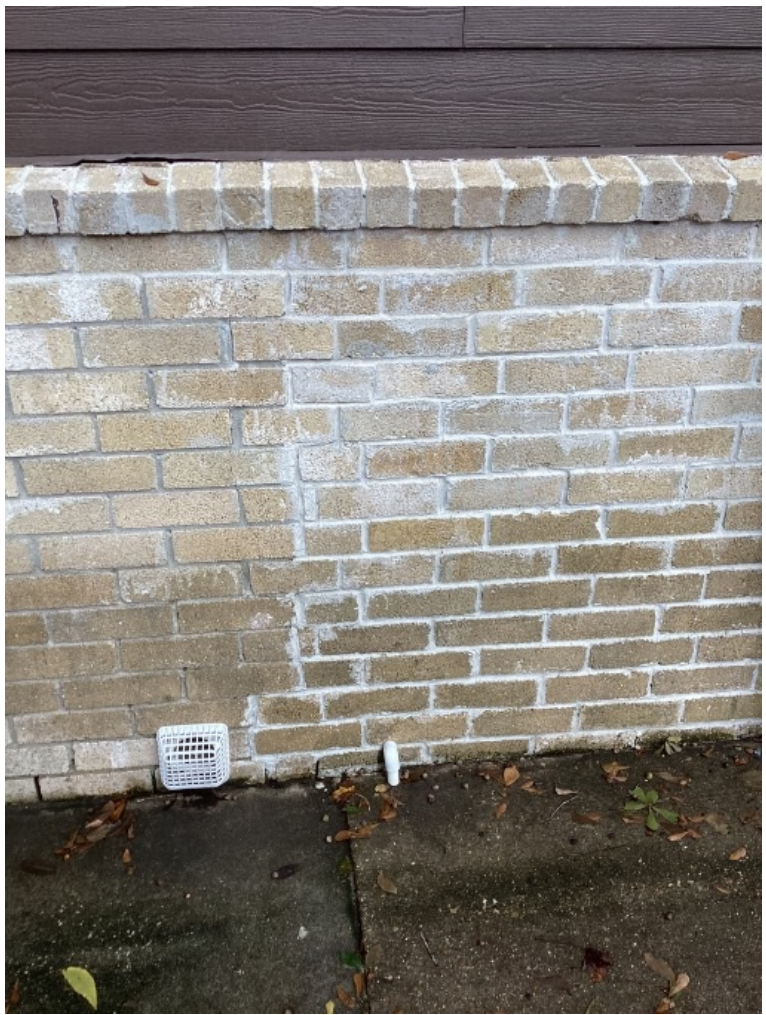
Junction between the garage and the 2nd addition brick facade along the right side of the home.

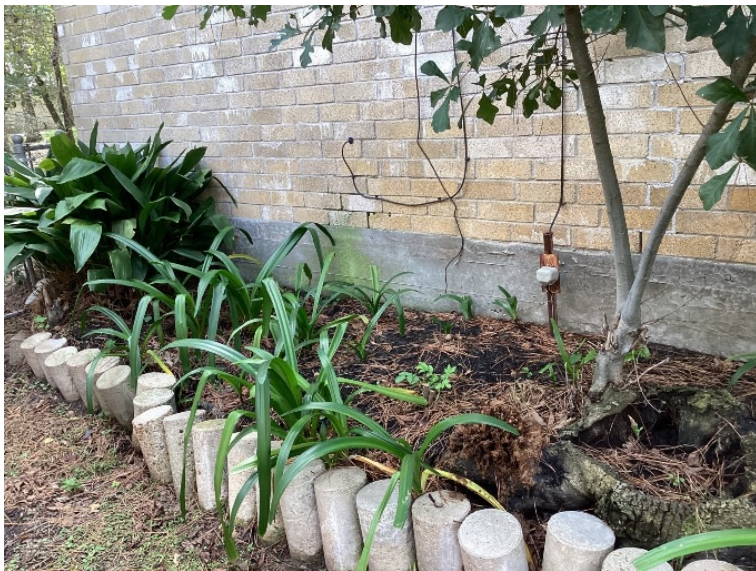
Foundation exposure at front, for reference. No cracking noted at the foundation at any location.

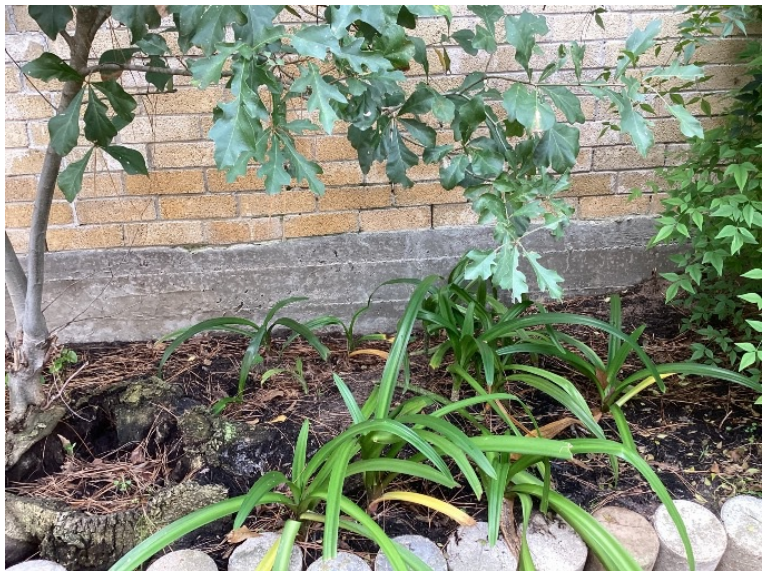
Foundation exposure at front, for reference. No cracking noted at the foundation at any location.

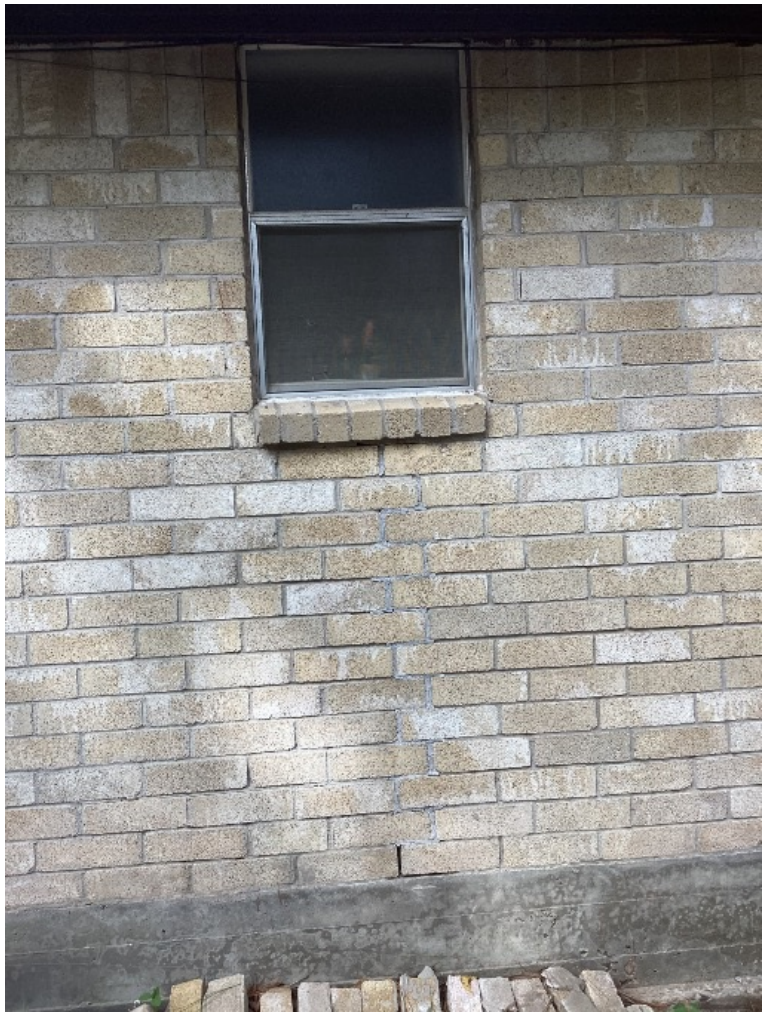
Mortar cracking from hallway bath window to foundation, left side of the home.

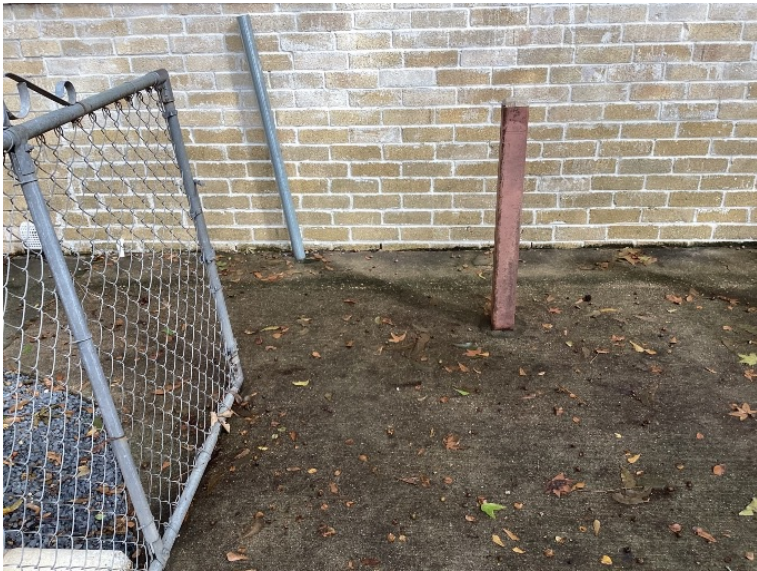
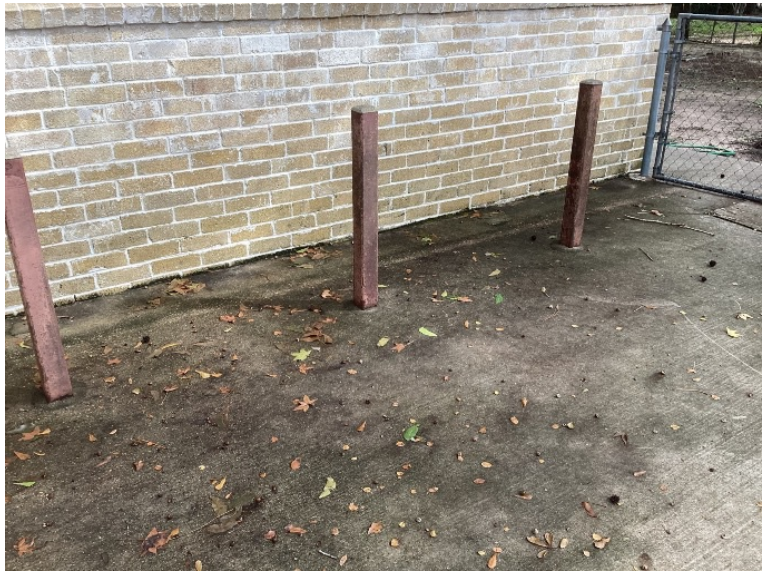
At the right side of the home, a driveway has been poured against the home with a negative slope. This driveway is in place above the bottom run of the brick and is obstructing some weep holes along the rear section.

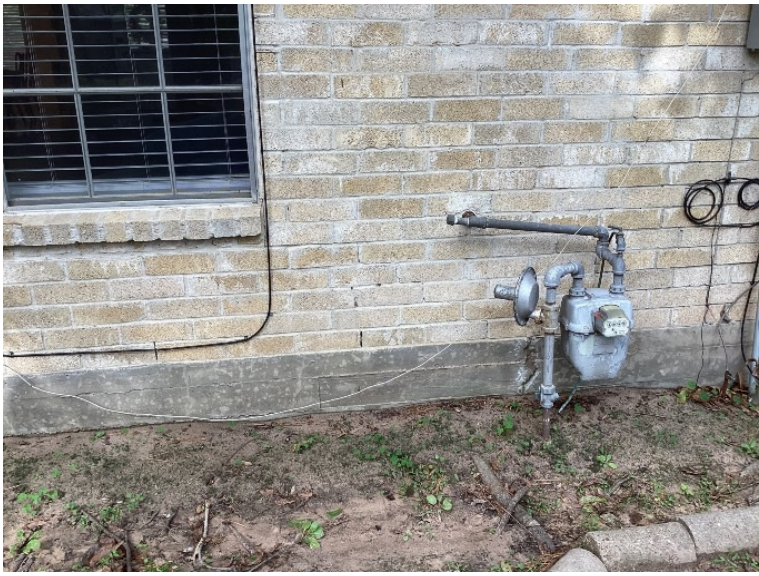
Stairstep cracking from window to gas meter, rear left of home.
