Property Inspection Report

Texas Premium Inspections

1213 55th St

Date of Inspection: 6/17/2023

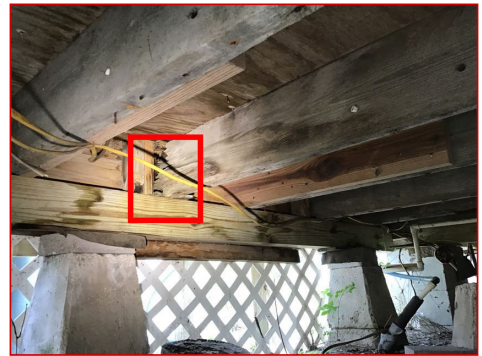
- The home had uneven floor framing not unusual in a home of this age, of this quality, located in this area.
- Damaged to floor joists should be repaired by a qualified contractor.
- Floor joist had less than the recommended 1.5 inches of bearing at their end. The inspector recommends additional bearing be provided.
- Evidence of foundation slope is evident throughout the structure. Recommend a qualified, licensed foundation company to evaluate, assess and offer remedies for possible repairs as needed before your Inspection Objection Deadline has expired.

Damaged framing

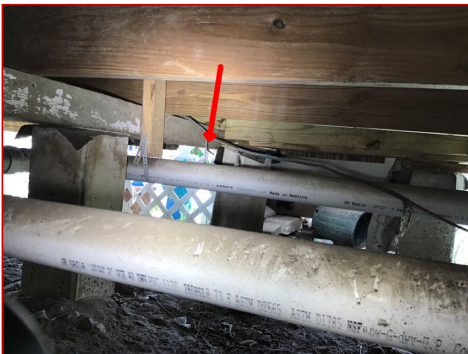
No end support, front

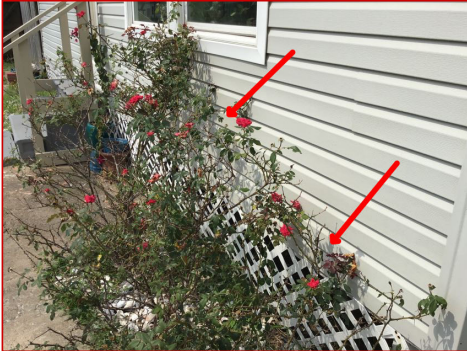
Cut back vegetation

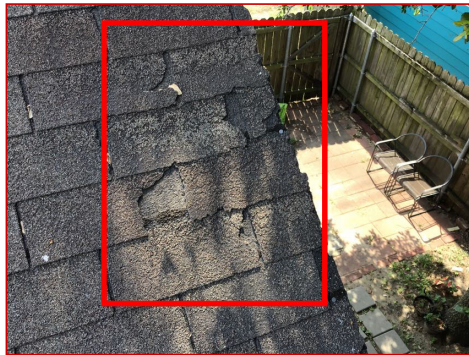
- **The roof had several cracked, damaged and/or broken shingles, that should be replaced to help prevent damage from moisture intrusion to the home materials, the roof structure and to prevent damage like decay, or development of microbial growth such as mold.**

Damaged shingles

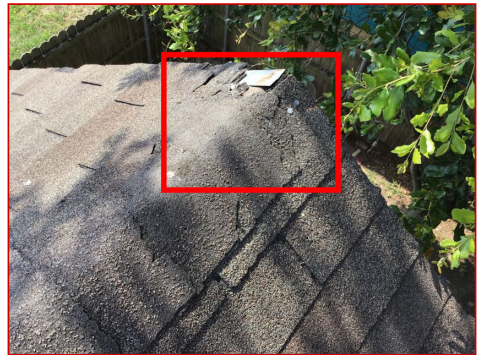
Damaged/ missing shingles

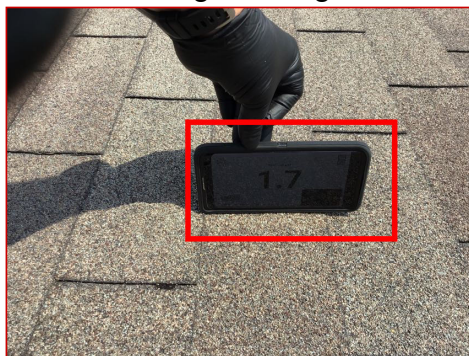
- **Asphalt shingles on portions of the roof on this structure were installed on roof slopes having less than 2 & 12 minimum slope required by manufactures for the warranty to remain in effect. Due to the low slope of the roof being under 2/12, the roof covering is improper for this application. A modified bitumen, thermoset single ply, liquid applied, rubber or a sprayed polyurethane foam roofing should be used to keep water from infiltrating the structure. This present condition highly increases the chance of leakage in this area.**

Area of low slope

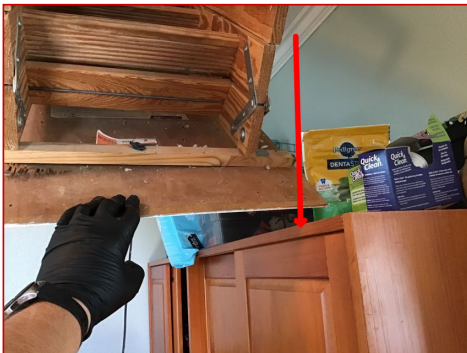
- Roof vents, also called turtle vents, were installed as part of the roof structure ventilation system.
- The occupant's belongings blocked access to the attic access hatch and the attic was not inspected. Moving the occupant's belongings exceeds the scope of the General Home Inspection. Because defective conditions may exist in the attic, the Inspector recommends that it be inspected by a qualified inspector after access has been provided.

Obstructed attic access

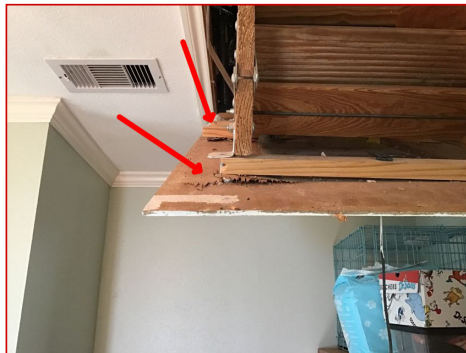
Damaged attic ladder

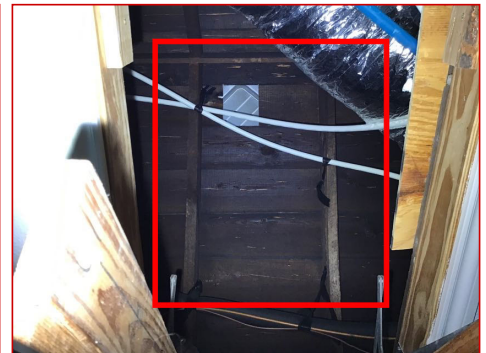
Blackened sheathing

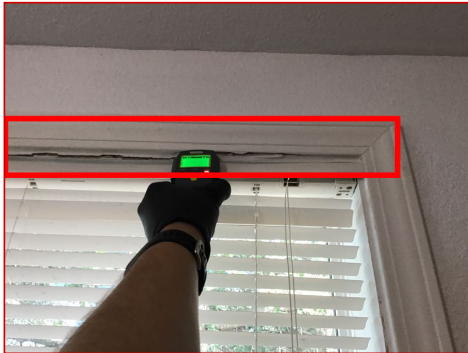
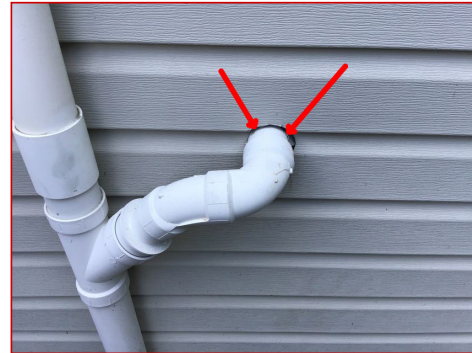
Evidence of moisture intrusion, rear bedroom

Seal all pipe penetrations

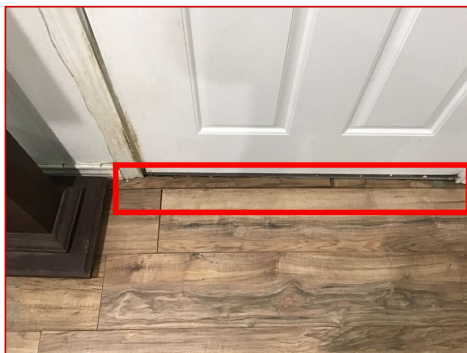
Damaged laminate flooring

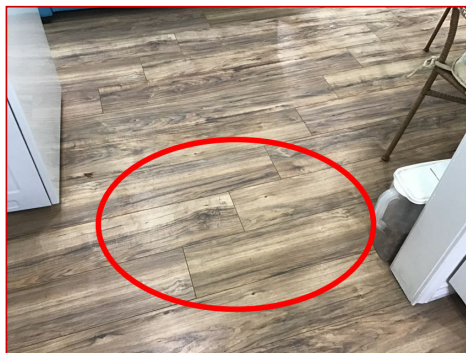
- There are areas of concern in the sub flooring that move and sink when pressure is applied compromising the support of the sub flooring / soft spots! Due to the floor covering, inspector cannot visually see damage or issues. Inspector recommends that further investigation of these areas should be completed before your option period has expired.

Soft area noted

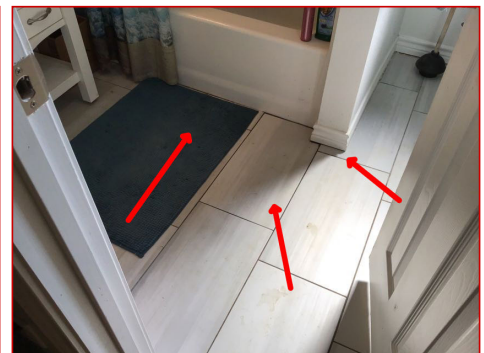
- Sagging floors are apparent. This condition could indicate greater than normal movement within the structure and potential structural problems could exist.

Sagging floor, attached bath

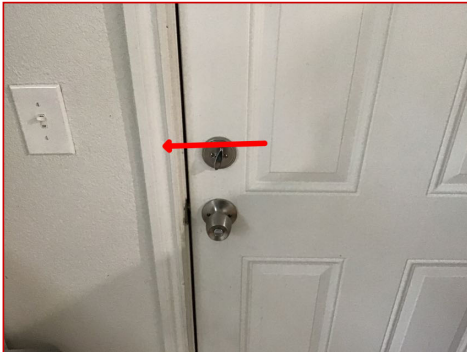
Inoperable deadbolt, left

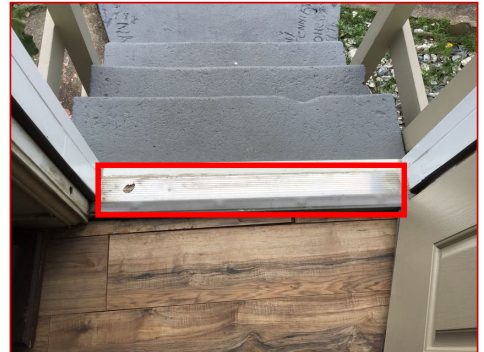
Inadequate support below threshold

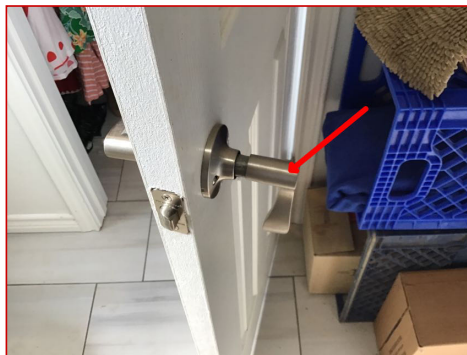
Loose hardware, bath closet

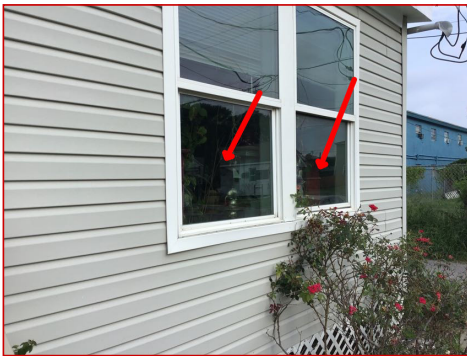
Example of missing screens

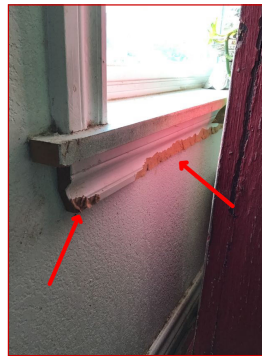
Damaged trim, living room

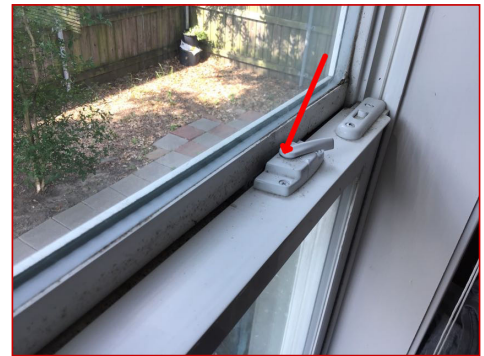
- One or more windows did not lock / latch. Recommend repair for safety purposes.

Misaligned latch, rear bedroom

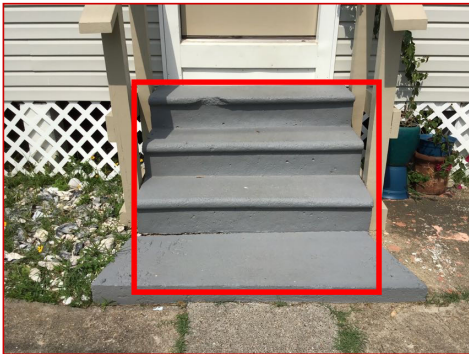
Uneven stairway/ riser height varies

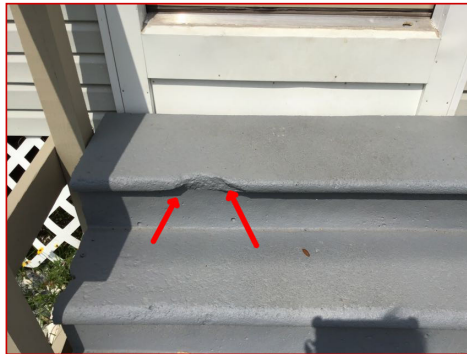
Damaged tread

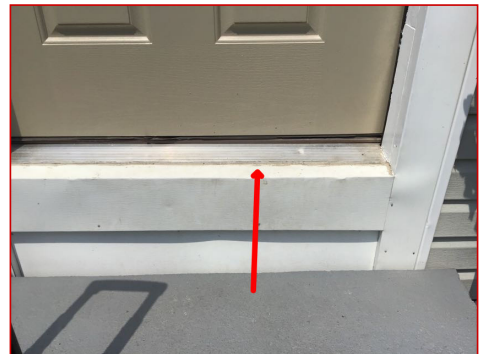
- Exterior stair risers exceeded the 7 3/4-inch maximum recommended by generally-accepted current standards. This condition is a potential trip hazard.

Exceeds maximum riser height

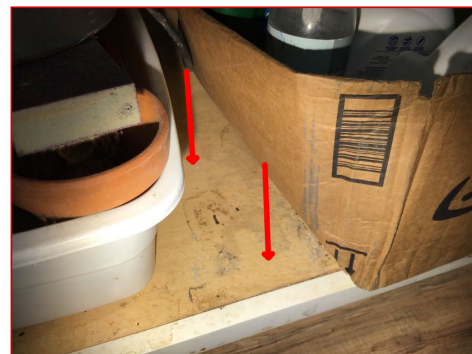
- The floor of the kitchen sink cabinet exhibited damage from past moisture intrusion. The moisture meter showed no elevated levels of moisture present in the floor at the time of the inspection indicating that the source of the leak has been repaired.

Evidence of prior moisture intrusion

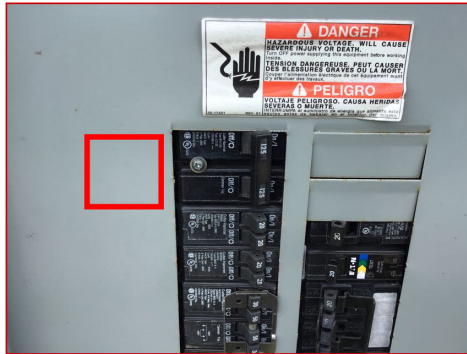
125 amp main breaker/ missing label

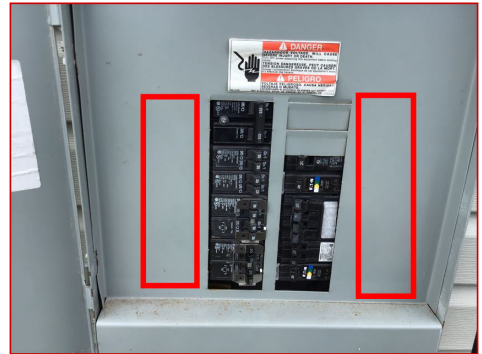
Unmarked ledger

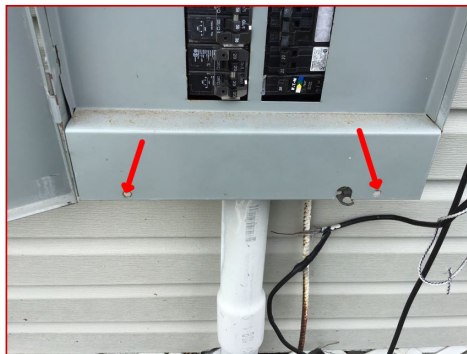
Missing dead front screws

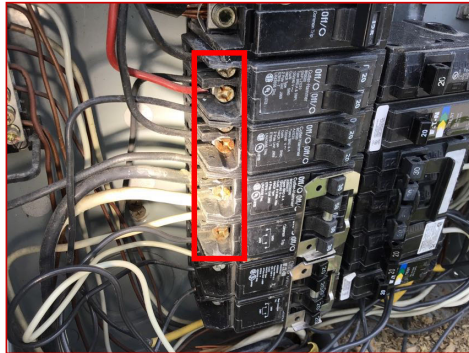
• One or more rusted breakers are present and should be replaced. Recommend licensed electrician to evaluate the cause for the rusty breakers, and repair as needed.

Corroded breakers

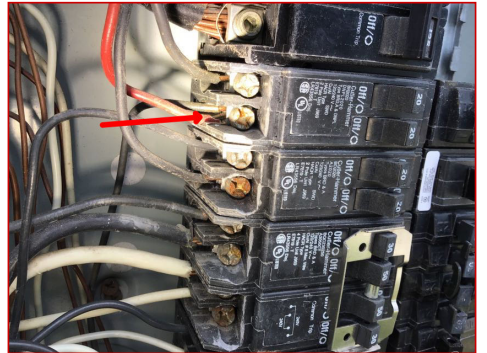
Double tap

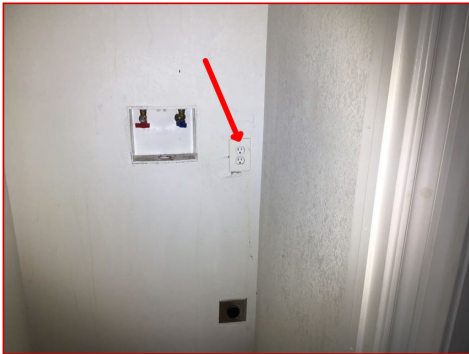
Loose outlet, laundry area

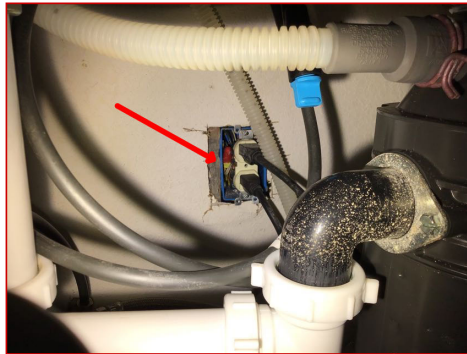
Missing cover plate, below kitchen sink

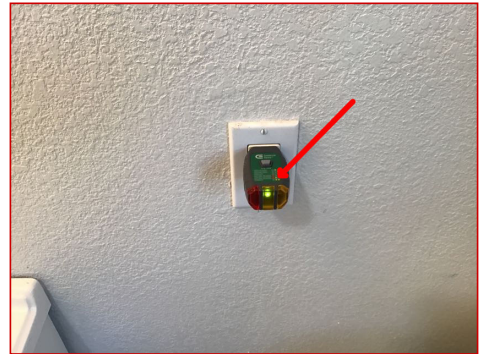
Ungrounded outlet, hall bath

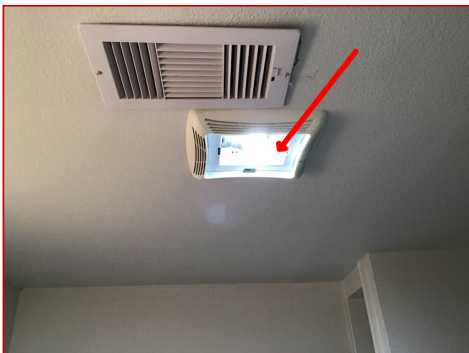
Missing diffuser, hall bath

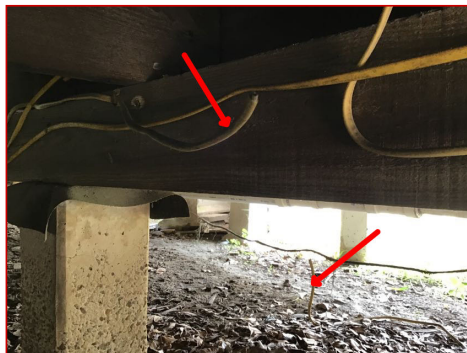
- Wires have been improperly spliced and terminated - This conditions poses a Safety and FIRE HAZARD!
- A 125-volt single phase, 15 or 20 ampere-rated receptacle outlet shall be installed at an accessible location for the servicing of heating, air-conditioning, and refrigeration equipment. The receptacle shall be located on the same level and within 25' feet.
- One or more light fixtures are missing a diffuser and should be replaced.

Example of improperly terminated wires

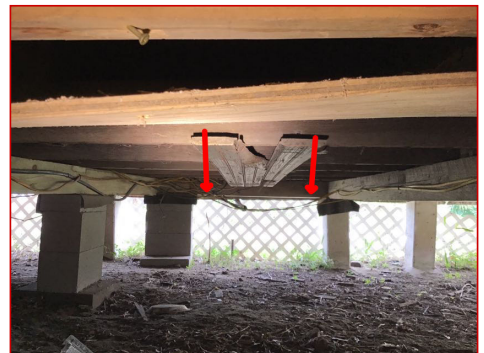
Example of unsupported wires, below structure

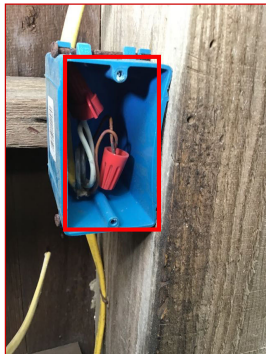
Example of missing cover plate

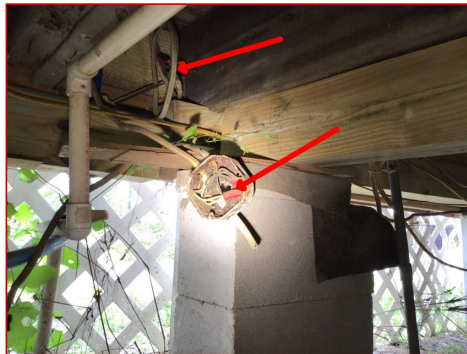
Example of improperly terminated wires/ missing cover plate

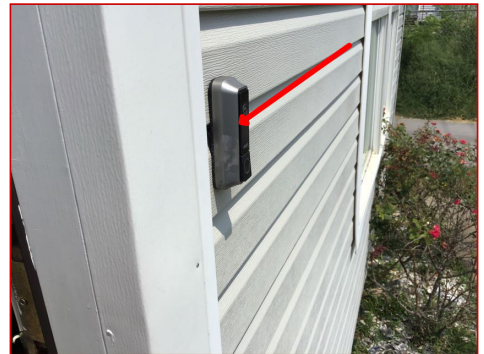
Inoperable doorbell

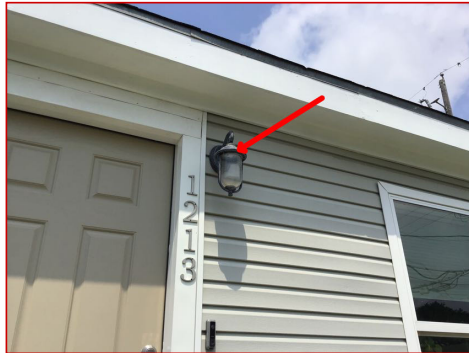
Inoperative exterior light

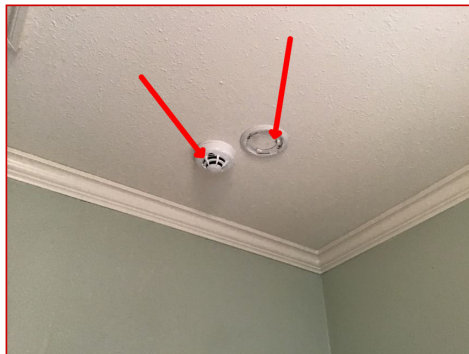
- There are fire or smoke detectors missing or not present in all locations required. Alarms are required in each sleeping room and directly outside each sleeping area in the immediate vicinity. A smoke alarm is also required in the room containing a fireplace. SAFETY HAZARD! All smoke detectors should be installed in accordance with the manufacturer's recommendation and be UL listed.
- There is one or more current smoke detectors that are inoperative. SAFETY HAZARD!

Inoperative/ missing smoke detectors

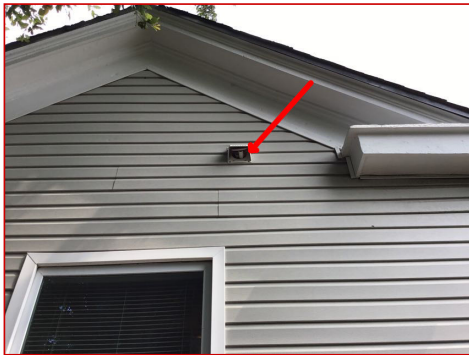
Improper auxiliary drain location

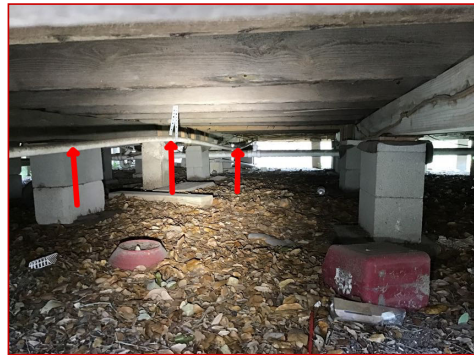
Improperly sloped primary drain pipe

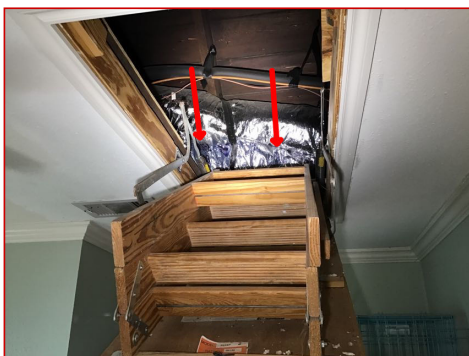
- There is one or more duct tubes that are touching and should be separated by at least one inch, 1", to allow air passage between them, eliminating the possibility for moisture to accumulate.

Ductwork touching

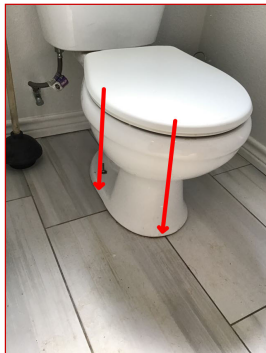
Loose at floor/ missing sealant

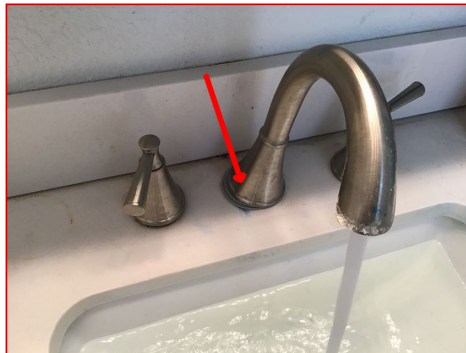
Loose faucet, attached bath sink

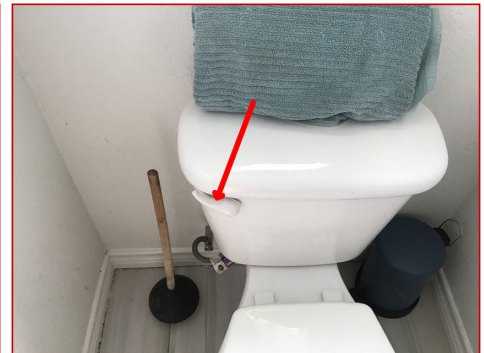
Sticking handle, attached bath

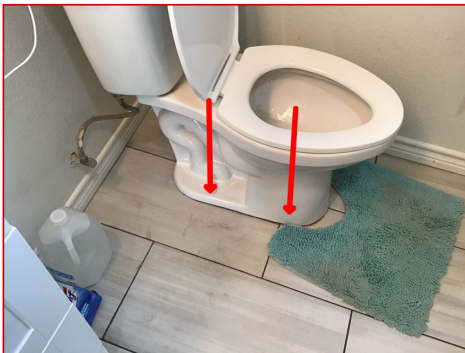
Loose at floor/ missing sealant, hall bath

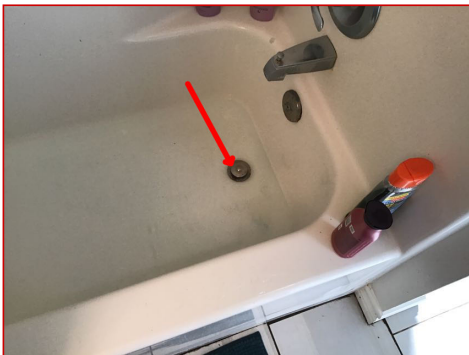
- The bathroom sink was slow to drain.
- Water drainage at the tub in the bathroom, primary bathroom appeared to be inadequate. This could be due to a clogged trap but also may indicate a blockage of the waste pipe.

Slow to drain, attached bath

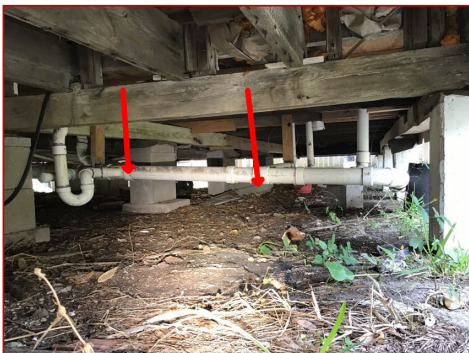
Inadequate support for waste line

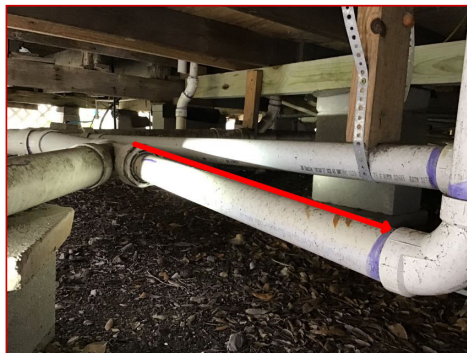
- Waste pipes visible in the under structure were improperly sloped. This condition may result in improper drainage, pipe blockage or damage.
- Supports for the **ABS** or PVC waste pipe visible in the under structure were located too far apart. The maximum support spacing recommended by generally-accepted modern plumbing standards is 4 feet.

Improperly sloped waste pipe

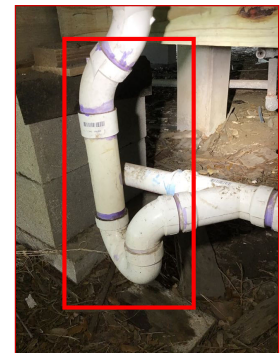
Leaking waste pipe, below hall bath tub

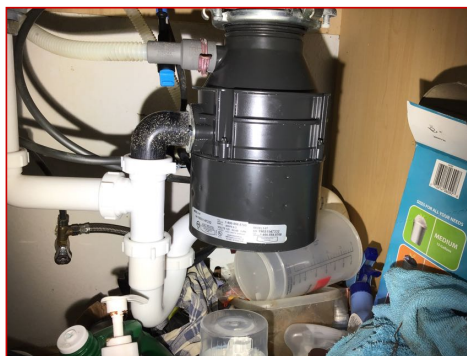
- At the time of the inspection, the Inspector observed few deficiencies in the condition and operation of the food waste disposal. Notable exceptions will be listed in this report.
- The food waste disposer appeared to be inoperable at the time of the inspection.

Food waste disposer/ no response

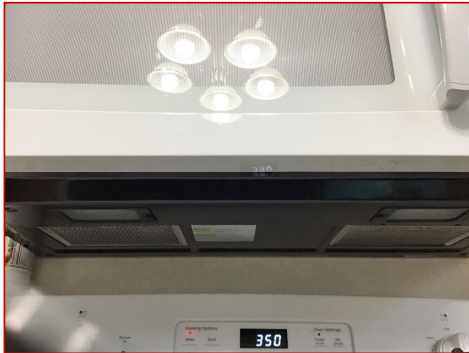
Range hood/ inoperative

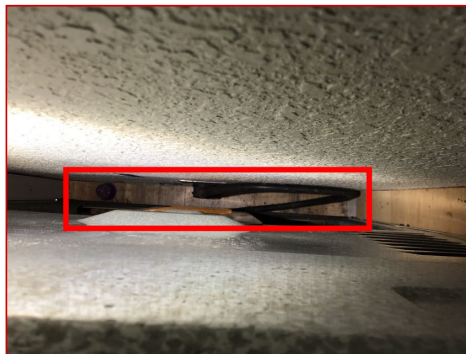
- The Inspector observed few deficiencies during inspection of the electric range. Notable exceptions will be listed in this report.
- Anti-tip bracket for the slide in range was not installed, a child standing on the open oven door could overturn the range causing an unsafe condition creating a LIFE SAFETY HAZARD! This should be repaired immediately!

Missing anti tip bracket

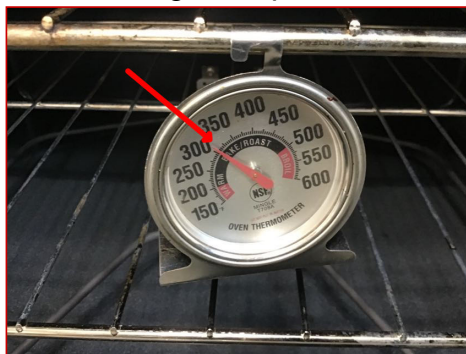
Thermostat out of range

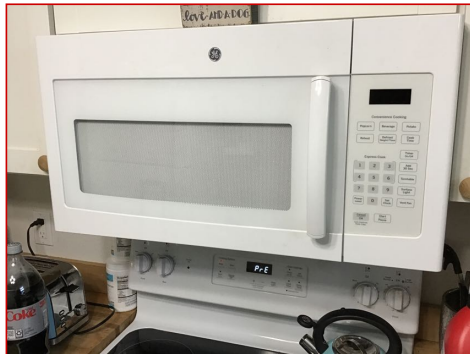
- The microwave oven was inoperative at the time of inspection. This should be further investigated and repairs undertaken, if necessary.

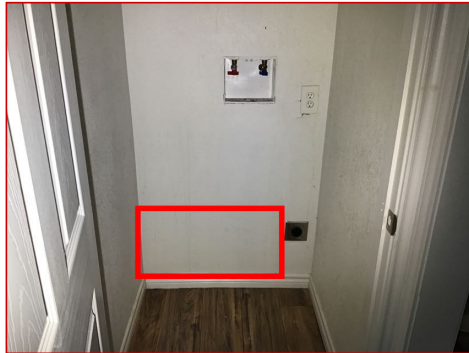
Laundry area/ no vent to exterior
