# NEW CONSTRUCTION FINAL INSPECTION REPORT

# 24607 Charlton Green Lane Spring Tx 77389

Heather Nava & Justin Nava NOVEMBER 22, 2020

# PROPERTY INSPECTION REPORT

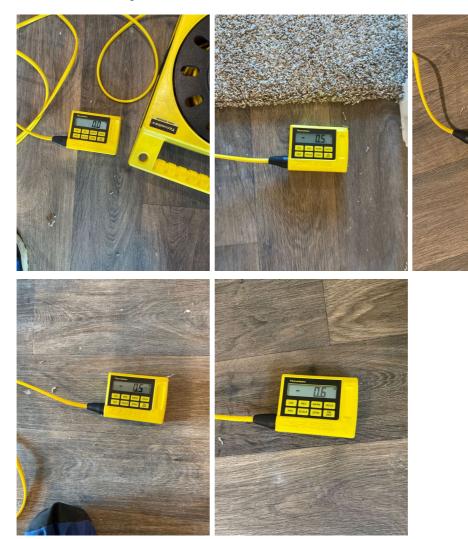
#### Foundation Inspected with Digital Level:

This foundation was measured with the use of an electronic digital measurement tool. Multiple elevation points were registered on the foundation throughout the property to determine if there were elevation variations that indicated excessive movement of the foundation. At the time of this inspection the measured areas did not indicate any variations that, in this inspector's OPINION, indicated any need for invasive repairs to the foundation.
