TEXAS OFFICIAL WOOD DESTROYING INSECT REPORT

4449 Sherylwood Drive	Port Arthur	77642	
Inspected Address	City	Zip Code

4449 Sherylwood Drive	Port Arthu	ur	77642	
Inspected Address	City		Zip Code	
1A Tri-City Exterminating Company	1B	TPC	L 5063	
Name of Inspection Company		SPCS Business	s License Number	
1C 3304 Spurlock Road	Nederland		627 (409) 724-2843	
Address of Inspection Company	City	State Zip	- Parameter - Para	>
1D. Jason Allbritton Name of Inspector (Please Print)	1	 Certified Applicator Technician 	check o	ne)
	1F. 03/28/23			
		Inspection Date		
Jonathan Layton Name of Person Purchasing Inspection	Seller Agent	☑ Buyer ☐ Manage	ement Co. Other

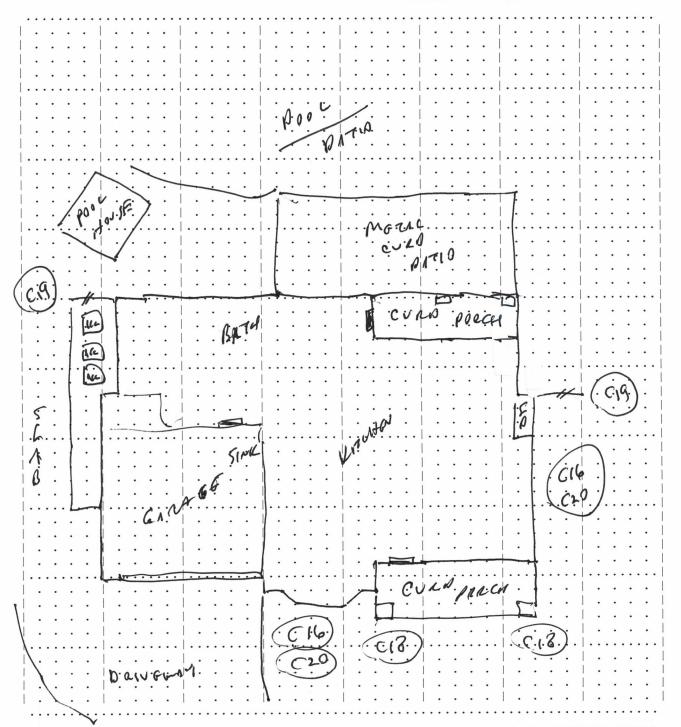
DIAGRAM OF STRUCTURE(S) INSPECTED

(C16) foliage against exterior siding (C18) wood deay on columns (C19) attach wooden fencing (C20) bark mulch against slab

SEE PAGE ONE SCOPE OF INSPECTION (SECTION J) AND RECOMMEND MONITORING ALL CONDUCIVE CONDITIONS IN THE FUTURE, IF A WARRANTY IS NEEDED IN ANY OF THOSE AREAS, A TREATMENT IS RECOMMENDED.
