Swimming Pool Inspection

Date: 4/3/2023

Address: 4449 Sherylwood Dr, Port Arthur 77642

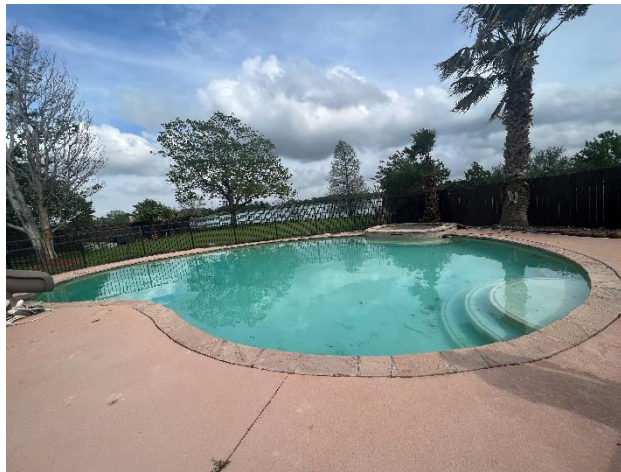
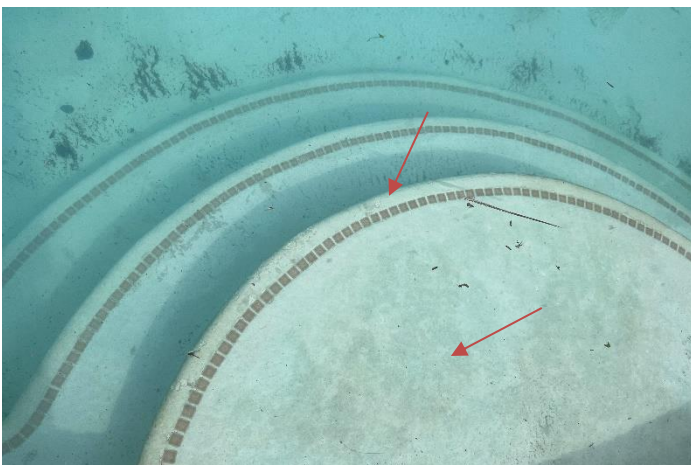
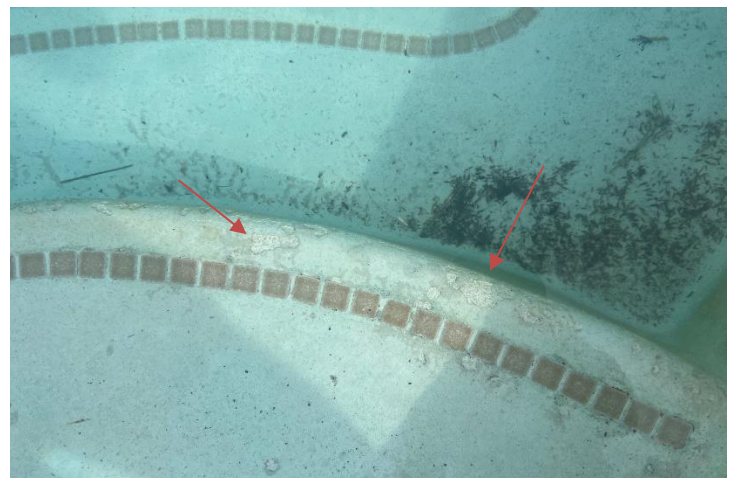
1. Plaster: Plaster lifespan is usually about 10 years, the plaster is very stained and mottled from old age and/or chemical maintenance. The copper staining appears to be from the heater(which is being bypassed). The plaster is in good shape in regards to it appears to be holding water great, and no structural leaks are noticed. Attached photos to visually explain:

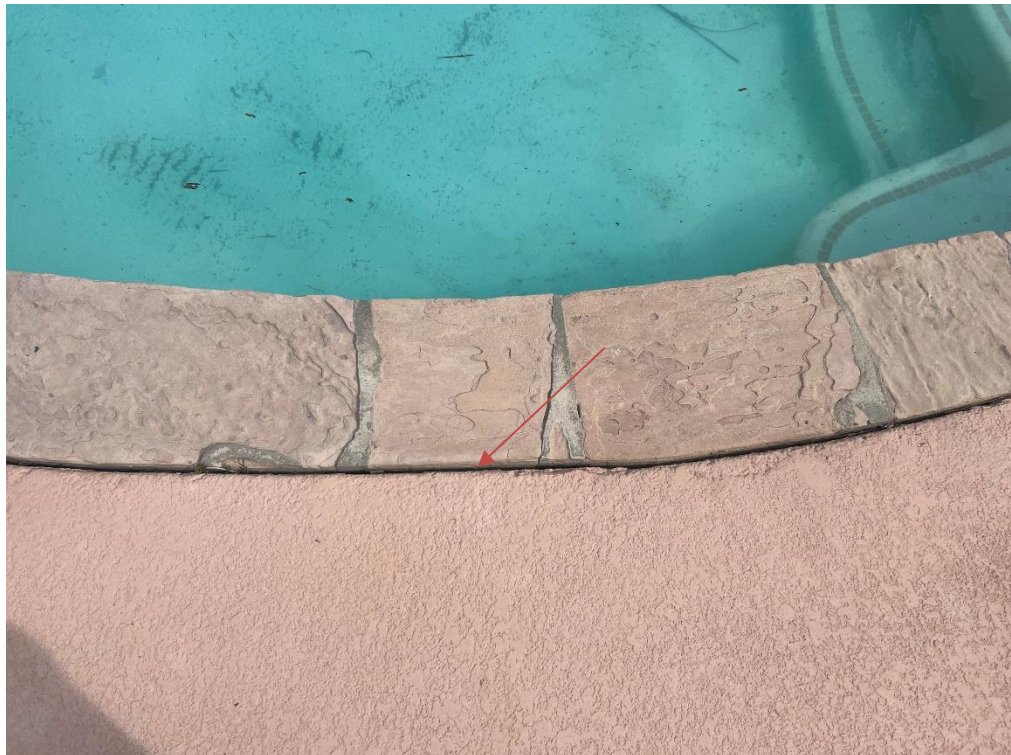
2. Expansion joint: Expansion joint/mastic joint/deck-o-seal is gone. This is an epoxy joint that prevents water from rain, overflow, etc, from getting in-between the structure of the pool, and the deck. This prevents deck shifting and should be replaced every 5-8 years, as needed.

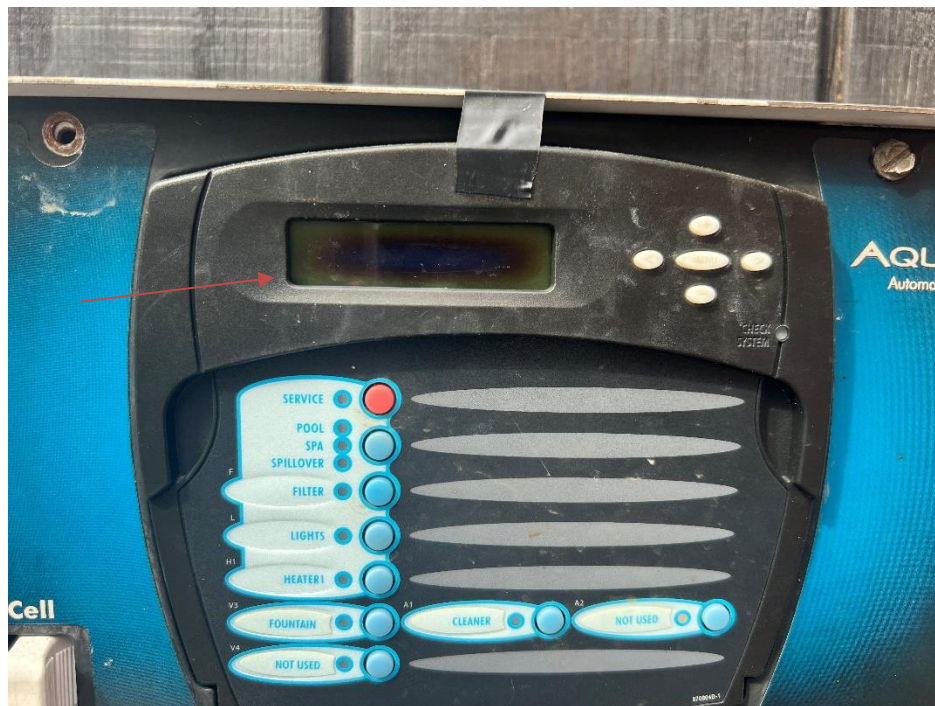
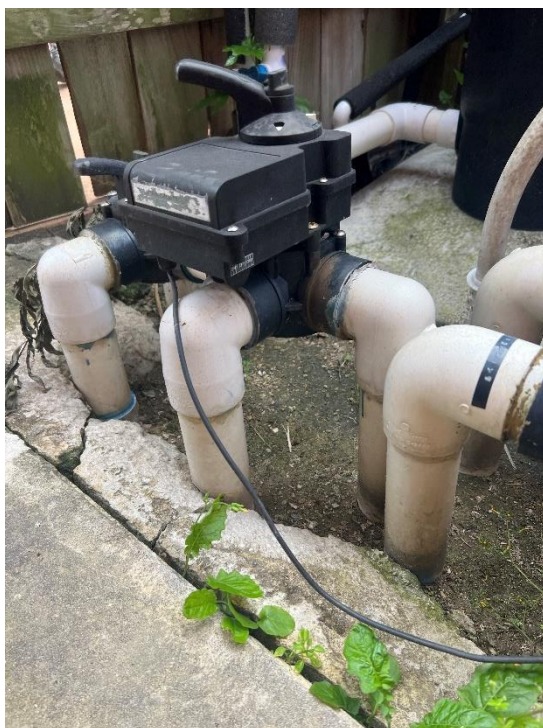
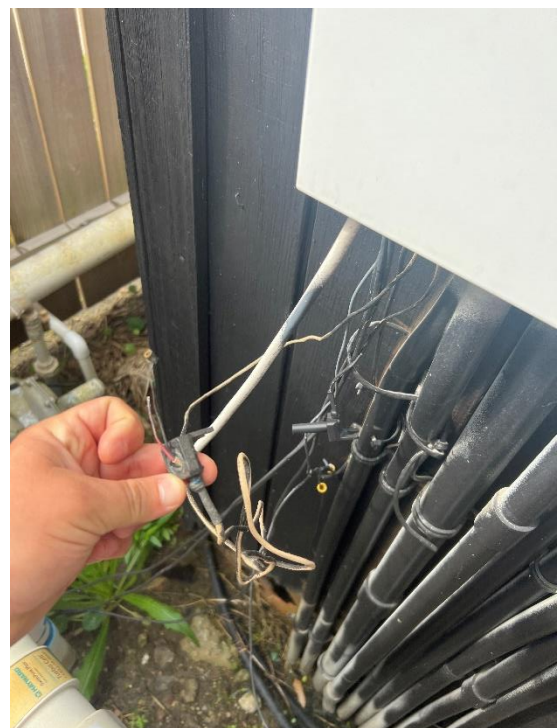
- Automation system: The LCD Display on the automation system seems to be sun-burnt, as if the door panel was opened for an extended period of time. The water temperature sensor has been disconnected and is bare low voltage wiring hanging below the automation system. The return valve actuator also is nonfunctional, which will keep the system from entering SPA mode.

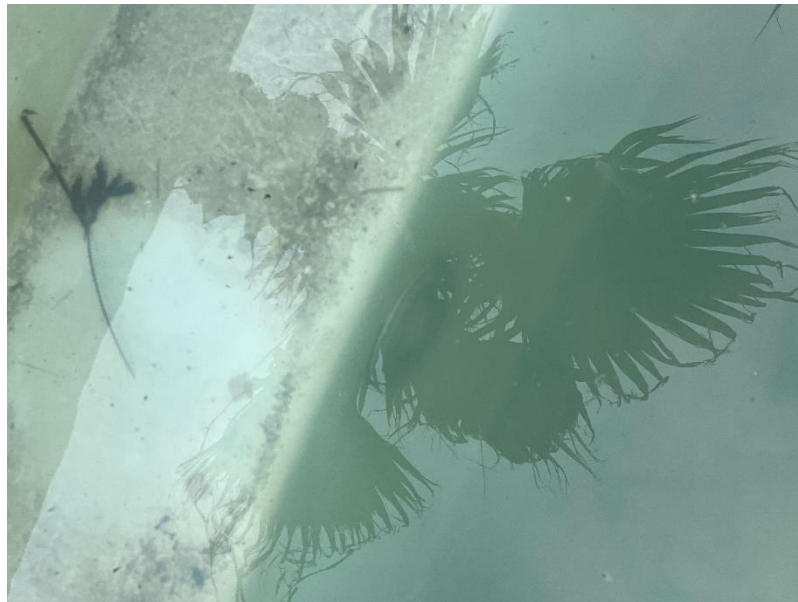
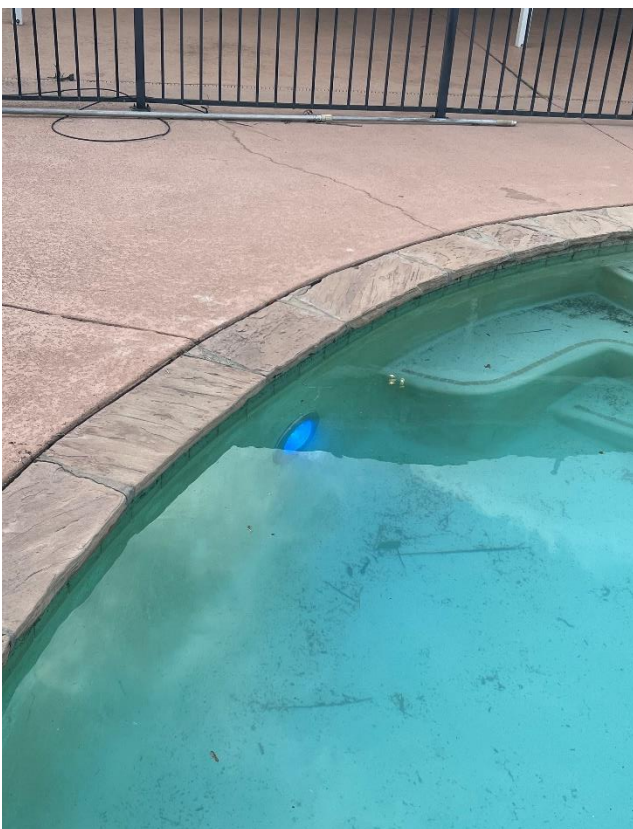
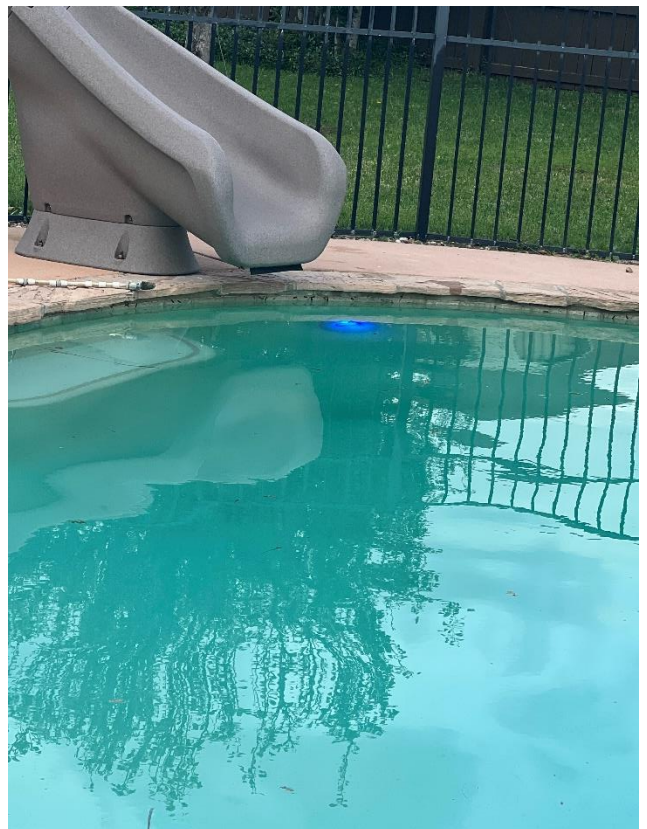
4. Light: Pool lights are in working condition, however the spa light is in not working condition. GFCI is in working condition, and both pool lights are working completely properly. Currently installed is a Hayward Colorlogic, and it is not a serviceable light, and would need to be entirely changed.

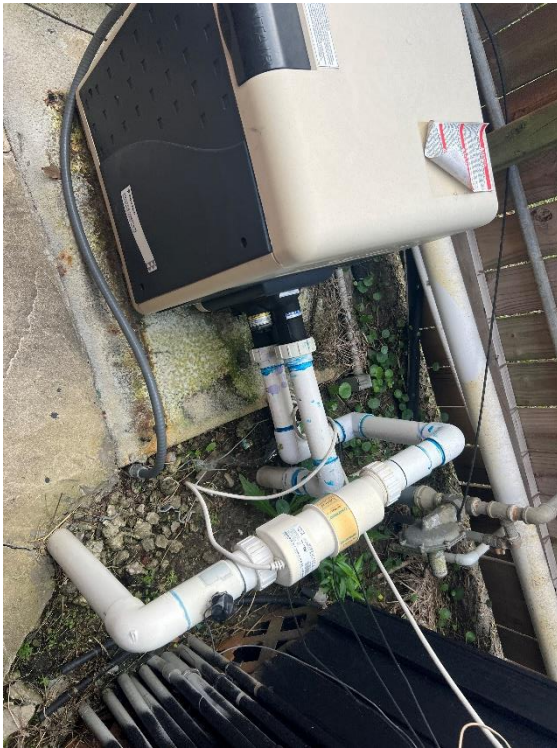
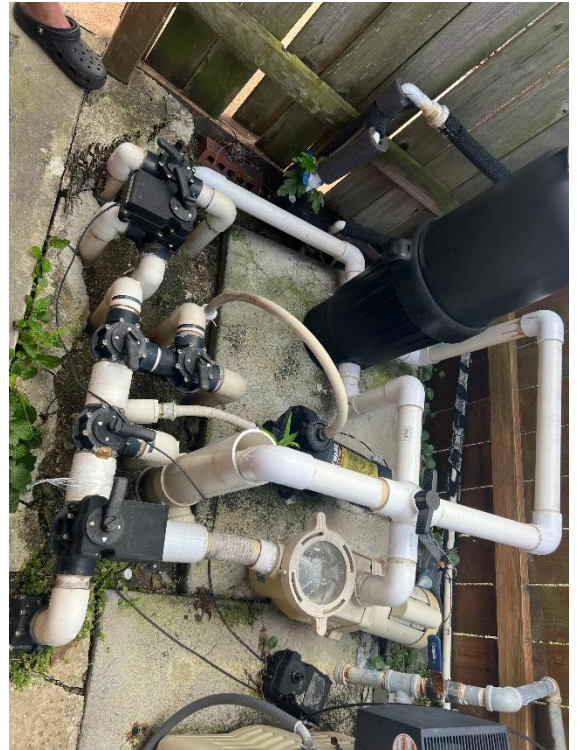
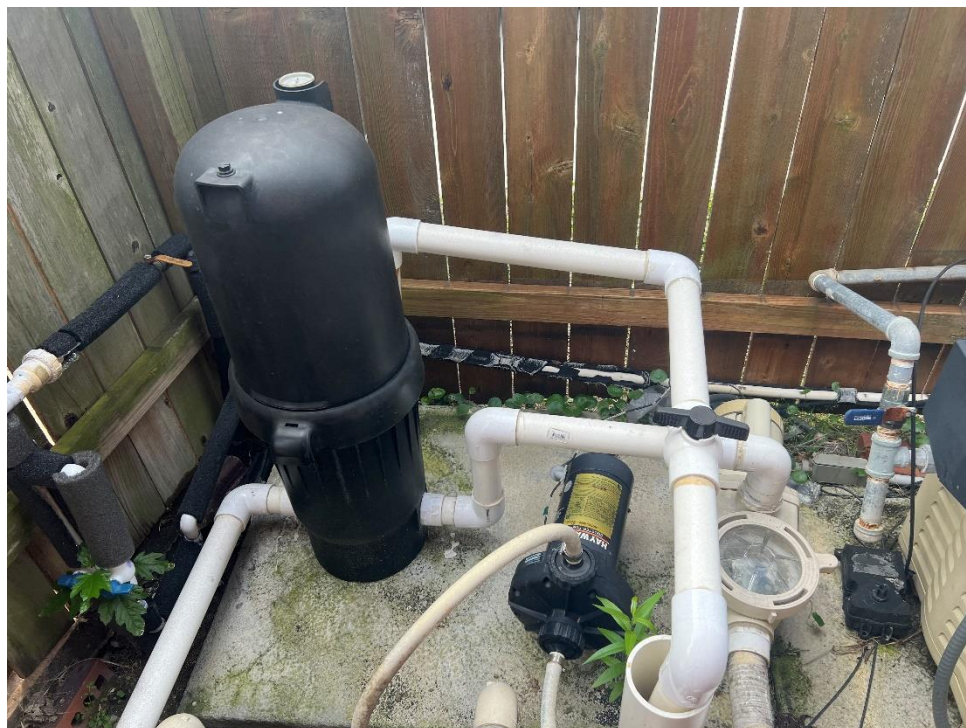
5. Equipment: Pool equipment has a leak in suction manifold, a cracked heater manifold, and a cracked booster pump housing. All of these items have already been quoted and approved to be repaired by Pool-Aid. Booster pump and heater will both be bypassed so pool can flow and filter. Pool filter has been replaced at some point, and was replaced with a small cartridge filter that will work, however will need to be cleaned frequently to function properly, as it is a small cartridge filter for the size of the pool.
