PREMIUM INSPECTIONS

2707 Mapleglade Dr, Humble, TX 77339

Date of Inspection: 3/23/2020 Time: 9:00 AM

Property Inspection Report

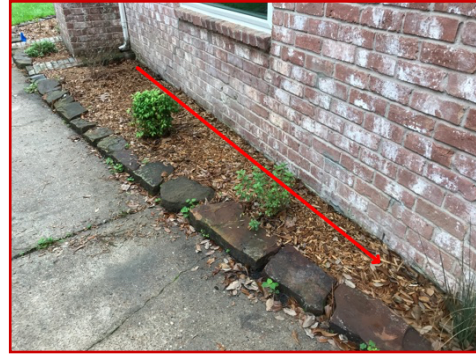
- The top of the foundation wall had inadequate clearance from grade. The top of the foundation wall should be a minimum of six inches above soil. Inadequate clearance may result in moisture intrusion of the structure. Excessively high moisture levels can result in damage to the home structure or materials from decay or deterioration and may result in conditions which encourage the growth of microbes such as mold fungi. The Inspector recommends re-grading around

Inadequate foundation clearance to grade

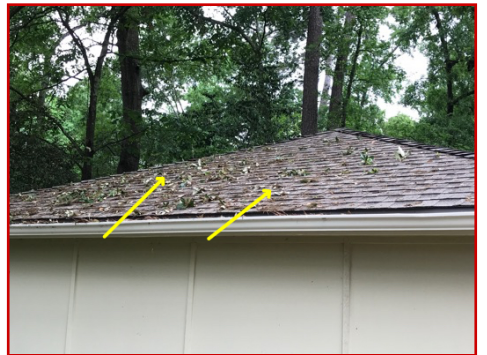
Debris on roof surface

- Debris should be removed from the roof to avoid moisture damage to the shingles.

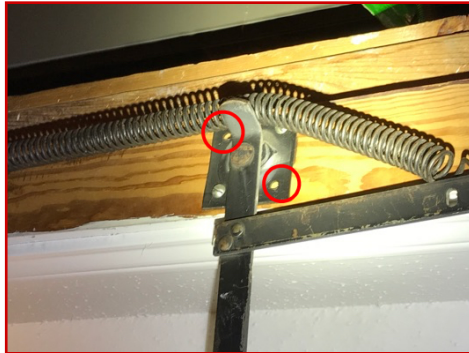
Improper/missing fasteners in attic ladder

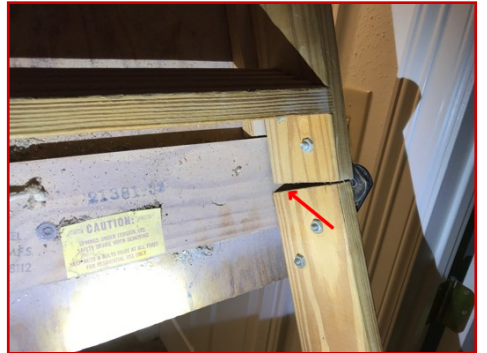
Gaps at ladder hinges

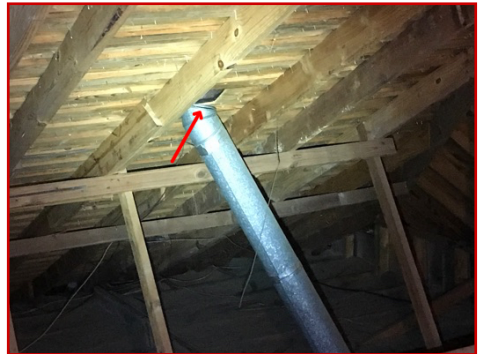
Detached vent hood exhaust in attic

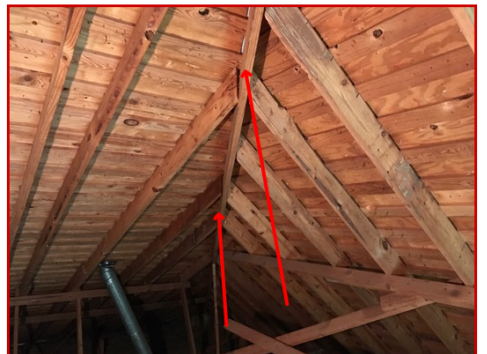
Rafter has no support after joint

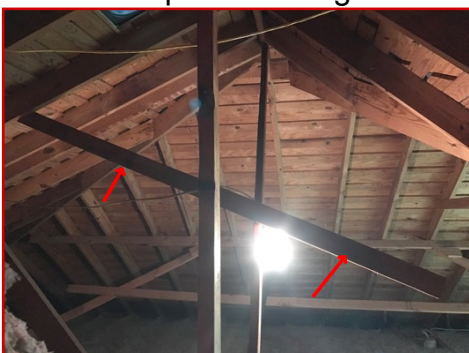
Apparent loose collar tie

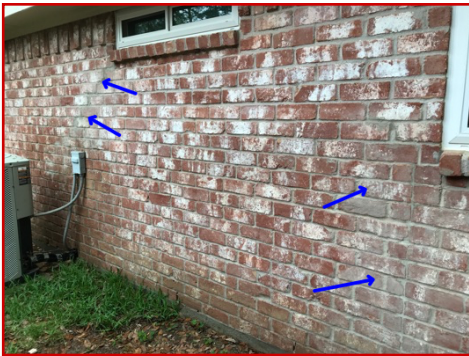
Brick repairs

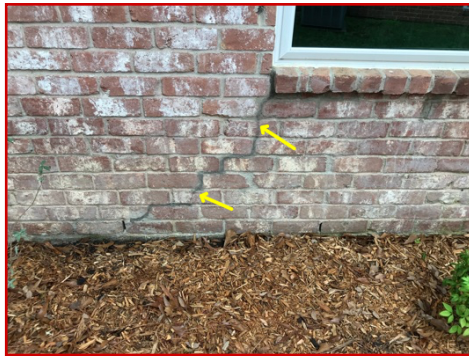
Crack at right of house

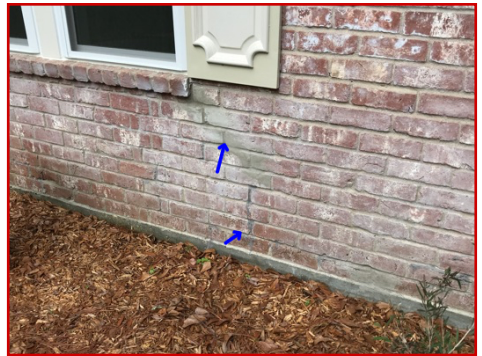
Multiple brick repairs

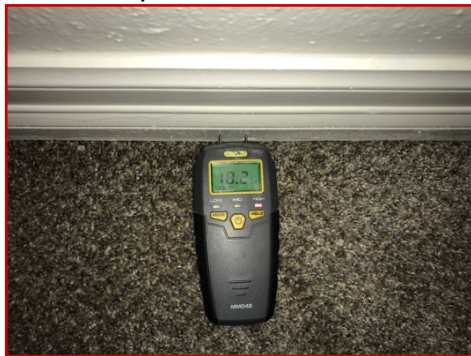
Elevated moisture levels in the master bedroom base board

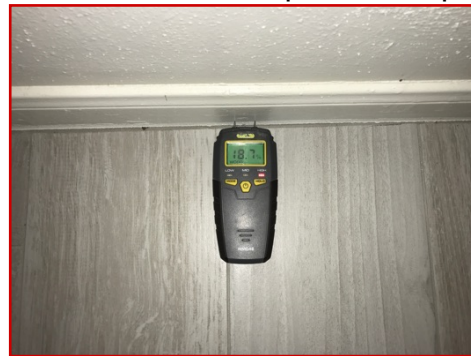
Elevated moisture levels in laundry room and kitchen

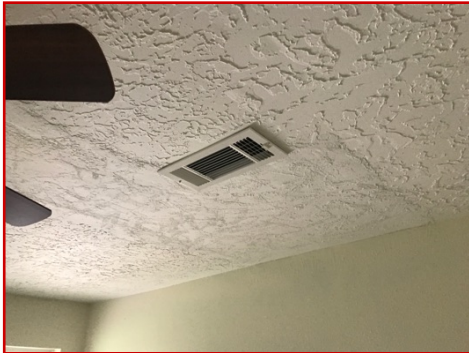
Ceiling patch in bedroom

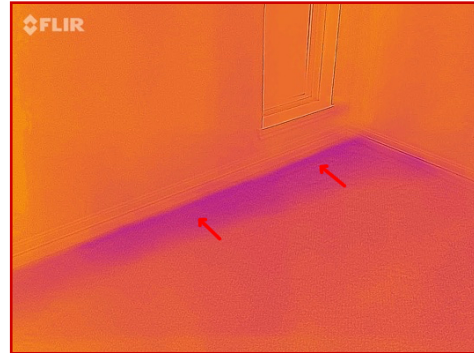
Carpet in master bedroom tested with elevated moisture levels

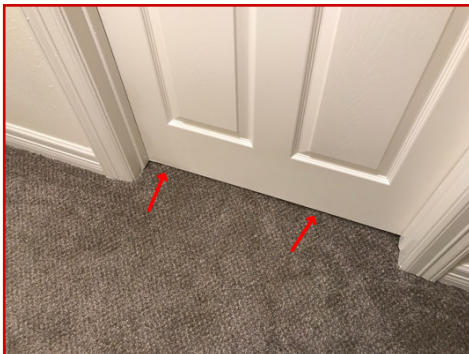
Bedroom doors are rubbing on carpet

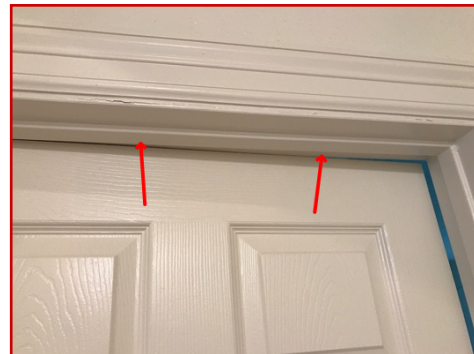
- At the time of the inspection, the Inspector observed no apparent deficiencies in the interior condition of exterior doors. This item was in satisfactory condition at the time of the inspection.
- At the time of the inspection, the Inspector observed few deficiencies in the condition of the interior doors. Notable exceptions will be listed in this report.
- One or more interior doors rubbed on the carpet and needed to have the bottoms cut.
- An interior door to the bedroom was binding on the jamb and would not close.

Front bedroom door rubs on jamb, will not close

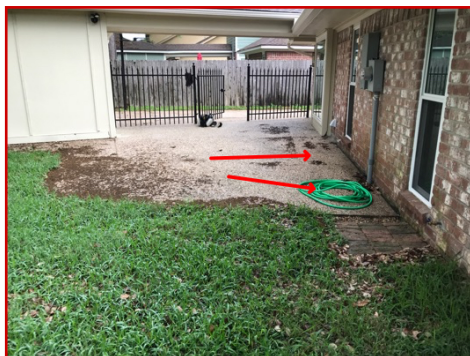
- This patio was located in the rear of the home.
- This patio was constructed of poured concrete.
- **Patio appears to slope towards the home. Recommend correction to prevent possible moisture intrusion to the home.**

Rear patio appears to slope towards the house

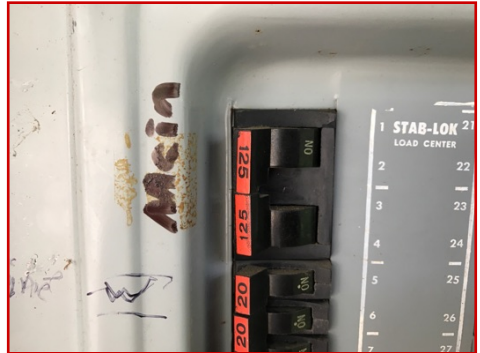
125 amp main breaker

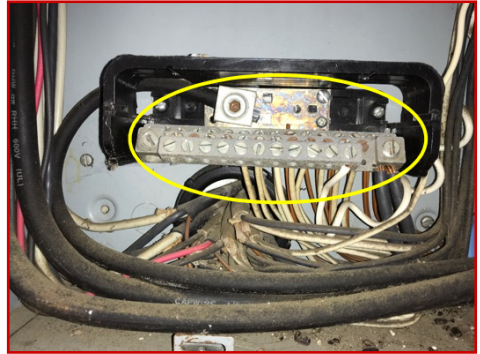
No visible bonding tab or screw

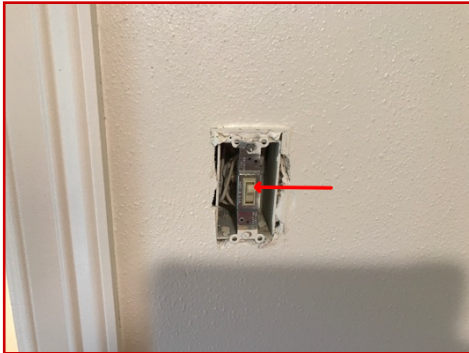
Missing outlet cover in bedroom

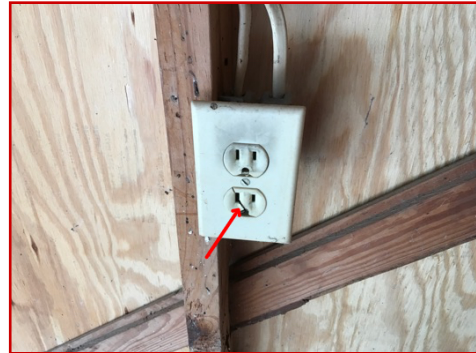
Damaged outlet in garage

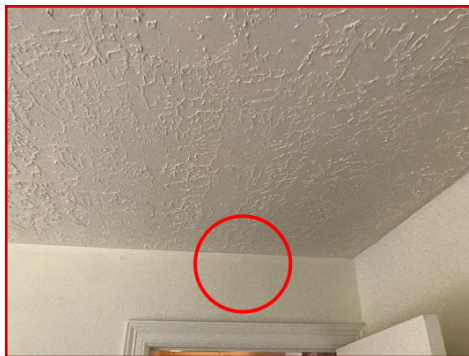
- There are fire or smoke detectors missing or not present in all locations required. Alarms are required in each sleeping room and adjoining areas. A smoke alarm is also required in the room containing a fireplace. **SAFETY HAZARD!** All smoke detectors should be installed in accordance with the manufacturer's recommendation and be UL listed.

Missing smoke detectors in bedrooms

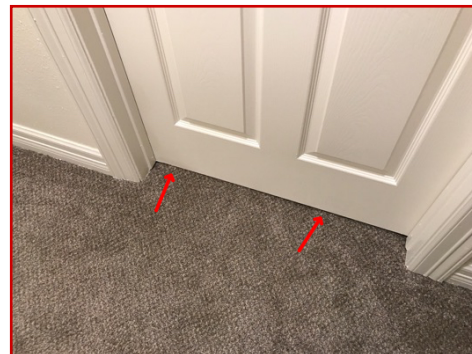
• In some rooms, return air registers were not located in the same room as supply registers and the gap beneath the door leading to the area in which the return air register was located had less than the recommended minimum 3/4-inch gap . Door bottoms in rooms where this condition exists should be trimmed in order to maintain adequate air circulation and heating system performance.

Bedroom doors are rubbing on carpet

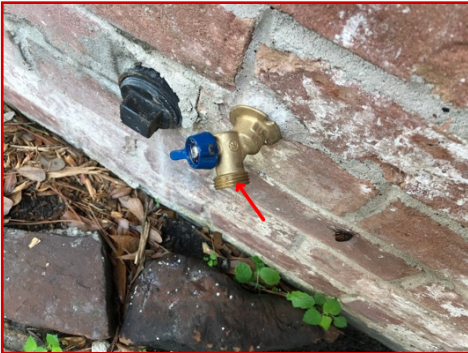
Missing anti siphon valve

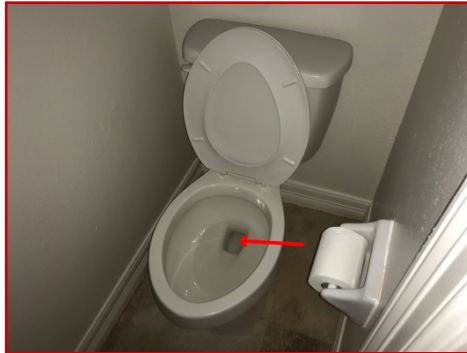
Master toilet runs continuously

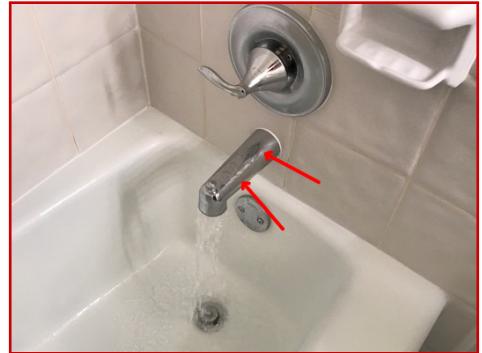
Hallway tub spout is extremely loose

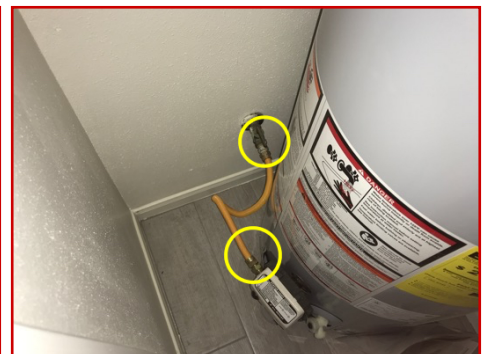
Missing sediment trap in gas supply

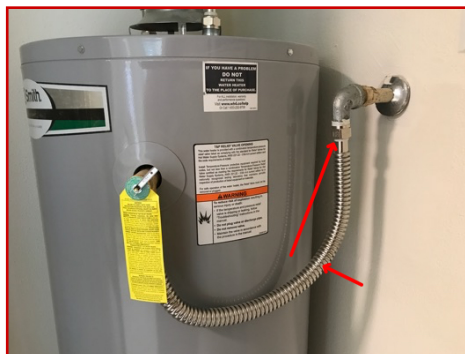
- The pipe serving the TPR Valve as a drain pipe is not approved material. This material, flexible style, is most likely not well suited to this application, and should be a smooth interior material, so for safety reasons, it may need to be replaced.

TPR valve, improper slope, possible improper material

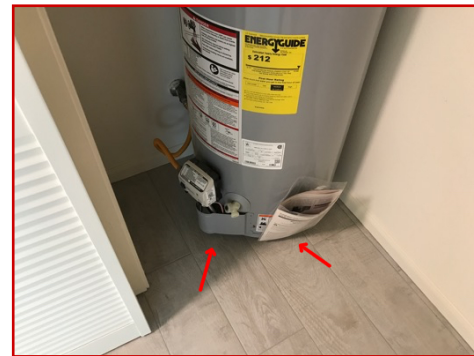
Missing catch pan at water heater

- No safety catch pan and drain was found for the water heater. This should be repaired by the installation of a pan with a drain by a qualified professional.

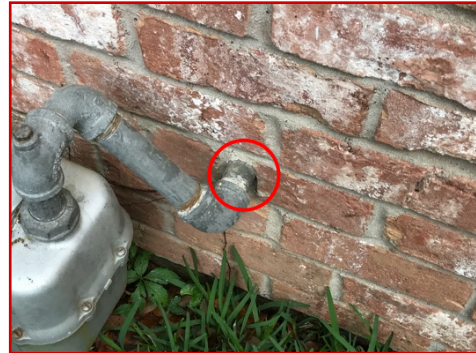
Missing protective cover at entry point

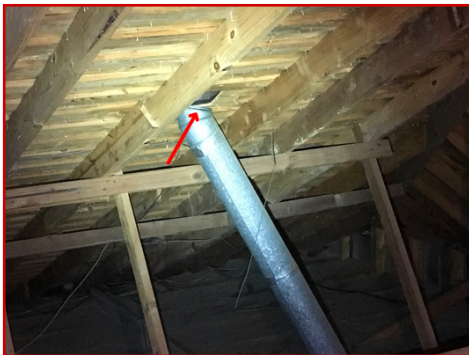
Detached vent hood exhaust in attic

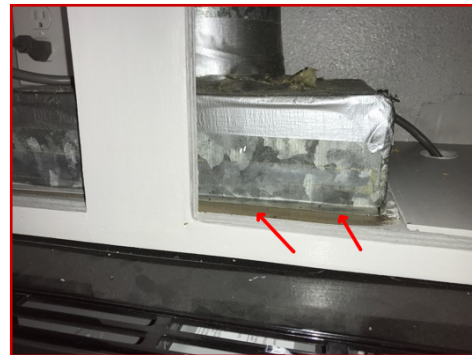
- The exhaust vent of the range hood discharged exhaust to the home exterior.
- At the time of inspection, the exhaust fan was functioning as intended.
- At the time of inspection, the light in the exhaust hood was performing as intended.
- A kitchen range exhaust vent visible in the attic had become disconnected and may exhaust excessive amounts of grease and moisture into the attic. Excessive moisture deposited into the attic may result in damage to home materials from decay or encourage the growth of microbes such as mold. Exhaust vents should terminate at the home exterior.
- The range hood transition in the cabinet above the range is not properly sealed and may vent excessive amounts of moisture or grease to the cabinet interior. Recommend correction by a qualified professional.

Range hood is not properly sealed in cabinet

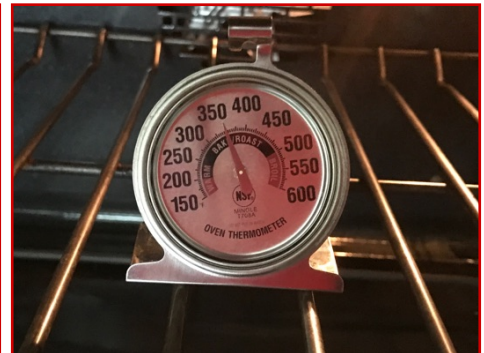
After 30 min lower oven is with in specs

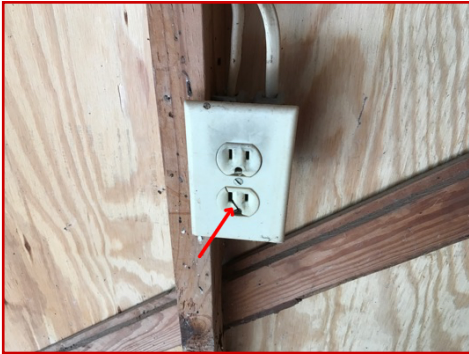
Damaged outlet in garage

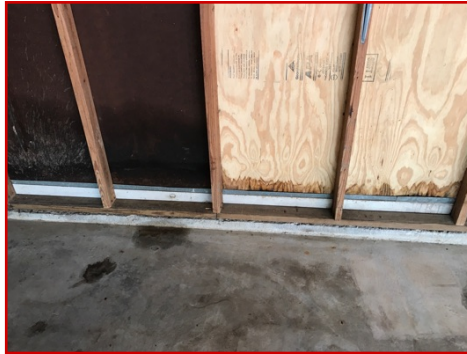
Moisture intrusion in siding

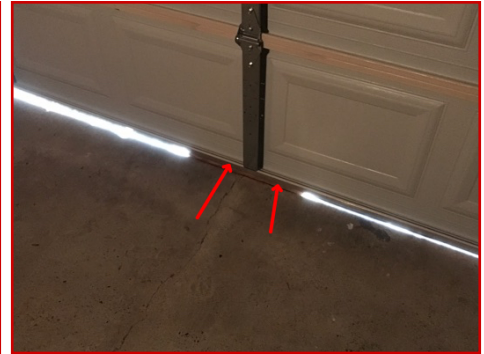
Pressure sensor did not respond

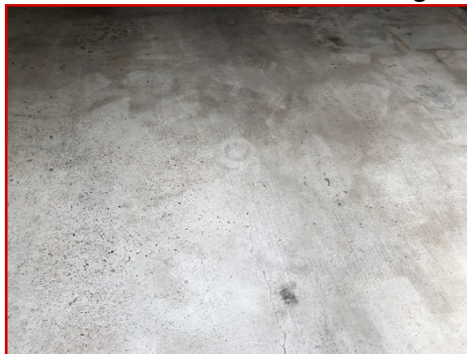
Typical cracks in garage floor

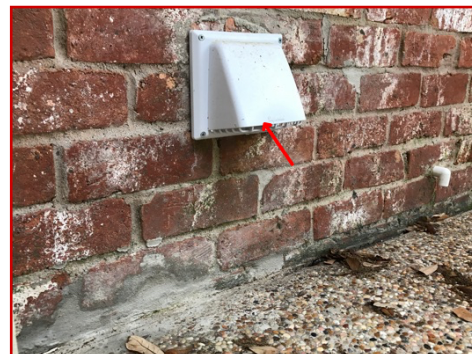
- The Inspector observed few deficiencies during inspection of the dryer vent cover and dryer tube. Notable exceptions will be listed in this report.
- The dryer vent outlet has a screen installed. Recommend removal of the screen or replacing the cover with an open louvered vent as it poses a potential fire hazard by trapping lint. FIRE HAZARD!

Dryer vent has a screen on it
