PROPERTY INSPECTION REPORT FORM

Address of Inspected Property: 224 Calvit Hempstead, TX. 77445

Date of Inspection: October 19, 2022

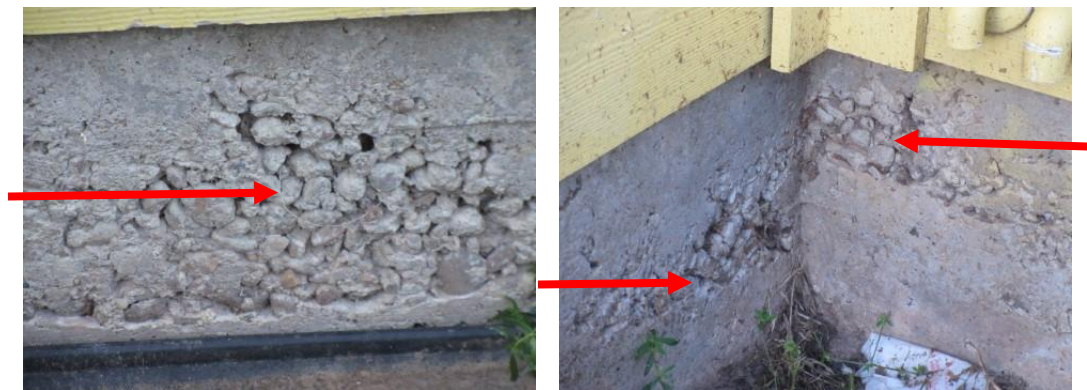
Honeycombing of the foundation wall was observed in multiple areas on the left, right & back sides of the structure. The honeycombing may or may not extend deep into the concrete. It can be caused by a poorly graded concrete mix, by too large of a coarse aggregate, using unclean form boards, or by insufficient vibration at the time of placement. Honeycombing may result in further deterioration of the concrete because moisture can easily work its way into the honeycombed areas. Severe honeycombing should be repaired to prevent further deterioration of the concrete surface. Recommend sealing.

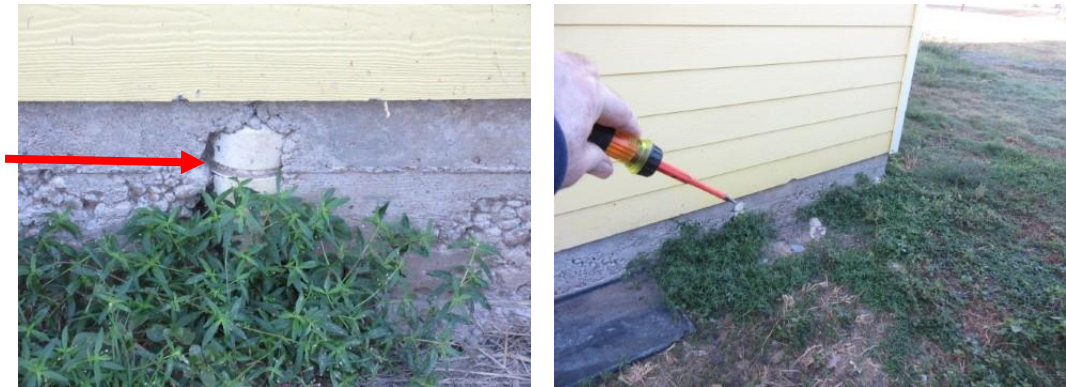
Exposed drainpipe was observed on the back side of the structure. Recommend sealings.

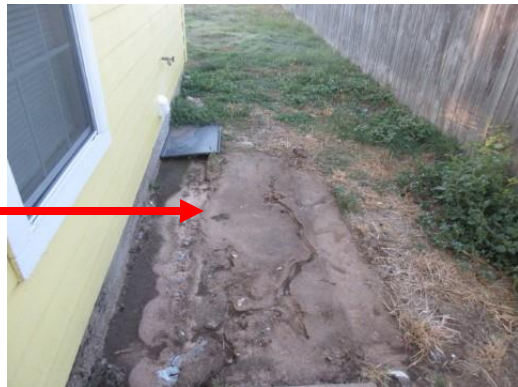
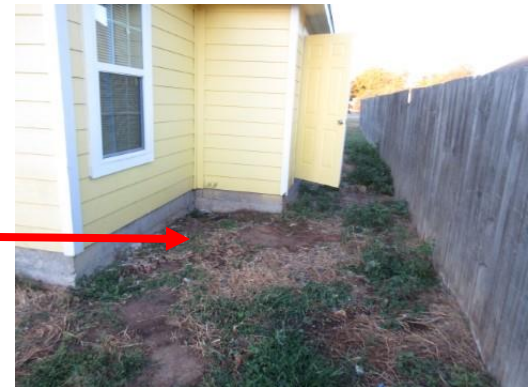
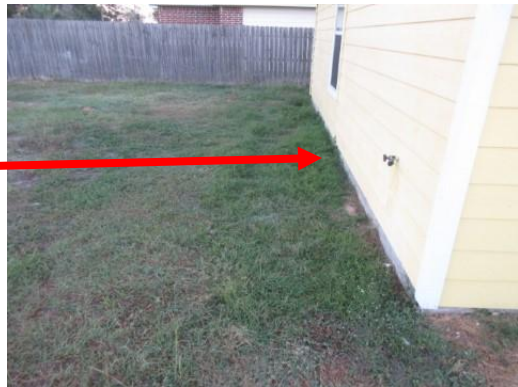
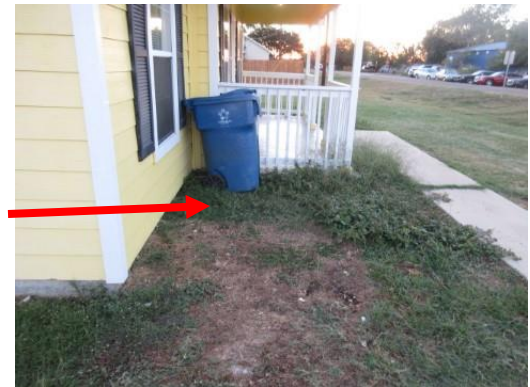
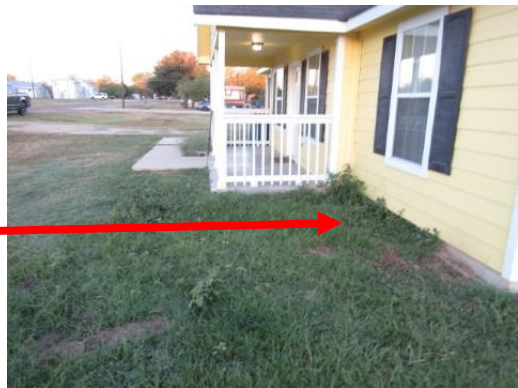
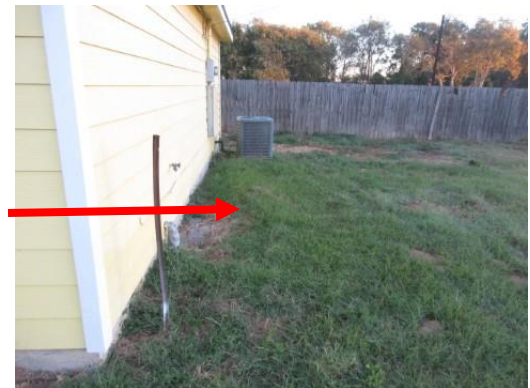
There were areas around the structure where the grading does not have the minimum clearance of 6" for siding as required. Recommending pulling back/reworking the clearances in these areas to a minimum of 6" as required.

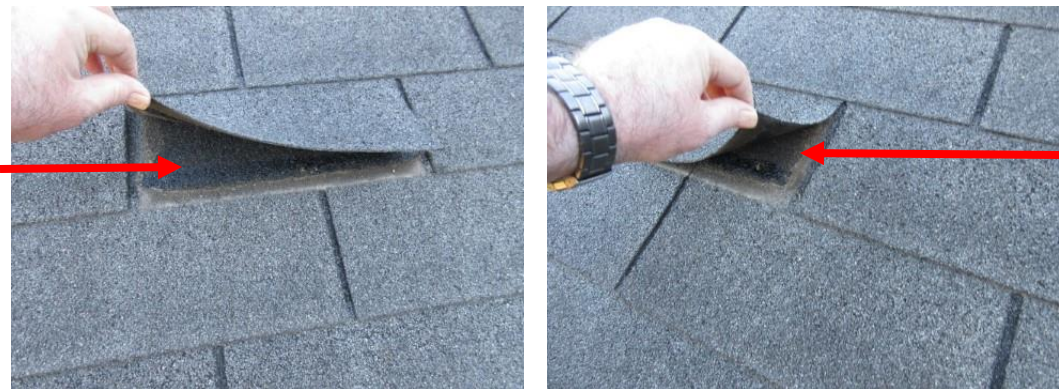
The shingle adhesion is not properly secured & the shingles can be easily lifted in some areas. This is of concern due to potential wind damage.

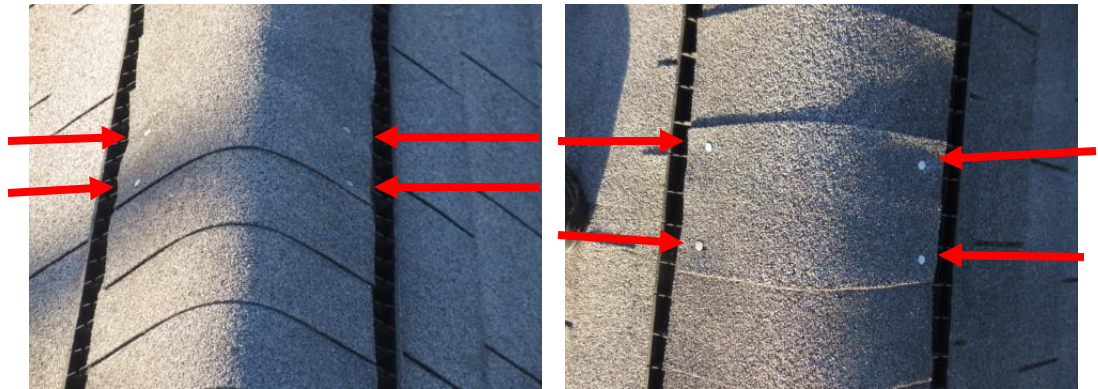
Multiple exposed nail heads were observed in some areas. Recommend sealing all exposed nail heads.

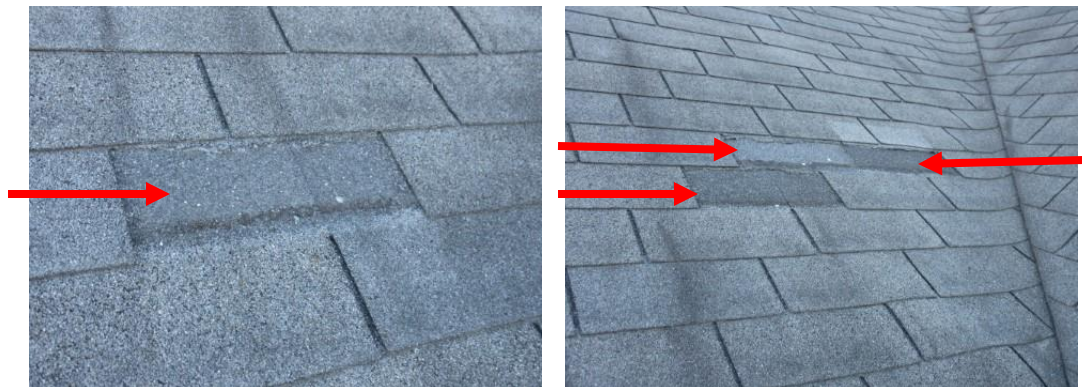
Damaged/missing shingles were observed on the front left side of the roof. Recommend repair/replacement.

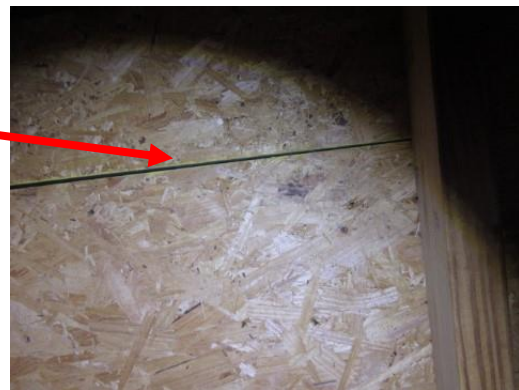
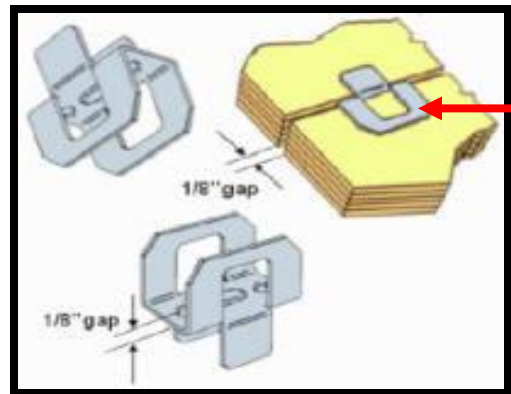
Metal clips/roof deck spacers are missing between the roof decking in some areas.

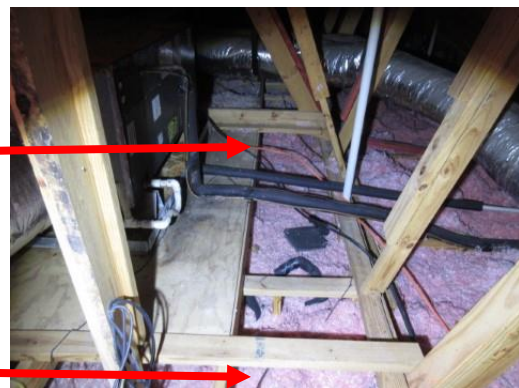
The attic does not solid flooring at least 24" wide for access to the appliances where access is required & does not have a 30" wide by 30" deep work area along all sides of the appliances where access is required.

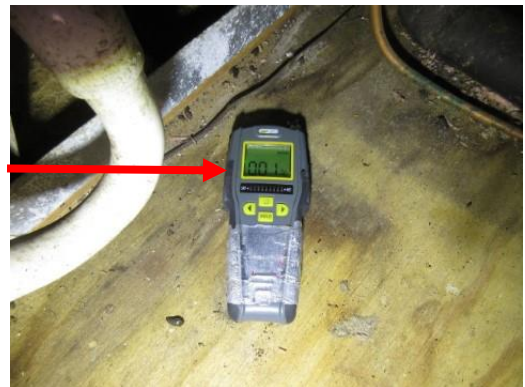
Existing/previous moisture penetration/staining was observed in the attic decking by the HVAC equipment. A moisture reading was performed in the accessible area & no moisture was detected at the time of the inspection.

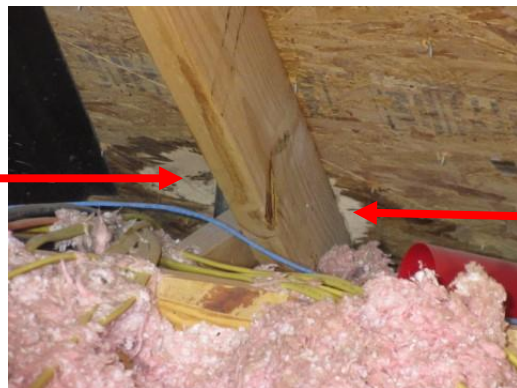
Existing/previous moisture penetration/staining were observed at the back right side of the attic however the inspector was unable to get to the area where the moisture penetration/staining was observed & could not determine if an active leak was observed. Recommend further evaluation.

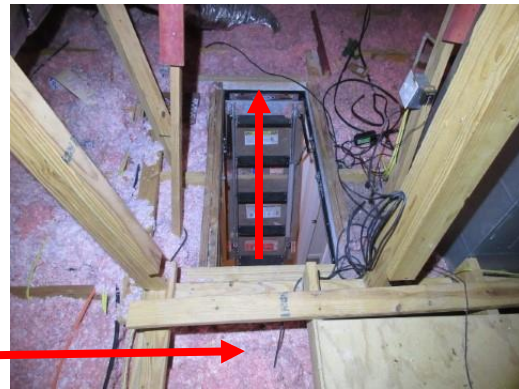
The attic access ladder is reversed in relation to accessing the equipment/passageway. This makes entering and exiting the attic space difficult and unsafe.

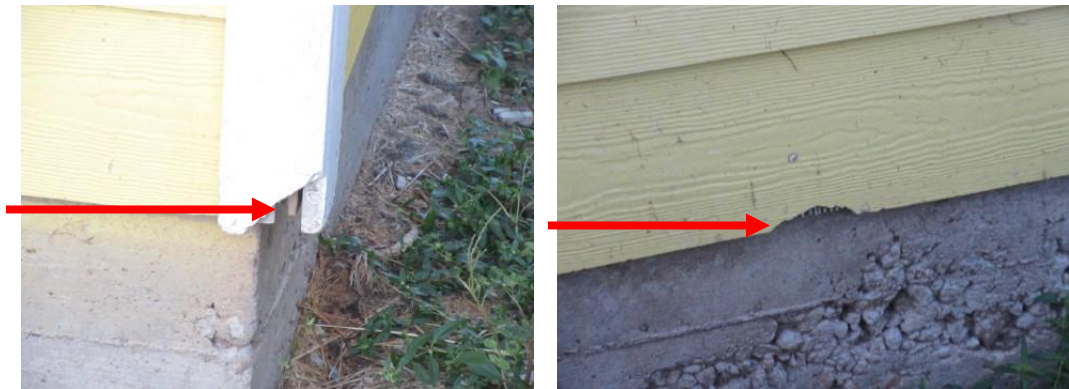
Minor damage/decay to siding/trim was observed in some areas around structure. Recommend repairing/replacing as needed.

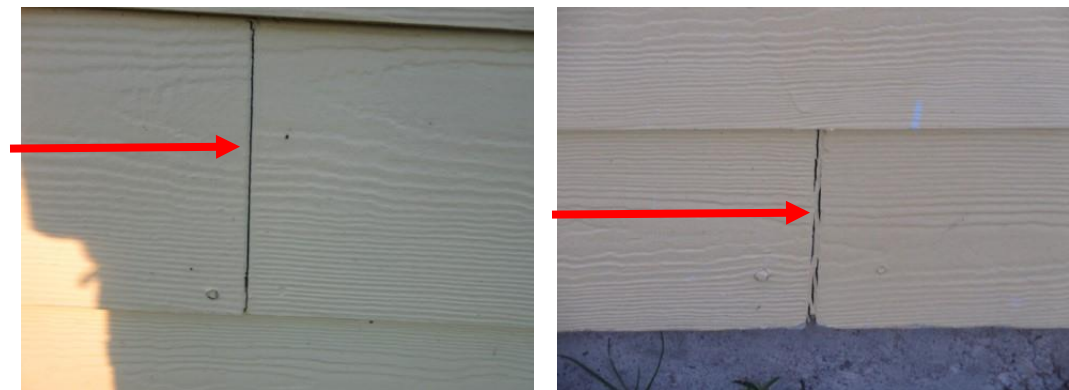
Deteriorated caulking/sealant was observed in some areas. Recommend sealing as needed.

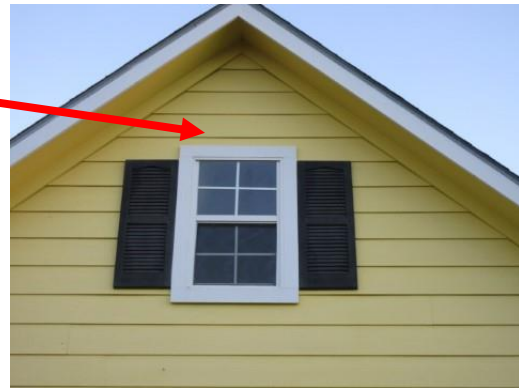
☒ Flashing is not installed above the horizontal trim board on the front side of the structure. Flashing is required above all continuously projected trim.

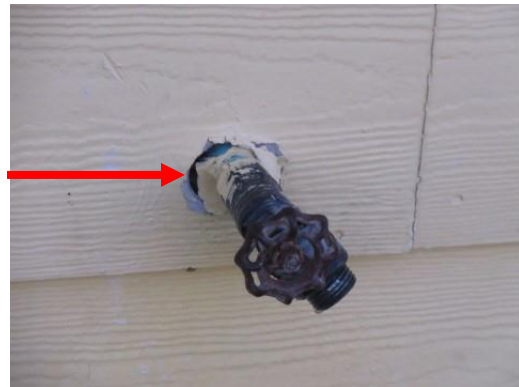
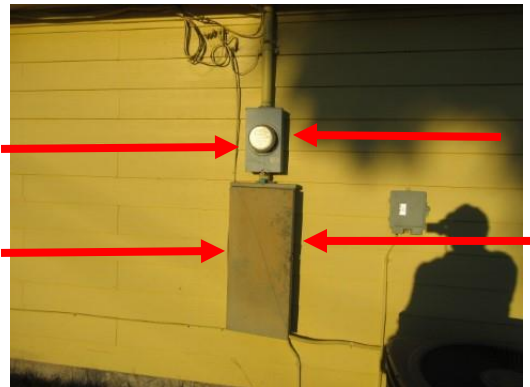
☒ Recommend sealing all exterior penetrations to prevent possible moisture penetration including but may not be limited to: Electrical penetration, exhaust vents, doorbell, electrical panel/disconnect/conduit penetrations.

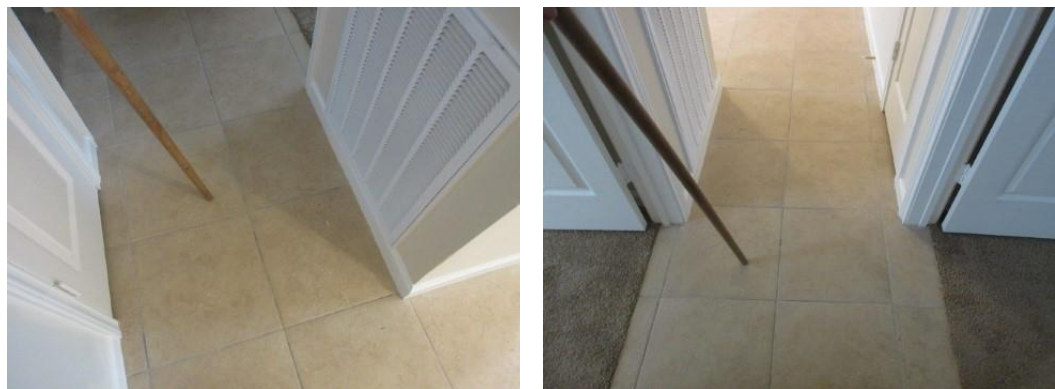
Some of the floor tiles in the hall outside the hall bathroom are not properly set as noted by the hollow sound when tapped. Recommend monitoring on a continual basis.

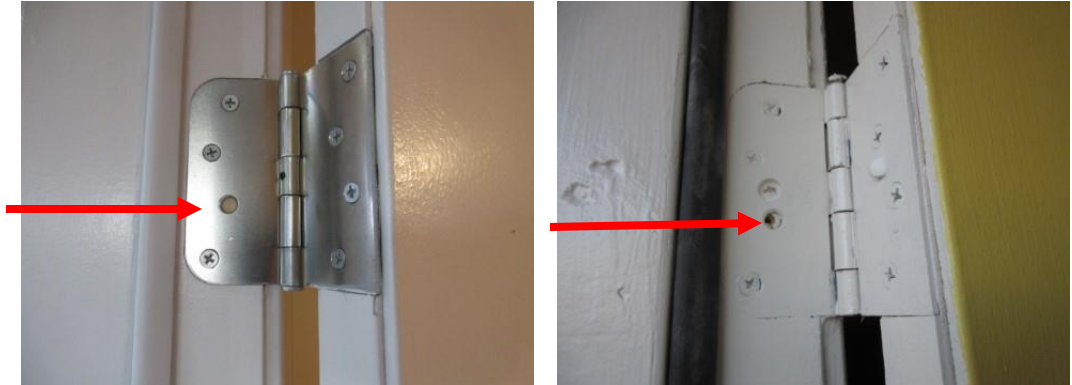
The front & back doors are missing fasteners at the hinges. Recommend replacing.

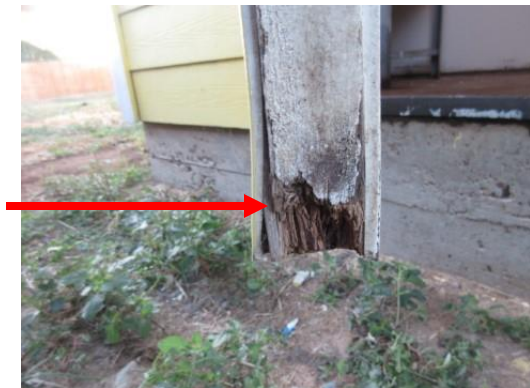
Damaged/decayed door was observed at the base of the door leading into the exterior storage area. Recommend repair/replacing.

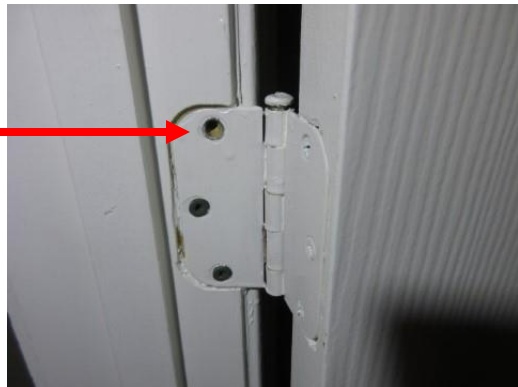
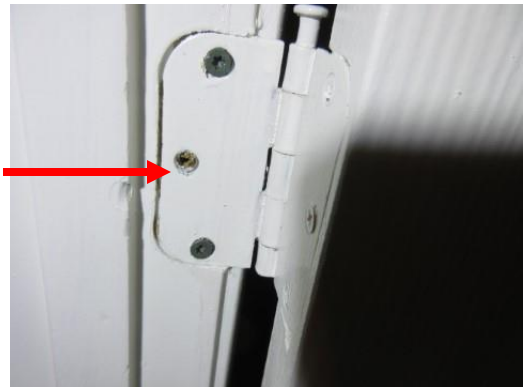
The closet door at the back right bedroom is missing fasteners at the hinges. Recommend replacing.

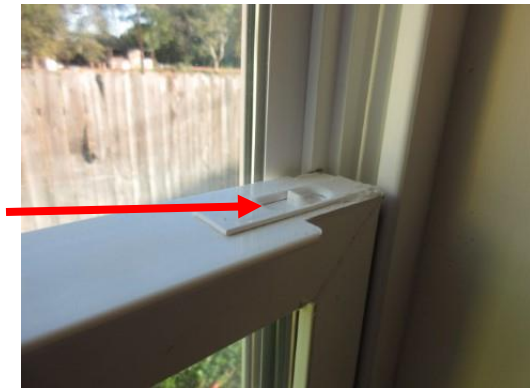
The tilt release at the window in the back right bedroom could not be disengaged under normal conditions. Recommend repair/replacing.

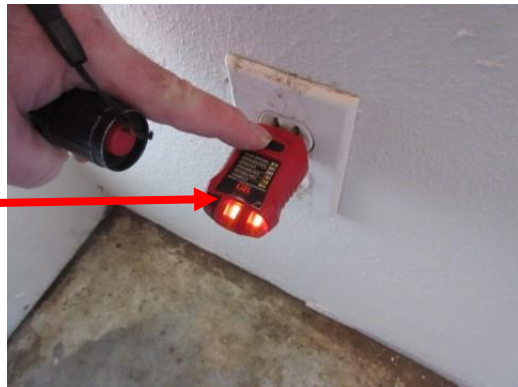
The outlets less than five and a half feet above the floor are not tamper resistant as required by today's standards.

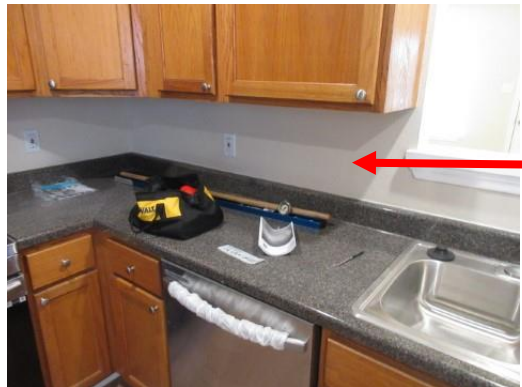
No disconnect was observed within the line of site of the dishwasher or a lockable breaker was not observed at the panel. This is a safety issue & should be corrected. Recommend further evaluation/repair.

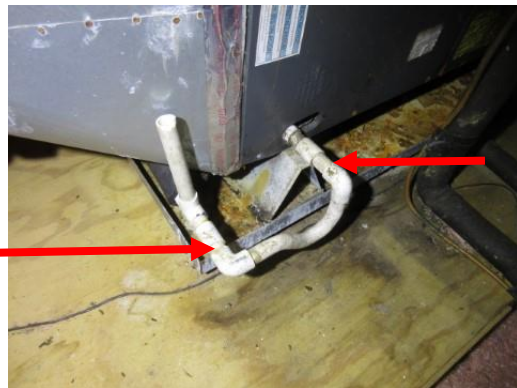
The primary drain line in the attic is not fully insulated a minimum of the 1st 15' from the evaporator coils. Recommend properly insulating to prevent possible moisture damage due to condensation forming & dripping into the attic space.

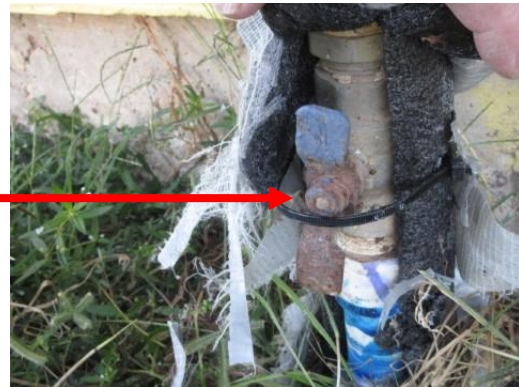
The main water supply shut off valve on the right side of the structure did not function as intended. The valve could not be closed under normal conditions. Recommend replacing.

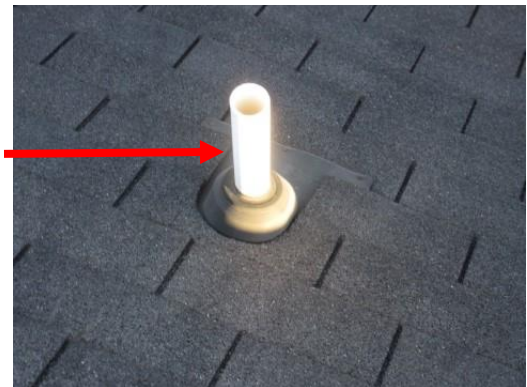
The drain waste vent pipes at the roof line have not been painted. Recommend painting to prevent deterioration of the plastic piping exposed to the elements.

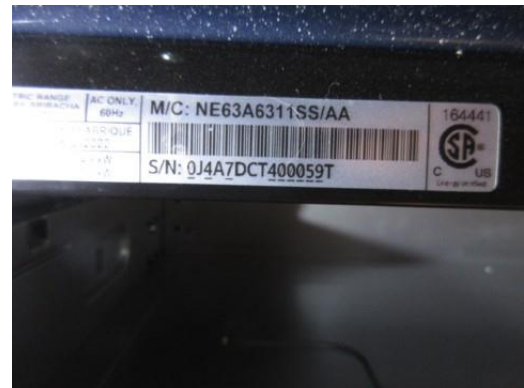
No anti-tip device is provided for the range. Recommend the installation of an anti-tip device as required.
