Report Identification: 224 Calvit Hempstead, TX. 77445

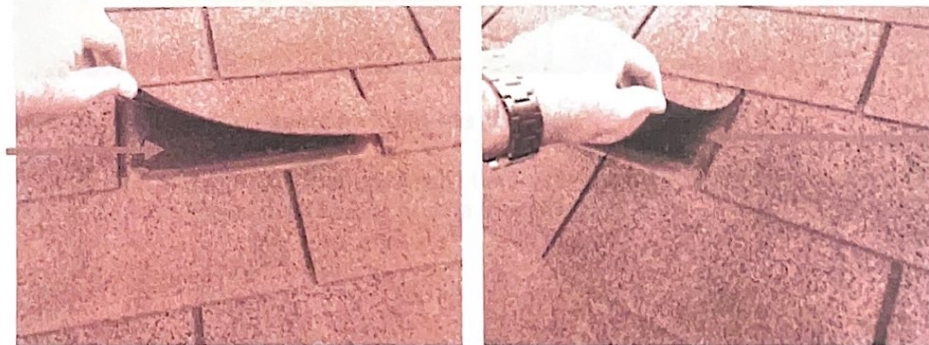
The shingle adhesion is not properly secured & the shingles can be easily lifted in some areas. This is of concern due to potential wind damage.

Multiple exposed nail heads were observed in some areas. Recommend sealing all exposed nail heads.

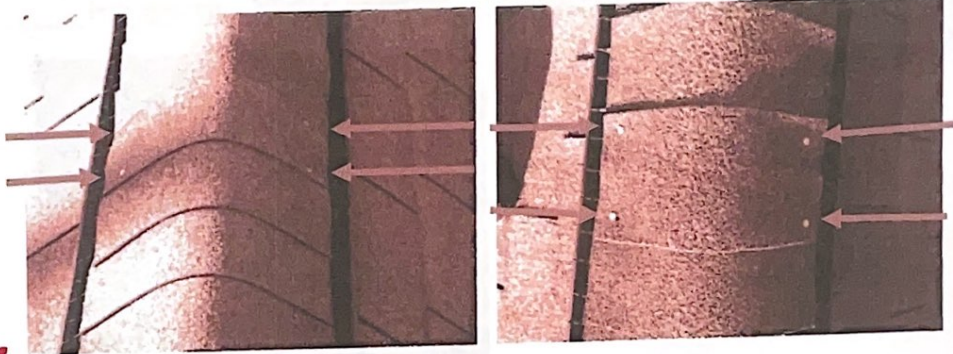
Damaged/missing shingles were observed on the front left side of the roof. Recommend repair/replacement.

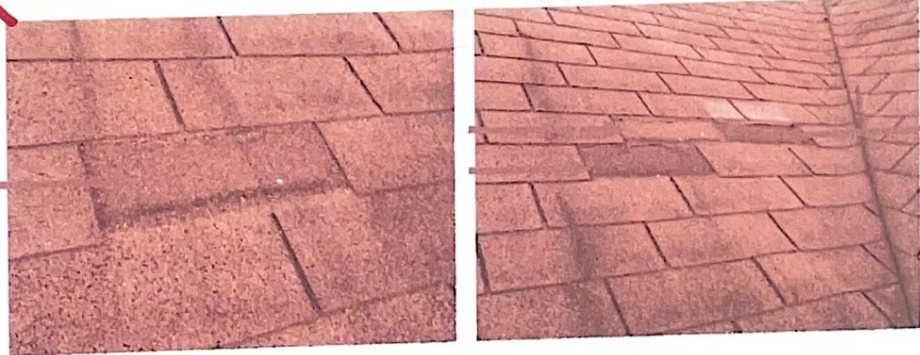
Shingle granule loss exposing asphalt was observed.

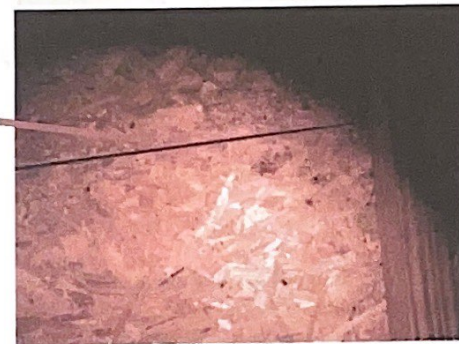
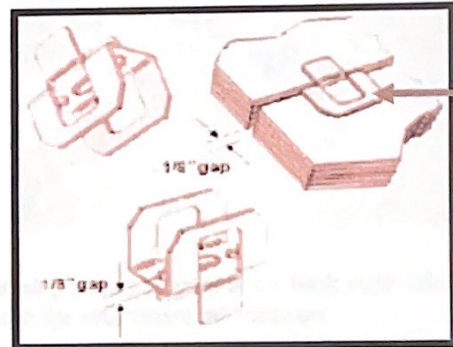
- Metal clips/roof deck spacers are missing between the roof decking in some areas.

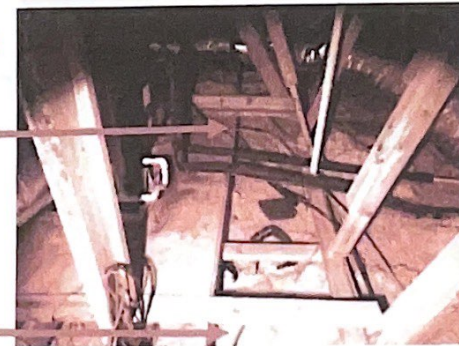
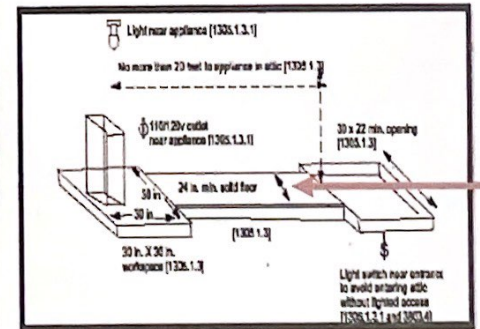
- The attic does not solid flooring at least 24" wide for access to the appliances where access is required & does not have a 30" wide by 30" deep work area along all sides of the appliances where access is required.

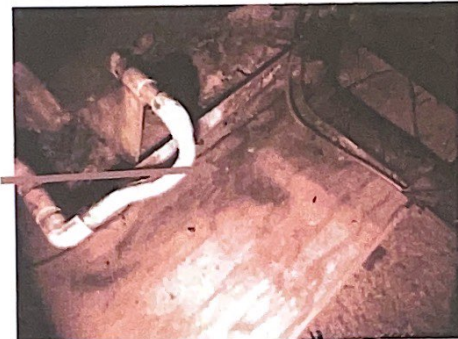
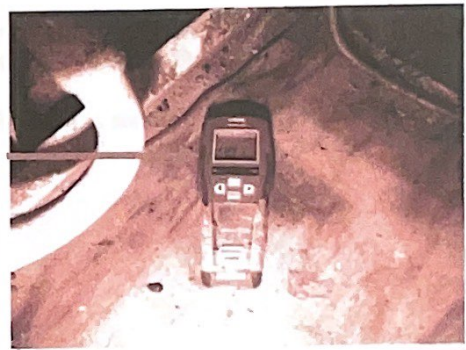
Existing/previous moisture penetration/staining was observed in the attic decking by the HVAC equipment. A moisture reading was performed in the accessible area & no moisture was detected at the time of the inspection.

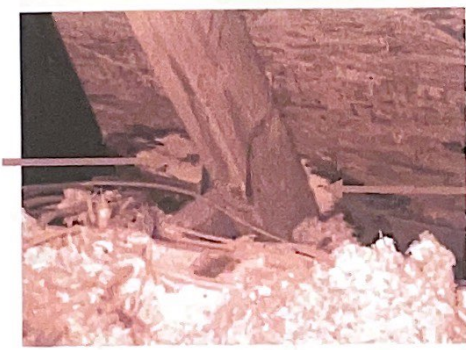
Existing/previous moisture penetration/staining were observed at the back right side of the attic however the inspector was unable to get to the area where the moisture penetration/staining was observed & could not determine if an active leak was observed. Recommend further evaluation.

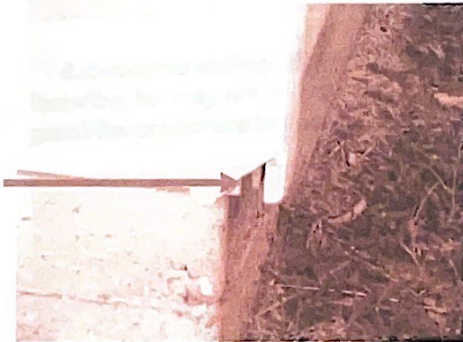
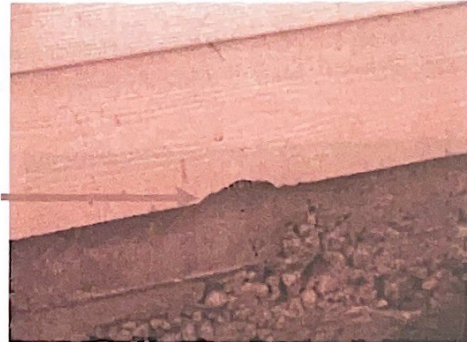
Minor damage/decay to siding/trim was observed in some areas around structure. Recommend repairing/replacing as needed.

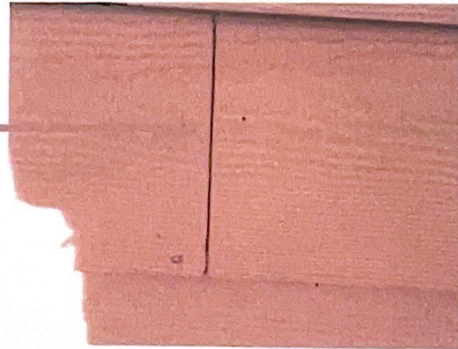
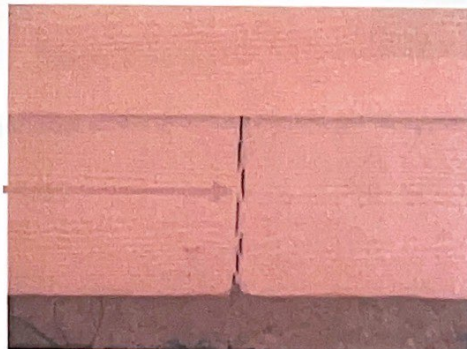
Deteriorated caulking/sealant was observed in some areas. Recommend sealing as needed.

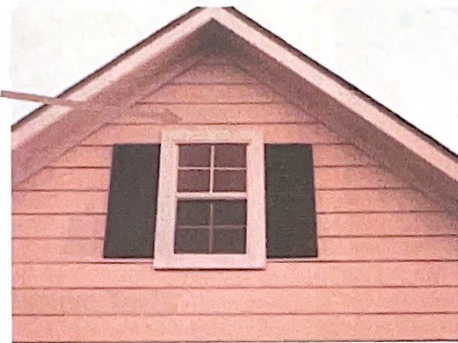
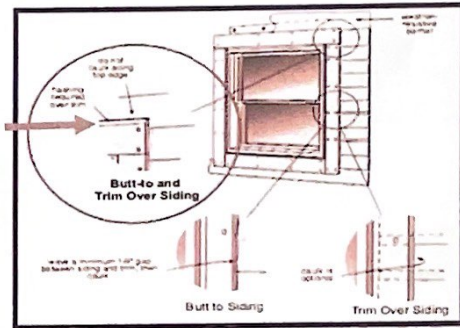
Flashing is not installed above the horizontal trim board on the front side of the structure. Flashing is required above all continuously projected trim.

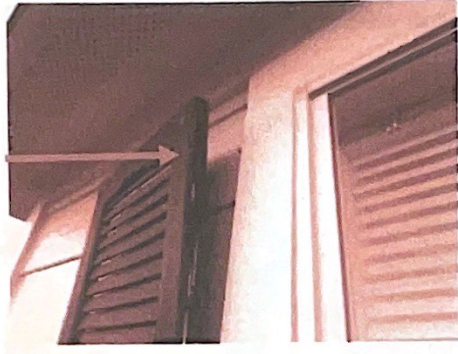
The shutters at the front left & front right sides of the structure are not properly secured to the wall.

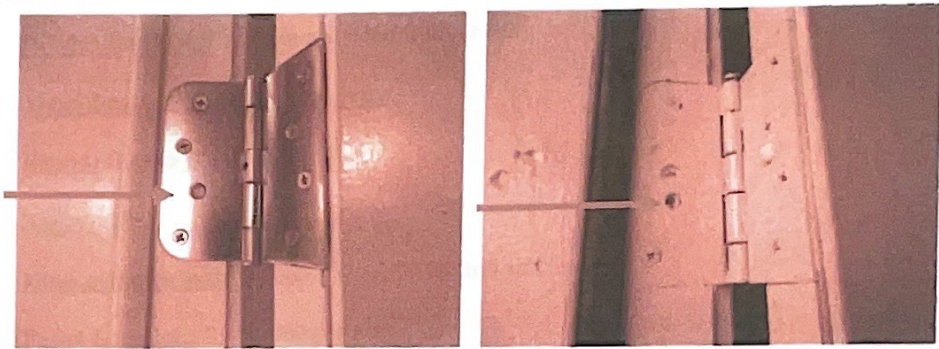
The front & back doors are missing fasteners at the hinges. Recommend replacing.

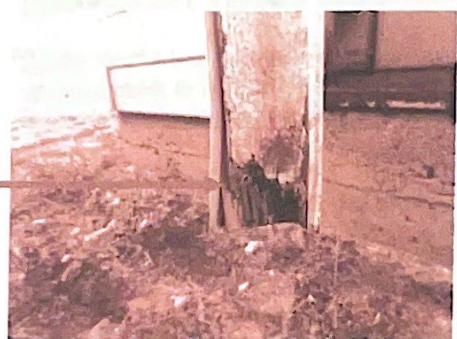
Damaged/decayed door was observed at the base of the door leading into the exterior storage area. Recommend repair/replacing.

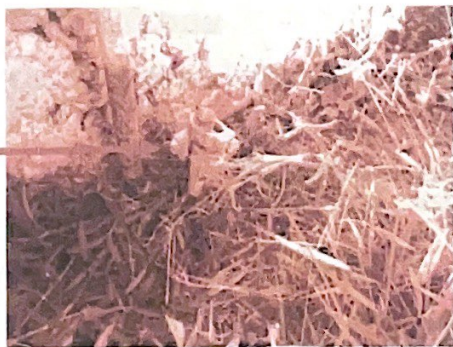
The grounding electrode is not flush with the ground. Since grounding electrodes are typically 8' long and are required to be driven 8' feet into the ground, it is recommended that the grounding electrode be driven flush with the ground or properly protected from damage/impact.

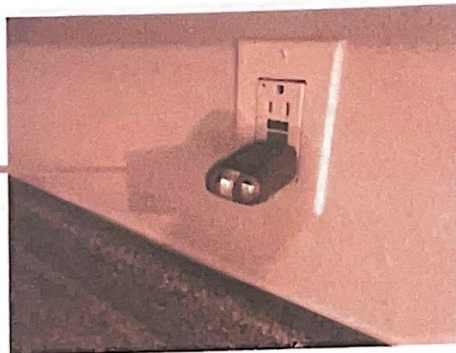
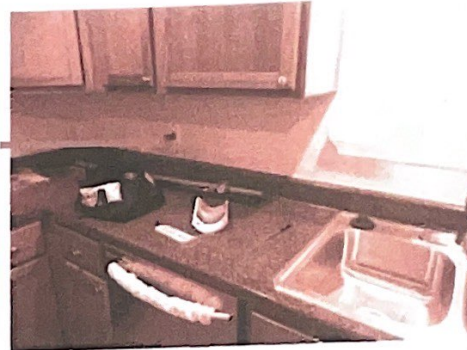
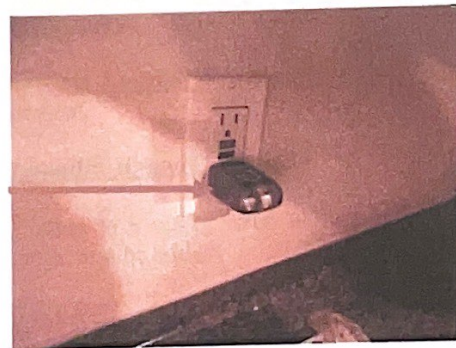
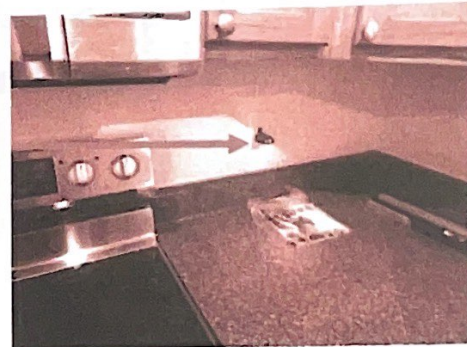
GFCI outlets in the kitchen have reversed polarity & would not trip when tested. This is a safety issue, it is recommended that the outlet be repaired/replaced.

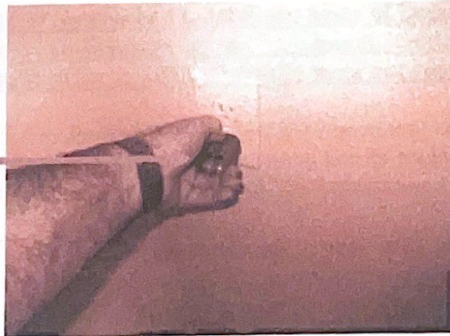
This is a safety issue as required by today's standards. It is recommended that GFCI protection be added.

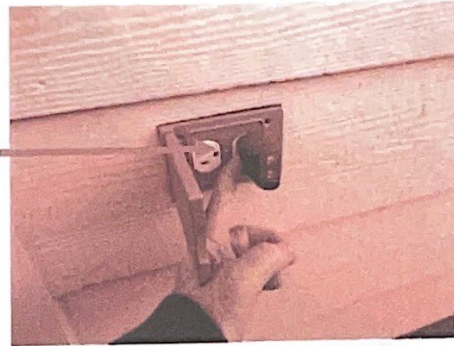
The back porch outlet is not GFCI protected. This is a safety issue, it is recommended that GCFI protection be added as required.

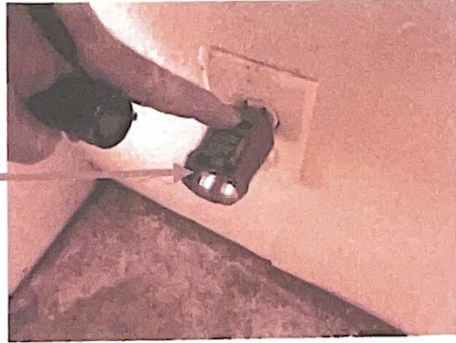
The outlet in the exterior storage area is not GFCI protected. This is a safety issue, it is recommended that GCFI protection be added as required.

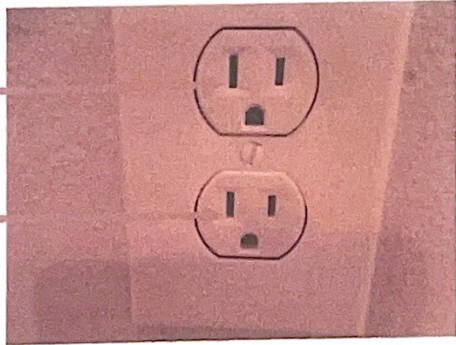
The outlets less than five and a half feet above the floor are not tamper resistant as required by today's standards.
