Home Inspection Report

9002 Hemlock St.
Richmond, TX 77469

PROPERTY INSPECTION REPORT

Inspection Date: 03/14/2020

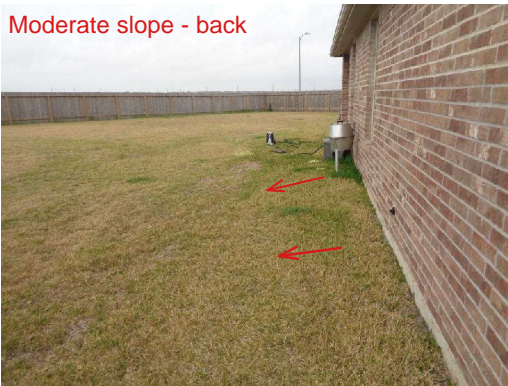
Moderate slope - back

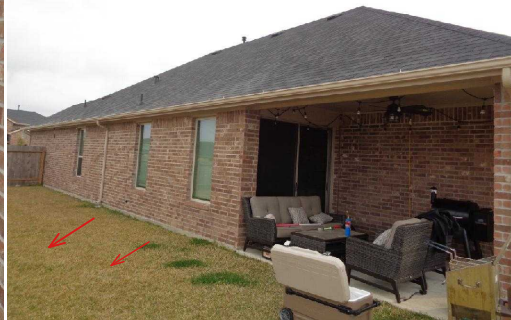
Moderate slope - right

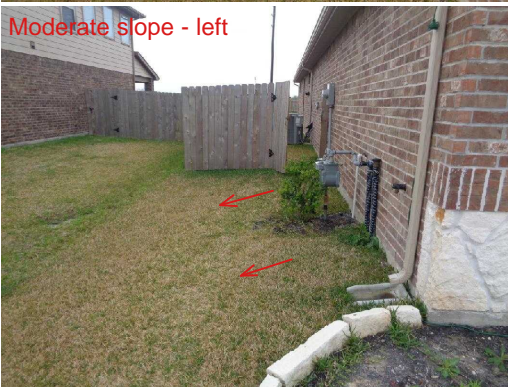
Moderate slope - left

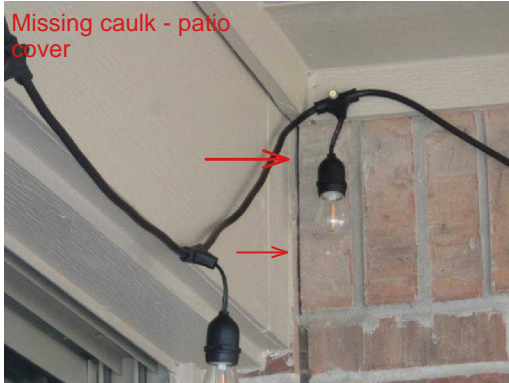
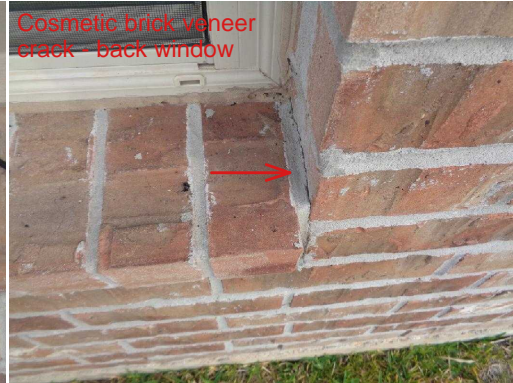
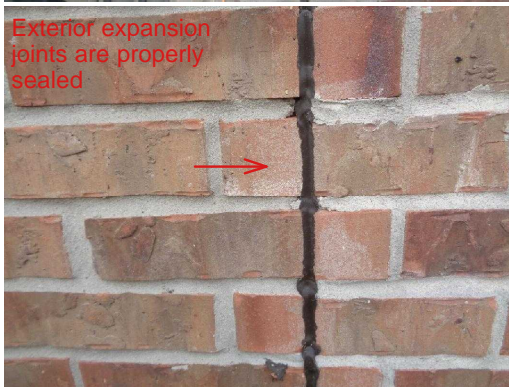
- Missing - caulk - exterior patio wall - needs repair.

- Cosmetic brick veneer crack - master bedroom window.

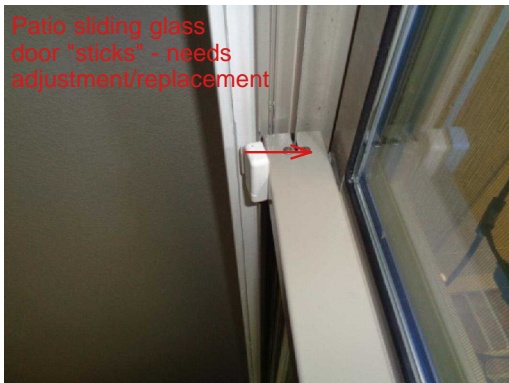
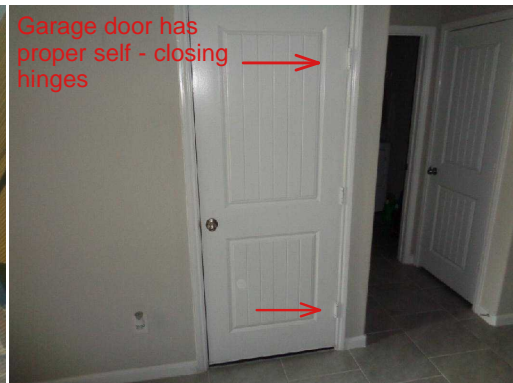
- Patio sliding glass door "sticks" - needs adjustment/repair.

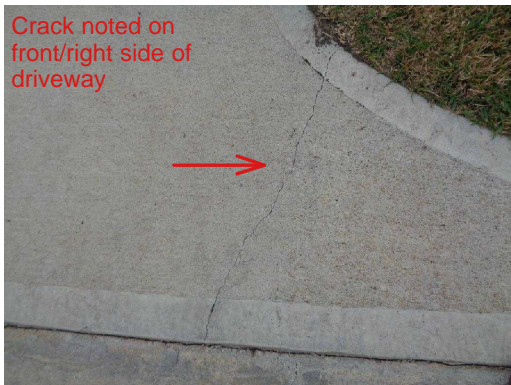
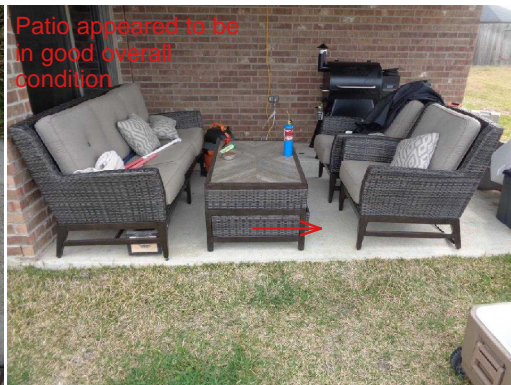
- Surface crack noted on front/right portion of driveway.

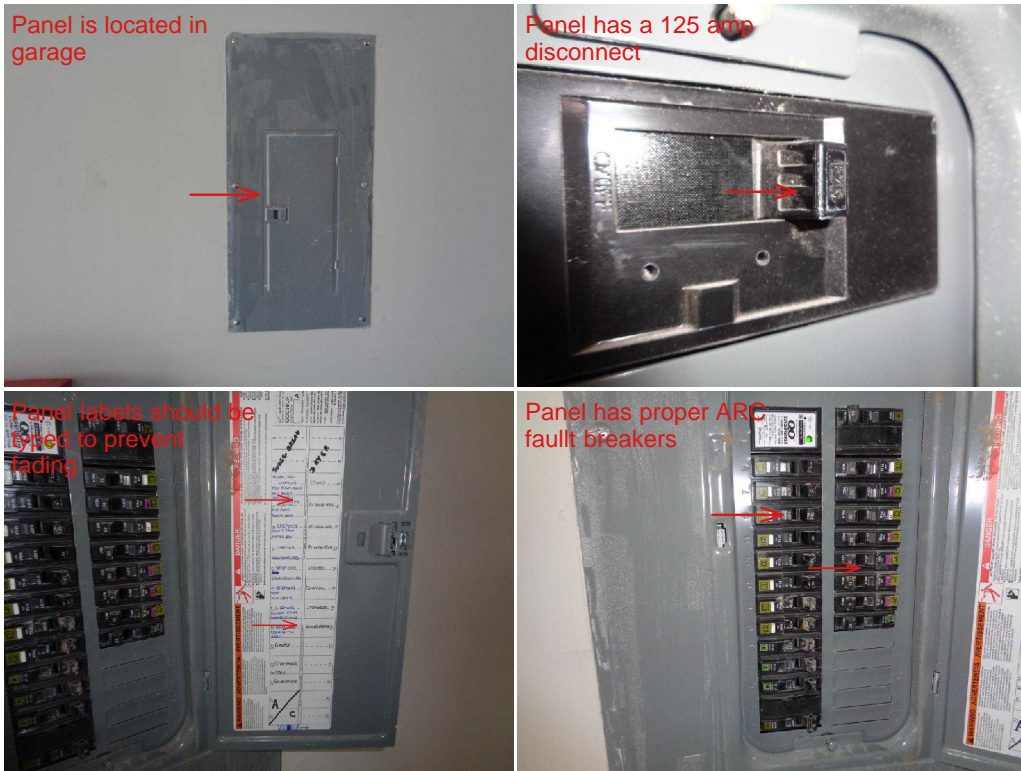
- The panel has a 125 amp disconnect which is adequate for this size of house.
- The panel appears to have aluminum entry branches.
- The aluminum entry branches have anti - oxidant compound which prohibits oxidation.
- The panel appears to have proper ARC fault type breakers.
- The panel has a whole house surge protector.
- The panel labels should be typed to prevent fading.
- The electrical system appears to be properly grounded via an 8 ft. grounding rod.
- The gas meter appeared to be properly bonded.

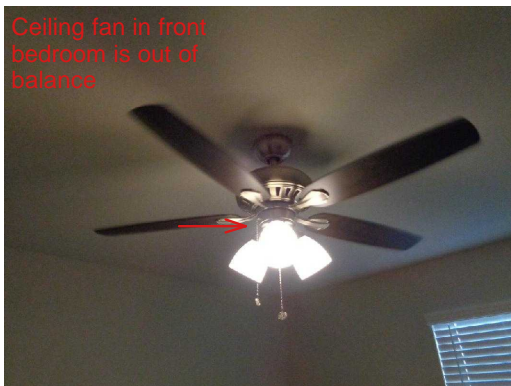
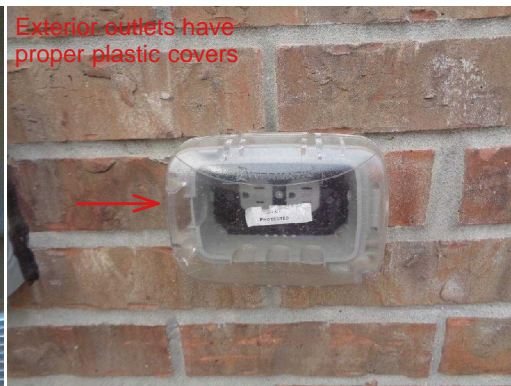
- Ceiling fan in front bedroom is out of balance - needs adjustment.

- Ceiling fan in front bedroom is out of balance - needs adjustment. Type of Wiring: - Copper

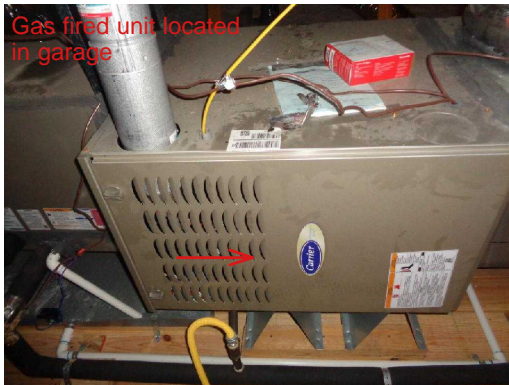
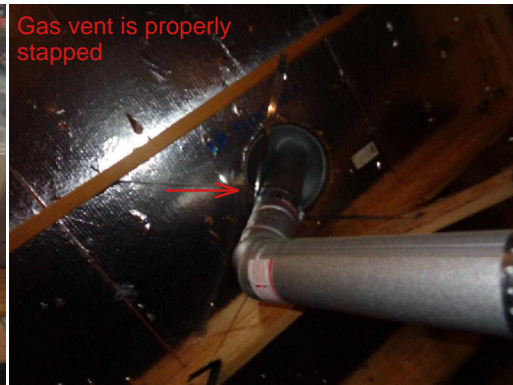
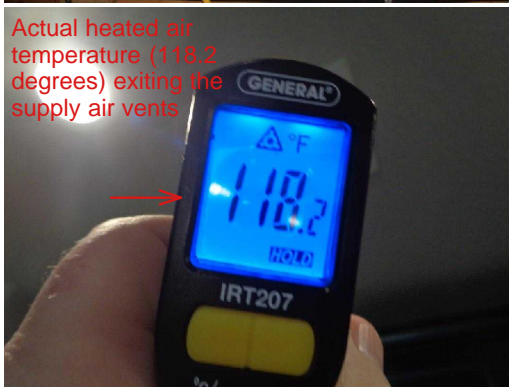
- The furnace gas exhaust vent appears to be properly strapped.

- Heating system appeared to be functioning as designed. Heated air exiting the supply air vents was 118 degrees vs an ambient air temperature of 75 degrees produces a differential of 43 degrees which is acceptable per industry standards.

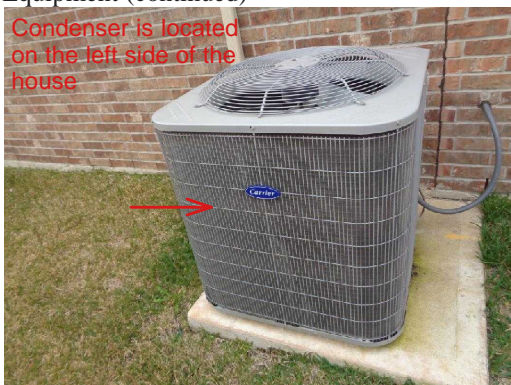
Condenser is located on the left side of the house

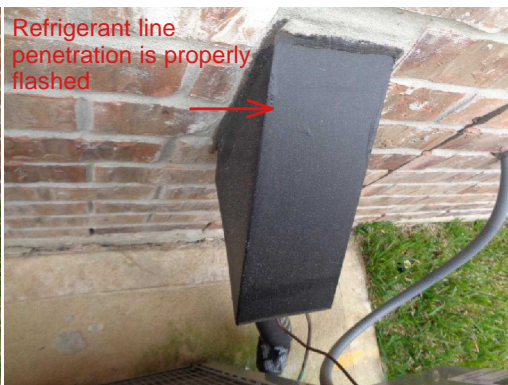
Refrigerant line penetration is properly flashed

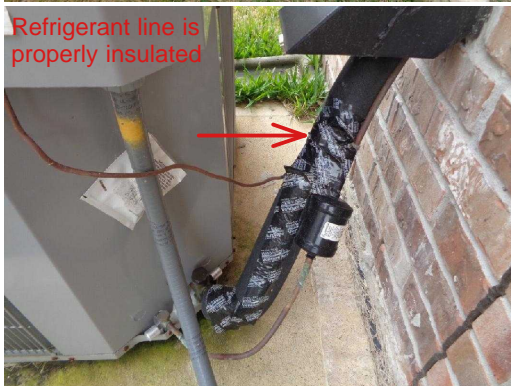
Refrigerant line is properly insulated

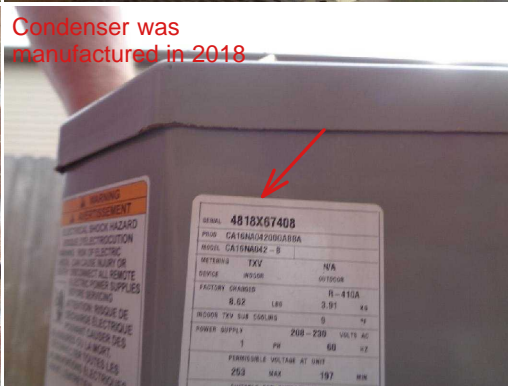
Condenser was manufactured in 2018

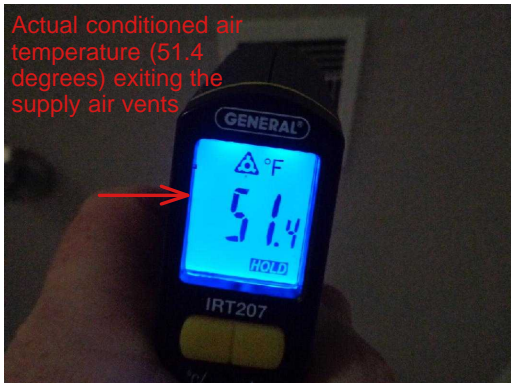
Actual conditioned air temperature (51.4 degrees) exiting the supply air vents

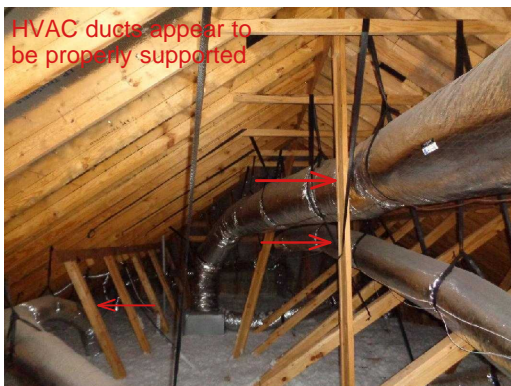
HVAC ducts appear to be properly supported

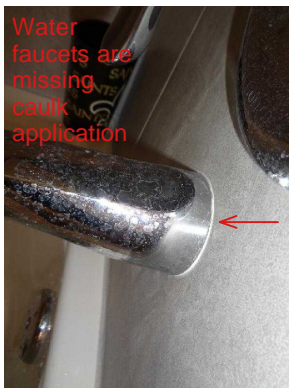
B. Drains, Wastes, and Vents - Comments: - PVC, - Missing clear caulk application on tub water faucet features - needs repair.

B. Drains, Wastes, and Vents - PVC, - Missing clear caulk application on tub water faucet features - needs repair.

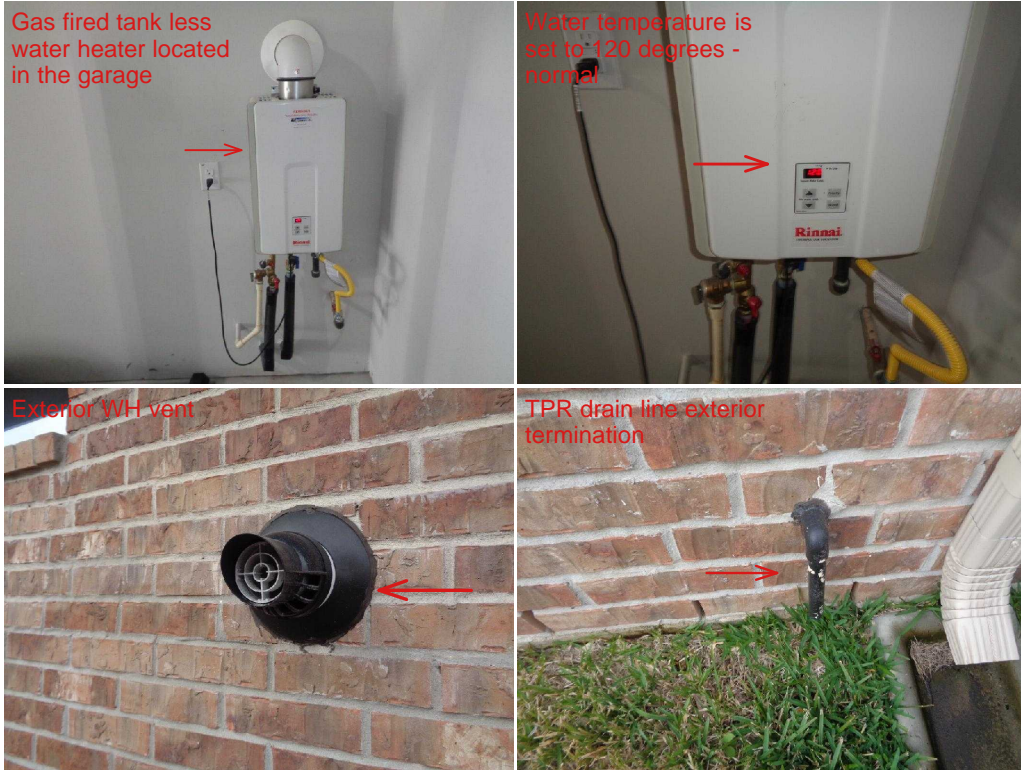
Comments: - Rinnai - Tankless - The water heater is a gas fired unit located in the garage.

- The water heater has a TPR drain line exterior termination.

- The water temperature is set to 120 degrees.

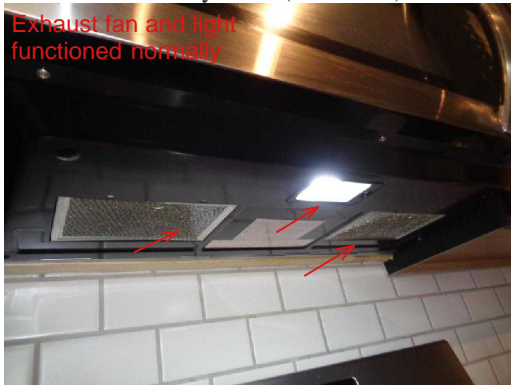
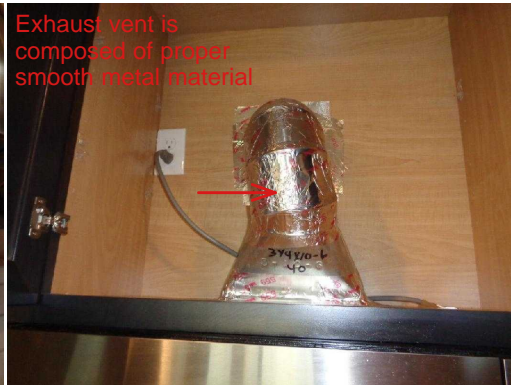
- Filters need to be replaced/cleaned.
