PROPERTY INSPECTION REPORT

1903 Sekola Ln
Spring TX 77386

Meredith Taylor & Iram Humberto Guerrero
JUNE 8, 2021

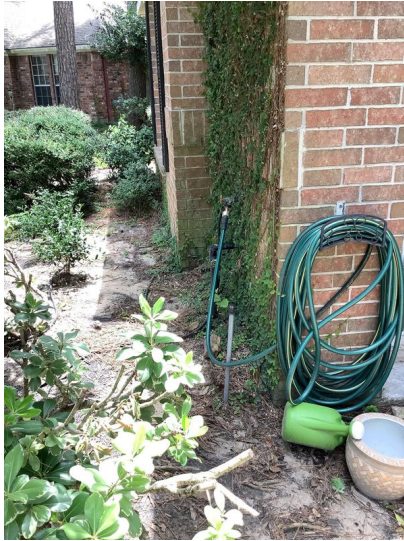
Heavy Foliage:

The heavy foliage around the structure should be trimmed and lowered to allow observation for insect activity. This condition is also conducive to moisture issues.

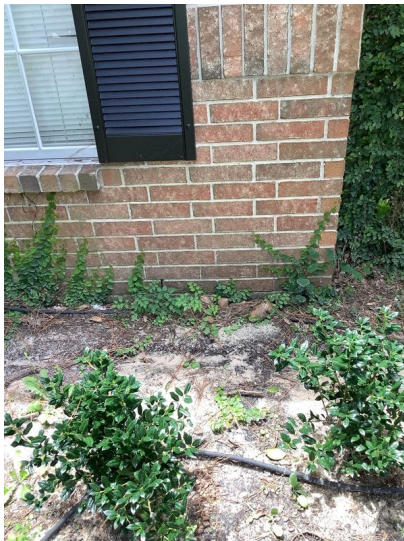
High Soil:

The high soil around the structure should be trimmed and lowered to allow observation for insect activity. This condition is also conducive to moisture issues.

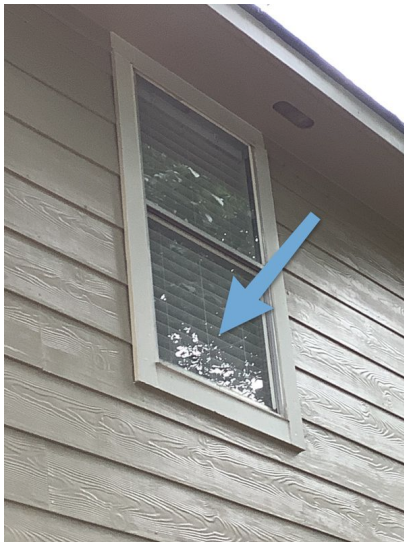
1: Missing Screens

There were missing window screens.

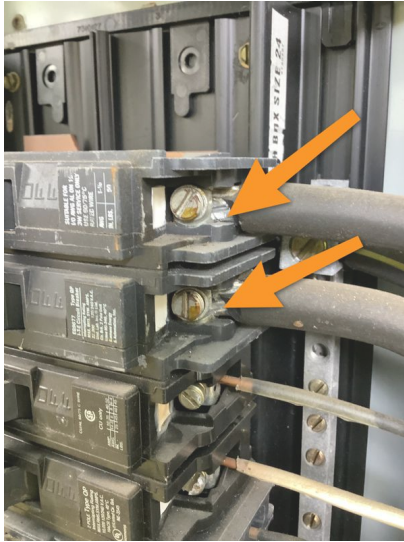
1: Aluminum - Missing Anti Oxidants

There was not visible anti-oxidants on aluminum conductor terminations within the panel.

Recommendation: Contact a qualified electrical contractor.

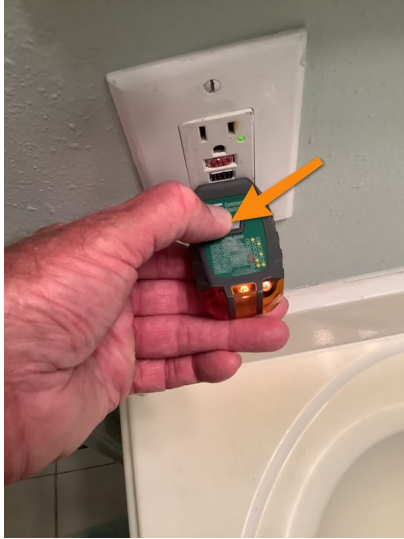
The GFCI outlet in 2nd floor bath and kitchen do not trip when tested with a handheld tester. Replacement is recommended.

Recommendation: Contact a qualified electrical contractor.

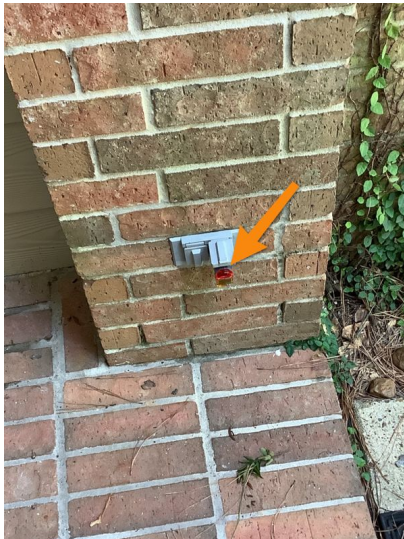
2: Exterior outlets

The exterior outlets appear to be dead.

Recommendation: Contact a qualified professional.

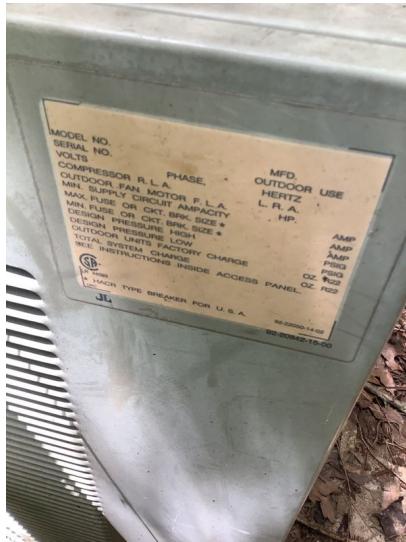
Faded label

The Rheem condenser appears old. Manufacturers say they are no longer efficient to maintain after 16 years.

Recommendation: Contact a qualified professional.

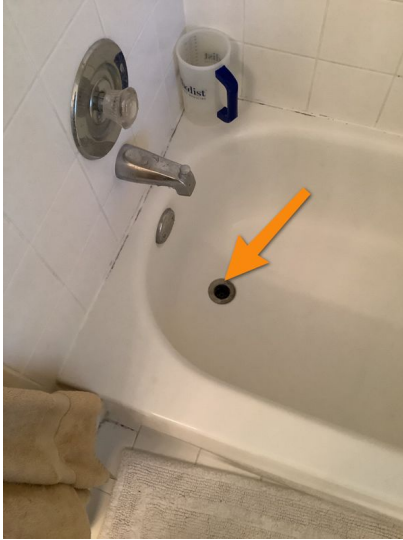
The bathtub stopper was not present at the time of inspection.

Recommendation: Contact a qualified plumbing contractor.

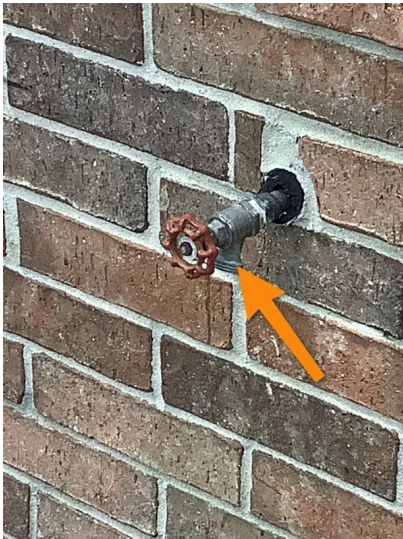
2: Anti-Siphon Exterior Fixture

For safety reasons, an anti-siphon valve should be added to the exterior faucets to prevent cross contamination of the water supply.

Recommendation: Contact a qualified plumbing contractor.

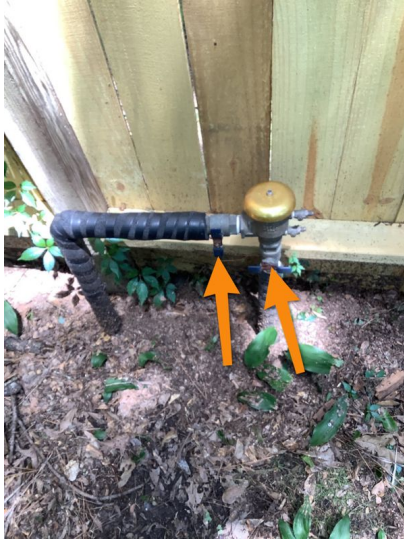
Shut off valves were rusted closed. Could not get them turned on without damaging.

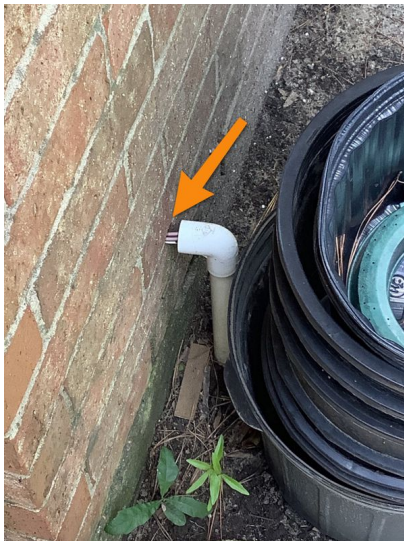
2: Seal

Recommend sealing the protective conduit to the brick veneer.

Recommendation: Contact a qualified professional.

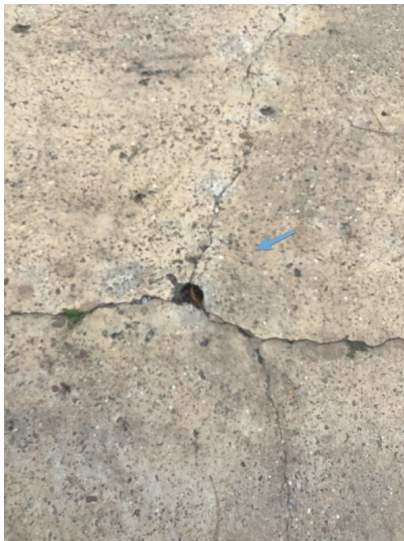
Cracking was observed at the driveway. Recommend a qualified professional evaluate and repair as needed.

Recommendation: Contact a qualified professional.
