# **Inspection Report**

100 Jay Court

Lake Jackson, TX 77566

# PROPERTY INSPECTION REPORT

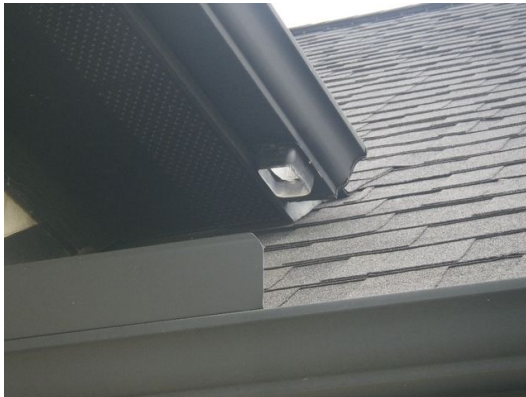
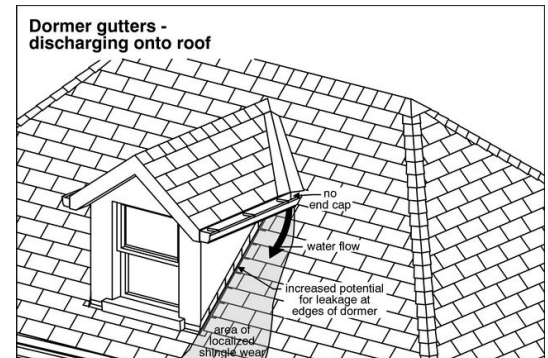
**NOTE:** Upper roof downspouts discharge onto lower roof surfaces, creating potential for accelerated wear of shingles beneath the point of discharge. Ideally, downspouts should be installed that extend to lower-level gutters.

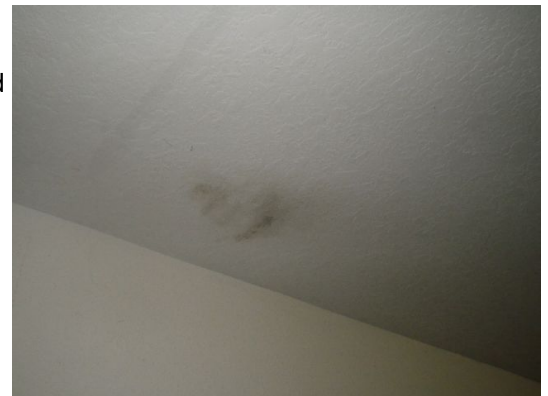
**NOTE:** A stain is present on the garage ceiling near the north wall between the water heater and the rear garage door. The area is located beneath the rear roof valley and may have been caused by previous rainwater penetration. The stain was dry at the time of inspection as measured with a moisture meter. Further evaluation by a roofing contractor is recommended if record of repair cannot be verified.

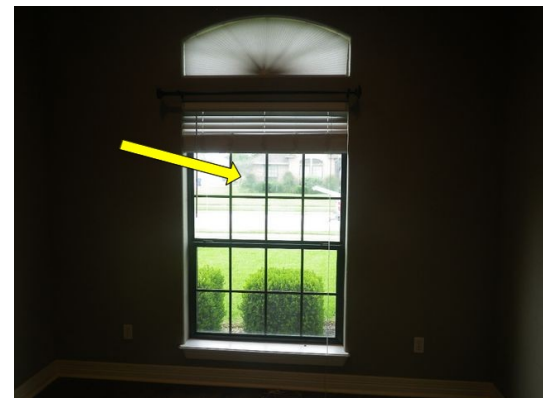
Low-emittance coatings have failed on the double-pane light unit of the formal dining area window, causing a grainy appearance on inner pane surfaces. The condition cannot be corrected without replacement of the affected double-pane glass unit.

Desiccant seals have failed in the double-pane sash unit of the bedroom 1 left window, causing silica haze on interior pane surfaces.

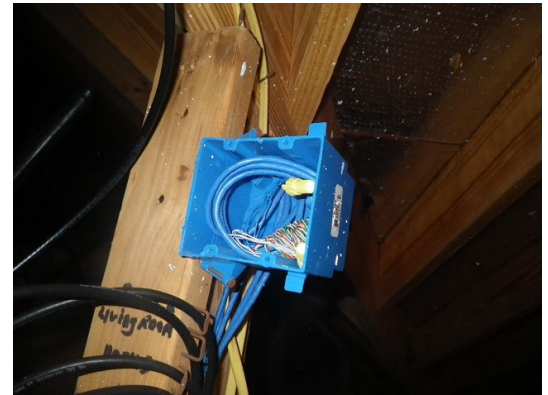
An uncovered junction box is present on attic roof structure near the access opening. All wire connections should be contained in covered junction boxes that are secured to structure. All instances should be identified and repaired by an electrician.

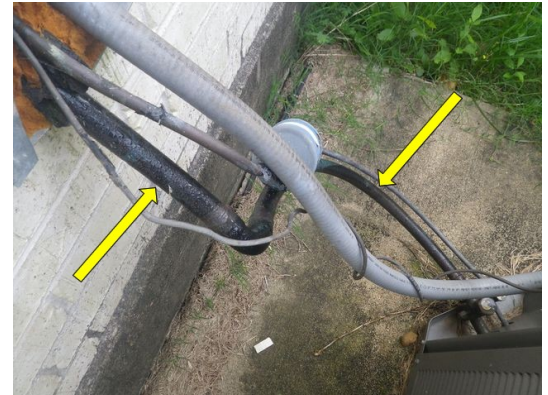
The temperature drop measured across the evaporator coil of the air conditioning system is lower than considered typical. A temperate drop of 11 to 12 degrees was measured, whereas differentials of 15 to 22 degrees are considered normal. This usually indicates that servicing is needed. A qualified heating and cooling technician should be consulted to further evaluate this condition and the remedies available for correction.

Insulation is missing from exterior refrigerant tubing, creating excess condensation and allowing increased heat gain. Replacement is recommended.
