## PROPERTY INSPECTION REPORT

Prepared For: Justin & Lesley Miller  
(Name of Client)

Concerning: 1513 Nagle Street, Houston, TX 77003  
(Address of Inspected Property)

By: Jared Owen, TREC: PI 21225 06/01/2020  
(Name and License Number of Inspector) (Date)

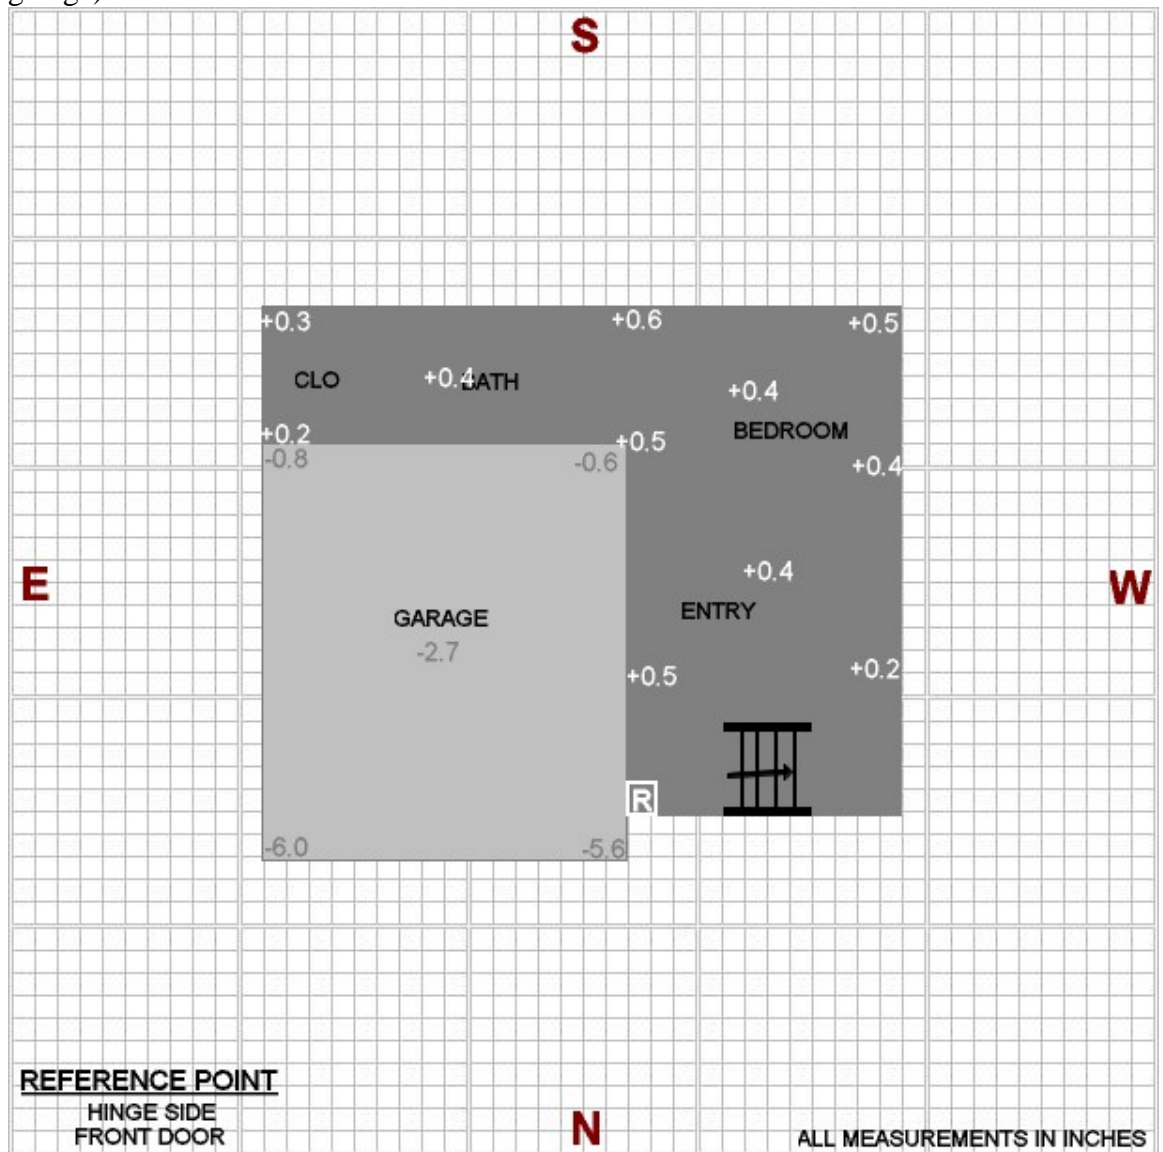
A foundation elevation survey was conducted during the inspection. The floor plan below represents data gathered using a Zip Level and adjusting for floor covering height differences. i.e. differences between tile, carpet and wood flooring(except step down to garage). Greatest variance was 0.6". Not drawn to scale.

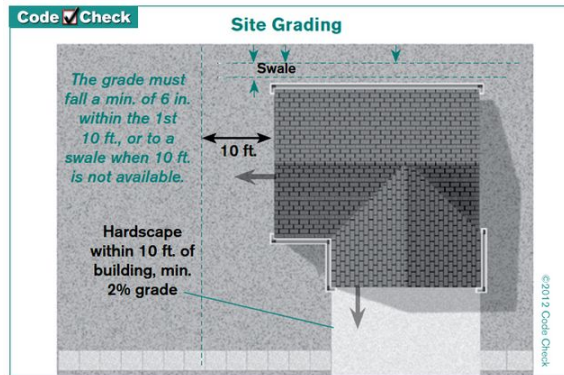
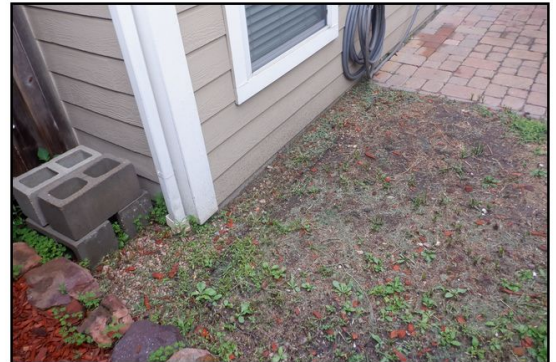
Soil grade and drainage patterns around some areas of the house do not appear to properly direct water away from the foundation to aid in controlling runoff water and could cause differential movement of the foundation or water penetration during heavy rains.

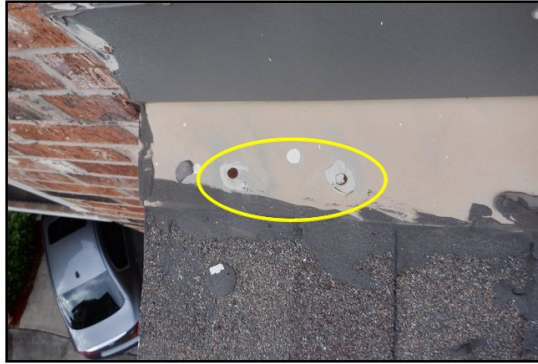
Exposed staples / nail heads / fasteners observed on the roof are not properly sealed. Water entry possible.

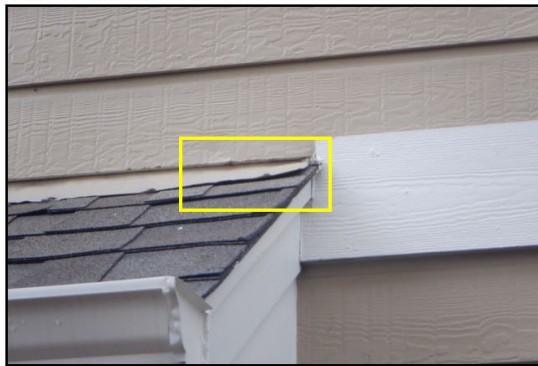
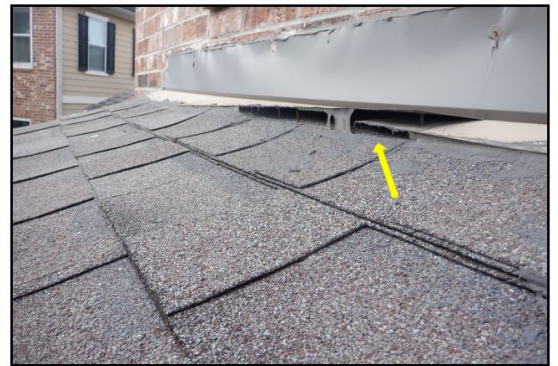
Lower side of flashing is not sealed down, wind-driven rains can cause water penetration.

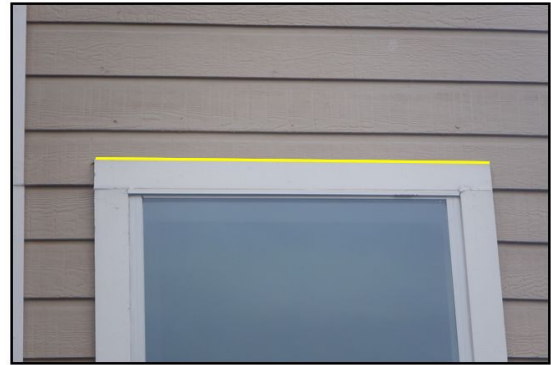
Head flashing missing over window/door trim pieces. Without head flashing over window trim, sealing must be maintained as a defense against water penetration.

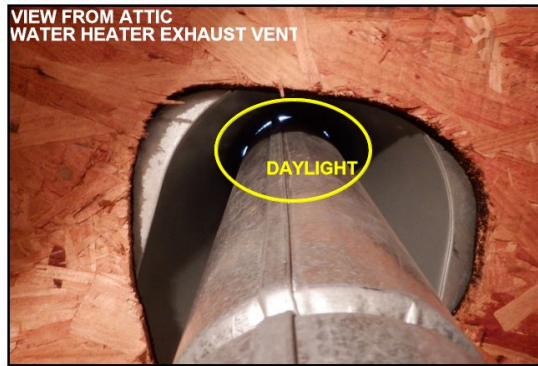
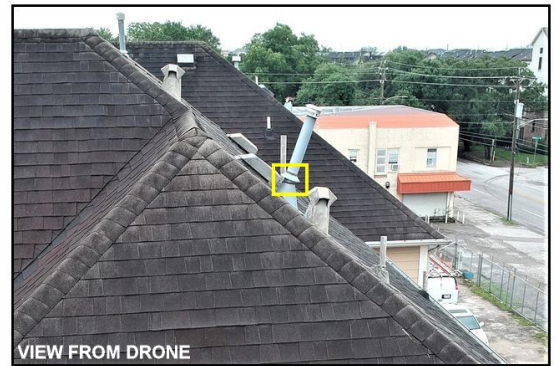
Storm collar not properly positioned on water and/or house heater vent pipe.

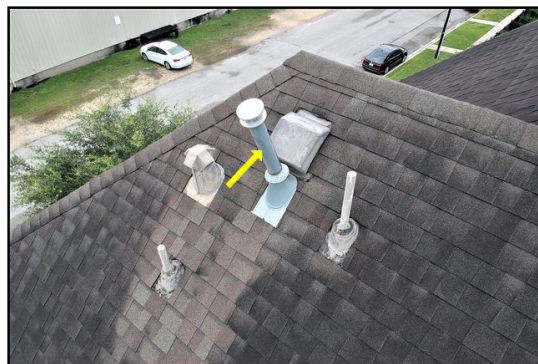
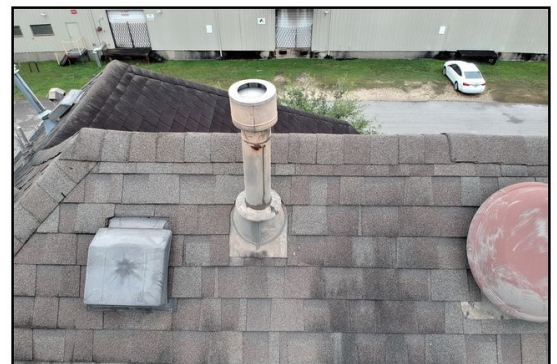
Recommend painting all exposed metal to prevent rusting and extend service life.

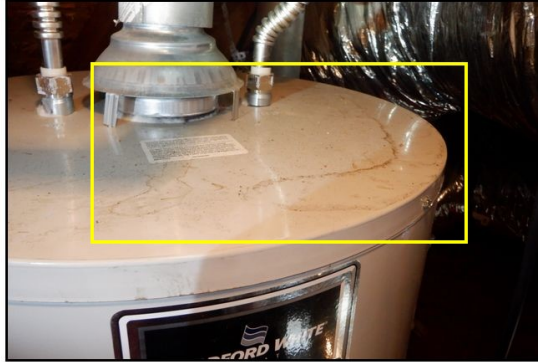
Water / rust stains on top of water heater, indication of possible previous water penetration. No active water penetration observed at time of inspection.

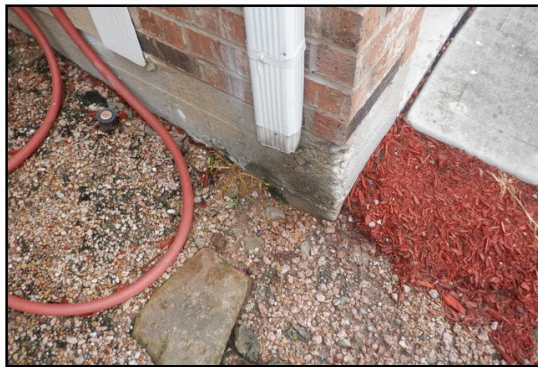
The elbow is missing at the end of the downspout at one or more locations.

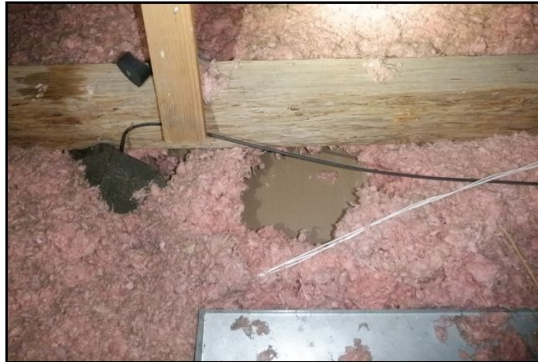
Insulation not properly positioned/missing in areas, etc.

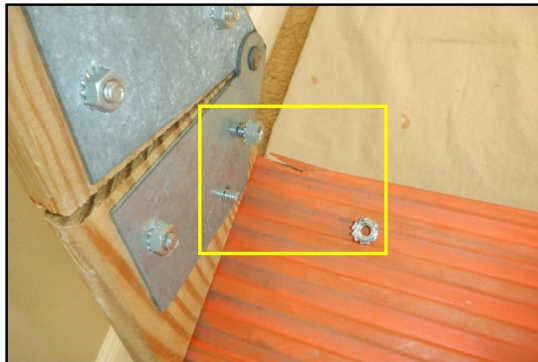
Tighten loose / replace missing nuts and bolts on stairway sections.

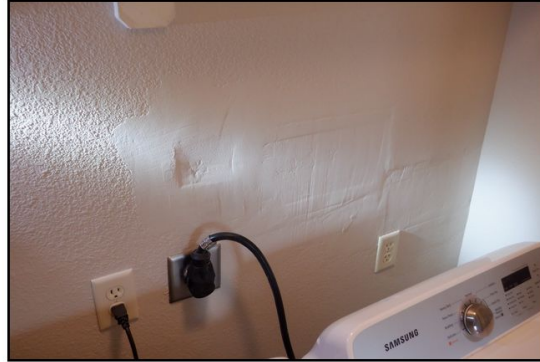
*Patch / repair(s) noted at laundry room; This inspection does not rate the substance or adequacy of these repairs.*

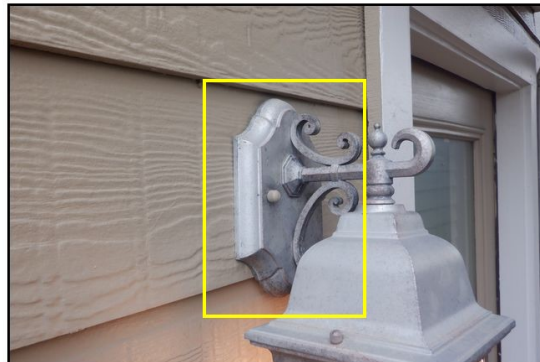
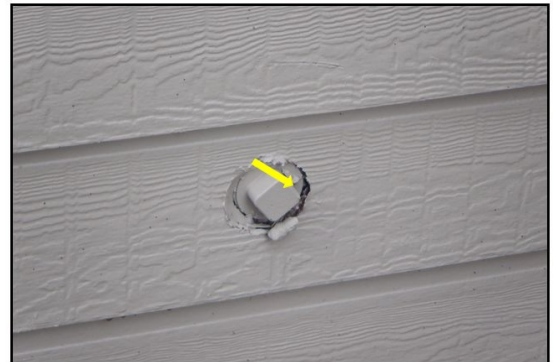
Need sealing/caulking around all holes and exterior siding penetrations on top and both sides, (leave the bottom open) to prevent water entry. Including but not limited to dryer, bath and range top vents, light fixtures, etc.

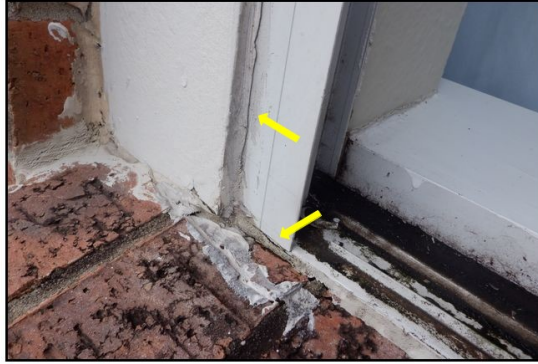
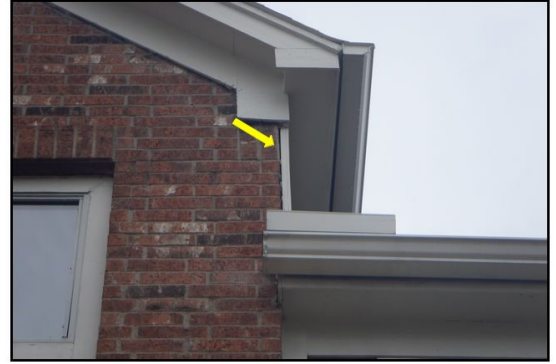
Caulking missing and/or deficient around windows / vertical trim / joints in siding. May allow wind driven rain entry.

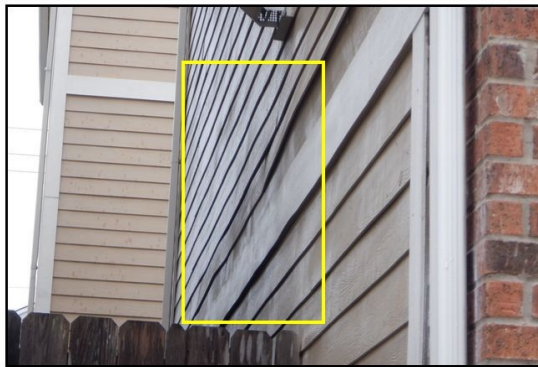
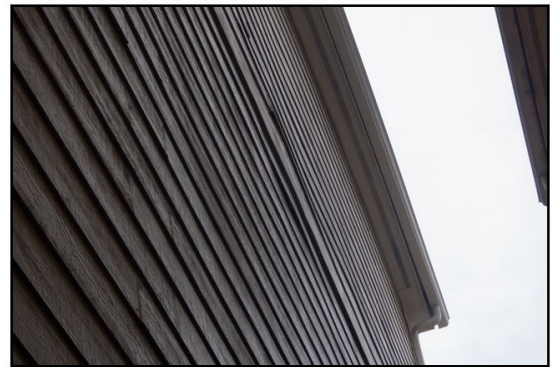
Observed some wavy cement board siding in one or more locations, cause is unknown. Possible improper installation.

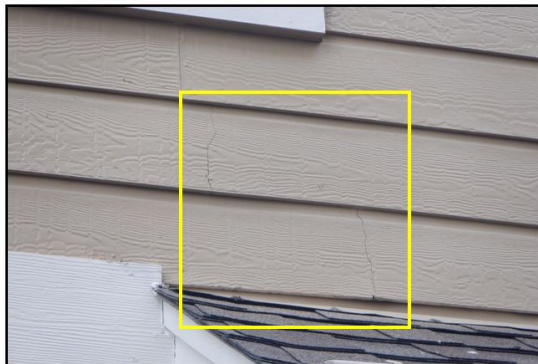
Observed one or more areas of damaged / cracked / chipped cement board siding.

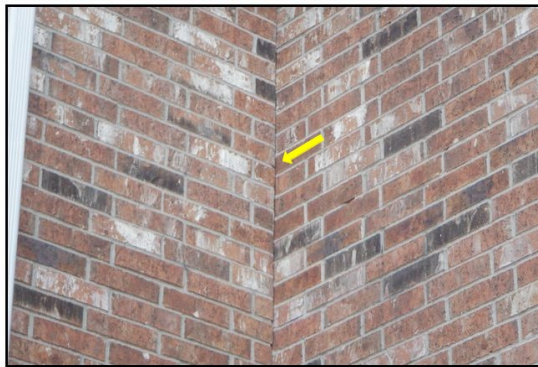
Expansion joint(s) and / or inside corners in brick veneer need caulking. Ensure any mortar present in the expansion joint is first removed before sealing.

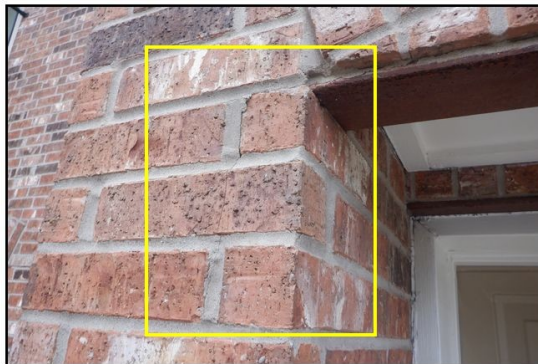
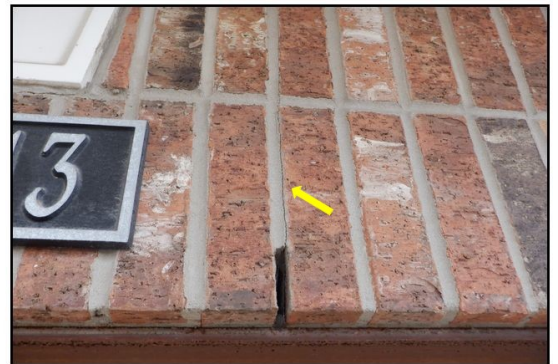
Cracks in brick veneer and/or repairs, one or more locations, Recommend buyer take photographs of cracks, their location, and width [ruler across the crack] with a high-resolution camera that has a date stamp for future reference.

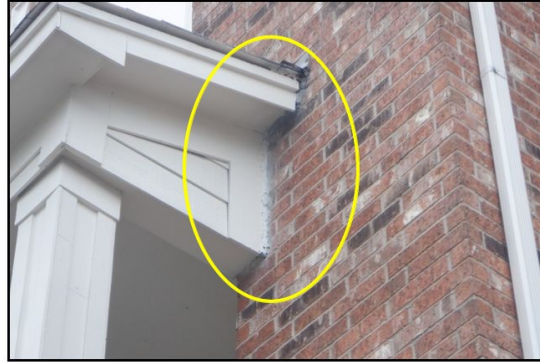
*Possible patch / repair(s) noted at north wall (balcony-wall intersection); This inspection does not rate the substance or adequacy of these repairs.*

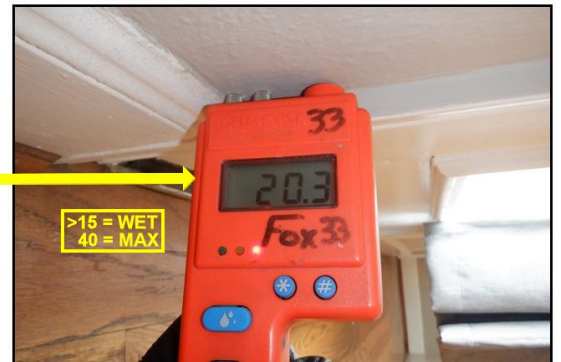
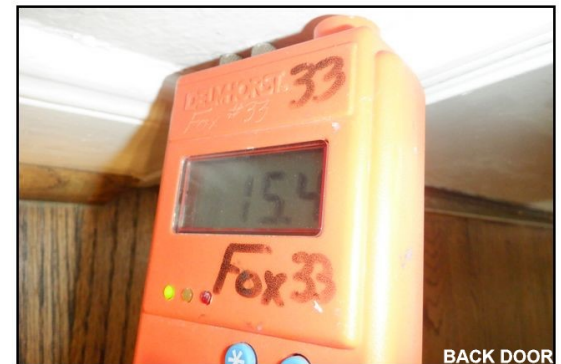
**Water penetration detected at balcony and back doors. Did not observe door pan flashing at door thresholds (see Exterior Doors section below). Recommend further investigation / repair by a qualified professional.**

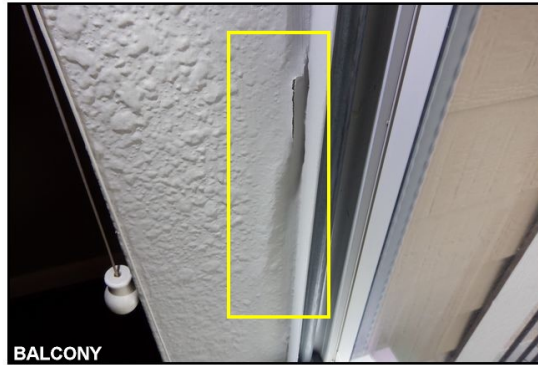
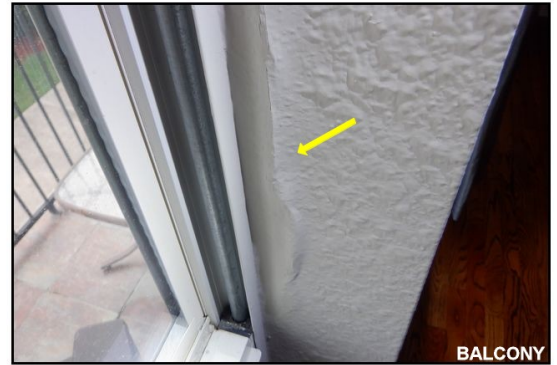
Water stains/damage to the interior of one or more window jambs. Moisture meter indicated that the stains were not active (wet) at the time of inspection.

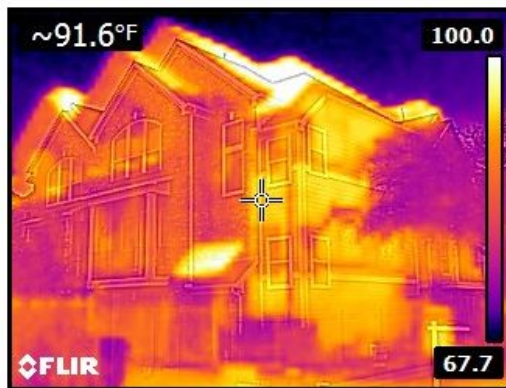
No significant thermal anomalies observed at the time of inspection.

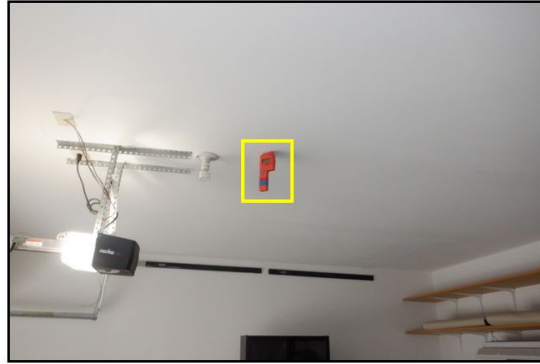
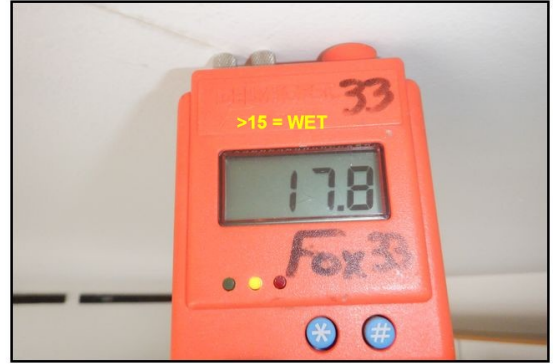
**Observed several suspected water stains in ceiling of garage. Majority of stains were not active (wet) at time of inspection, however moisture meter registered 1 water stain as active (wet). Source of moisture is unknown - no leaks observed from dishwasher / sink located in kitchen somewhat above this area. Recommend further investigation to determine root cause.**

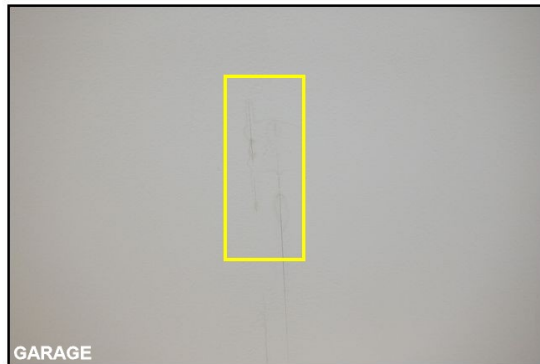
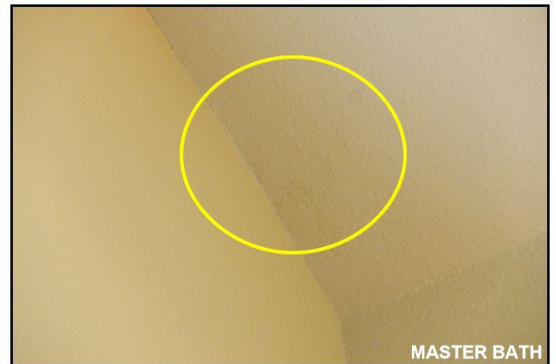
Suspected water stains, damage or repairs observed, moisture detection equipment indicated that stains are not active (wet) at the time of inspection; garage, master bath.

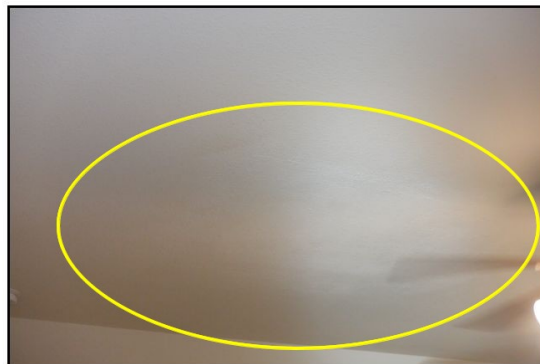
*Patch / repair(s) noted at master bedroom; This inspection does not rate the substance or adequacy of these repairs.*

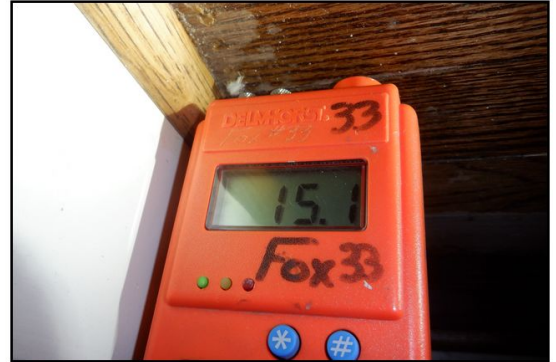
**Moisture meter registers water stains as active (wet); first floor bedroom closet (near bath). Source of moisture is unknown, no visible leaks observed from nearby sink. Recommend further investigation to determine root cause.**

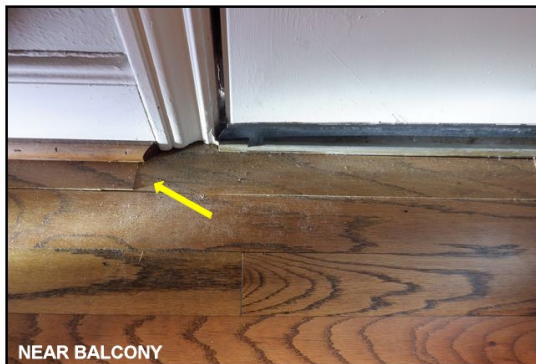
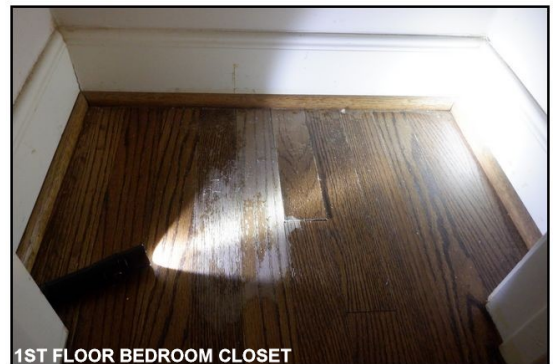
Water damaged wood flooring. Observed cupping/unevenness of wood flooring, an indication of past or present high moisture conditions below wood flooring.

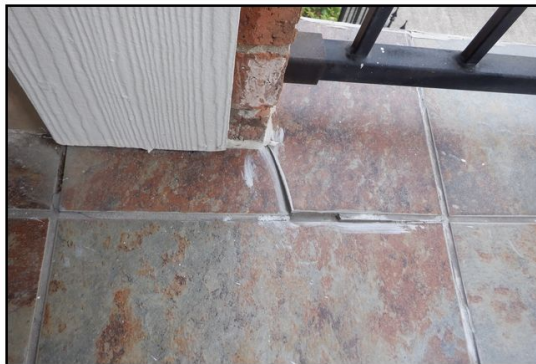
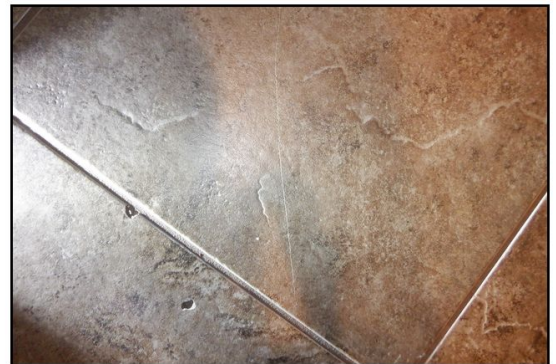
Cracked/chipped and/or loose floor tile observed in; balcony, kitchen.

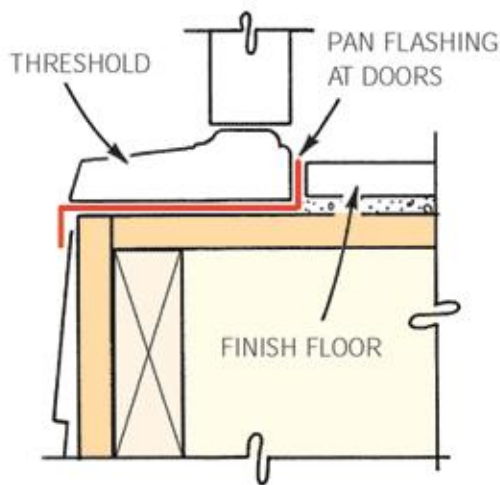
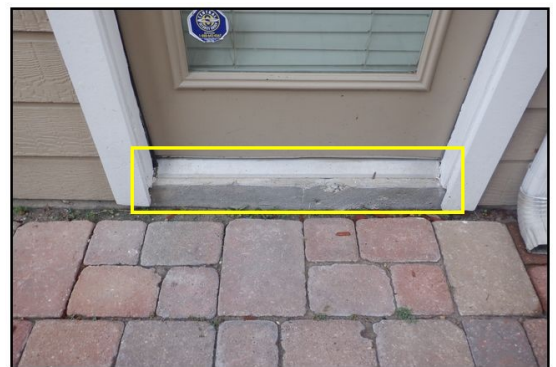
Did not observe door pan flashing at exterior door location(s). Properly installed door pan flashing helps prevent wind-driven rain/water penetration from damaging interior building components. High-risk areas include exterior doors with little to no roof or balcony overhang protection from the elements. It is not uncommon for Fox Inspection Group inspectors to observe evidence of water penetration (water damaged wood flooring or water-stained carpet tack strip) on the second-floor balcony doors. For additional information, you may watch a 5-minute video on flashing where the first few minutes show door pan flashing by clicking this link [YouTube - Class Exterior Door Pan Flashing](#). Active water penetration detected at balcony and back doors (see Evidence of Water Penetration section above). Recommend further investigation and subsequent repair.

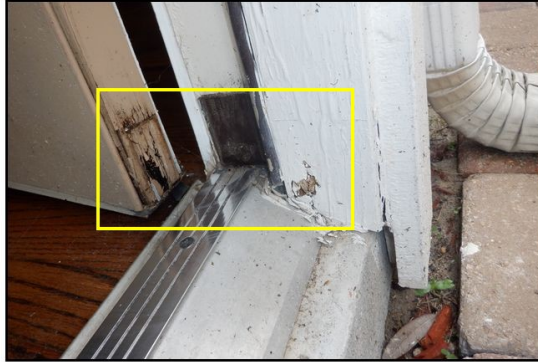
Wood rot of lower door and/or jamb; back door.

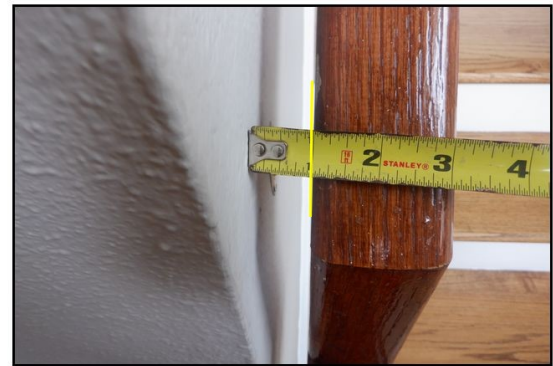
Stairway handrail does not comply with code, a section of the handrail does not have required clearance from the wall, It is a "hand/finger/knuckle grabber" (handrails adjacent to a wall shall have a space of not less than 1-1/2 inches (38mm) between the wall and the handrail) Per UBC 1006.2, IRC 311.5.6.2.

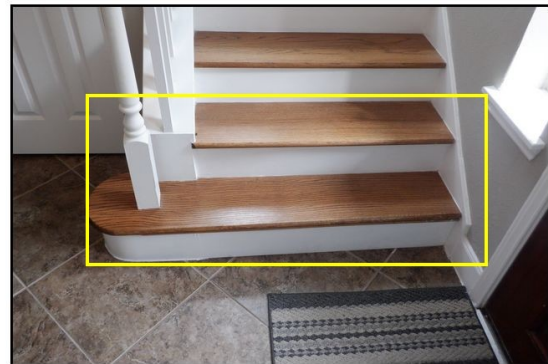
The stairway has a tripping hazard, Risers are not the same height along the entire height of the steps. Stairway does not comply with the current industry standard, Per IRC 311.5.3.1 & UBC 1006.3 requires "The greatest riser height within any flight of stairs shall not exceed the smallest by more than 3/8 inch."

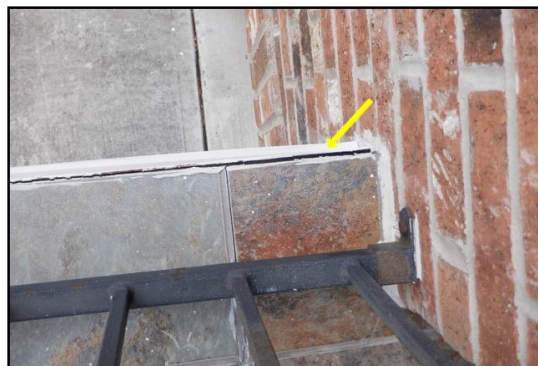
Grout missing / deficient between balcony tiles at one or more locations. Recommend repair to prevent water entry at balcony.

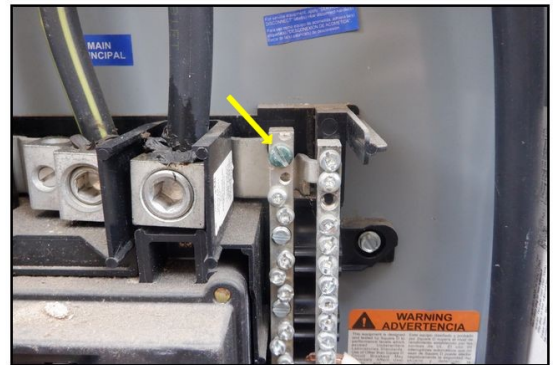
150 AMP ELECTRICAL SUB PANEL LOCATED AT SOUTH EXTERIOR WALL  
Improper wiring to sub-panel, there is no floating neutral. It does not comply with NEC 250-61b National Electric Code.

Don't bond neutral and ground wires downstream of service box

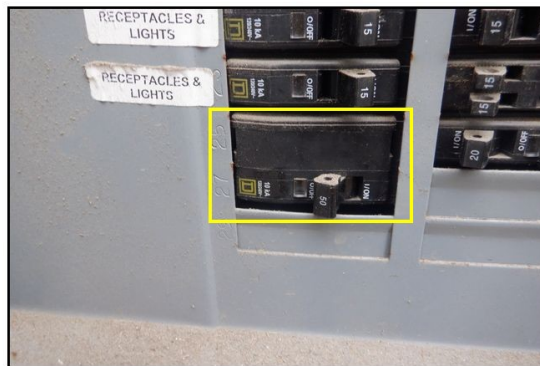
One or more breaker(s) were off at time of inspection. Inspector does not turn on breakers found in off position due to potential short/electrical problem, recommend inquiring seller regarding information regarding any/all breaker(s) found in the off position.

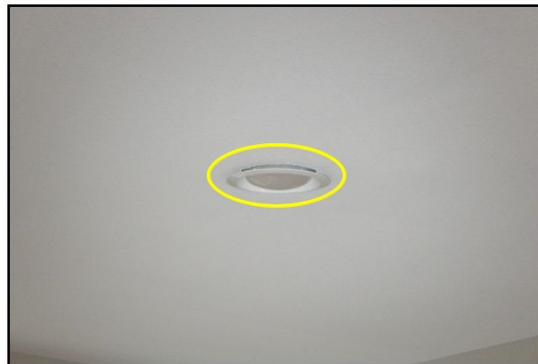
Light not secured; second floor dining area.

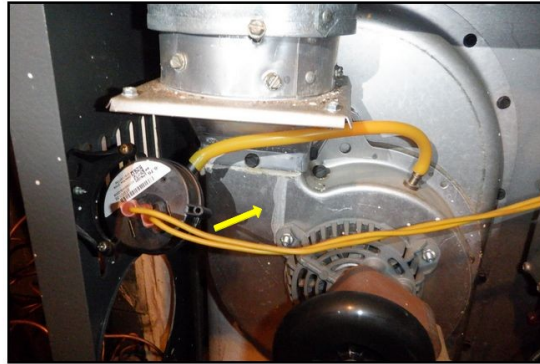
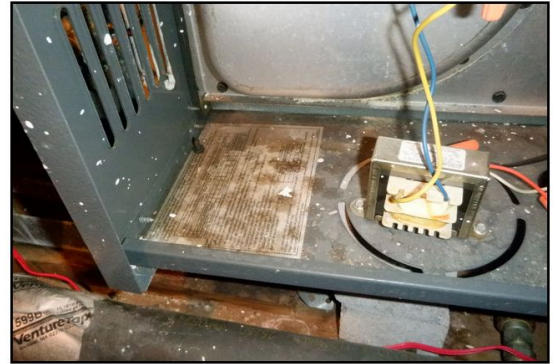
Water/Rust stains on the unit.

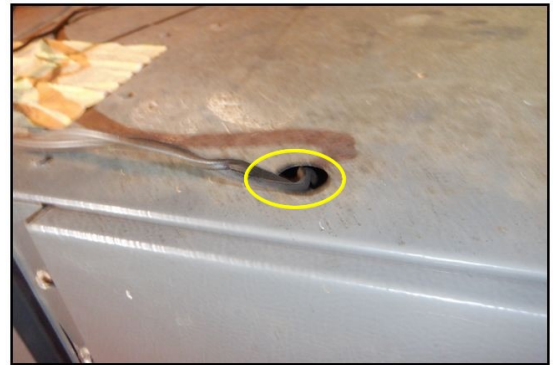
Thermostat wiring not secured to attic unit(s), missing small fitting that secures wiring to the cabinet to prevent pulling loose by service personnel or homeowner.

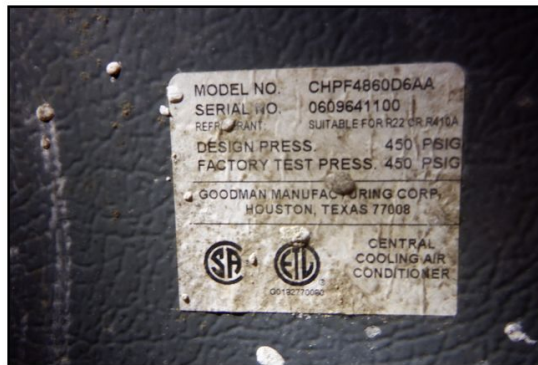
**E-coil at or near the end of serviceable life. The client should budget for repair/replacement.**

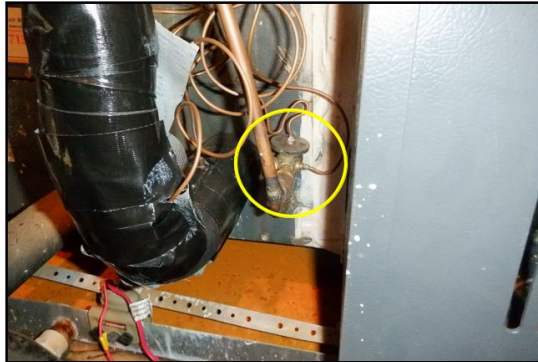
The TXV valve does not have the entire assembly wrapped/insulated.

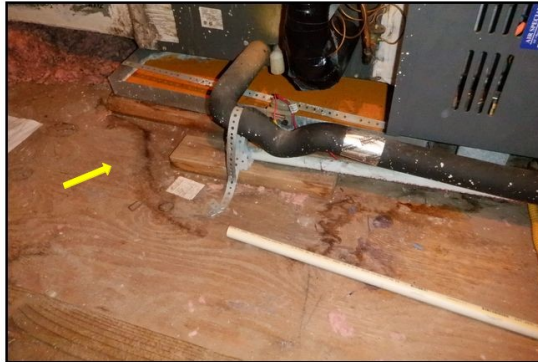
Water stain(s) observed in attic near HVAC unit. Possible indication of previous leak from unit / components / vent.

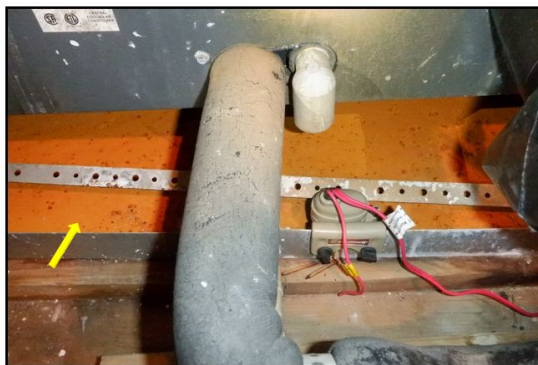
*Water / rust stains observed in secondary pan; indication coil has a history of leaking/dripping condensation into the pan.*

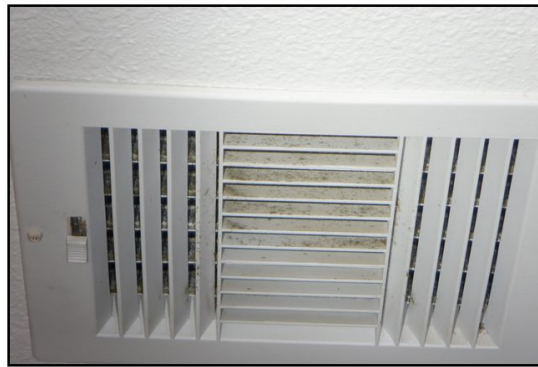
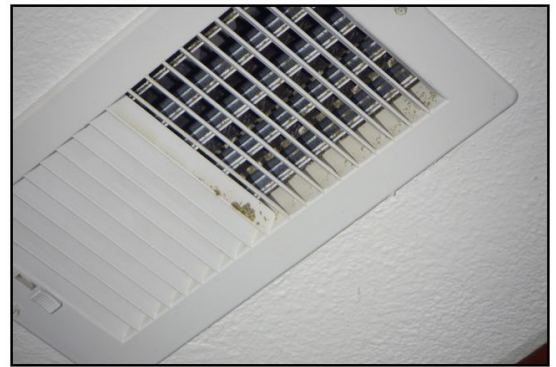
Observed possible micro-organism growth on air supply grills/vents which may be a concern due to increased awareness of environmental issues associated with molds. *This inspector does not inspect for and is not qualified to render opinions on any type of environmental or other biohazards. If this is a concern or potential concern, Fox Inspections recommends having our company or a qualified professional of your choice for further information / investigation.*

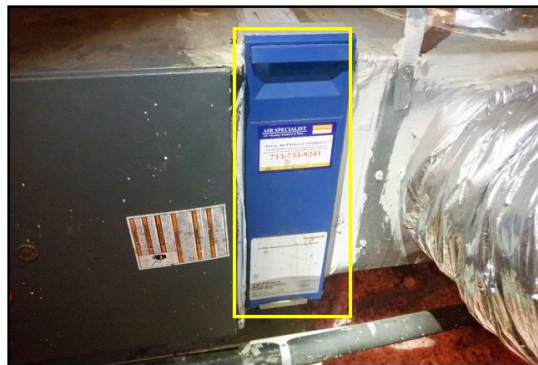
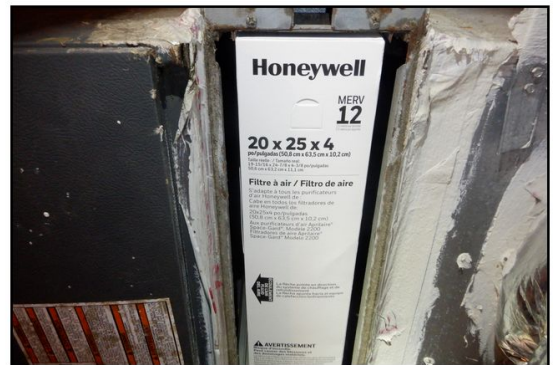
*Media air filter(s) located in the attic that requires changing/cleaning every 6 months, recommend checking guide for proper maintenance information.*

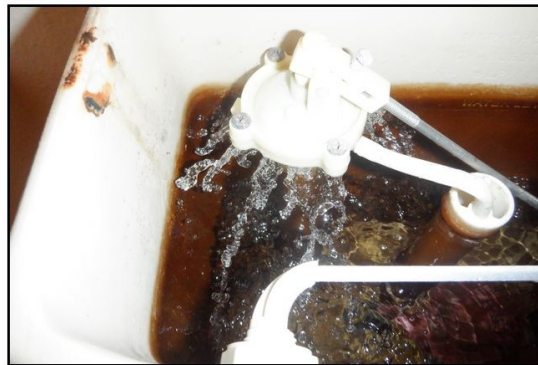
Tank refill device defective, replace; master bath.

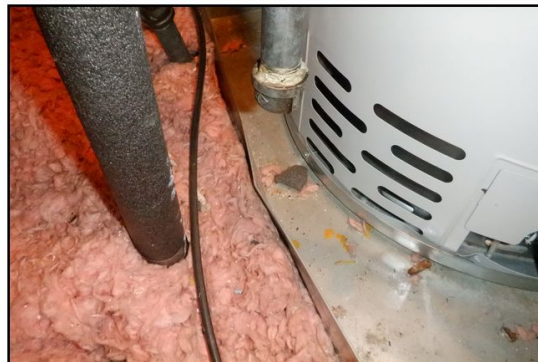
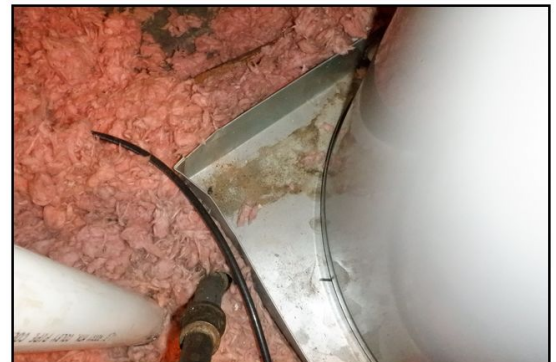
*Water / rust stains in drain pan, indication of previous leak from unit / vent / piping.*

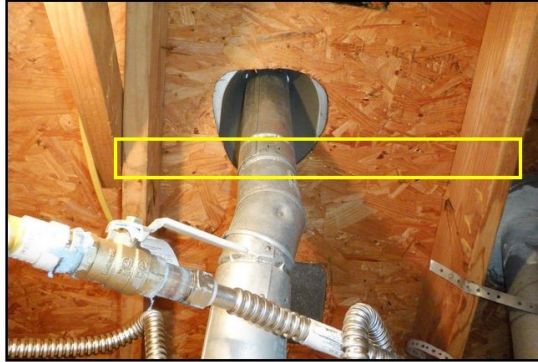
Vent pipe(s) is (are) not properly secured (strapped) in place.

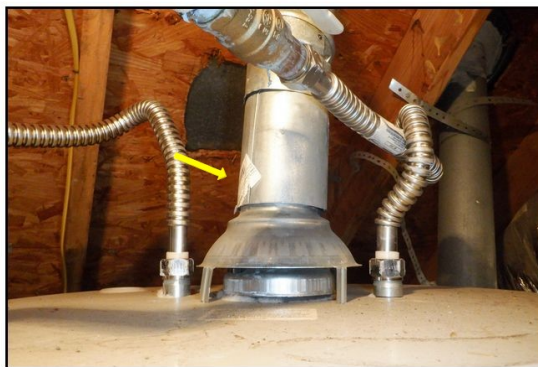
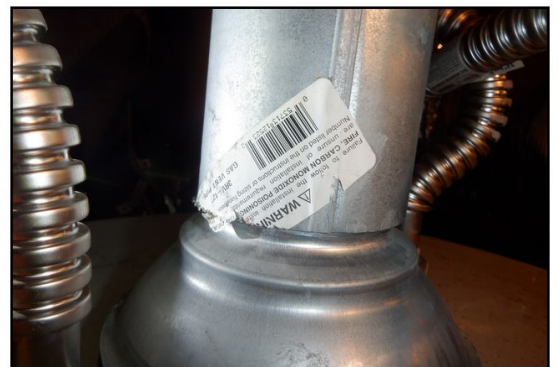
Vent pipe connection(s) improper, inside out / upside down. May not fully contain products of combustion in the duct.

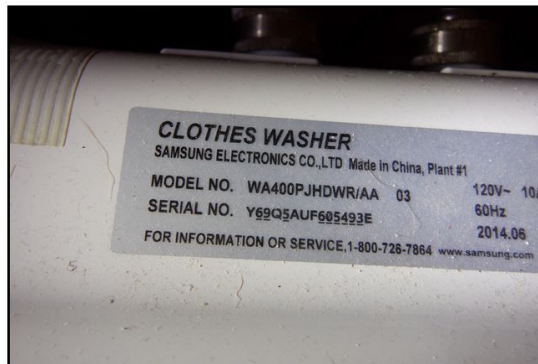
**Reference: CPSC Recall # 17-028**

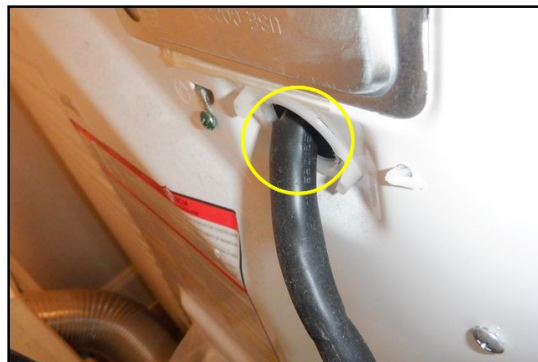
Electrical cord is not secured to back of unit (missing small bushing).
