Property Inspection Report

PROPERTY INSPECTION REPORT

Concerning: 2881 Sun River Lane

Inspection Date: 2022-07-27

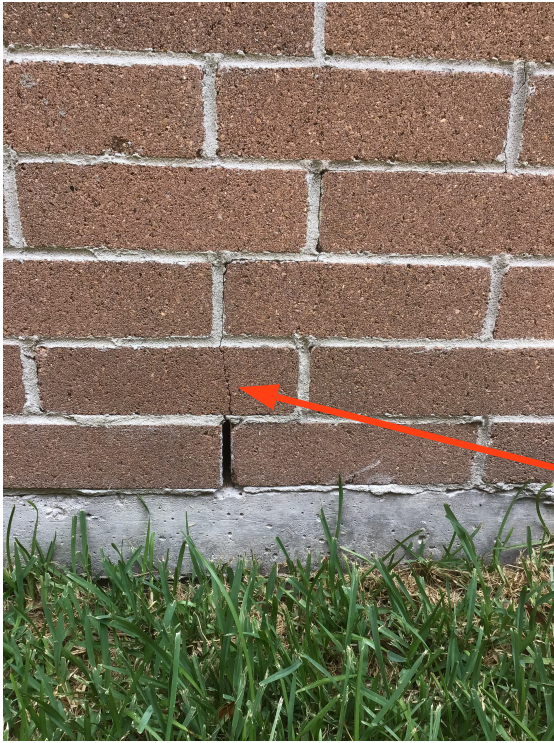
- 1) There are cracks in the mortar at the left side rear

Cracks in the brick veneer

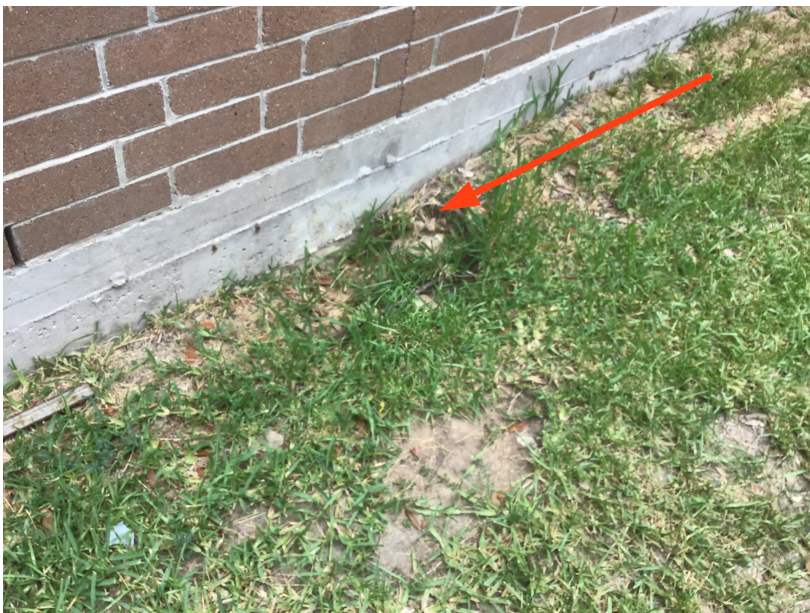
- 1) Low area next to the foundation on the left side front

Low area next to the foundation

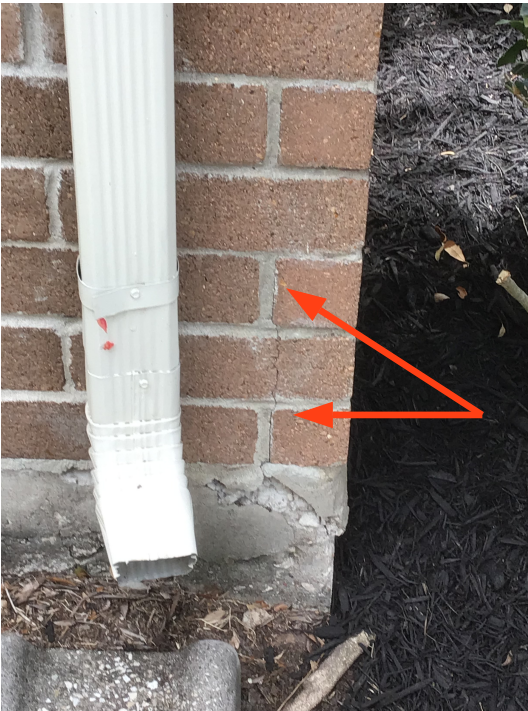
Cracks in the brick veneer

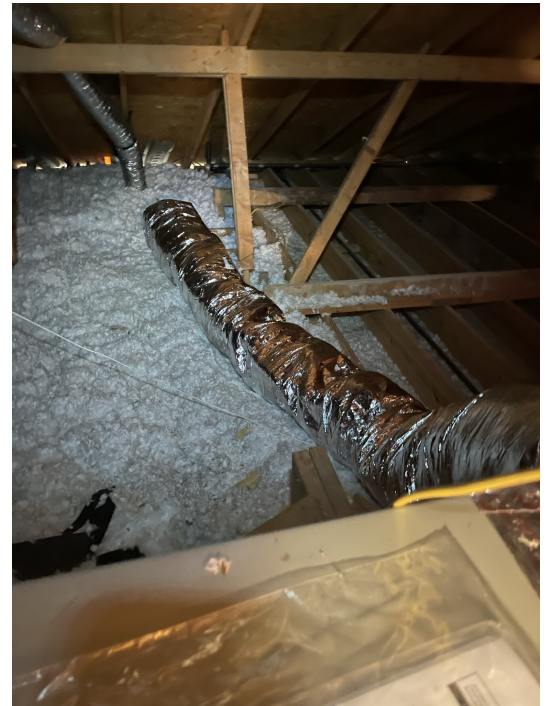
- 1') Improper access to HVAC equipment in the attic - gaps in the catwalk and obstruction in the catwalk
- 2) Falling vertical insulation

Support AC duct

Improper access to appliances in the attic

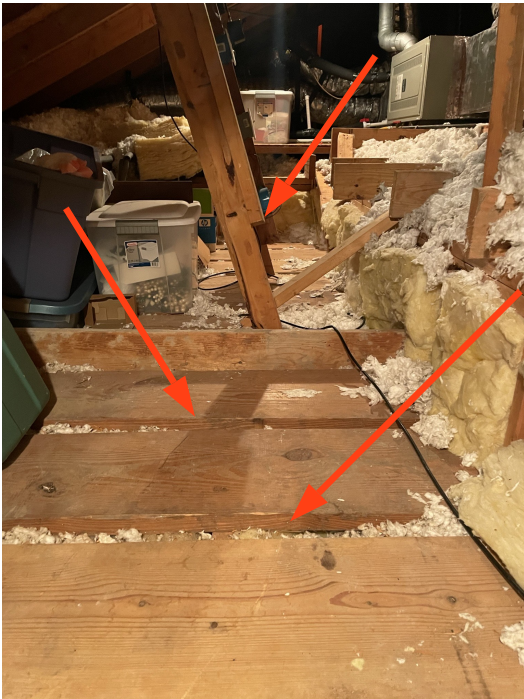
Falling insulation
