PROPERTY INSPECTION REPORT

Concerning: 2915 Loganberry Park Lane, Houston, TX
(Address or Other Identification of Inspected Property)

By: Danny Drake, Lic ##5322 11/27/2019
(Name and License Number of Inspector) (Date)

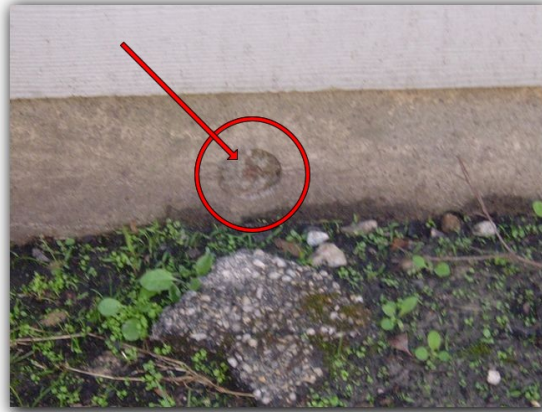
- 1: The exposed post tension cable ends need sealant.

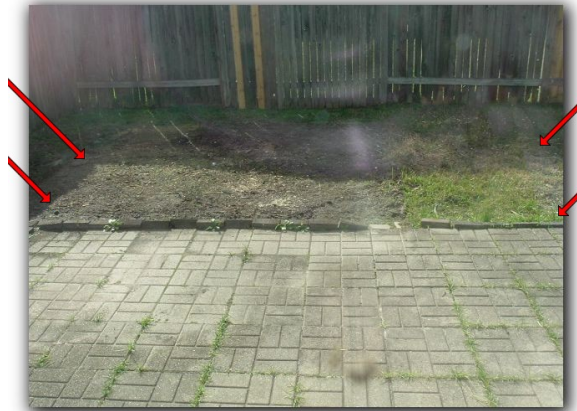
2: Ponding conditions were observed at the rear of the house. The water needs to drain towards the street.

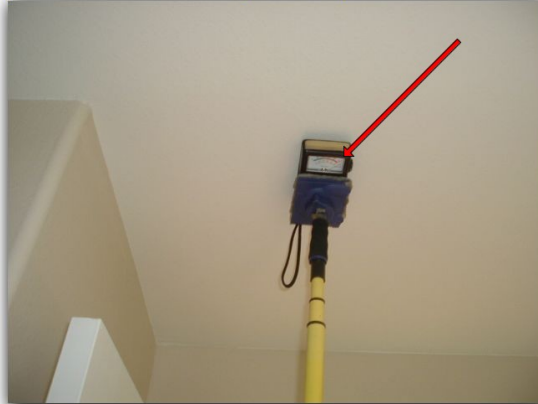
High moisture was detected in the ceiling above the entry area of the master bathroom.

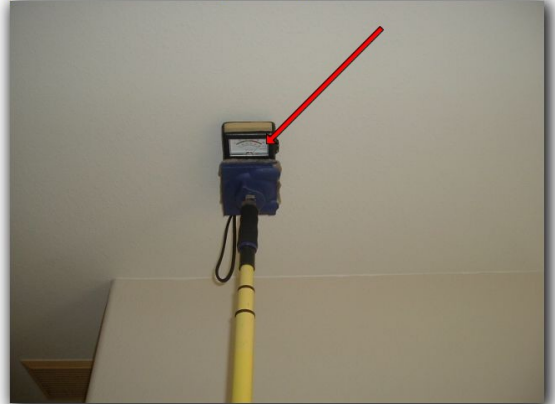
High moisture was detected in ceiling above entry area of the master bathroom linen closet

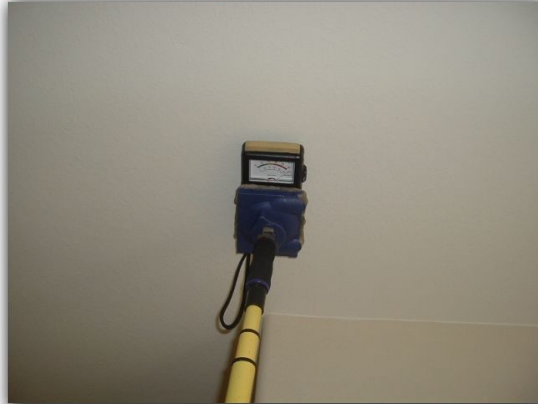
High moisture was detected in ceiling above entry area of the master bathroom linen closet There is evidence of water penetration in the attic at the type B vent to the HVAC unit.

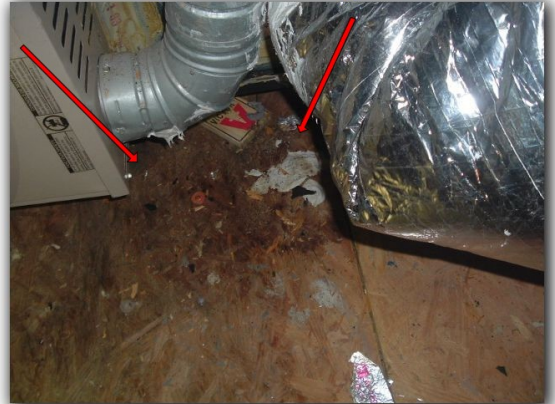
There is evidence of water penetration in the attic at the type B vent to the HVAC unit.

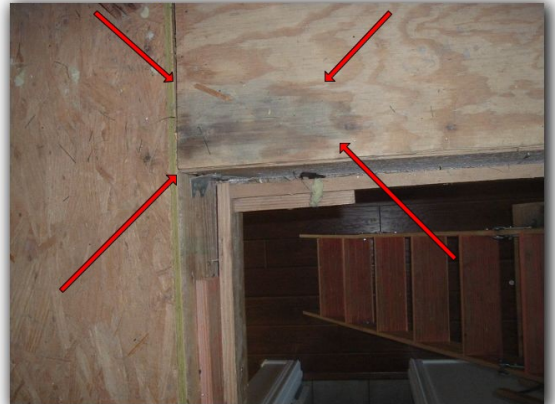
There is evidence of water penetration in the attic at the roof vent.

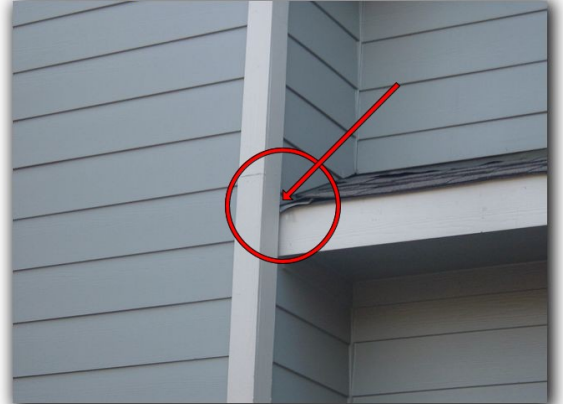
Needs kickout flashing at the front of the house

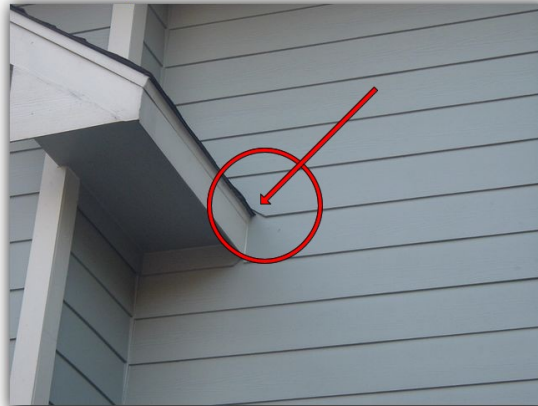
Needs kickout flashing at the front of the house

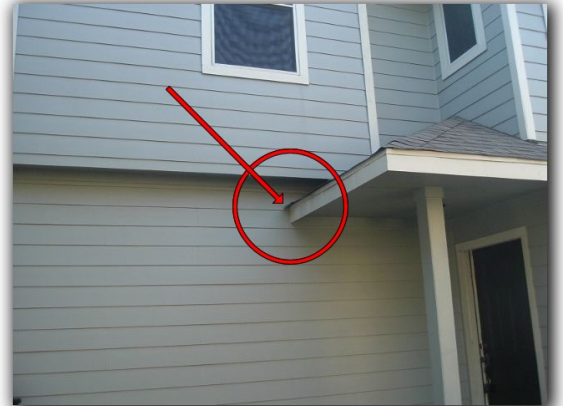
Needs kickout flashing at the front of the house

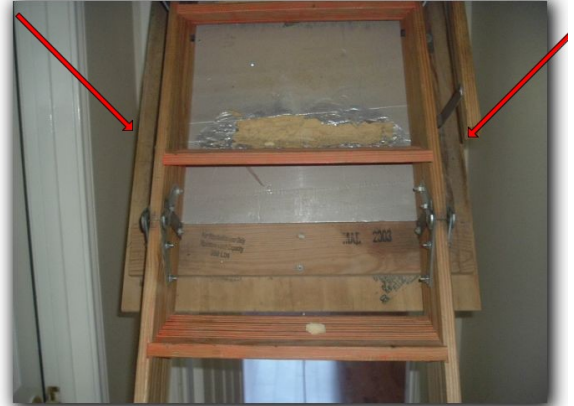
4: The attic ladder requires 16 D nails at the frame. The attic ladder hatch needs weather stripping. Note there are animal traps visible in the attic.

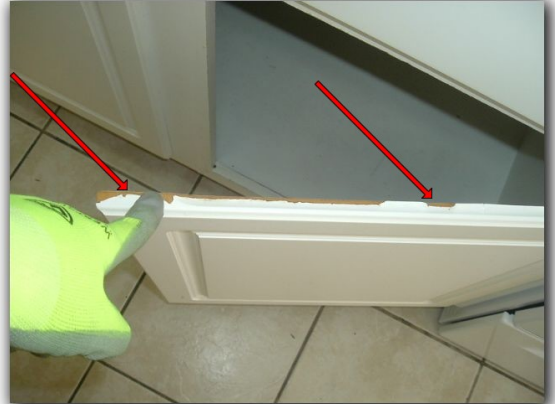
The kitchen cabinets/drawers have visible delamination.

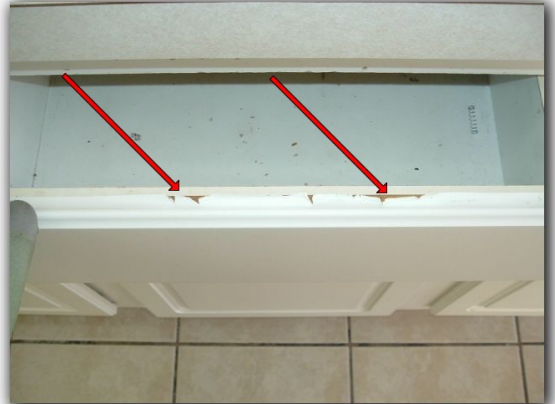
The kitchen cabinets/drawers have visible delamination.

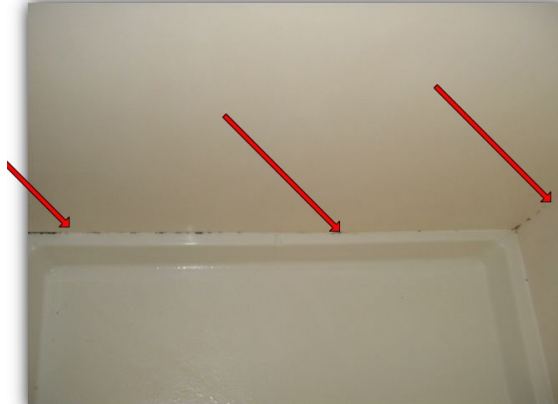
The master shower needs repair to the sealant.

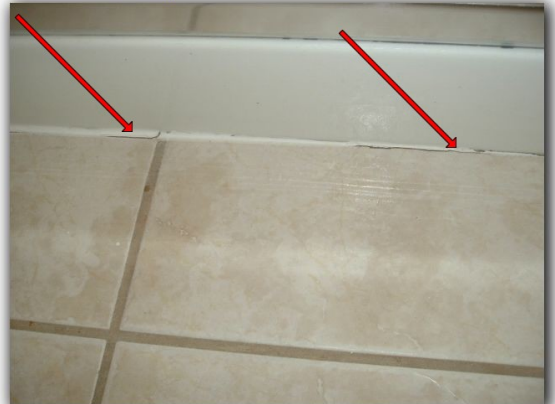
The master shower needs repair to the sealant.

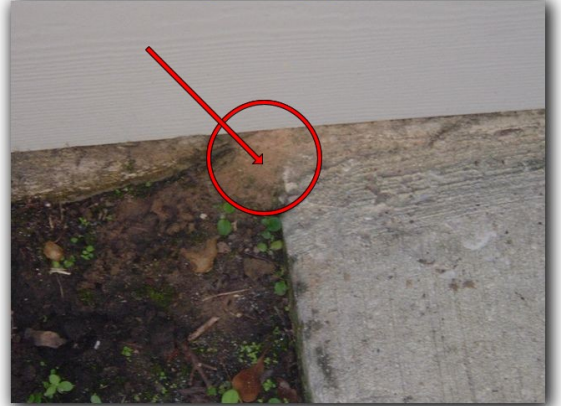
There are visible dirt tubes at the right side of the garage.

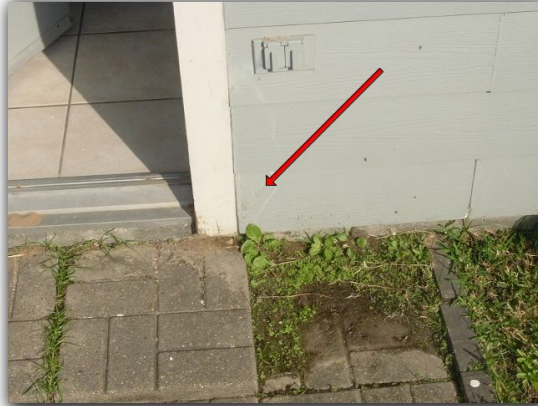
The rear exterior siding has damage.

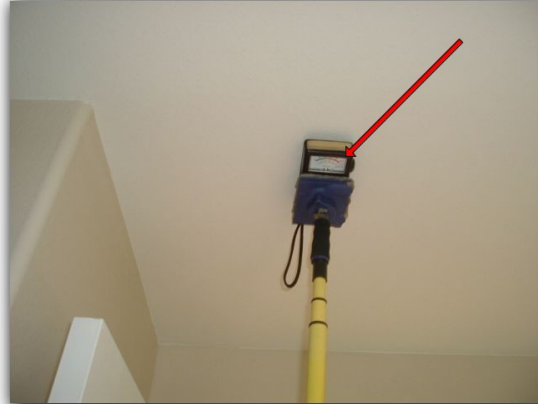
High moisture was detected in the ceiling above the entry area of the master bathroom.

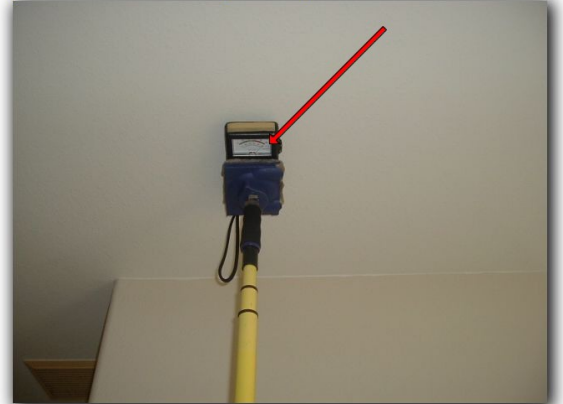
High moisture was detected in ceiling above entry area of the master bathroom linen closet

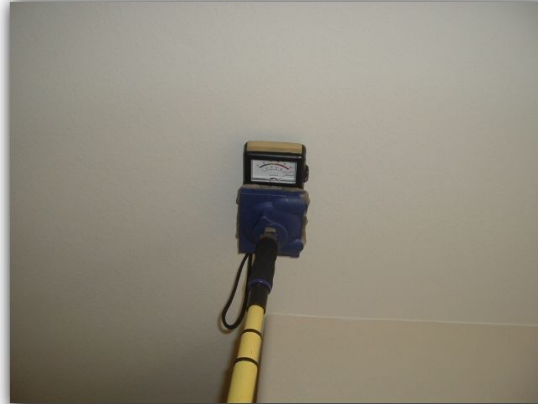
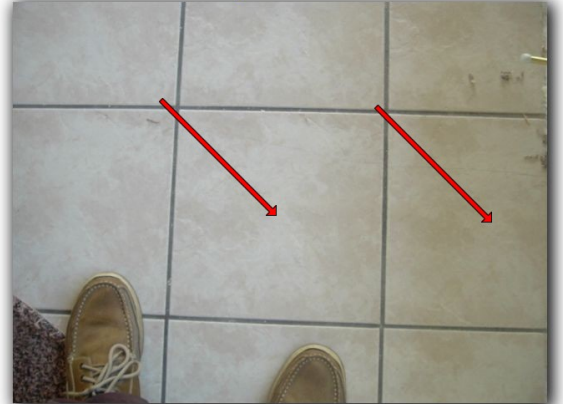
High moisture was detected in ceiling above entry area of the master bathroom linen closet There are cracked tiles at the front entry

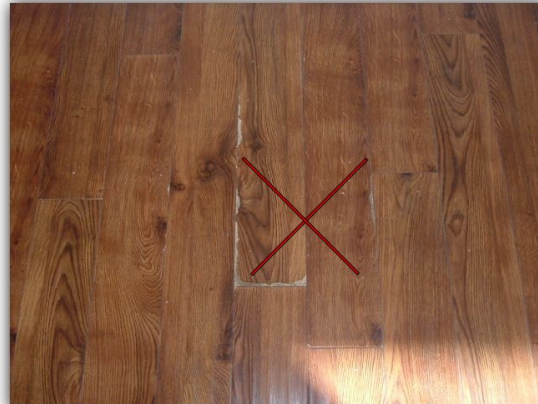
The wood flooring at the front den has damage.

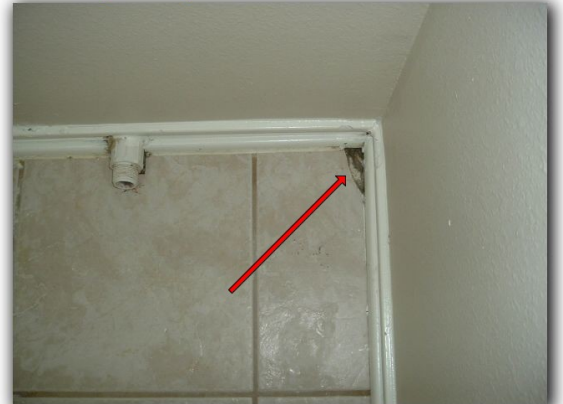
The tile has damage at the utility room

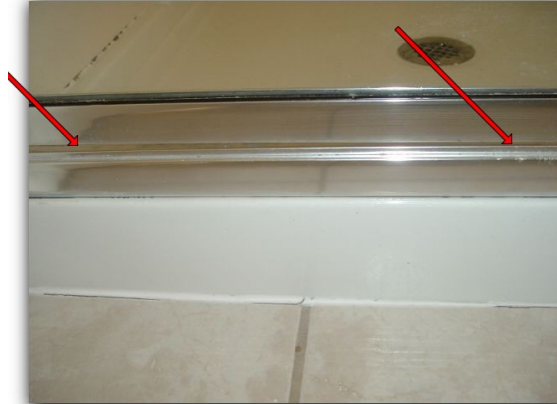
The master shower door bottom seal needs repair.

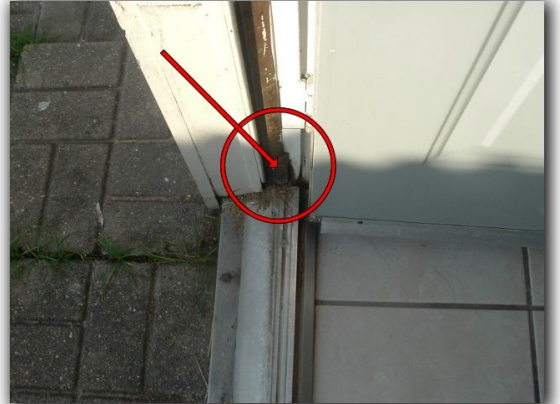
The rear entry door frame and trim has decay.

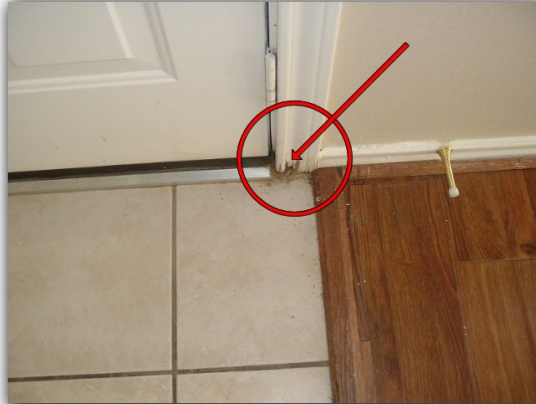
The rear entry door frame and trim has decay.

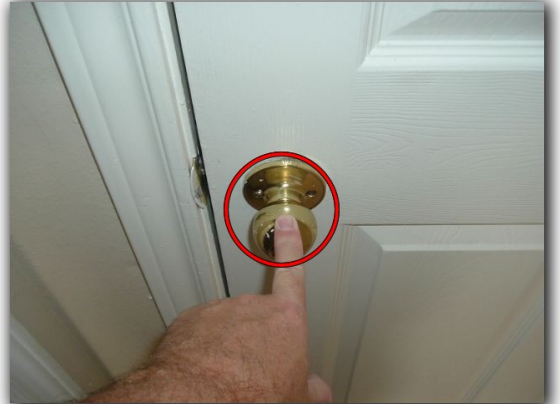
The garage door knob is loose.

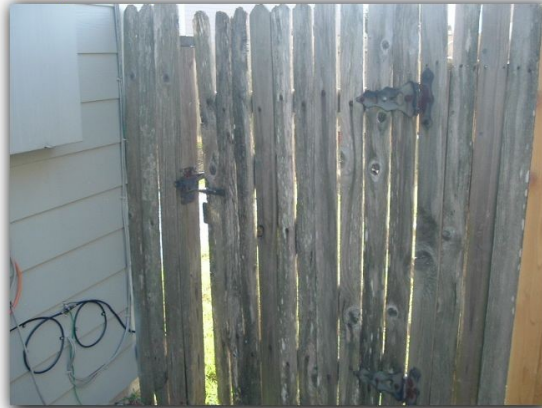
The wood gate has damage.

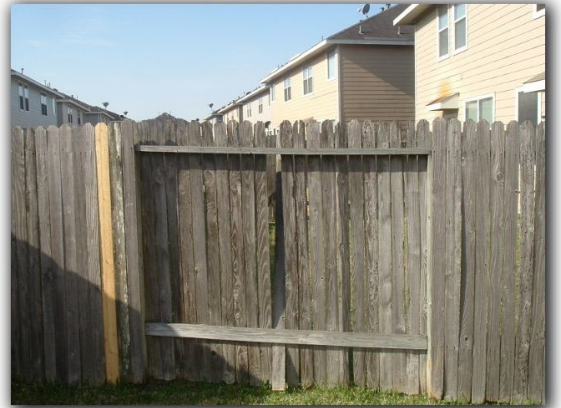
There are damage/decayed/loose pickets.

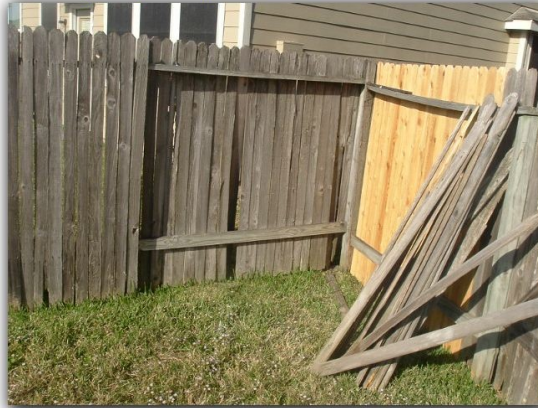
There are damage/decayed/loose pickets.

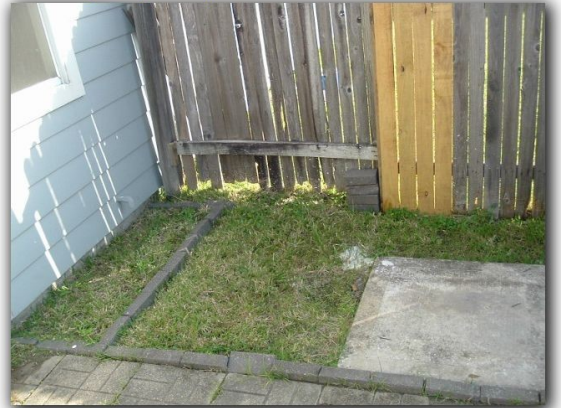
There are damage/decayed/loose pickets.

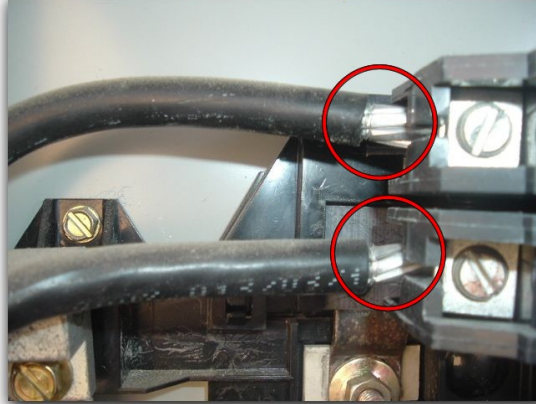
The aluminum service wires require anti corrosive compound

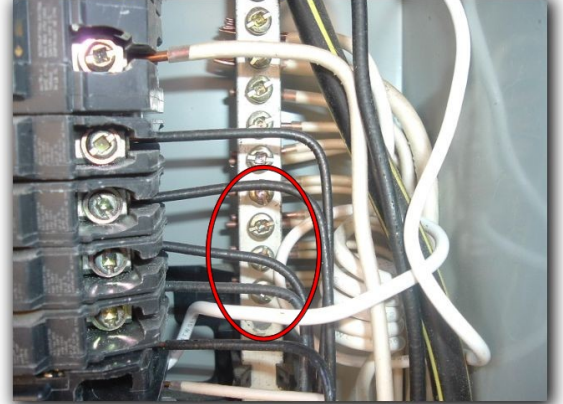
There are double lugged neutral wires in the panel box.

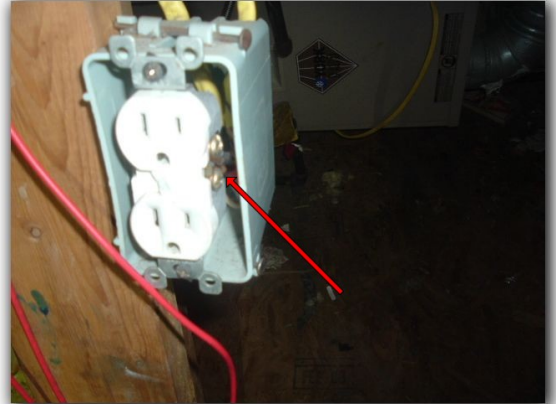
Install the cover plate at the attic receptacle

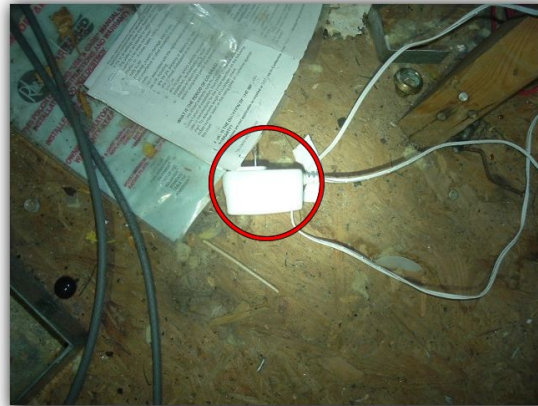
Remove the extension cord from the attic.

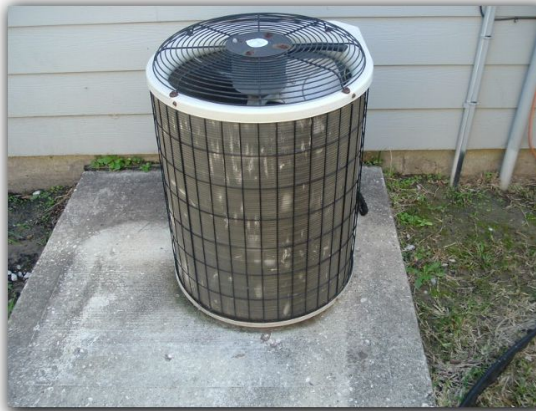
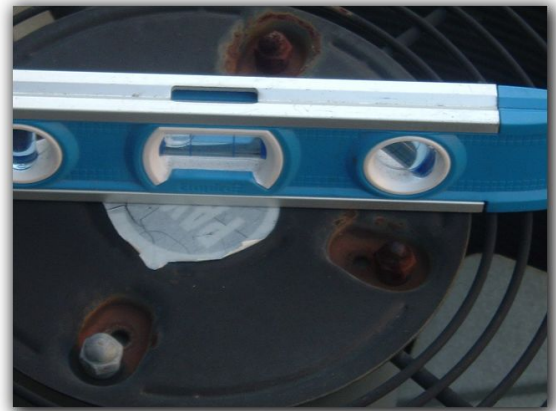
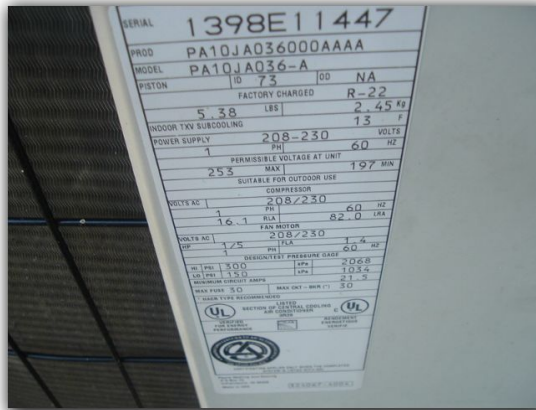
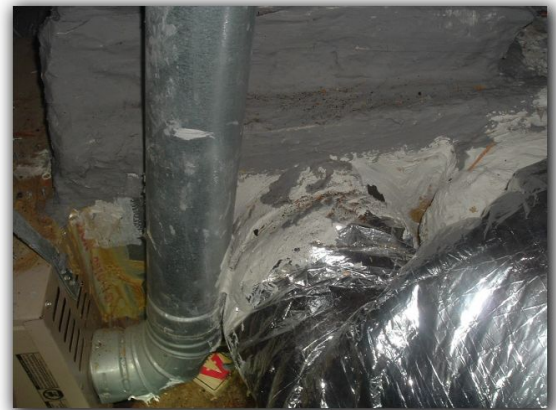
13: The system is the old outdated R 22 type of freon. The exterior condenser is out of level. The AC system was non functional at time of the inspection. *Get an estimate for replacing the system from a licensed/bonded AC TECH.*

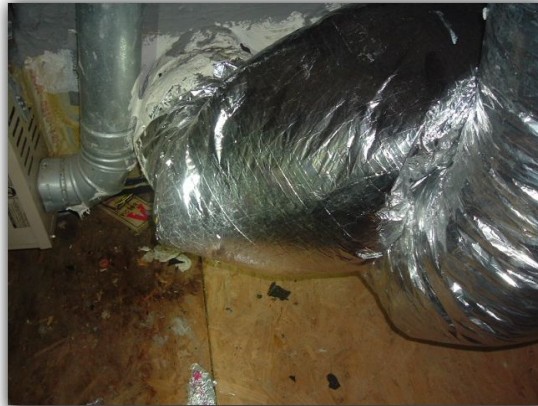
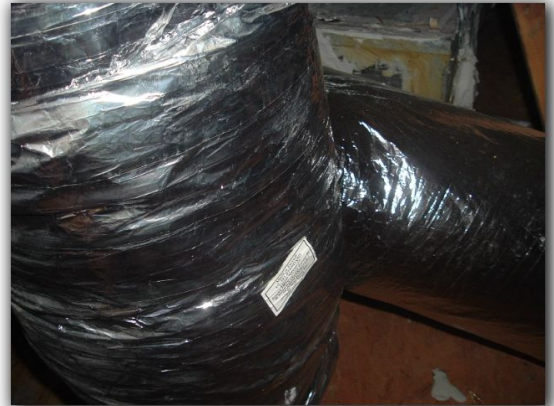
14: there are kinked ducts in the attic. The ducts touching must be separated with fiberglass insulation to prevent condensation.

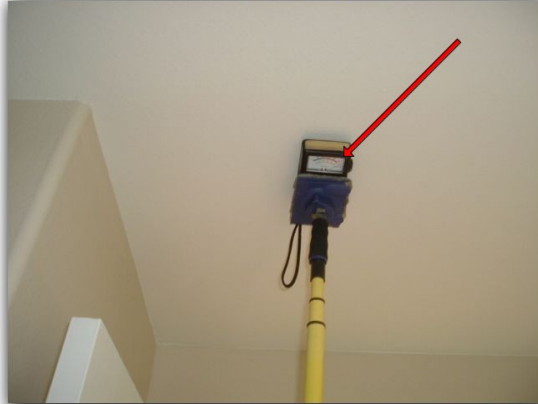
High moisture was detected in the ceiling above the entry area of the master bathroom.

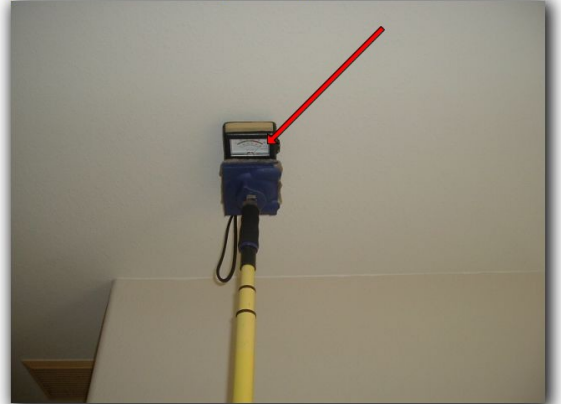
High moisture was detected in ceiling above entry area of the master bathroom linen closet

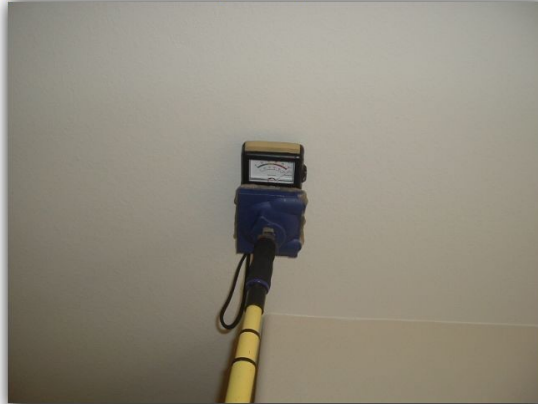
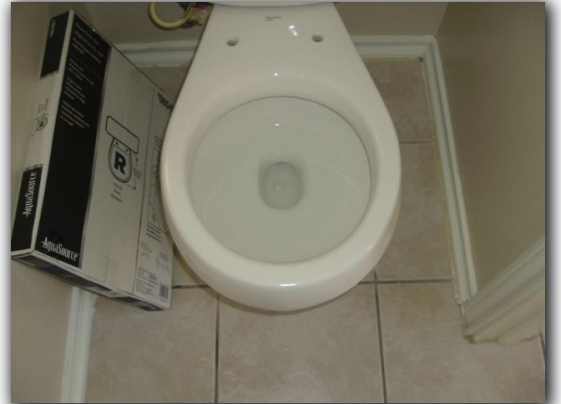
High moisture was detected in ceiling above entry area of the master bathroom linen closet

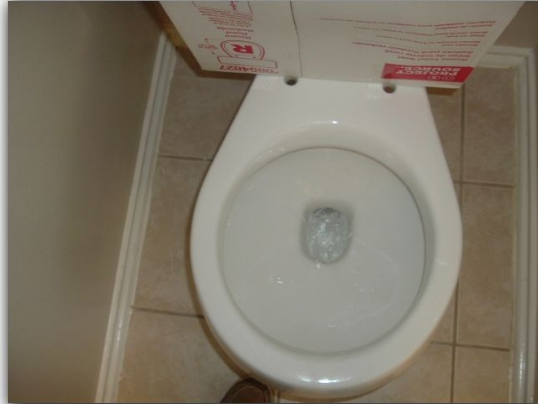
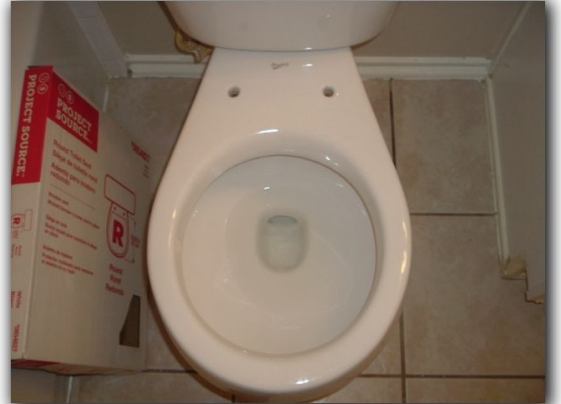
Install the missing toilets seats

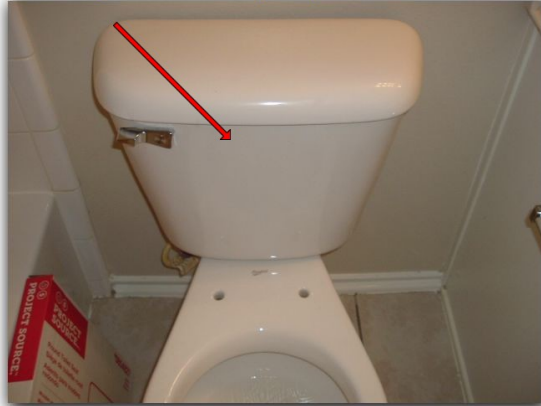
The second floor guest toilet flush assembly is noisy.

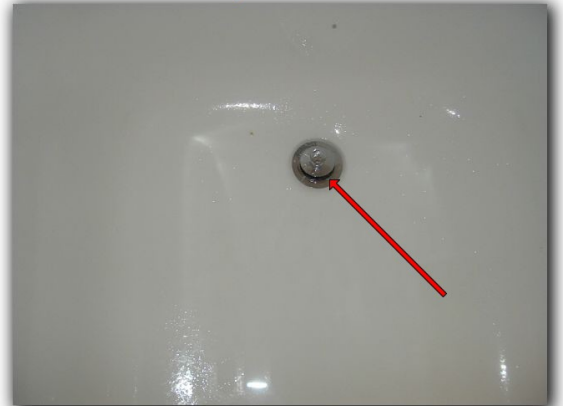
Remove the hair obstruction from the guest tub drain.

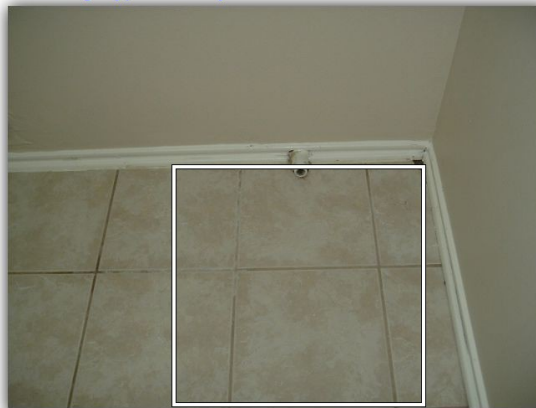
Install the emergency pan at the utility room

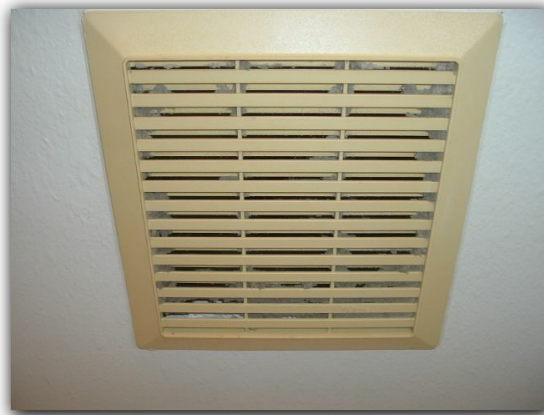
17: Clean the dust from the motors.

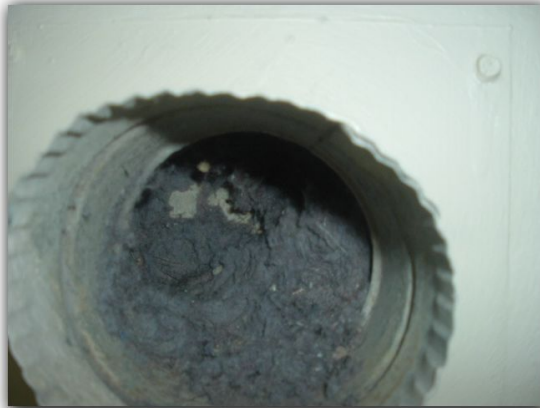
- 18: Clean the lint from the duct. Seal the duct at the roof deck to prevent lint blow back into the attic.
