RESIDENTIAL ROOF INSPECTION

MAR 23, 2022

2614 South Bromton Dr.
Pearland, TX
77584

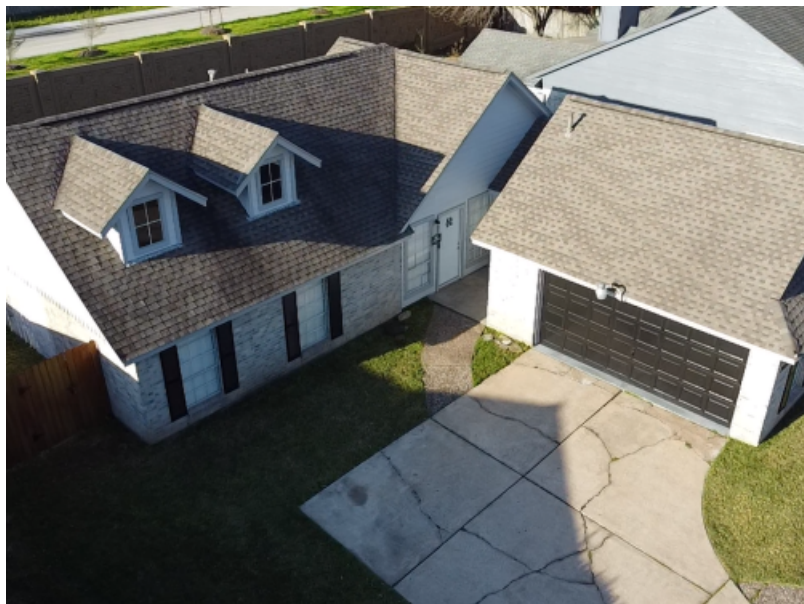
Roof Color and granule retention is excellent

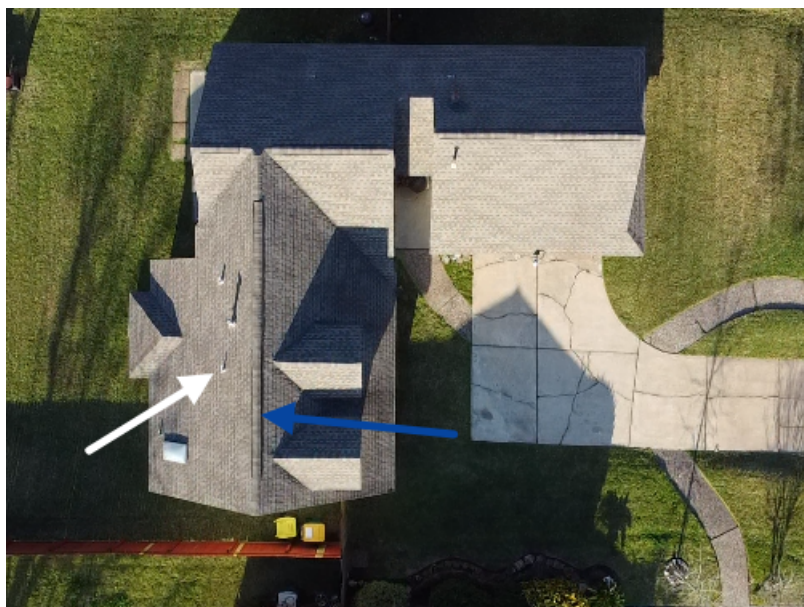
Approximate location of water stain inside w/ Blue arrow. Nearest roof penetration/potential leak point with white arrow. The stain is up slope from this area and several feet away horizontally.

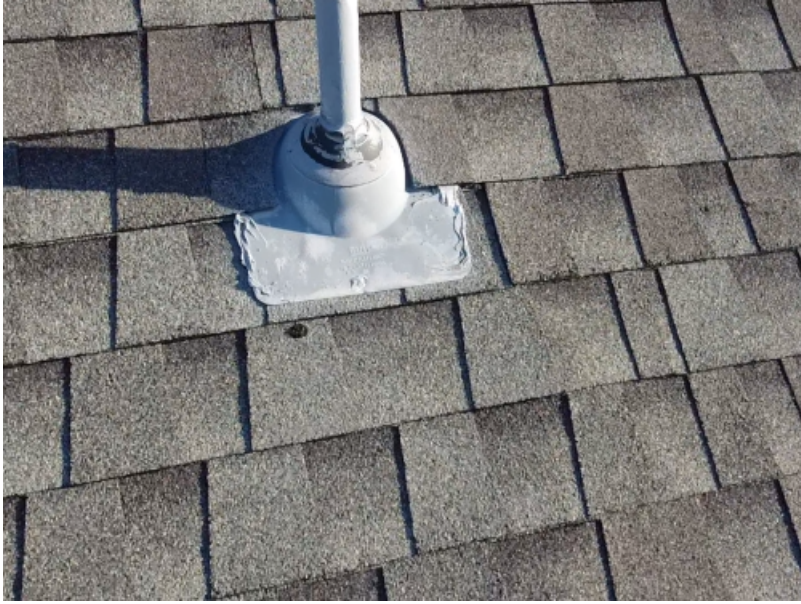
Closest penetration is well sealed and installed.

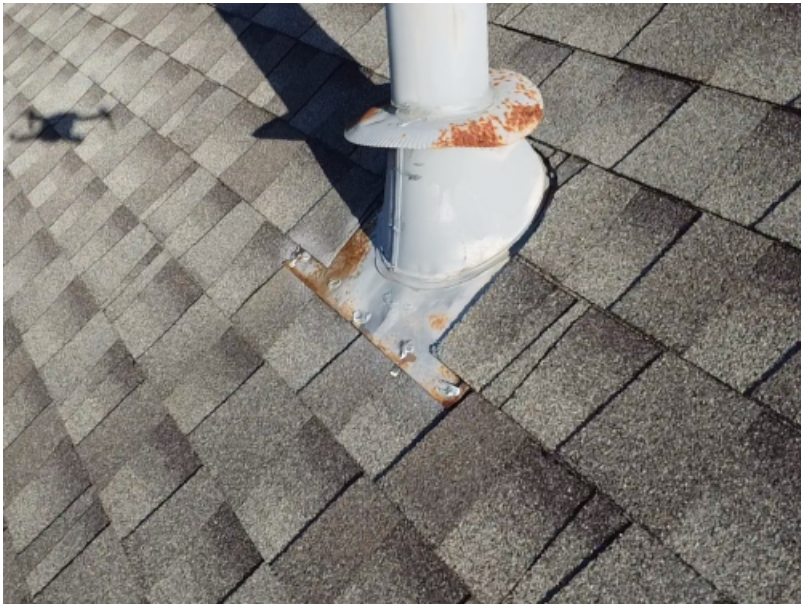
Sealed fasteners

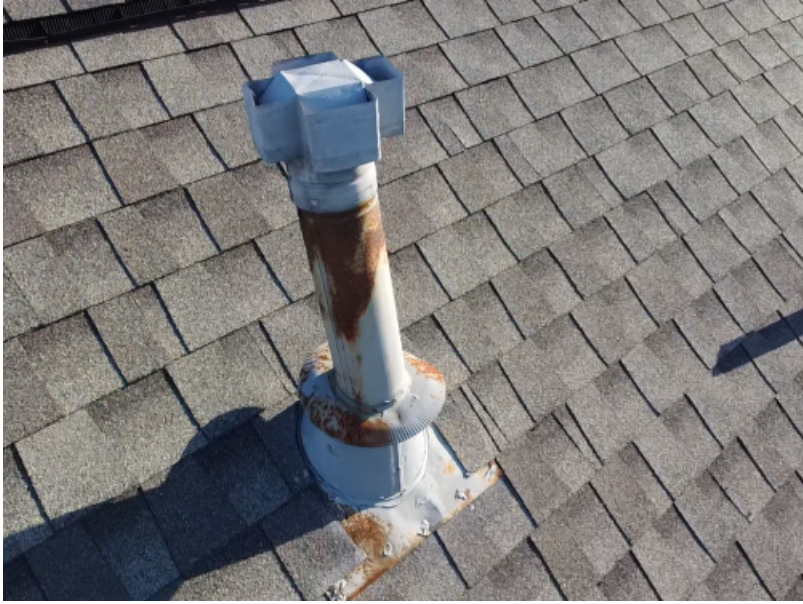
Some surface rust

Roof is in good condition. Recommend roof maintenance to address surface rust on metal accessories. This will include complete reseal of all penetration, skylight and flashing.

This includes cleaning debris on the roof, resealing all access points, and painting accessories.

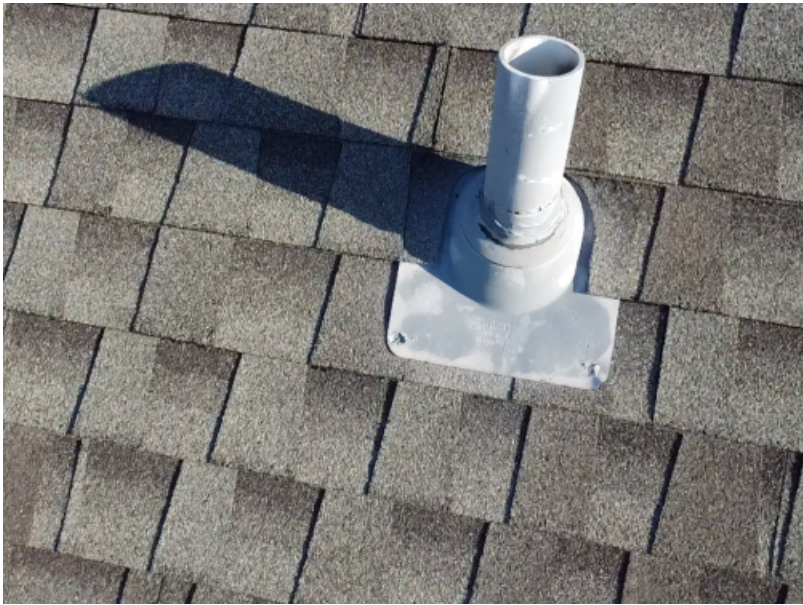
Pipe boot installed using industry best practice. No exposed fasteners.

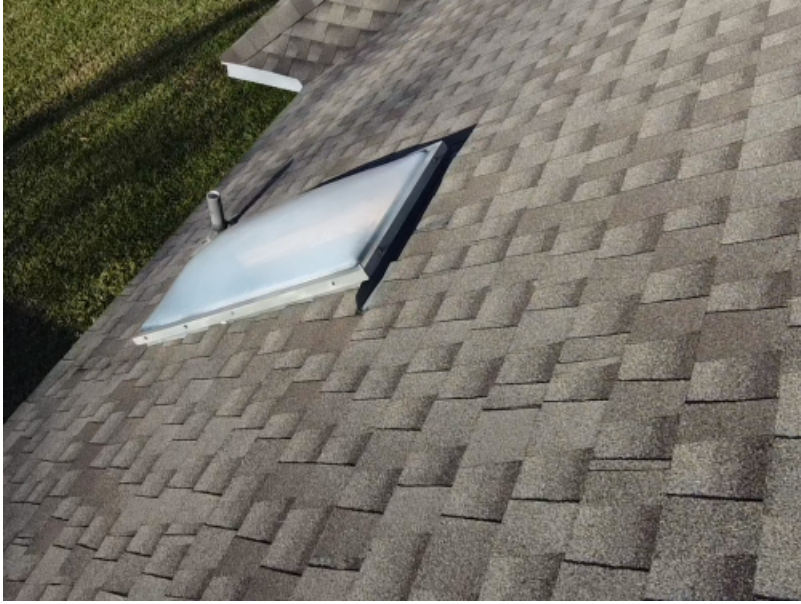
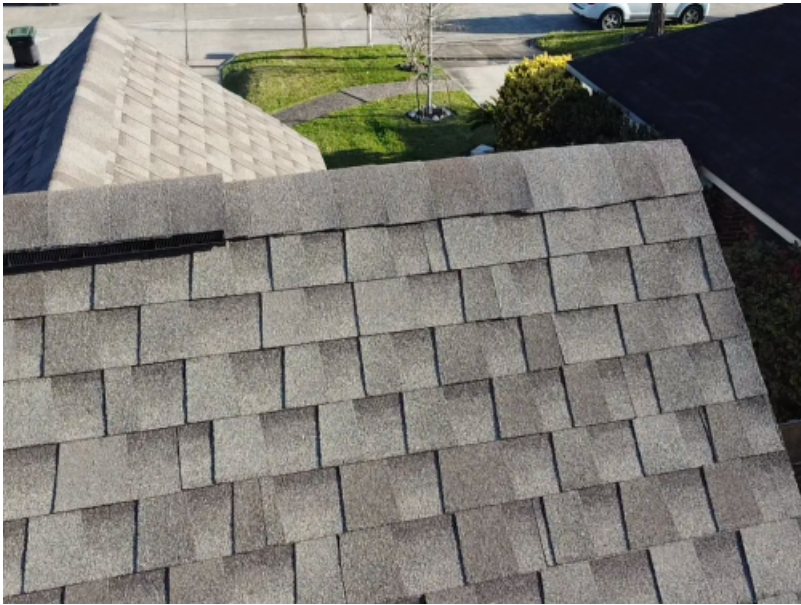
Ridge cap and vent are present and installed properly

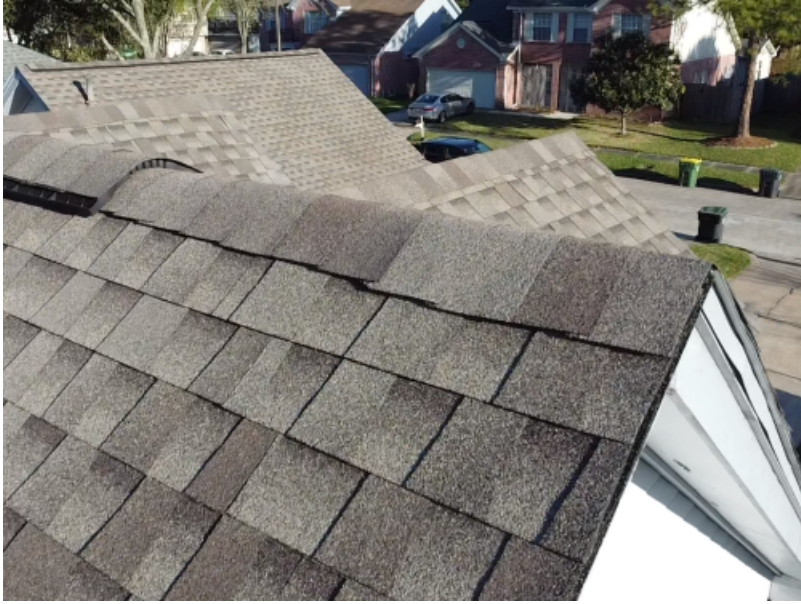
Ridge cap and vent are present and installed properly

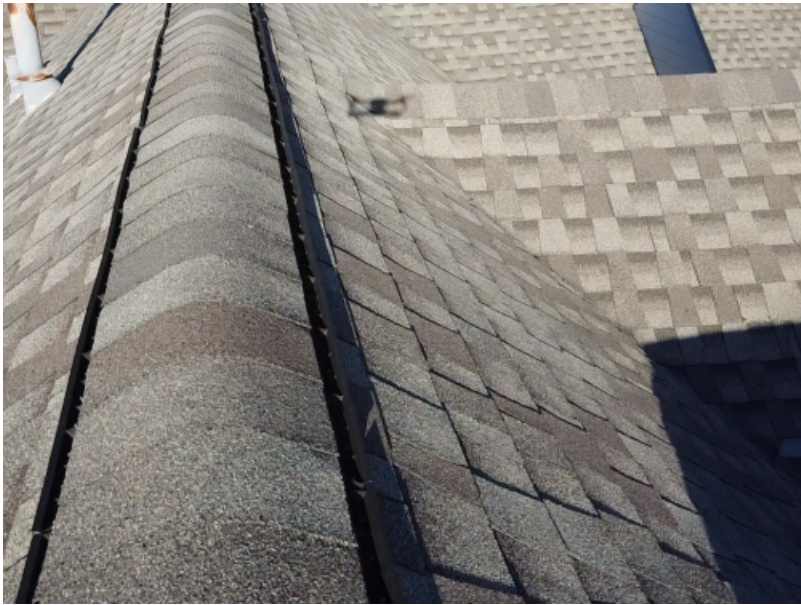
Ridge cap and vent are present and installed properly

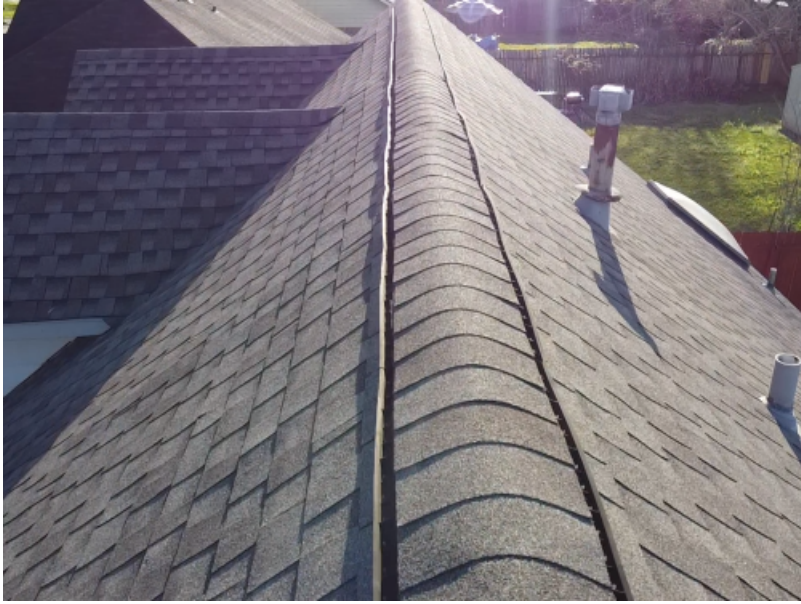
Ridge cap and vent are present and installed properly

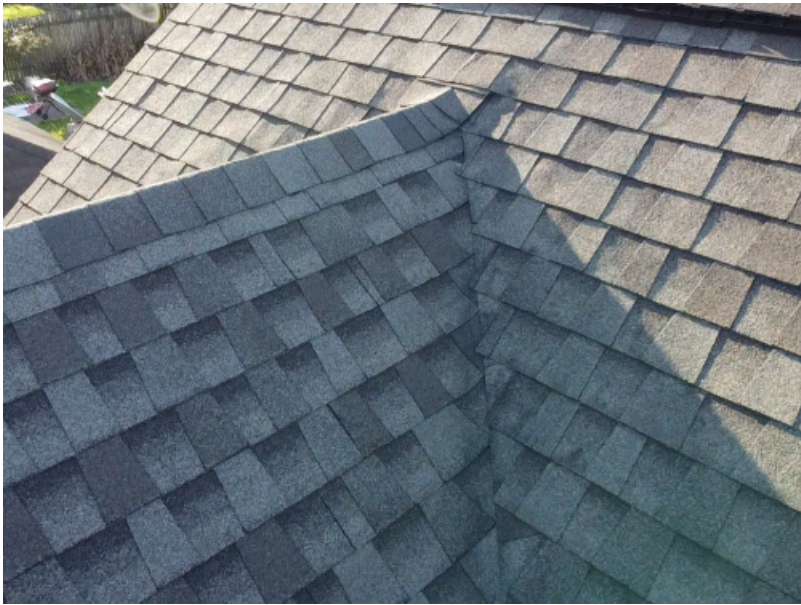
Valley shingles installed correctly

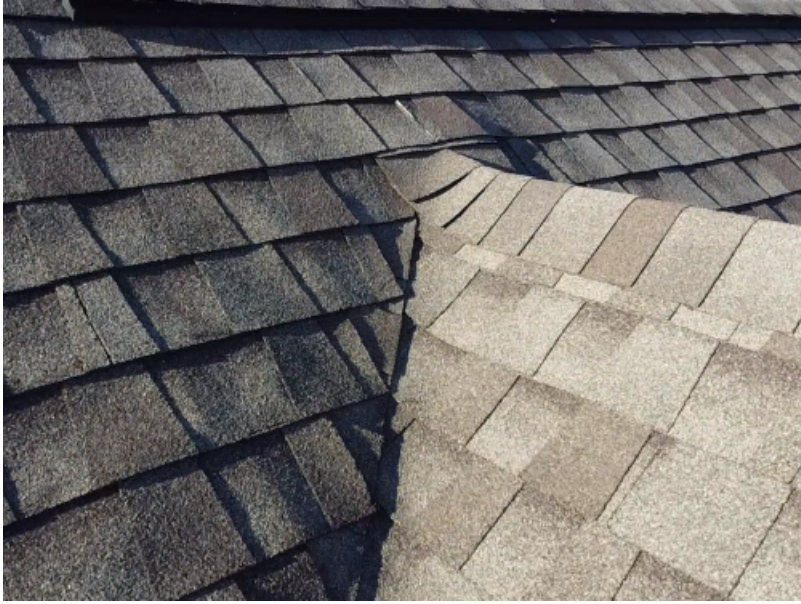
Valley shingles installed correctly

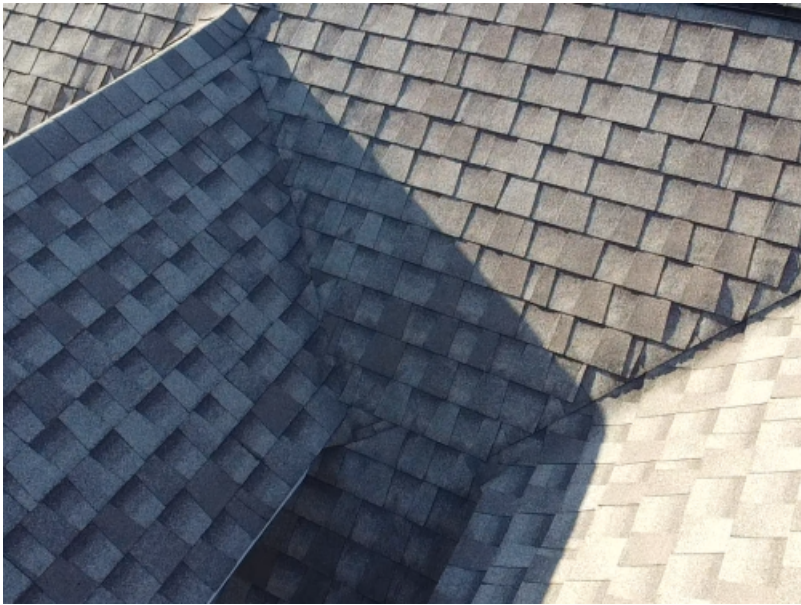
Valley shingles installed correctly
