HEDDERMAN SERVICES

STRUCTURAL INSPECTION

1119 Walden Hill Ct
Houston, TX 77077

APRIL 11, 2022

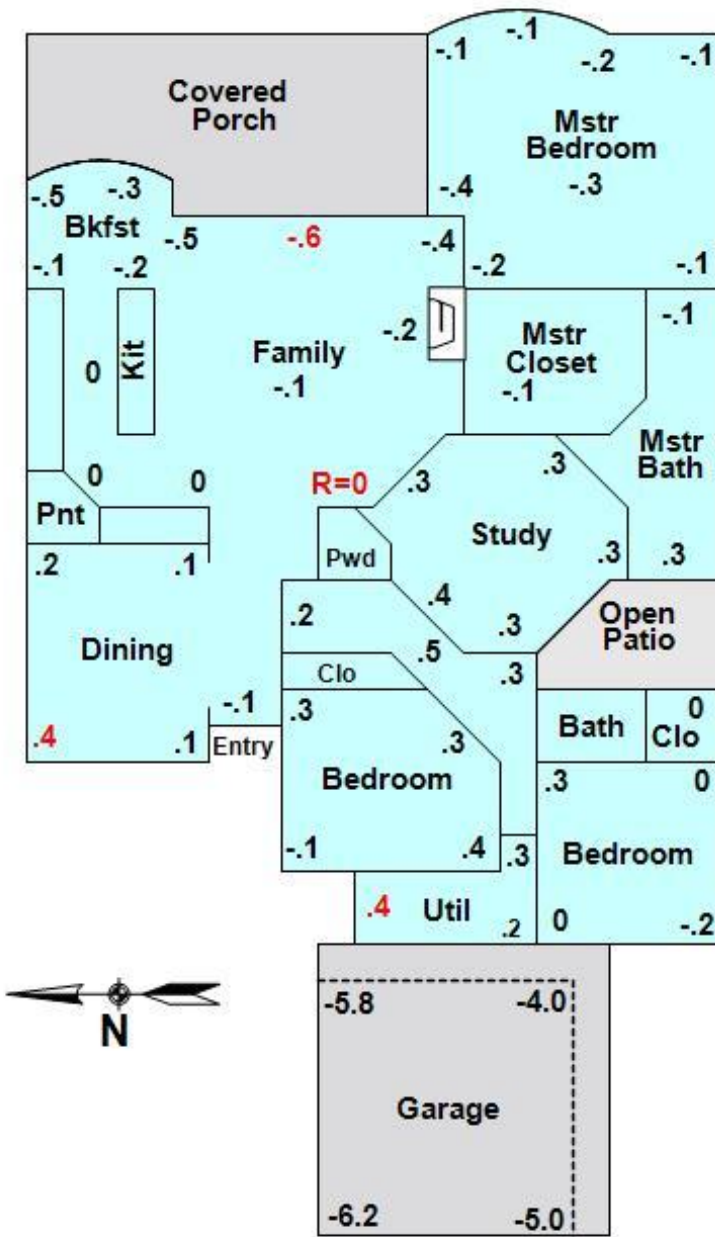
**Elevation Readings
1119 Walden Hill Court**

The floors were checked with an electronic level, and were observed to be acceptably level throughout the house. The difference in elevation between the high point and low point was 1.0 inch. The high point was located at the front of the house at the utility room and dining room, and the low point was located at the rear of the house at the family room. The unlevelness takes place over a horizontal distance of approximately 40 feet.

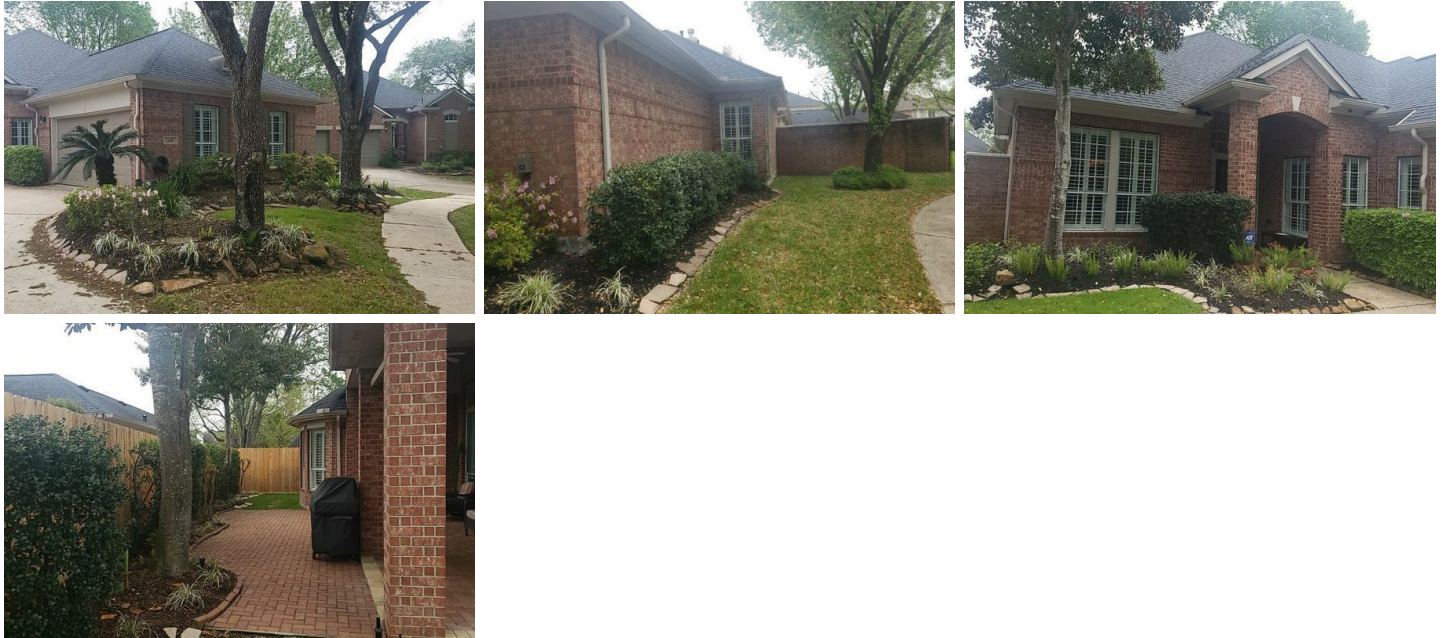
4.3.1 Other Observations

TREES - RECOMMEND ROOT BARRIER

Trees and/or foliage were observed in the vicinity of the house, which can contribute significantly to differential movement of the house foundation. Care should be taken to prevent the trees and foliage from removing an excessive amount of water from near the foundation of the house. Consideration should also be given to cutting the tree roots that extend under the foundation, and installing a root barrier to prevent any further moisture from being removed from under the interior of the house.

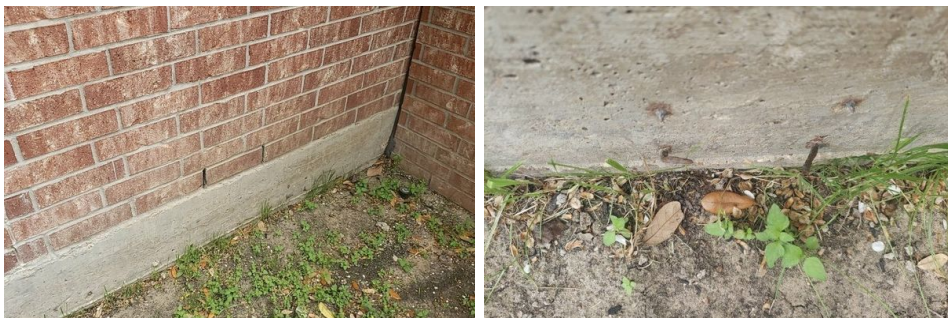
4.3.2 Other Observations

FOUNDATION - EXPOSED NAILS

SOUTH

Exposed nails were observed at the face of the foundation concrete. These present a hazard to foot traffic, and need to be cut off flush with the face of the concrete.

Obtain Cost Estimate

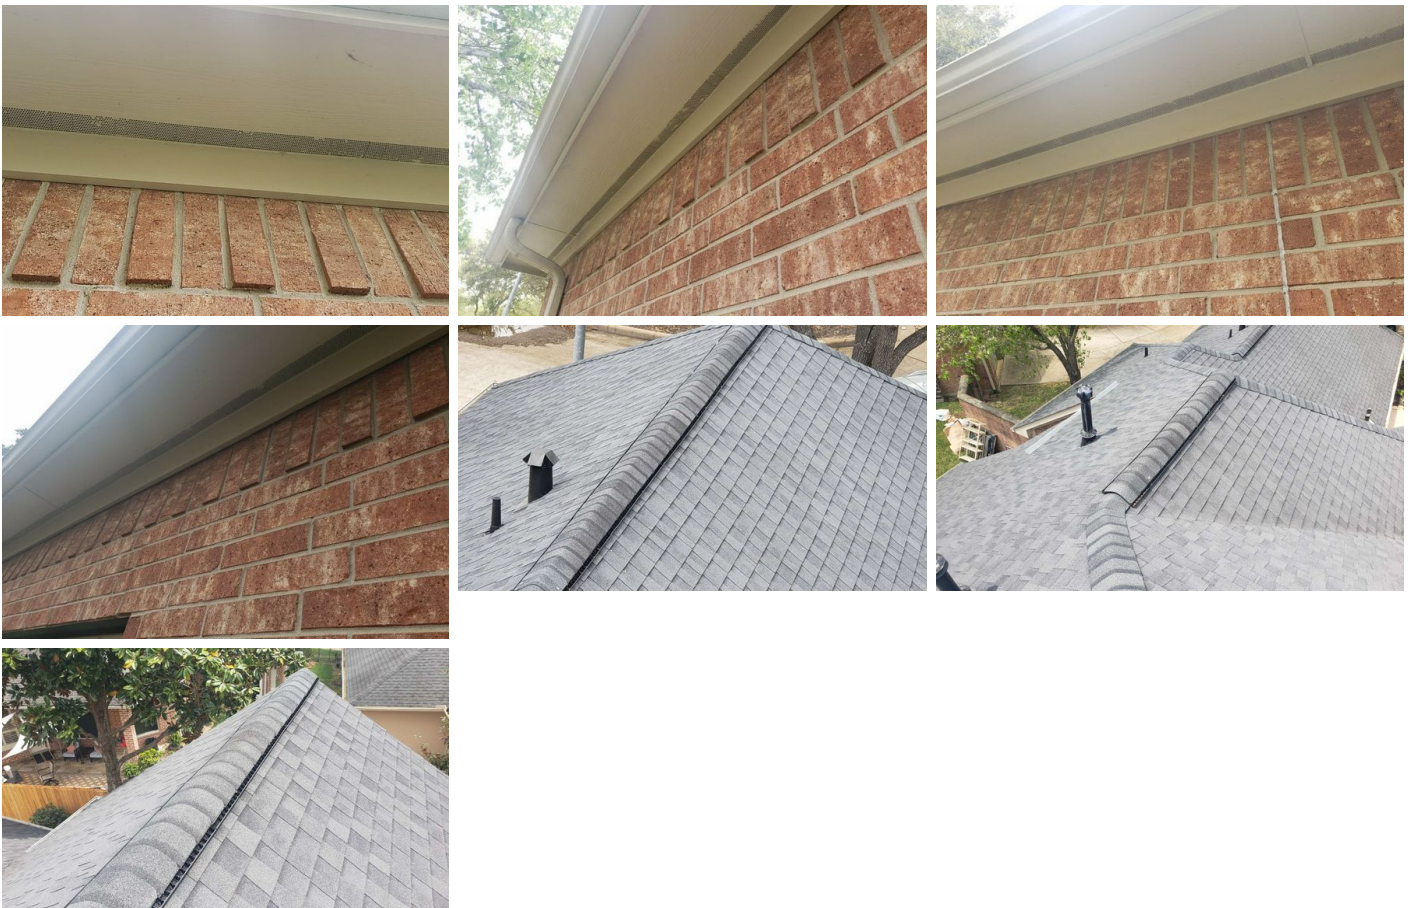
Wear and Deterioration: Composition - Some

Discolored

The composition roof surface was showing evidences of some deterioration of the roof surface as described above and shown below.

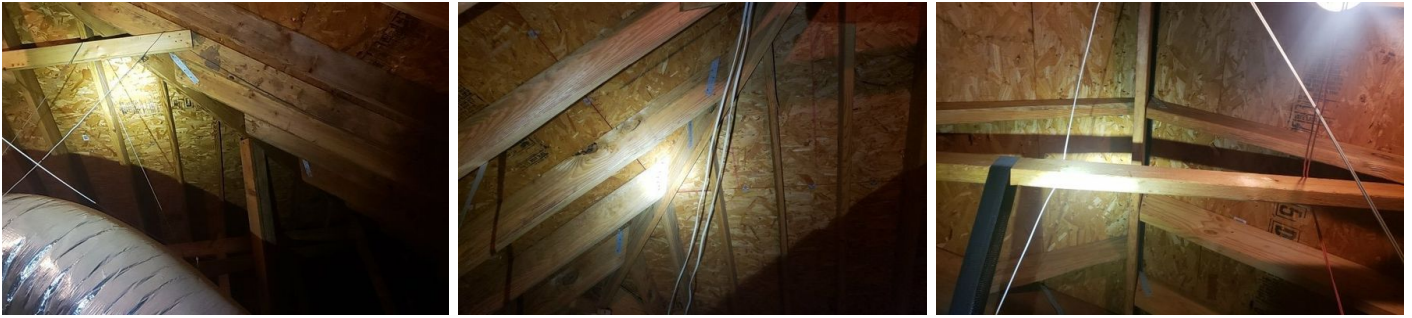
Hurricane Clips/Straps: Hip

Wind uplift or hurricane clips and/or straps were observed to be installed at hip rafters. This provides a stronger structure and will be more resistant to wind uplift from hurricane and tornadoes.

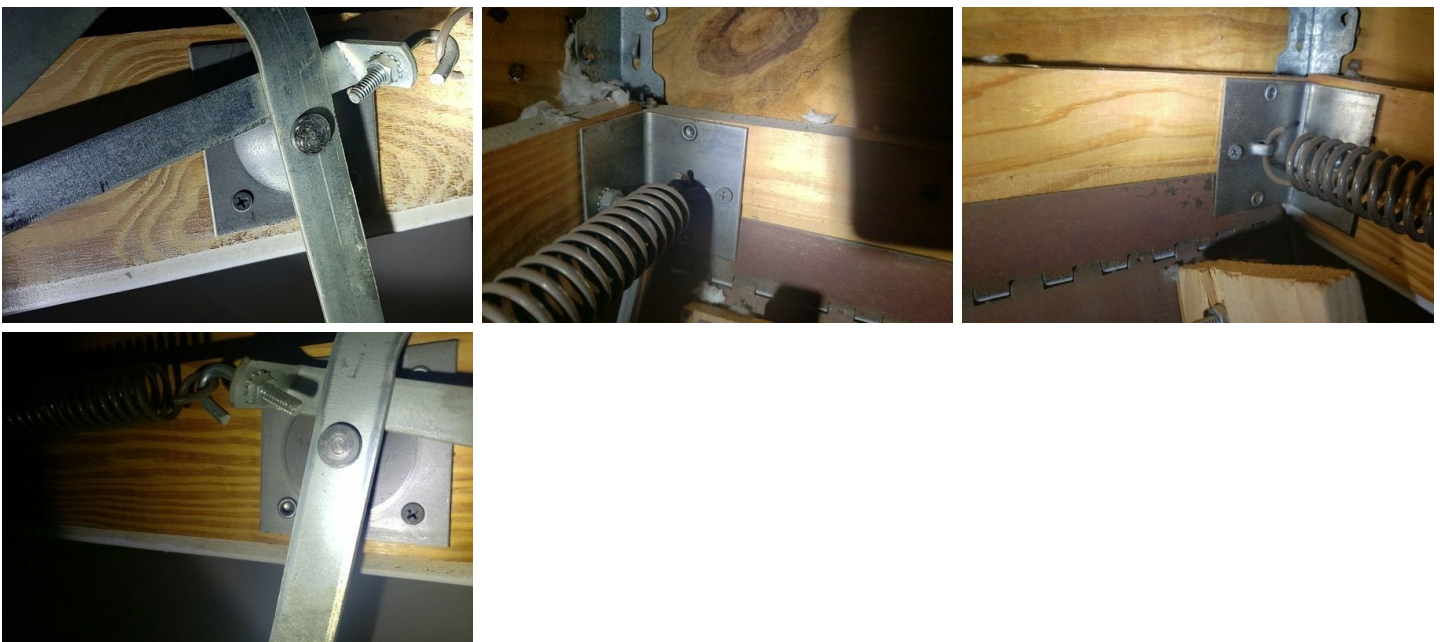
LADDER ATTACHMENT IMPROPER

The stair assembly was not properly installed or secured to the framing members, and repair is needed for safety purposes. The condition(s) can be a safety hazard, and repair is needed, as an improperly installed stair assembly can possibly collapse.

Obtain Cost Estimate

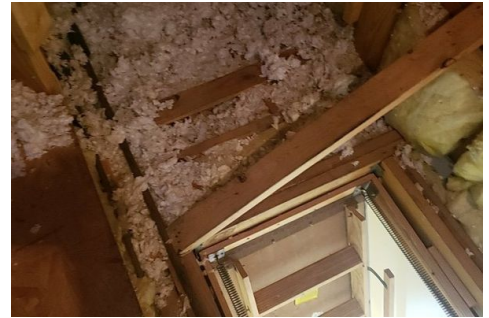
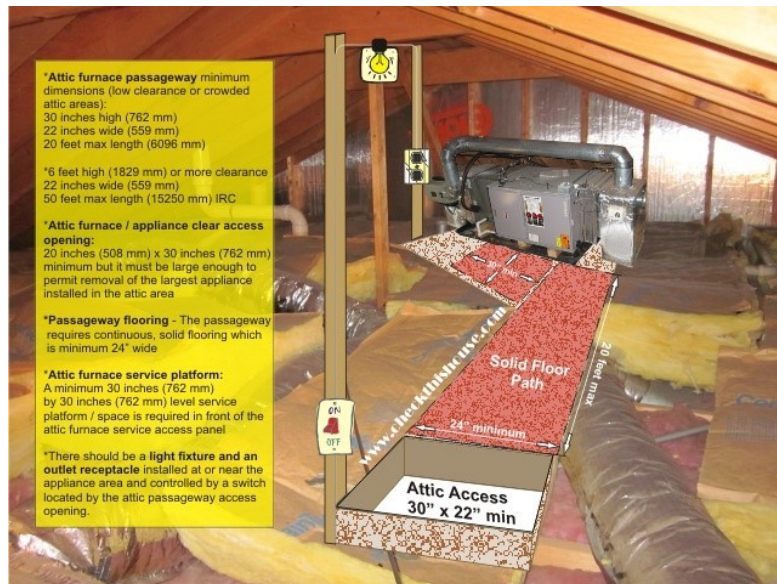
9.2.1 Service decking/platform decking

INADEQUATE WALKWAY DECKING

M1305.1.3

Obtain Cost Estimate

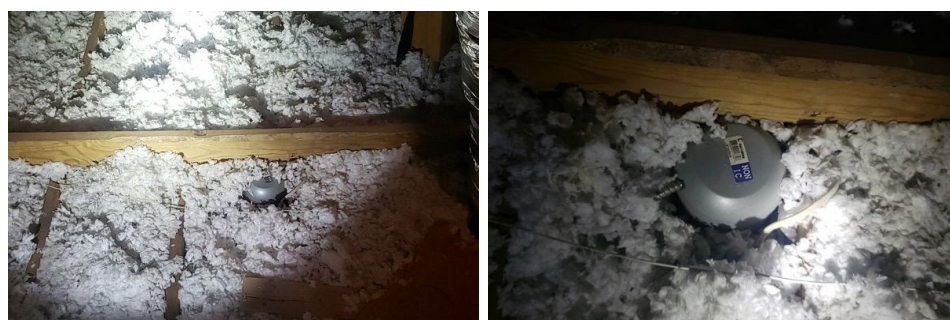
9.4.1 Insulation

CONTACT WITH RECESSED LIGHTS - LABELED AS NON-IC

The insulation was in contact with the recessed lights, which can be a fire hazard and shorten the life of the light bulbs. The recessed cans were specifically labeled as "Non-IC", which indicates that the recessed can cannot be in contact with the insulation. It is recommended that the insulation be pulled back to provide a three inch air space around the recess lights.

Obtain Cost Estimate

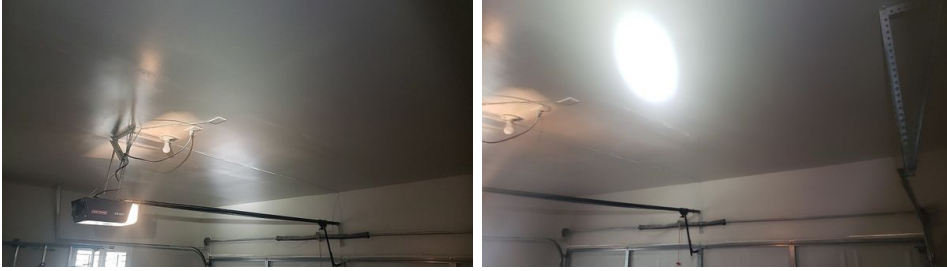
GARAGE

Patches in the sheetrock were seen. The cause of the patching could not be determined at the time of the inspection, and further investigation into the cause of the patch with the homeowner is recommended.
