MECHANICAL INSPECTION

1119 Walden Hill Ct
Houston, TX 77077

PROPERTY INSPECTION REPORT FORM

Marley Vansanten <i>Name of Client</i>	04/11/2022 12:30 pm <i>Date of Inspection</i>
1119 Walden Hill Ct, Houston, TX 77077 <i>Address of Inspected Property</i>	
Daniel Koteles <i>Name of Inspector</i>	TREC #21157 <i>TREC License #</i>
<i>Name of Sponsor (if applicable)</i>	<i>TREC License #</i>

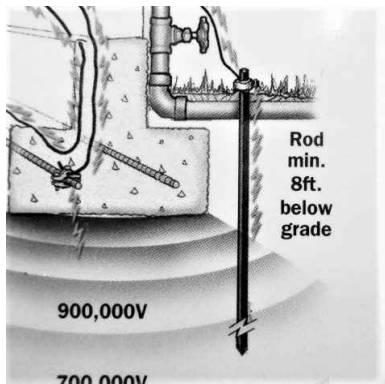
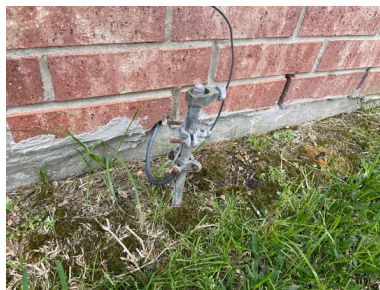
The ground rod was sticking out of the ground a few inches, and, since ground rods are typically 8 feet long and all 8 feet of the rod are required to be in the ground, it is recommended that the ground rod be pounded down flush with the top of the ground. The clamp on the rod should be an acorn clamp is approved for direct burial in the ground.

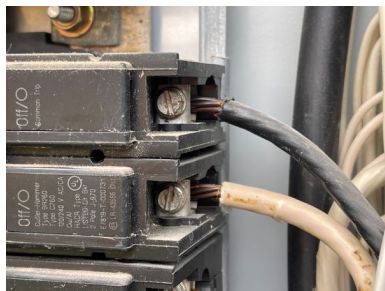
4: Wiring Discolored

The wiring was discolored which can indicate overheating or some other issue. Have a service company determine the source of the problem and make any necessary repairs.

Recommendation: Contact a qualified professional.

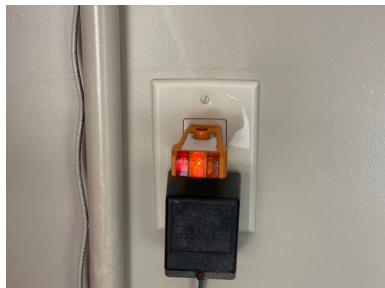
An outlet in which the hot and neutral (black and white) wires were reversed, causing reversed polarity.

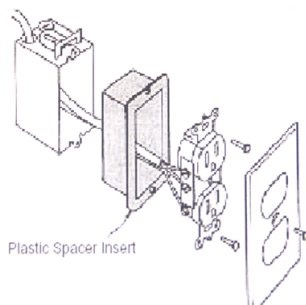
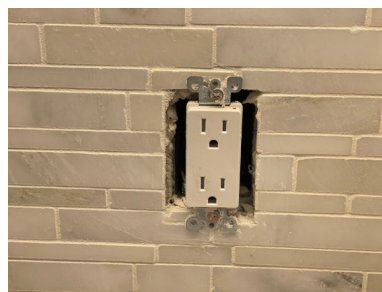
3: Outlets - Box extenders missing at backsplash

We observed outlets located in countertop backsplashes that were not protected by extender boxes. This is considered to be a fire hazard, and it is recommended that the extender boxes be installed.

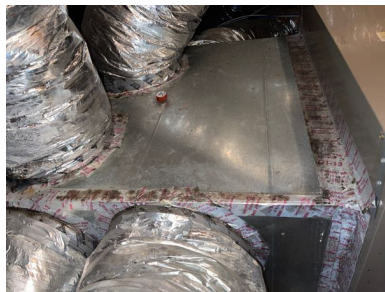
Microbial growth was observed on the outside of the air handler and/or evaporator coil casing. This condition can be indicative of a moisture/condensation problem, possibly due to air leaks at the equipment and/or a lack of adequate attic ventilation, or possibly some other problem. Further investigation is recommended with a service company to determine the cause of the microbial growth and to determine if the growth is present inside the equipment and/or air ducts. It is recommended that you obtain a cost estimate for any needed repairs.

Recommendation: Contact a qualified professional.

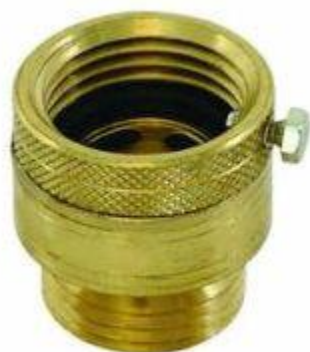
1: Vacuum Breaker - Missing

The atmospheric vacuum breaker devices were missing at one or more of the hose bibbs, and it is recommended that they be installed to prevent cross connections, which can allow contaminated water to enter the potable water supply.

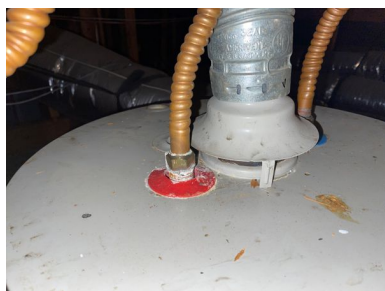
1: Fittings - Corroded

The piping at the top of the water heater was severely corroded at the fittings and is in need of repair.

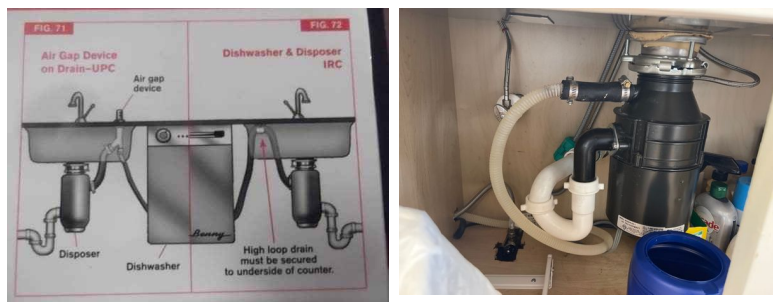
The drain line under the sink was not equipped with an anti-siphon device, nor was it looped up so that the top of the loop is at least six inches above the entrance of the drain line into the disposal. It is recommended at least that the drain line be looped to prevent the water from the garbage disposal from siphoning back into the dishwasher, or an anti-siphon device installed.

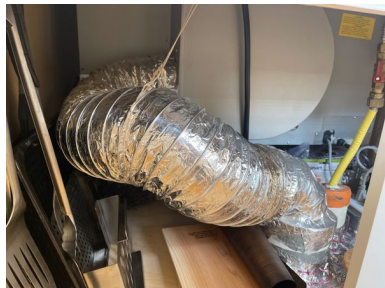
1: Flexible vent pipe - Replace

One or more sections of the vent pipe for the equipment was a flexible vent material, rather than rigid sheet metal vent pipe. An approved sheet metal vent pipe is required. Flexible vents can allow a buildup of grease in the joints of the flex duct, which is a known fire hazard.
