Wood Destroying Insect Report

Inspection Performed by Juan Mireles TPCL #838092 4/11/2022

1119 Walden Hill Ct.

TEXAS OFFICIAL WOOD DESTROYING INSECT REPORT

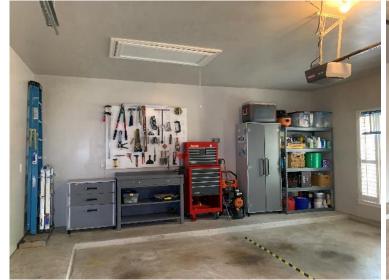
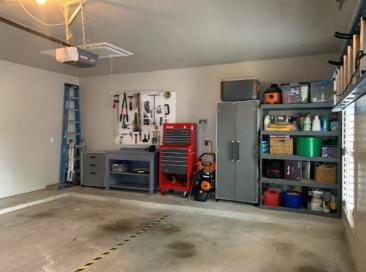
Items stored in garage obstructing view

Conducive conditions obstruct visibility and limit the inspection for wood destroying insects. It is recommended that all conducive conditions be corrected and the obstructed areas be reinspected once the work is complete.

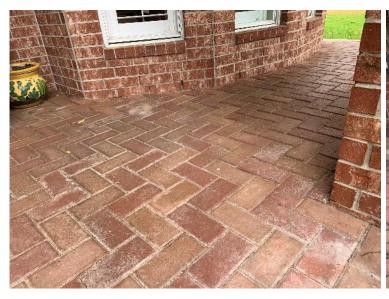
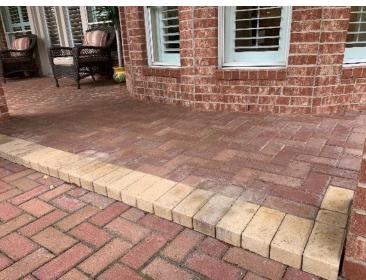
Tile/Pavers obstructing view of the foundation

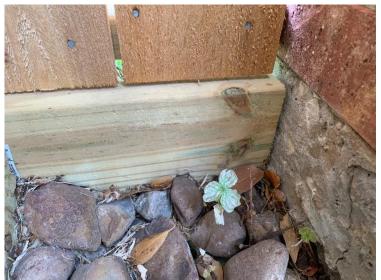
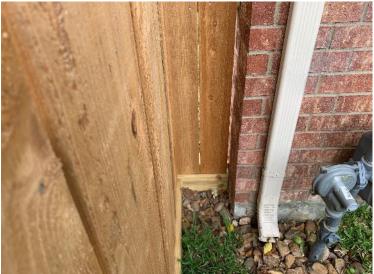
Wood fence in contact with the ground and structure

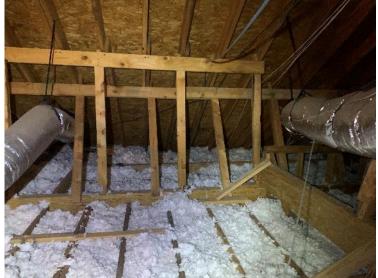
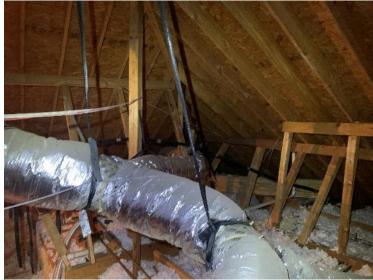
Pics of the attic
