Dukes Home Inspections Property Inspection Report

97 Bird Farm Rd, Huntsville, TX 77320 Inspection prepared for: Michael Hinks Real Estate Agent: Ryan Canada - Keller Williams Realty

> Date of Inspection: 5/25/2022 Time: 1:00 PM Age of Home: 2008 Size: 2390 Weather: Clear and 82 degrees Home faces west Home is furnished. Sellers present.

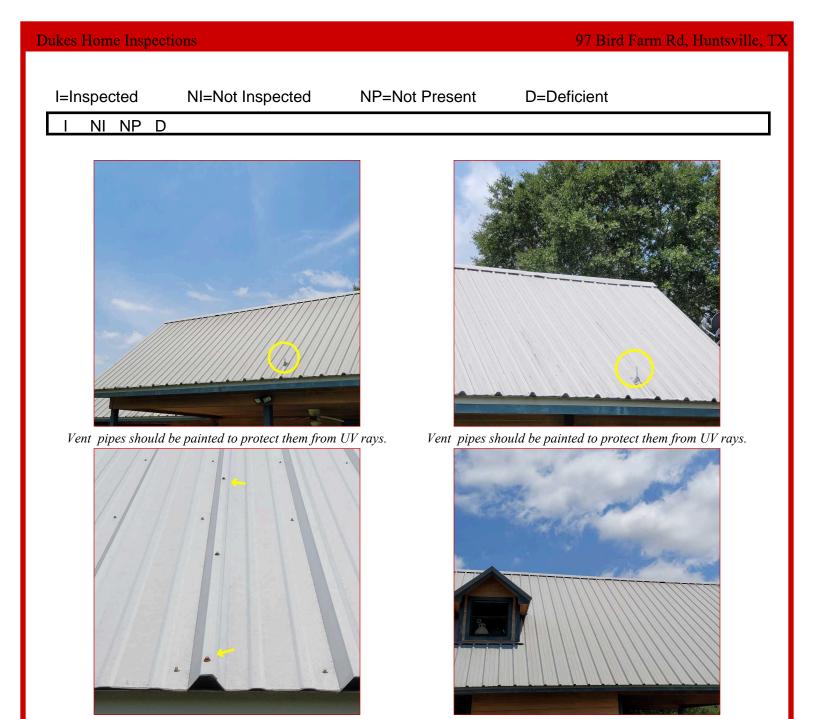
West side.

Screws are rusty in multiple locations.

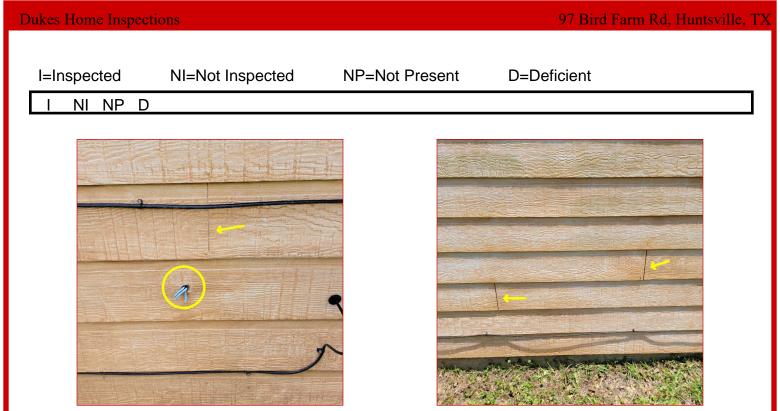
Caulking needed at one or more places around the home/building. Caulking needed at one or more places around the home/building. This is common maintenance. This is common maintenance.
