# HOUSTON INSPECTIONS

**January 27, 2021**

## PROPERTY INSPECTION REPORT

Concerning: 4815 Raven Bluff Ln, Katy, TX 77494  
(Address or Other Identification of Inspected Property)

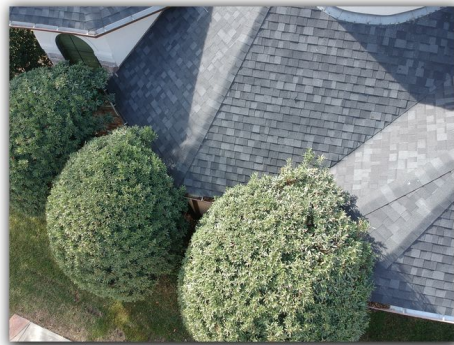
Tree limbs were noted in contact or within 3' of the roof covering. Ideally the tree limbs should be trimmed back away from the roof covering to prevent damage to the roof.

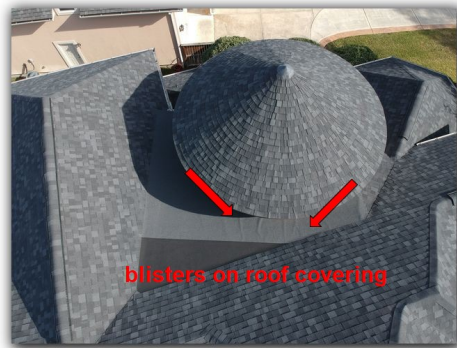
Blisters were noted at areas of the roof covering. Blisters form when there are pockets of air or moisture trapped between layers of your roof's membrane or between the membrane and the roof deck. As the sun heats the roof, those pockets expand and stretch the membrane. In severe cases, the membrane will actually crack when the pressure becomes too great. Even if the membrane doesn't crack, blisters are usually cyclical problem. That is, once they form, the membrane stretches permanently, which allows for even more air or moisture to infiltrate the membrane layers and cause even more expansion

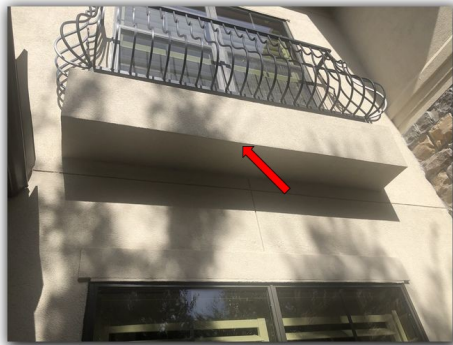
- Weepscreeds / drainage openings missing at the stucco walls - This could lead to the build up of moisture / water in the wall cavities and create future problems.

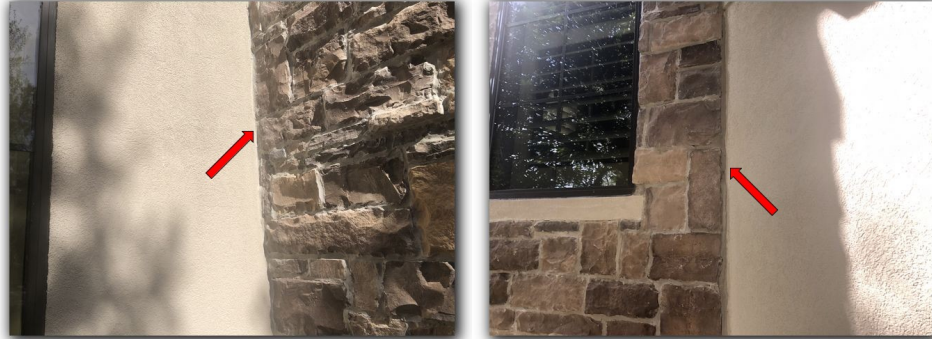
The transition between the dissimilar material has not been installed properly (mortar installed versus backer rod and sealant). These area will be vulnerable for future cracking and separation.

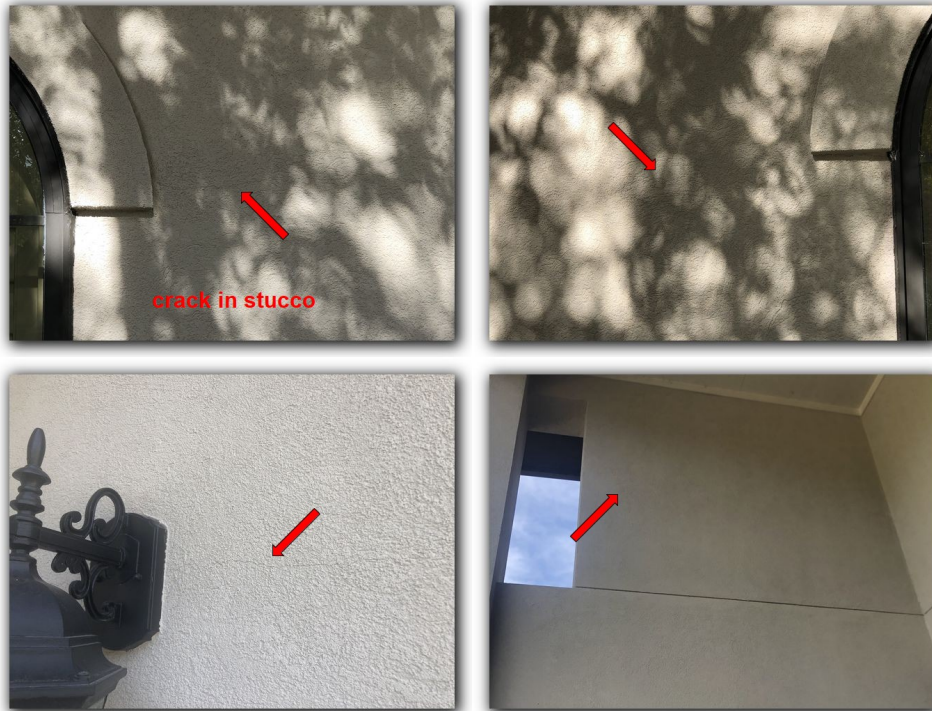
Cracks were found at several areas of the stucco walls. Recommend repairs.

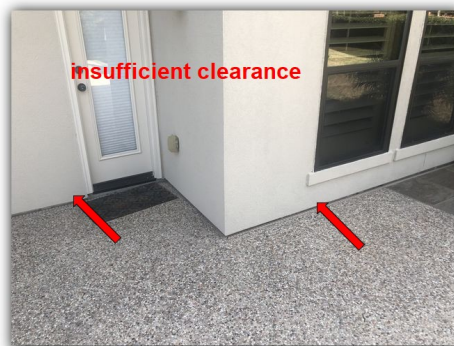
The clearance between the stucco veneers and the flatwork / grade is improper at the rear flatwork. Recommend improvement to reduce the likelihood of underlying decay.

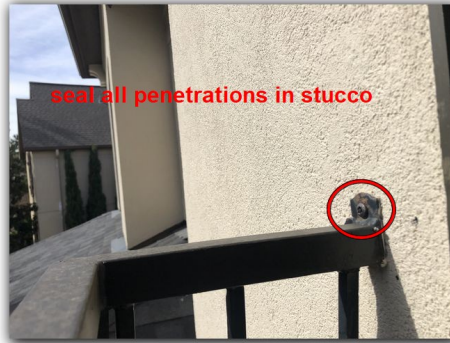
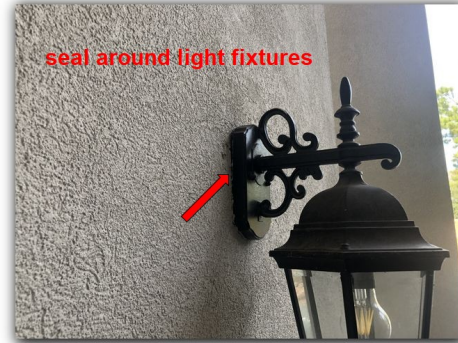
All penetrations into a stucco wall should be sealed and maintained regularly.

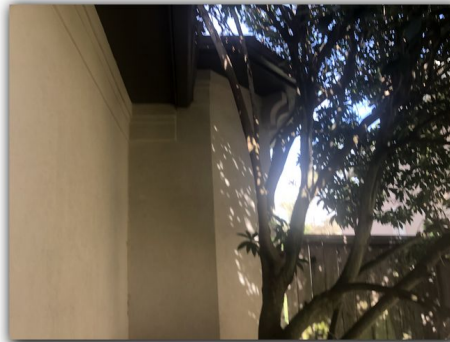
Tree limbs were noted in contact with the exterior walls. The tree limbs should be trimmed away from the walls to prevent future damage.

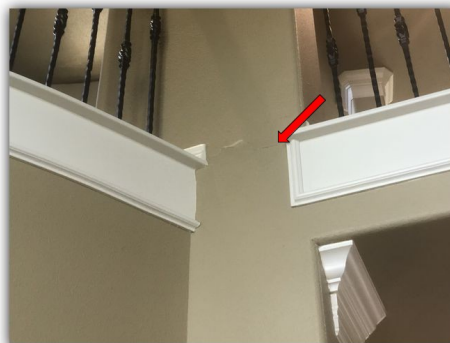
Cracks were found on the interior of the property as evident of settlement.

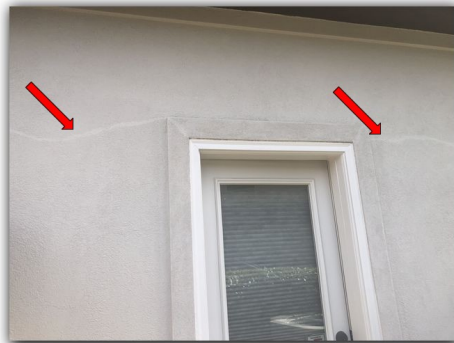
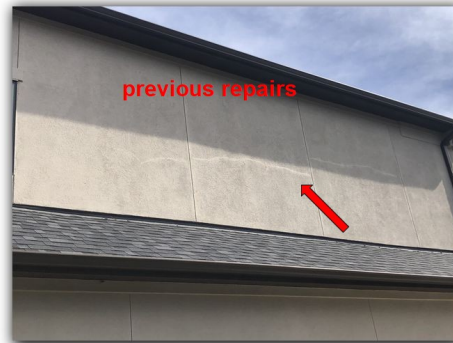
Evidence of previous repairs were found on the exterior of the structure as evident by patching and other signs.

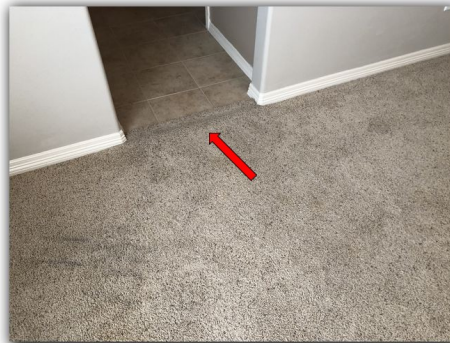
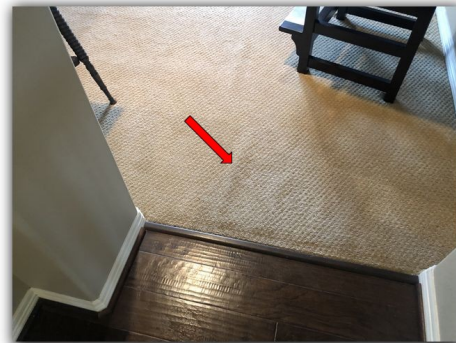
Sections of the carpet are in need of stretching as evident by loose and un-even sections.

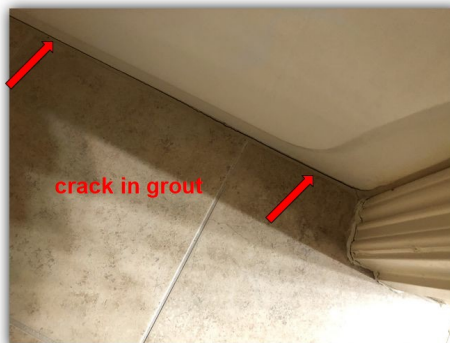
Damaged and missing grout was found at the floor tiles in the upstairs left guest bathroom.

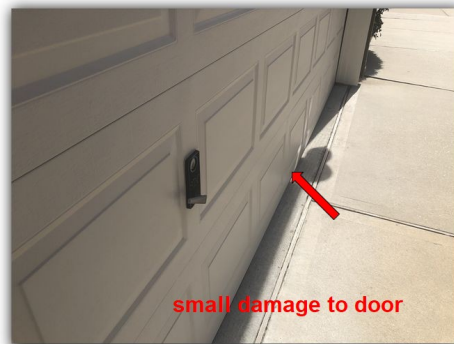
Damage was found at the garage door panels. Recommend repairs.

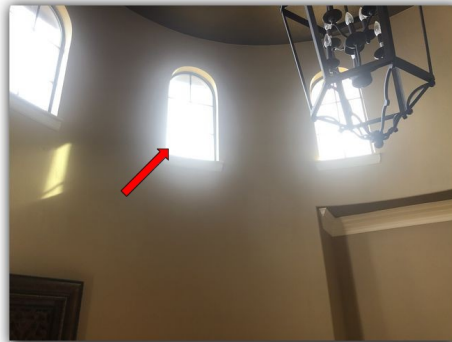
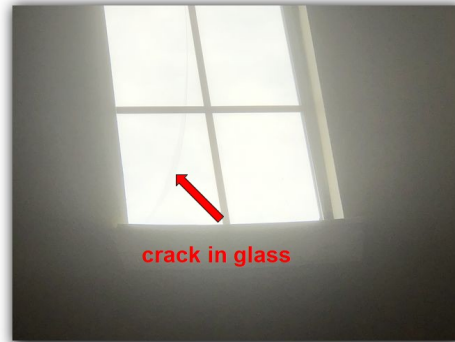
Cracked glass was found in the stairway rotunda.

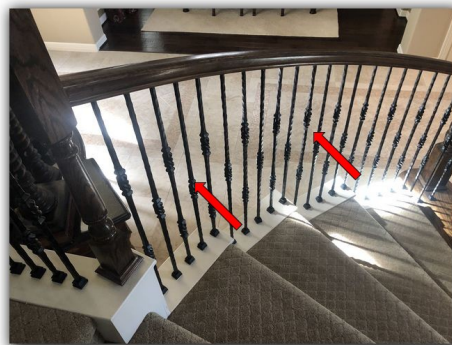
Loose balusters were noted at lower section of the interior stairs. Secure as needed.

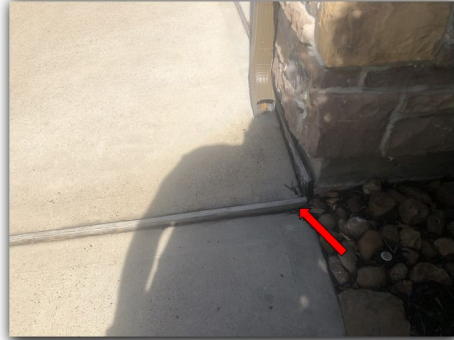
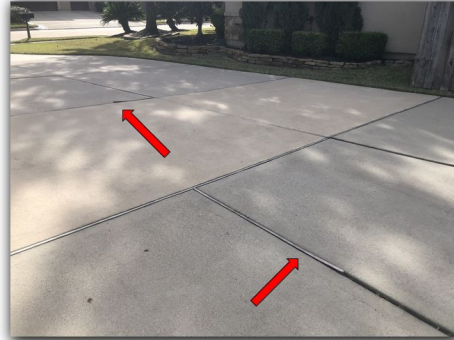
Loose and missing wood form boards were found at the driveway.

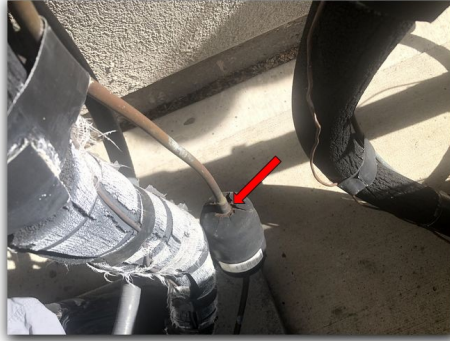
The refrigerant line dryer(s) at the exterior portion of the air conditioning system(s) is rusted. These components should be inspected annually, cleaned and repainted to prevent leaks and other problems from developing.

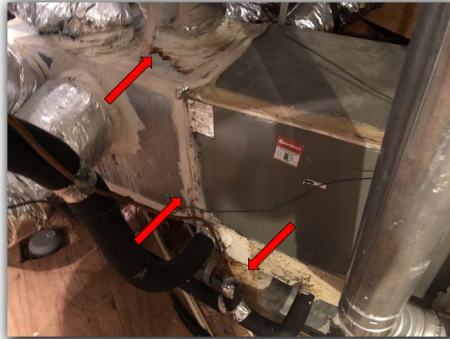
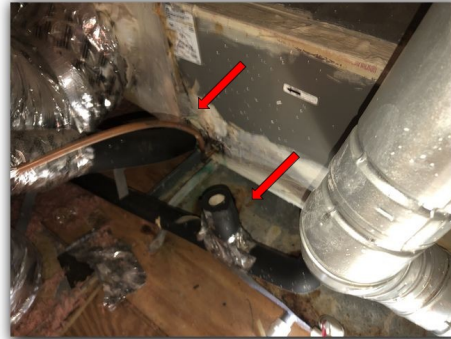
Evidence of past condensation was found on the exterior of the evaporator coil housing(s) of Unit 1 & 3 in the attic. This has led to moisture related problems, i.e. mildew, rust & corrosion, etc. Recommend further evaluation by a licensed HVAC contractor to determine the needed repairs to correct this problem.

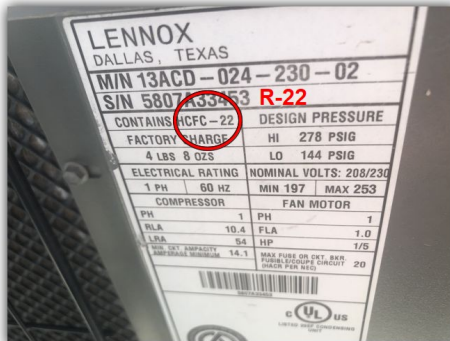
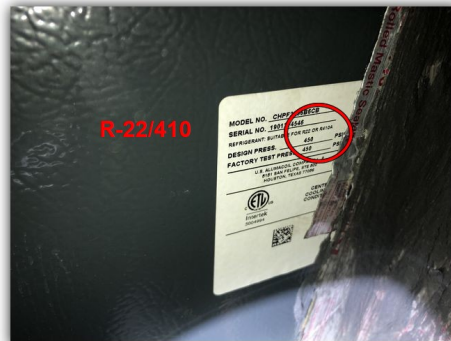
During the inspection of the exterior and interior units of unit 2, labels were found that indicate that refrigerant gases could have been mixed, i.e. R-22 and R-410a. This is typically not allowed and can lead to future problems. We recommend that a licensed HVAC contractor to further evaluate the system to determine if gases have been mixed and if repairs are needed.

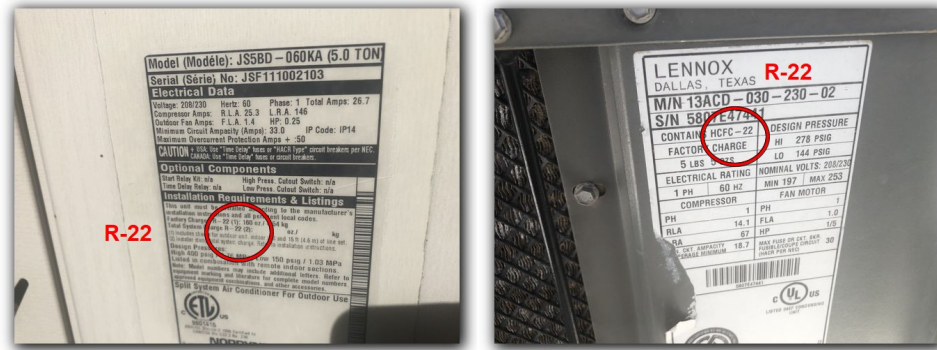
During the inspection of the cooling equipment labeling was found that indicates the system has been charged with R22. As of January 1, 2020 R22 is no longer manufactured, installed (new systems), or imported in the US. This will create financial obstacles when servicing this unit and will eventually create a situation where the system cannot be re-charged or repaired. The client is urged to take this into consideration and discuss this situation in more detail with a licensed HVAC contractor.

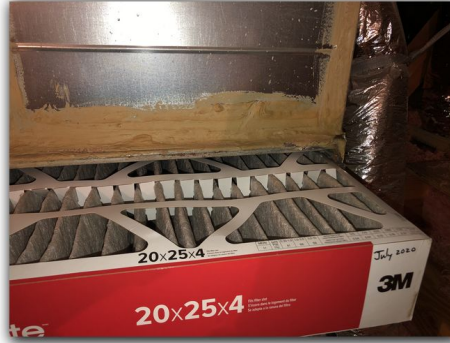
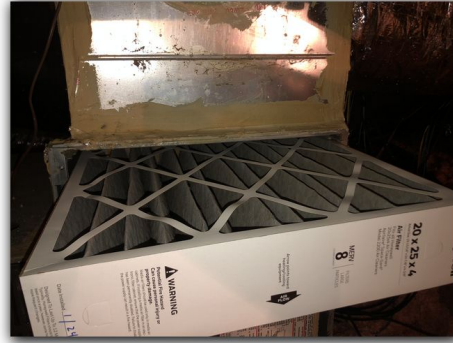
The return air filter(s) are dirty and need(s) to be changed.

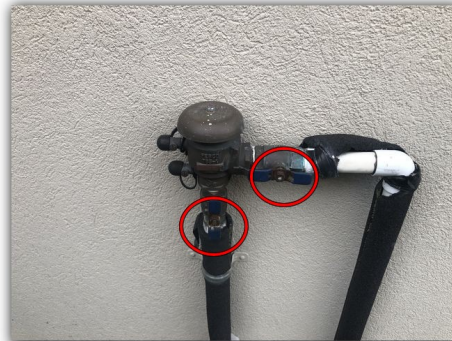
Rust and corrosion were found at the valve handles installed at the backflow prevention device. The valve handles should be repaired as the rust will eventually cause the handles to become inoperative.

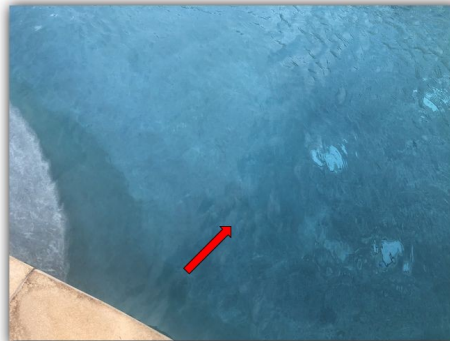
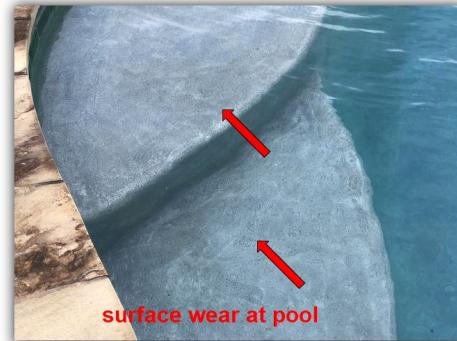
The plaster surface is showing signs of normal wear consistent with the aging of the pool. Recommend further evaluation of the surface by a qualified tradesman as needed.

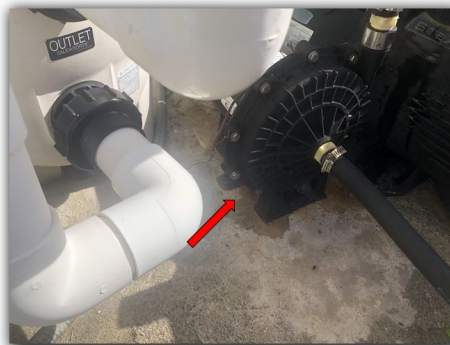
Leaks were found at the casing/flange of the polaris motor of the pool system. Repair by a qualified tradesman is recommended.

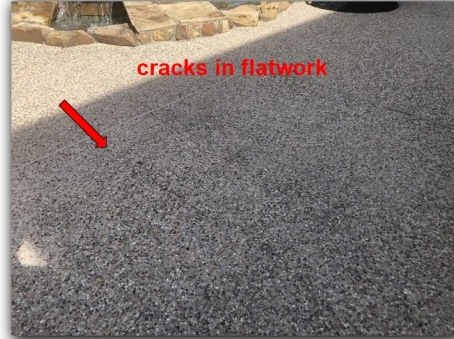
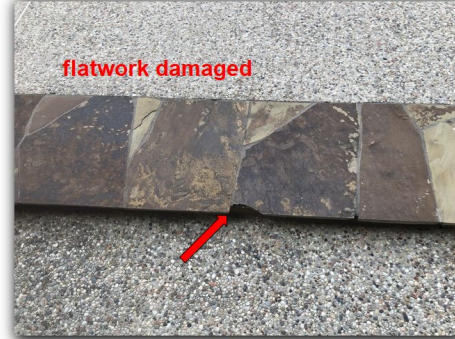
Small cracks/damage were noted at the flatwork of the pool surround possibly due to settlement of the pool. Recommend repairs as needed.

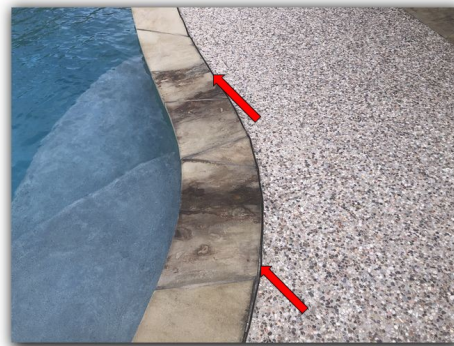
Damaged and missing sealant was found at several areas between the pool coping and decking. All damaged and missing sealant should be repaired/replaced to prevent the leakage of water into these voids.

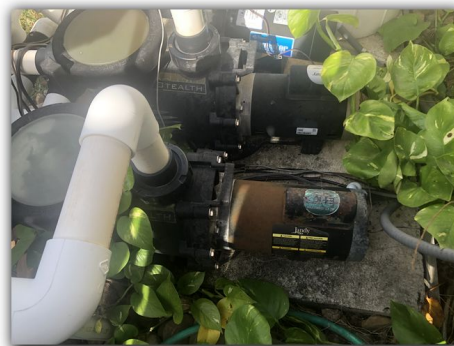
Rust and corrosion was noted at the exterior housings of the pumps and motors.

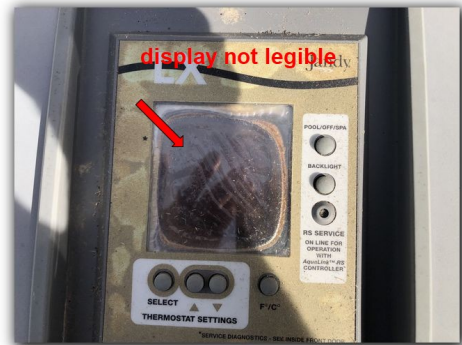
At the time of the visual inspection, the pool / spa heater was performing its intended function. However, the heater appears to be older as evident by condition of covering, rust on unit, faded display, etc. The heater could be approaching the end of its useful life. The client should budget for repairs / replacement in the future.
